Ocean Exploration and Research

FY17 FFO Projects

1. Grant Number (if applicable): NA17OAR0110214
2. Amount of funding from OER: \$89,969
3. Project Title: Peleliu's Forgotten WWII Battlefields
4. Area of Operation (include a map and/or coordinates):
Peleliu, Republic of Palau, Caroline Islands. WWII invasion beaches: White 1, 2 and Orange 1, 2, 3 (Appendix 1)

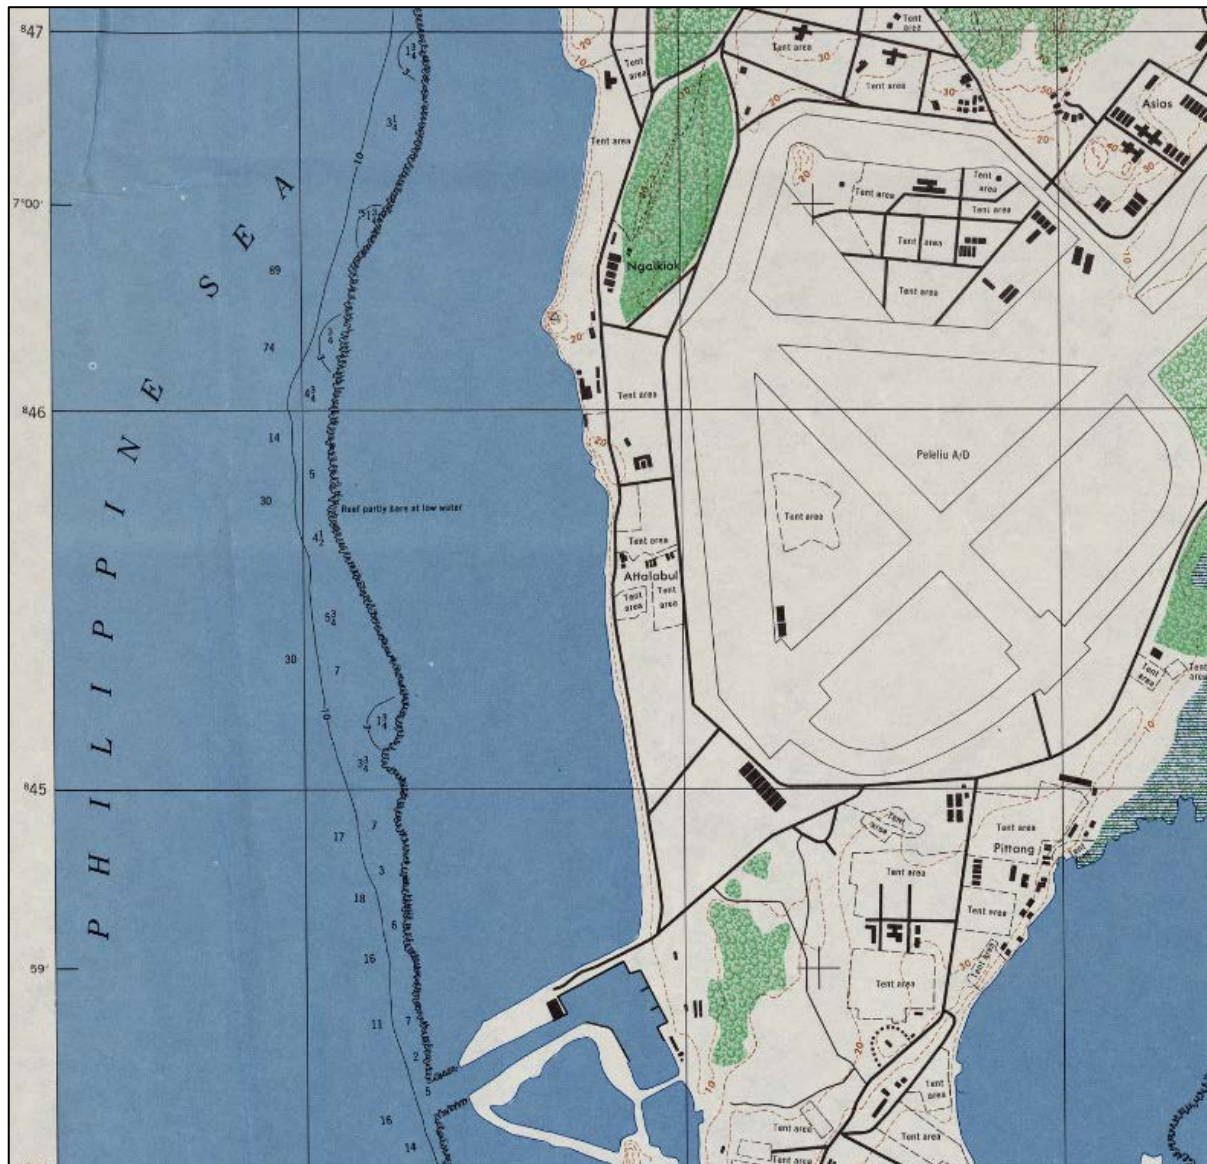
Figure 102. Detail from 1946 map of Peleliu titled “Ngarmoked NW-D, Palau Islands.” Note southern harbor and tent areas on the White and Orange beaches. U.S. Army Map Service, 1946.

The heaviest area of landscape modification occurred at the southern end of Orange 3. Following establishment of the Peleliu Naval Base, the U.S. Navy Seabees filled the reef to create an artificial harbor for small craft (Figure 102). Nevertheless, WWII cultural materials are still visible in the construction of the marina; part of the fill for land reclamation includes the pontoon barges from the 1944 Orange beach LST ramp. Moreover, post-battle cleanup is exhibited nearby; the extensive remains of an U.S. aircraft graveyard are present on the southern side of the marina. The aircraft, likely deposited at the harbor after the war for shipment, never managed to leave the island. Post-war, aluminum and iron scrap drives were common throughout the Pacific. Similar scrap middens from salvaged WWII sites have been encountered throughout the Marianas, Marshall, and Caroline Islands (Spennemann 1998).
