Working Paper 78-1

# DETERIORATION OF ASBESTOS CEMENT SHEET MATERIAL IN THE MARINE ENVIRONMENT

UNC Sea Grant College  
Working Paper 78-1

December, 1978

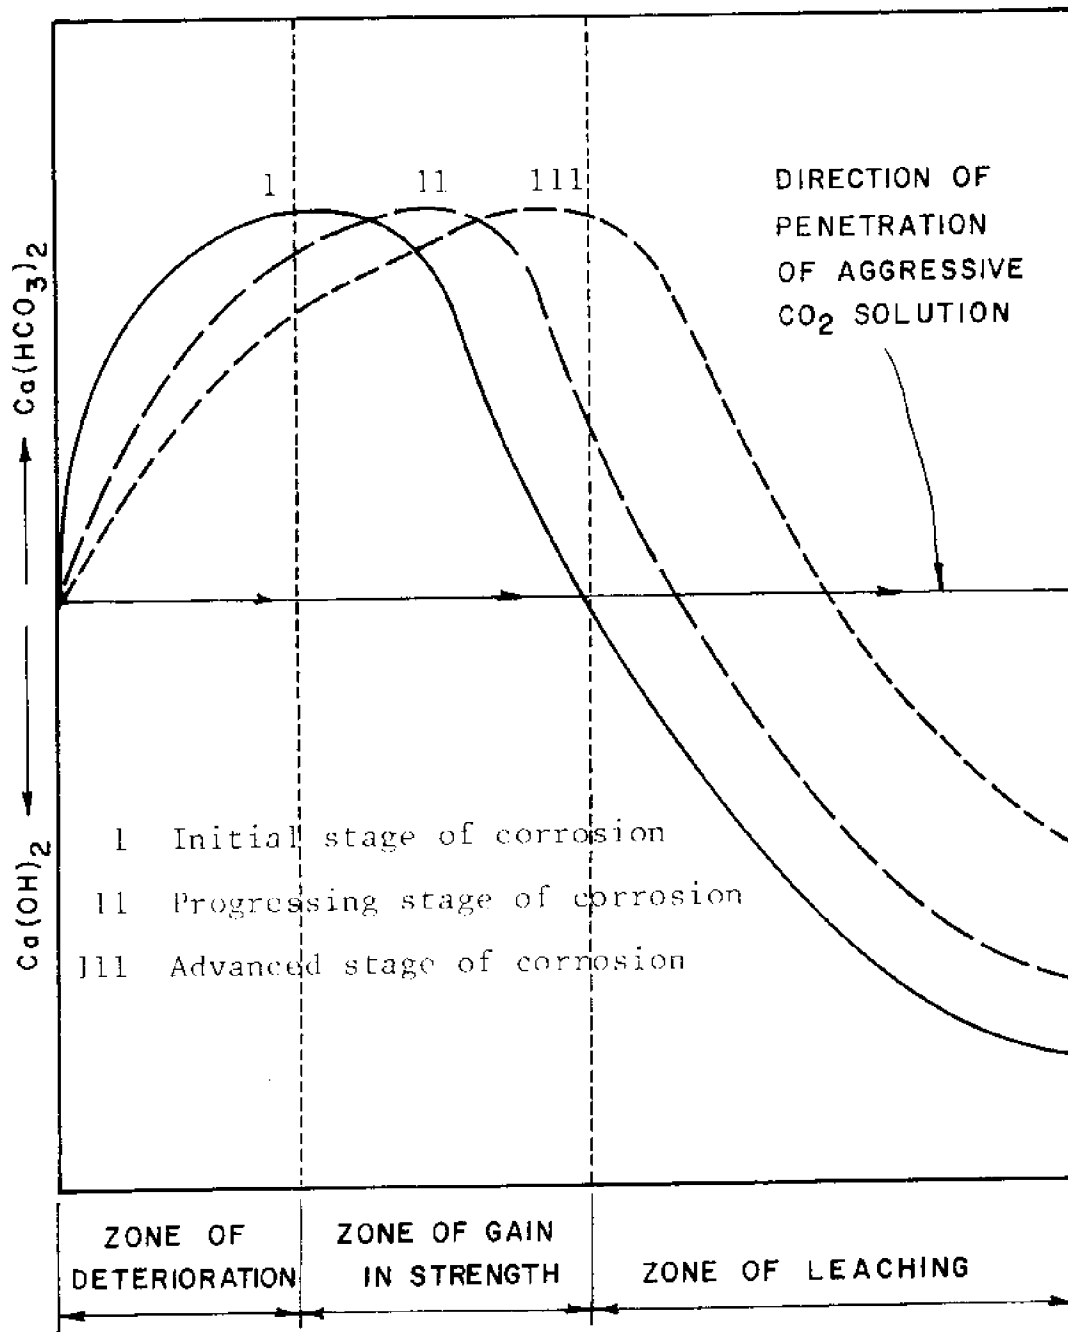
Figure 1. Stages of Corrosion Due to Carbonic Acid Attack. (After Biczok, p. 285 (1967)).

Carbonic acid corrosion takes place in cement through percolation. Successive stages of this corrosion, schematically represented in Figure 1, are reported by Biczok (1967). There are three mechanisms by which carbonic acid alters the makeup of cement as the water seeps through the structure. They are represented in Figure 1 as zones of (a) deterioration, (b) strength gain, and (c) leaching.

The deterioration zone is characterized by the formation of  $\text{Ca}(\text{HCO}_3)_2$  through the reaction between  $\text{H}_2\text{CO}_3$  and  $\text{CaCO}_3$ . Most cement products form an outer layer of  $\text{CaCO}_3$  by exposure to the atmospheric  $\text{CO}_2$  prior to structural application. If the structure is located in an environment containing aggressive  $\text{CO}_2$ , all of the  $\text{Ca}(\text{OH})_2$  is depleted from the surface layer, leaving the cement open to attack by  $\text{CaCO}_3$  dissolving in the form of  $\text{Ca}(\text{HCO}_3)_2$ .

The bicarbonate-saturated water penetrates the structure, and uncarbonated water is therefore vulnerable to the aggressive  $\text{CO}_2$  as well as the  $\text{Ca}(\text{HCO}_3)_2$  in solution. The effect is initially beneficial, since  $\text{CaCO}_3$ , which is poorly soluble, is precipitated by both reactions. The dense nature of  $\text{CaCO}_3$  leads to a strengthening of the material, hence the name of the second zone of cement transformation.

After enough  $\text{Ca}(\text{OH})_2$  has reacted with the percolating water to deplete the solution of its aggressive  $\text{CO}_2$ , removal of the other cementing constituents takes place through the physical movement of the water. This leaching zone leads to a seepage flow which is evidence of how far advanced the deterioration of the cement is. If bicarbonate is found in the flow, the cement is highly corroded, and deterioration can be expected to increase.

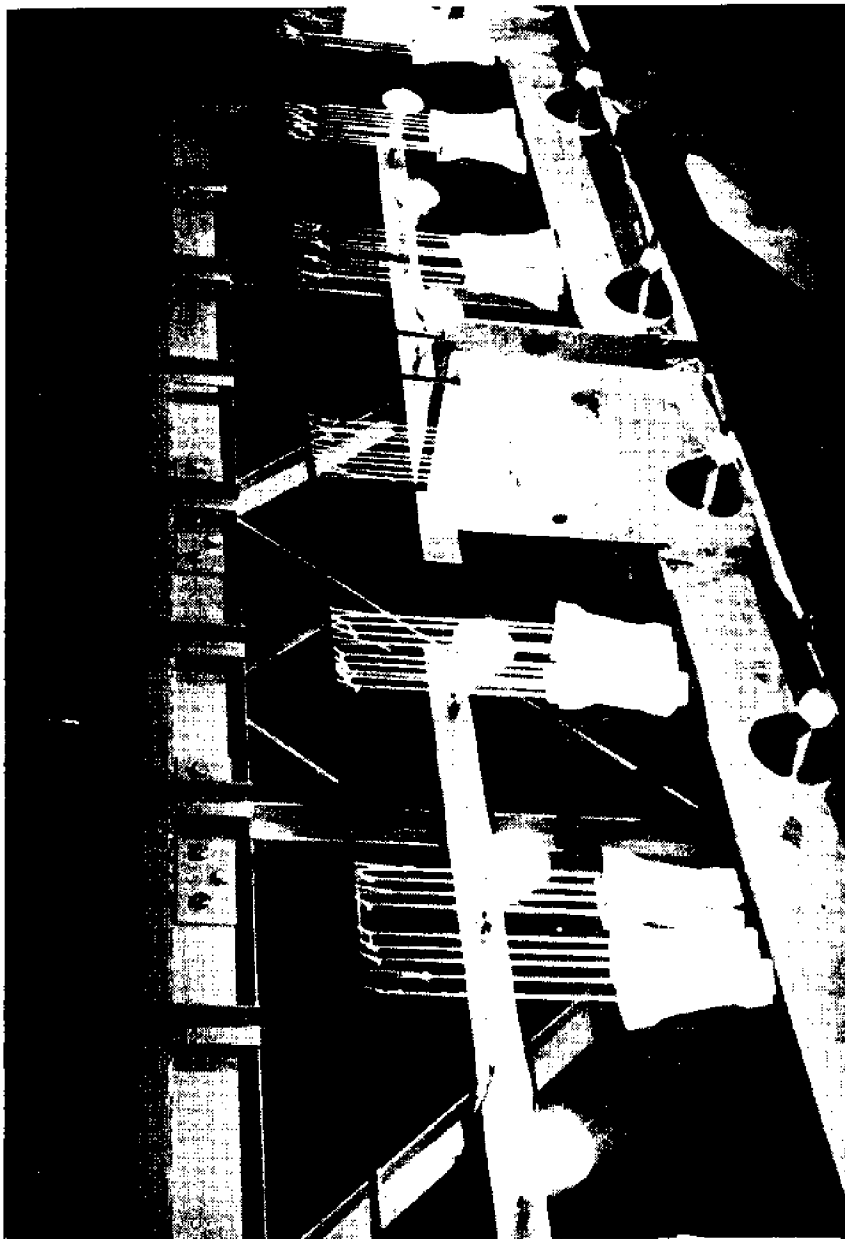
Figure 4. Wetting/Drying Apparatus at Beginning of Test Program.

(Note: Drying Cycle).

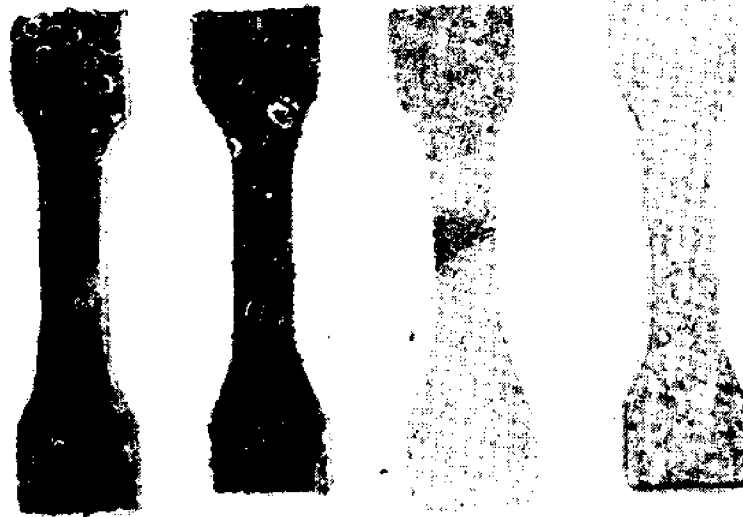
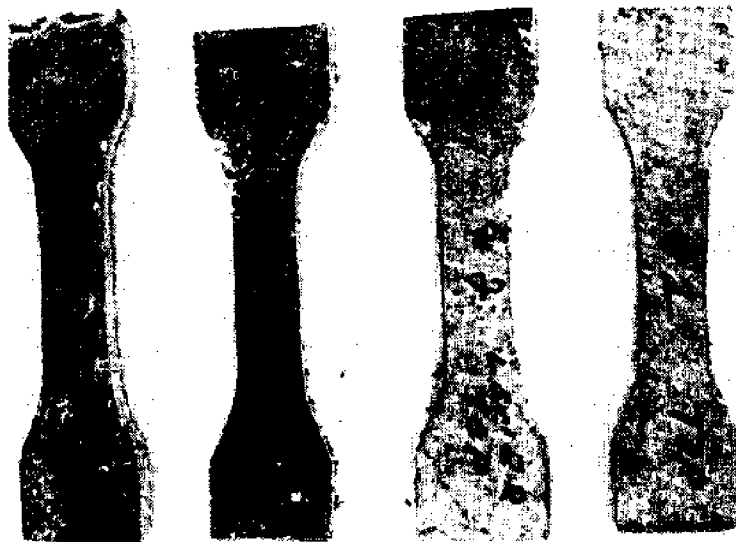
Figure 11. Specimens Cut from Field Asbestos Cement Sample.

failure. This approximately 8-year-old bulkhead had been cured through the normal process. Its initial components consisted of chrysotile and Type II Portland cement with no additives. The bottom half of the sample had been in place below the low water level and had evidence of considerable biological growth on the forward face (see Figure 11). Just above this region was an area that had been subjected to a considerable splashing of the canal water and had a noticeable yellow stain on the surface facing the canal (see Figure 11). The top region of the sample was located approximately 90 cm (2.95 ft.) from the water surface and showed no signs of staining or biological growth (see Figure 11).

a) Face of Samples Exposed to the Canal.

b) Backside of Samples Exposed to Backfill.

The soft powdery surface was also evident in the field specimens. Again, however, distinction arose between specimens taken from above the water line and those from below the water line. Although there was some surface softening of asbestos cement above the water line, the material appeared very solid. Asbestos cement from below the water line, on the other hand, gave an appearance of extensive deterioration, having degenerated to a loosely packed, fibrous consistency. The face of the material exposed to the canal was covered with barnacles.
