Submarine Sand Recovery System

Keauhou Bay Field Test

September 1976

Sea Grant Technical Report
UNIH-SEAGRANT-TR-77-02

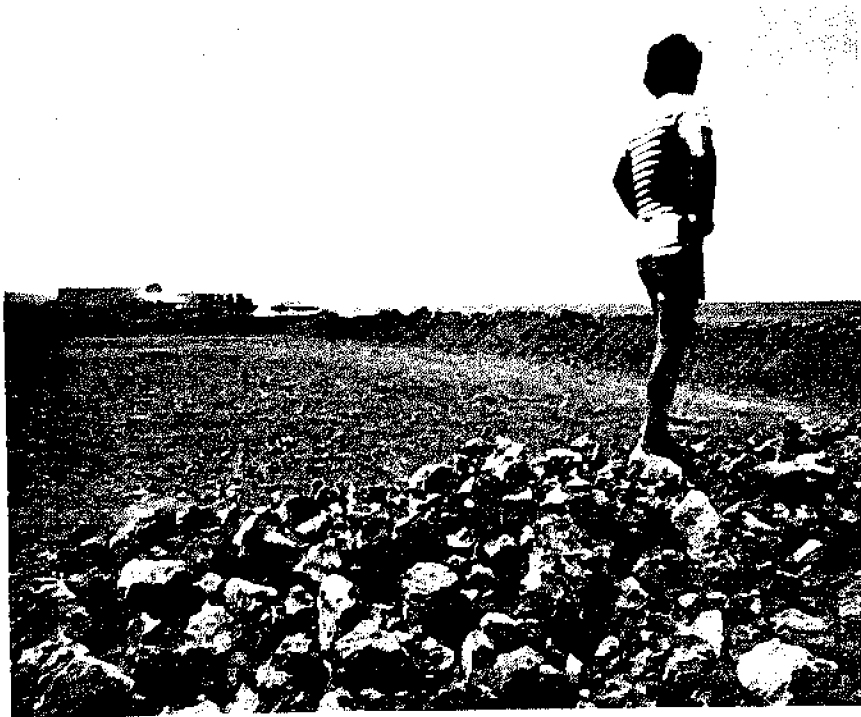
Figure 15. Deposition basin just after completion

A deposition basin 100 ft x 300 ft x 6 ft deep was designed to hold 6000 cu yd of sand. An adjoining settling pond 40 ft wide by 60 ft long by 4 ft deep connected by a weir to the discharge basin was designed with a safety factor of two to remove all suspended solids and allow only clear water to flow back to the sea.

The basins were created in a rough lava field; approximately two weeks were required to complete the work, which included the construction of a short access road, at a total cost of approximately \$5,000. Figure 15 shows the deposition basin just after completion.

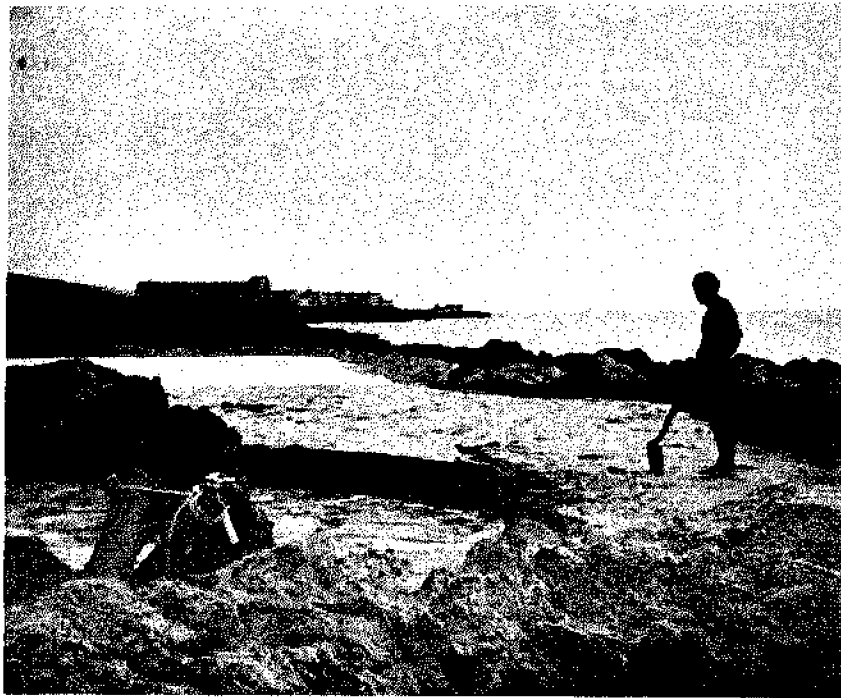
Figure 21. Sand discharging into basin

No precise means was available for measuring the percentage of solids in the flow--again, because of budgetary limitations. Every 15 minutes, a sample of the slurry was drawn off into a graduated cylinder near the discharge side of the pump. After the mixture settled, a reading was obtained. Since the flow near the pump was still turbulent and not stratified, it is believed these samples were valid. Good duplication was achieved. As a check, this was occasionally carried out at the end of the discharge pipe. The samples taken here varied considerably from the top to the bottom in the flow and could not be relied on unless an average was taken. Figure 21 shows the discharge when pumping a fairly high percentage of sand; the basin is nearly full.
