## Initial Effects of a Hurricane Storm Surge on Barrier Island Vegetation

Florida Sea Grant College Program

Technical Paper 81

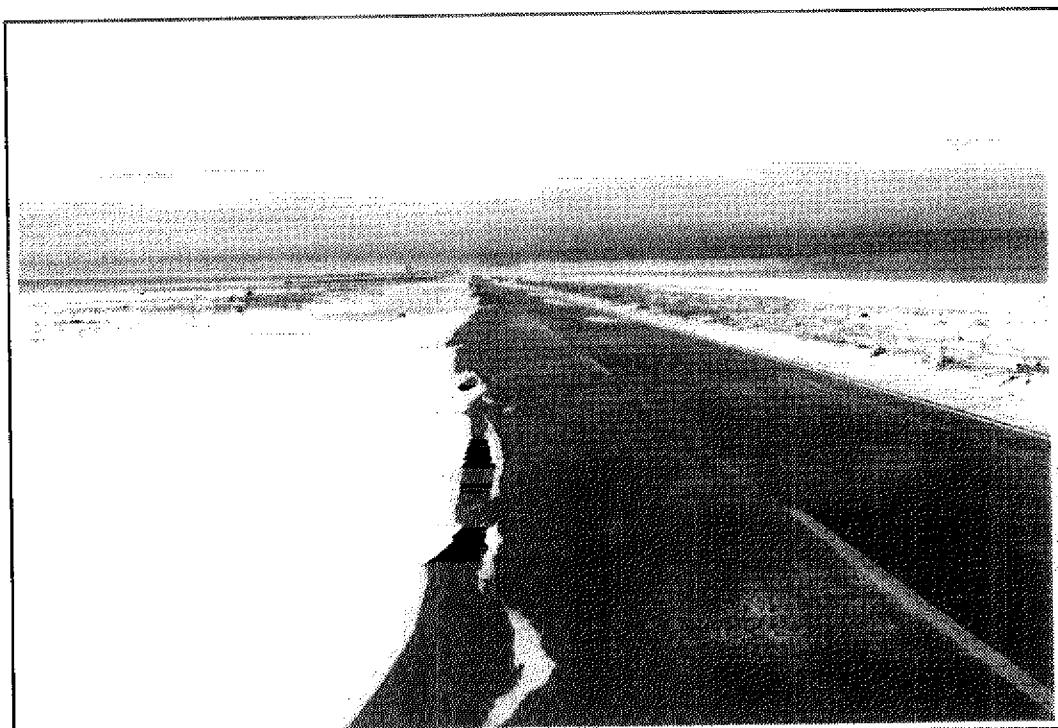
**Figure 1.** Ft. Pickens Road damaged by Hurricane Opal storm surge. October 1995.

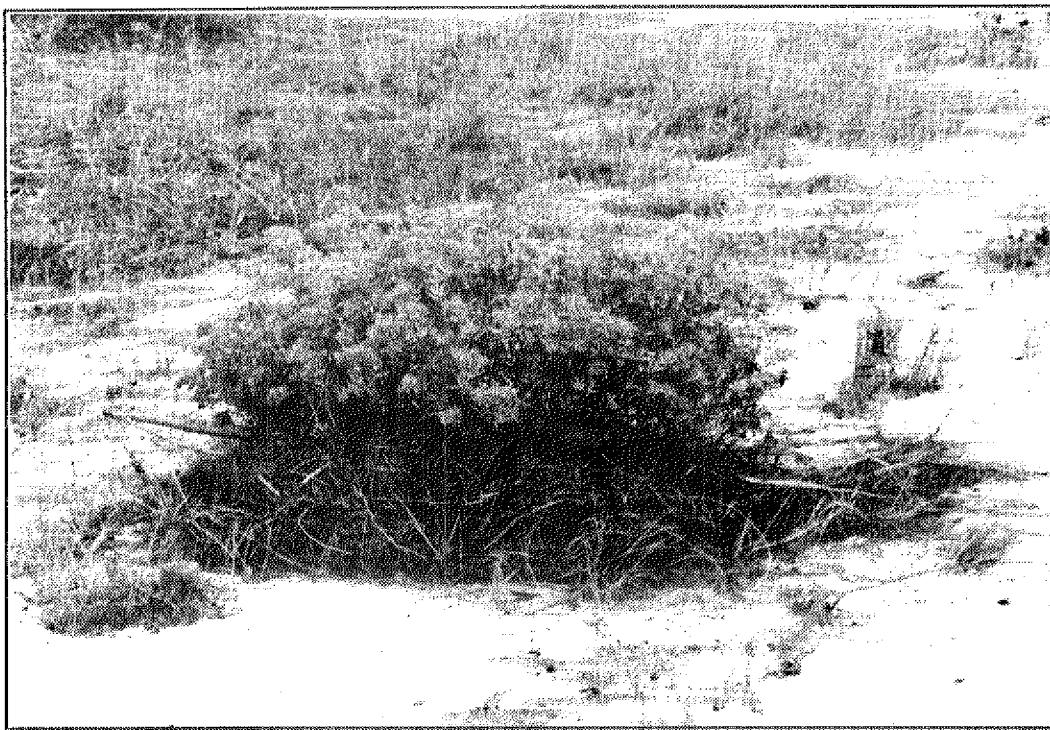
**Figure 3.** Uprooted sea oats plants piled up against a bush of *Solidago sempervirens* by flowing water.

On the western portion of the island, massive dunal erosion was limited to a narrow area along the Gulf or South side. At least one line of dunes was destroyed along this shore but the dune fields are still intact. Water, however, obviously flowed into the dune areas even where erosion did not occur, seeking paths through the swales where they could be found. In some swales, waterborne debris lines were as high as eight feet on the slopes of the dunes and, although there is no evidence of significant erosion within this dune field, vegetation that is sensitive to salt water that either touches the plant or covers the roots was affected (see Figure 3).

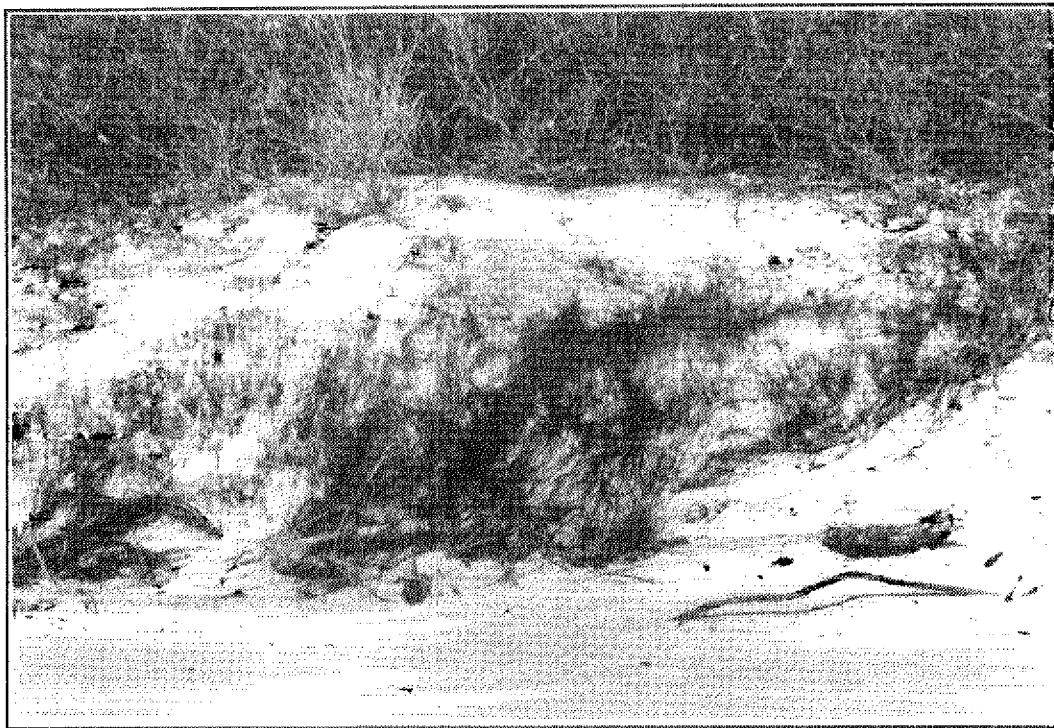
**Figure 4.** Sand Live Oak roots protrude from the side of a partially eroded dune. Note the density of the root structure.

*Quercus geminata* - sand live oak. These trees are often windsculpted as they grow on the dunes but they were tenacious anchors for sand in the face of storm surge flow. The largest relict dune segment we

identified in the eastern portion of the park was held together primarily by the extensive root networks of *Quercus geminata*. They did not appear to respond negatively to saltwater overflow but, where uprooted, the effects were terminal (see Figure 4).

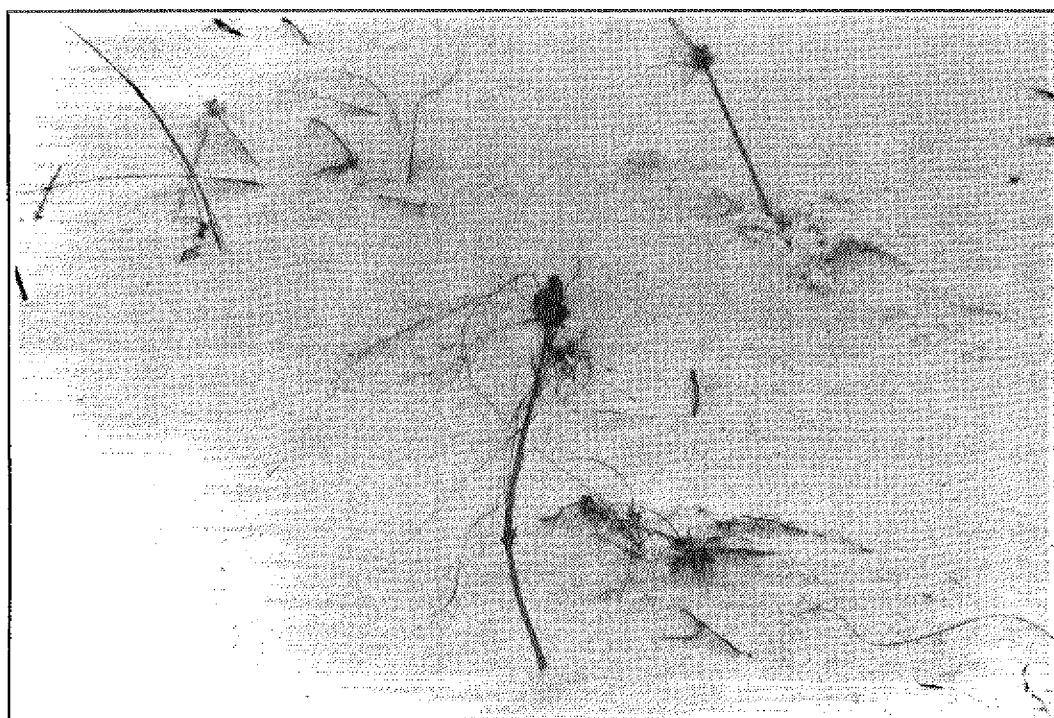
**Figure 5.** Sea oat roots exposed by Hurricane Opal storm surge at Ft. Pickens. October 1995.

indicates that this plant is not particularly effective at holding sand in place in a storm surge environment. Uprooting, by itself, was not fatal to *U. paniculata*, however. The storm surge eroded the dunes but it also deposited sand in significant amounts down-surge or, in this case, northward across the island. In those instances where the rhizomes of individual *Uniola* plants were able to remain covered with sand after the surge abated, survival rates appear to be good. In fact, in the eastern portion of the park where the storm surge damage was most spectacular, newly emerging sea oats were almost the only living vegetation noticeable 2-4 weeks after the storm surge event. Analysis of a small sample of these newly-sprouting plants revealed that the sprouts were from plants that had been buried often with up to 18-inches of sand. The knotted appearance of the rhizomes indicated that these plants had been moved to their present location, probably flowing and tumbling with the sand and water as the storm surge came across the island. They proved hearty in this environment.

Although it was heartening to see that large numbers of sea oat plants survived the storm surge, completely uprooted *Uniola* plants were also the dominant surface debris feature. By the second week after the storm, large piles of brown, brittling sea oat plants marked the path of the storm surge at Ft. Pickens. Based on laboratory studies of *Uniola* (Wagner, 1964), it is probable that the sea oat plants that were uprooted by the storm surge and remained uncovered after the surge abated died quickly.

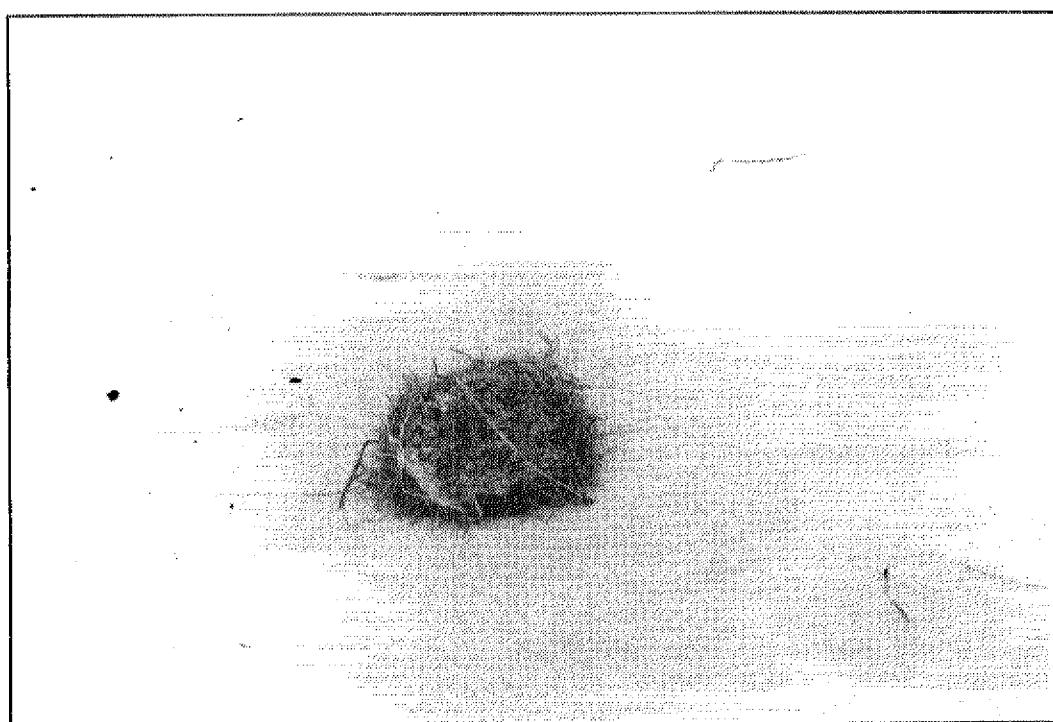
**Figure 7.** Close-up of Pickens Bundle after Hurricane Opal storm surge. October 1995.

Pickens Bundles are tightly woven bundles of sea oat roots that natural aeolian movement forms into regular shapes. These shapes vary from almost cylindrical in the early stages of formation to elliptical or football-shaped to almost perfectly spherical. The density of the bundle increases as the bundle evolves from cylindrical to spherical and the assumption is that, given enough time, aeolian movement, and rootlet material, the ultimate Pickens Bundle shape will be spherical. The dimensions of ten bundles collected are as follows:

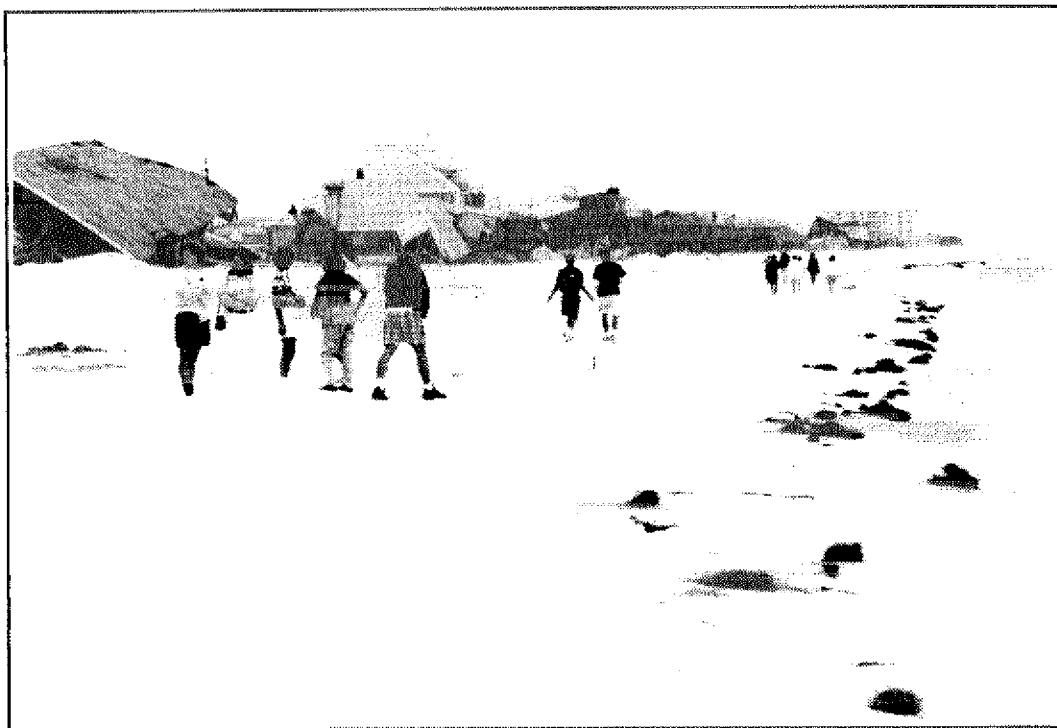
**Figure 9.** Among the massive home destruction, Pickens Bundles and vegetative material line the Pensacola shore. November 23, 1995.

The destruction Hurricane Opal wrought on the natural dune environment in the eastern portion of the Ft. Pickens park area was almost complete. Although the impact on man-made structures was not mentioned in this report, the damage to communities along Santa Rosa Island was devastating. Not only buildings were destroyed but the basic infrastructure of a modern community - roads, water and sewer systems, power lines, telephone lines, and television cabling systems - were all damaged or demolished. The human tragedy associated with Hurricane Opal is immense (see Figure 9).
