**ENVIRONMENTAL SURVEYS BEFORE, DURING, AND AFTER OFFSHORE
MARINE SAND MINING OPERATIONS AT KEAUHOU BAY, HAWAII**

WORKING PAPER NO. 28

December 1977

**University of Hawaii
Honolulu, Hawaii**

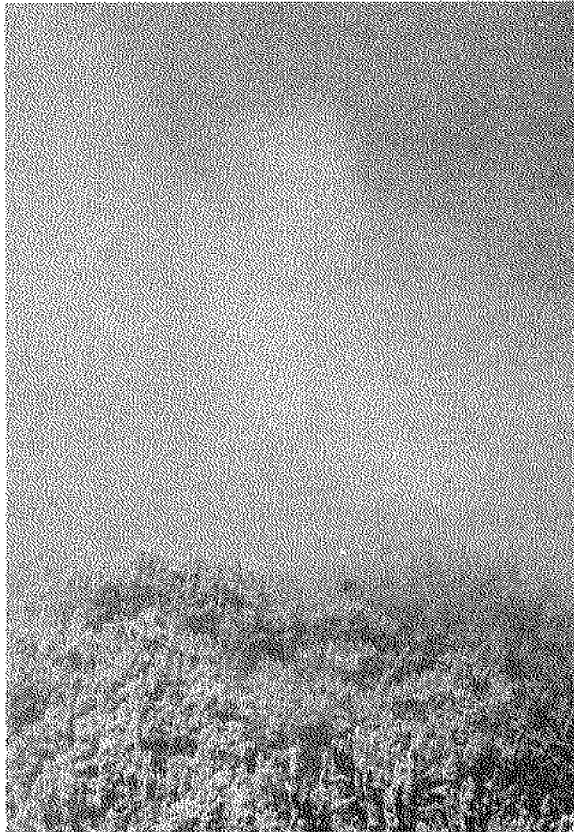
Plate 3. Sediment-laden water migrating from the vicinity of sand recovery operations towards a flourishing coral community nearby

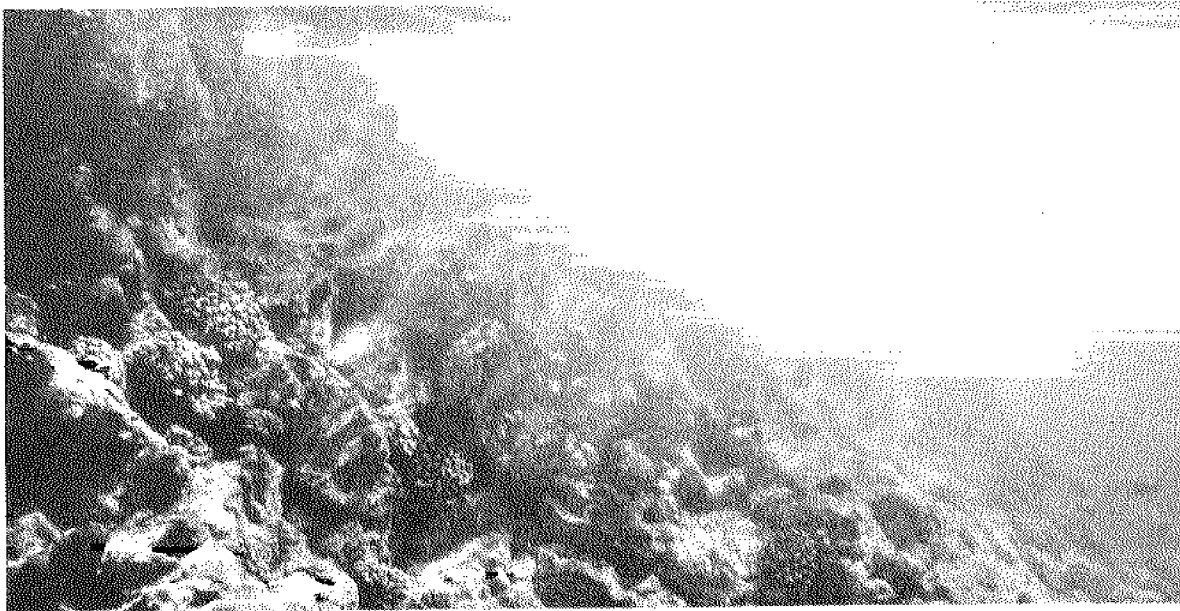
Plate 7. Upper submerged shoreline showing algal and coral communities offshore from the settling pond

Quadrat surveys at both the basin and control sites were conducted near the shoreline at water depths between 0 and 3 m below high tide level (Plate 7). The algal communities within these bands were similar in their exposure to wave action, composition, tidal range, and zonation. Within these bands were three zones of algal growth, each dominated by different algae, although at times the zonation pattern became indistinct. Furthest and highest from the ocean was an elevated splash zone consisting of closely cropped growths of the red alga *Ahnfeltia concinna*; an intermediate and highly diverse zone was composed of up to 12 species of algae; and a third, lower supra-surge zone was dominated by the encrusting red coralline alga *Porolithon onkoides* and the brown alga *Sargassum* sp. Quadrat surveys included sampling of all three zones at both sites.

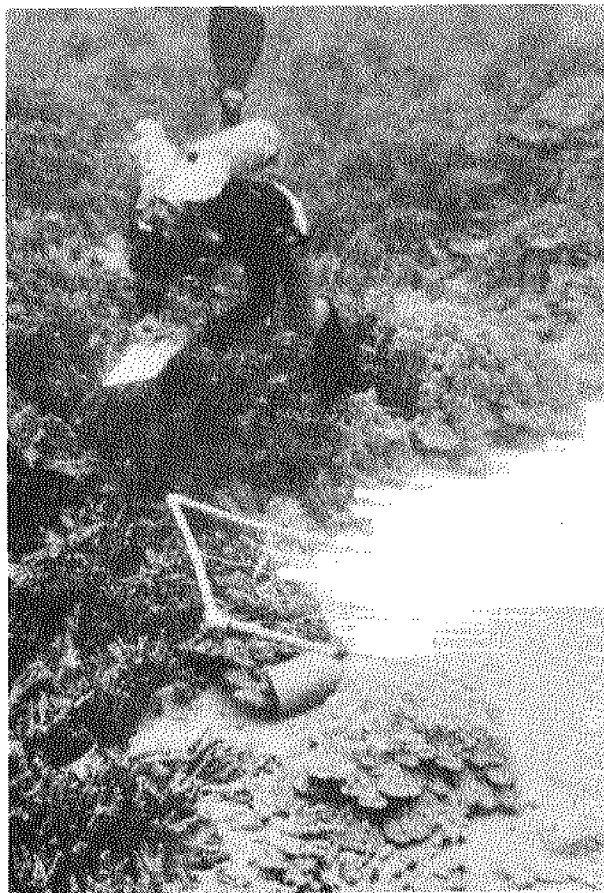
Plate 8. A diver estimating the abundance and composition of the algal community using a one meter square quadrat

A meter square quadrat with 121 points of intersection was used to estimate the species composition and relative abundance of algae within the 3 m wide band close to the settling basin and control sites (Plate 8). The species of algae or type of substratum (e.g., rock), lying directly under each intersection point of the quadrat was recorded by a diver on a plastic slate and later transcribed to data sheets.

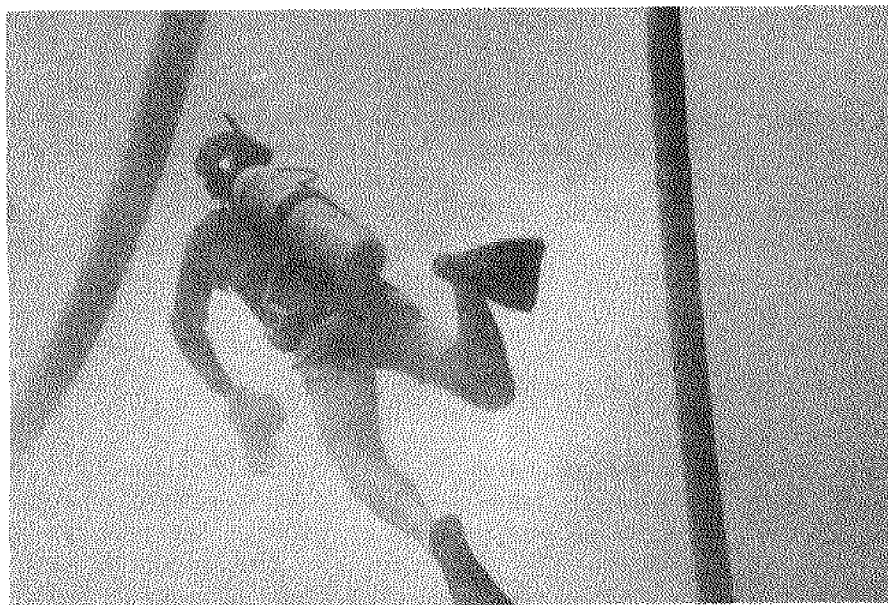
Plate 12. Sediment plume generated during operation of SSRS probe is shown.

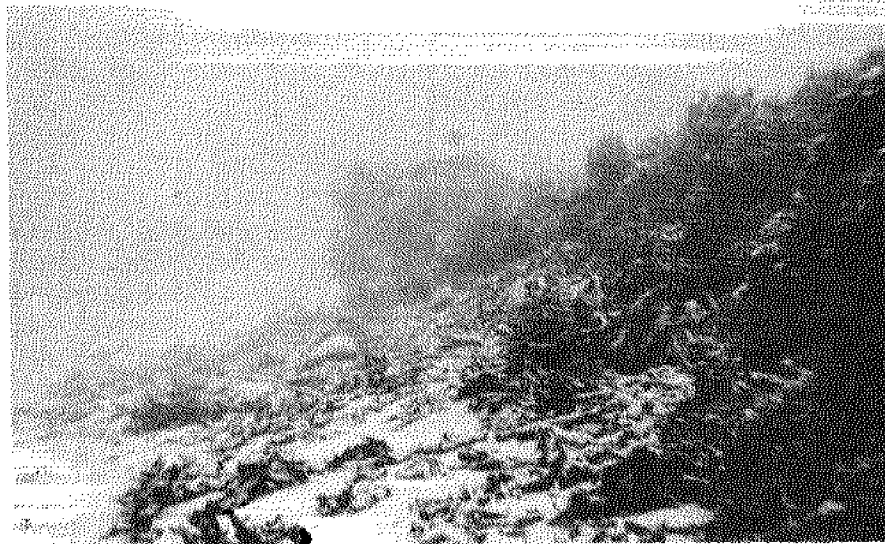
Plate 15. The zone of exposed and migrating coral fragments caused by the transport and removal of sand away from the coral reef-sand deposit boundary of the deposit by mining operations. This area showed the greatest amount of reef undermining.

Diver examination did indicate that many of the broken fragments were still alive; some of these may survive and regenerate.

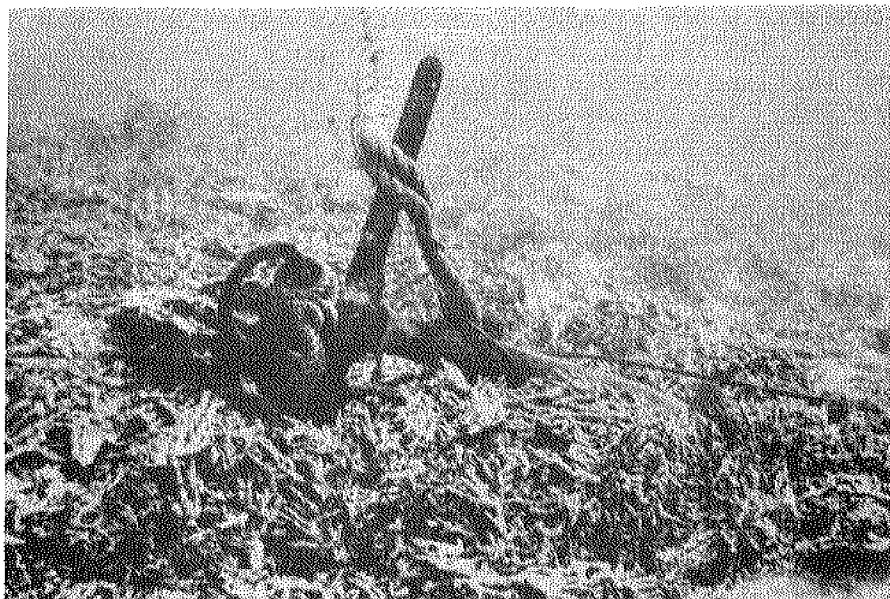
Plate 16. Structural damage to fragile living finger coral communities caused by the dragging of the pumping platform and ship's anchor

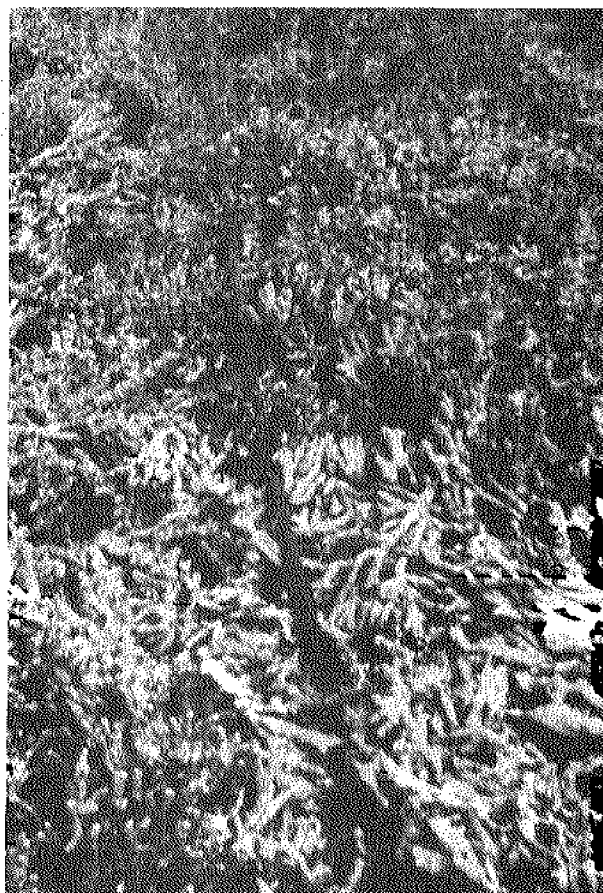
Plate 17. Damage to finger coral communities caused by the movement and swath of anchoring cables

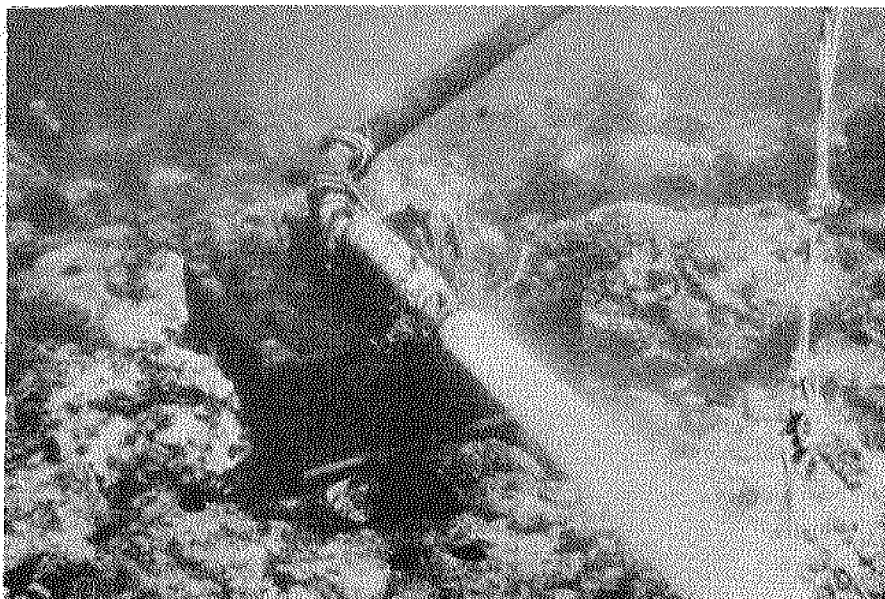
The concrete block assembly used for the anchoring of the deep end of the metal pipe used for the transfer of offshore sand from the recovery site to the settling pond did not appear to cause much damage to the coral reef (Plate 18). The bottom near the shoreline is more rugged, less dominated by live coral, and more dominated by live filamentous and coralline algae. Furthermore, the concrete anchor appeared to be stable and did not show signs of movement. Thus, damage appeared to be limited to algae and corals (especially *Pocillopora meandrina*) which were covered or crushed by the concrete block assembly during initial placement.

Plate 18. The concrete block assembly used to anchor the deep end of the metal pipe used for transfer of sand slurry from the recovery site to the settling basin. The block is resting on a coral reef community at a depth of about 5 m.

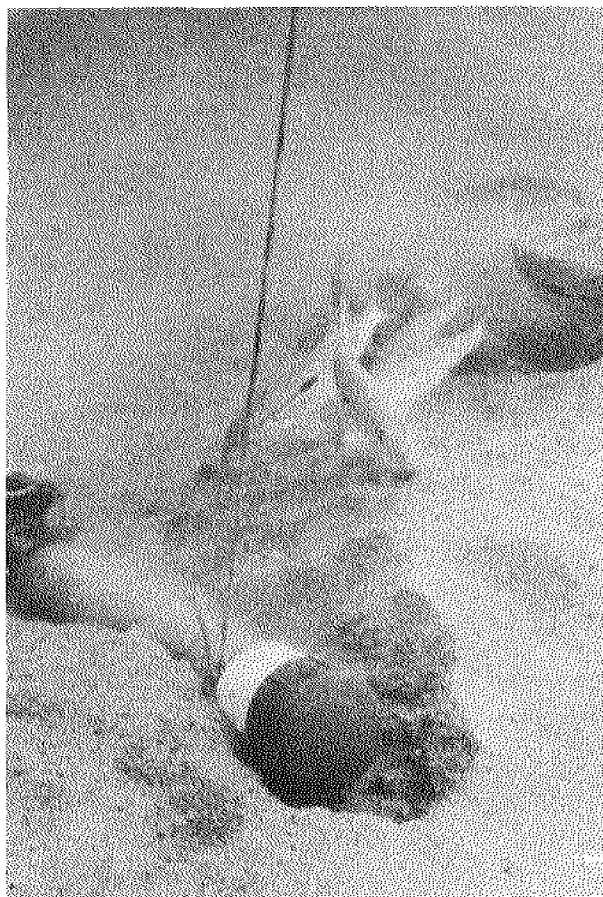
Plate 22. Goatfish (*Mulloidichthys samoensis*) feeding on organisms uncovered during operation of the SSRS probe, approximately 2 minutes after moving the fluidizing pipe to this location

It is interesting to note that while the sand suction probe was in actual operation, many large individuals of *Mulloidichthys samoensis* (weke) would actively feed on the organisms which became exposed as the sand tumbled down into the cone created by the SSRS probe and the fluidizing pipe (Plates 22 and 23). Although smaller weke were seen near the edge of the sand cone, they never attempted to feed in this manner. In fact, no other carnivorous reef fishes were observed to feed in this way.

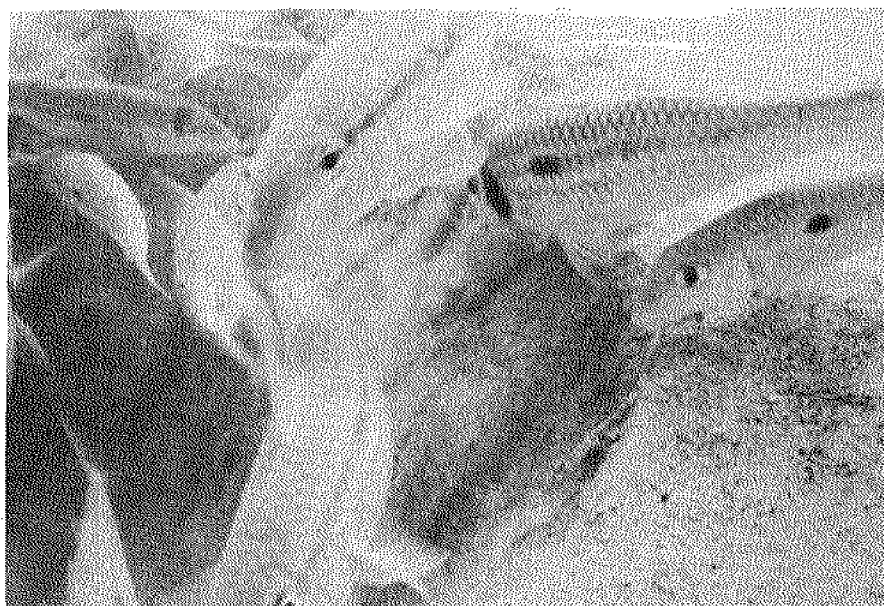
Plate 23. Goatfish (*Mulloidichthys samoensis*) feeding on organisms uncovered during operation of the SSRS probe, approximately 5 minutes after moving the fluidizing pipe to this location
