Nelson Lagoon Coastal Hazard Assessment

Arctic Coastal Geoscience Laboratory (Ver. April 2021)

Nelson Lagoon, AK

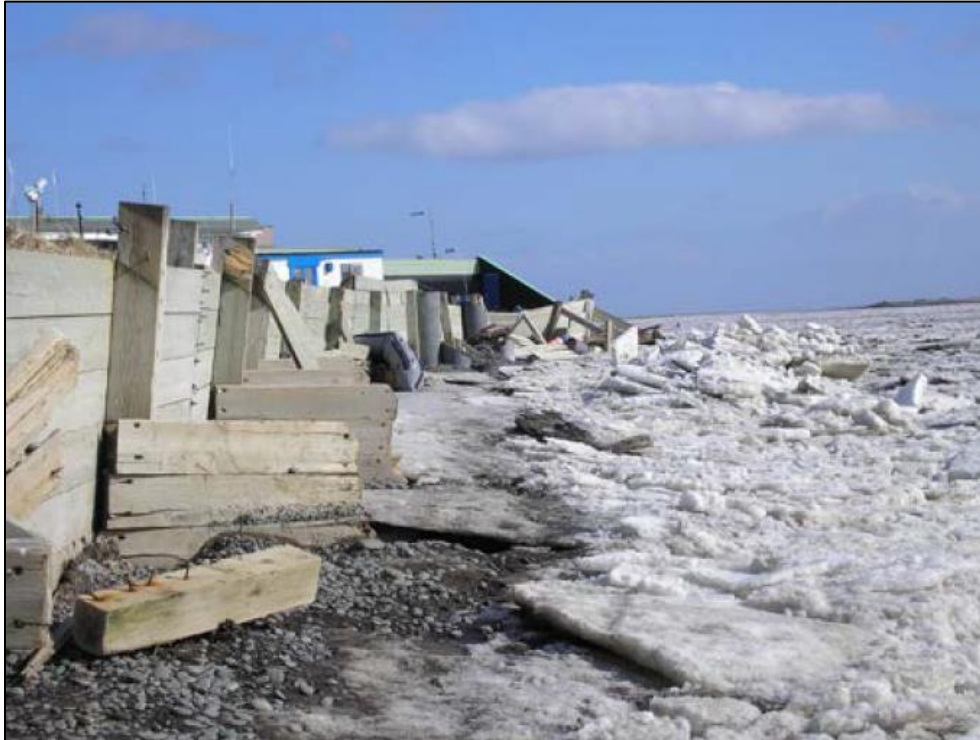
Figure 17.
Bench ice along
the Nelson
Lagoon sea wall
in 1995. Image
Credit: HDR,
2011

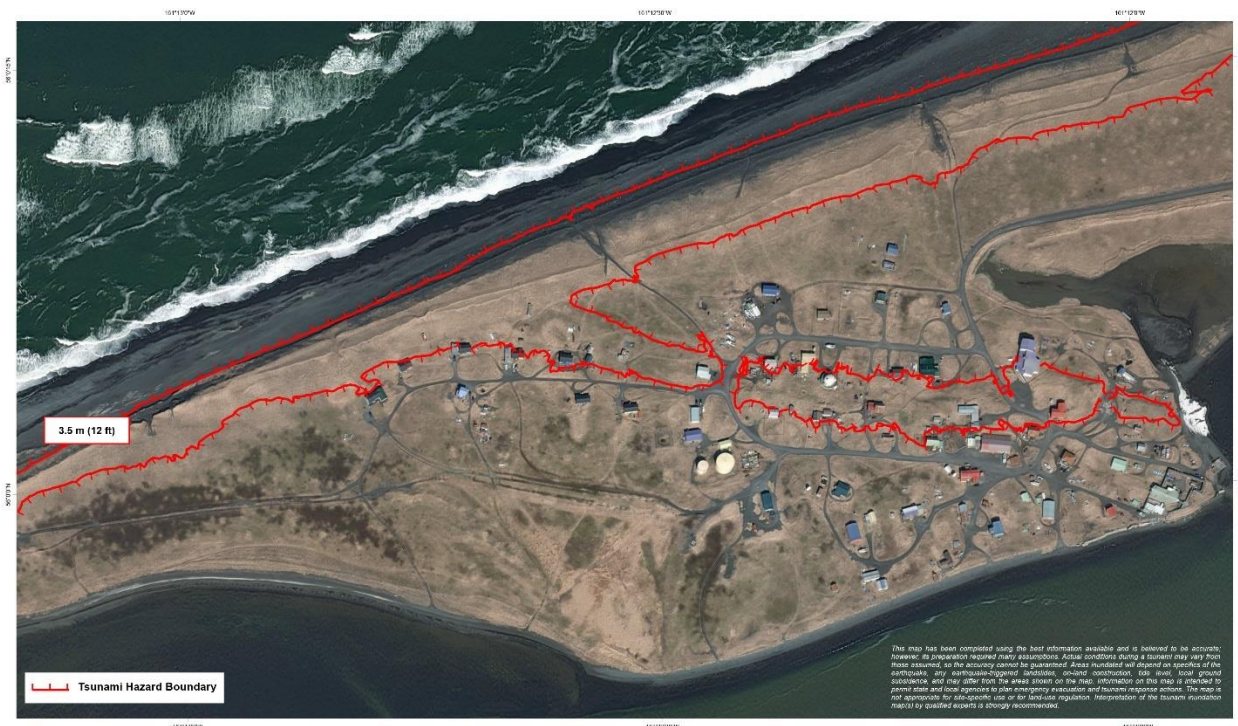
Figure 21. Tsunami hazard map of Nelson Lagoon, produced by the Alaska Earthquake Center for the Alaska Division of Geological and Geophysical Surveys (from Suleimani et al., 2020). Information on this map is intended to permit state and local agencies to plan emergency evacuation and tsunami response actions. The map is not appropriate for site-specific use or for land-use regulation. (URL: https://dggg.alaska.gov/webpubs/dggg/ri/oversized/ri2020_001_sh001.pdf).

Nelson Lagoon is at risk of infrastructural damage and loss of life as a result of both earthquakes and tsunamis, which are caused by seismic activity on or beneath the ocean floor. Fortunately, Nelson Lagoon is shielded from most tsunamis by the Aleutian Island chain itself, as most seismic activity occurs on the southeast side of the island chain; however, tsunami risk remains a threat. Tsunamis within Bristol Bay are likely to come from one of three sources: underwater landslides, transpacific tsunamis, or volcanic eruptions (Suleimani et al., 2020). In 2020 the DGGs conducted a tsunami hazard assessment and determined that during severe tectonic scenarios Nelson Lagoon the maximum assumed runup height above mean highest high water (MHHW) is 3.5m (11.5ft.; **Figure 21**; Suleimani et al., 2020). A surge of this magnitude would compromise much of the town's infrastructure, particularly on the lagoon side of the spit and through the center of the town (**Figure 21**).

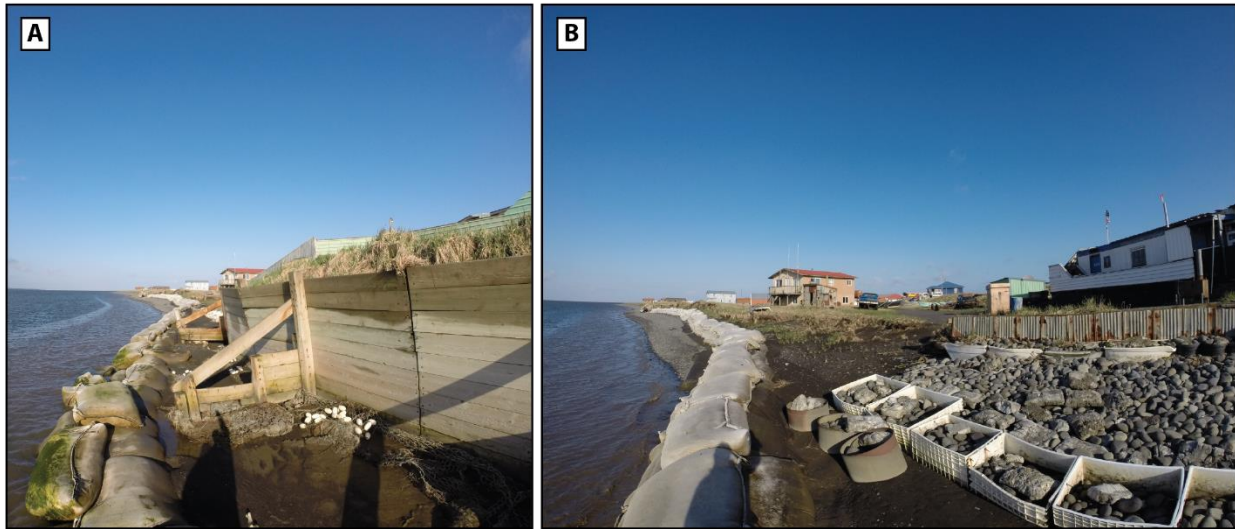
Figure 24. Seawall and sediment containers in place along the lagoon coastline of the community . A) the seawall and gabions, the geotextile containers can be seen on the left, and B) the geotextile containers fronting the community to the west of the seawall. May 2019.

A timber seawall is already in place along a small portion of the lagoon side of the community, although it is in poor condition due to undermining and flanking. Despite its poor condition, this wall has been the primary protection for the community for almost three decades, making it, overall, a highly successful structure. In recent years, the community has installed the following major erosion protection measures along this stretch (USACE, 2007): (a) gabions along the seawall to anchor existing wood in the breakwater (**Figure 24A**), and (b) approximately 170 linear meters of sediment containers constructed with geotextile fabric (**Figure 24B**).

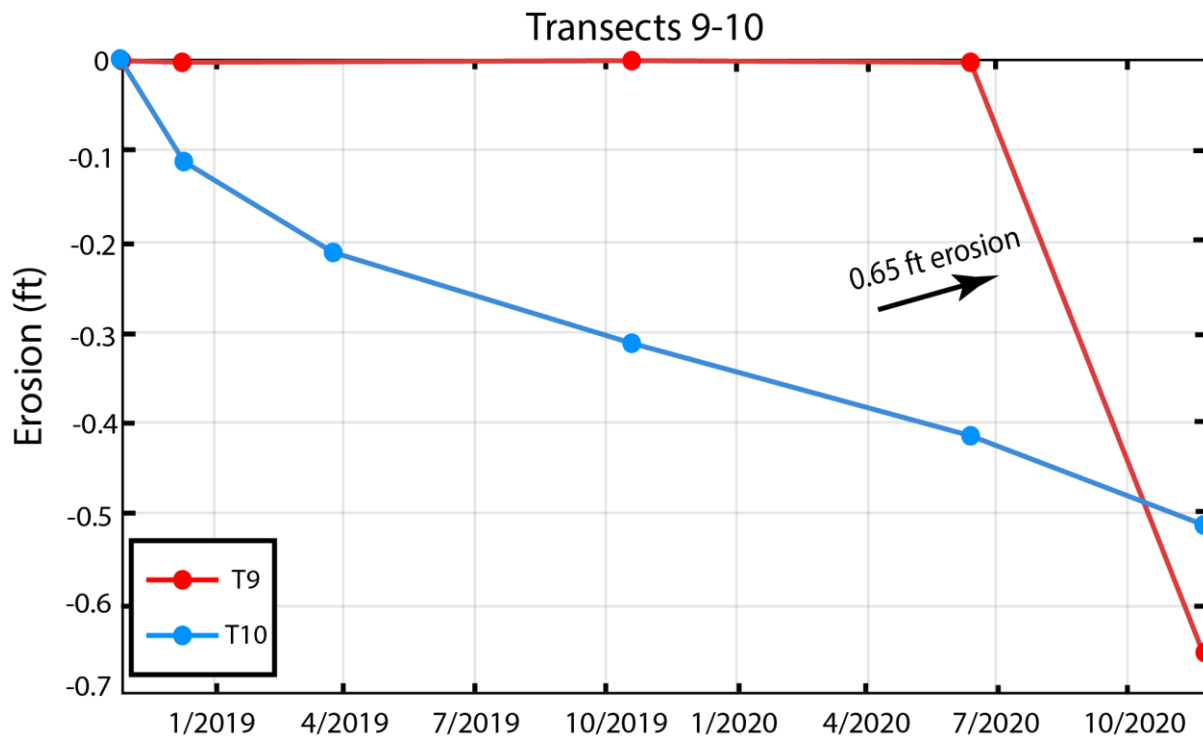
Figure 29. Graph showing erosion monitoring stake measurements at transects 9-10 taken by local environmental coordinators. Each transect is represented by a different colored line and the dots on the lines represent single measurements. The y-axis is the erosion in feet.

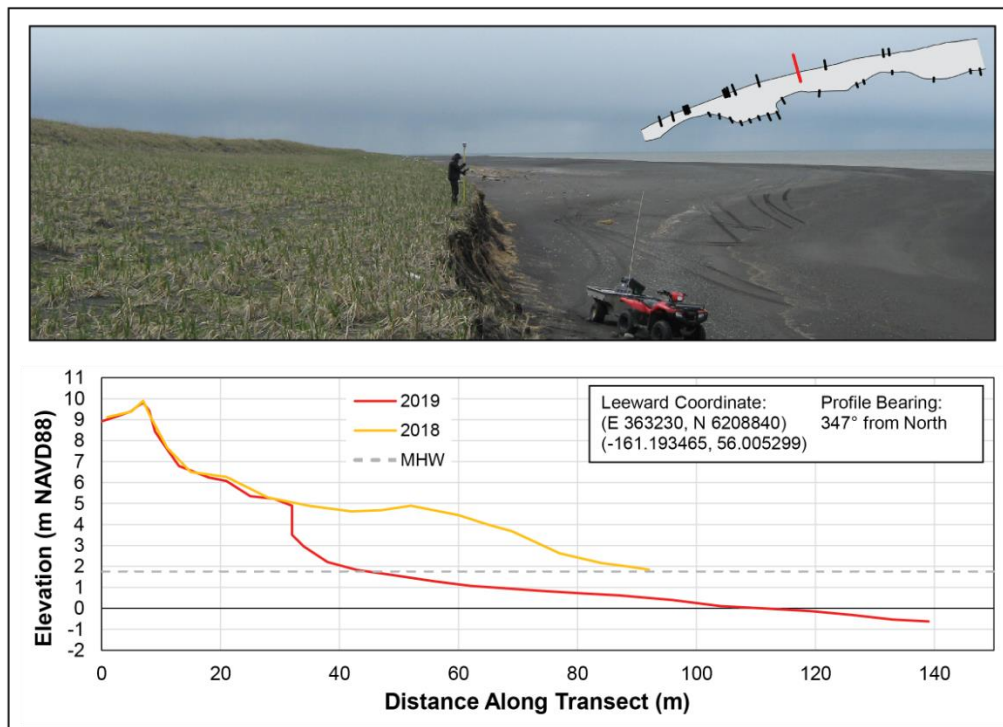
Figure 31. Coastal profile K collected along the ocean side beach . Notice up to 4 m (13 ft) of bluff eroded along this backshore windward side of the spit in one year. Displayed transect is K in figure 23.

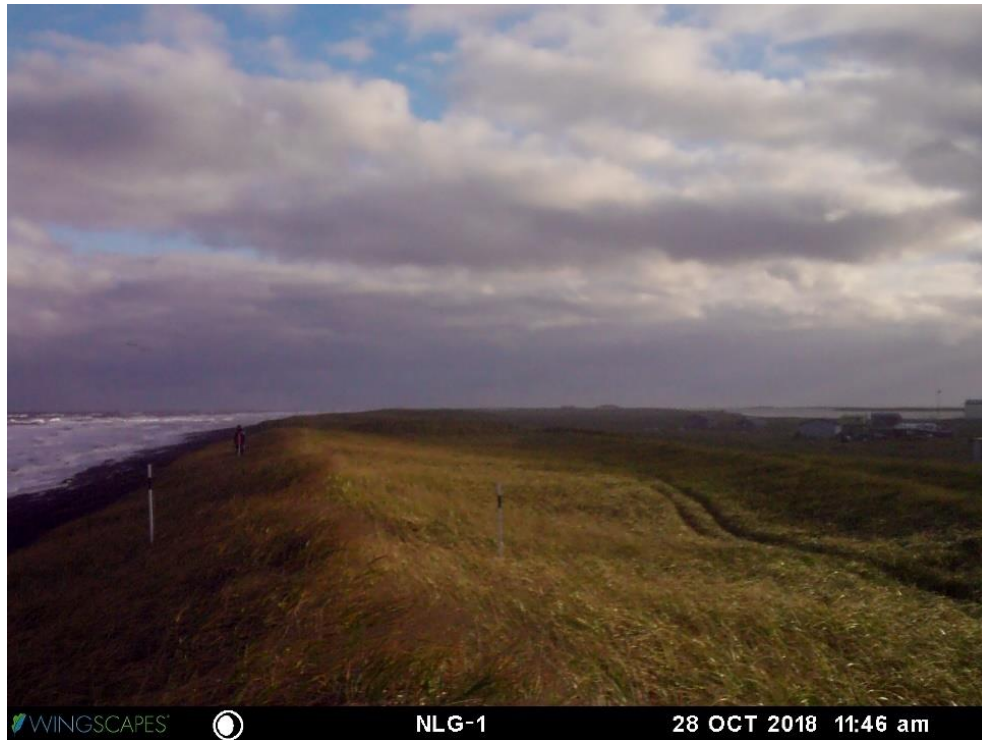
Figure 33. Time-lapse picture and compiled video of erosion monitoring site 1 . Images taken at Nelson Lagoon site 1 from October 2018 to May 2019. (URL: <https://youtu.be/r6fS1wvpeAs>).

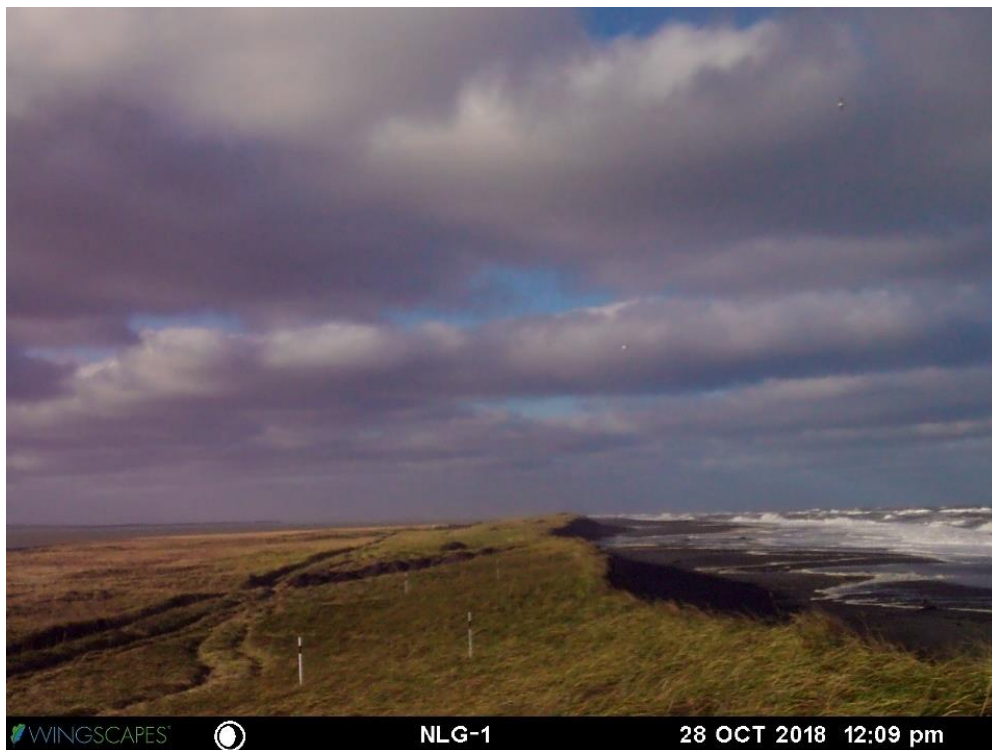
Figure 34. Time-lapse picture and compiled video of erosion monitoring site 2 . Images taken at Nelson Lagoon site 2 from October 2018 to May 2019. (URL: <https://youtu.be/-FmvEXaPZvg>).

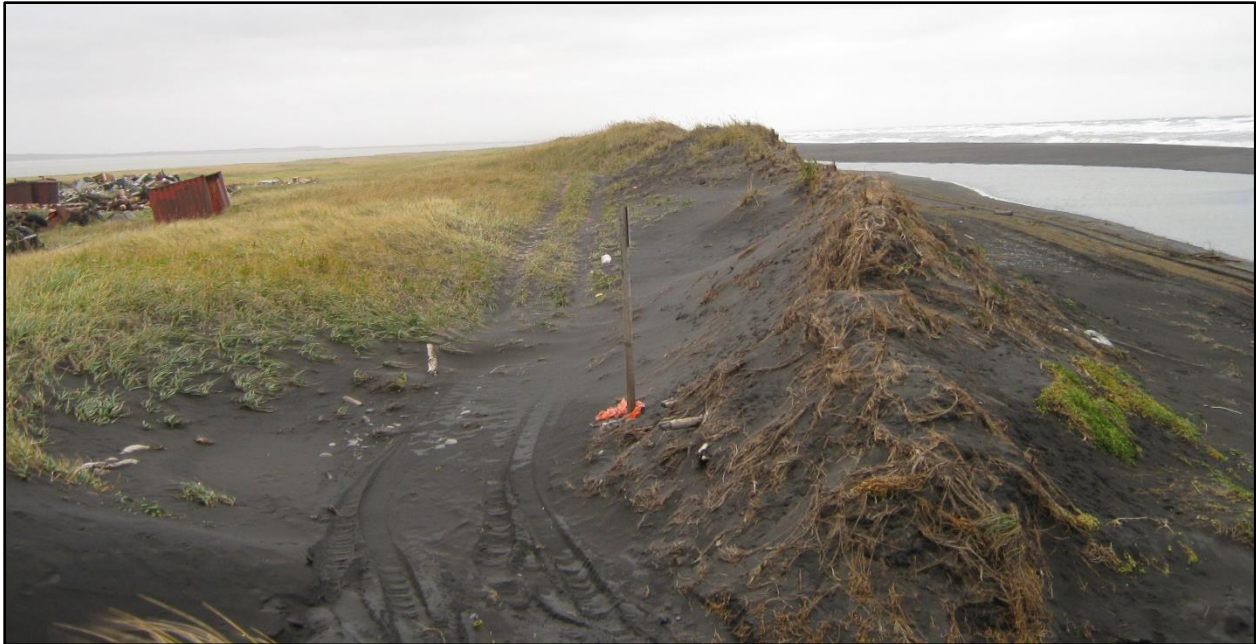
Figure 39. Photograph showing remnants of an overwash and flooding event at the access road from the beach to the solid waste disposal site, which can be seen to the left. October 2018.

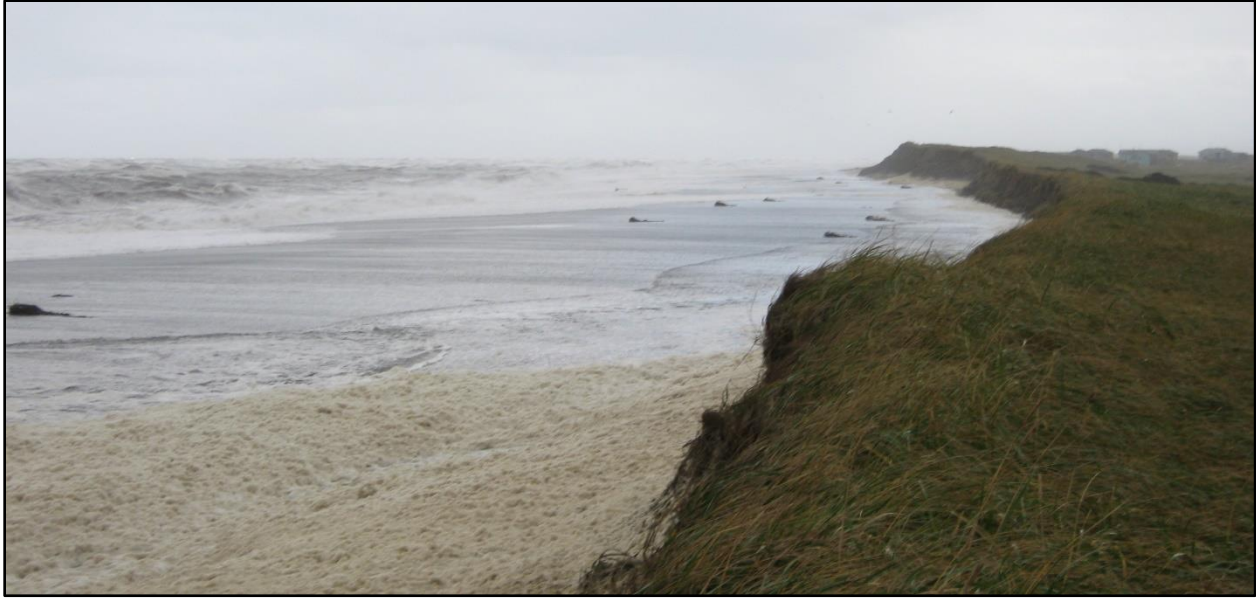
Figure 41. Photograph taken during a relatively minor storm event from the solid waste disposal site looking towards the community on the ocean side of the spit. As the bluff face erodes, sediment at or near the vegetation line is removed and there is an increase in the slope of the dune toe as it retreats landward. October 2018.

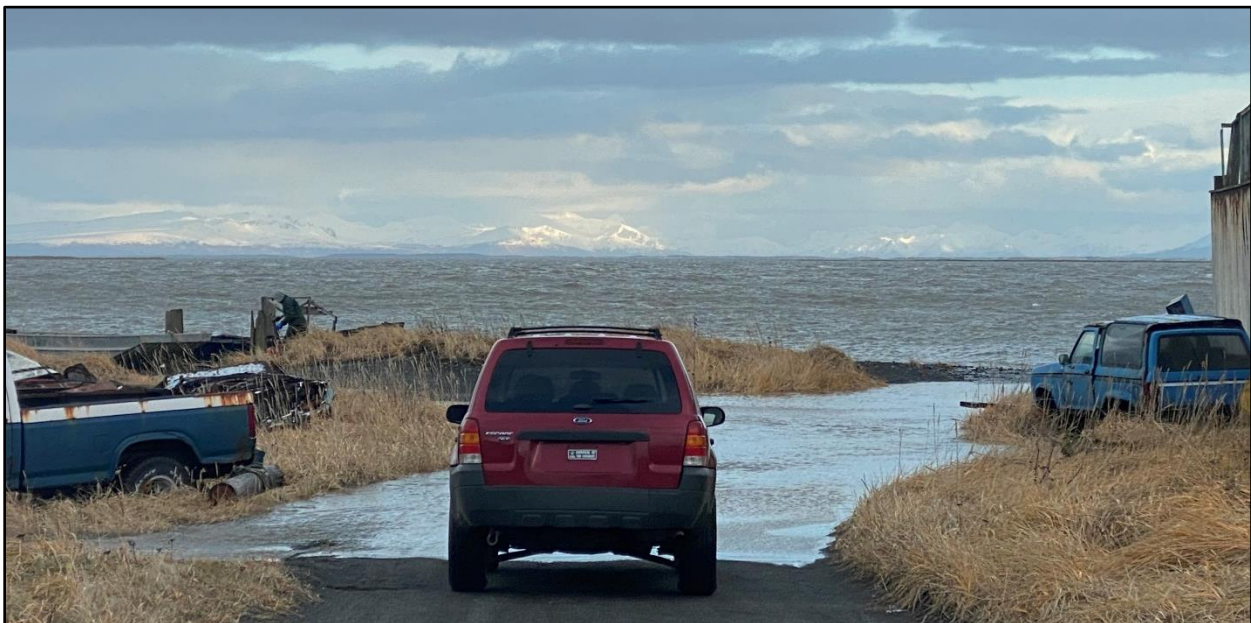
Figure 44. A flooded road near the retaining wall on the east side of the community . This stretch of coastline floods regularly during high storm-tides. Image provided by Angela Johnson, November 2020.

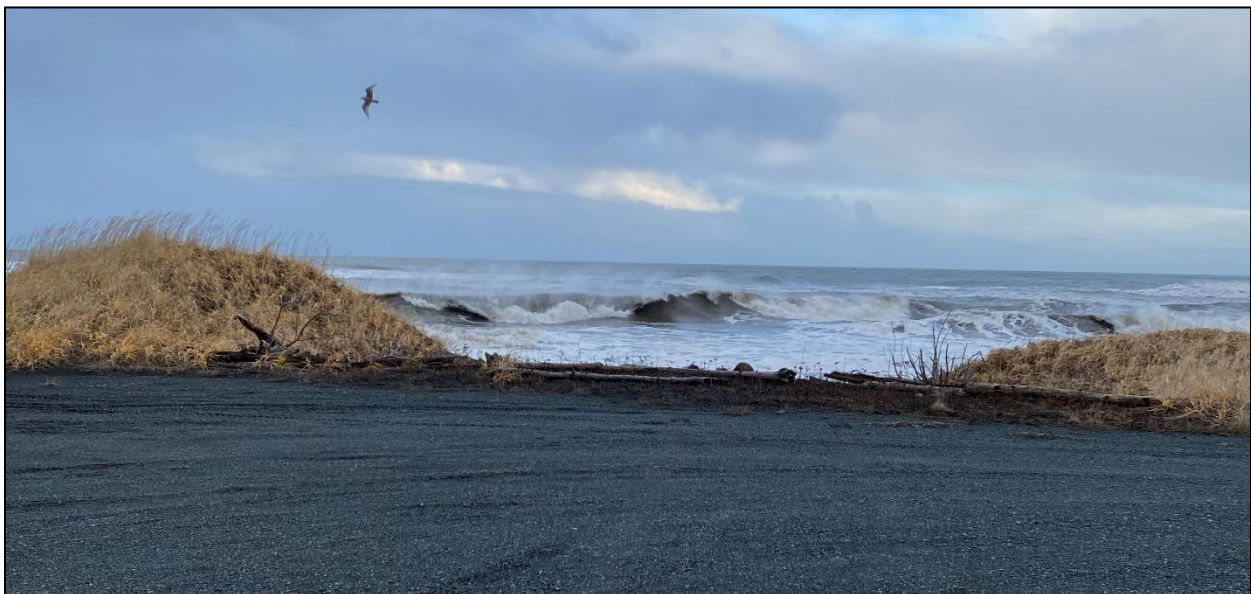
Figure 49. Fore-dune breach along the ocean shoreline fronting community airstrip . Image generously provided by Angela Johnson, November 2020.
