1 **Title:** Restoration of tropical seagrass beds using wild bird fertilization and sediment regrading

26 **Abstract**

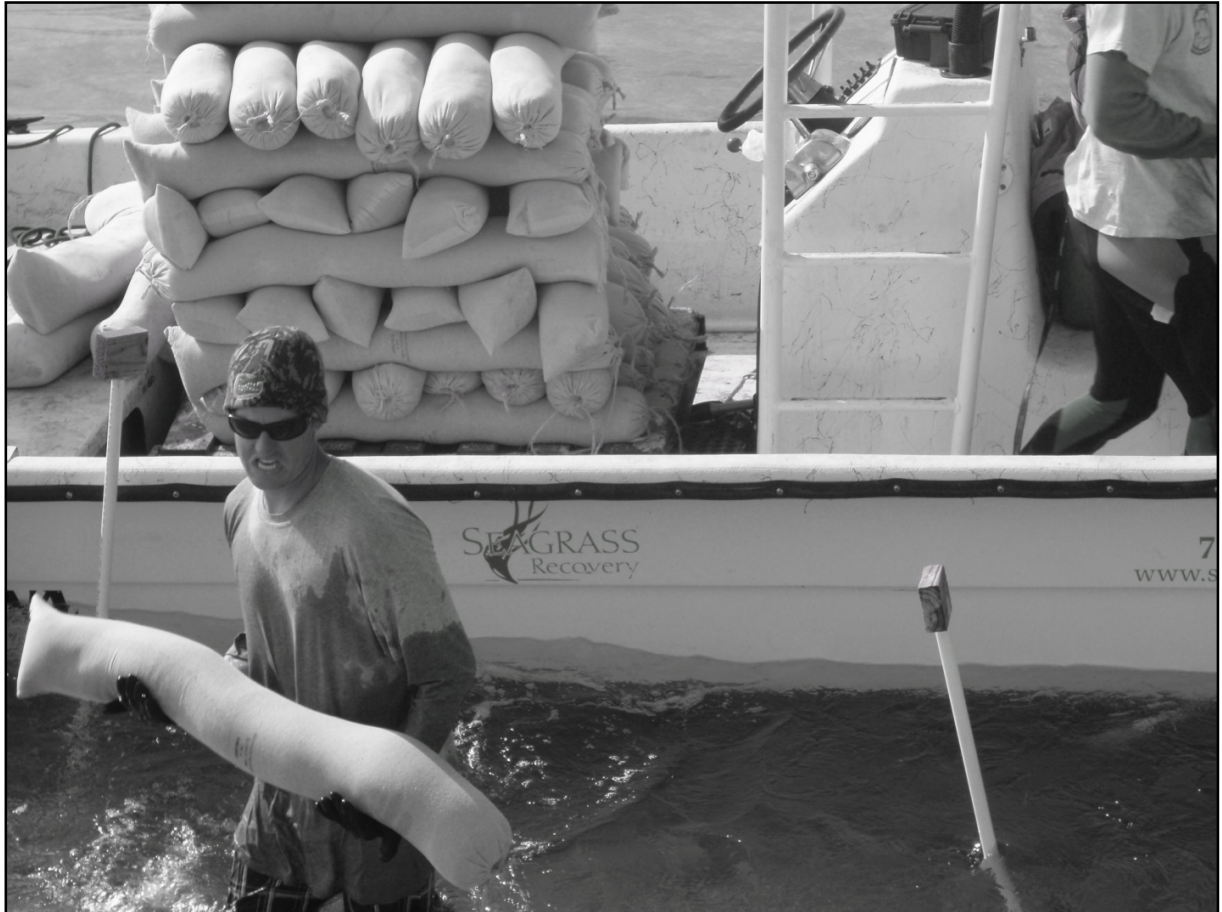
835 Figure 3  
836  
837  
838

167 In Experiments 2 and 3, sediment tubes were used to regrade excavated seagrass beds.  
168 The tubes (1.0 – 1.5 m long, 15–20 cm dia.), filled with fine-grained calcium carbonate screening  
169 sand (0.63 – 0.85 mm dia.), were manually deployed into injuries from a shallow draft vessel  
170 (Fig. 3).

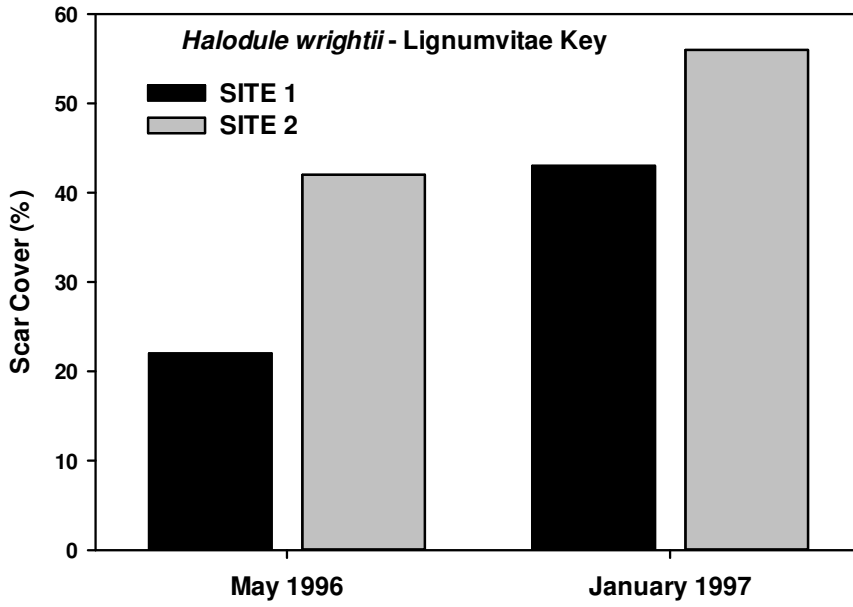
885 Figure 5

313 In May 1996, when the *H. wrightii* transplants began coalescing and it wasn't possible to  
314 distinguish cover between the original treatments, we measured the percent of each scar covered  
315 by seagrass. Percent cover of *H. wrightii* in the scars at Sites 1 and 2 were 22 and 40%,  
316 respectively (Fig. 5). By January 1997, 639 days since planting, *H. wrightii* cover in the scars  
317 increased to 43% at Site 1 and 56% at Site 2 (Fig. 5). *Halodule wrightii* continued to grow and  
318 expand rapidly, colonizing unplanted portions of the scars, and by January 2000 the scar at Site 1  
319 had become completely covered with *H. wrightii* (Supplementary Fig. 1d).

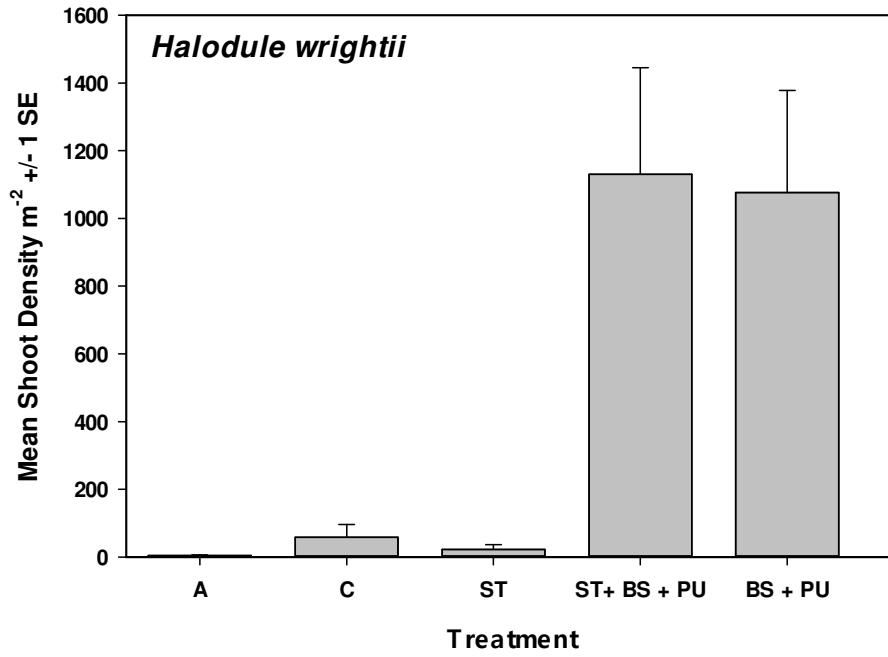
977 Figure 7  
978  
979  
980  
981

341 Short-shoot counts of *H. wrightii* ranged from 4.0 m<sup>-2</sup> in the adjacent seagrass bed to  
342 1130 m<sup>-2</sup> in the ST+BS+PU treatment (Fig. 7). One-way ANOVA for *H. wrightii* shoot density

343 revealed differences among treatments ( $p < 0.0001$ , Table 2). Pairwise comparisons of the shoot  
344 density data revealed that the two bird stake treatments with PUs (ST+BS+PU and BS +PU) had  
345 significantly higher *H. wrightii* shoot densities than the other three treatments (ST, C, and A),  
346 which were not significantly different from each other (Fig. 7; Table 2).

420 injuries with biodegradable fabric tubes filled with fine-grained calcium carbonate sediment  
421 provided a satisfactory physical substrate for the growth of both *H. wrightii* and *T. testudinum*  
422 (Figs 7, 8, and 9). However, the results of Experiment 2 demonstrated that fertilizing with bird  
423 stakes and planting *H. wrightii* yielded the highest density and recovery rates of seagrass and it  
424 was evident that sediment tubes were not a necessary pre-requisite for recovery of relatively  
425 smaller propeller scars.

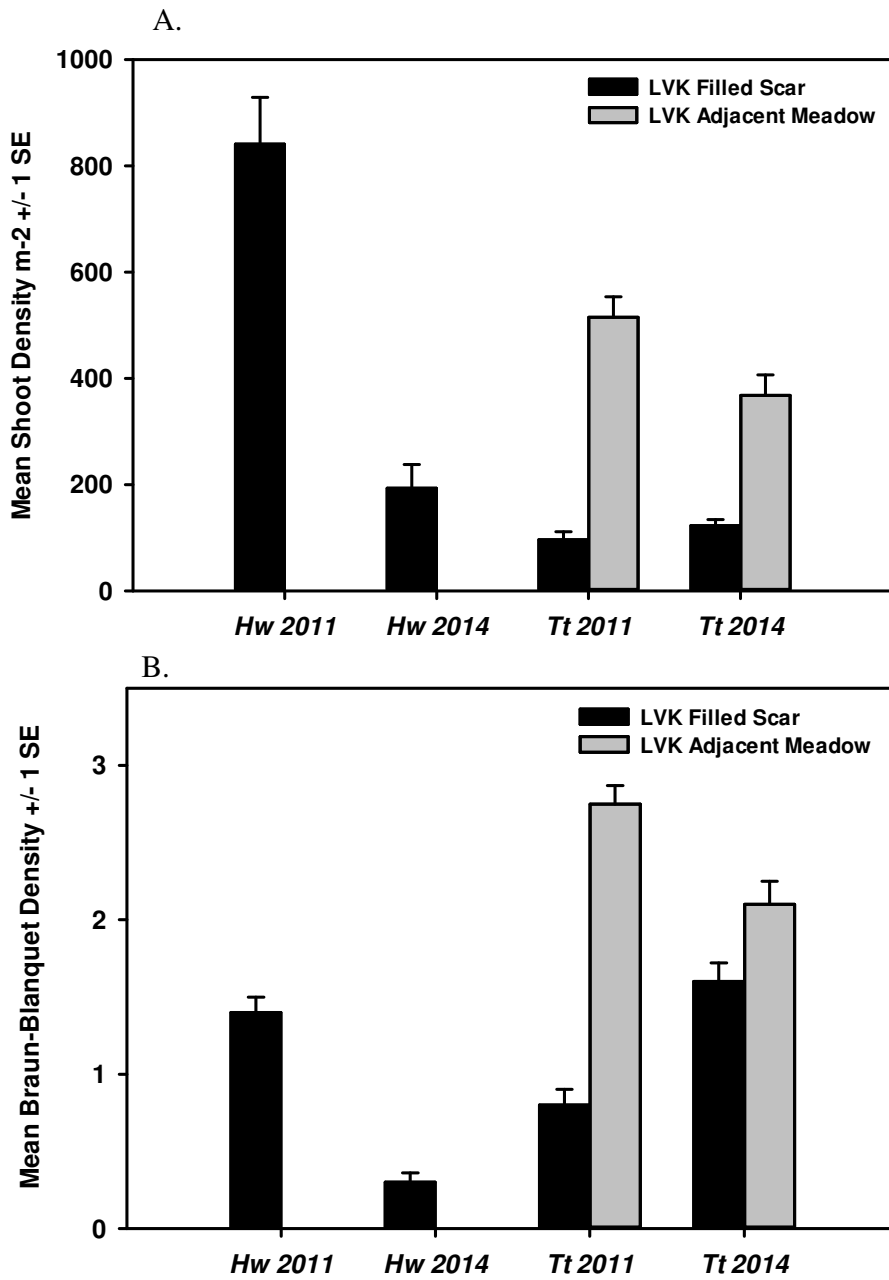
1050 Figure 9

772 **Figure 9.** Shoot density ( $\pm$  SE) for *Halodule wrightii* and *Thalassia testudinum* in experiment 3  
773 in October 2011 and October 2014. Data are for shoot densities of *T. testudinum* and *H. wrightii*  
774 in the filled scar and *T. testudinum* in the adjacent undisturbed seagrass bed. There was no *H.*  
775 *wrightii* observed in the adjacent undisturbed seagrass bed.

377 We returned to the site in May 2009, removed all the remaining bird stakes and observed  
378 very little *T. testudinum* at the site. In October 2011 *H. wrightii* densities in the filled scar in  
379 decreased from  $\approx 4000$  shoots  $m^{-2}$  recorded in September 2005 to 840 shoots  $m^{-2}$  (Fig. 9). This  
380 decline continued, and by 2014 densities were slightly less than 193 shoots  $m^{-2}$ . In 2011  
381 *T. testudinum* shoot densities were 96  $m^{-2}$  and increased to 122  $m^{-2}$  in 2014, or 33% of the  
382 density in the adjacent undisturbed seagrass bed (367 shoots  $m^{-2}$ ) (Fig. 9). No *H. wrightii* was  
383 observed in the adjacent undisturbed *T. testudinum* meadow in either 2011 or 2014.
