**Rip currents near coastal structures in Lake Michigan: characterization and assessment  
for warnings**

## **Abstract**

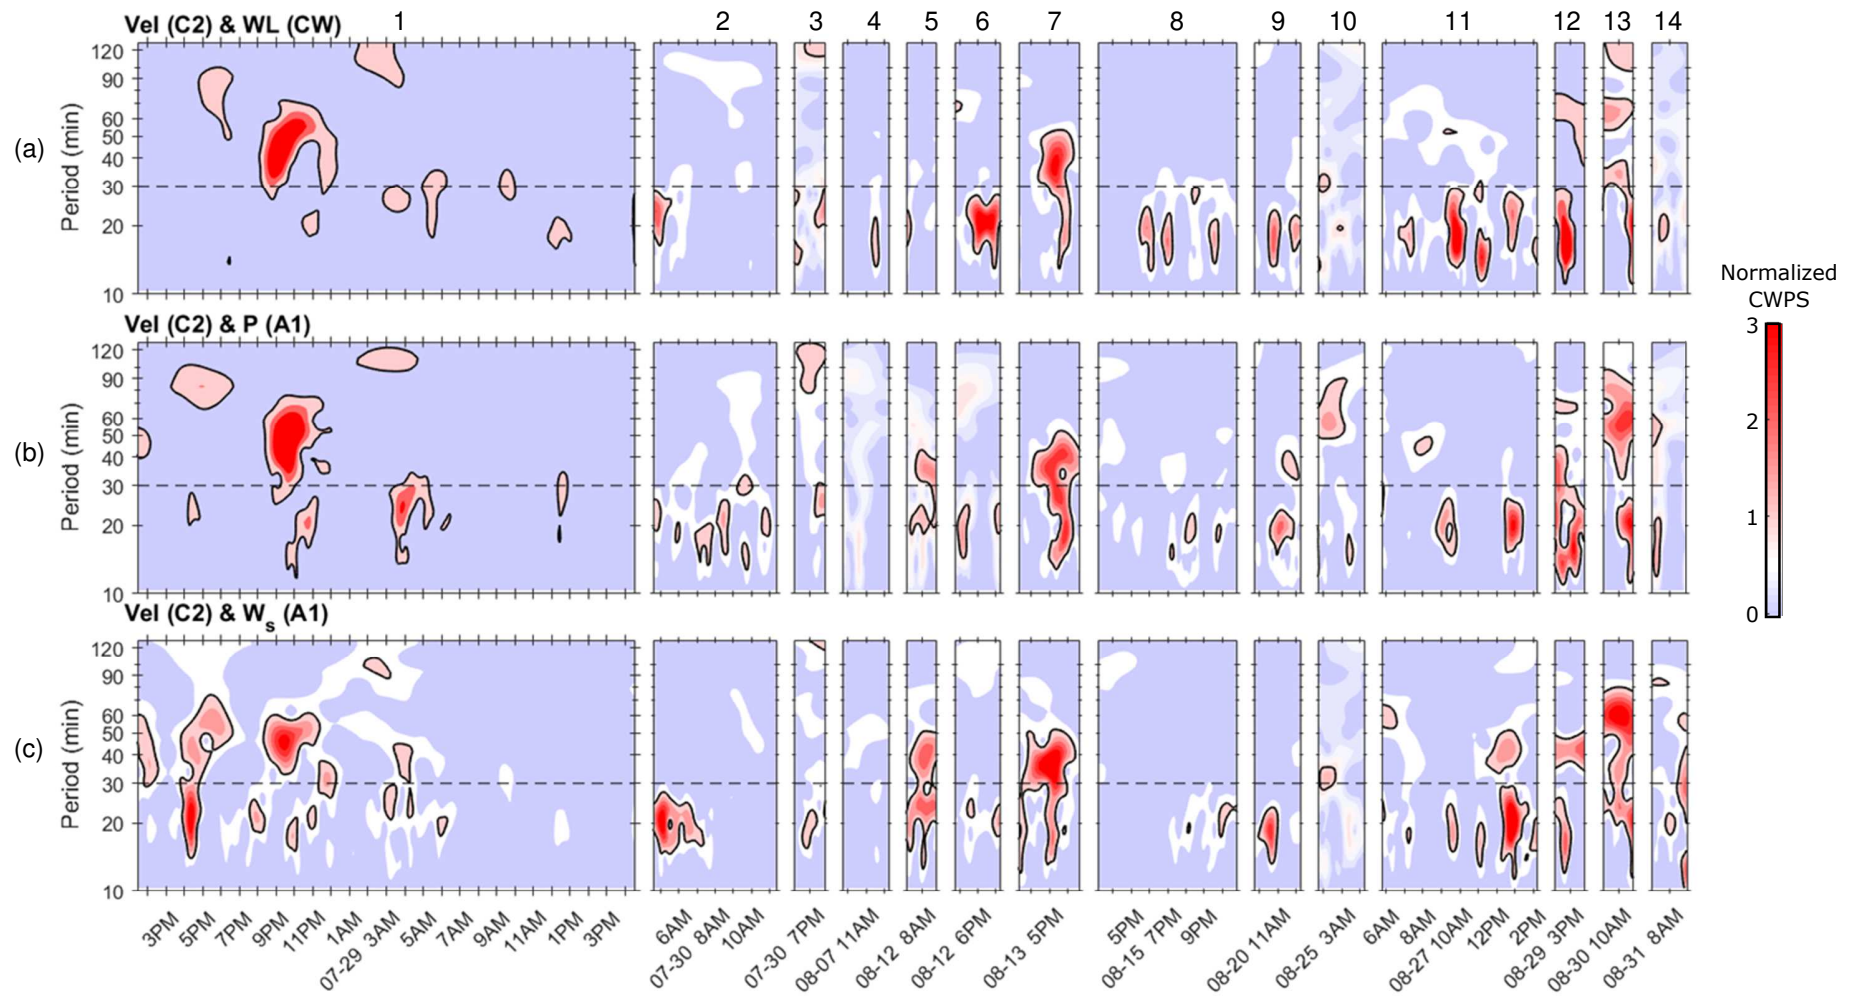
Fig. 5.

Environmental proxies were further associated with velocity pulsations in identified rip current events. Fig. 5 (a), (b), and (c) show the normalized cross-wavelet power spectra (CWPS) of the observed current velocities at C2 and water levels, atmospheric pressures, wind speeds, respectively. Based on the energetic CWPS shown in Fig. 5, we observed that the rip currents pulsed at similar periods as water levels and atmospheric factors, further supporting the association between the environmental proxies with the rip current events. Particularly, significant common power (normalized CWPS > 1) was observed at periods < 30 minutes, suggesting that the VLFs, a key component of rip velocities (Fig. 3), were associated with or even caused by the environmental proxies. The results based upon CWPS analysis support the previous finding that atmospheric disturbances (proxies IV, VI, VII) or/and induced water level fluctuations (proxy V) can lead to dangerous rip currents near structures (Linares et al., 2019).

To sum up, based on the time series (Fig. 4) and the cross-wavelet analysis (Fig. 5), the identified deflection or shadow rip currents were associated with the seven environmental proxies. Proxies I and III were characterized by high waves and favorable wind directions. Proxy

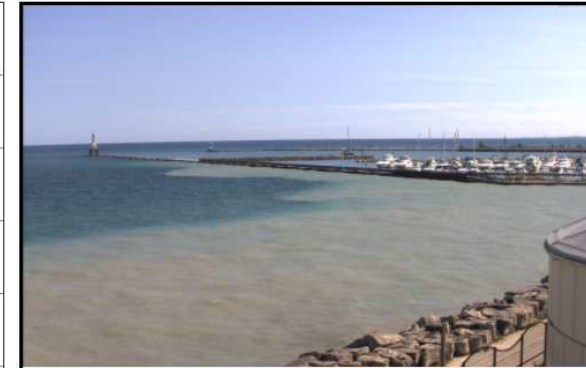
Fig. 7.

**Fig. 7.** A webpage display for providing real-time assessments of potential occurrences of rip currents near the north breakwater at Port Washington, WI. A rip current event on 2019/08/15, as an example, was assessed to be in the *high-risk* tier with a total point of 10.5 using the SRiCAM. Current conditions of the nine factors, a real-time webcam image, and safety messages are displayed on the webpage.

(~750 m) in Fig. 7 using the transformation method (Bechle et al., 2012; Wanek and Wu, 2006) and tracking plume propagations over multiple images, the speed of rip currents was estimated to be 0.2 m/s, similar to measured rip velocities (Table 2). Overall, visual identification based on sediment plumes was illustrated at the study site (Fig. 6, 7) and at other locations across Lake Michigan (Fig. 8), suggesting that image observation can be widely applied to direct reflect rip current risks near coastal structures.

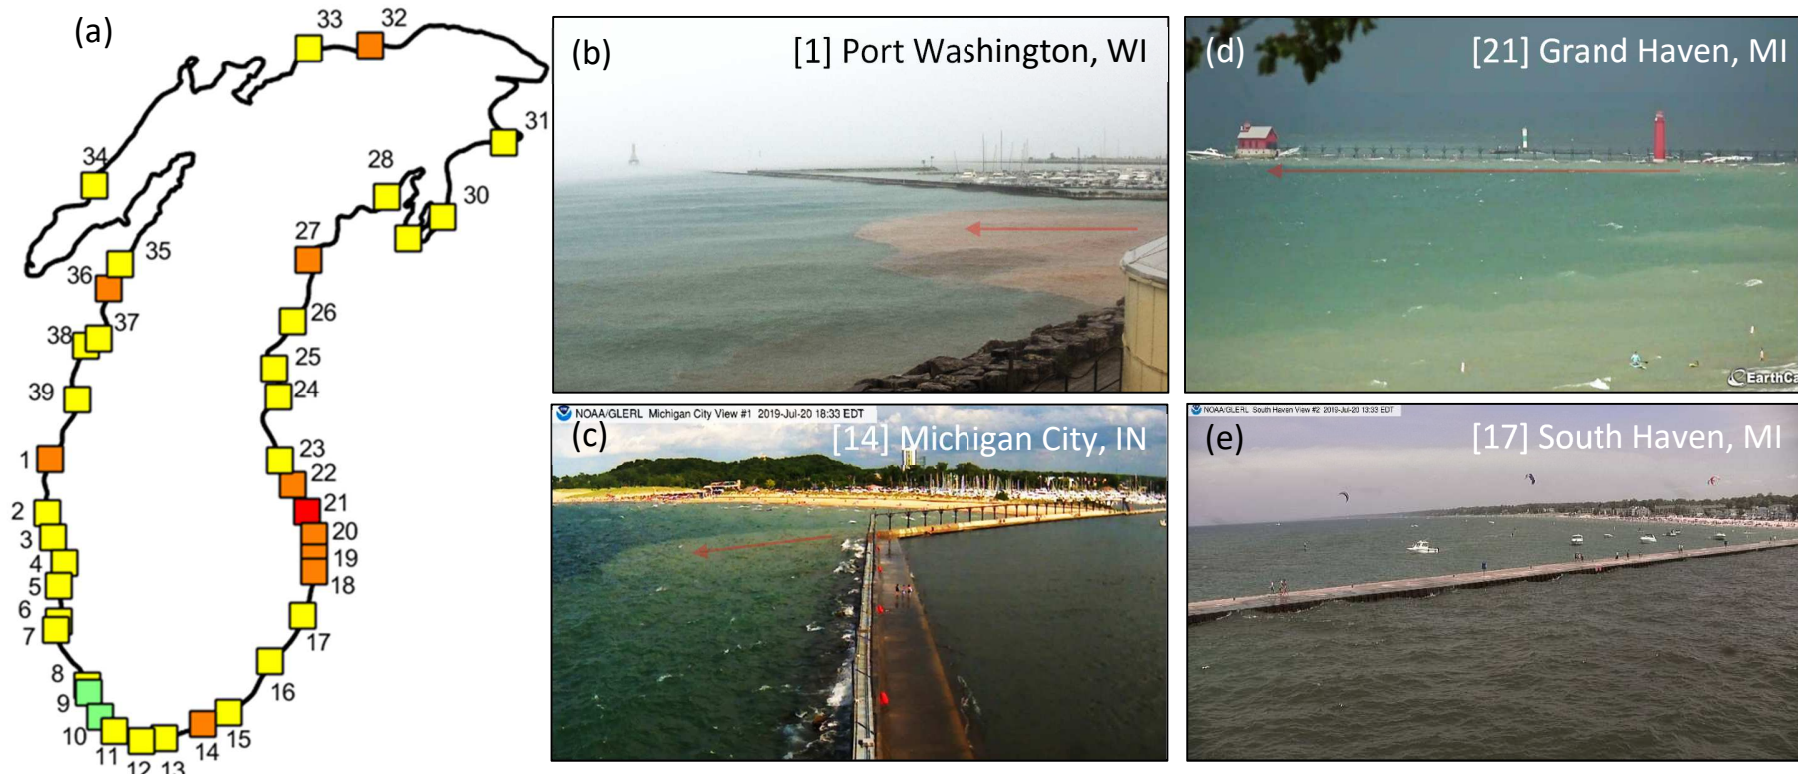
Figure 8.

**Fig. 8.** (a) Assessment of rip current potential occurrences on July 20, 2019 at 39 locations near harbor breakwaters in Lake Michigan. (b-d) images with sediment plume signatures (marked as red arrows) obtained from the three webcams at sites [1] Port Washington (on the west coast of Lake Michigan), [14] Michigan City, IN (on the south coast), and [21] Grand Haven, MI (on the east coast). (e) An image without sediment plume signature at site [17] South Haven, MI.

Applicability of the SRiCAM to other locations near harbor breakwaters around Lake Michigan was examined. Assessments were based on observation data in Lake Michigan from multiple sources including 12 NDBC offshore wave buoys for wave factors, 20 NDBC and ASOS weather stations for winds and pressure factors, and 10 NOAA water level gages for high-frequency water level fluctuation factor. Specifically, nearshore waves were estimated using the dispersion relation (Dean and Dalrymple, 1991). Observed wind directions were compared against shoreline and structure orientations at each location to determine the “updrift” or “downdrift” factor. Fig. 8 (a) shows an example of applying the SRiCAM to assess risks of rip currents on 2019/07/20 at 39 locations in Lake Michigan including Port Washington, WI. The majority (27 out of 39) of locations were assessed as being at *moderate* risk, 10 at *high* risk, and 2 at *low* risk. The assessed risk tiers were consistent with the visual images of rip current occurrences at three locations spanning across the west, south, and east coasts of Lake Michigan at Port Washington, WI ([1]; Fig. 8b), Michigan City, IN ([14]; Fig. 8c), and Grand Haven, MI ([21]; Fig. 8d), respectively. In the three images, rip-induced sediment plumes, shown as red arrows in Fig. 8 (b, c, d), were captured by the camera A2 at the study site (Fig. 1), a webcam by the Great Lakes Meteorological Real-Time Coastal Observation Network and an EarthCam

(earthcam.com), respectively. Note that the image of Fig. 8 (e) shows choppy water without apparent sediment plumes at South Haven ([17]). The assessment was a *moderate* risk, suggesting that there were possible hidden rip currents near the breakwater. In some cases, the assessment outcomes were not yet certain. The assessment for Sheridan Park ([8]) and Chicago, IL ([9]), two locations close to each other, were a *moderate* risk ( $TP=5$ ) and a *low* risk ( $TP=2$ ), respectively. Further study is needed to adjust the environmental proxies in the SRiCAM to the risk tier due to differences in site-specific conditions and local structure configurations. Overall, applicability of the SRiCAM in assessing potential rip current occurrences at locations near harbor breakwaters in Lake Michigan is promising. Future work should be devoted to incorporating and integrating the SRiCAM into regional cyberinfrastructures like the Great Lakes Beach Hazards (National Weather Service, NOAA, 2020) for providing real-time warnings for rip currents near harbor breakwaters in the Laurentian Great Lakes.
