## RESEARCH ARTICLE

# How does over two decades of active wood reintroduction result in changes to stream channel features and aquatic habitats of a forested river system?

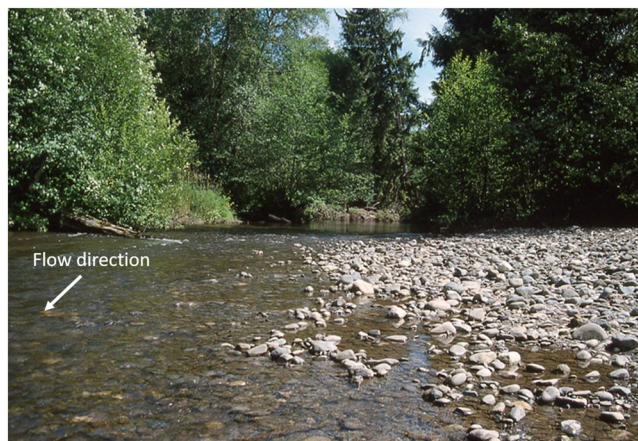
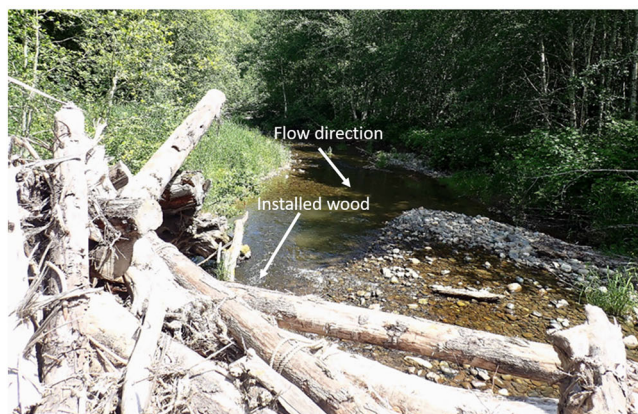
**FIGURE 3** (a) Photo points of Deep Creek, rkm 0.0 to 1.0. Plane-bedded channel in 1997. (b) Photo points of Deep Creek, rkm 0.0 to 1.0. Forced pool-riffle channel in 2020. Note increased wood and reduced substrate size in 2020 [Color figure can be viewed at [wileyonlinelibrary.com](http://wileyonlinelibrary.com)]

Figures 3–7 are examples of some of these changes. Between rkm 0.0 and 1.0 we observed that extensive wood accumulation resulted in a visual change from a plane-bed dominated reach to a forced pool–riffle sequence (Figure 3a,b). The creation of an anastomosing stream reach occurred where a mid-channel engineered logjam was created between rkm 0.3 and 0.5, and new channels formed (Figure 2a). Channel narrowing and vegetation recruitment on the stream banks and gravel bar areas also resulted from the change in wood accumulation (Figures 2a and 3b).

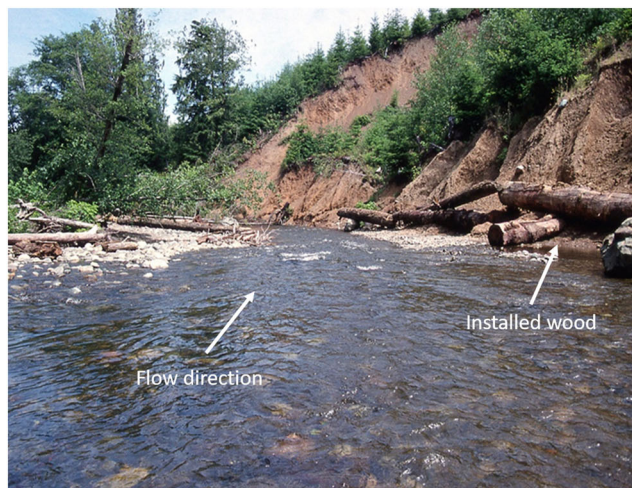
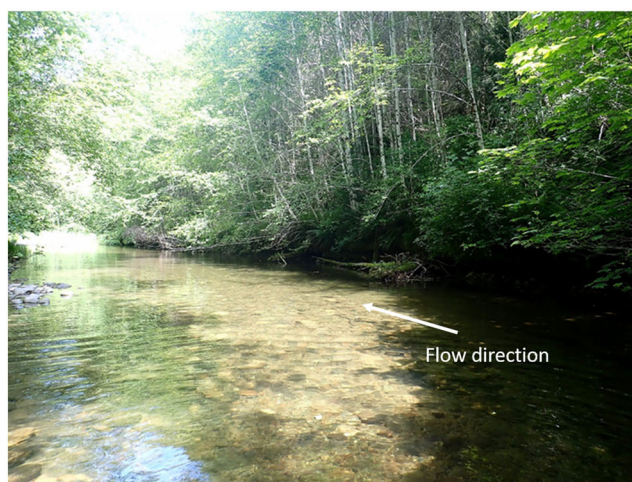
**FIGURE 4** (a) Photo points of Deep Creek, rkm 1.0 to 2.0. Deep-seated landslide in 1997. (b) Photo points of Deep Creek, rkm 1.0 to 2.0. Deep-seated landslide revegetation and stabilization in 2020 [Color figure can be viewed at [wileyonlinelibrary.com](http://wileyonlinelibrary.com)]

For rkm 1.0 to 2.0 there were several significant changes associated with the increase in wood accumulations. A deep-seated landslide from rkm 1.5 to 1.6 revegetated due to the construction of a wood revetment along the toe of the failure on the east bank of Deep Creek (Figure 4a,b). The revetment allowed riparian vegetation, particularly red alder (*Alnus rubra*), to establish on the placed wood as well as the stabilized hillslope (Figure 4b). The wood pieces, combined with the stabilization of the landslide, resulted in a narrower active channel, riparian encroachment and a decrease in the observed width-to-depth ratio through the reach (Figures 2a and 4b). Secondary channels now occur in the majority of Deep Creek between rkm 1.5 and 2.0 (Figure 5a,b).

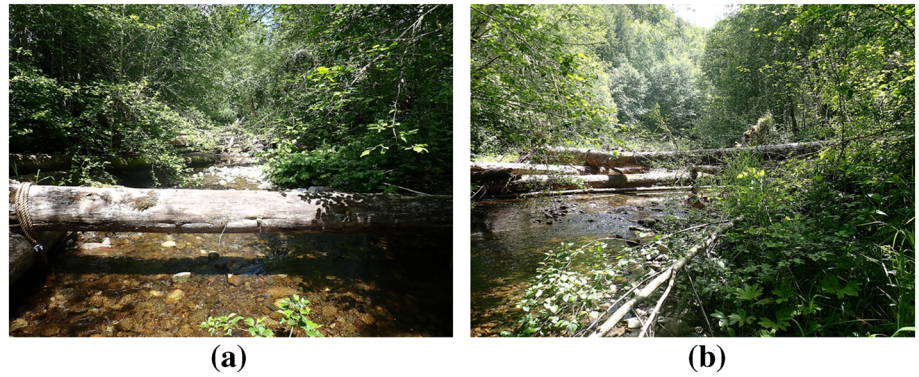
**FIGURE 6** (a) Photo points of Deep Creek, rkm 2.0 to 3.0. Plane-bed channel in 1997 prior to wood placement. (b) Photo points of Deep Creek, rkm 2.0 to 3.0. Forced pool-riffle [Color figure can be viewed at [wileyonlinelibrary.com](http://wileyonlinelibrary.com)]

Approximately 400 m of Deep Creek between rkm 2.0 and 3.0 was converted from a cobble-dominated substrate with a widened channel and a lack of pools to a reach with reduced streambed particle size, noticeable wood accumulations, and increased pool area (Figure 6a,b). Observed bar deposits are now gravel rather than cobble, and channel narrowing, along with vegetation encroachment, are common. Pools have become more frequent and larger in observed surface area. Wood accumulation areas include channel-spanning logjams at rkm 2.2, 2.7, and 2.8 (Figure 2a). Side channels also now exist at rkm 2.2, 2.4, 2.6, and 2.9 (Figure 2a).

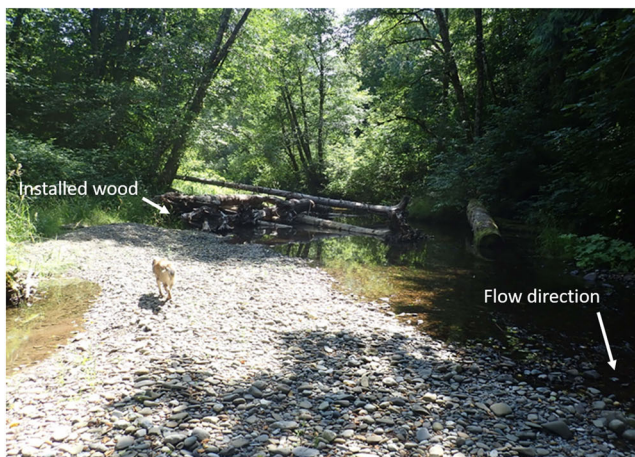
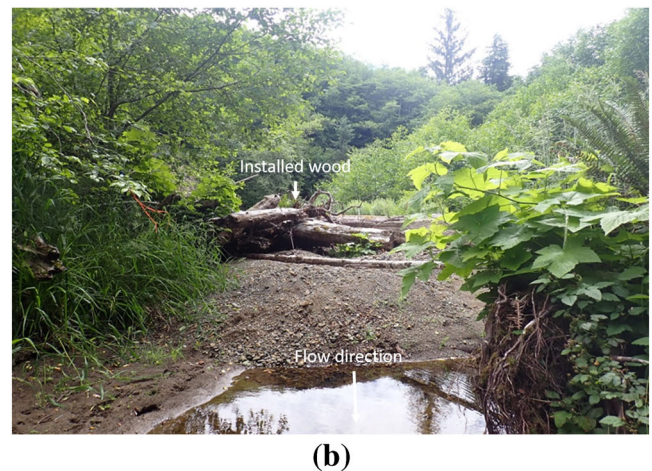
**FIGURE 7** (a) Photo points of Deep Creek, rkm 3.0 to 4.0. Photo from 1997. Channel with wood and reduced streambed particle size in 2020. (b) Photo points of Deep Creek, rkm 3.0 to 4.0. Increased sediment storage and vegetation in 2020 [Color figure can be viewed at [wileyonlinelibrary.com](http://wileyonlinelibrary.com)]

The Deep Creek reach with the identified fewest observed changes was between rkm 3.0 and 4.0. This reach of Deep Creek was identified during restoration implementation as less suited to be treated with the addition of wood. Thus, with the exception of wood placement at rkm 3.7 to 3.9, where the valley begins to widen, there was not significant wood placement. The only changes observed in this reach are associated with an engineered logjam associated island at rkm 3.7, where a side channel and forested island have formed (Figure 2a,b). The area with the logjam has increased sediment storage, streambed fining, increased wood accumulation, and a decreased width-to-depth ratio (Figure 7a,b).

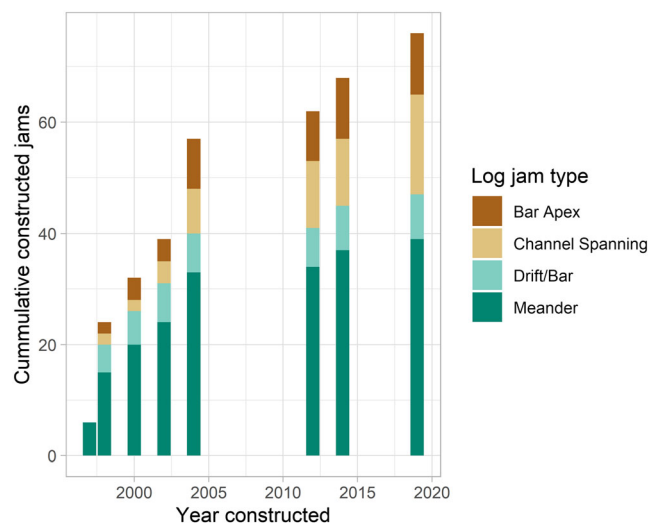
**FIGURE 9** Deep Creek cumulative constructed logjams between 1998 and 2021 [Color figure can be viewed at [wileyonlinelibrary.com](http://wileyonlinelibrary.com)]

The number of constructed logjams increased over time in Deep Creek (Figure 9). The proportion of logjams that were

identified as meander jams was the largest, followed by channel-spanning and bar apex jams (Figure 9). A comparison between constructed and natural logjams reveals a difference in the distribution of logjam type ( $\chi^2 = 11.2$ ,  $p = 0.05$ ) (Figure 10). Meander and channel-spanning jams make up 75% of all constructed jams in Deep Creek (Figure 10). Natural jams have a relative even distribution between channel-spanning, drift/bar, and meander jams. Channel-spanning jams constitute approximately 25% of the jam type, regardless of whether they are constructed or natural jams. Logjam type by location was dominated by meander jams, with the

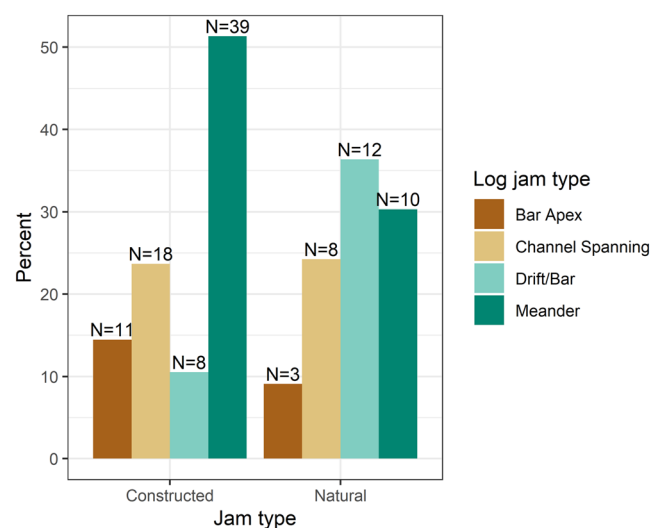
**FIGURE 10** Deep Creek natural versus restored logjam type [Color figure can be viewed at [wileyonlinelibrary.com](http://wileyonlinelibrary.com)]
