T/B APEX 3508: Best Practices for Detection and Recovery of Sunken Oil

ABSTRACT

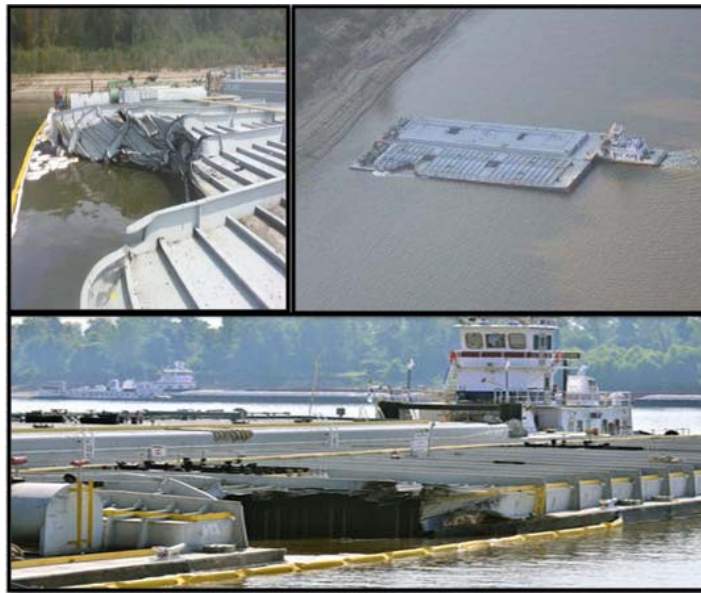
Figure 1: T/B APEX 3508 Damage (Courtesy of the U.S. Coast Guard)

damage assessments and commence the investigation (See Figure 1). Upon the Coast Guard's arrival on-scene on the night of September 2, 2015, the Oil Spill Removal Organization (OSRO) had boomed off the barge and placed absorbents pads within the breached cargo hold. Only light sheening was visible in vicinity of the cargo tank. The Responsible Party's Qualified Individual immediately arrived on-scene and activated the vessel response plan, including mobilization of their designated salvage company. The Coast Guard established a safety zone from mile 938-922, in effect closing the Mississippi River in the vicinity of the incident due to the uncertainty of oil migration and the possibility of the spread of oil via passing traffic.

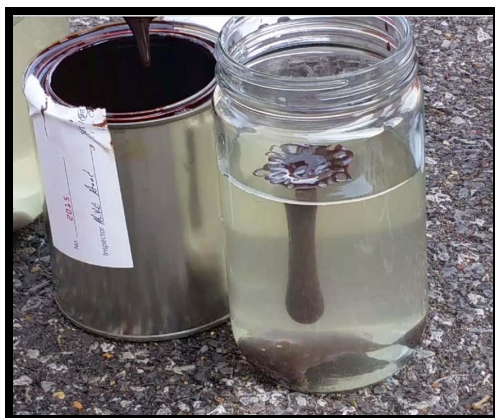
Based on tailgate tests by the NOAA SSC conducted on September 4, 2015, a heated sample and representative sample of river water indicated the product likely sank (See Figure 2). Slow shaking of the sample also suggested the CSO remained a cohesive mass as opposed to breaking into smaller droplets in the weak river currents present during the incident. Finally, an adhesion tailgate test showed CSO affinity for oleophilic snare. Tailgate tests (See Figure 2) were invaluable to the sunken oil workgroup in choosing future sunken oil detection and recovery techniques (Schweitzer et al., 2016).

Figure 2: Tailgate Test Photo (Courtesy of NOAA)

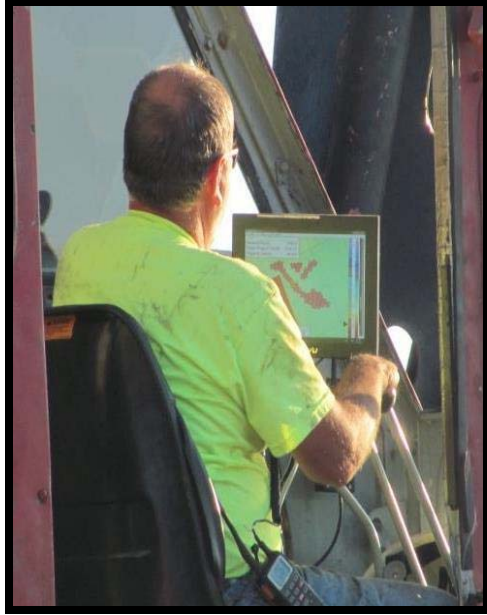
of water collected per grab while preventing the loss of recovered material. Additionally, the clam shell used ClamVision proprietary software which employed six GPS transponders on the bucket head, providing real-time imagery to the crane operator tracking recovery progress (See Figures 5 and 6).

Figure 5: ClamVision (U.S. Coast Guard)
