Natural Disaster Survey Report

"Pike-Buchanan  
Flash Floods of July 15, 1979

National Weather Service, NOAA  
U.S. Department of Commerce  
Silver Spring, Maryland

October 1979

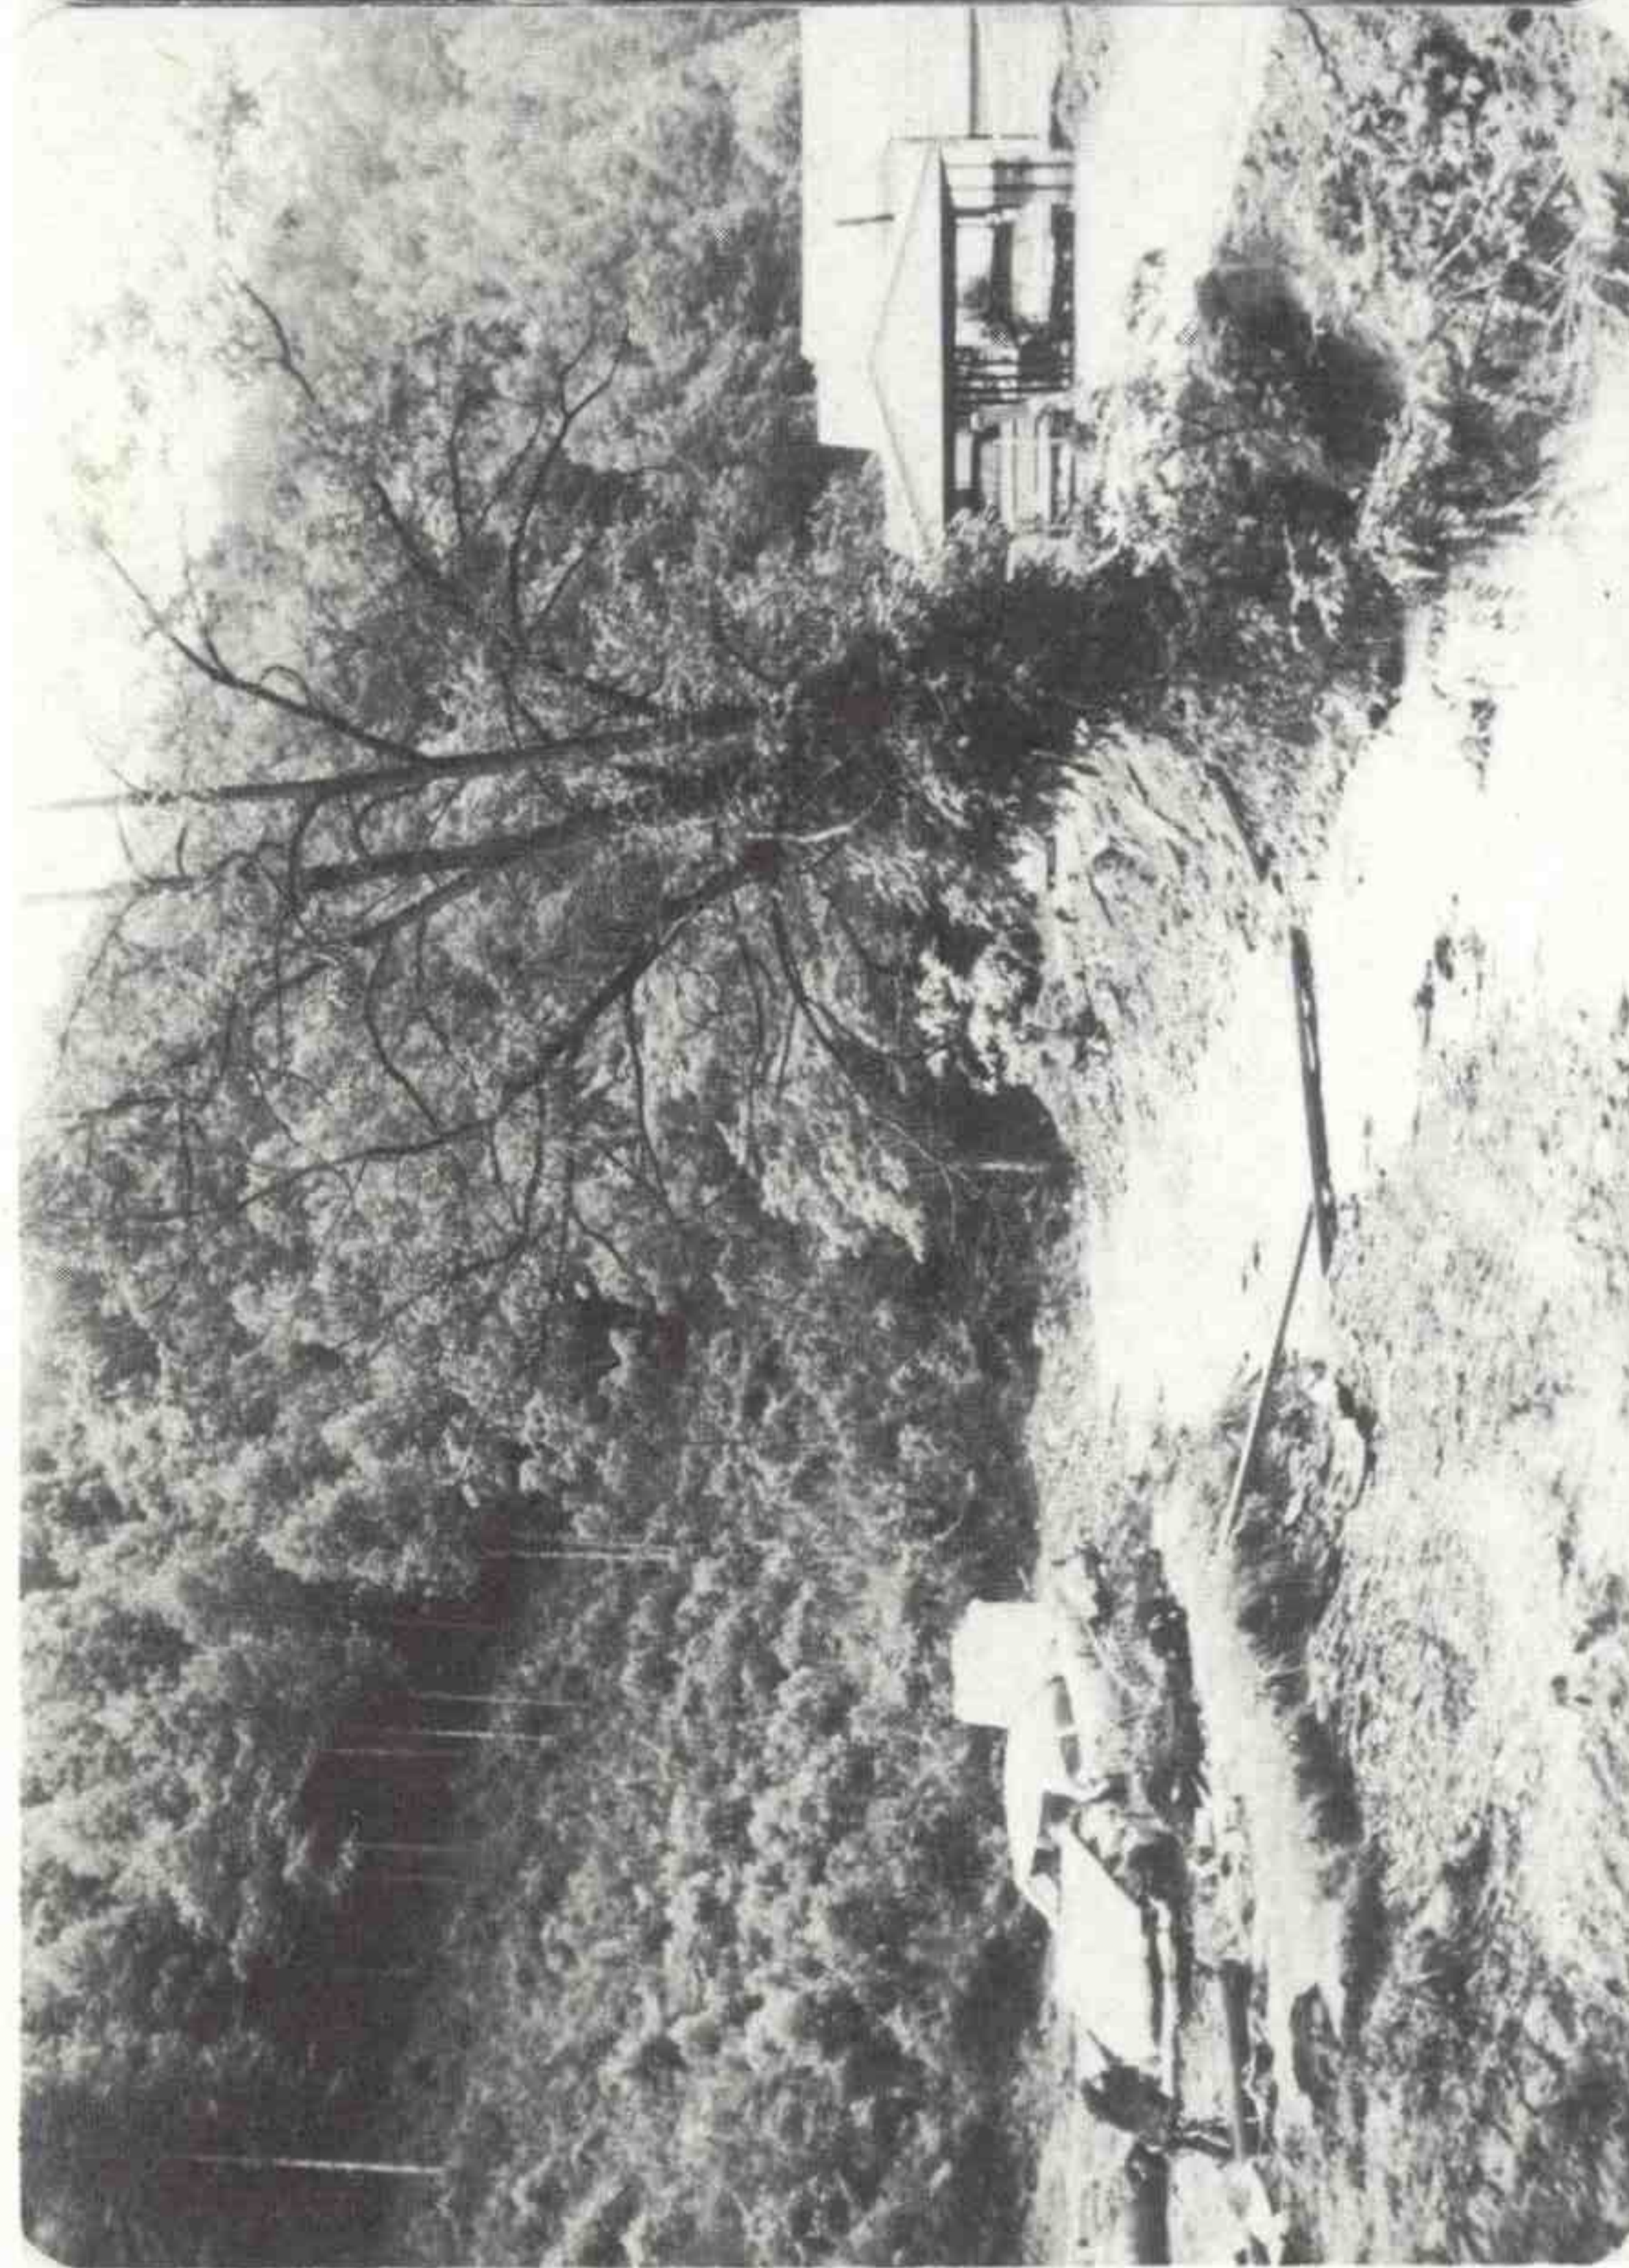
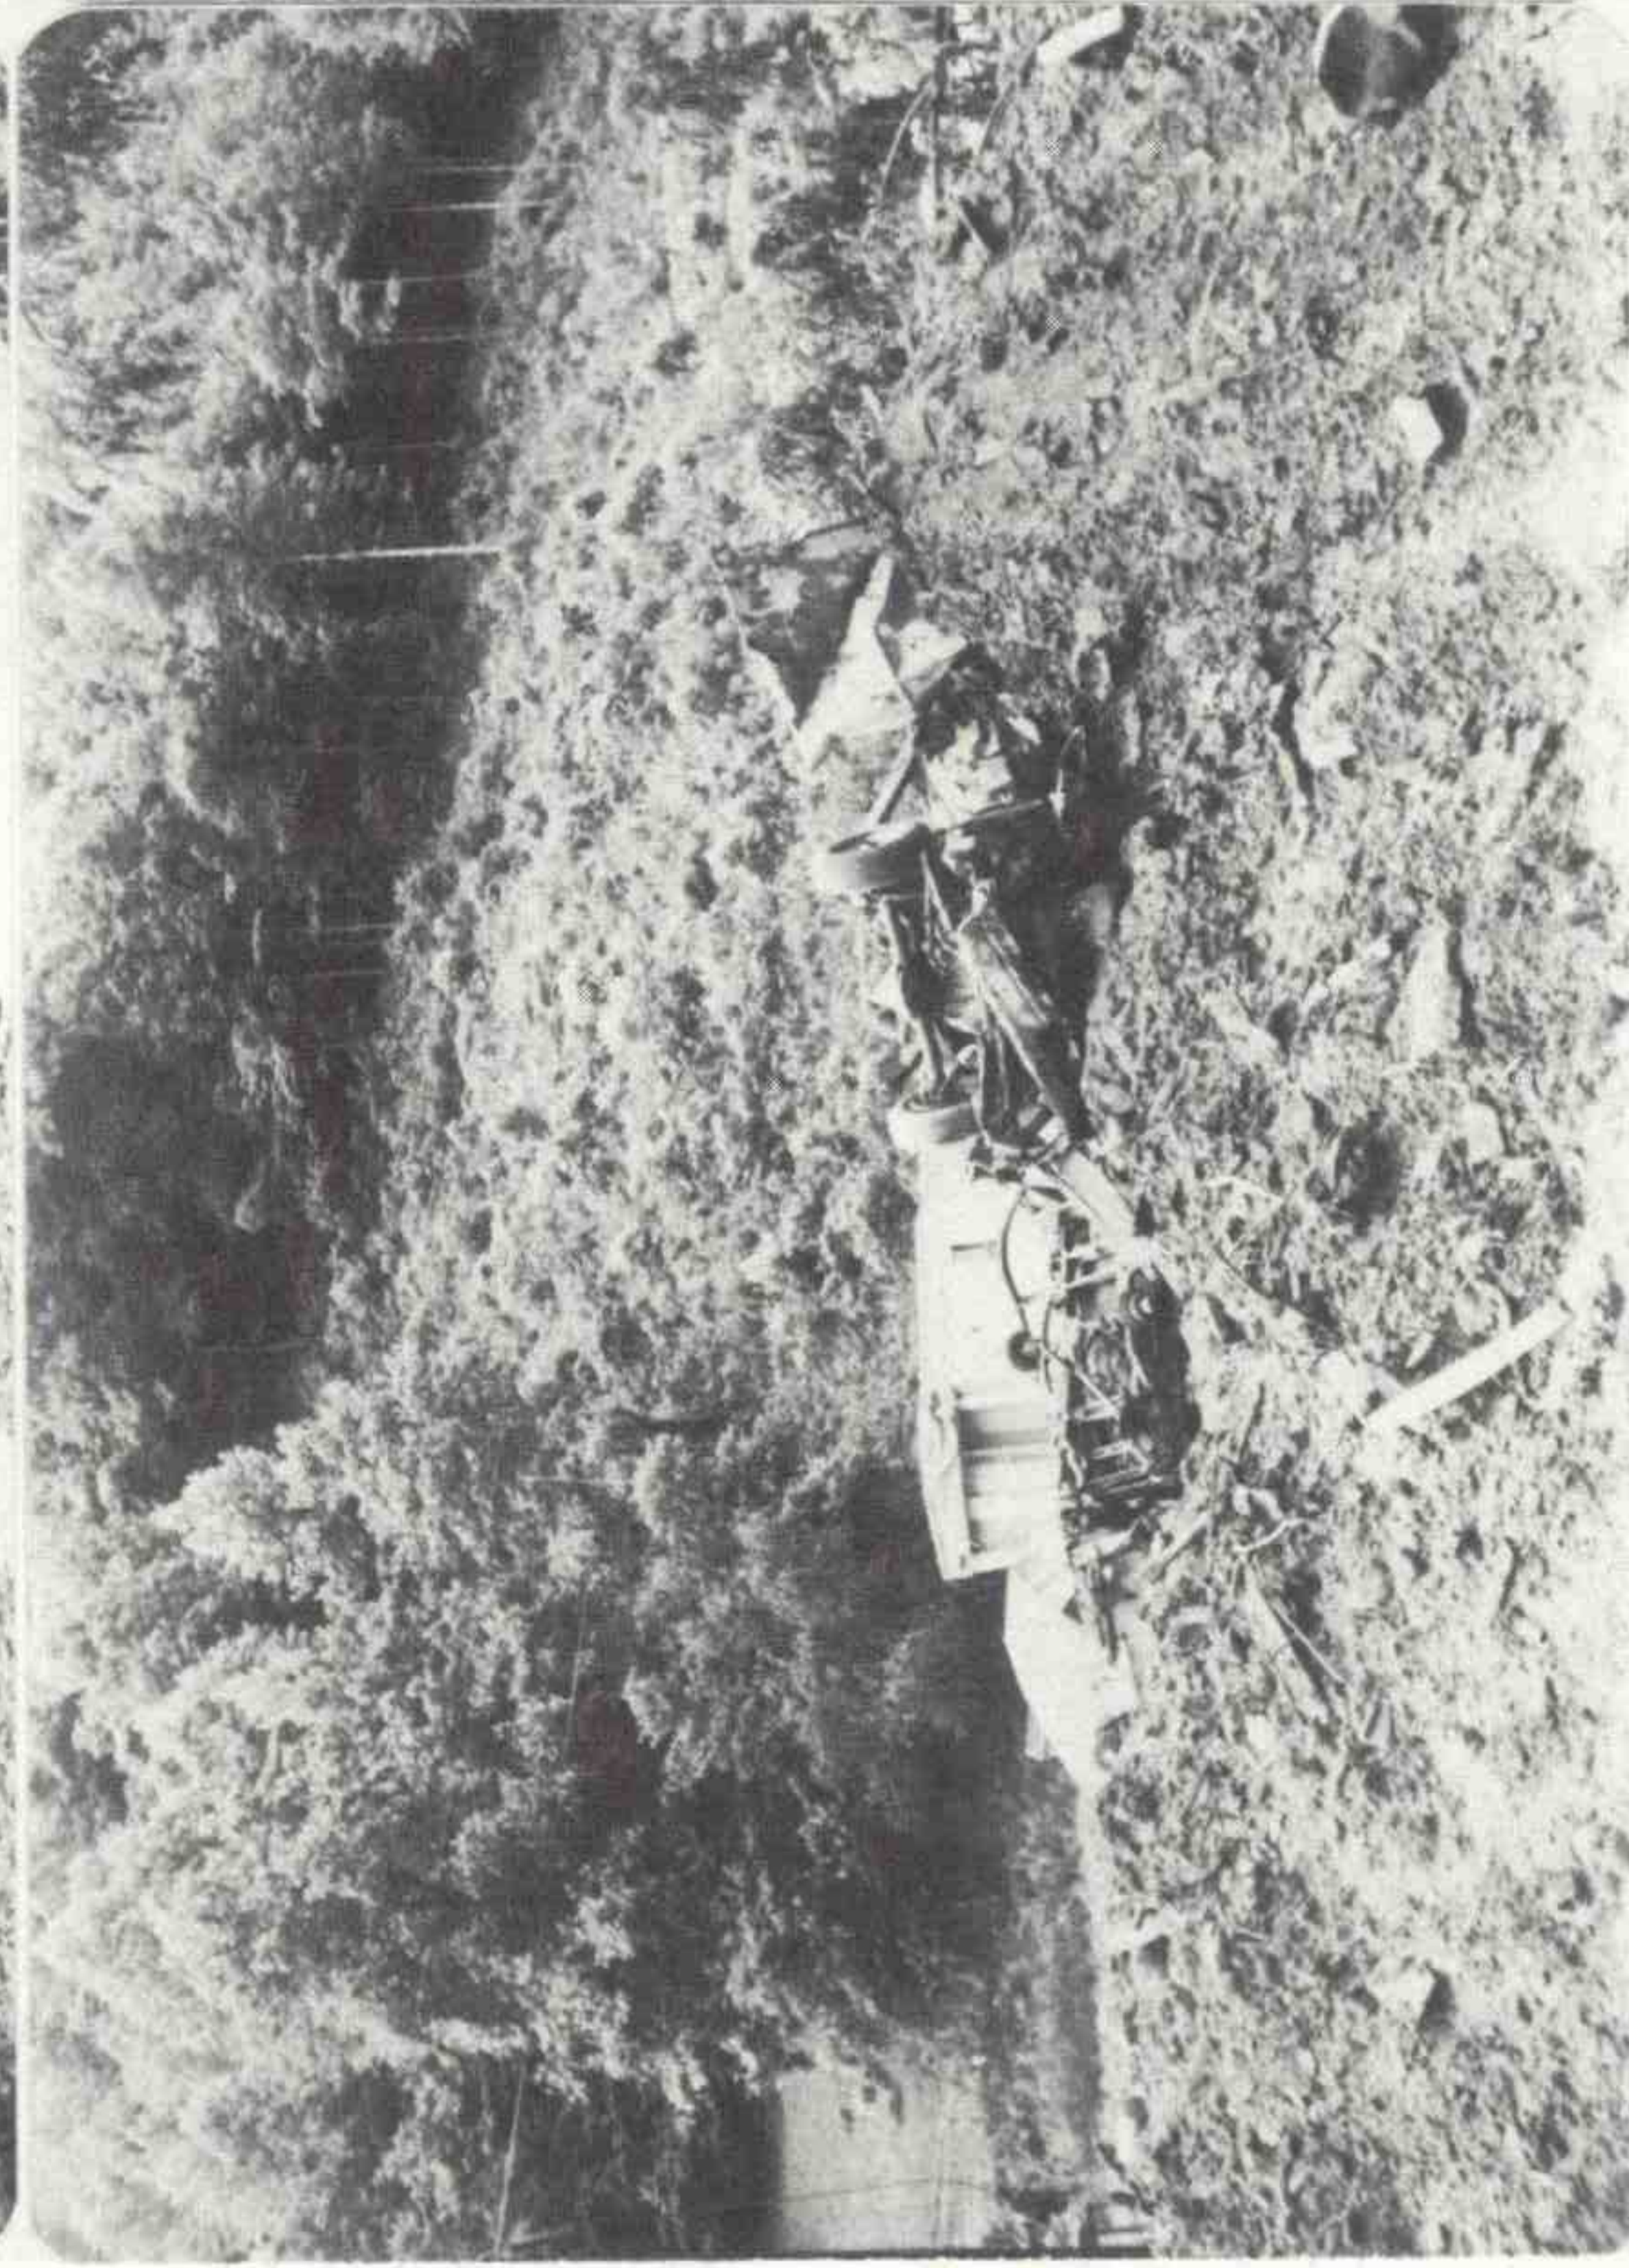
Figure 2.3

Damage survey reports indicate more than 250 homes destroyed or damaged in Pike County and about 200 homes in Buchanan County. Several hundred people were evacuated to public shelters. More than 250 private bridges of the kind in figure 2.3 (lower right) were destroyed. About 50 miles of public road and a dozen bridges were destroyed (figure 2.4).

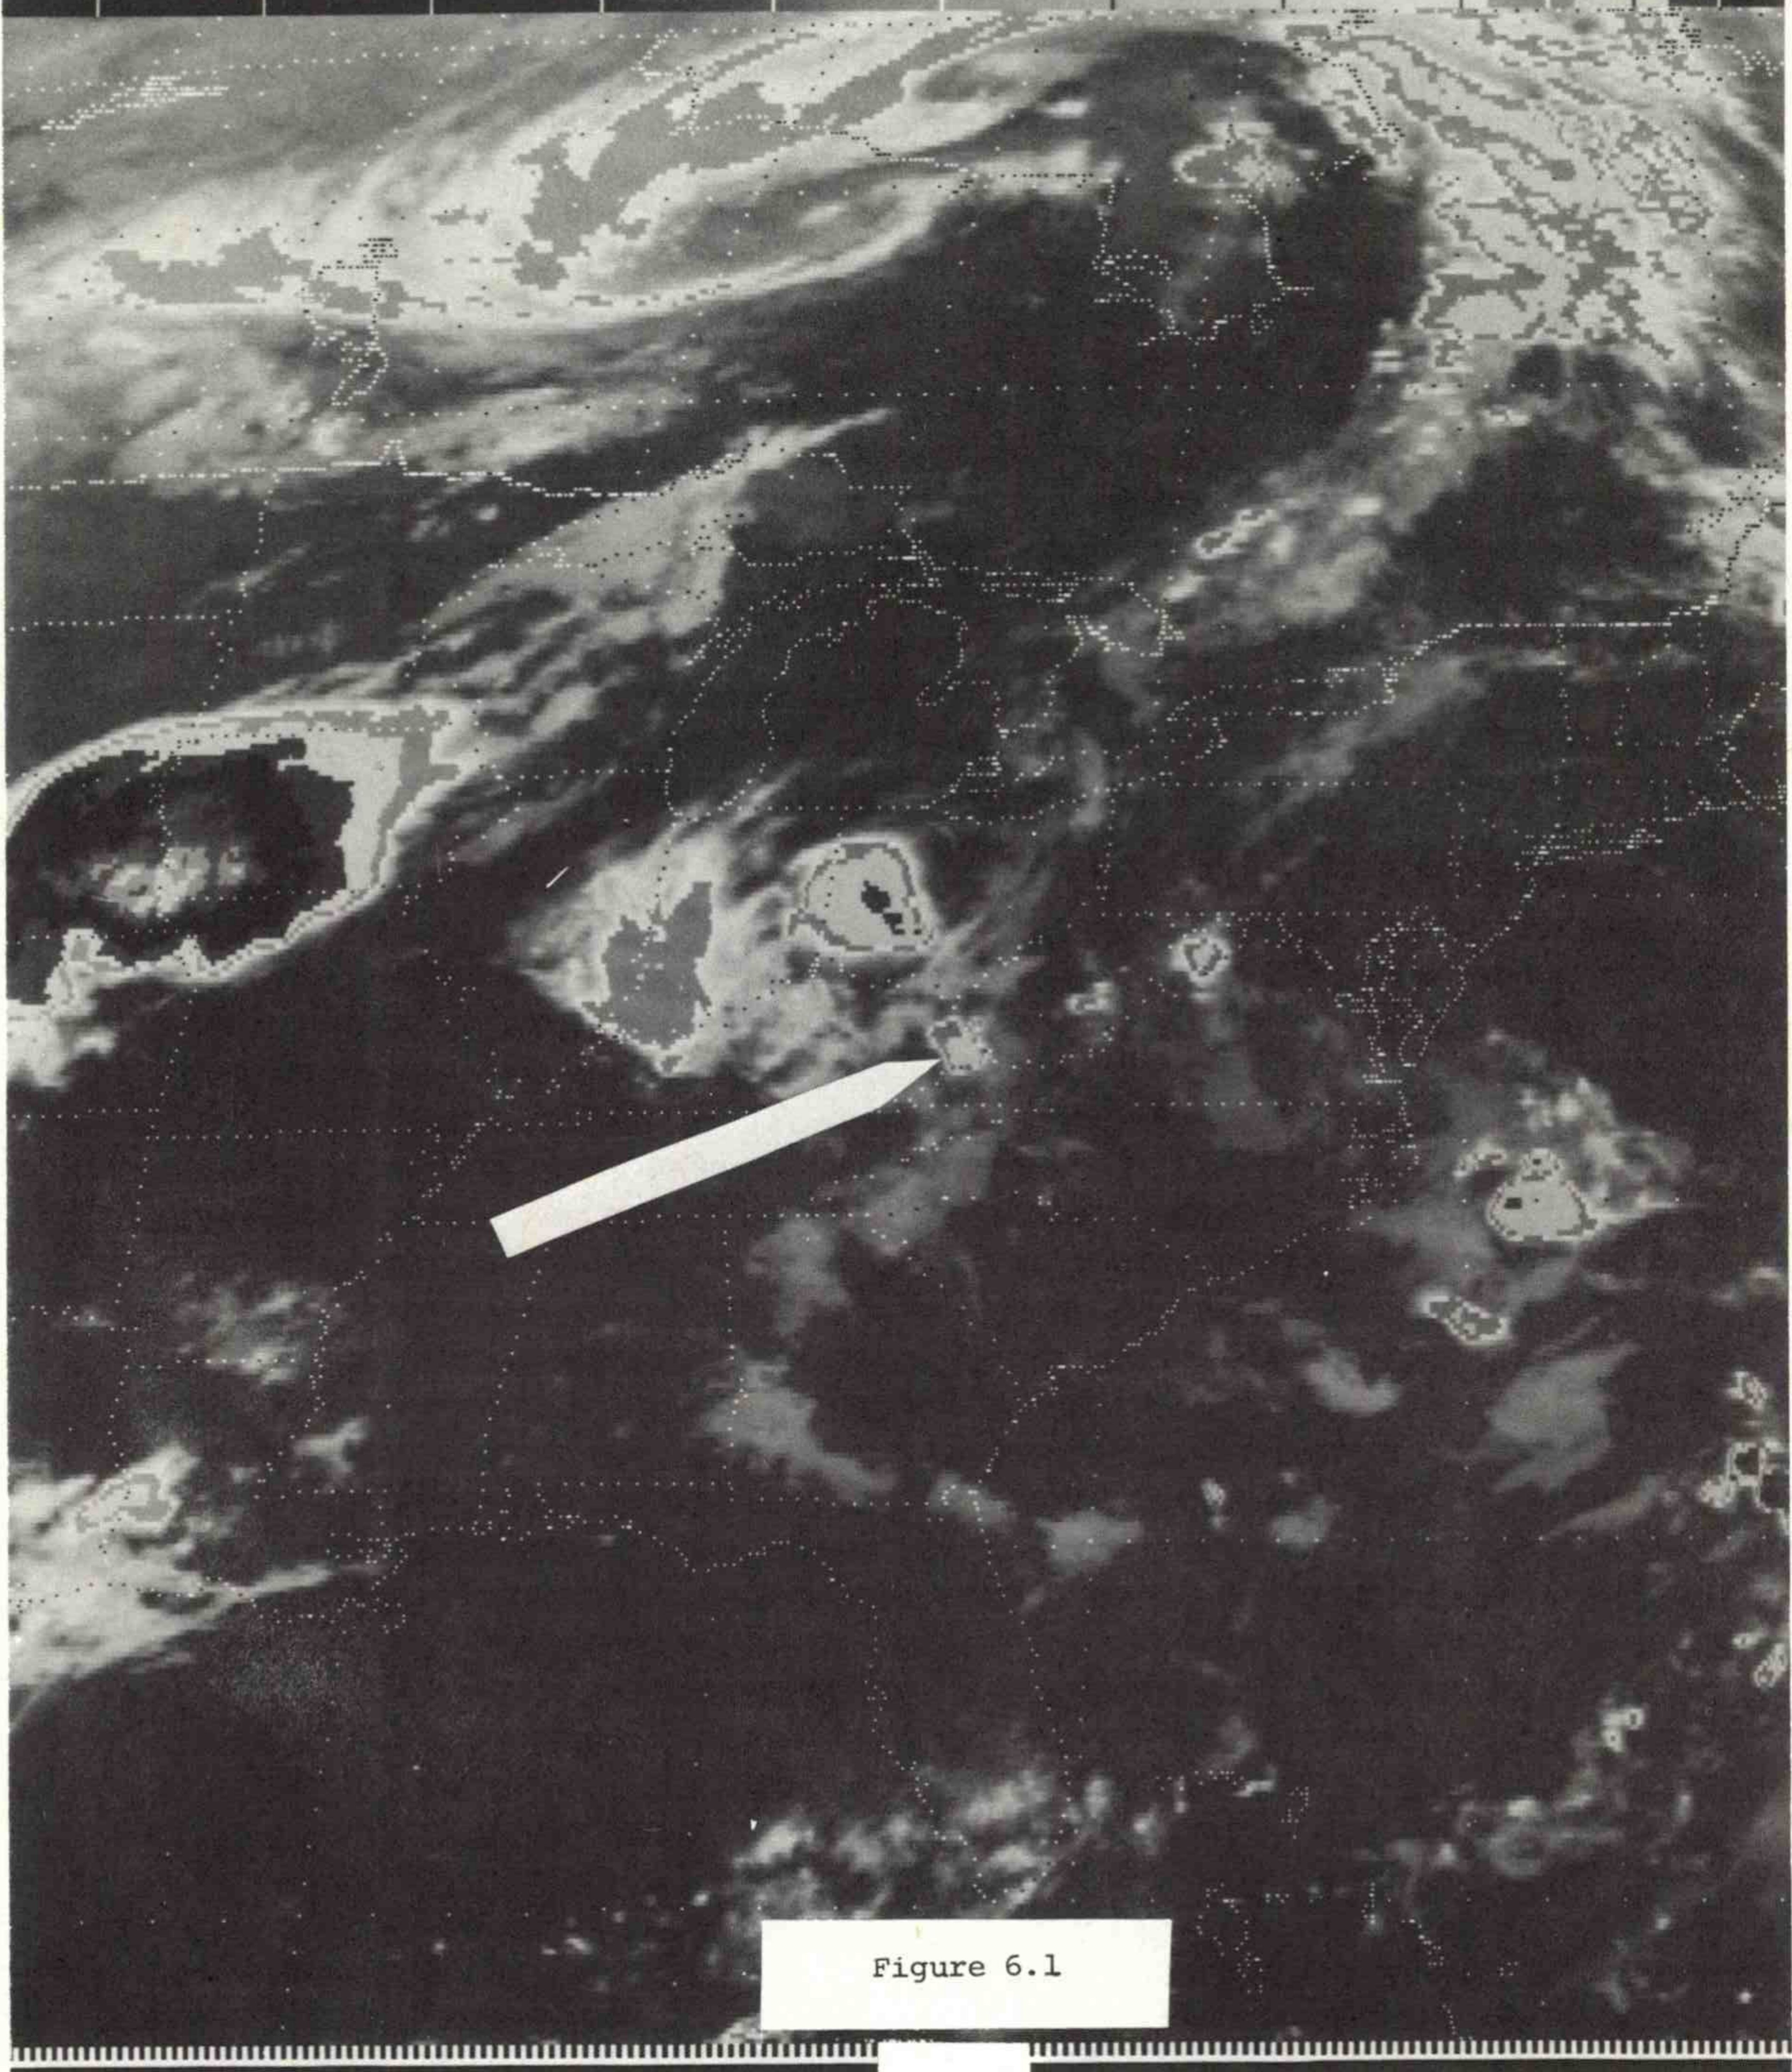
Figure 6.1

0730 15JL79 22E-2MB 01041 18061 DB5

In summary the small cell that eventually increased in intensity and size to produce the flash flood was noticeable in the post analysis at 0530Z (0130 EDT). It continued to develop with cell mergers evident at 0700Z (0300 EDT). From accounts of residents in the area, some of the heaviest rainfall began about this time lasting up to two hours before ending. This timing coincides with the apparent maximum intensity observed by satellite between 0900Z and 0930Z (0500 to 0530 EDT).
