1 **Constraints on restoring landforms and habitats on storm-damaged shorefront lots in**
2 **New Jersey, USA**

3
4
5
6 Karl F. Nordstrom^{a*} and Nancy L. Jackson^b
7

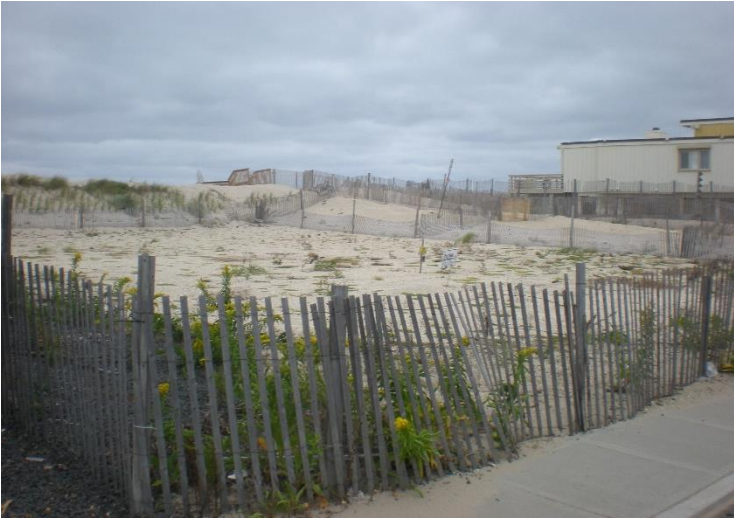
274 Site visits in October 2016 revealed that large cultural debris was removed from all empty
275 lots. Fig. 2 is typical of the appearance of empty lots four years after the storm. Wooden-slat
276 sand fences (Fig. 2) were the most conspicuous cultural features. Fences were used to control
277 aeolian transport, build foredunes and demarcate property boundaries. Evidence of stewardship
278 of the municipally-managed seaward foredune was occasionally seen in new vegetation plantings
279 (Fig. 2), but the privately-managed portion of most lots showed no indication of active
280 landscaping after clearance of debris. The most conspicuous native vegetation was American
281 beach grass (*Ammophila breviligulata*), planted on the foredune, and isolated patches of seaside
282 goldenrod (*Solidago sempervirens*), apparently occurring through natural colonization landward
283 of the foredune (Fig. 2). The density of native vegetation was often in small patches at the

284 margins of lots where the surface was not graded following removal of structures or where sand
285 had accumulated against fences, creating incipient dune forms on an otherwise deflated surface
286 (Fig. 2, left foreground).

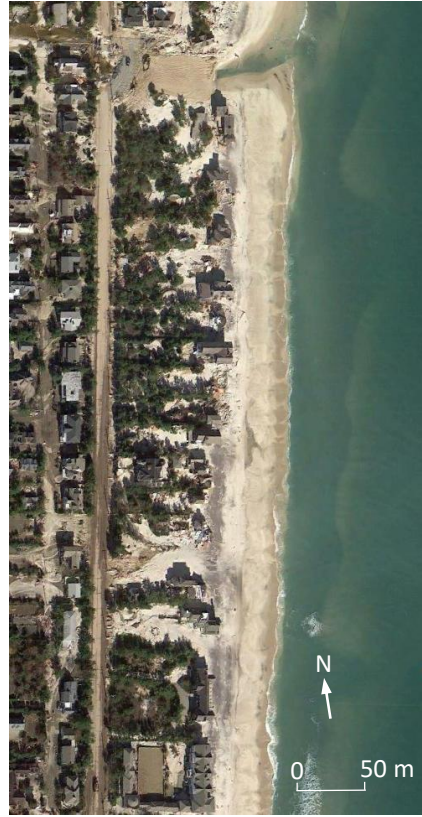
291 Before Sandy, many lots were well vegetated landward and seaward of houses and within
292 vegetated strips along boundaries between lots (Fig 3a), with much of the vegetation being
293 woody shrubs (densely vegetated category in Table 1). Much of the pre-existing vegetation was
294 disturbed by overwash or aeolian transport from the storm (Fig. 3b). By 2016, undeveloped lots
295 were mostly devoid of woody shrubs (Table 1) or pre-existing topographic diversity (Fig. 3c).
296 Some of the vegetation that survived the storm was removed mechanically along with the
297 remnant structures to expedite clearance of debris. Decrease in vegetation cover through time on
298 developed lots where houses were not removed or were rebuilt by 2016 (Fig. 3d) implies that
299 little human attention was given to aid reestablishment of vegetation, whether the lots were
300 occupied or not. The stabilization of foredunes seaward of lots restricted transport of sand inland

301 from the beach to create new incipient dunes on the lots, and no attempts were made to
302 reestablish topographic diversity using earth-moving equipment.
