# Rapid assessment of abrupt urban mega-gully and landslide events with structure-from-motion photogrammetric techniques validates link to water resources infrastructure failures in an urban periphery

**Abstract.** Mass movement hazards in the form of mega-gullies and landslides pose significant risks in urbanizing areas, yet they are poorly documented. To obtain primary data on the size, frequency, and triggers of abrupt mega-gullies and landslides in urban areas, rapid assessment methods based on structure-from-motion (SfM) photogrammetric techniques and watershed models were developed and deployed in the Los Laureles Canyon, a rapidly urbanizing watershed in Tijuana, Mexico. Three abrupt earth surface hazards were observed over a 5-year study period including two mega-gullies and one landslide, and all were linked to a combination of rainfall and water resources infrastructure failures (WRIFs): (1) water main breaks resulted from rainfall-driven gully erosion that undermined supply lines, and the resulting water jets caused abrupt mega-gully formation; this represents one of the first studies to document this process in an urban environment; (2) antecedent saturation of a hills

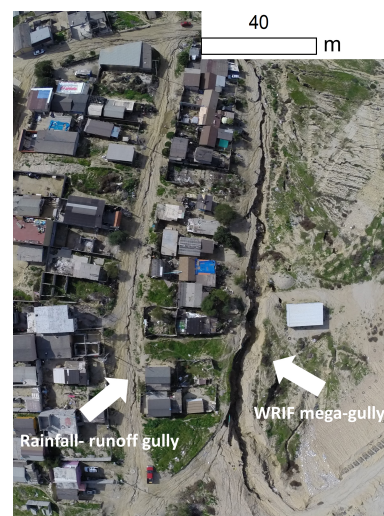
The mega-gullies observed here are large compared to rainfall-generated gullies surveyed in the study area (Gudino-Elizondo et al., 2018a), which had a mean gully width of 1.5 m and a mean depth of 0.5 m. In terms of size, mega-gully A was up to 8 m wide and 4 m deep and mega-gully B was up to 10 m wide and 7 m deep. Mega-gullies A and B were also long with lengths of 100 and 200 m, respectively. They were also more developed than rainfall-generated gullies, with greater connectivity to the stream channel, which enhances sediment delivery to the stream network. Figure 7 presents an aerial image which provides a visual comparison of mega-gully B to a rainfall-driven gully network on a neighboring unpaved road.

**Figure 7.** High-resolution photograph showing the contrast between gullies generated by rainfall–runoff only (road on left) and mega-gully B (road on right).
