NOAA Technical Memorandum NWS SR-189

**WOLF CREEK FLOOD OF SEPTEMBER 17-19, 1996**

June 1997

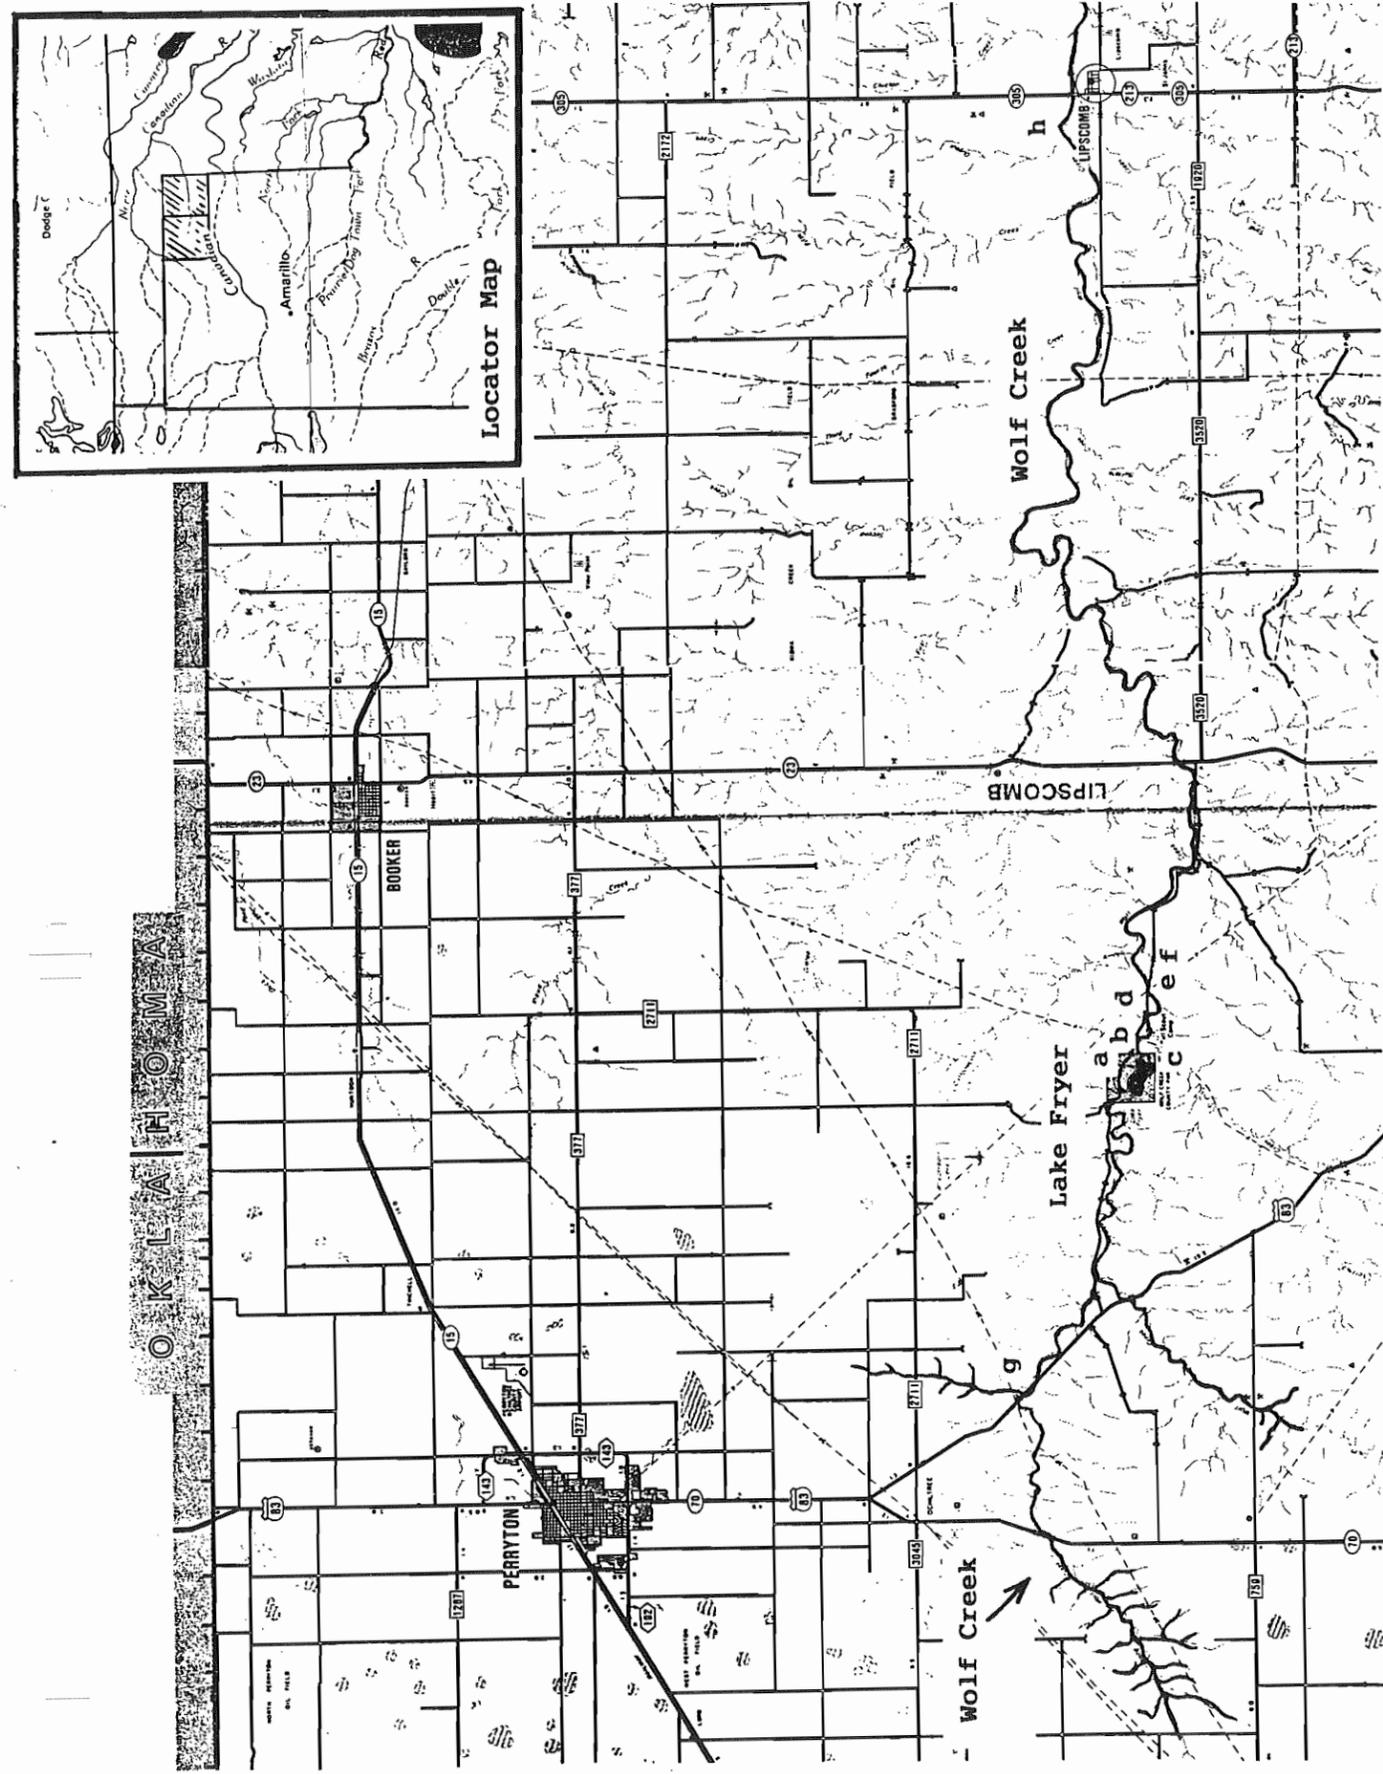
Fig. 1. Map of the northeastern portion of the Texas Panhandle, showing area of flood on Wolf Creek. Letters indicate locations of photos shown in Fig. 3. Ochiltree (l) and Lipscomb (r) Counties are the small cross-hatched squares in the inset locator map.

Wolf Creek (Fig. 1) is a small watershed creek which originates in Ochiltree County, and flows through Lipscomb County (both part of Amarillo's Hydrologic Service Area) and then into northwest Oklahoma. This report will detail the events which led up to the record flooding which occurred along Wolf Creek on September 18, 1996. This flood resulted in an estimated \$500,000 in property damage in Ochiltree and Lipscomb Counties in the northeast Texas Panhandle. Figure 2 shows the WSR-88D estimated and the observed rainfall for this event. Circumstances that resulted due to the flood, the magnitude and damage of the flood and findings and recommendations for ways to mitigate the potential hazards posed by flooding are also discussed.

The topography of the region is composed of gently rolling hills with deep creek channels. Many smaller tributaries run into Wolf Creek as the creek makes its way to Lake Fryer (Fig. 1). Further downstream the topography becomes flatter, with the creek channels becoming progressively wider as the creek makes its way across Lipscomb County. Figure 3 shows photos taken after the flood at Lake Fryer and downstream locations. An automated USGS river gauge is located along the creek at Lipscomb in central Lipscomb County. This site is currently not a river forecast point; and at the time of this event, little flood information was available.

Flooding also occurred in Ochiltree County in areas upstream and downstream from Wolf Creek County Park. Several residences and ranches experienced flooding. Several of the residents downstream of Lake Fryer had to be evacuated by helicopter as their homes became islands. Many roads were also flooded. The flooding caused significant damage to the road surfaces along U.S. Highway 83 (Fig. 3g) and FM Road 759 (a few miles south of the location of Fig. 3g—see Fig. 1 for map).

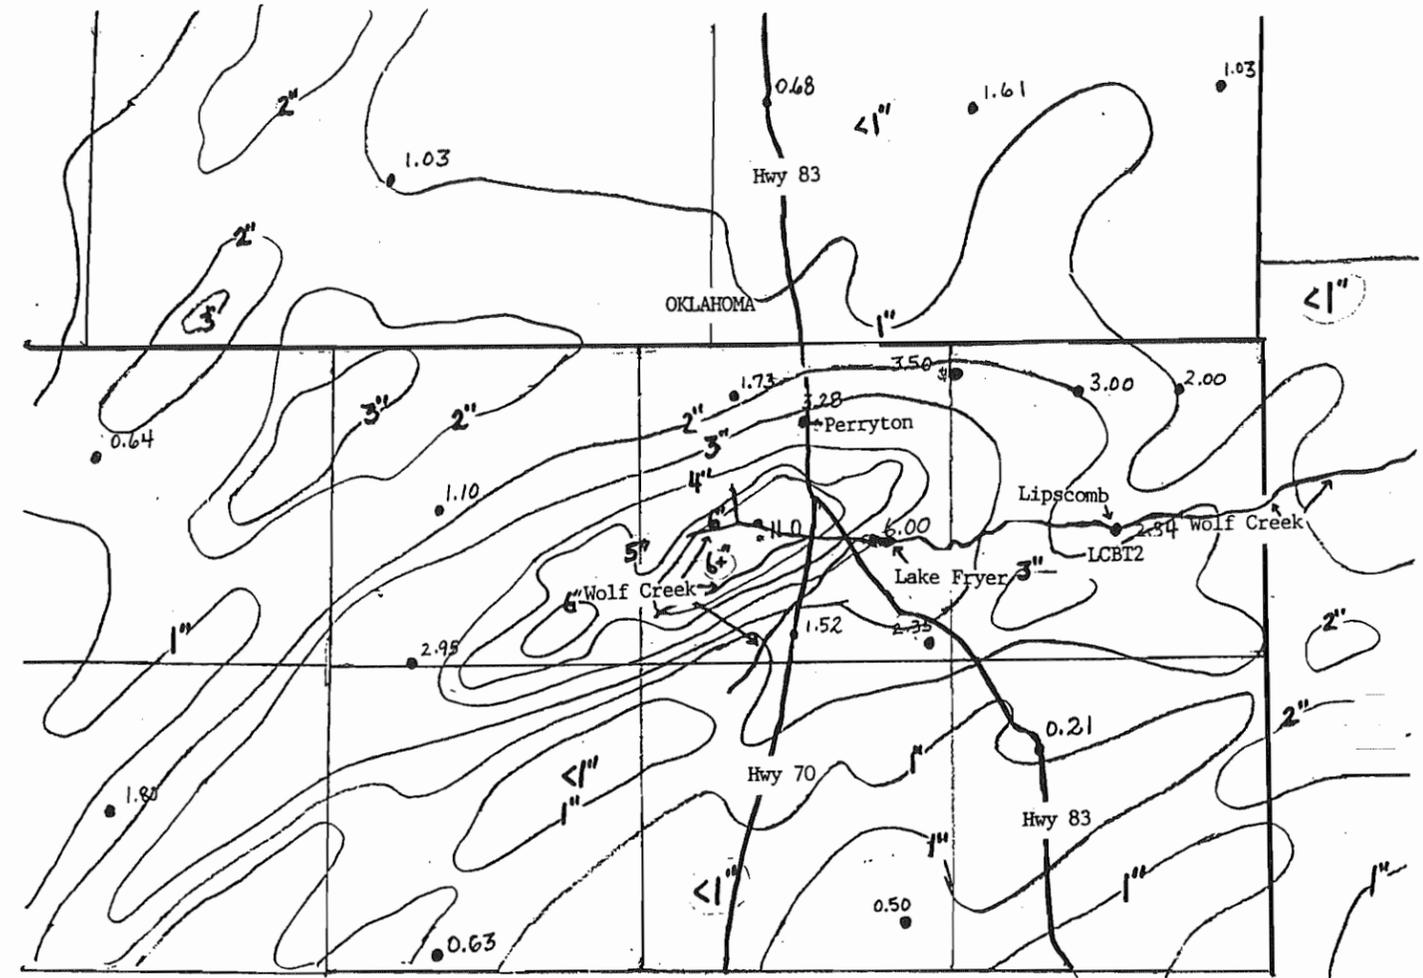
Fig. 2. Isohyets based on contouring the Storm Total Precip product from the Amarillo WSR-88D, with plotted rainfall reports available from the flood area.

Radar estimated as much as 8 in of rain fell across the headwaters of Wolf Creek during the evening and early morning hours of September 17-18, with an unofficial gauge report of around 11 in. Wolf Creek County Park reported around 6 in. As seen in Fig. 2, a comparison with the limited ground truth reports indicated the WSR-88D performed quite well overall. A few areas along the northern side of the heavy rain band were underestimated by about 1 in.

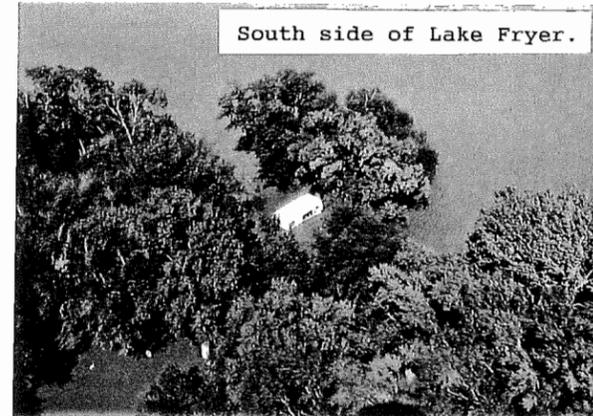
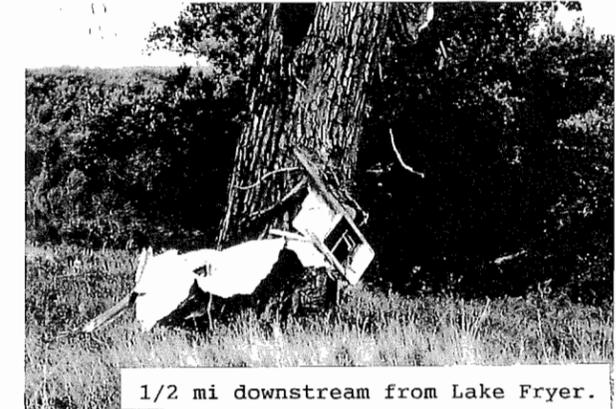
Fig. 3. Photos of Wolf Creek, showing damage.

Around 0800 CDT, both RVs that were first evacuated were drawn into the lake and eventually carried over the spillway. The concessionaire, who was trapped on the opposite side of the lake, saw both units and was concerned that they were still occupied. Fortunately, there were no injuries or fatalities. However, of the seven RVs at the park, two were carried downstream, three were considered total losses, and two escaped with little or no damage (Figs. 3c and 3d).

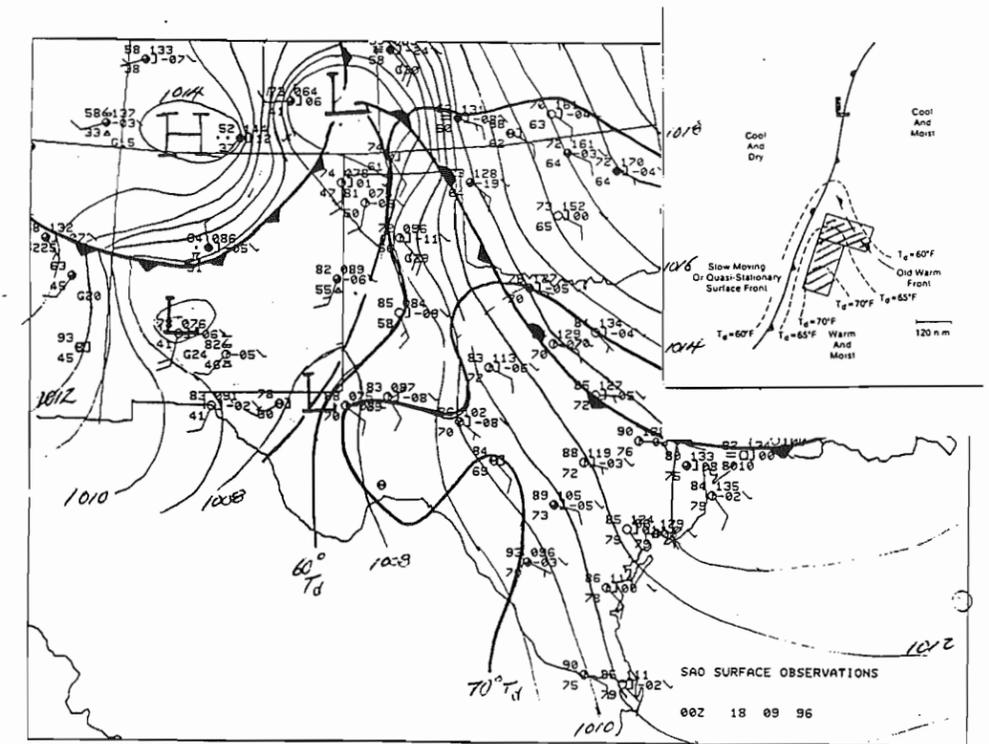
Fig. 4. Surface analysis for 0000 UTC September 18, 1996. Inset: Maddox typical flash flood event (possible flood watch area shown as shaded rectangles).

These conditions relate closely to the "synoptic flash flood type" (Maddox 1979). A comparison of the meteorological conditions on September 17 and the mean conditions of the synoptic flash flood type as presented by Maddox is found in Table 2. Actual analyses and Maddox synoptic flash flood meteorological analyses are compared for the surface, 850 mb and 500 mb in Figs. 4-6.

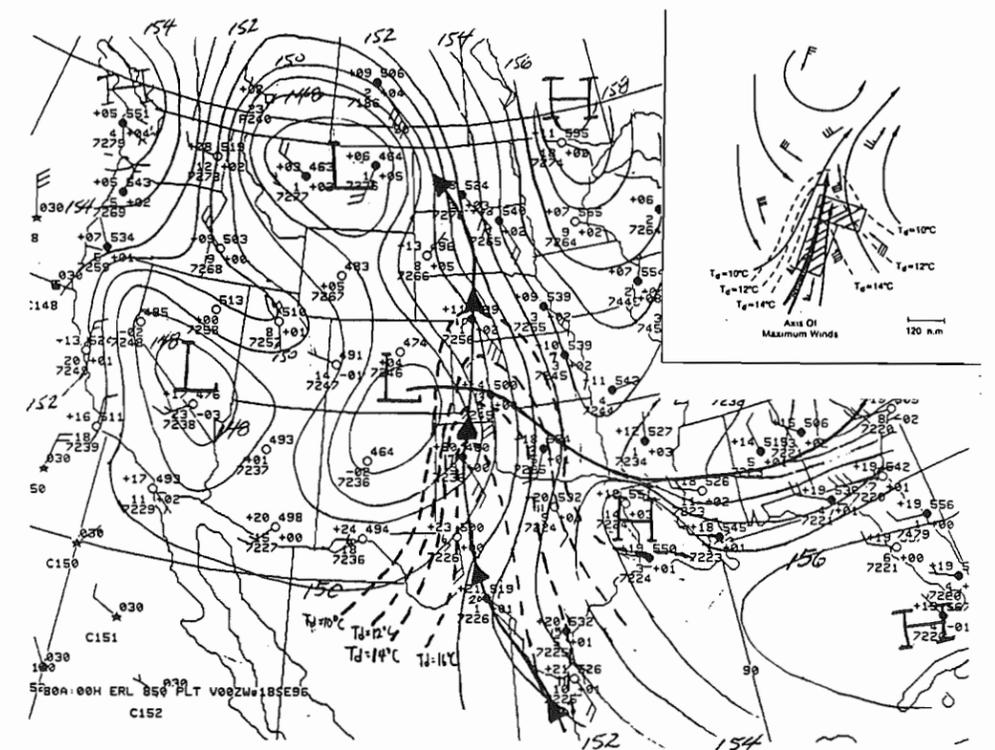
Fig. 5. Same as Fig. 4, except 850 mb analysis.

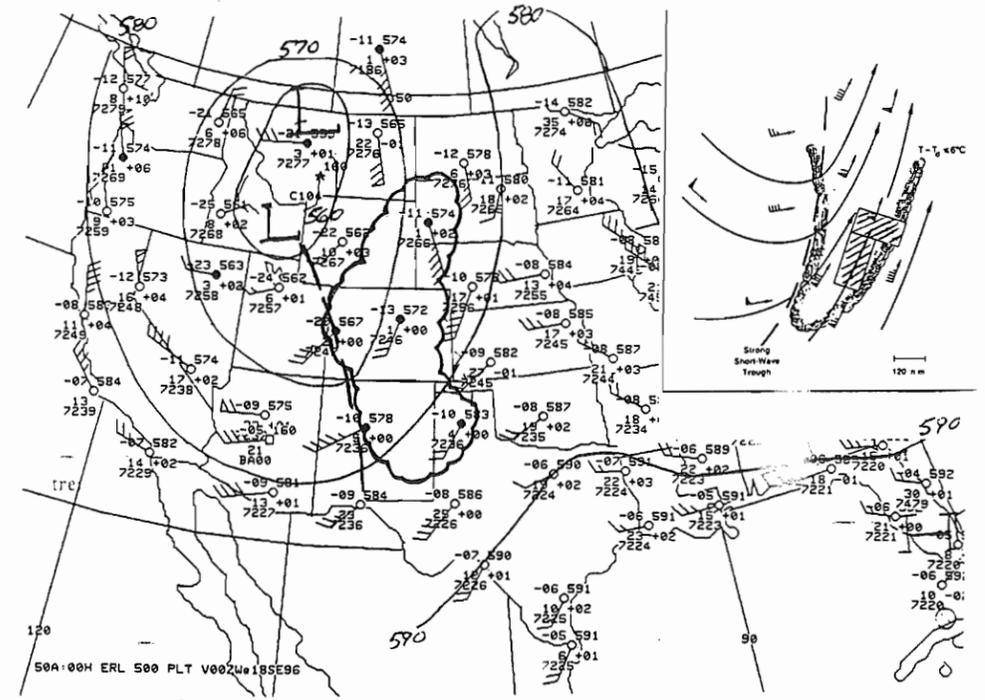
Fig. 6. Same as Fig. 4, except 500 mb analysis.

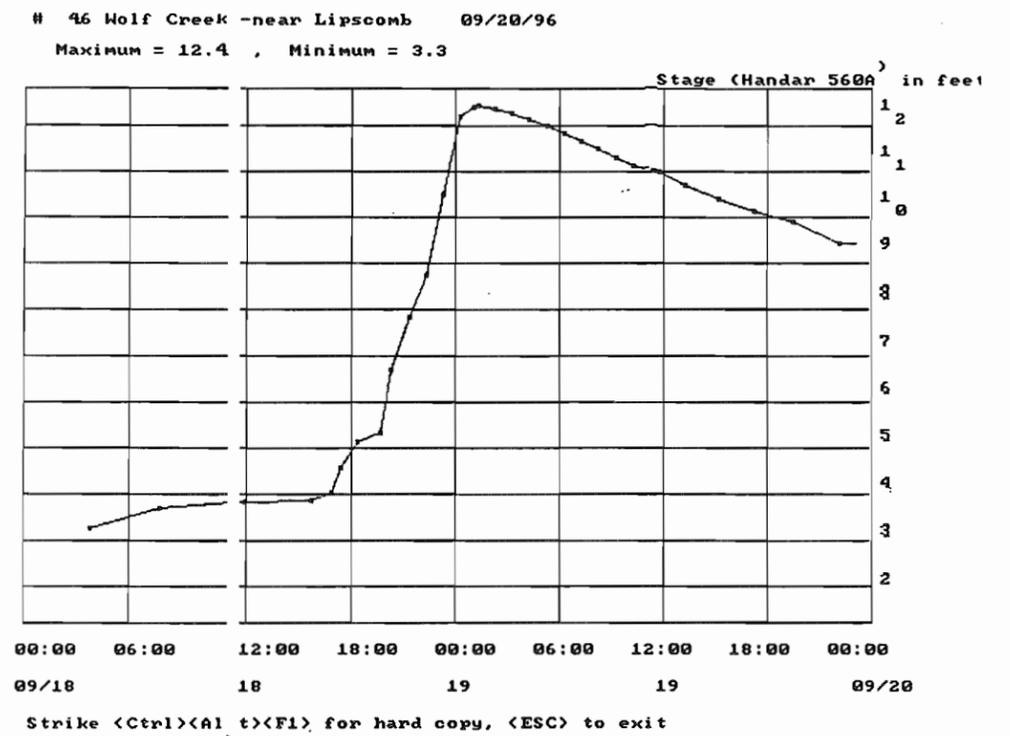
Fig. 7. River stages for Wolf Creek near Lipscomb.

Movement of the flood wave crest from Lake Fryer (1000 CDT September 18) to the gauging site at Lipscomb (0100 CDT September 19) took about 15 hr. Little information from previous floods was known for this site. The first indication of rising water was received at 2330 CDT September 18 from a HYDROMET alert. A stage of 10.47 ft was reported. Based on record flood stage information alone, a river flood warning was issued at 0003 CDT September 19. The river crested at a height of 12.44 ft at 0100 CDT. The stage went from 4.03 ft at 1630 CDT to 12.44 ft at 0100 CDT the following day (Fig. 7). The highest stage during the period of record was 11.57 ft in 1941.
