2024 Snapshot Day: Annual Volunteer Water Quality Monitoring Report

February 2025
National Marine Sanctuaries Conservation Science Series ONMS-25-02

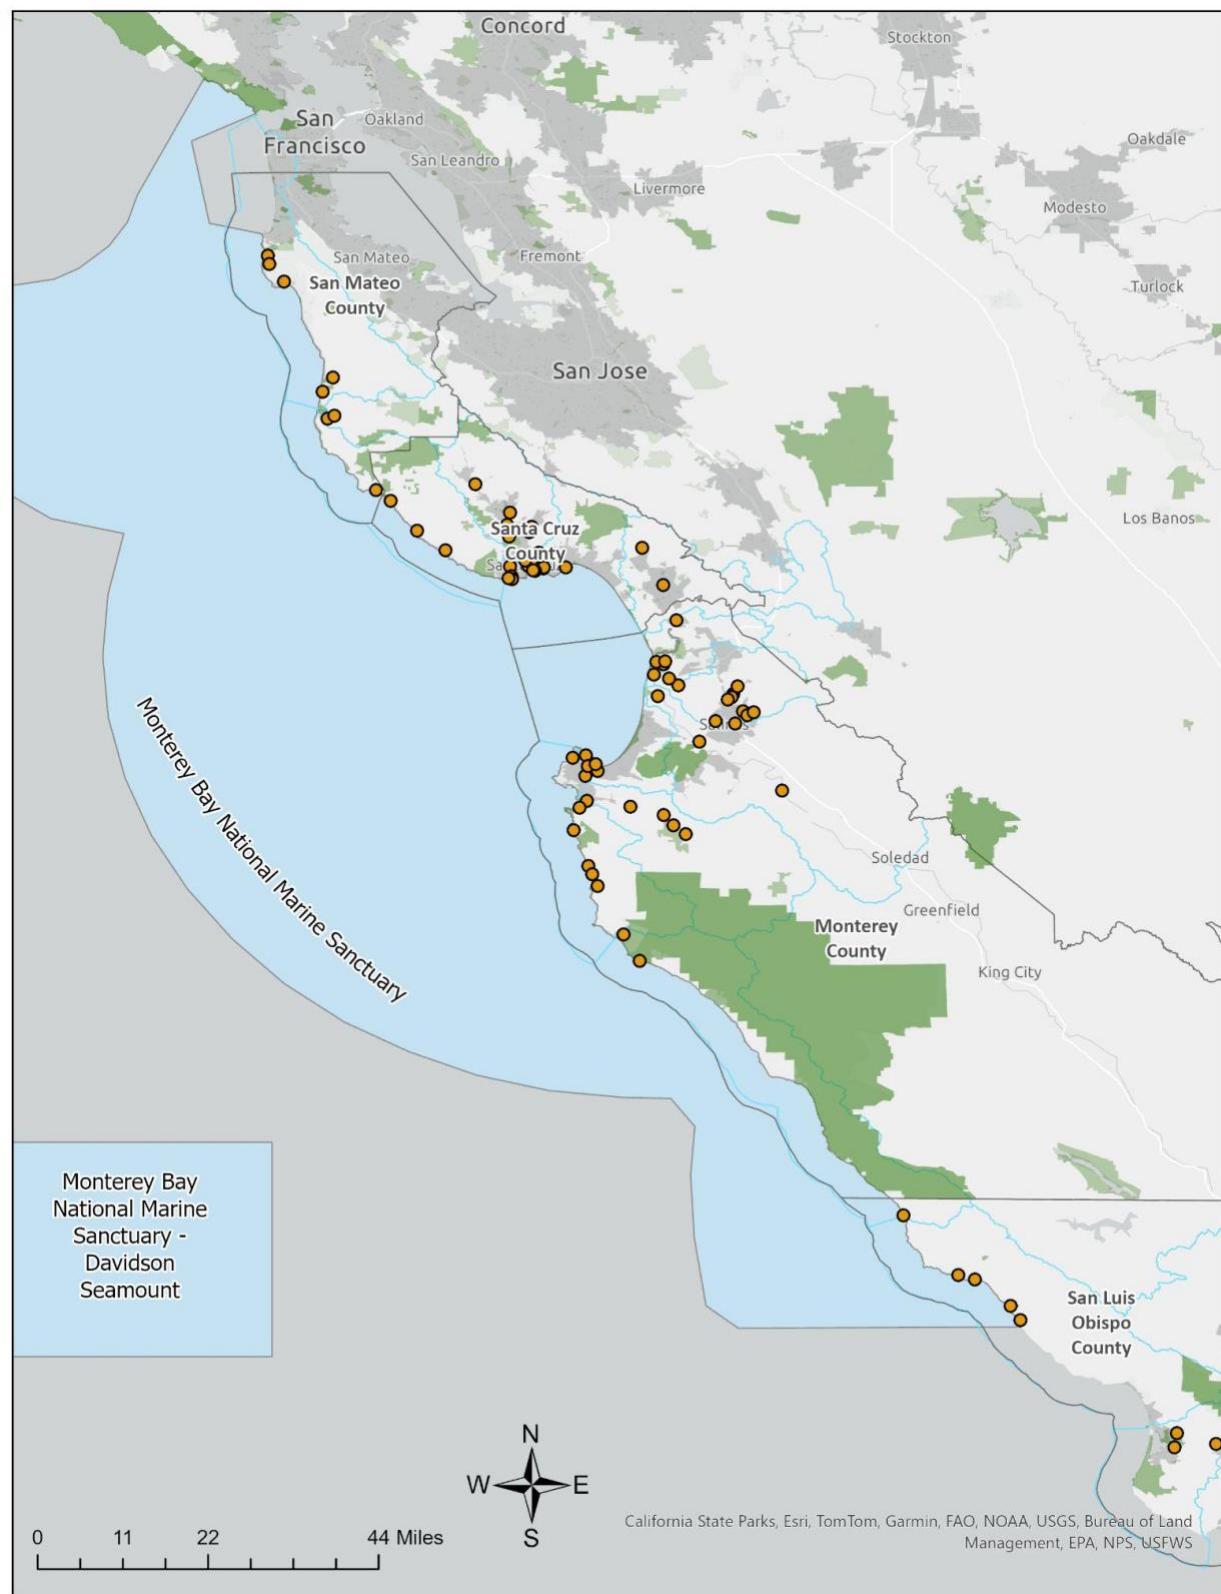
Figure 1. Map of Snapshot Day 2024 monitoring sites.

Each April, Snapshot Day training is conducted in all four counties bordering the sanctuary: San Mateo, Santa Cruz, Monterey, and San Luis Obispo (Figure 1). Since many Snapshot Day volunteers have never taken field measurements or collected water samples before, training is important in developing the necessary skills. Snapshot Day training covers the program's history, how to take field measurements, and how to collect lab samples. In 2024, Snapshot Day occurred on May 4.

On Snapshot Day 2024, 90 volunteers comprising 22 teams monitored 80 sites along creeks and rivers that flowed into MBNMS (Figure 1). That year, 12 sites were either completely dry, had water that was stagnant, or were unsafe to access. Seventy-six sites (95%) had flowing water. Twenty-one sites (28%) with flowing water met the WQOs for all lab and field parameters. Snapshot Day 2024 results revealed that no analyte had its highest number of WQO exceedances compared to the past 23 years (Table 2). All data by site are available in Appendix A (Table A.1). No data were available for 2020 due to the COVID-19 pandemic.

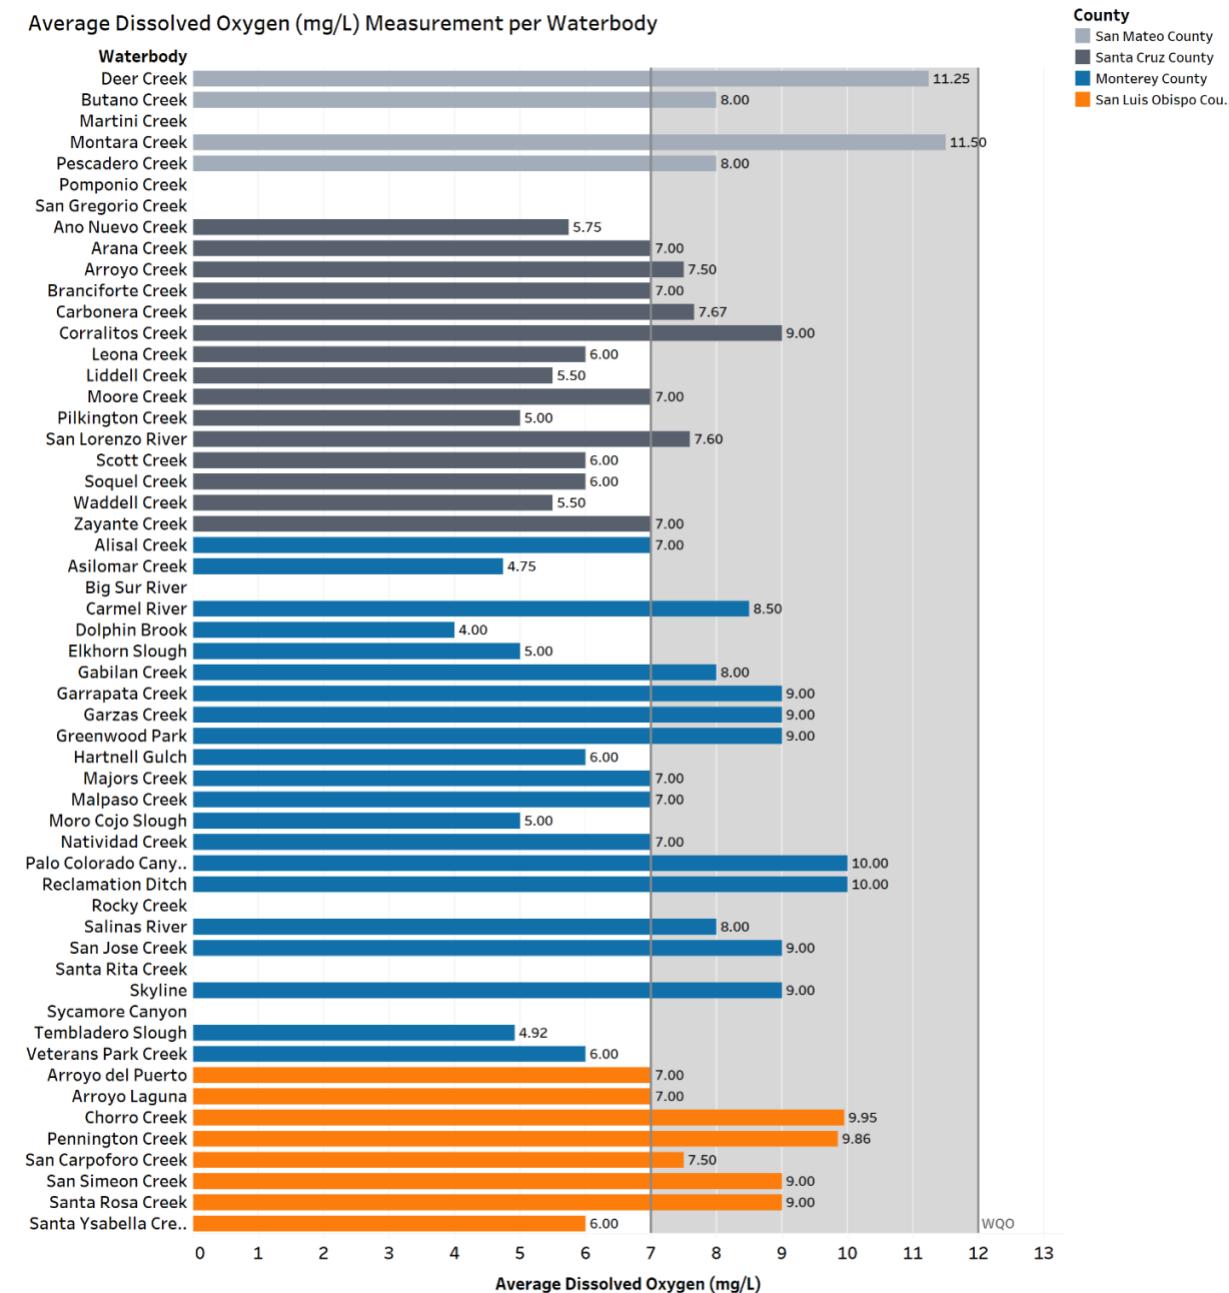
Figure 2. Average dissolved oxygen measurements for each waterbody monitored in 2024. Waterbodies with more than one site have averaged results. Waterbodies are separated by county and the WQO range is shown in gray.

The Basin Plan Objective for dissolved oxygen is 7–12 mg/L, an optimal range for cold-water fish. In 2024, 20 (26%) of the 76 sites where dissolved oxygen was measured were outside of the healthy range and did not meet the WQO. The lowest dissolved oxygen result of 3 mg/L was recorded from the Tembladero Slough at Preston Bridge in Monterey County (Table 3). No site had a dissolved oxygen level above 12 mg/L. No sites in San Mateo County were outside the WQO for dissolved oxygen.

The sites that did not meet the WQO for dissolved oxygen and their respective dissolved oxygen levels are listed in Table 3. Average dissolved oxygen results for each waterbody are shown in Figure 2.

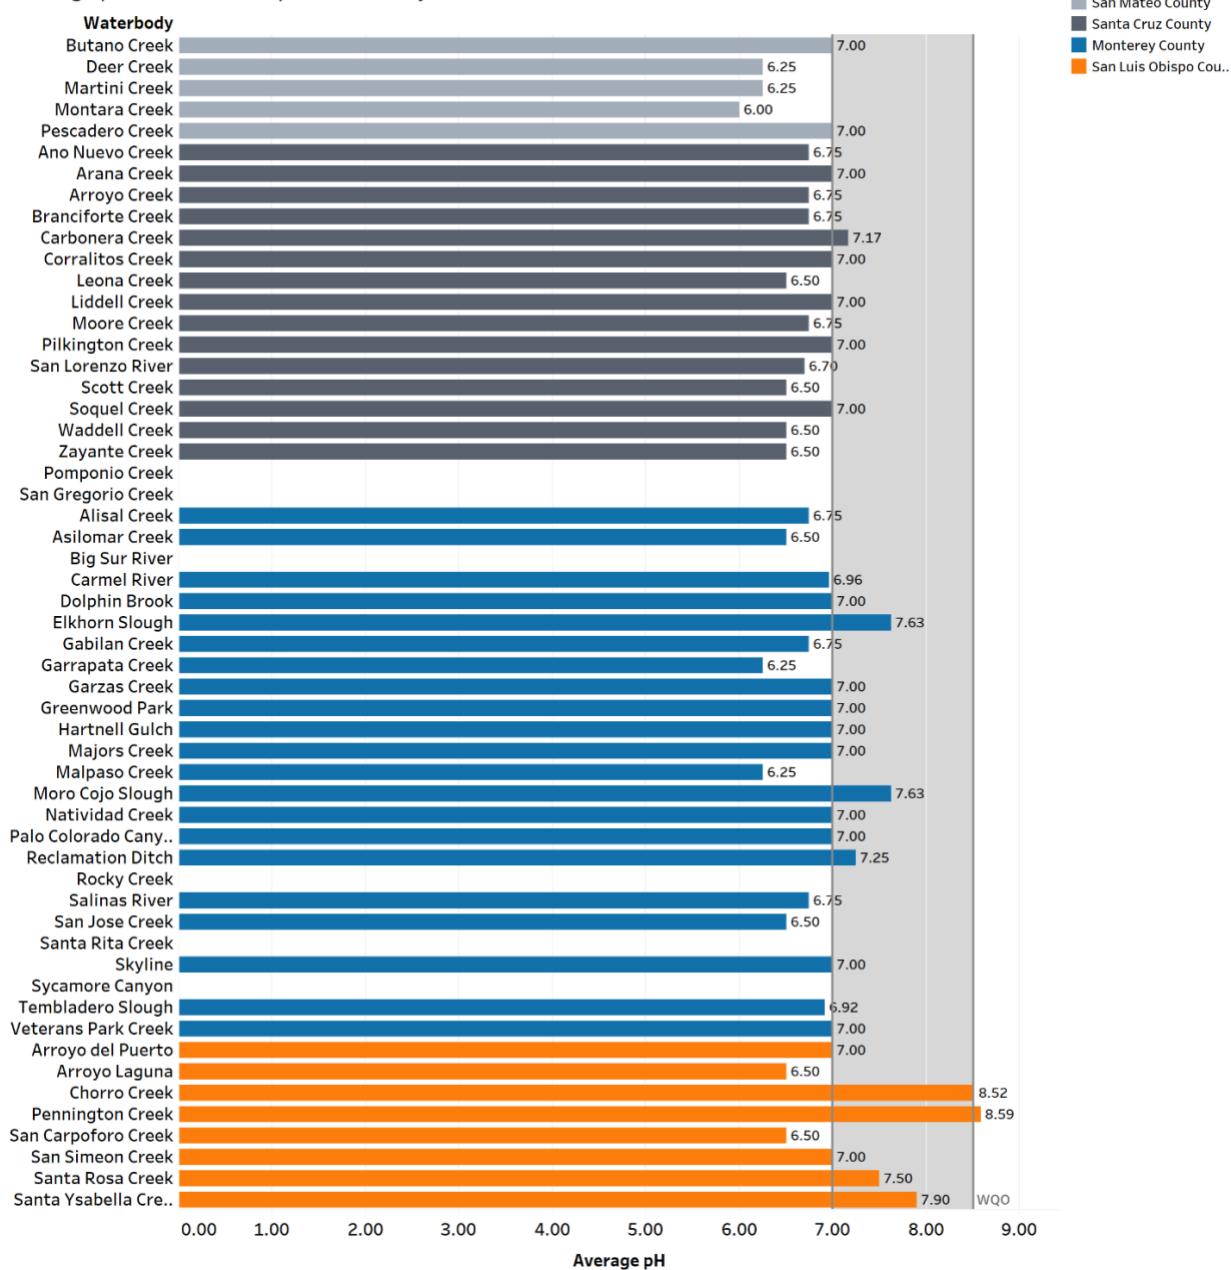
Figure 3. Average pH measurements for each waterbody monitored in 2024. Results were averaged for waterbodies where more than one site was measured. Waterbodies are separated by county and the WQO range is shown in gray.

The Basin Plan Objective states that pH should fall between 7 and 8.5. In 2024, 30 (39%) of the 76 sites where pH was measured did not meet this WQO. The lowest pH measurement (6.0) was at Montara Creek downstream of Date and Harte streets in San Mateo County. No sites exceeded a pH of 8.5.

The sites that did not meet the WQO for pH and their respective pH measurements are listed in Table 4. Average pH results for each waterbody are shown in Figure 3.

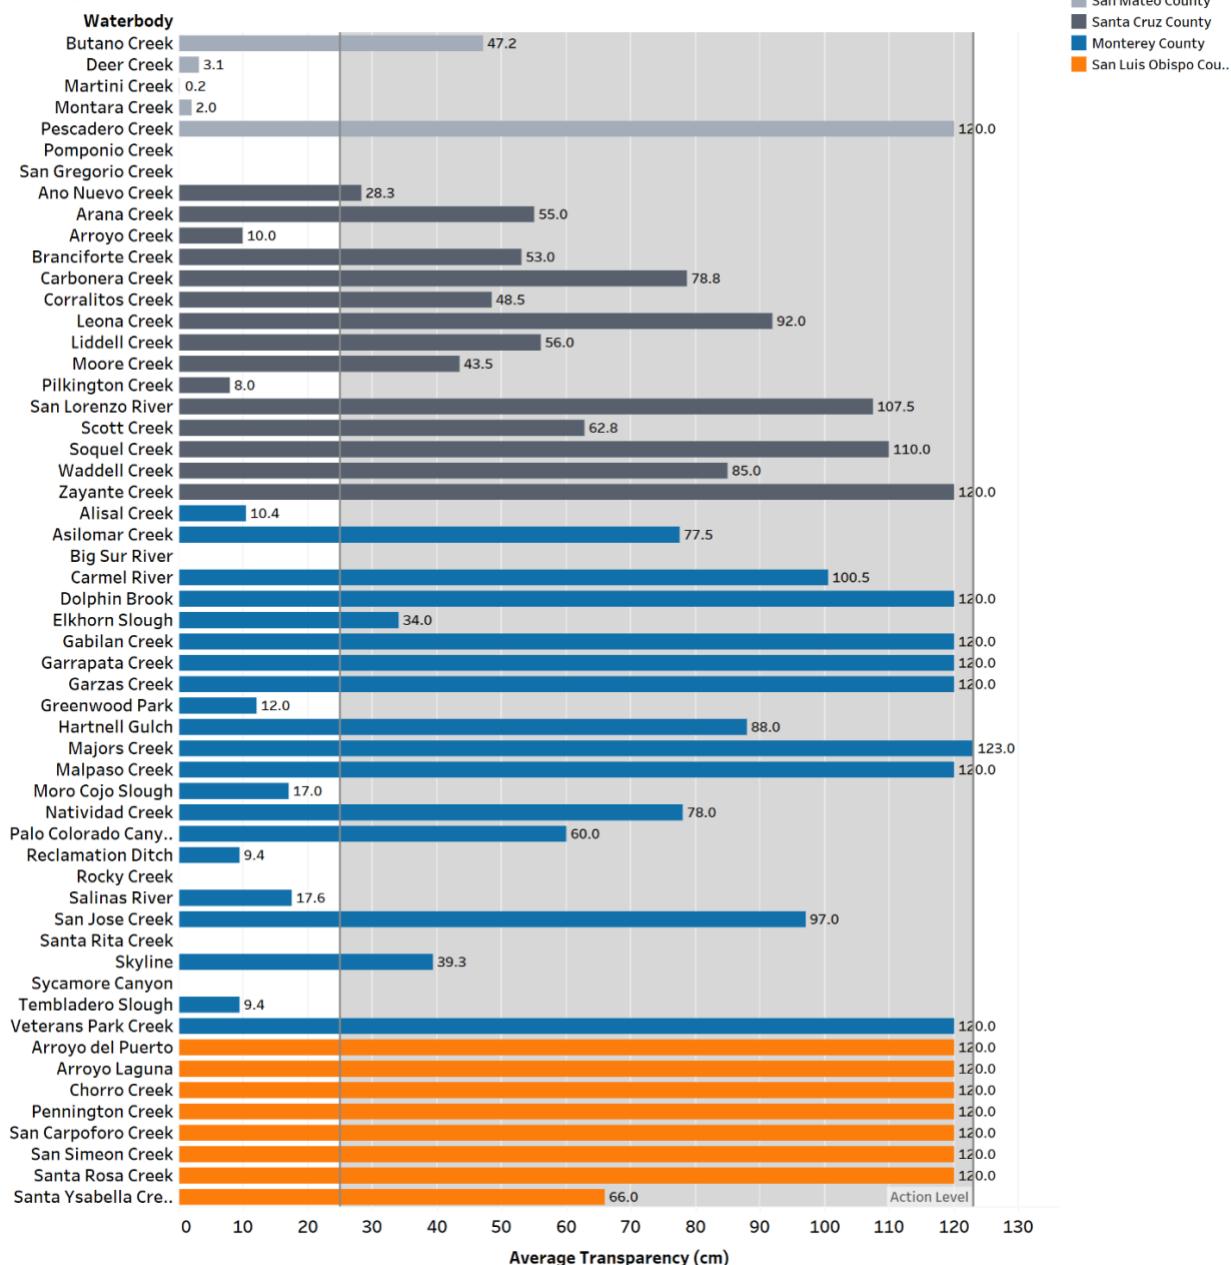
Figure 4. Average transparency measurements for each waterbody monitored in 2024. Results were averaged for waterbodies where more than one site was measured. Waterbodies are separated by county and the Action Level (25 cm) is indicated by the gray line. The shaded region signifies an acceptable transparency level and anything outside of the shaded region triggers action.

CCAMP's Action Level for transparency is set at 25 centimeters, meaning action is taken when visibility is at or below this threshold, as measured by Secchi disk depth. Transparency was measured at 76 sites and 18 (24%) did not meet the Action Level. The lowest transparency measurement of 0.2 cm was taken at Martini Creek in Montara State Beach at McNee Ranch in San Mateo County. No sites from San Luis Obispo County exceeded the Action Level for transparency.

The sites that did not meet the WQO for transparency and their respective transparency measurements are listed in Table 5. Average transparency results for each waterbody are shown in Figure 4.

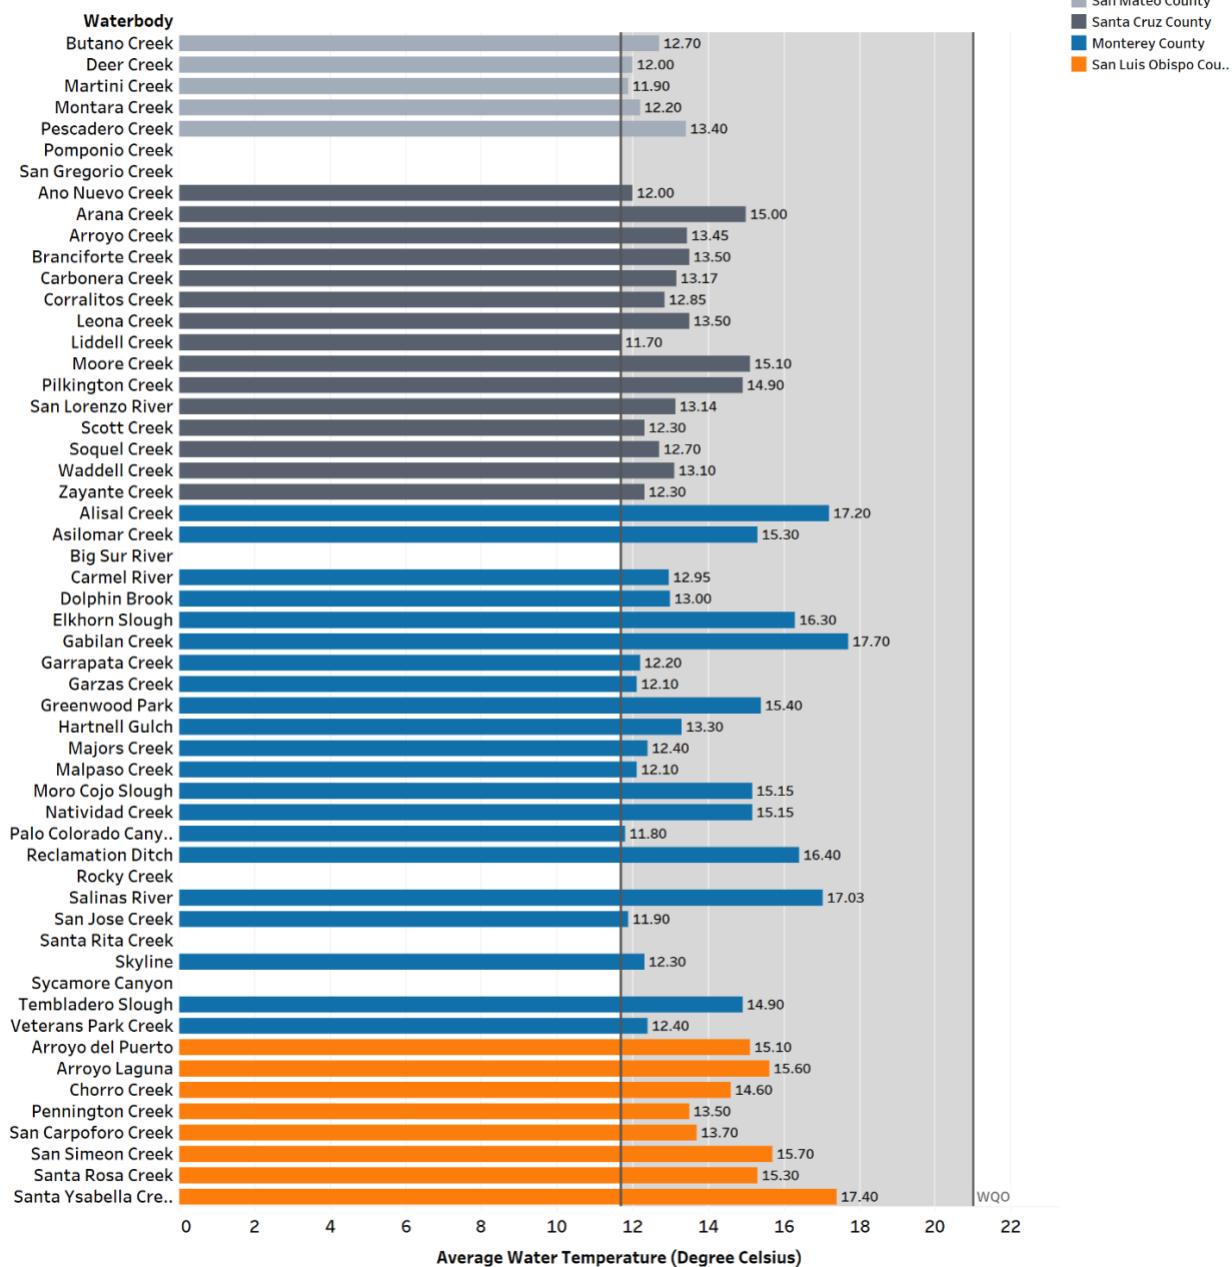
Figure 5. Average water temperature measurements for each waterbody monitored in 2024. Results were averaged for waterbodies where more than one site was measured. Waterbodies are separated by county and the shaded gray area indicates that all values measured fell within the WQO (average water temperature less than 21 °C).

The Basin Plan Objective sets the upper limit of acceptable water temperature at 21 °C. Temperatures above 21 °C can harm cold-water fish such as salmon and steelhead, as well as other aquatic organisms. In 2024, all sites met the WQO for water temperature. Average water temperature results for each waterbody are shown in Figure 5.

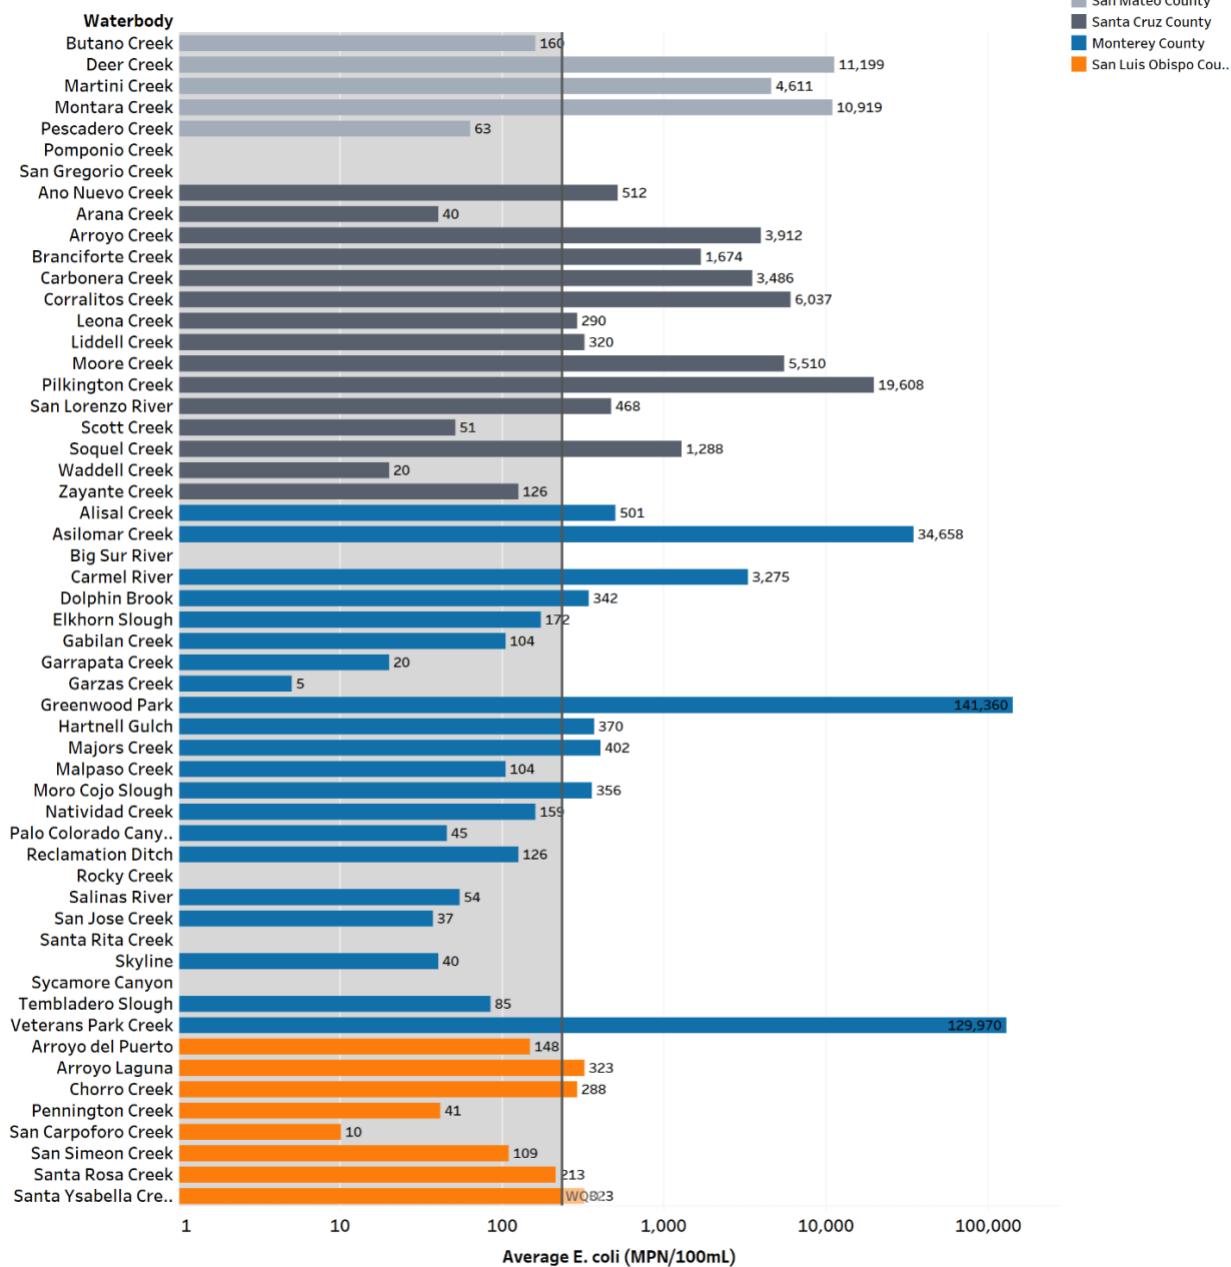
Figure 6. Average *E. coli* concentrations for each waterbody monitored in 2024. Results were averaged for waterbodies where more than one site was measured. Waterbodies are separated by county and the WQO range is indicated in gray.

The EPA has set a WQO for *E. coli* at 235 Most Probable Number (MPN)/100 mL. Thirty-three (43%) of the 76 sites where *E. coli* was measured did not meet the WQO. The highest *E. coli* result of 141,360 MPN/100 mL was from Greenwood Park at Central and 13th streets in Monterey County.

The sites that did not meet the WQO for *E. coli* and their respective *E. coli* levels are listed in Table 6. Average *E. coli* results for each waterbody are shown in Figure 6. Figure 7 illustrates *E. coli* results by geographic location.

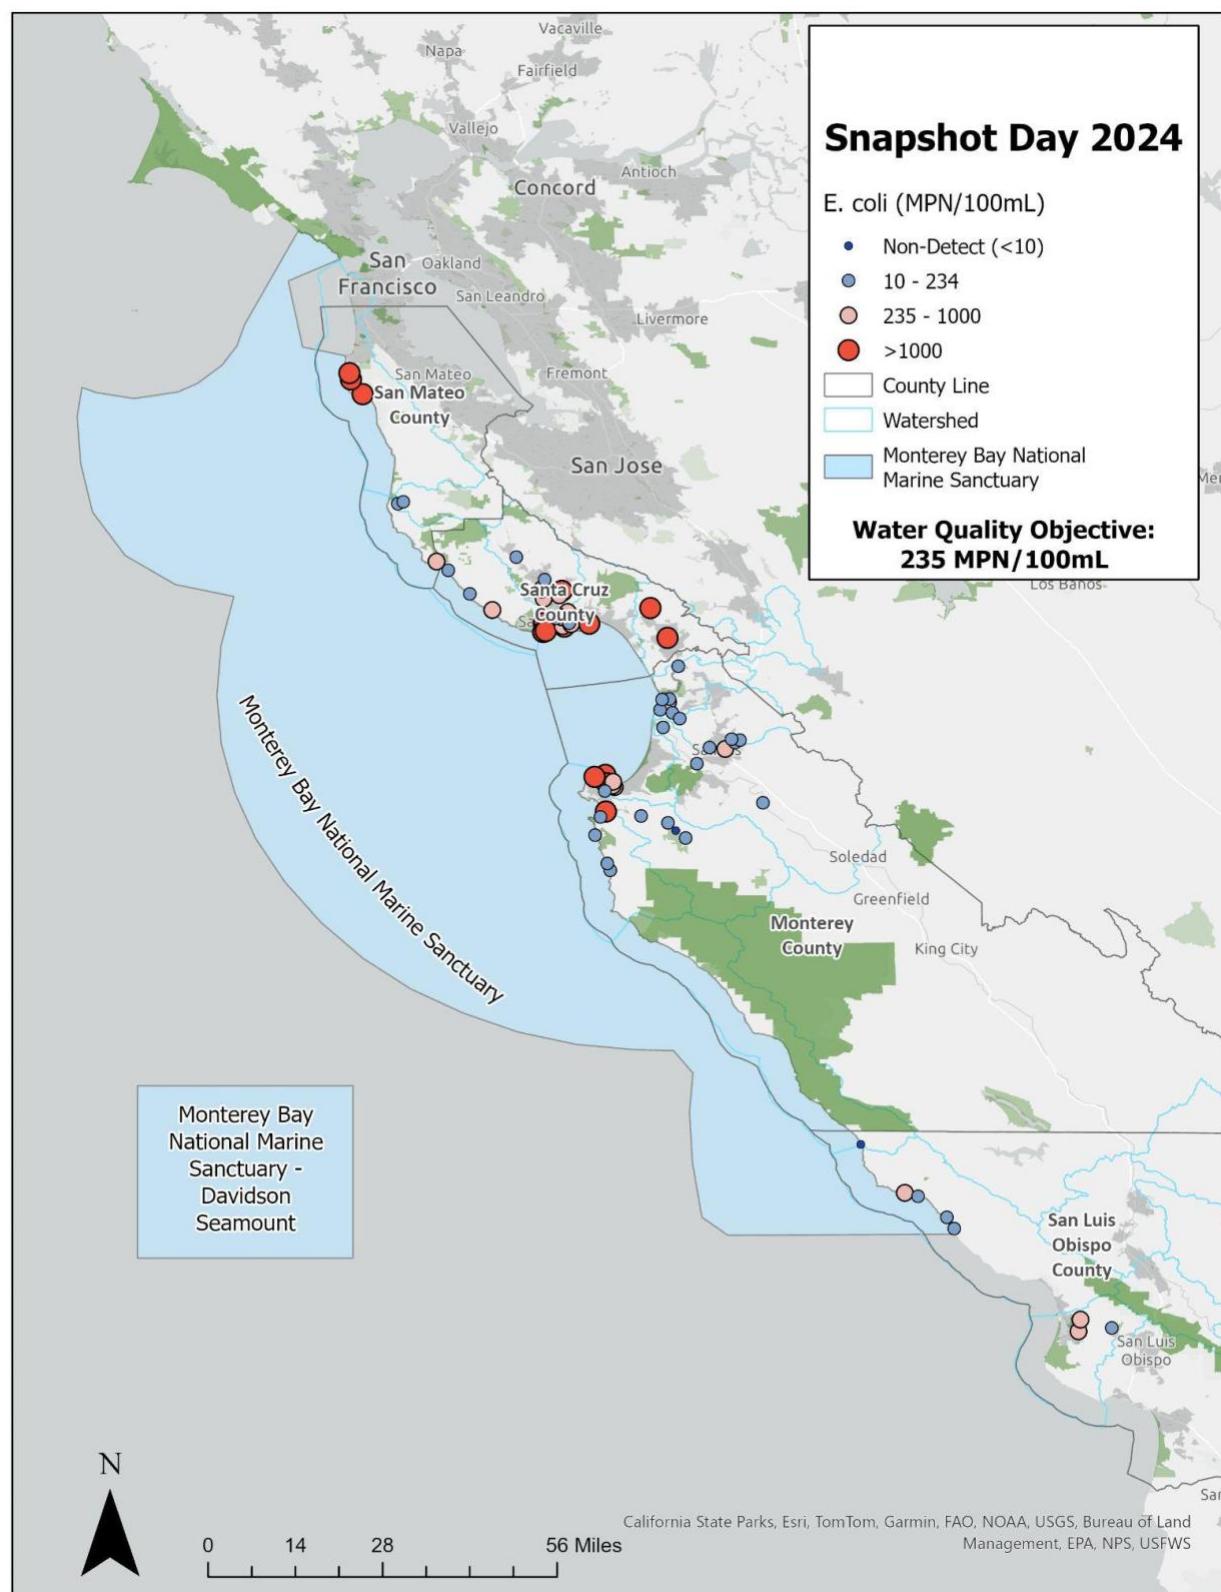
Figure 7. Map illustrating *E. coli* results for Snapshot Day 2024.

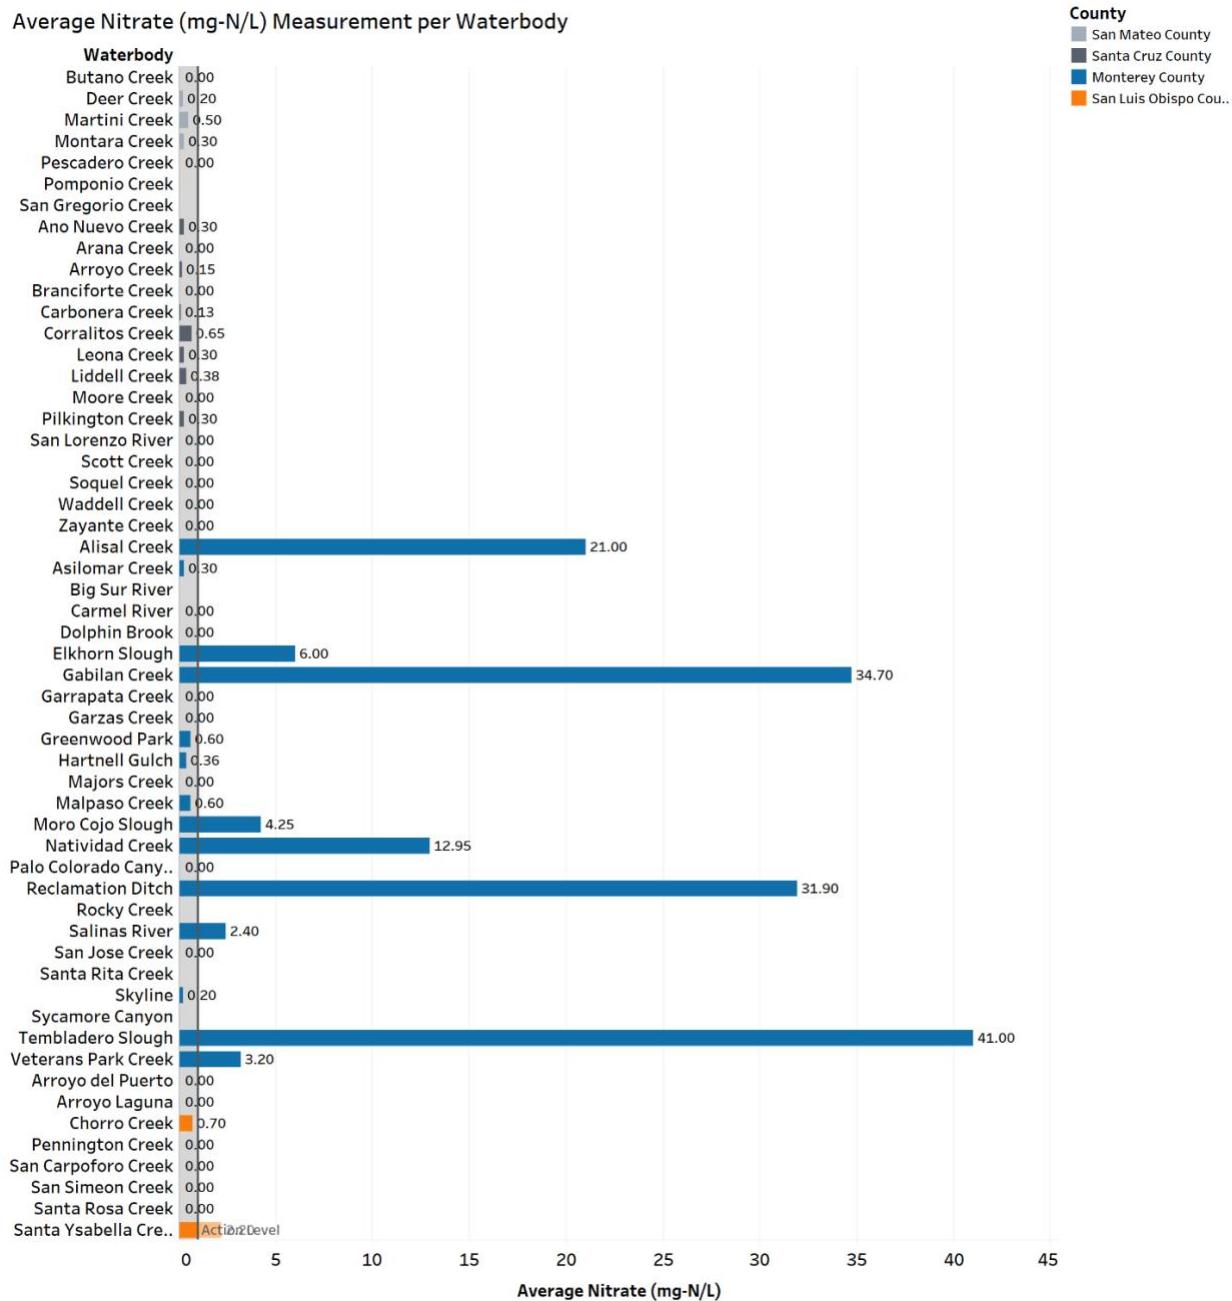
Figure 8. Average nitrate concentrations for each waterbody monitored in 2024. Results were averaged for waterbodies where more than one site was measured. Waterbodies are separated by county and the Action Level (1.0 mg-N/L) is indicated by the gray line.

Sixteen (21%) of the 76 sites measured for nitrate exceeded the CCAMP Action Level of 1.00 mg-N/L. The highest nitrate result of 53.3 mg-N/L was from the Tembladero Slough at Preston Bridge in Monterey County. Thirty-six (47%) sites had non-detectable levels of nitrate as N. No sites in San Mateo County exceeded the Action Level.

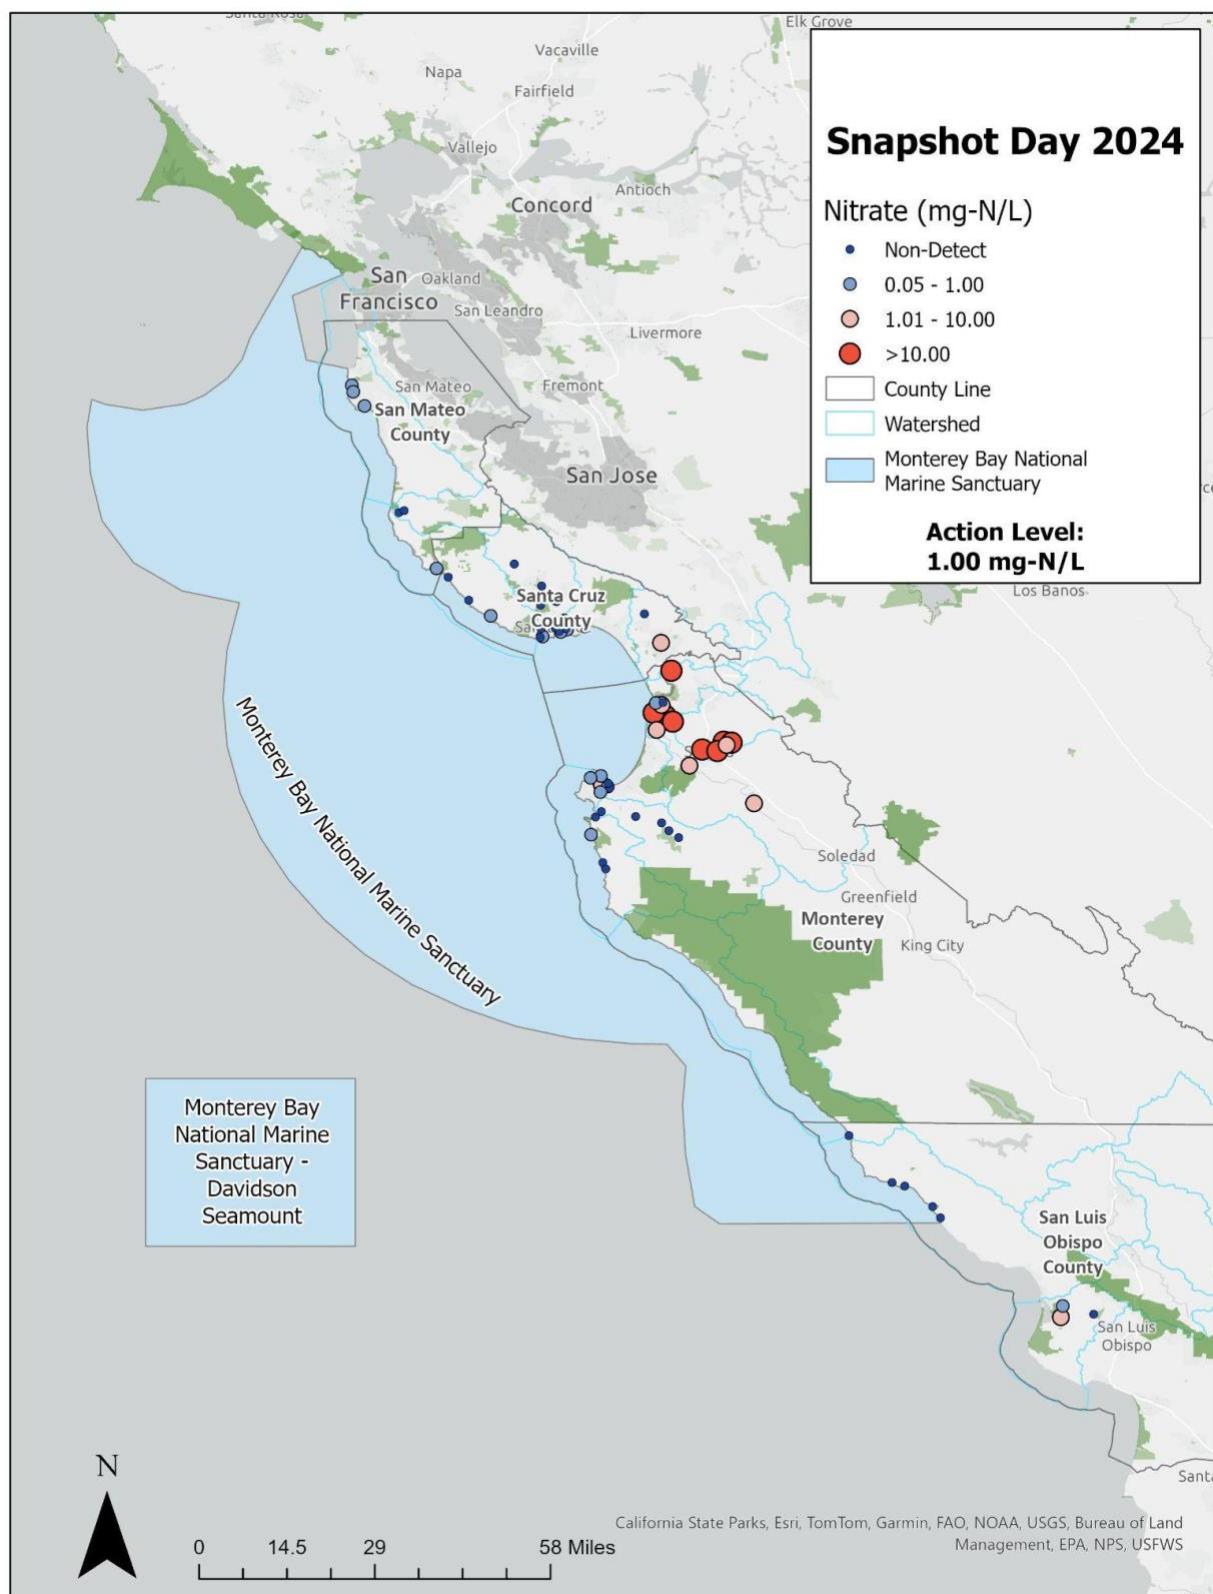
Figure 9. Map illustrating nitrate results for Snapshot Day 2024.

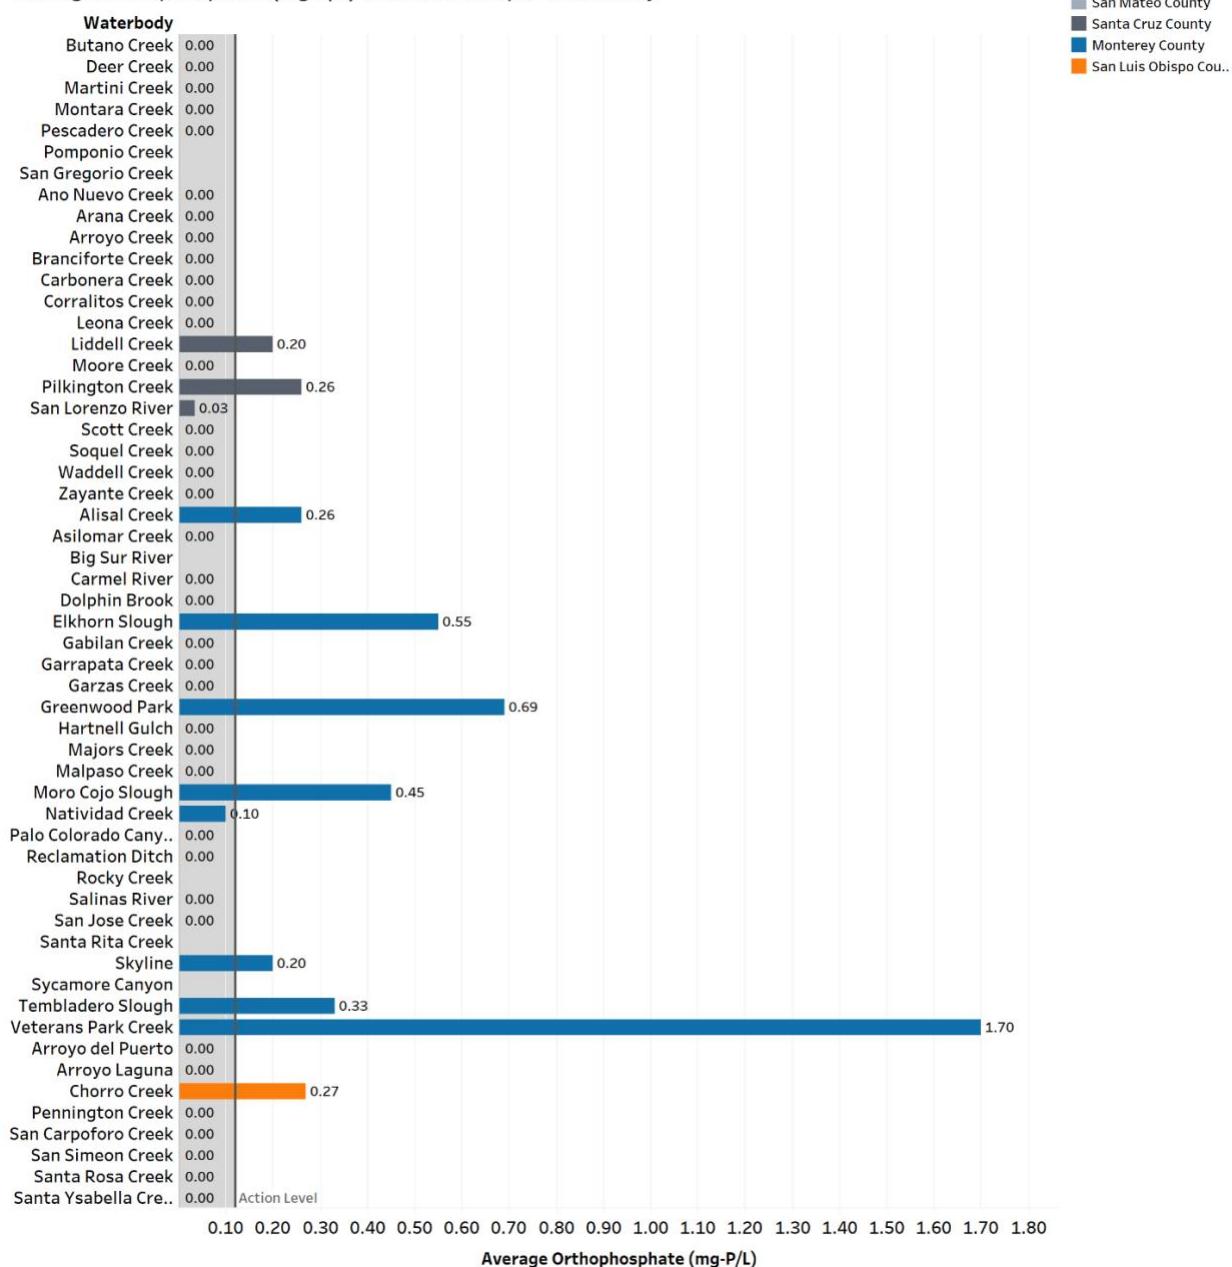
Figure 10. Average orthophosphate concentrations for each waterbody monitored in 2024. Results were averaged for waterbodies where more than one site was measured. Waterbodies are separated by county and the Action Level is indicated by the gray line.

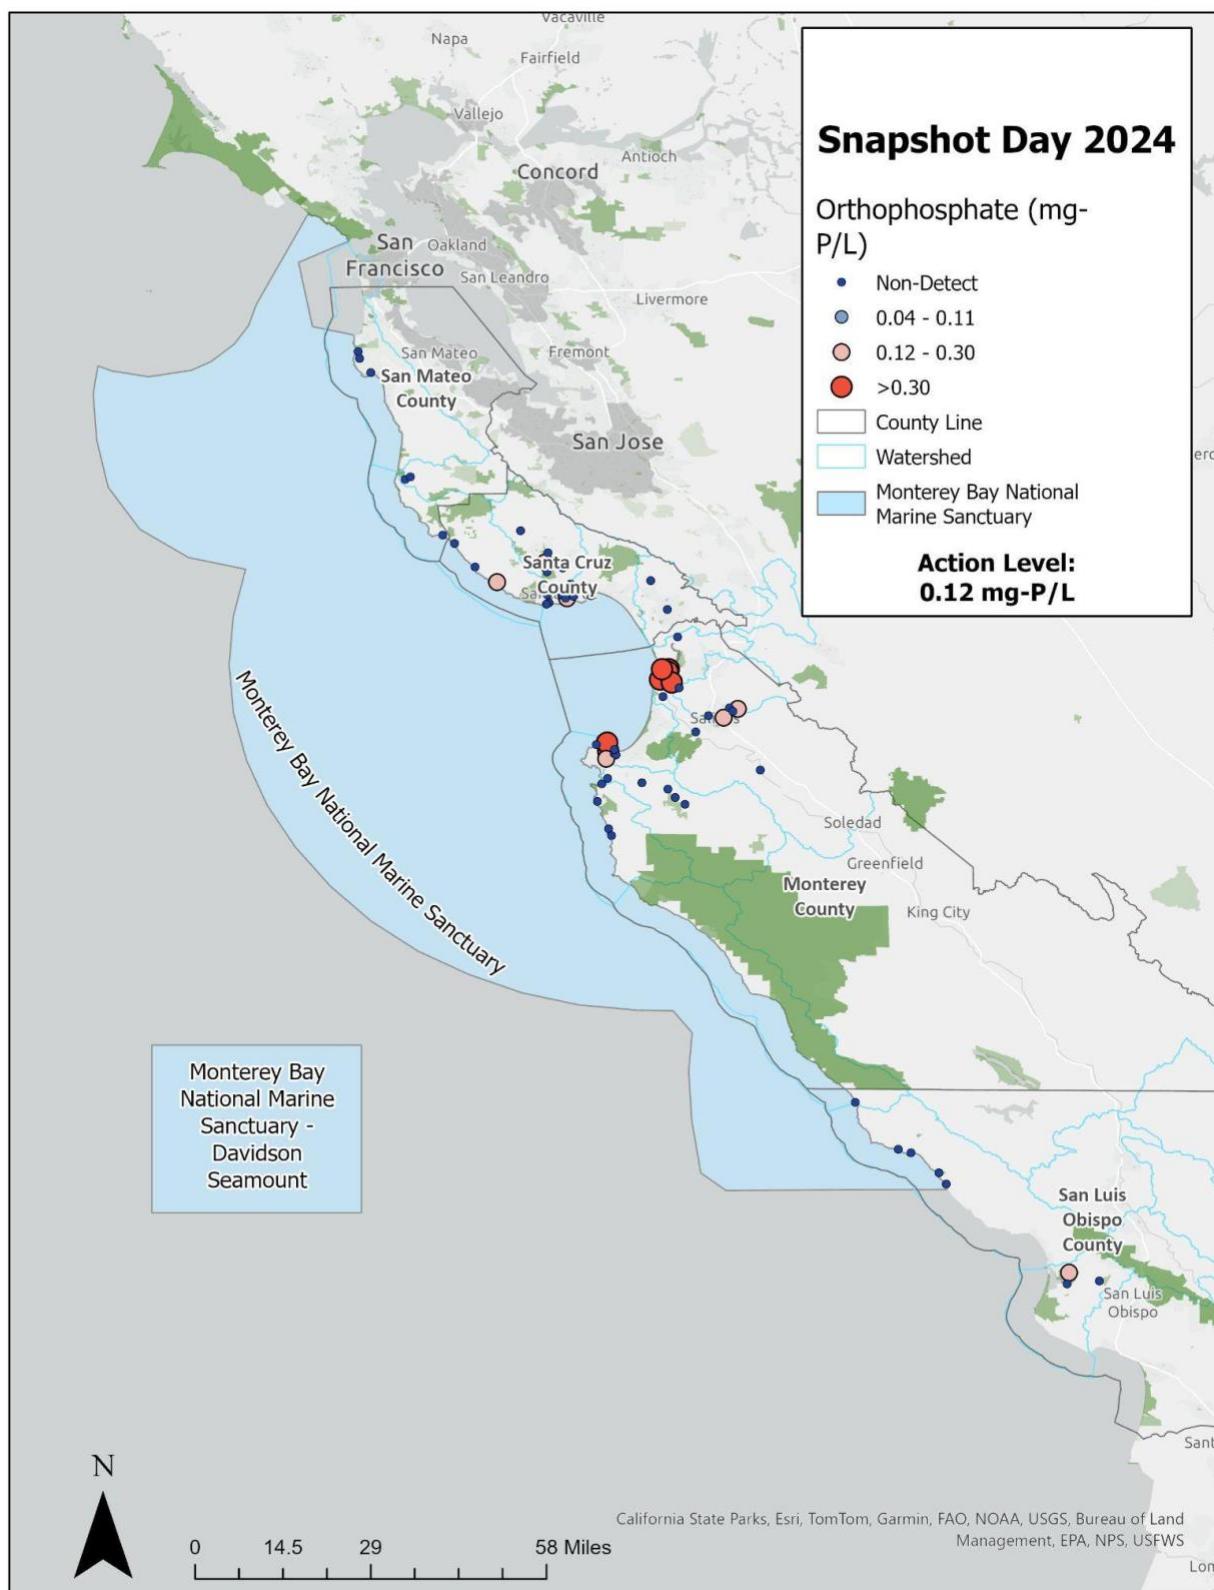
Figure 11. Map illustrating orthophosphate results for Snapshot Day 2024.

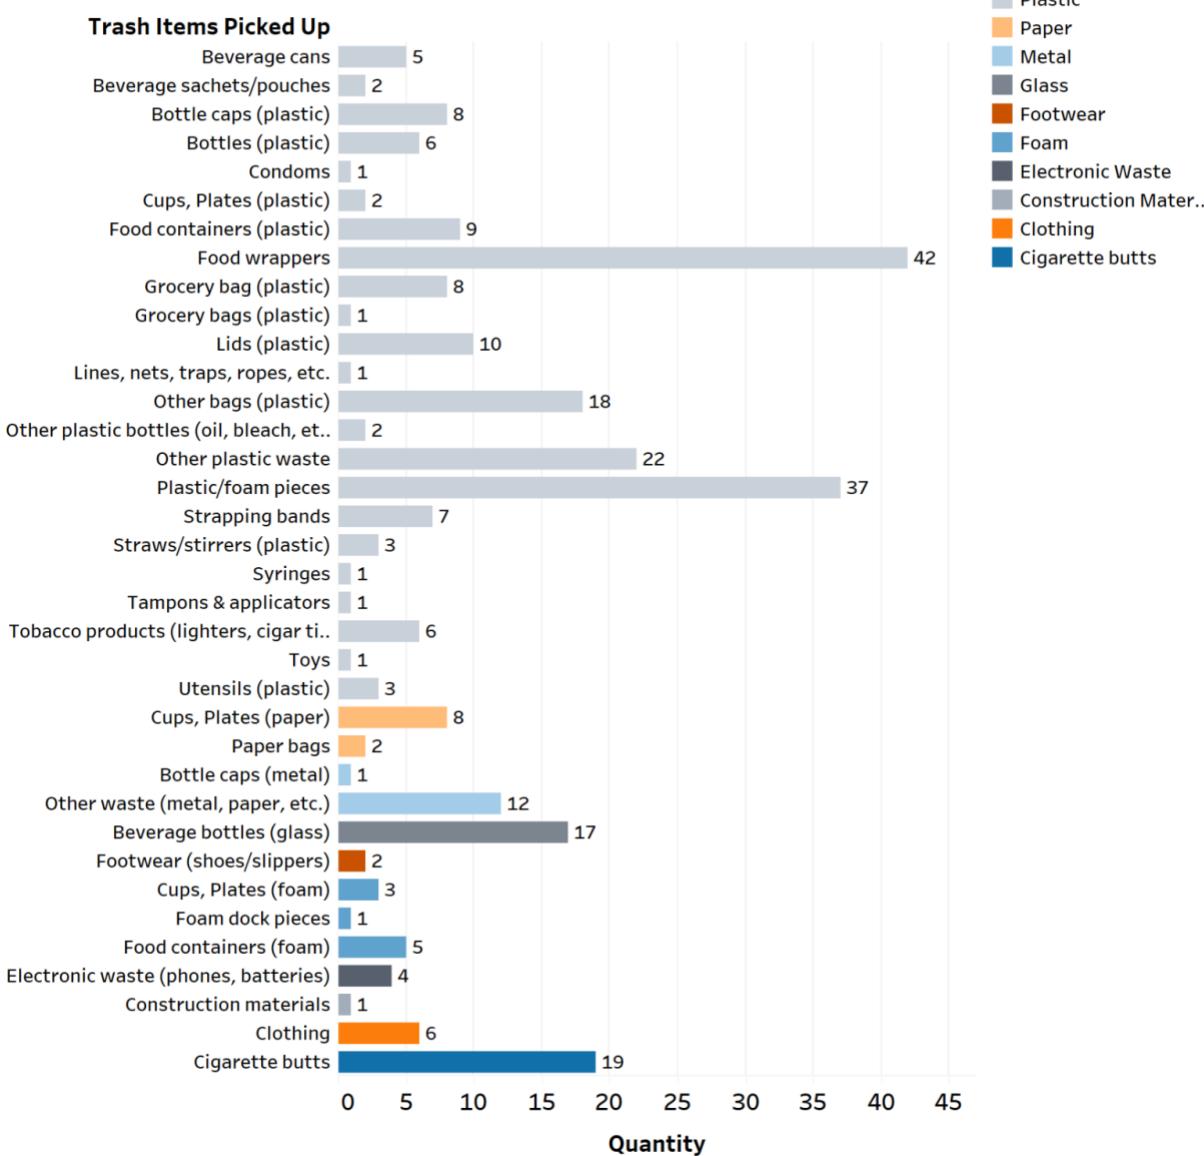
Figure 12. Type, quantity, and material of trash items collected by 2024 Snapshot Day volunteers.

Consistent with other Snapshot Day events over the previous 23 years, volunteers noted the presence of trash and debris at many sites in 2024. To better understand and quantify the amount of trash at the Snapshot Day sites, volunteers were asked to collect trash at their assigned sites for 10 minutes and record what they collected through the Clean Swell App developed by the Ocean Conservancy. On May 4th, at least 32 pounds of trash were recorded, with a total of 277 pieces of trash collected, 71% of which were plastic. The most common items were food wrappers (42 pieces), plastic/foam pieces (37 pieces), and unidentified plastic waste (22 pieces; Figure 12).
