2024 Snapshot Day: Annual Volunteer Water Quality Monitoring Report

February 2025
National Marine Sanctuaries Conservation Science Series ONMS-25-02

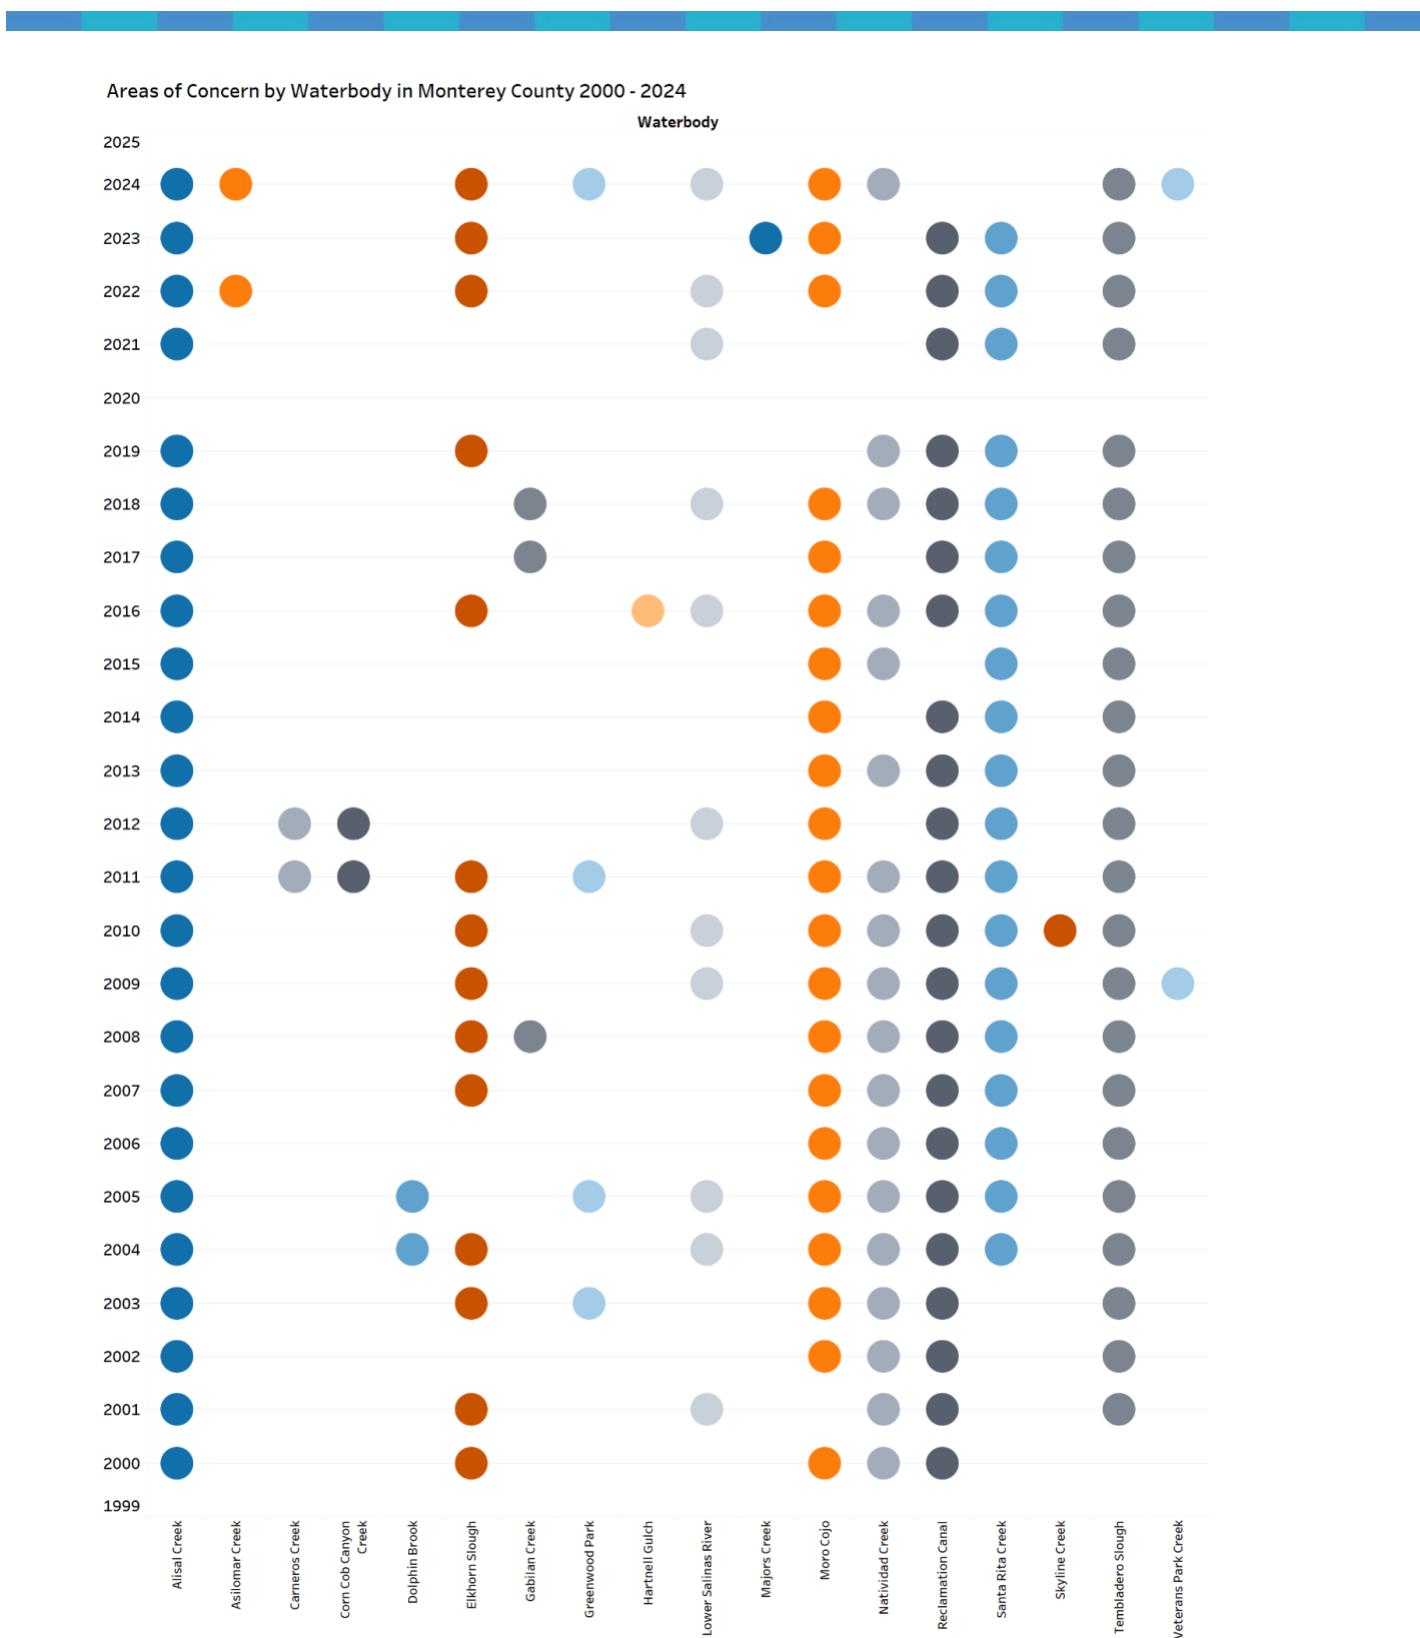
Figure 13. Years in which Areas of Concern (three or more WQOs or Action Levels exceeded) were detected for each waterbody in Monterey County from 2000–2024. Each color signifies a different waterbody.

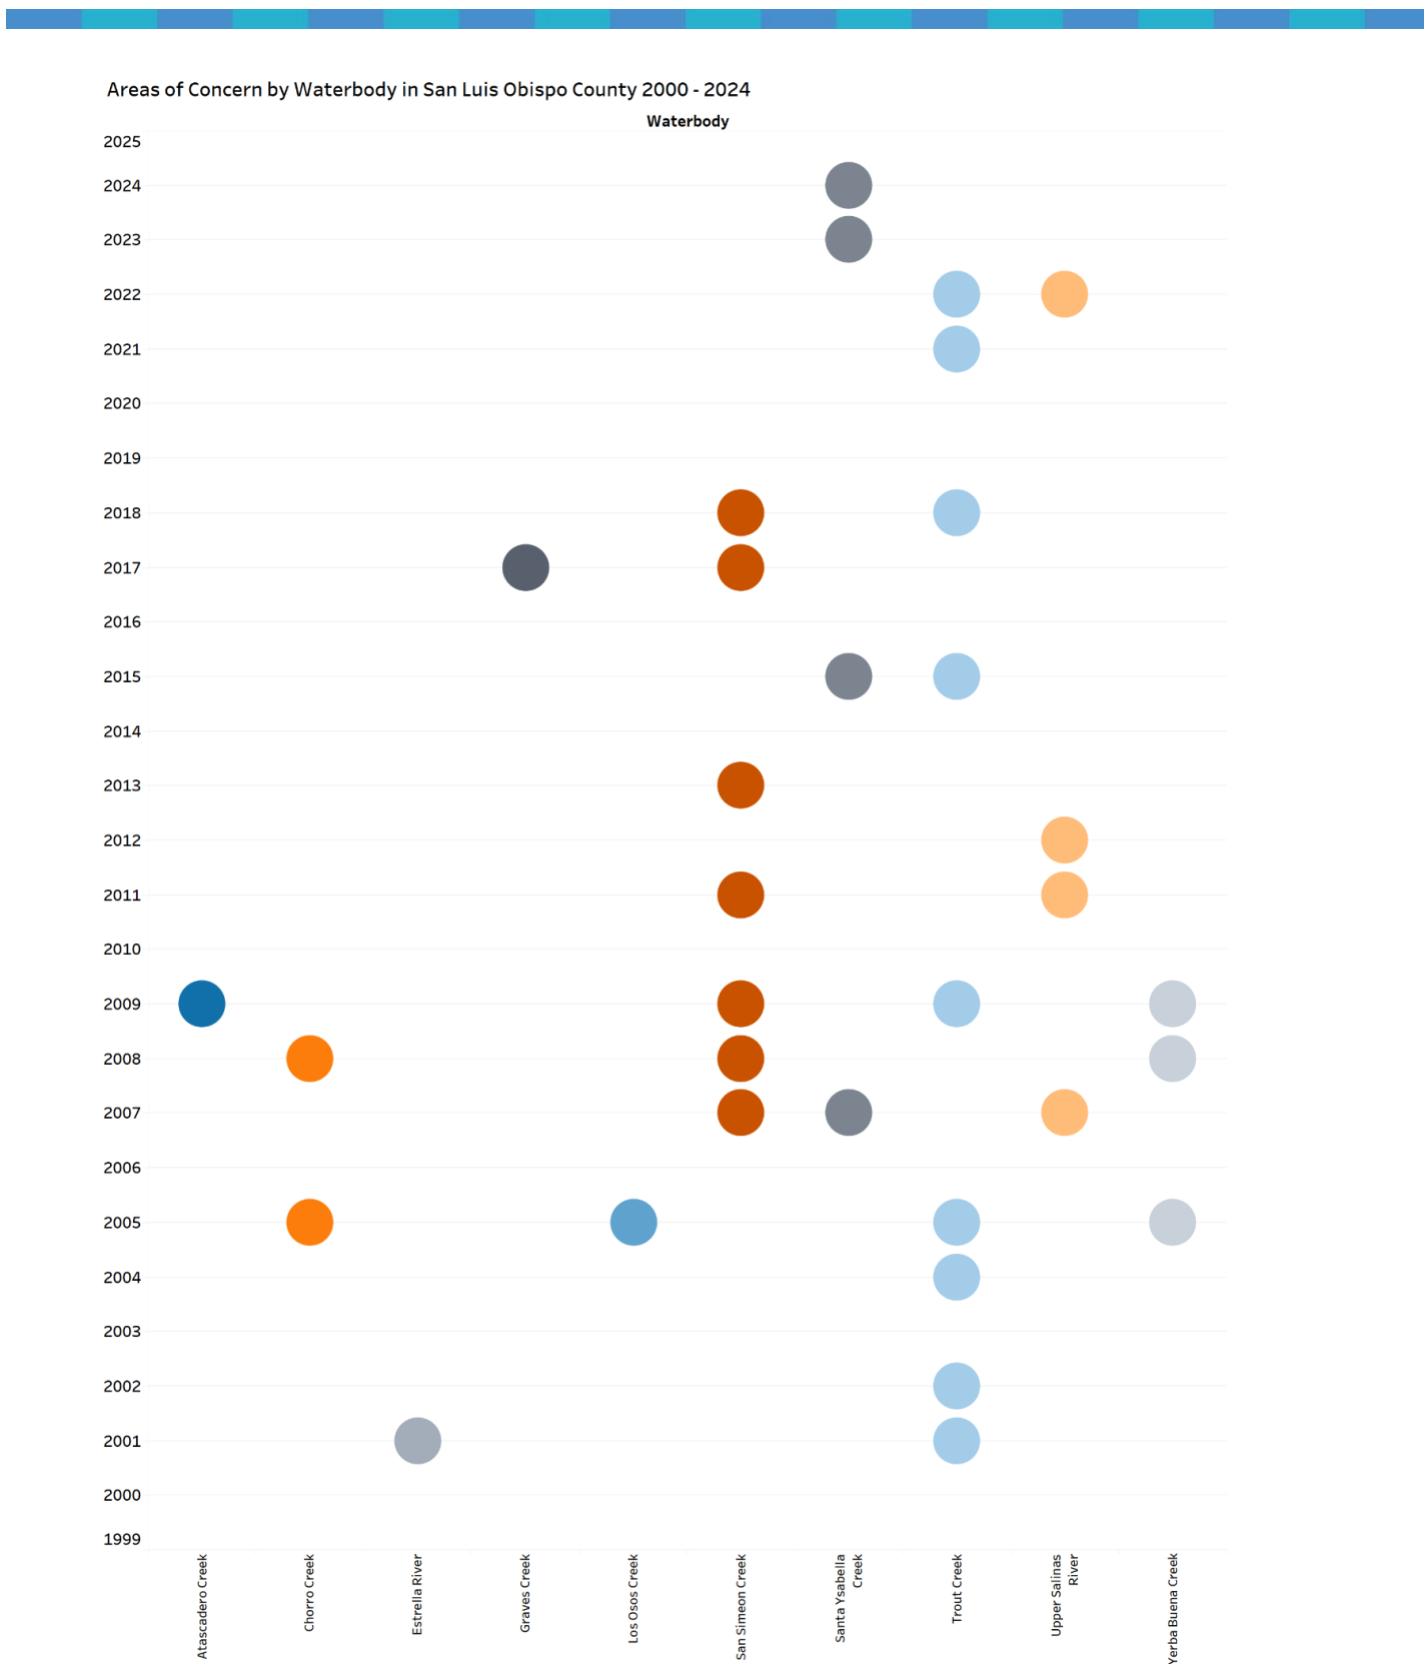
Figure 14. Years in which Areas of Concern (three or more WQOs or Action Levels exceeded) were detected for each waterbody in San Luis Obispo County from 2000–2024.

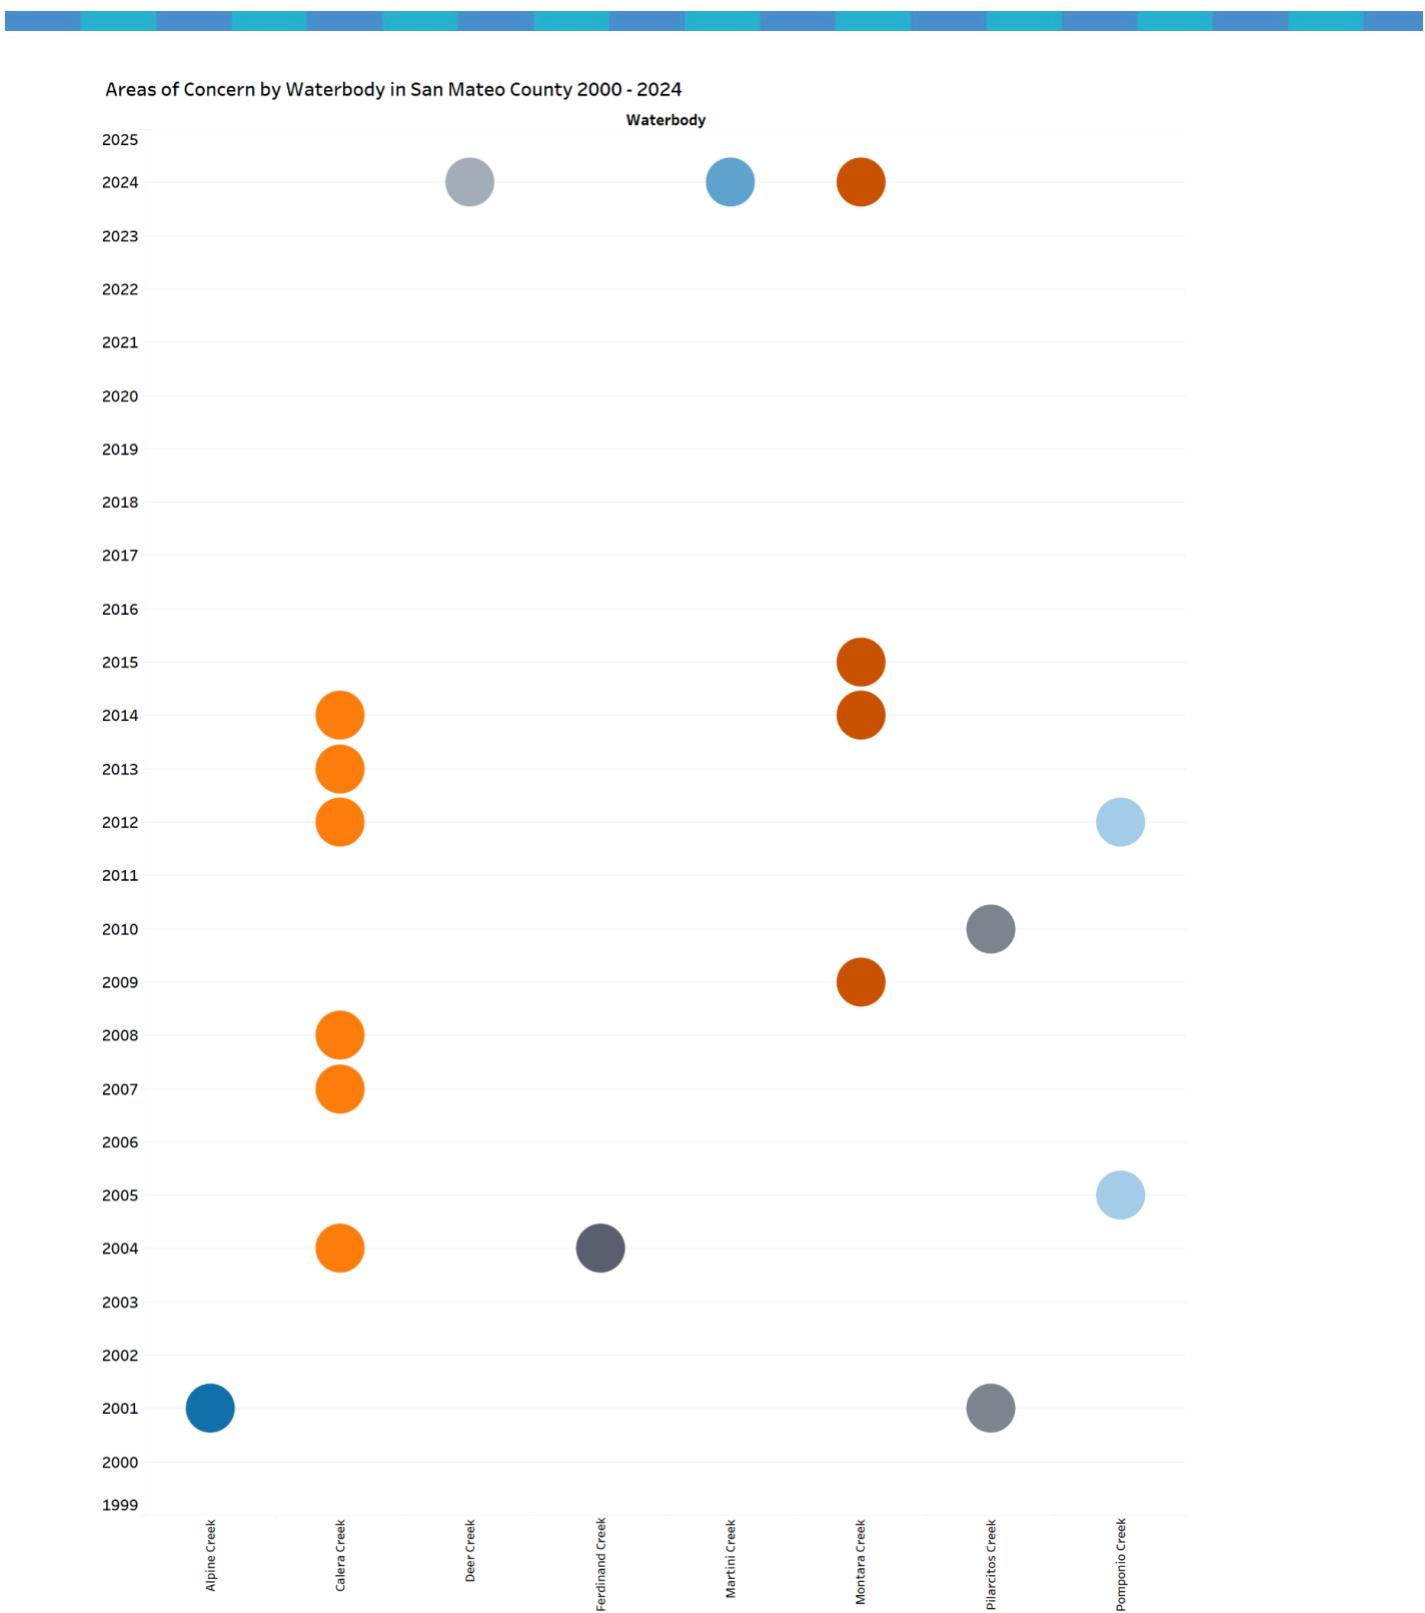
Figure 15. Years in which Areas of Concern (three or more WQOs or Action Levels exceeded) were detected for each waterbody in San Mateo County from 2000–2024.

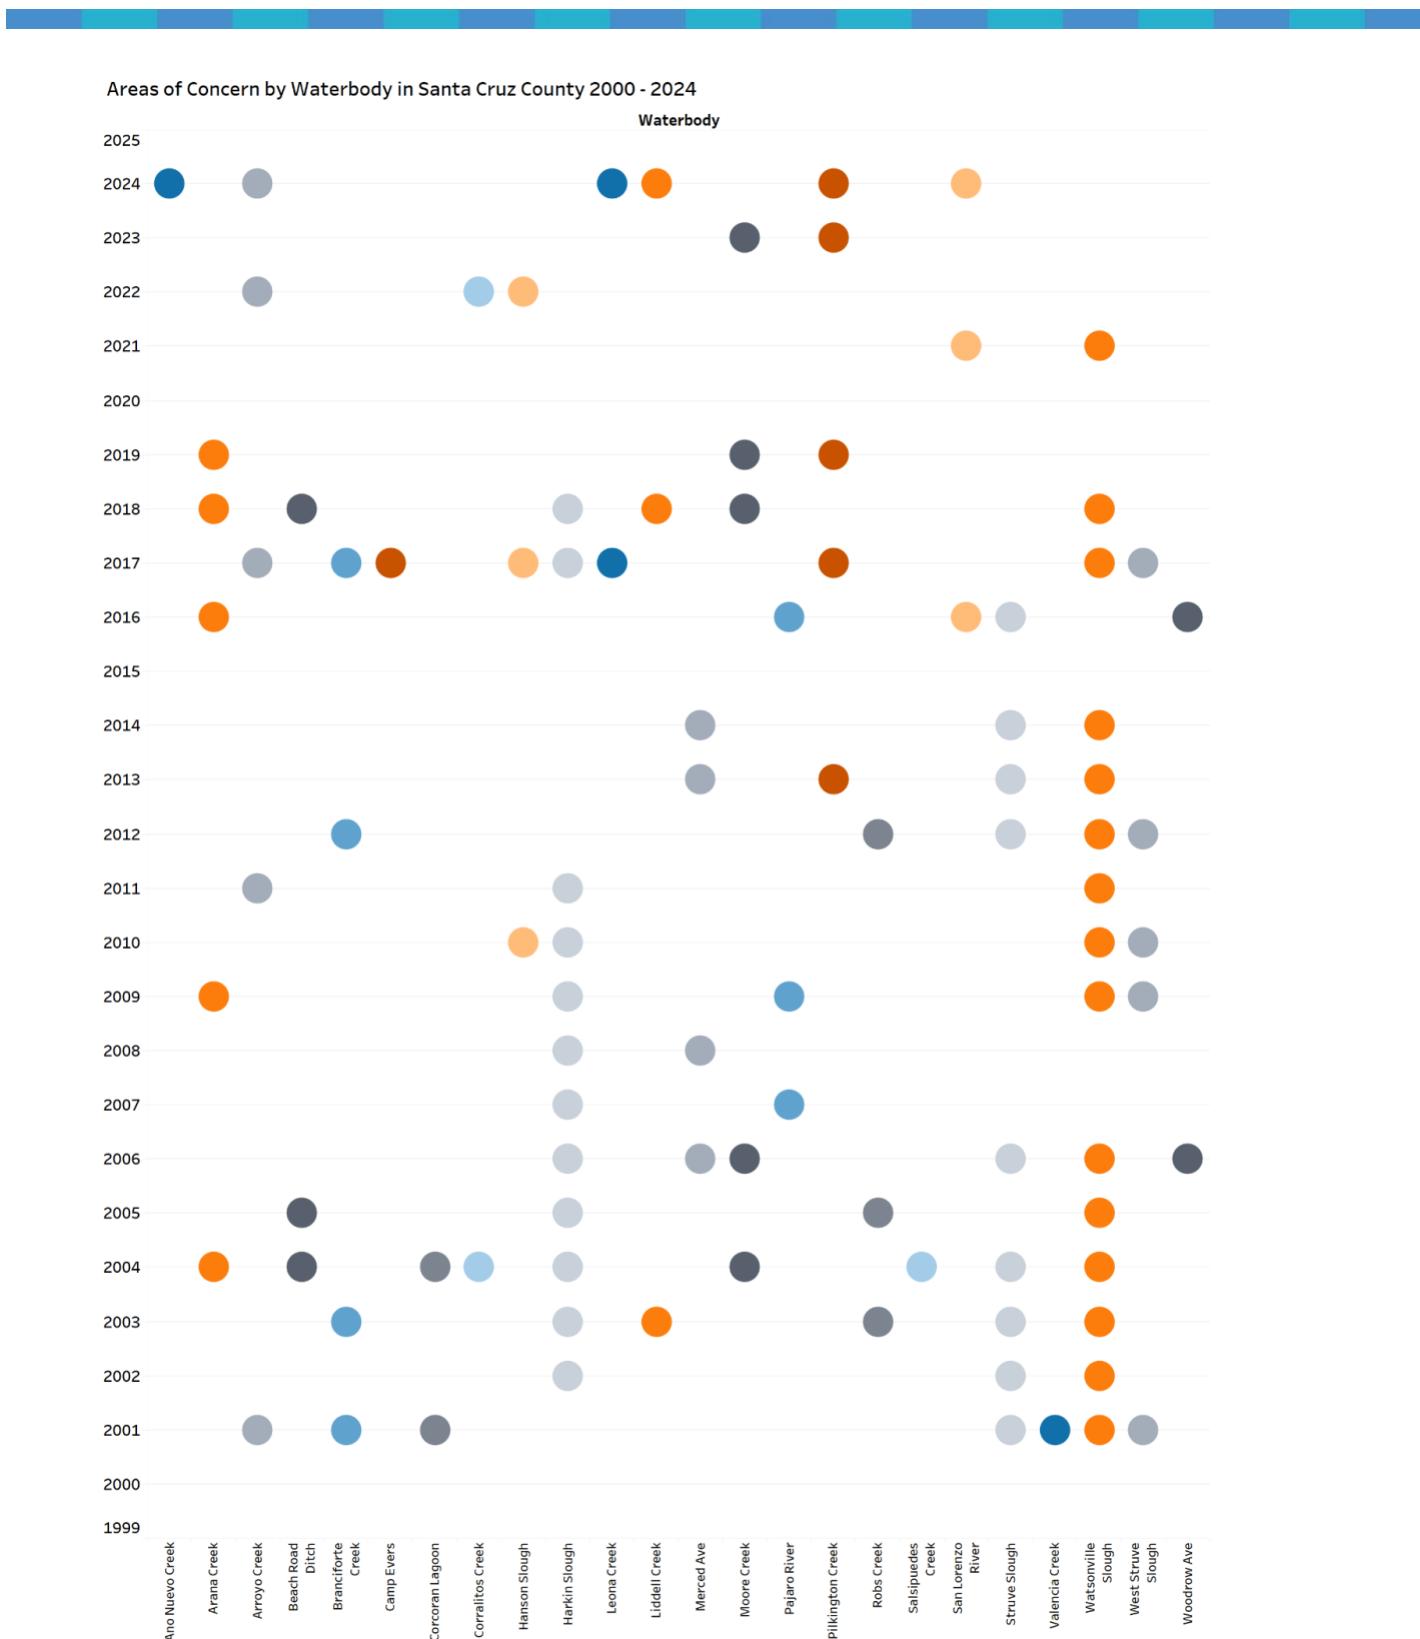
Figure 16. Years in which Areas of Concern (three or more WQOs or Action Levels exceeded) were detected for each waterbody in Santa Cruz County from 2000–2024.

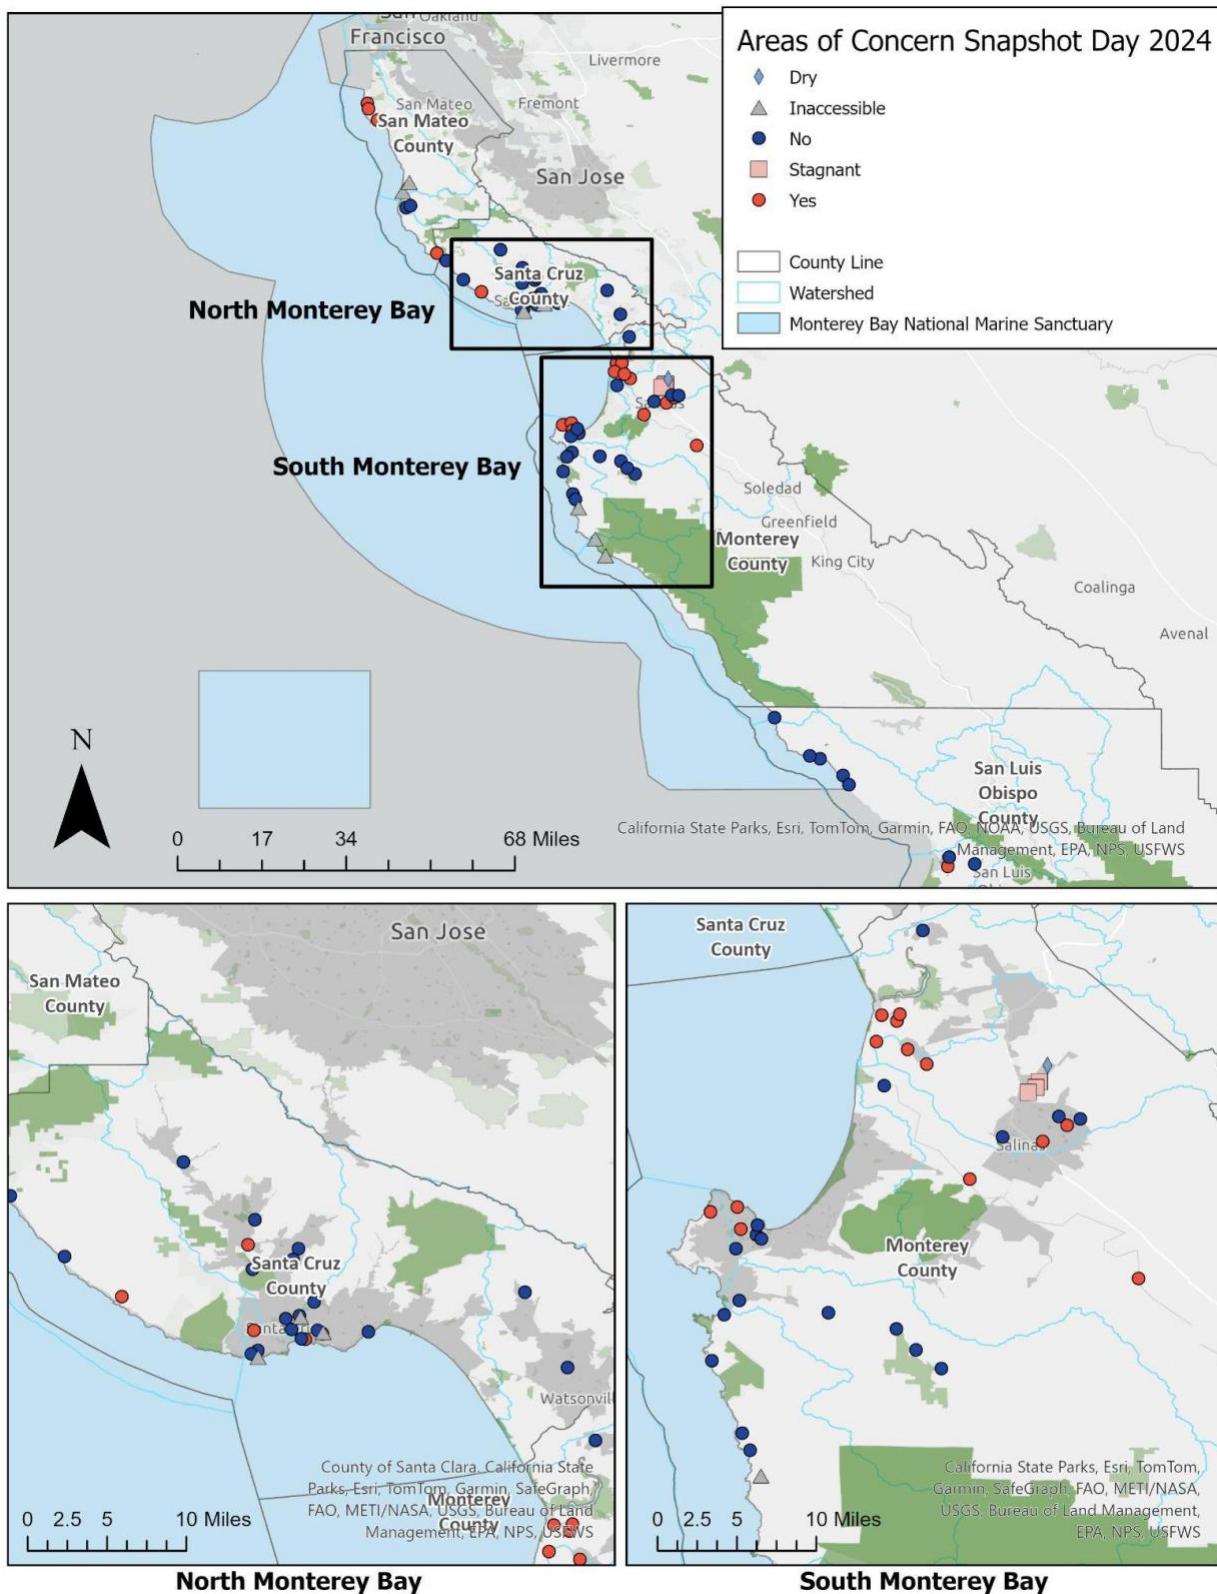
Figure 17. Maps of Areas of Concern identified by Snapshot Day 2024.

In 2024, 23 sites (30%) were designated Areas of Concern on 19 waterbodies. Four of the Areas of Concern are on two waterbodies that have been designated Areas of Concern for more than 10 of the past 22 years: Tembladero Slough and Alisal Creek, both located in Monterey County. The other nine Areas of Concern located in Monterey County are in Moro Cojo Slough, Castroville Slough, Asilomar Creek, Greenwood Park, Natividad Creek, Salinas River, and Veterans Park. Six other Areas of Concern are located in Santa Cruz County at Arroyo, Leona, Liddell, Año Nuevo, Pilkington, and Zayante creeks. Santa Ysabel was the only Area of Concern located in San Luis Obispo County. San Mateo County had three Areas of Concern on three waterbodies at Deer, Martini, and Montara creeks. This is the first time there have been Areas of Concern in San Mateo County in seven years.
