NOAA Technical Memorandum NWS WR- 147

OCCURRENCE AND DISTRIBUTION OF FLASH FLOODS IN THE
WESTERN REGION

Thomas L. Dietrich
Western Region Headquarters
Hydrology Division
Salt Lake City, Utah
December 1979

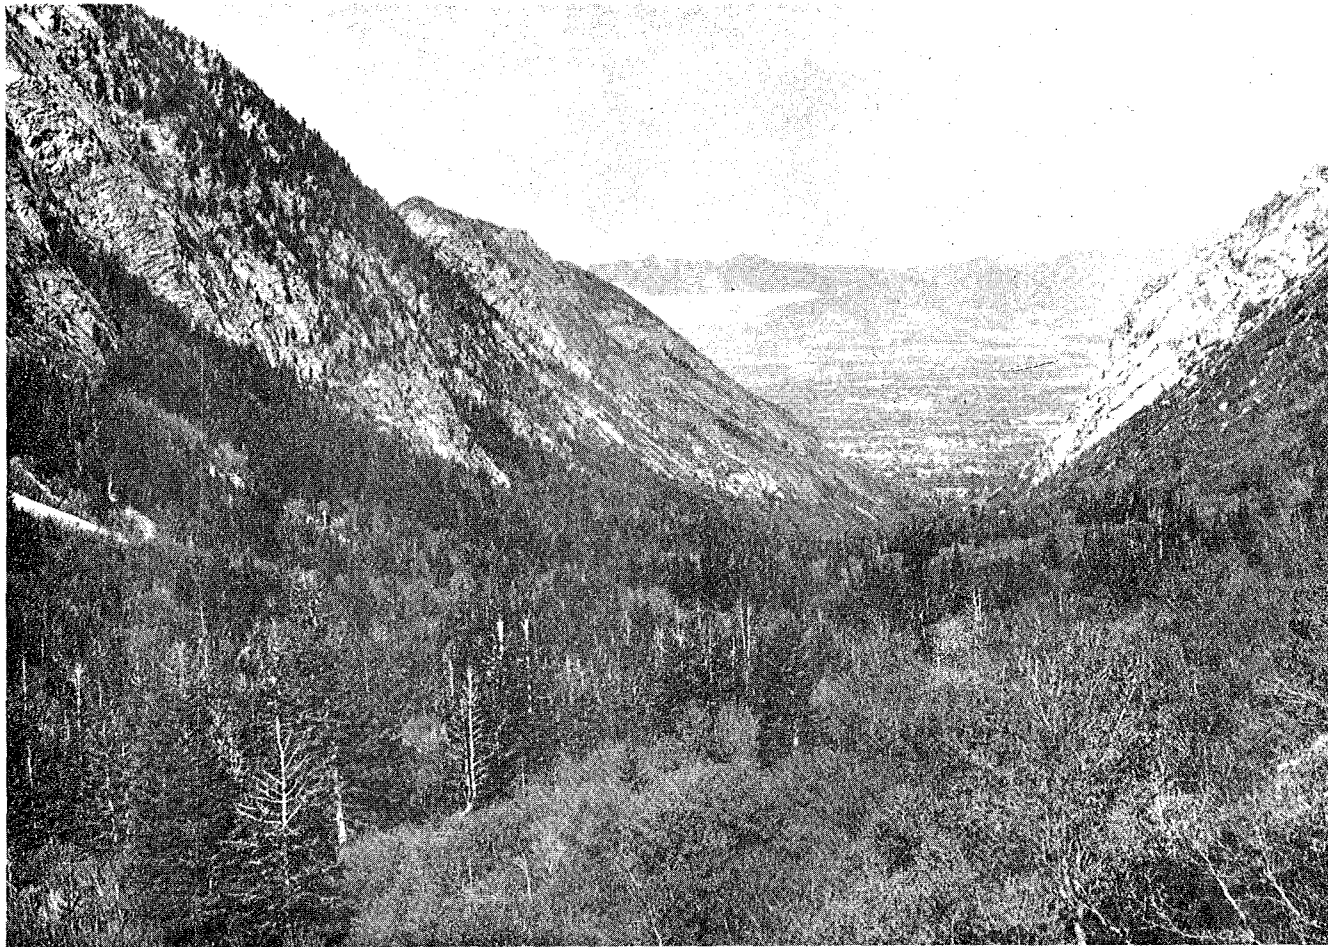
Figure 8. Little Cottonwood Canyon, near Salt Lake City, Utah

In the Western Region topography plays a very important role in the generation of flash floods. The steep slopes and cliffs (Figure 8) provide a strong orographic lifting mechanism intensifying the precipitation. The intense, short duration precipitation in turn produces rapid runoff and very high peaks for small amounts of rainfall.
