THE MISSISSIPPI RIVER GULF OUTLET:

A Study of Bank Stabilization

COASTAL ENVIRONMENTS, INC.
BATON ROUGE, LOUISIANA

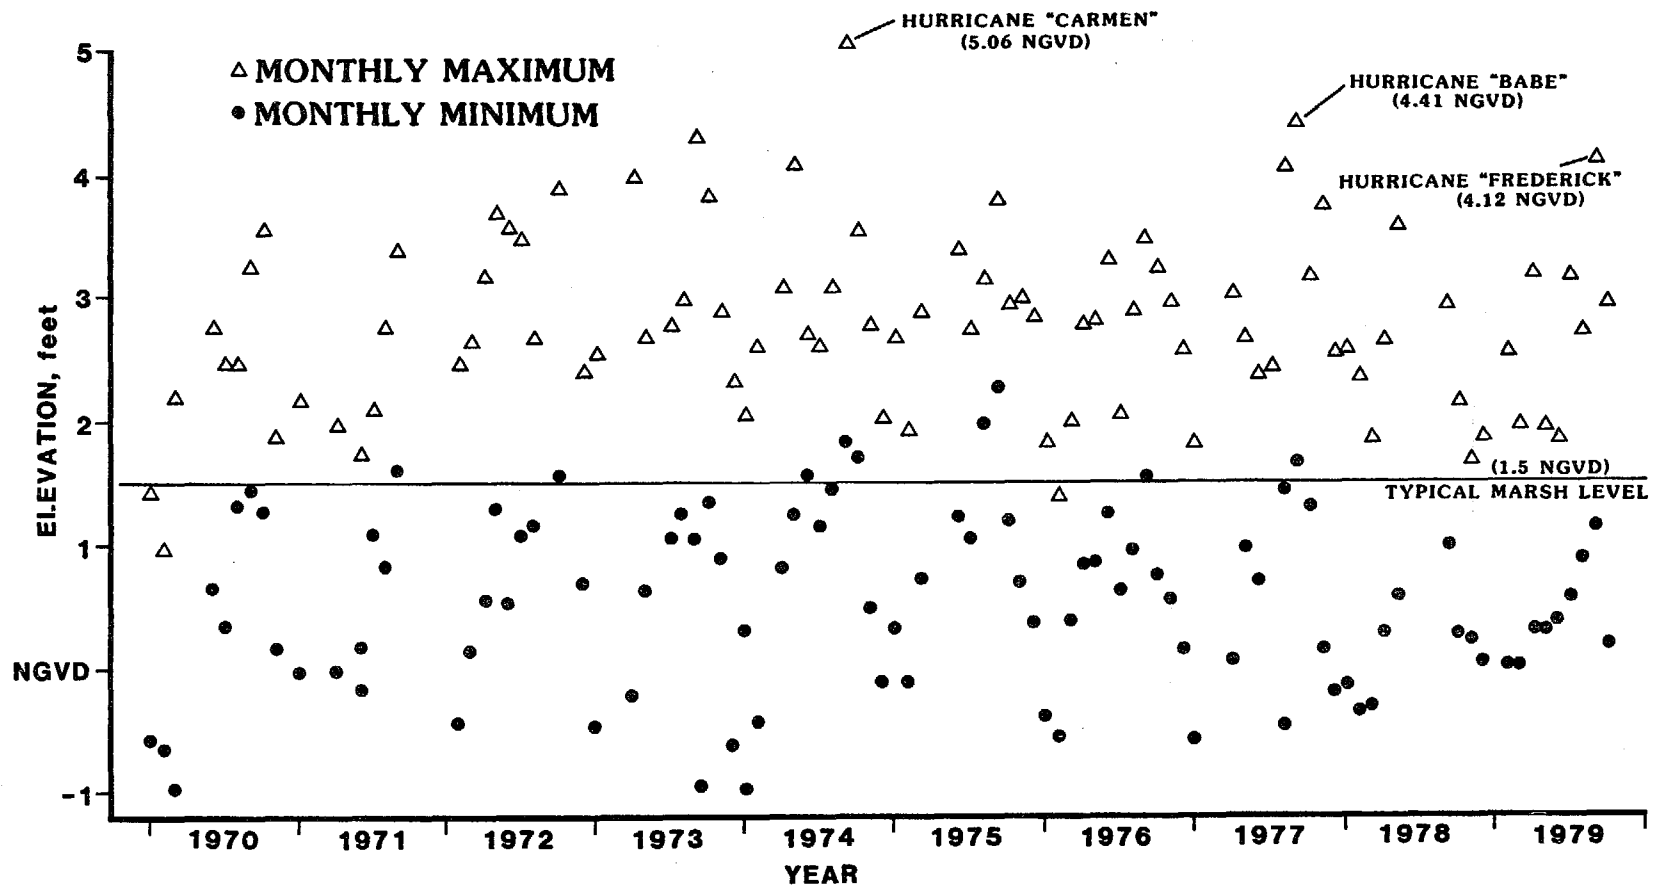
Figure 4. Monthly water level maximums and minimums from 1970 to 1979 for MRGO at Shell Beach, Louisiana. Data based on daily 8 a.m. stages (USACE 1970-1979).

High water extremes are more variable than low water extremes. Figure 4 demonstrates that the typical monthly high is 1.5 ft above marsh level (3.0 ft NGVD). But occasionally there are spurious highs that may exceed this level. These highs are caused by extremely strong southerly winds, of which the highest are generated by hurricanes. In the ten-year period catalogued in Figure 4, three hurricane-related highs are shown: Hurricane Carmen, Hurricane Babe, and Hurricane Frederic. The highest level, that associated with Hurricane Carmen, caused a water level rise 3.5 ft above marsh level (5.06 NGVD). The years 1970 through 1979 do not provide the complete high water picture, for this epoch did not receive any truly intense hurricanes. Table 2 (USACE 1972) provides a broader time frame from which high

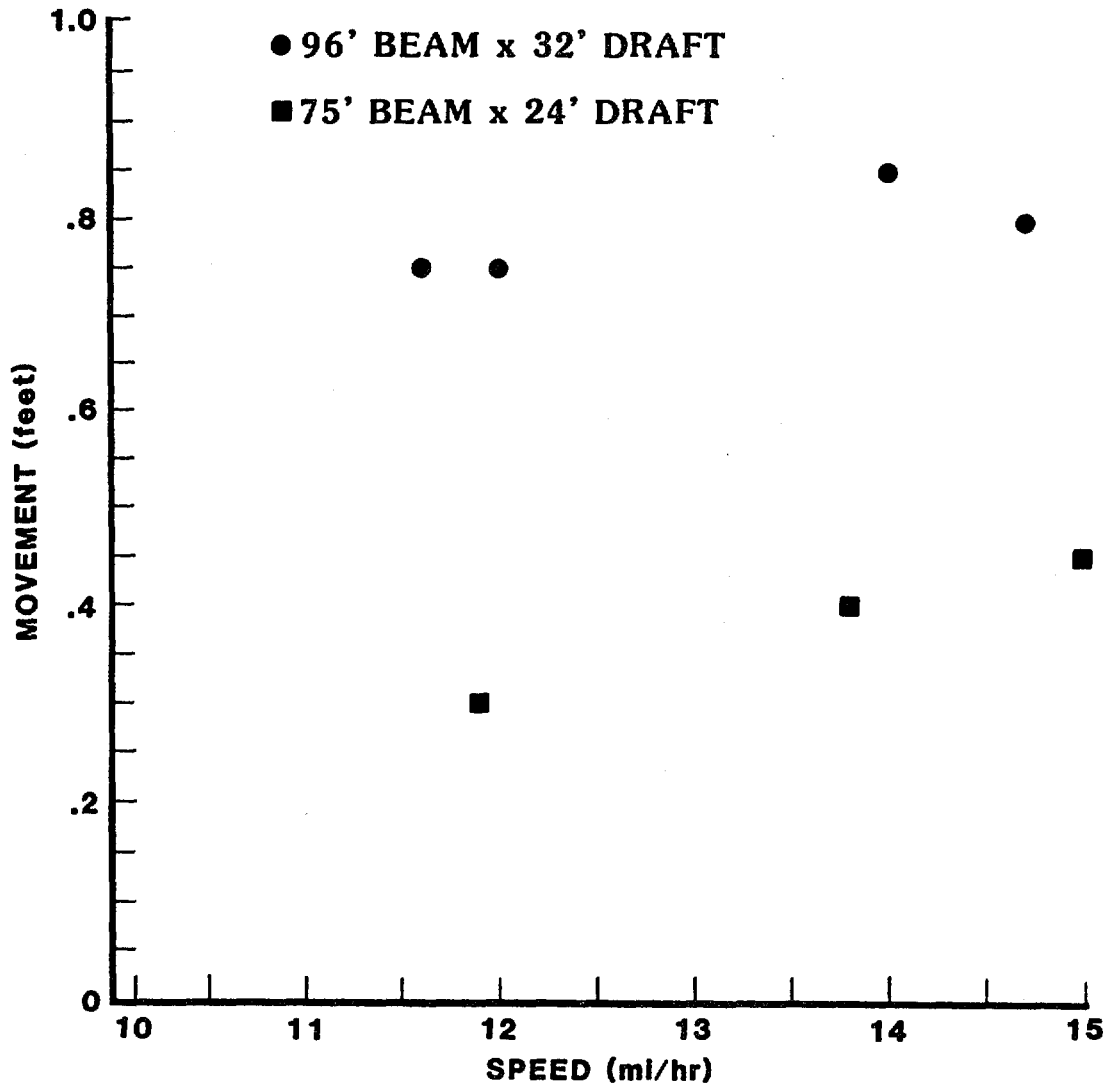
Figure 16. Relationship between ship speed and water-level movement on the MRGO for two contrasting vessel classes. Note that recorded movement is only a fraction of actual movement. (Vessel speed from data provided by Vessel Traffic Service, U.S. Coast Guard; water movements from USACE tide gauge data).

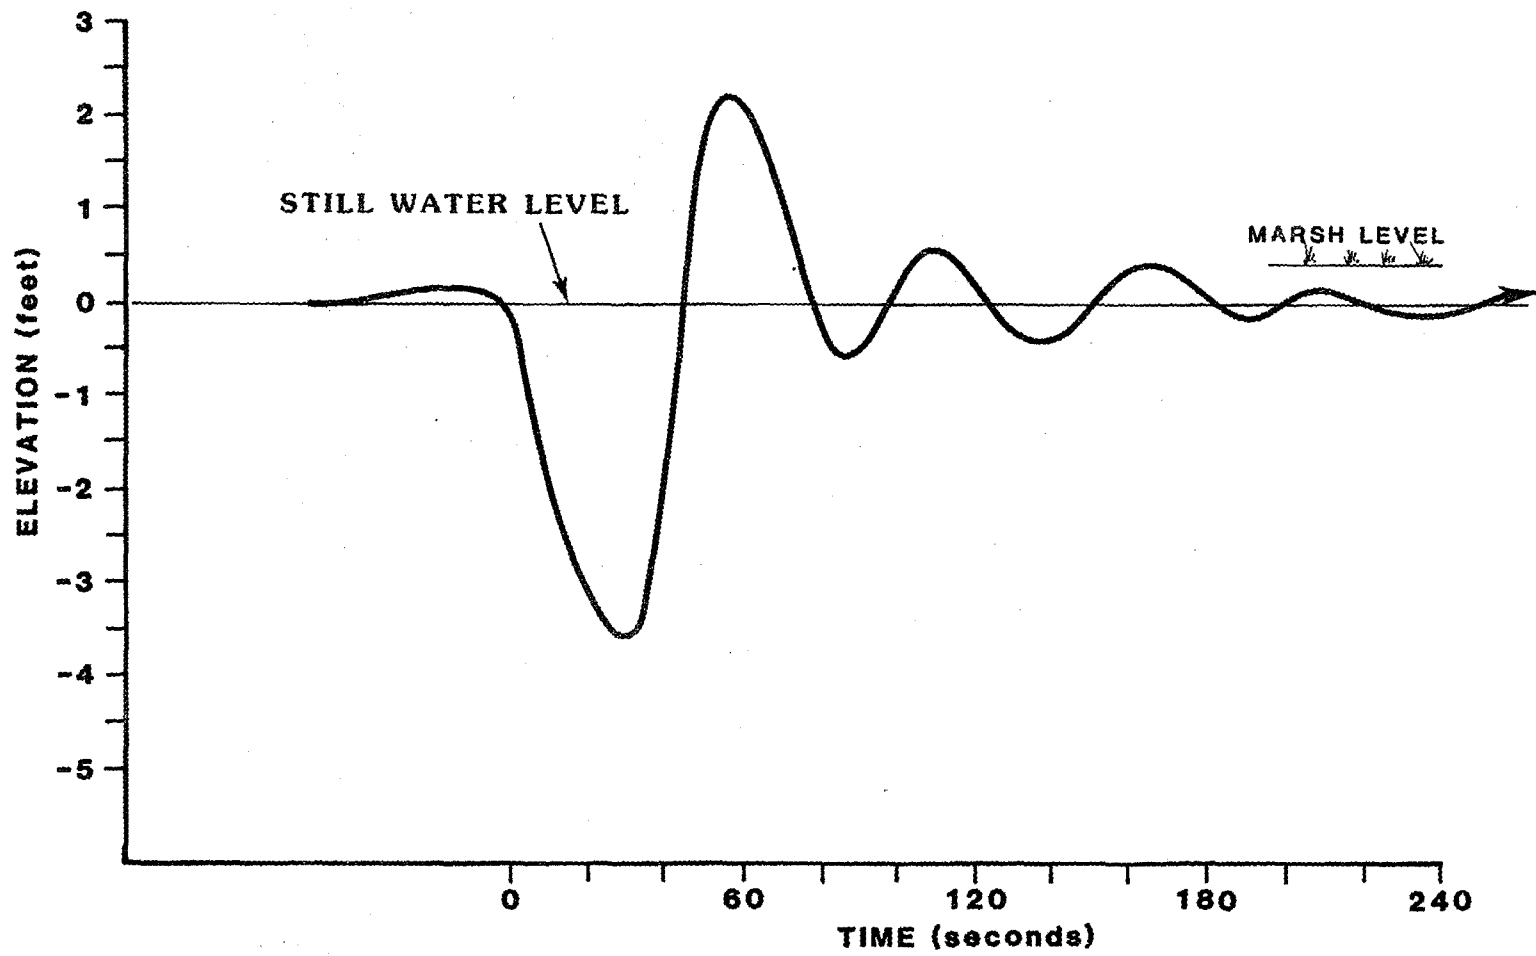
Figure 17. Water level response at MRGO station 1627 as the "Brussels" passes upbound.

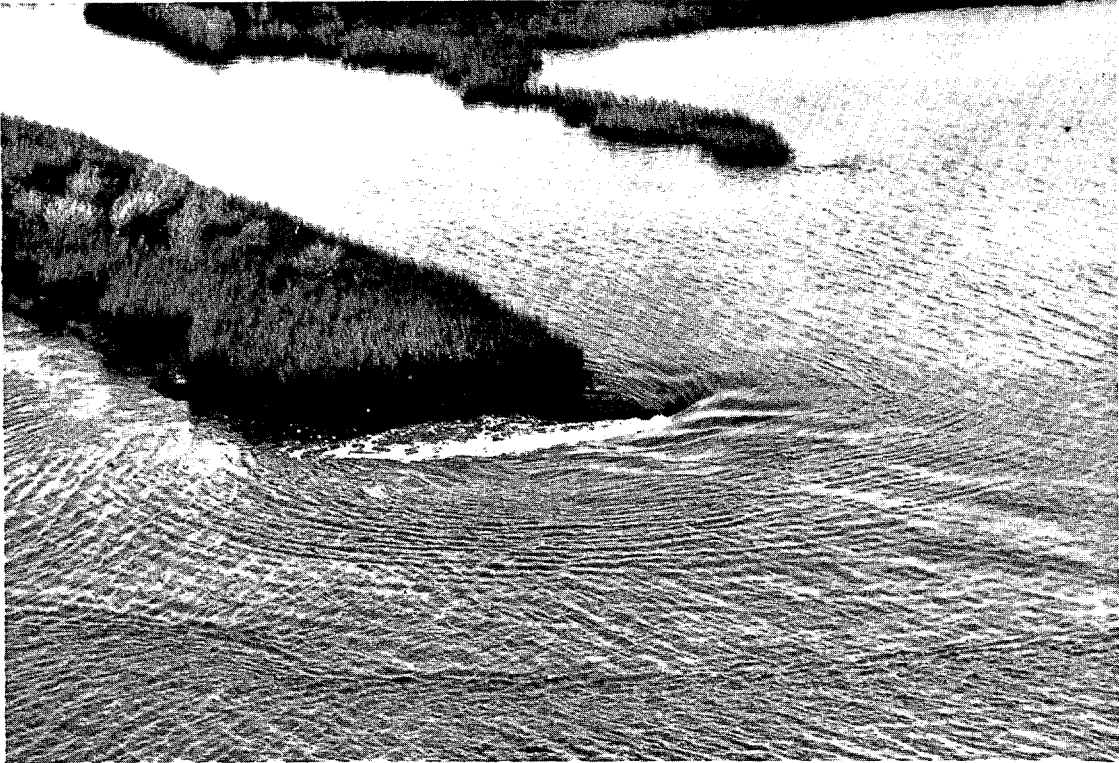
Figure 18. Low altitude oblique photograph of northeast shore of the MRGO at station 1095 as transverse wave from large displacement vessel causes drawdown. Note how bayou waters feed drawdown and thus mitigate wave activity in front of bayou.

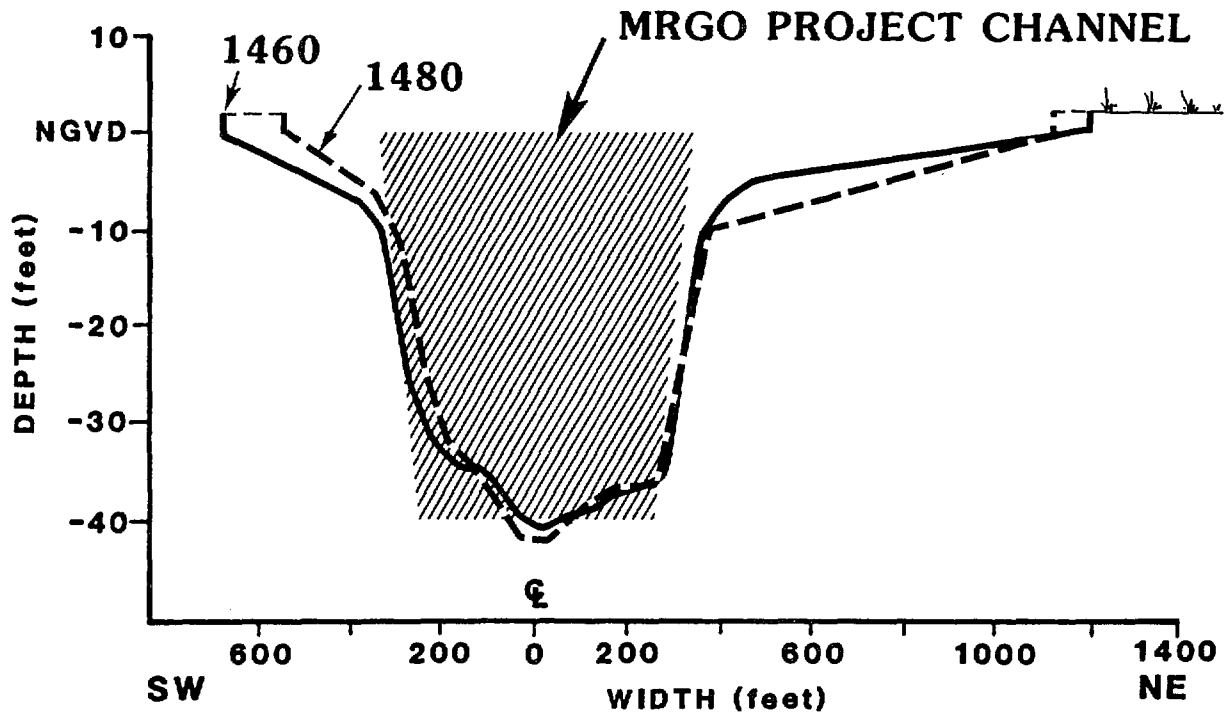
Figure 24. Typical MRGO cross sections in Lena Lagoon area (stations 1460 and 1480). November 1981 shoreline and July 1982 hydrography (USACE 1982a). Last maintenance dredging in 1972.

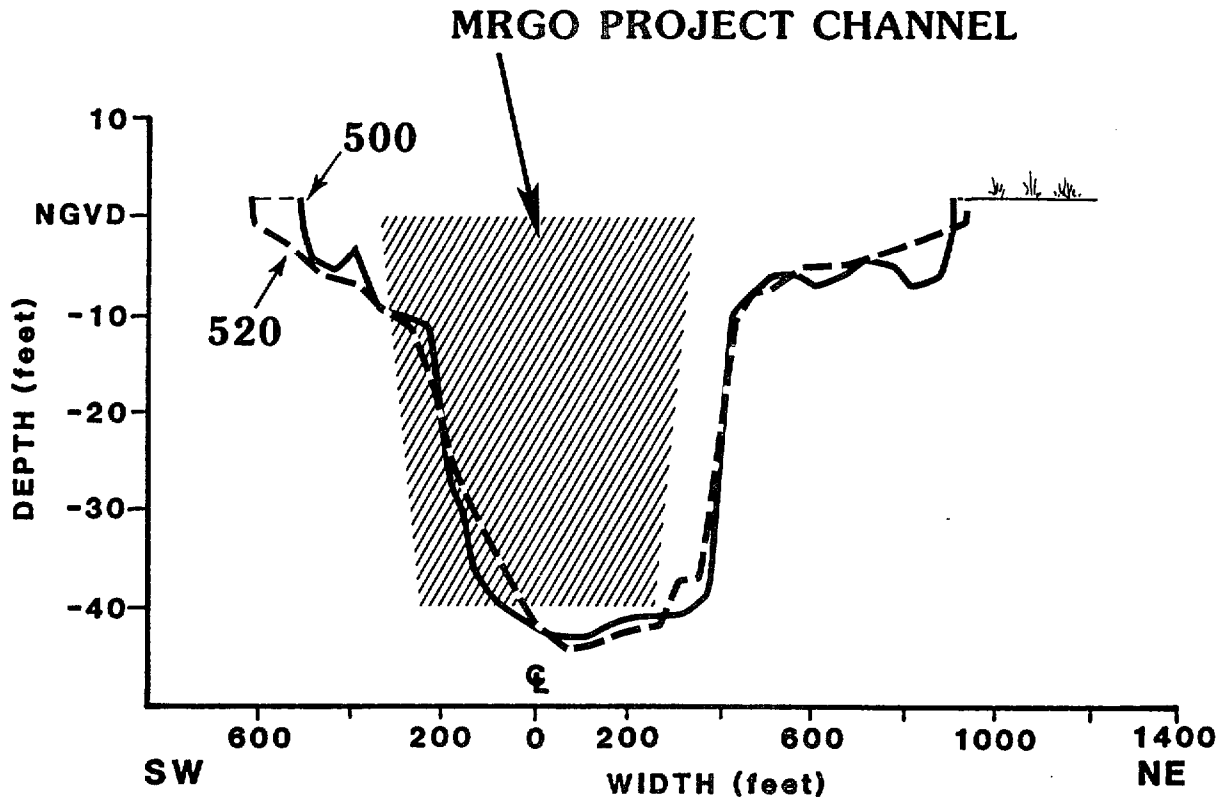
Figure 25. Typical MRGO cross sections in Bayou Ducross - Bayou Villere area (stations 500 and 520). November 1981 shoreline and July 1982 hydrography (USACE 1982a). Last maintenance dredging in 1972.

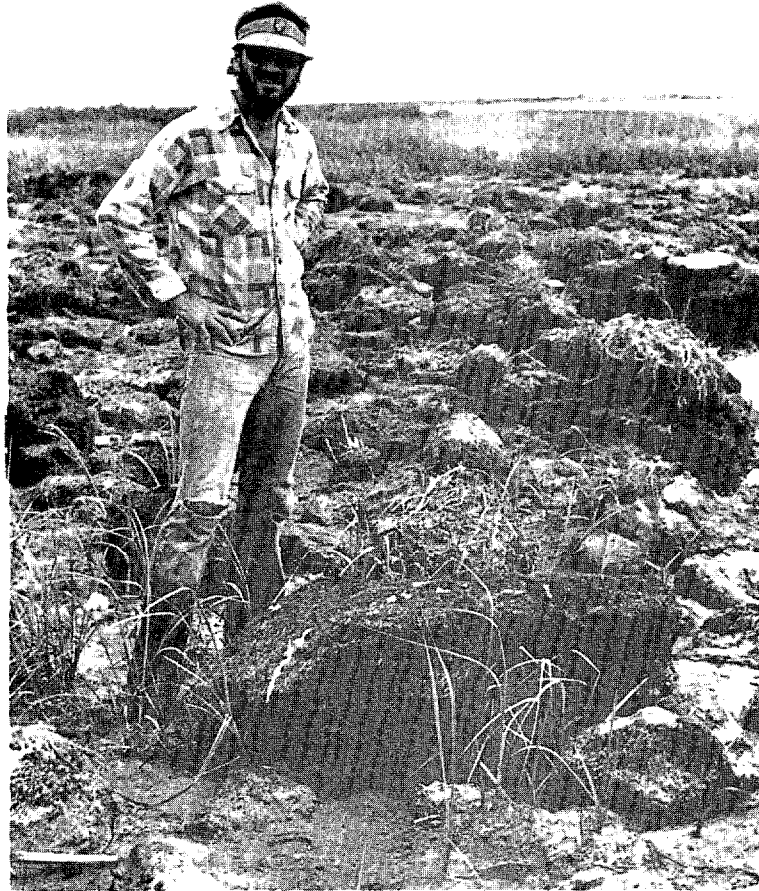
Figure 32. Large marsh block that has flipped onto marsh surface by a large transverse wave. Note numerous smaller blocks in background.

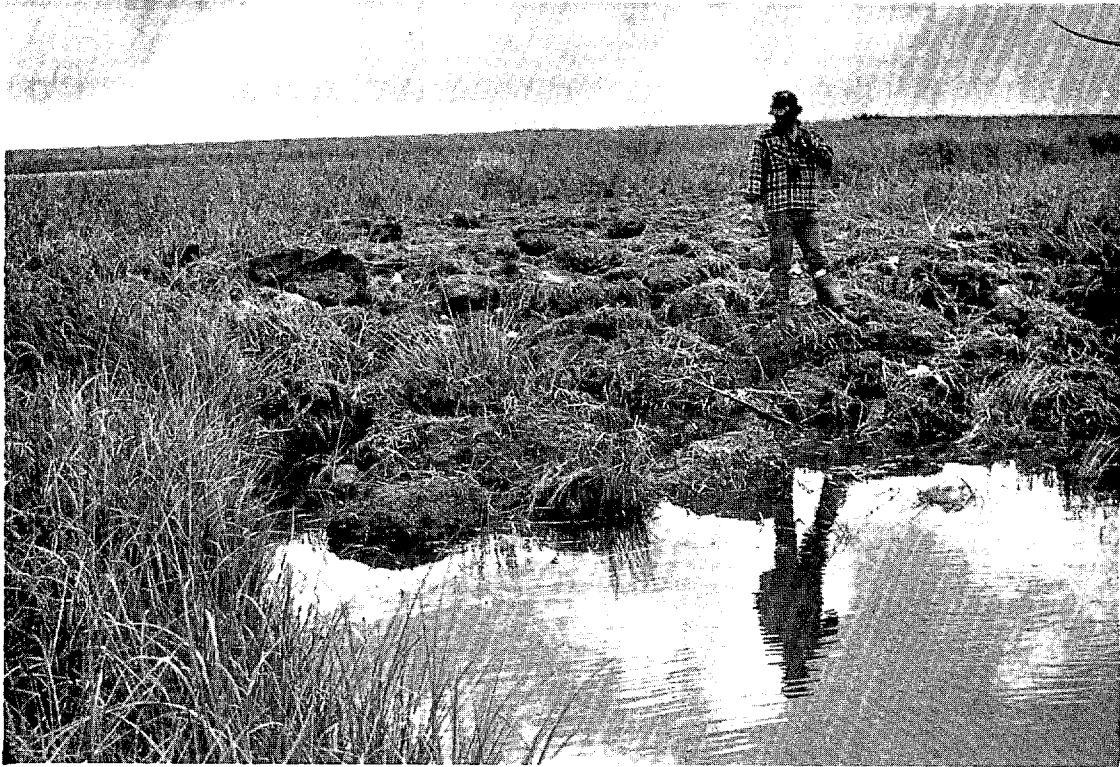
Figure 33. Marsh blocks deposited in cove by transverse waves.

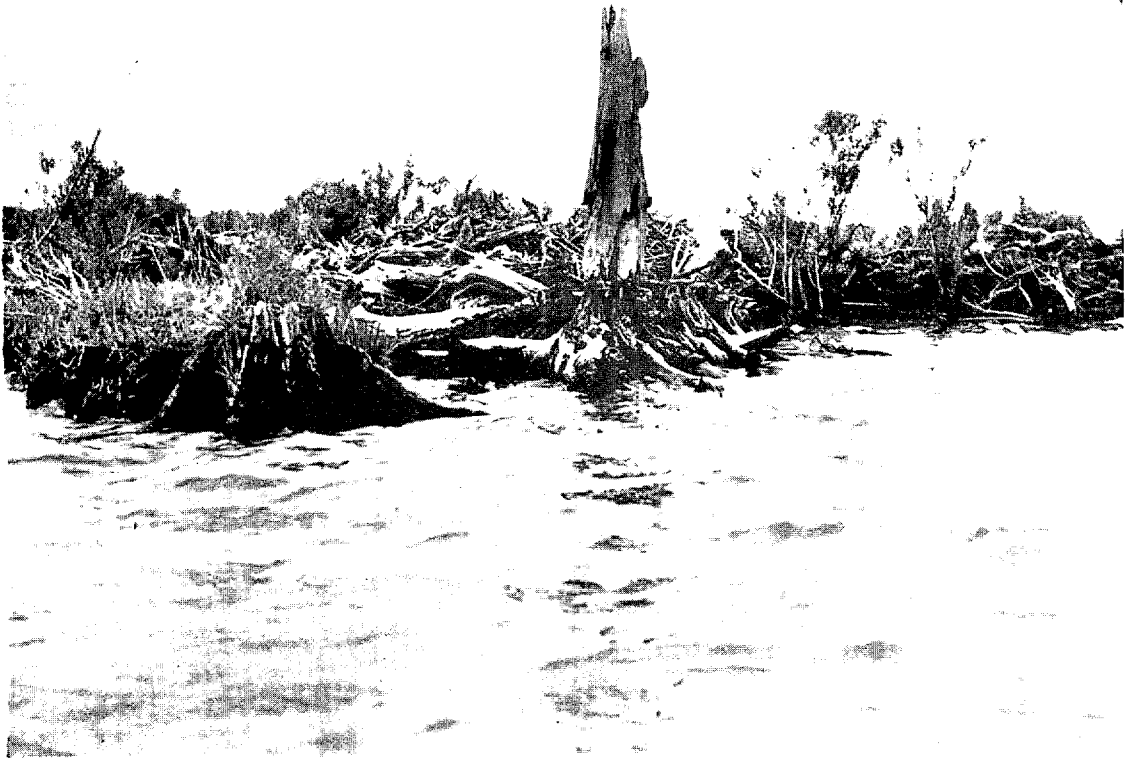
Figure 36. Swamp shoreline at station 870.

The stumps provide the greatest degree of erosional protection. Cypress is noted for its ability to resist rot, particularly if it has been covered with water and sediment. Even though many of the stumps along the shore may be as old as 500 years, the root systems are firmly attached in the substrate. Transverse waves have attempted in earnest to remove the stumps, but most remain intact in their growth positions (Figure 37). The net effect is for the stumps to reduce current flow, both during drawdown and return flow. Water level fluctuations are reduced and the shore is protected from severe erosion.

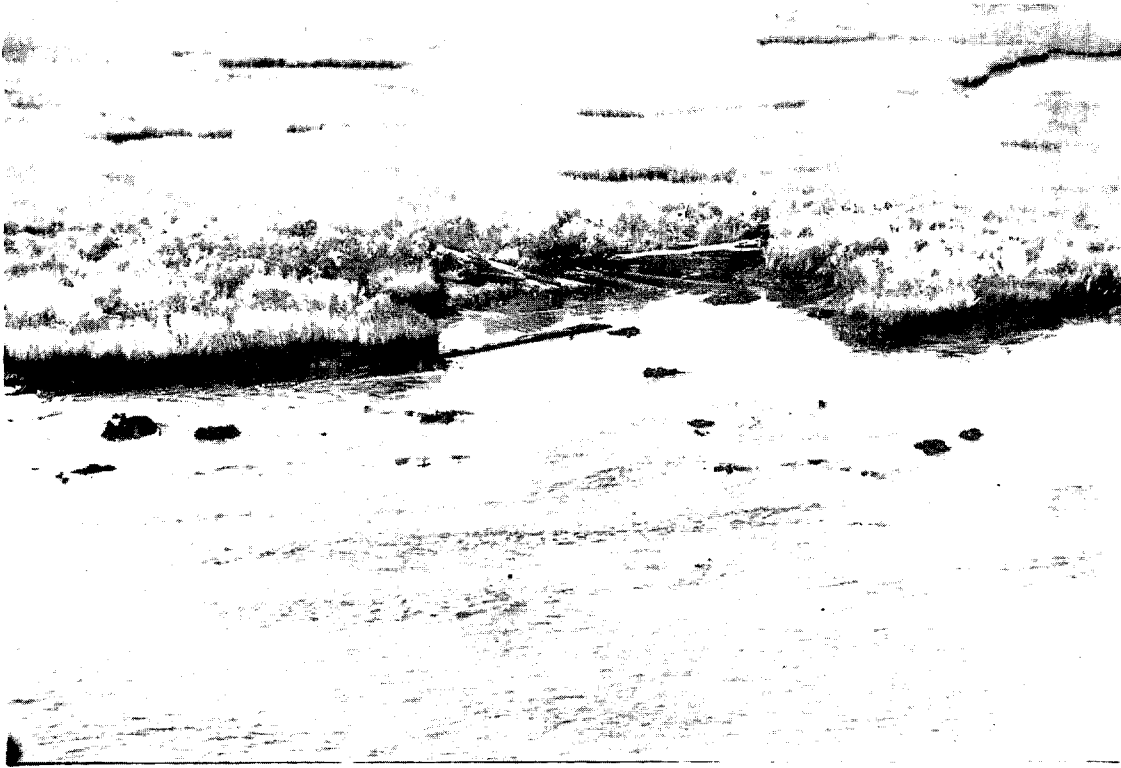
Figure 37. Transverse wave drawdown on swamp shoreline as large displacement vessel passes. Old stumps firmly implanted in adjacent shallow waters are providing a firm barrier to wave activity, thus shoreline erosion rate is relatively low in this area.

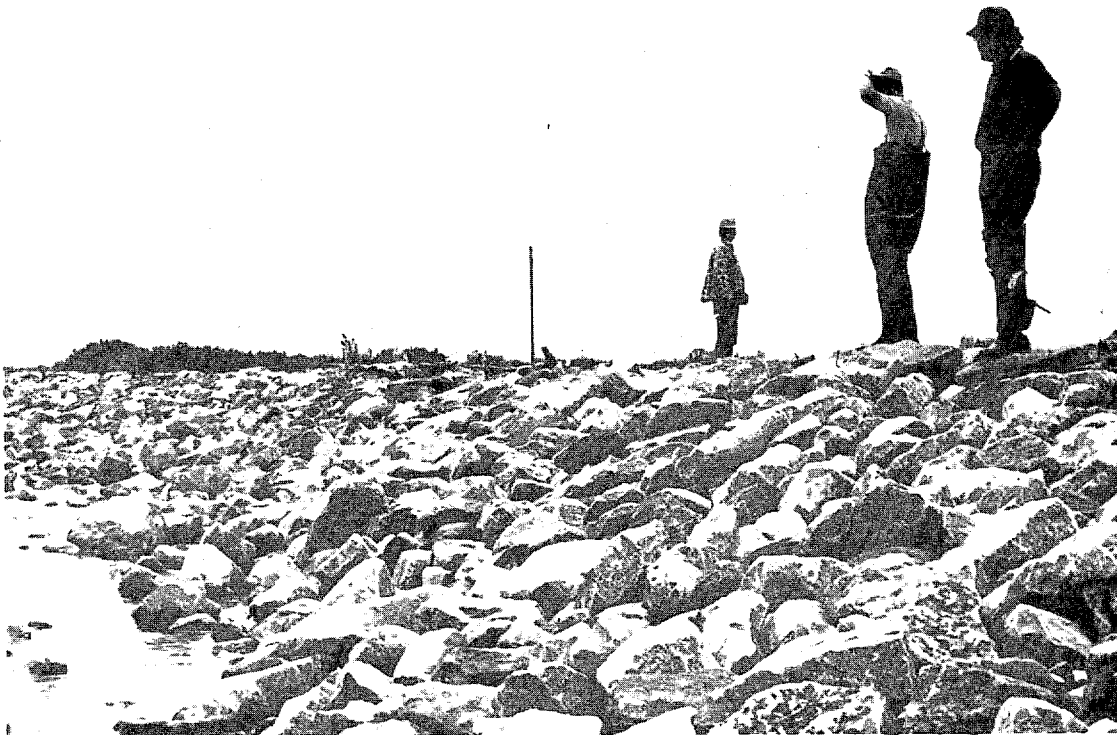
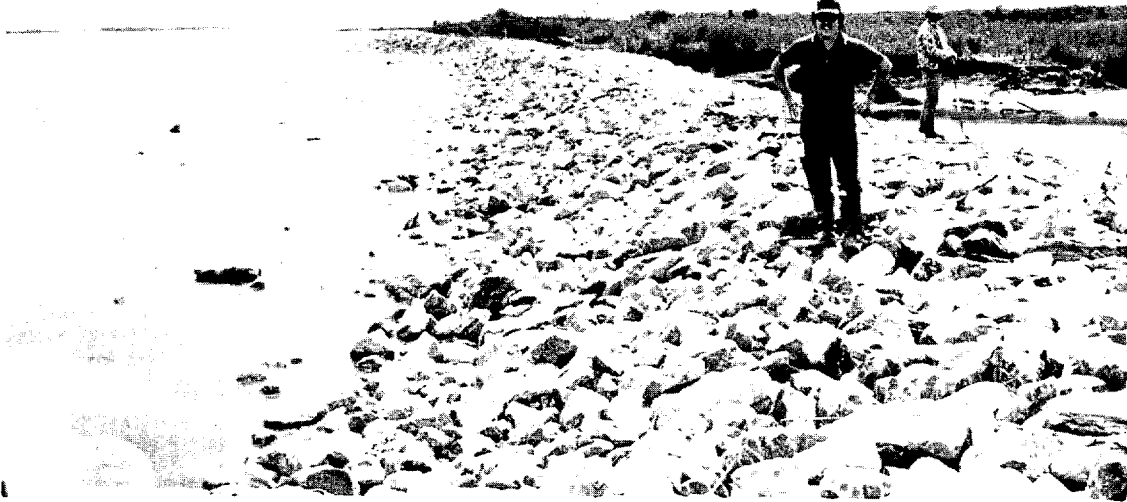
Figure 39. Photograph taken 27 March 1984 of test sections 1 and 2, MRGO foreshore protection project.

Figure 40. Photograph taken 27 March 1984 of test sections 1 and 2, MRGO foreshore protection project.

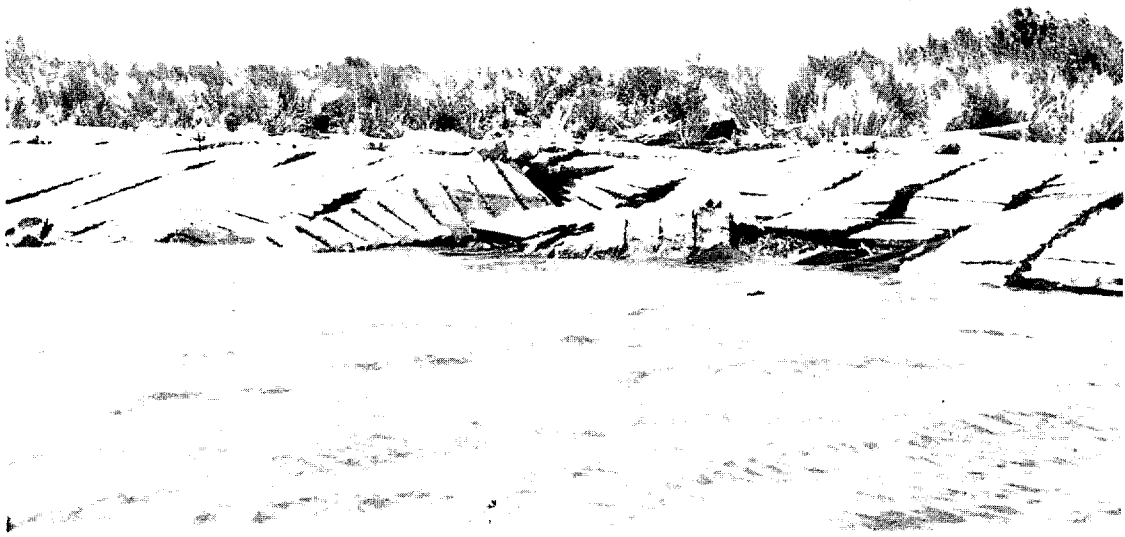
Figure 44. Photograph taken 27 March 1984 of failed test section 6, MRGO foreshore protection project.

Upon analyzing the Corps data it is apparent that none of the test sections would be suitable for use on the northeast shoreline. The 36-in layers of stone that were successful on the southwest shore would show massive settlements on the compressible marsh soils of the northeast shoreline. Construction would be extremely difficult since the shoreline is low and discontinuous. Finally, the cost of this type of
