EVALUATION OF THE RECREATIONAL FISHERY  
IN LAKE CANONCHET,  
NARRAGANSETT, RHODE ISLAND

Prepared for the Town of Narragansett  
through the Assistance to Local  
Communities Program of the Rhode  
Island Coastal Management Program

July, 1980

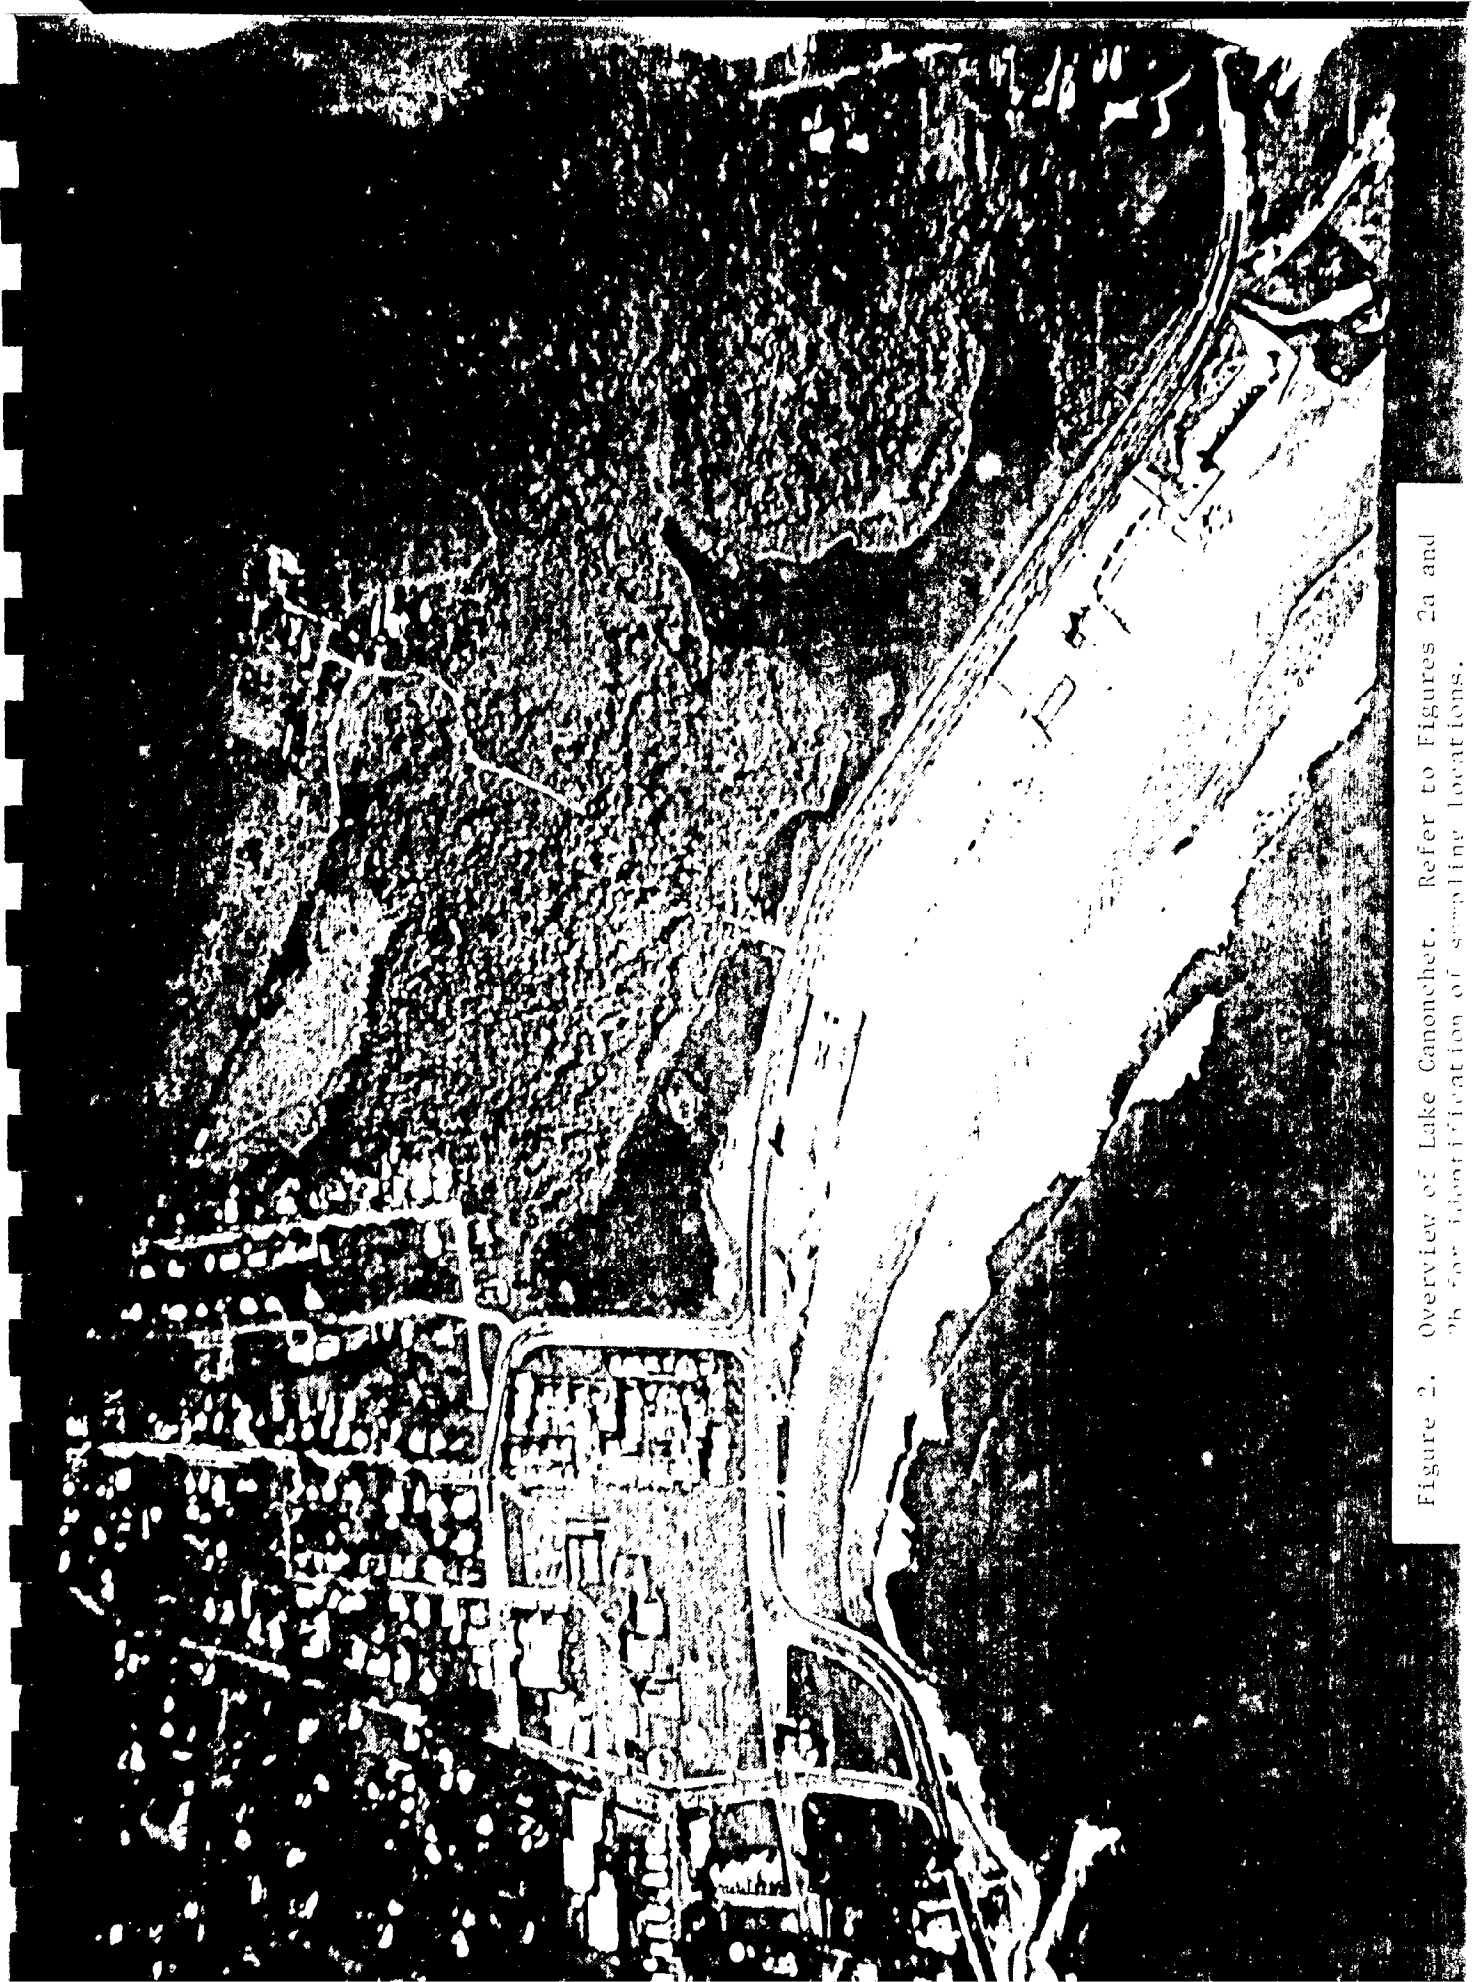
Figure 2. Overview of Lake Canochet. Refer to Figures 2a and 2b for identification of sampling locations.

In order to assist in the fisheries analysis and determination of management options, various water quality and limnological characteristics were measured (see Table 1). Temperature and dissolved oxygen were measured using a Beckman Fieldlab Oxygen Analyzer Model 1008. A Corning Model 610A portable field meter was used to record pH, and calcium carbonate ( $\text{CaCO}_3$ ) alkalinity was determined with the use of a Bausch and Lomb Spectrokit Reagent System. A bathymetric profile of the pond was determined from lead line soundings. This was an aid in the selection of trapping and seining sites. Figures 1 and 2 depict the pond bathymetry and identify sampling locations.
