St. Thomas East End Reserves Watershed Management Plan

May 2013

Horsley Witten Group, Inc.

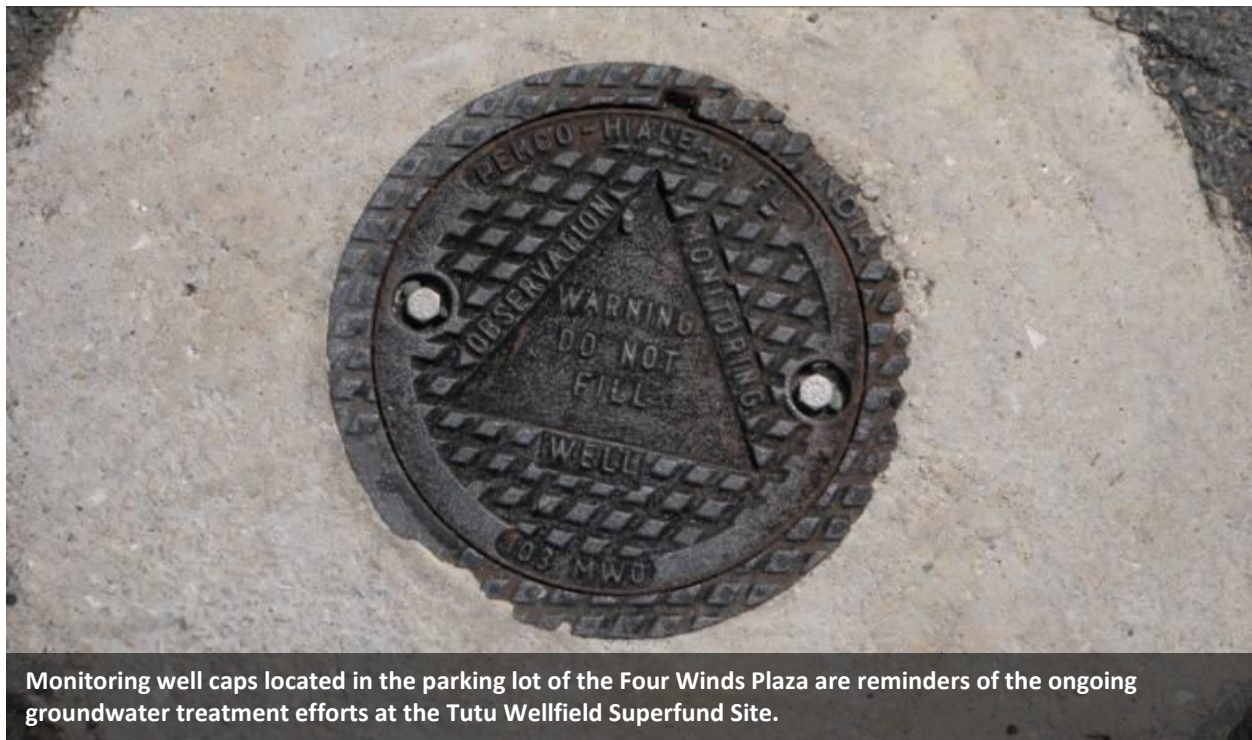
Monitoring well caps located in the parking lot of the Four Winds Plaza are reminders of the ongoing groundwater treatment efforts at the Tutu Wellfield Superfund Site.

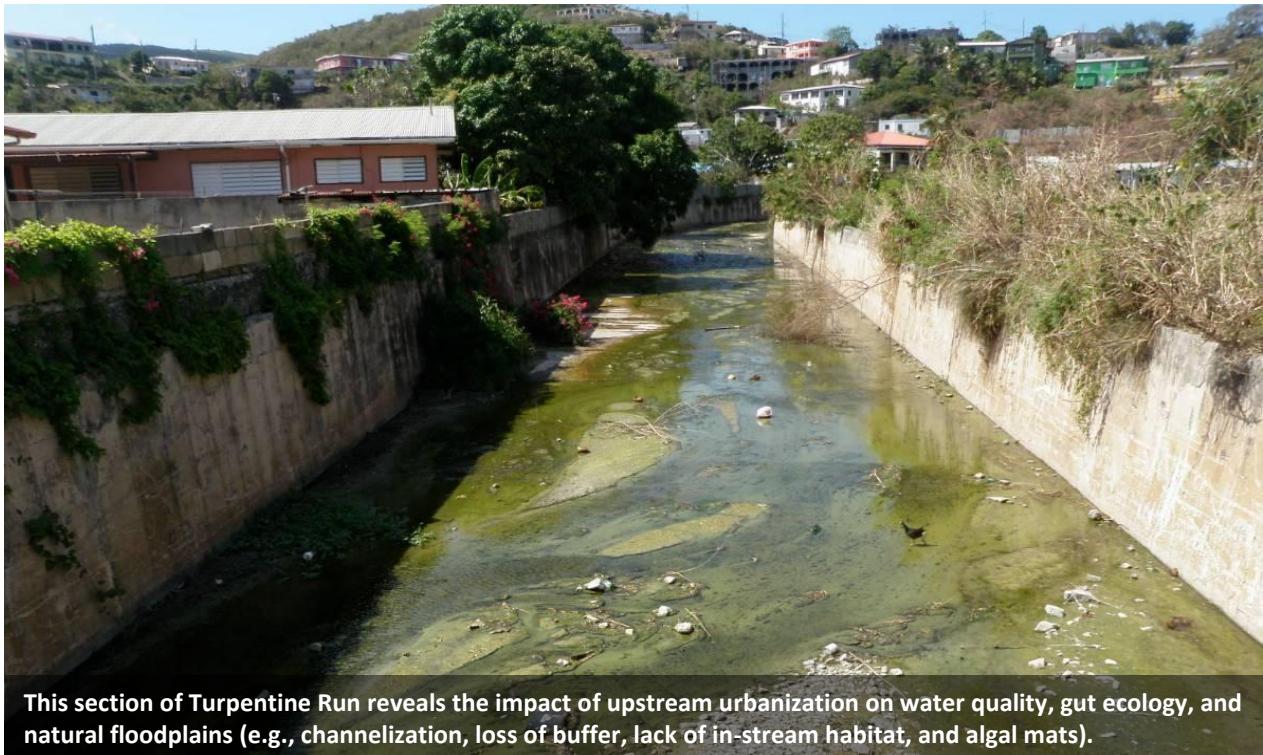
This section of Turpentine Run reveals the impact of upstream urbanization on water quality, gut ecology, and natural floodplains (e.g., channelization, loss of buffer, lack of in-stream habitat, and algal mats).

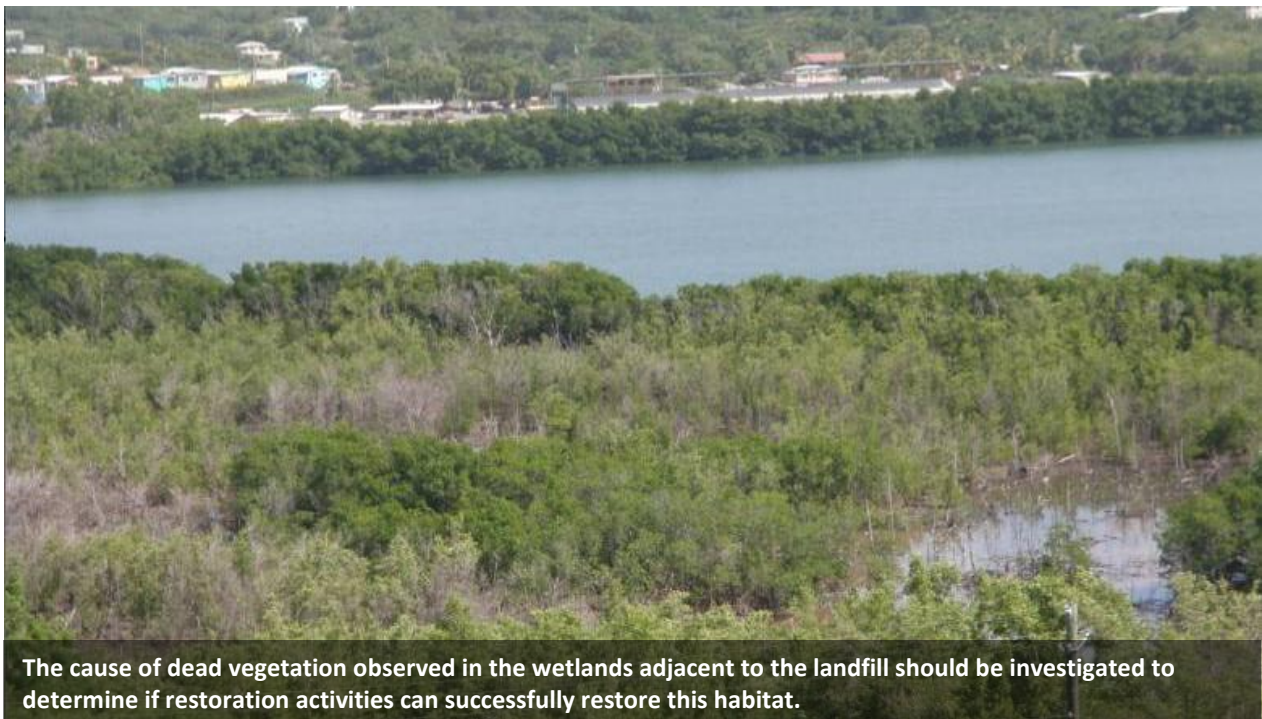
The cause of dead vegetation observed in the wetlands adjacent to the landfill should be investigated to determine if restoration activities can successfully restore this habitat.

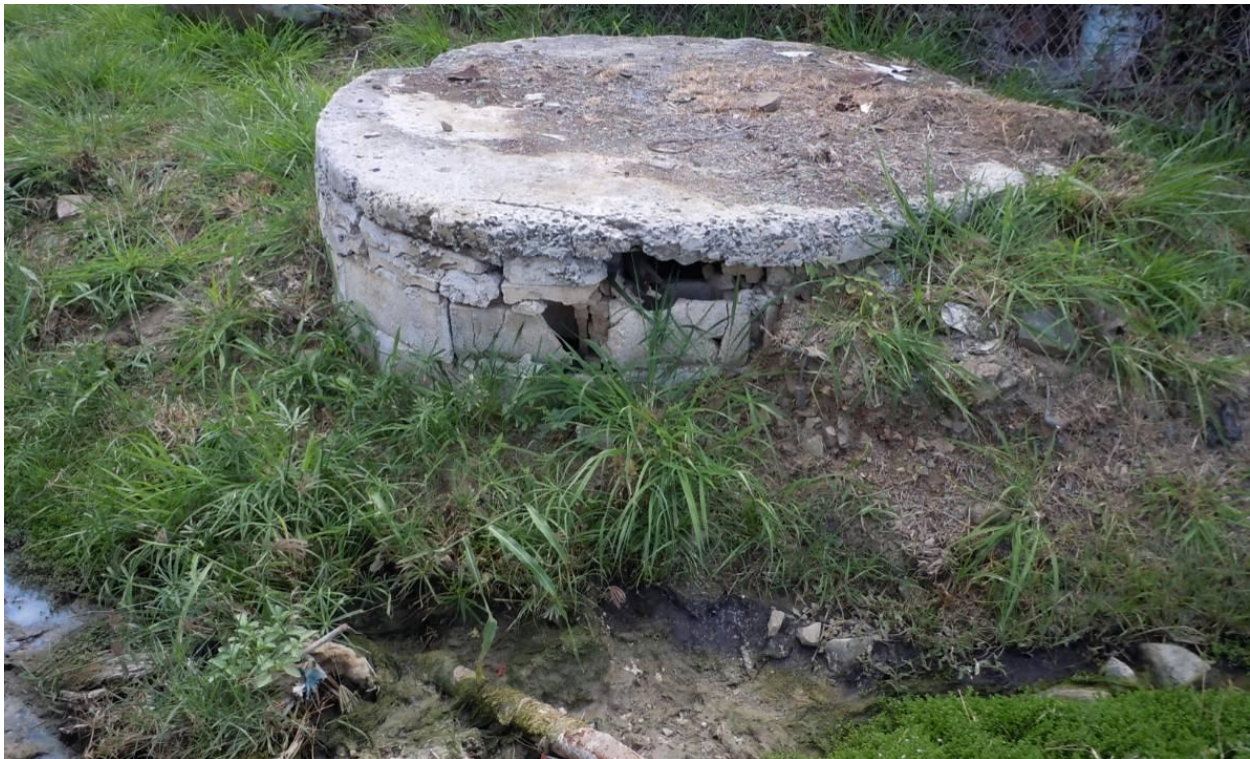
Deteriorating on-site sewage systems and evidence of recent wastewater discharges to guts were observed at multiple locations in the watershed.

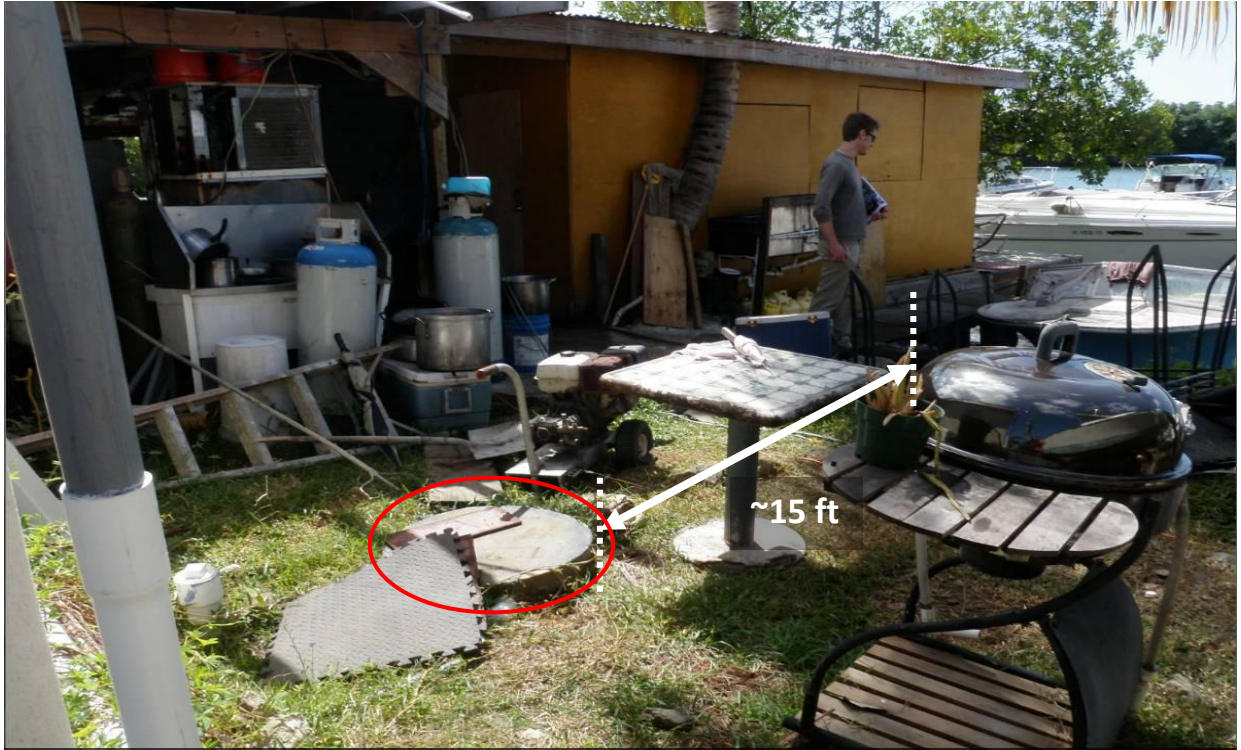
Between the restrooms and Benner Bay is the onsite wastewater system at “the Patch.” The access manhole for this OSDS is less than 15 ft from the water’s edge, leaving little distance for groundwater

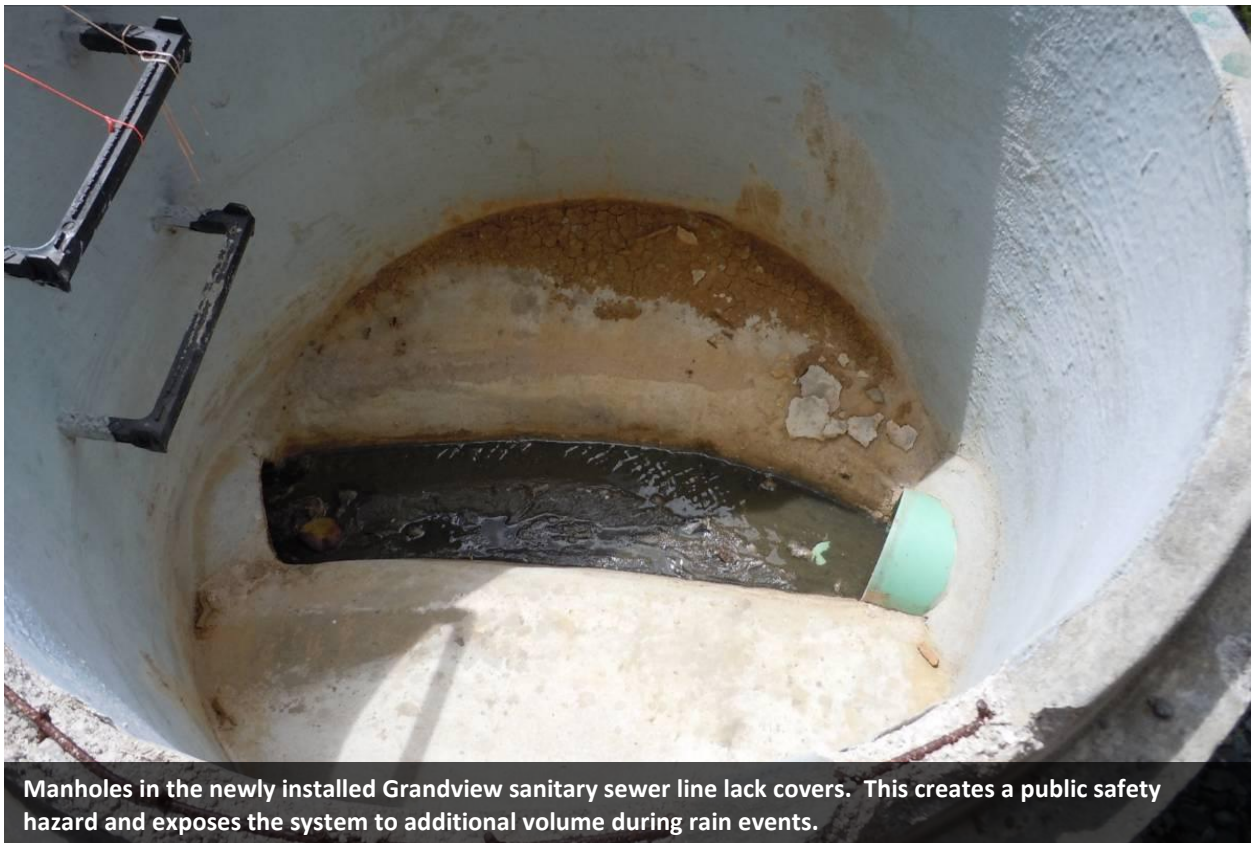
Manholes in the newly installed Grandview sanitary sewer line lack covers. This creates a public safety hazard and exposes the system to additional volume during rain events.

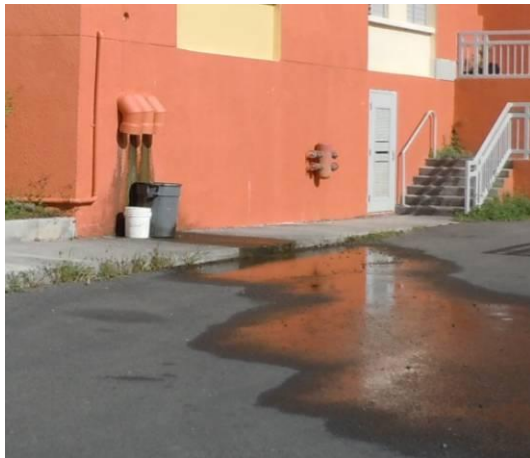
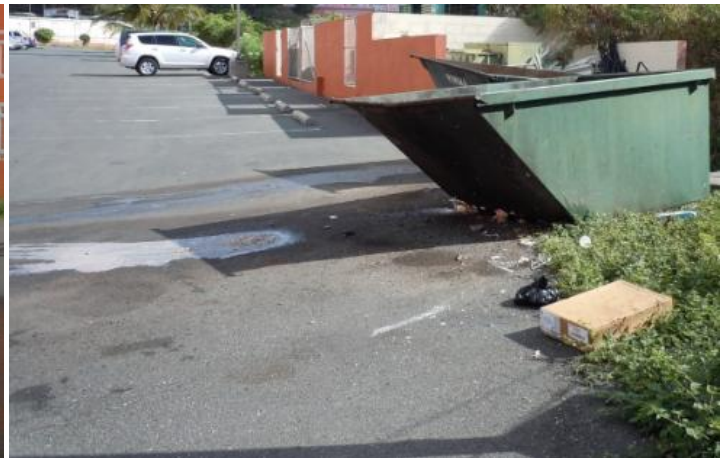
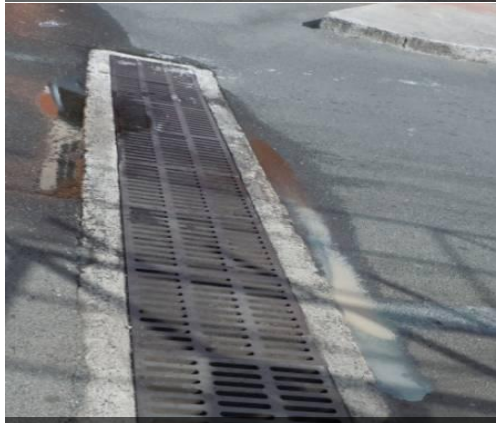
Unused cistern overflows, mop bucket waste, and dumpster juice at this site drain across the parking lot carrying pollutants into the storm drain system and discharging them downstream even when it is not

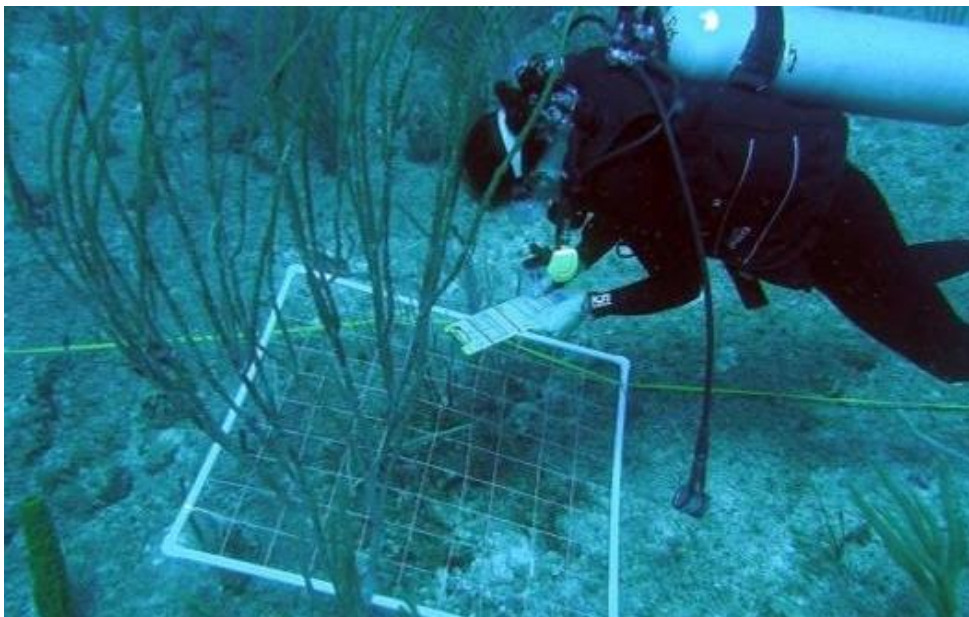
Biological characterizations of STEER included quantifying benthic habitat composition using quadrants (shown here), as well as establishing transects to document the abundance and diversity of fish, debris, and macro-invertebrates.

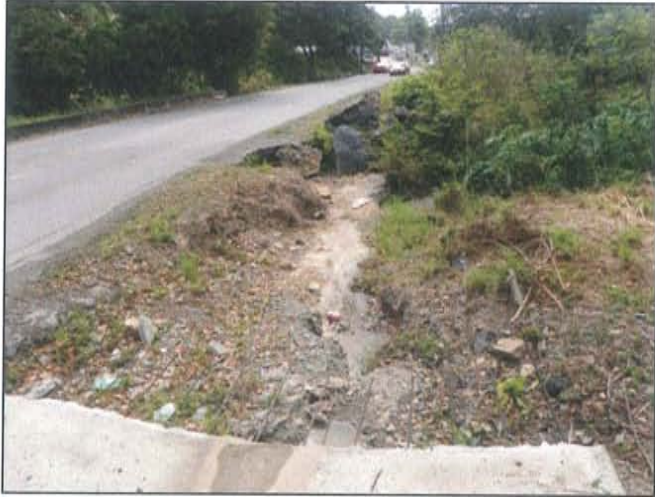
Concrete channel and scour downstream of culvert at TR-37.
