# Shoreline Situation Report

## PRINCE WILLIAM COUNTY, VIRGINIA

Special Report In Applied Marine Science and Ocean Engineering Number 119 of the

VIRGINIA INSTITUTE OF MARINE SCIENCE

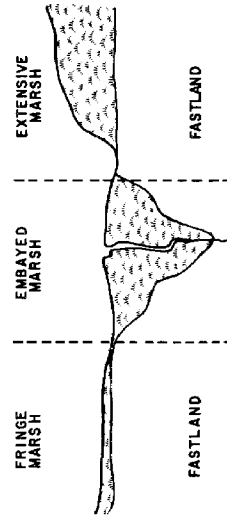
Figure 2

A plan view of the three marsh types.

The physiographic character of the marshes has also been separated into three types (see Figure 2). Fringe marsh is that which is less than 400 feet in width and which runs in a band parallel to the shore. Extensive marsh is that which has extensive acreage projecting into an estuary or river. An embayed marsh is a marsh which occupies a reentrant or drowned creek valley. The purpose in delineating these marsh types is that the effectiveness of the various functions of the marsh will, in part, be determined by type of exposure to the estuarine system. A fringe marsh may, for example, have maximum value as a buffer to wave erosion of the fastland. An extensive marsh, on the other hand, is likely a more efficient transporter of detritus and other food chain materials due to its greater drainage density than an embayed marsh. The central point is that planners, in the light of ongoing and future research, will desire to weight various functions of marshes and the physiographic delineation aids their decision making by denoting where the various types exist. The classification used is:

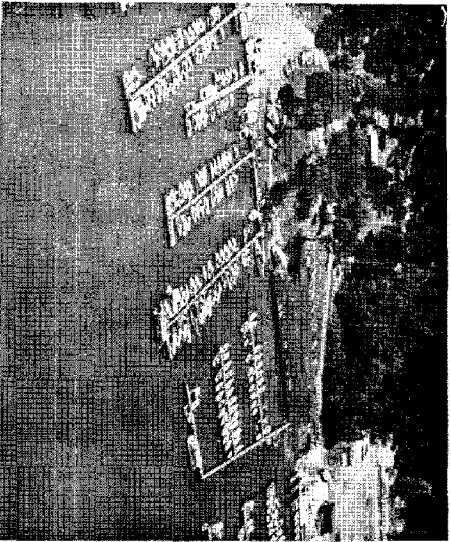
FIGURE 3

FIGURE 3: Marina facilities on Neabsco Creek, north of the railroad bridge (Subsegment 2b).

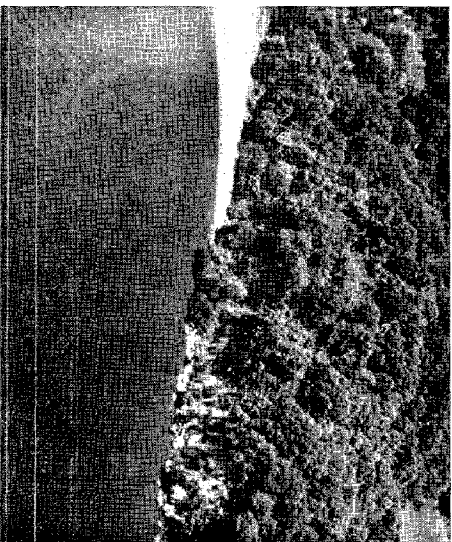
FIGURE 5

FIGURE 5: Bluffs and beach at Freestone Point (Subsegment 2b). The bluffs are composed primarily of rock and can withstand most erosive forces. The beach on the left side of the photo is one of the nicest in the county.

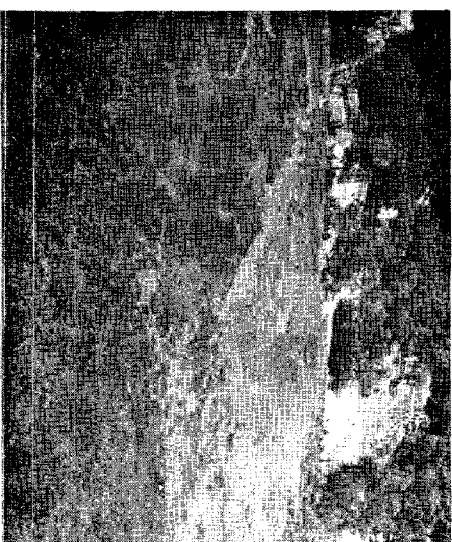
FIGURE 6

FIGURE 6: Embayed marsh fronting new development on Quantico Creek (Segment 4). Residential buildings behind valuable marsh areas are environmentally sound if proper precautions are taken to ensure there are no harmful effects on the marsh system.

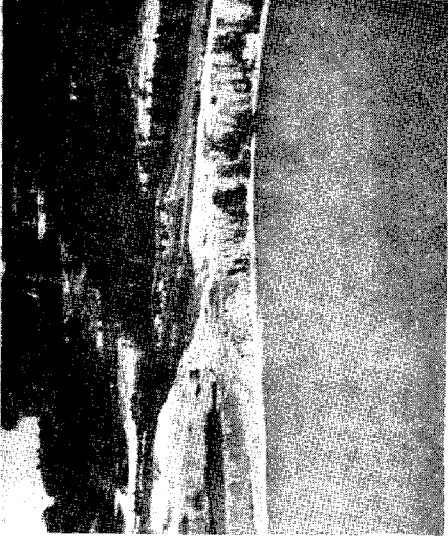
FIGURE 7

FIGURE 7: Vulnerable bluffs north of the VEPCO substation (Subsegment 3B). The bluffs will probably continue to erode at a slight to moderate rate until the area is artificially stabilized.

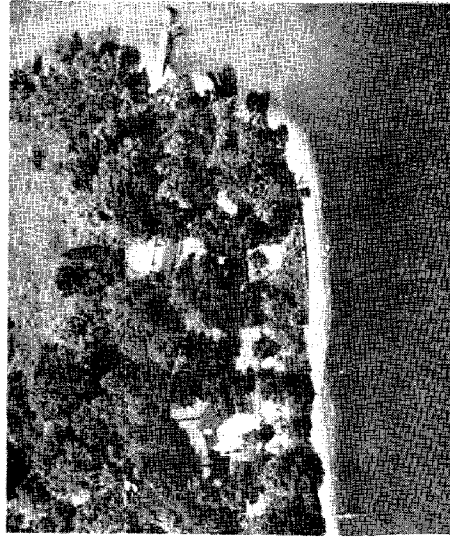
FIGURE 9

FIGURE 9: North end of Chopawamsic Island (Subsegment 5A). The house in the foreground is endangered by continued erosion of the bluff. Two sets of bulkhead seem to be ineffective in combatting the erosion problem. Downhill rain runoff is also a major factor in the erosion of the cliff.

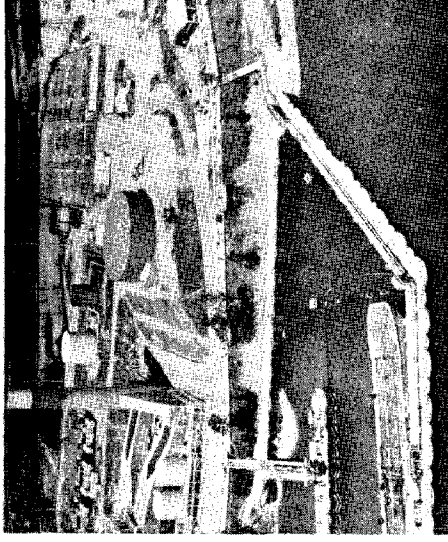
FIGURE 8

FIGURE 8: VEPCO substation on Possum Point (Subsegment 3B). The bulkhead is vertical steel sheet pile back-filled with a stone and sand aggregate.

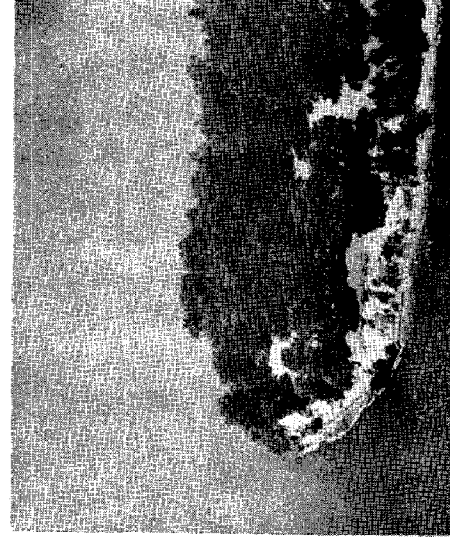
FIGURE 10

Several factors influence the location and rate of erosion for any section of shoreline. Along a major river such as the Potomac, a primary cause of erosion is wind generated waves. In bluff areas, waves attack the exposed cliff base. This process eventually undercuts the base of the cliff, causing the upper portion to slump. The height and growth of waves is controlled by four factors: The overwater distance across which the wind blows (the fetch), the velocity of the wind, the duration of time that the wind blows, and the depth of the water. Prince William County is affected by storms out of the northeast and southeast. Fetches during northeasters range from 2.5 to 6.6 nautical miles and during southeasters from 3.5 to 10.0 nautical miles. The southern end of Chopawamsic Island, having a fetch of 10.0 nautical miles from the southeast, has moderate erosion. Only pilings remain from an earlier attempt at bulkheading this section (see Figure 10).

FIGURE 10: South end of Chopawamsic Island (Subsegment 5A). The bulkheading of this area has failed, leaving the cliffs exposed to wind generated waves from the southeast.
