## **ADAPTIVE MANAGEMENT FOR IMPACTS TO EELGRASS HABITAT IN GLOUCESTER HARBOR**

Anthony R. Wilbur<sup>1</sup>, Brandy M.M. Wilbur<sup>2</sup>, and Phil Colarusso<sup>3</sup>

### **SUMMARY**

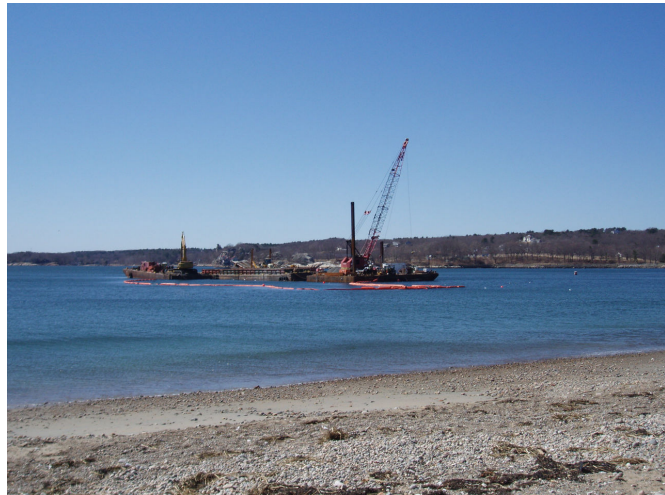
FIGURE 1. Barge and dredge located over eelgrass bed at Pavilion Beach during outfall construction.

Construction of the new outfall included dredging a corridor for the extent of the pipe, laying the pipe in the trench, and backfilling the trench with rip rap and dredged material. Construction in the subtidal environment involved mooring a barge and dredging along the corridor off Pavilion Beach for several months (Figure 1).

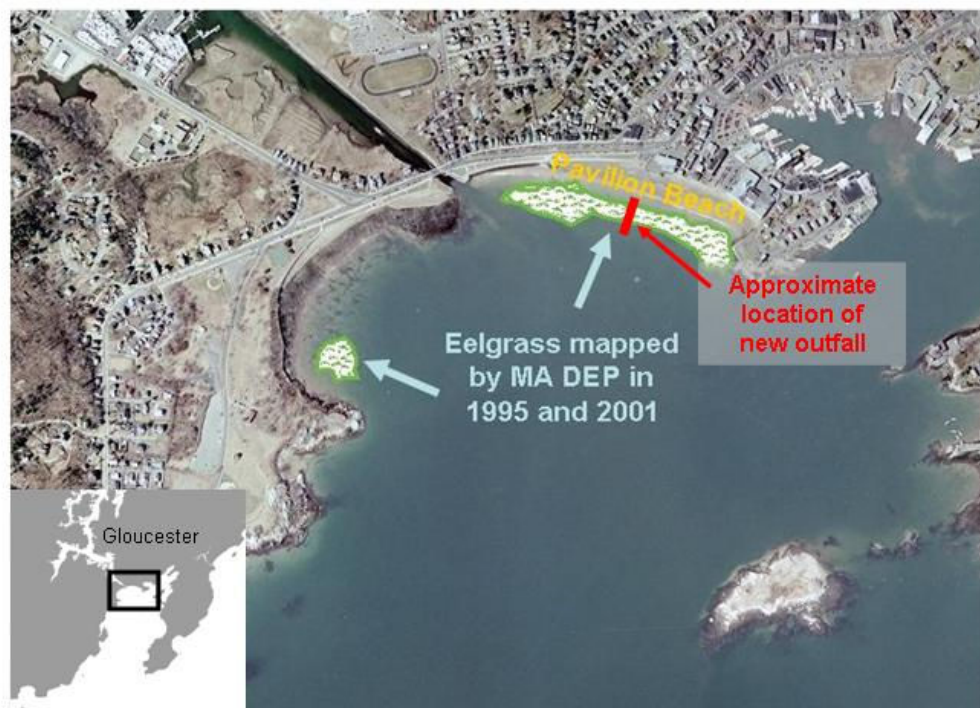
FIGURE 2. Distribution of eelgrass, as mapped by MA DEP (1995 and 2001), and location of Pavilion Beach in Gloucester Harbor.

Eelgrass (*Zostera marina*), an underwater marine plant that creates a valuable shallow water habitat, was mapped off Pavilion Beach in 1995 and 2001 by the Massachusetts DEP (Figure 2). Eelgrass habitat supports an abundant diversity of life, stabilizes seafloor sediments and adjacent shorelines, helps maintain water quality, and is a critical component of the marine food web. While the populations of eelgrass are severely diminished from historic levels and continue to steadily decline throughout most of its range in the north Atlantic Ocean, eelgrass in Gloucester Harbor appeared relatively stable during the recent past and expanded in certain areas within the harbor. The eelgrass bed off Pavilion Beach was an area that was expanding prior to construction (e.g., Metcalf and Eddy 2005).

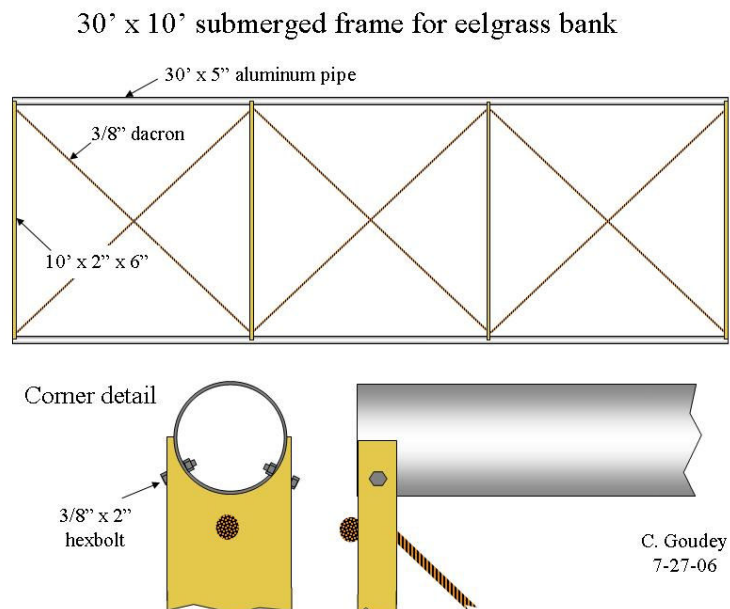
FIGURE 4. Schematic of 30' x 10' eelgrass raft (C. Goudey personal communication).

MIT Sea Grant designed and constructed an experimental hydroponic raft, meaning eelgrass was secured to the raft without substrate, to store eelgrass. The raft was constructed with a metal and wood frame with support rope positioned at 15" intervals lengthwise and crossways, stretched burlap-like mesh to contain plants, and floatation (four 15" polyfloats) to maintain vertical location in the water column (C. Goudey personal communication; Figure 4).

The burlap-like material was manufactured coconut fiber that was biodegradable and highly permeable. This material was stretched over the top of the raft frame and used to make 27, 1m<sup>2</sup> purses to contain the eelgrass. Individual plants were pulled through the top layer of the purse, and rhizomes were weaved through the bottom layer, creating a 'sandwich' or 'purse' to secure plants (Figure 5). The completed 1m<sup>2</sup> purse was attached to the top of the raft frame, and leaves floated above the purse. Approximately 150 shoots were weaved into each purse, resulting in nearly 4,000 shoots secured to the float.

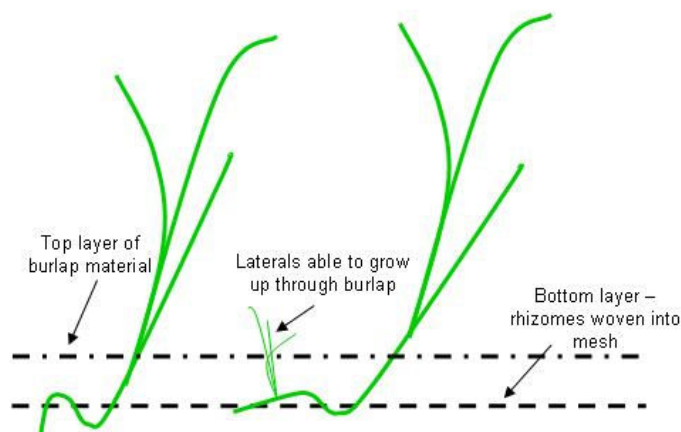
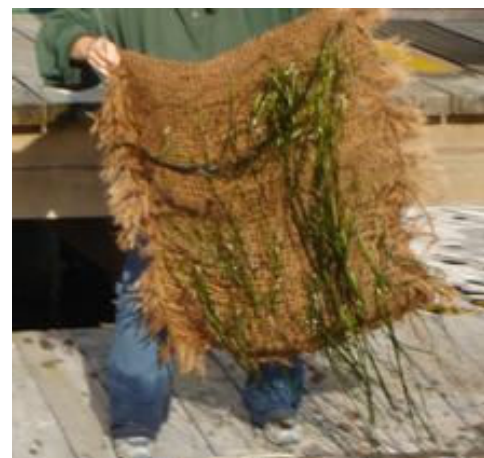
FIGURE 5. Schematic of 'weaved' eelgrass between two layers of coconut fiber (T. Evans personal communication) and photograph of purse being deployed to raft.

Water circulated through the material and light accessed the weaved roots and nodes. It was hoped that as roots grew, they would anchor and assimilate into the burlap, and the 1m<sup>2</sup> purses could be transported to transplant sites and secured to the bottom. Through time, the burlap would degrade on the seafloor, leaving the eelgrass (roots growing into the seafloor and leaves floating). The raft was designed to limit handling of the plants, from initial population of the raft to subsequent transplant. Limited handling would increase the potential for successful restoration.

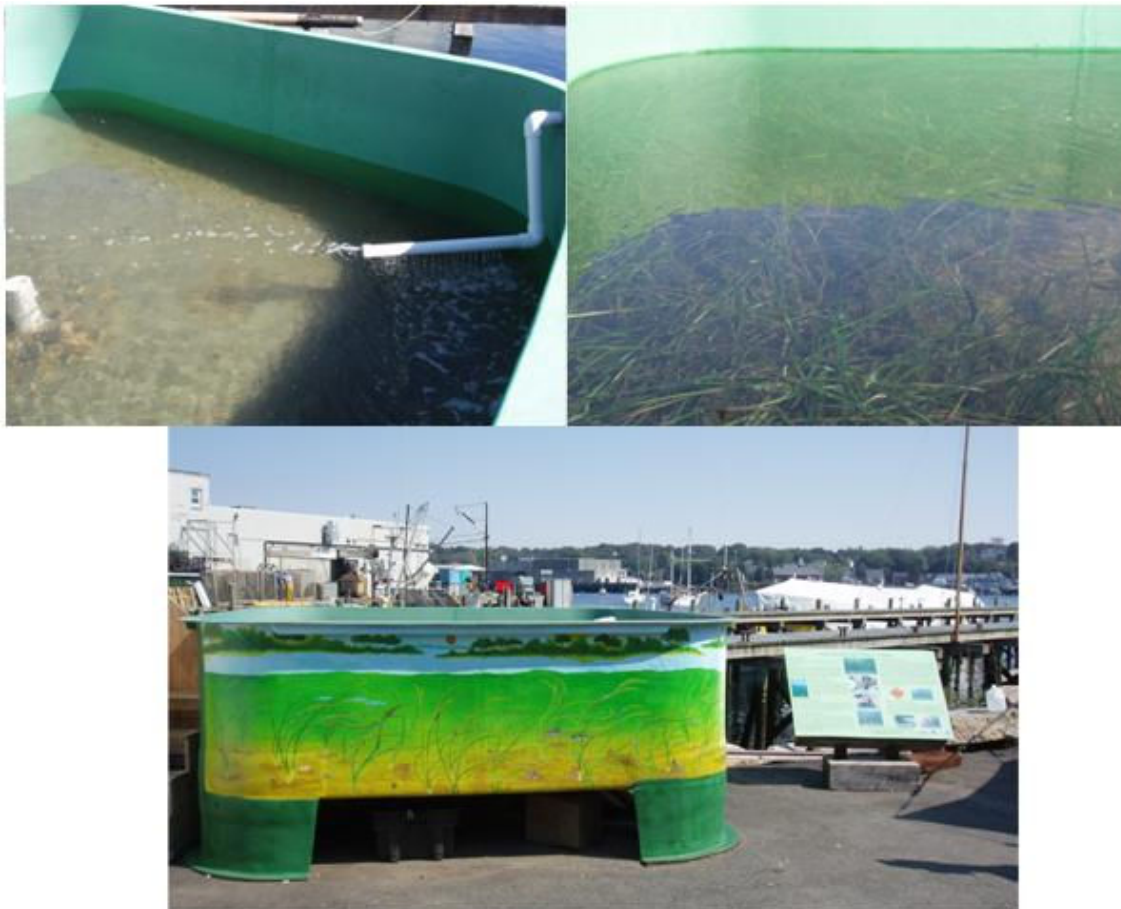
FIGURE 6. Flow-through tank at GMHC, showing (clockwise from top left) water flow with center standpipe, planted eelgrass, and tank with mural of eelgrass habitat and adjacent informational poster.

MIT Sea Grant set-up a 1,900 gallon fiberglass tank (10'x10'x3') at the GMHC (Figure 6). The tank was located in direct sunlight on the pier at GMHC and filled with 3" of sand-cobble mix (~1 cubic yard). A commercial dredge from Gloucester (Great Eastern) dredged and transported the sand-cobble mix – predominantly sand – from Pavilion Beach to the pier at GMHC. Material was shoveled from the pier and deposited and graded in the tank. The tank had flow-through seawater directly from Gloucester Harbor. Water was pumped from the harbor and drained through a 3" center standpipe, creating a circular current in the tank. The direction of water flow was periodically changed. Water depth was 24". Creatures, such as chink snail (*Lacuna vinca*), periwinkle (*Littorina littoria*) and fish (e.g., cunner, *Tautoglabrus adspersus*), naturally inhabiting eelgrass habitat, were added to the tank to demonstrate the diversity of life in eelgrass habitat and provide control algal growth.

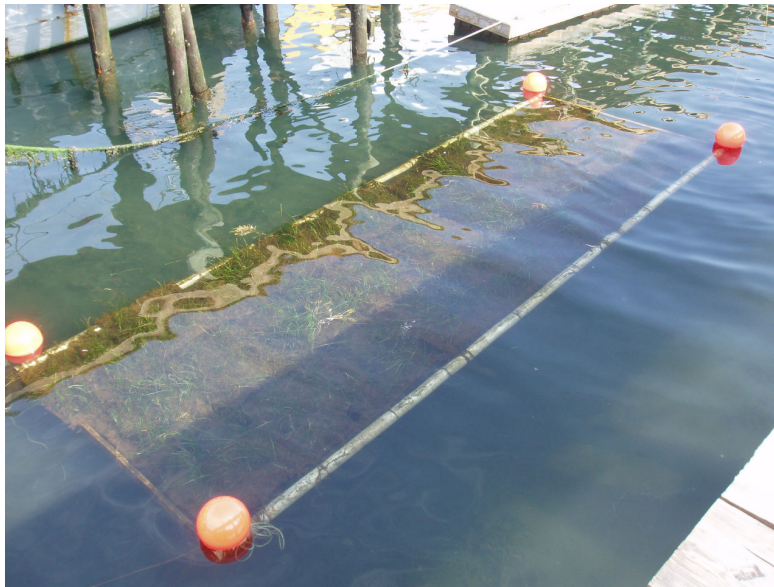
FIGURE 8. Raft with transplanted eelgrass floating between two piers at GMHC.

Over 4,000 shoots of eelgrass were weaved into the purses over three days (26-29 September) and attached to the raft. The eelgrass raft was secured between two piers at GMHC with good tidal flushing (Figure 8). The piers shaded the raft for periods of time at certain tides and time of day. Shoots were also planted in the tank at approximately 240 shoots/m<sup>2</sup>, totaling approximately 2,200 shoots. The remainder of harvested eelgrass was distributed to 10 regional schools participating in MIT Sea Grant's eelgrass stewardship project.

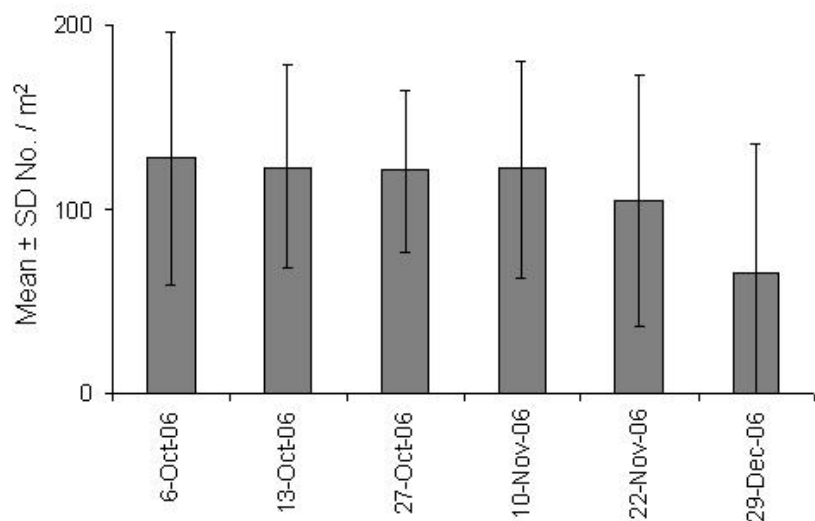
FIGURE 9. Mean shoot density ( $\#/m^2$ ) in raft from October to December 2006.

The approximate starting shoot density on the raft was  $150/\text{m}^2$ . Individual measurements of shoot density were variable, as evidence of the standard deviation calculation. Mean shoot density on the raft was, however, relatively consistent from October to November and declined in December (Figure 9). Filamentous algae accumulated on the raft and eelgrass in mid to late October. While the raft and eelgrass appeared covered with algae, most of the algae was not attached to the

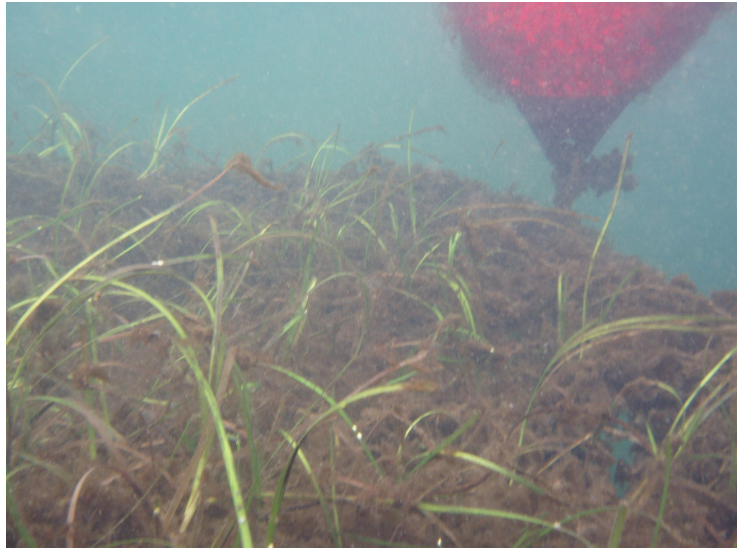
FIGURE 10. Underwater view of eelgrass on raft.

eelgrass and was easily brushed away. Water was moved over the raft and eelgrass by sweeping your arm over the raft from the middle to the edge, creating a current through and over the raft. The algae 'blew' off the raft and sank to the bottom. Efforts to brush the filamentous algae from the raft seemed relatively successful, as the eelgrass typically floated above the burlap-like material that was fouled and appeared healthy green (Figure 10). The abundance of algae seemed to decline in late November through December.

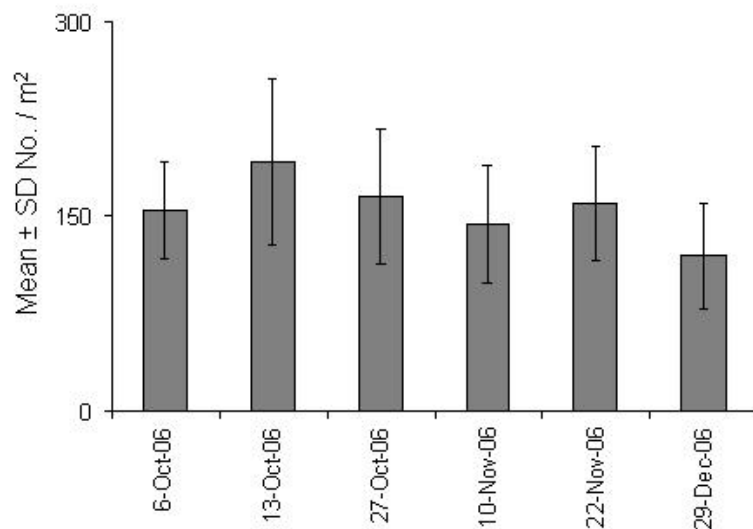
FIGURE 11. Mean shoot density (#/m<sup>2</sup>) in tank from October to December 2006.

The approximate starting shoot density in the outdoor tank was 240/m<sup>2</sup>. There was an initial decrease in shoot density, and then shoot density was relatively stable from October to November with a slight decline in December (Figure 11). Epiphytes covered much of the tank and eelgrass in October and early November. Creatures, such as chink snails, were added to the tank to attempt to control algal growth but did not result in a noticeable decrease in algae.

There were no notable changes in leaf length or width. Canopy height (cm) appeared stable in October (13 Oct = 49±3cm; 27 Oct = 45±6cm) and November (10 Nov = 45±4cm; 22 Nov = 44±11cm) and declined in December (29 Dec = 27±6cm). Temperature dramatically declined in January – March 2007, and shoot density and canopy height subsequently declined (personal observation). Shoots were counted in spring 2007, with approximately 70 shoots in the tank surviving the winter. Ten of the remaining shoots produced
