MATANZAS INLET GLOSSARY OF INLETS REPORT #5

by A. J. Mehta and C. P. Jones

Report Number 21

May 1977

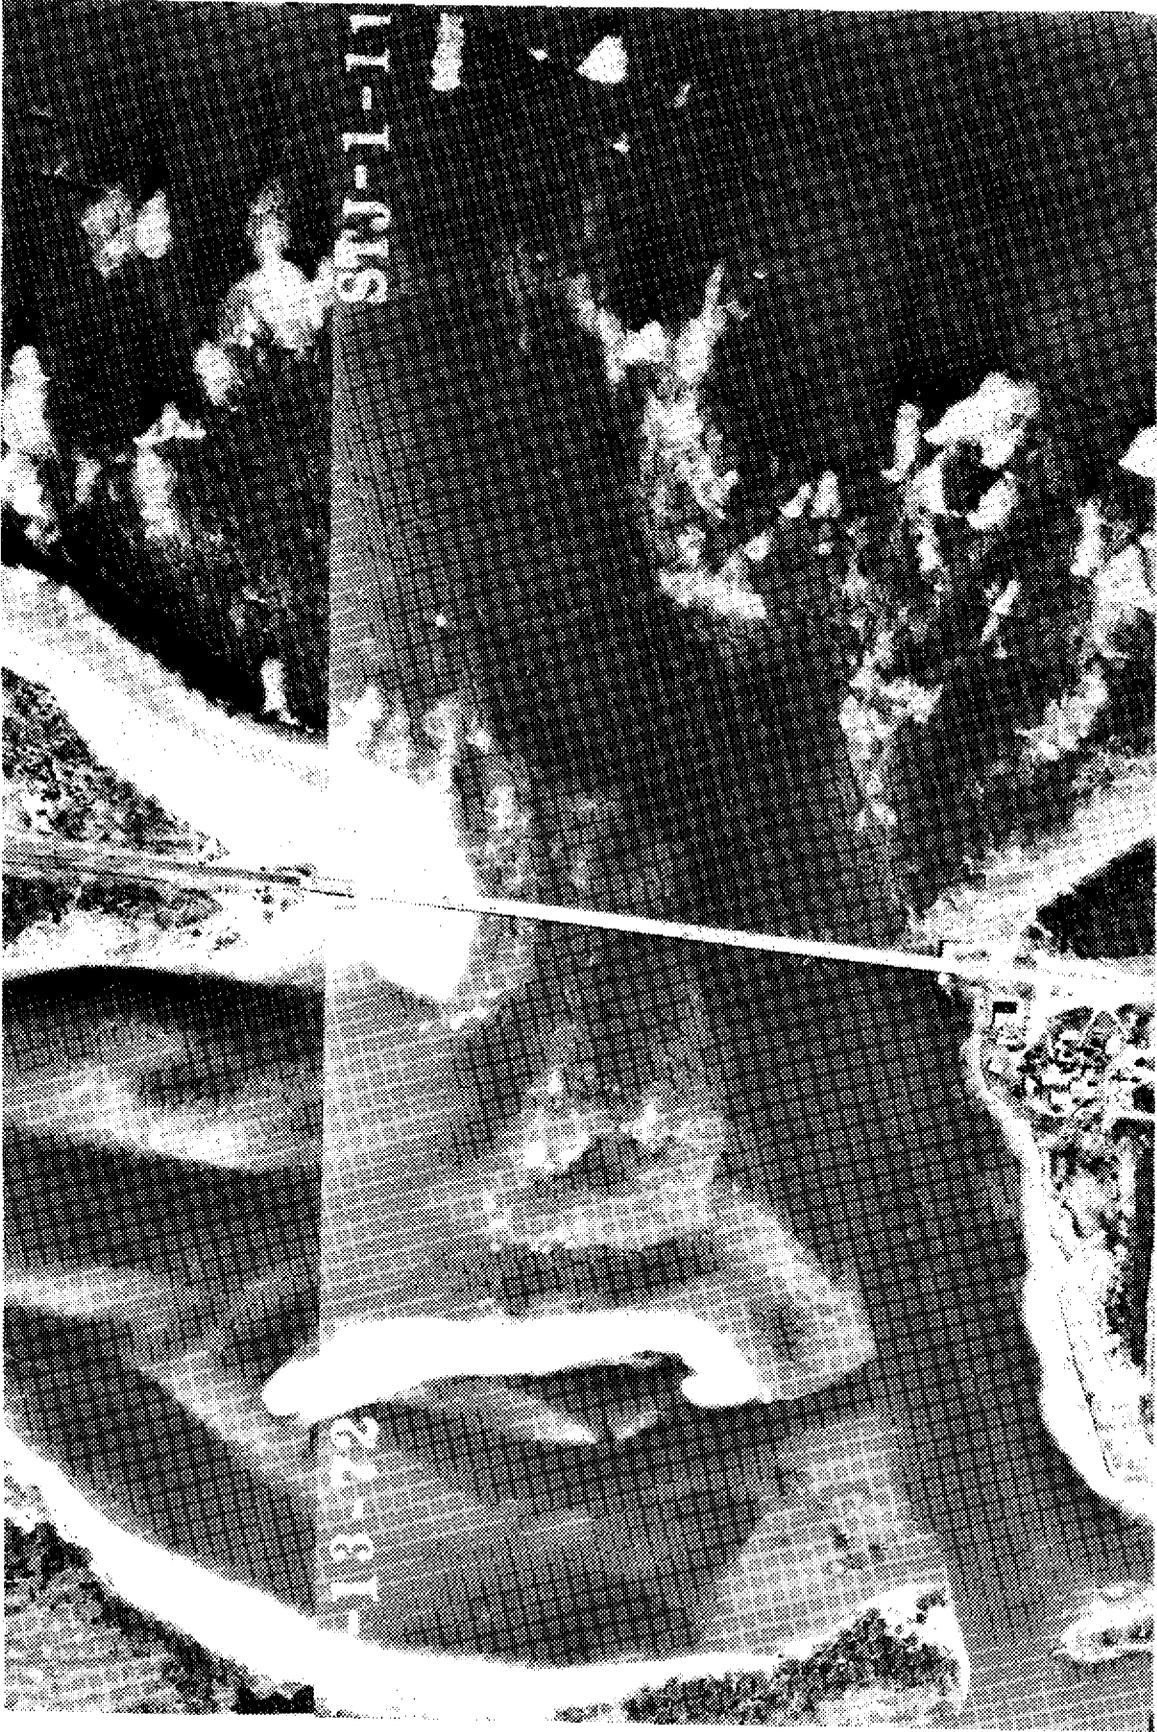
Fig. 1.4 Matanzas Inlet in 1972.

Matanzas Inlet, shown in Fig. 1.3 and Fig. 1.4, is a natural inlet connecting the Atlantic Ocean to the Matanzas River on the east coast of Florida in southern St. Johns County. The inlet is located approximately 13 miles south of St. Augustine and 40 miles north of Daytona Beach. Its coordinates are as follows:

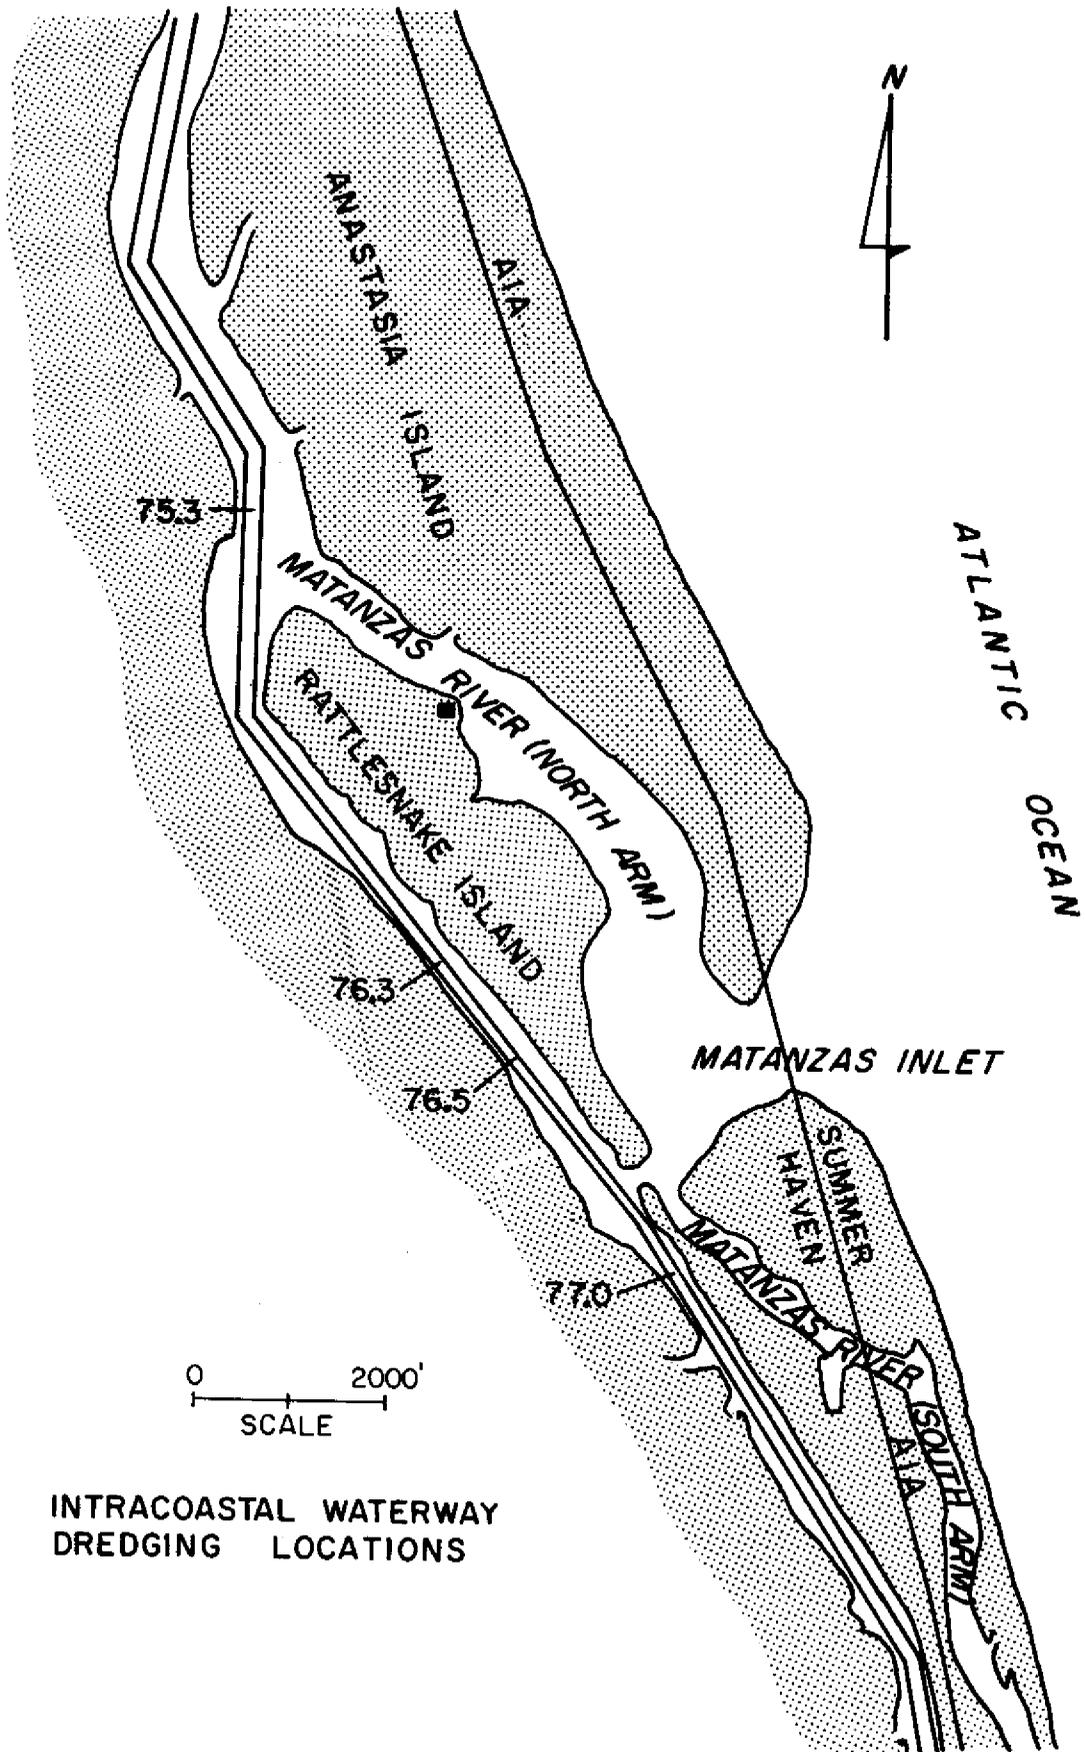
INTRACOASTAL WATERWAY
DREDGING LOCATIONS

Date	Location (measured in statute miles from Fernandina Beach. See Fig. 5.1 for location).	Amount Dredged (cubic yards)
1958	75.3	149,911
1960	75.3	118,078
1960	76.5	16,313
1962	75.3	126,189
1962	76.5	13,224
1963	75.3, 76.3	117,869
1964	75.3	66,900
1966	75.3	89,992
1966	76.3	7,112
1967	75.3	20,420
1968	75.3	53,413
1973	75.3	112,447

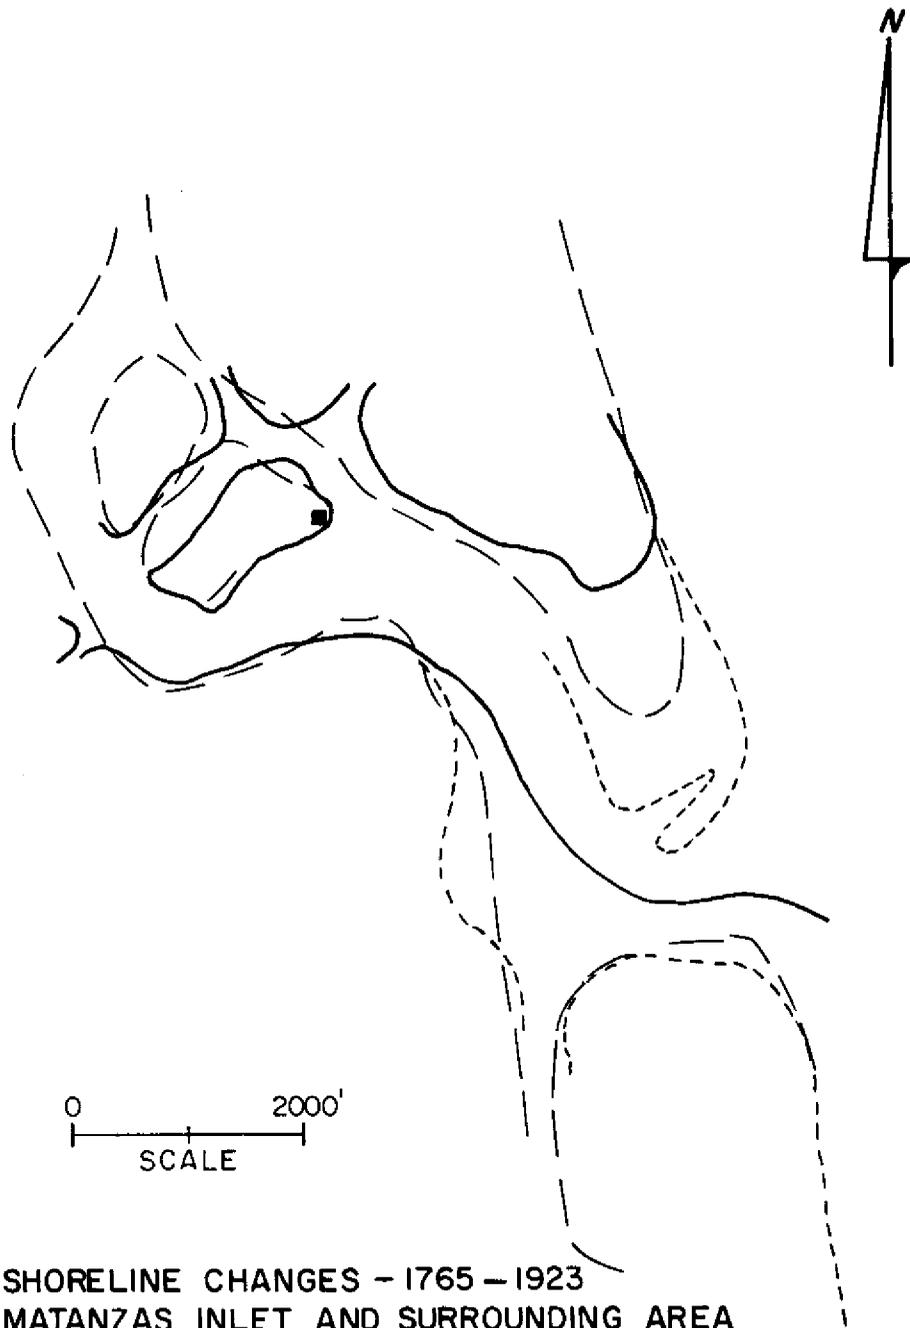
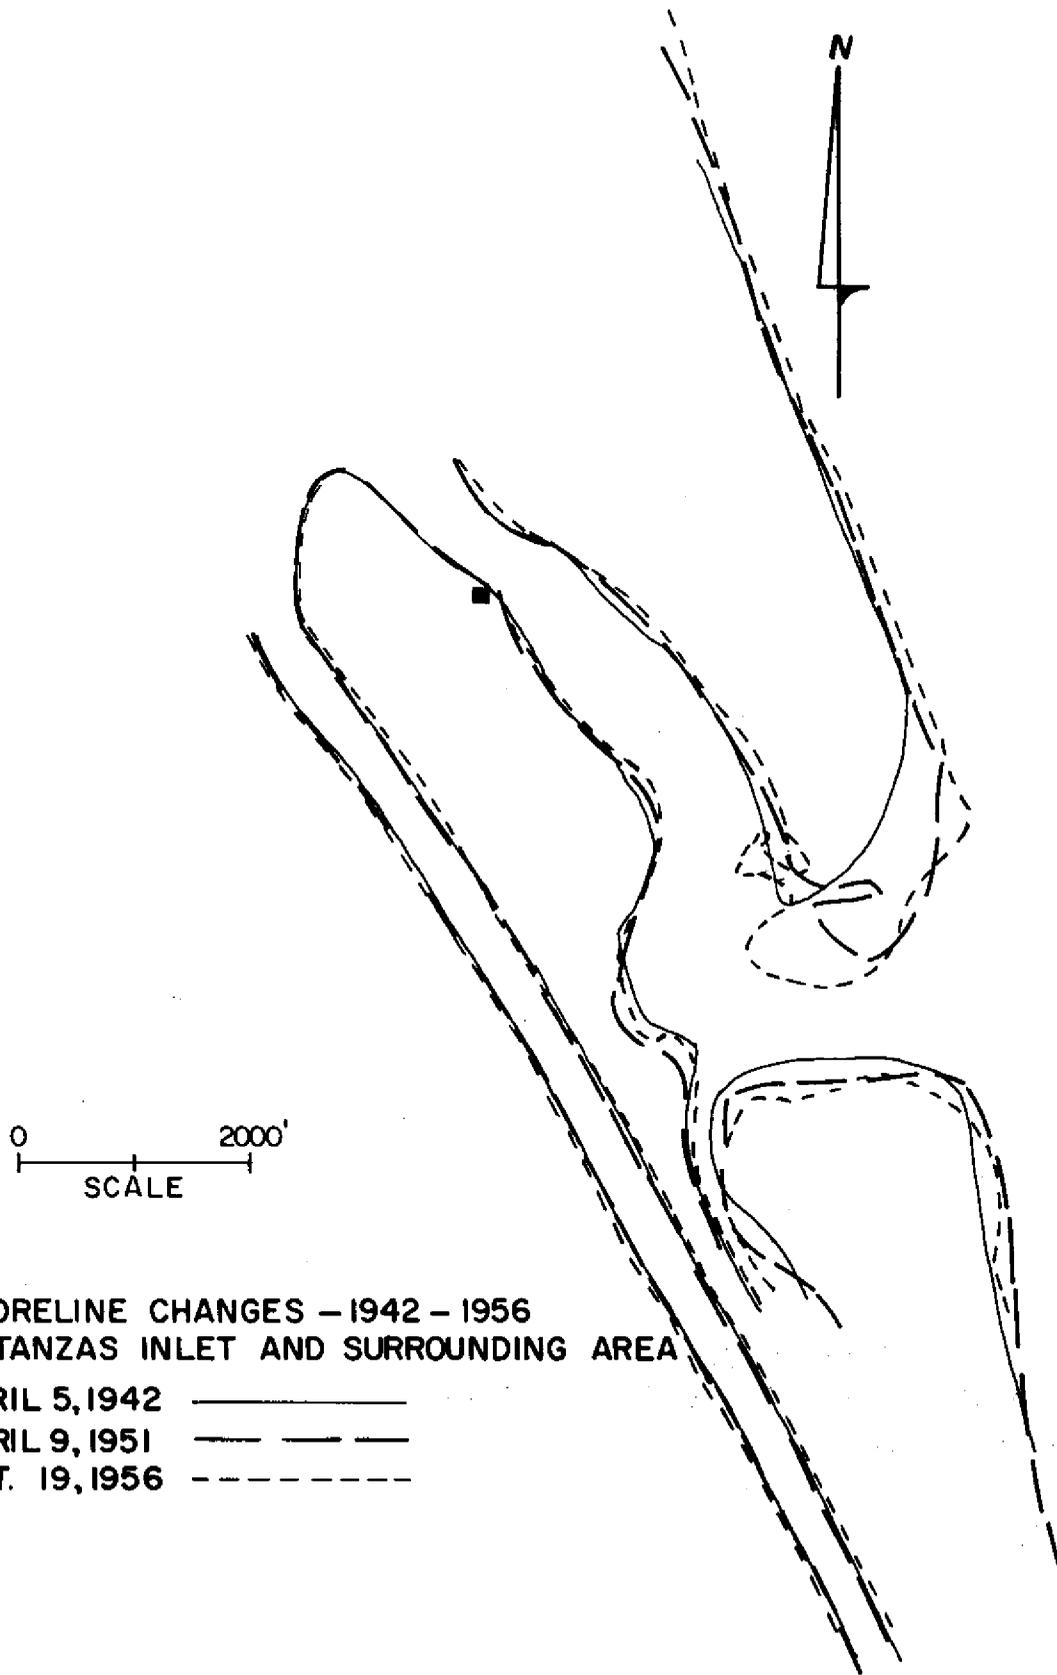
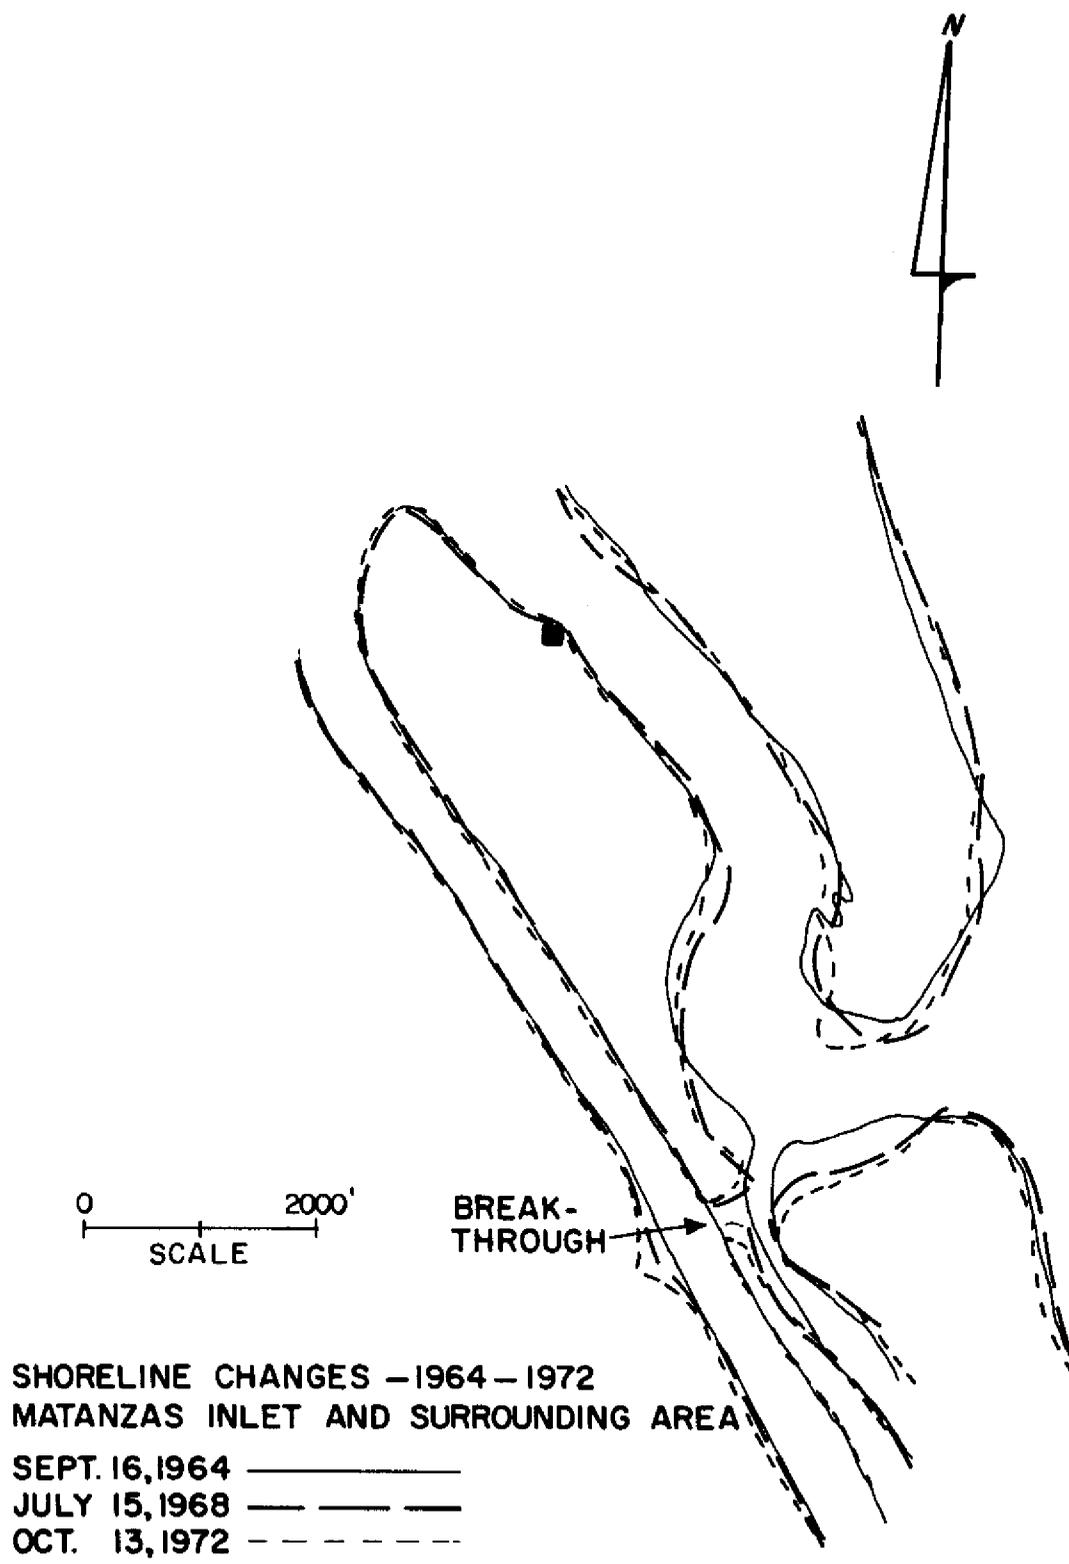
Fig. 6.8

**SHORELINE CHANGES - 1765 - 1923
MATANZAS INLET AND SURROUNDING AREA**

- 1765 —————
- 1882 - - - - -
- 1923

The major changes in the inlet and adjacent coastline are shown in Fig. 6.8. It is apparent that the southern tip of Anastasia Island has migrated southward while erosion has taken place along the north and east sides

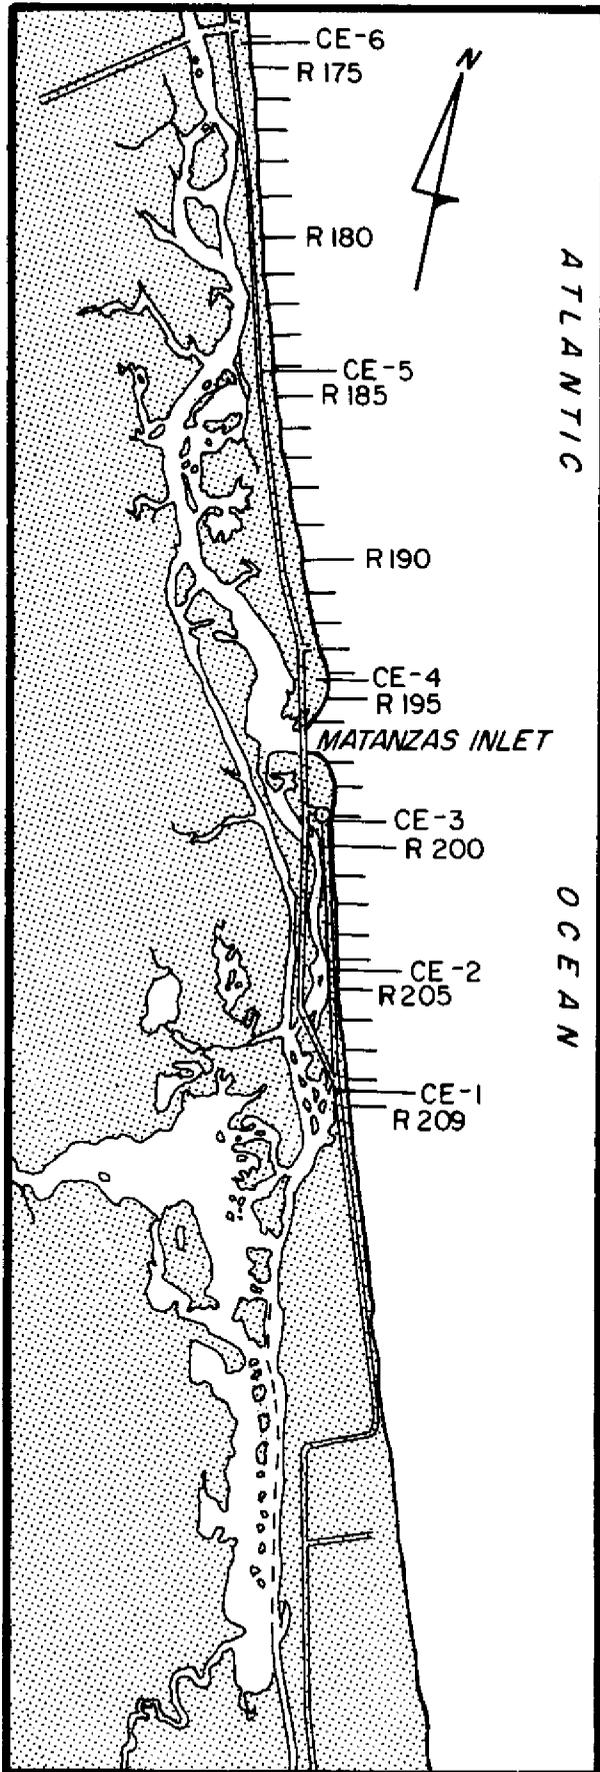
Fig. 6.9 Corps of Engineers (1965) profile lines are designated, "CE-1" through "CE-6." UF/COEL (1973) Setback line profile lines are designated "R175," etc. Unmarked lines are setback line profiles.

Fig. 6.9 Profile Line Locations.

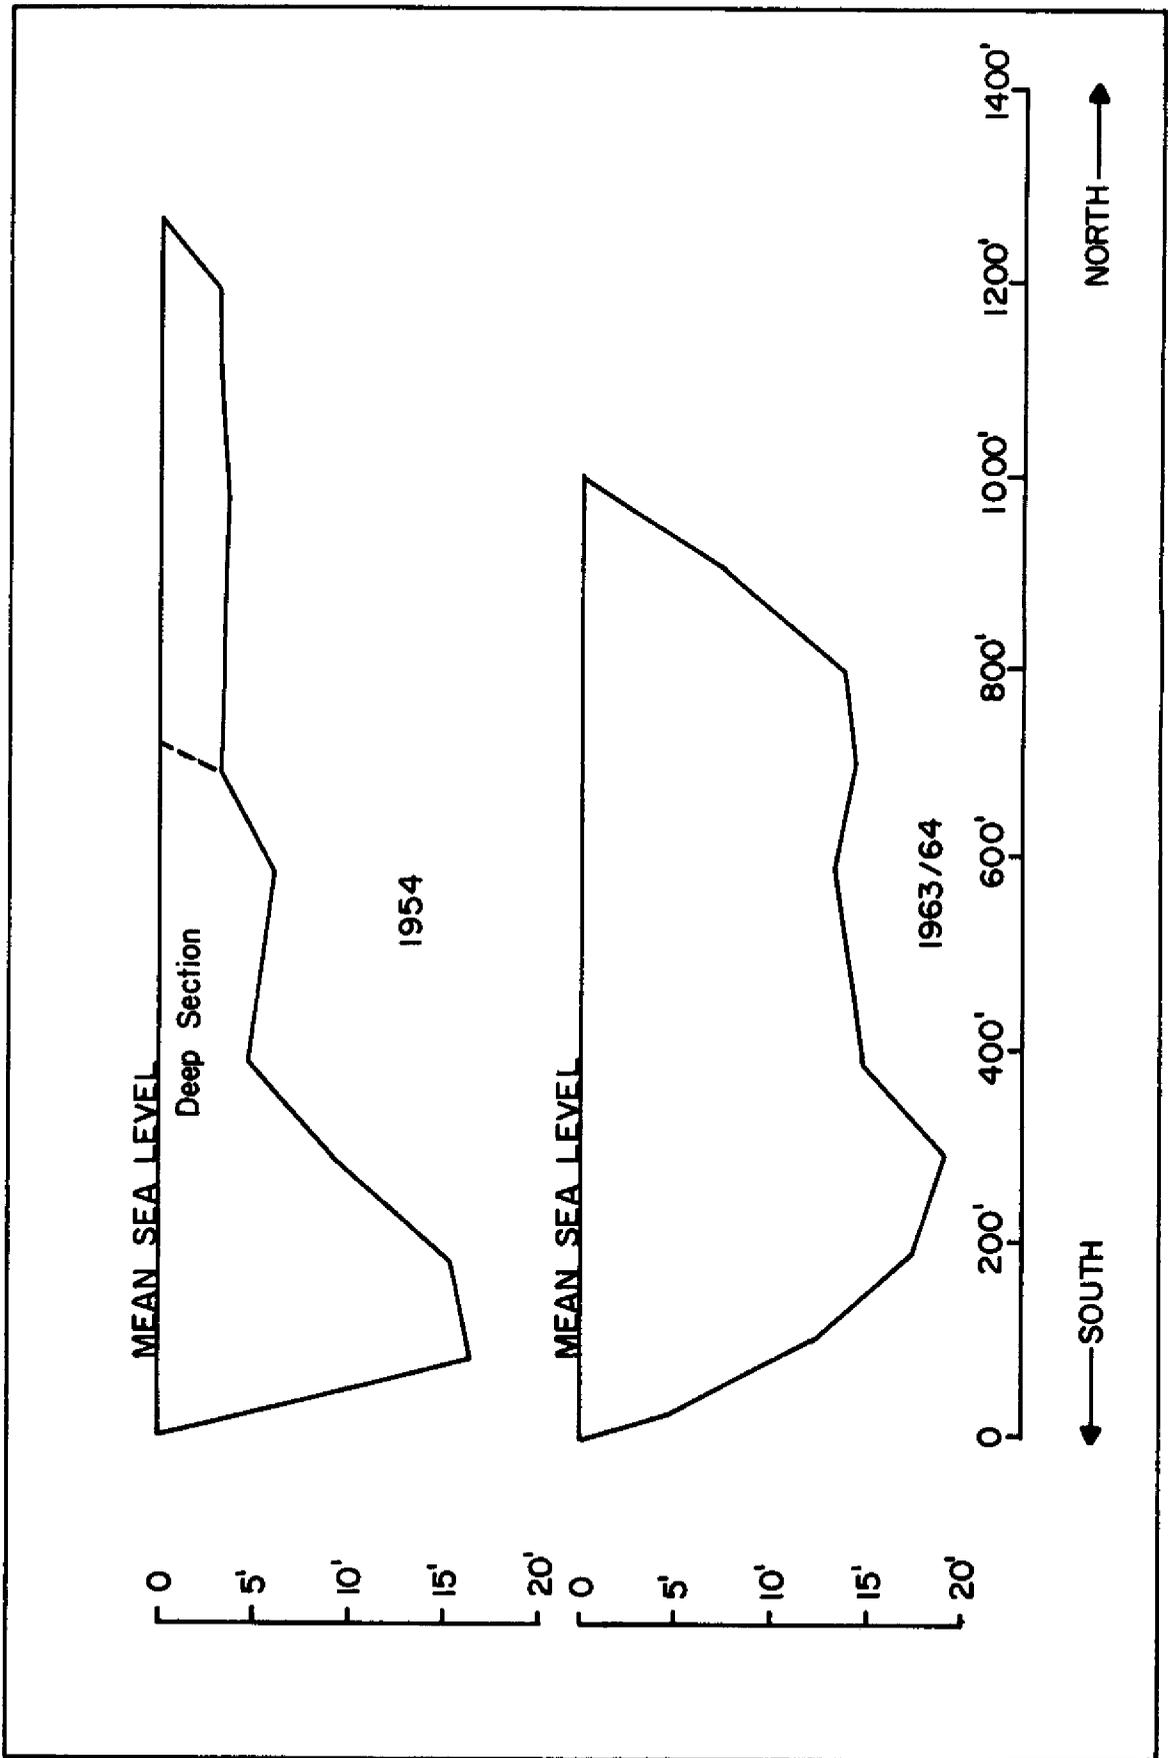
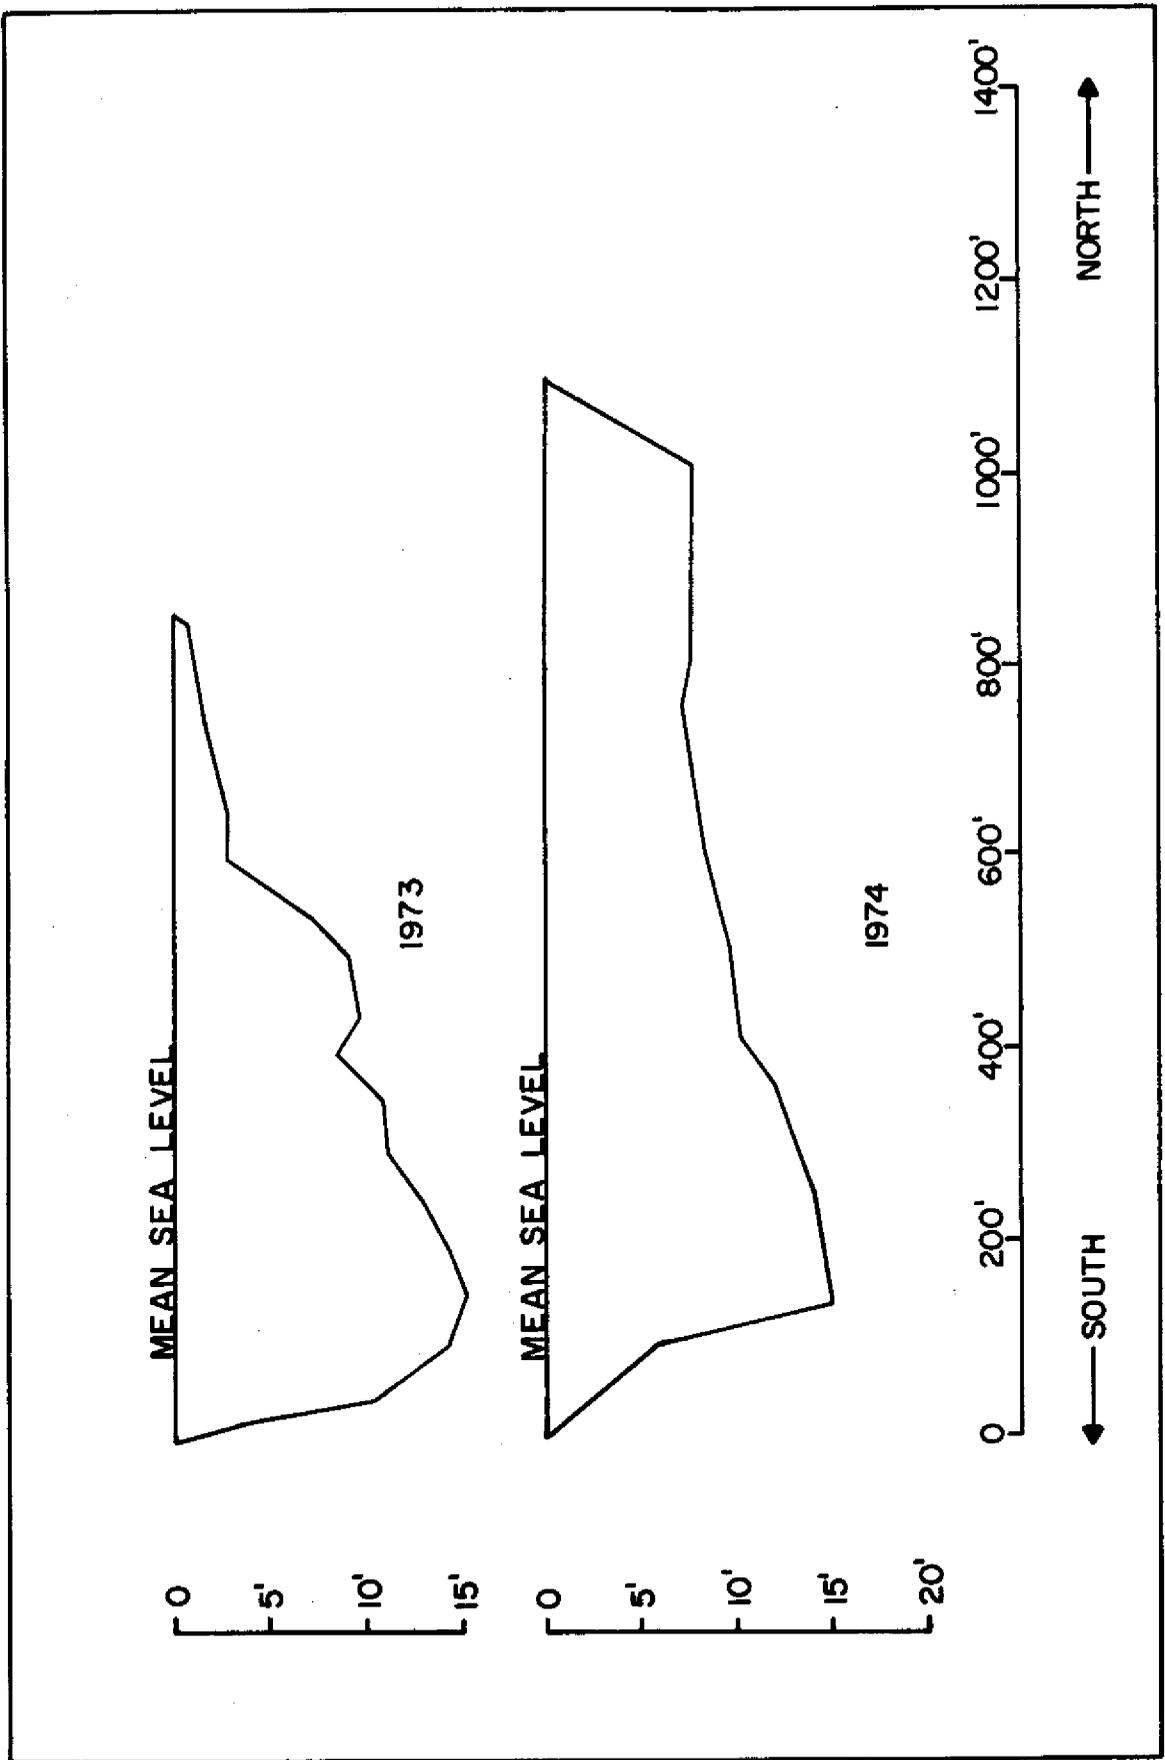
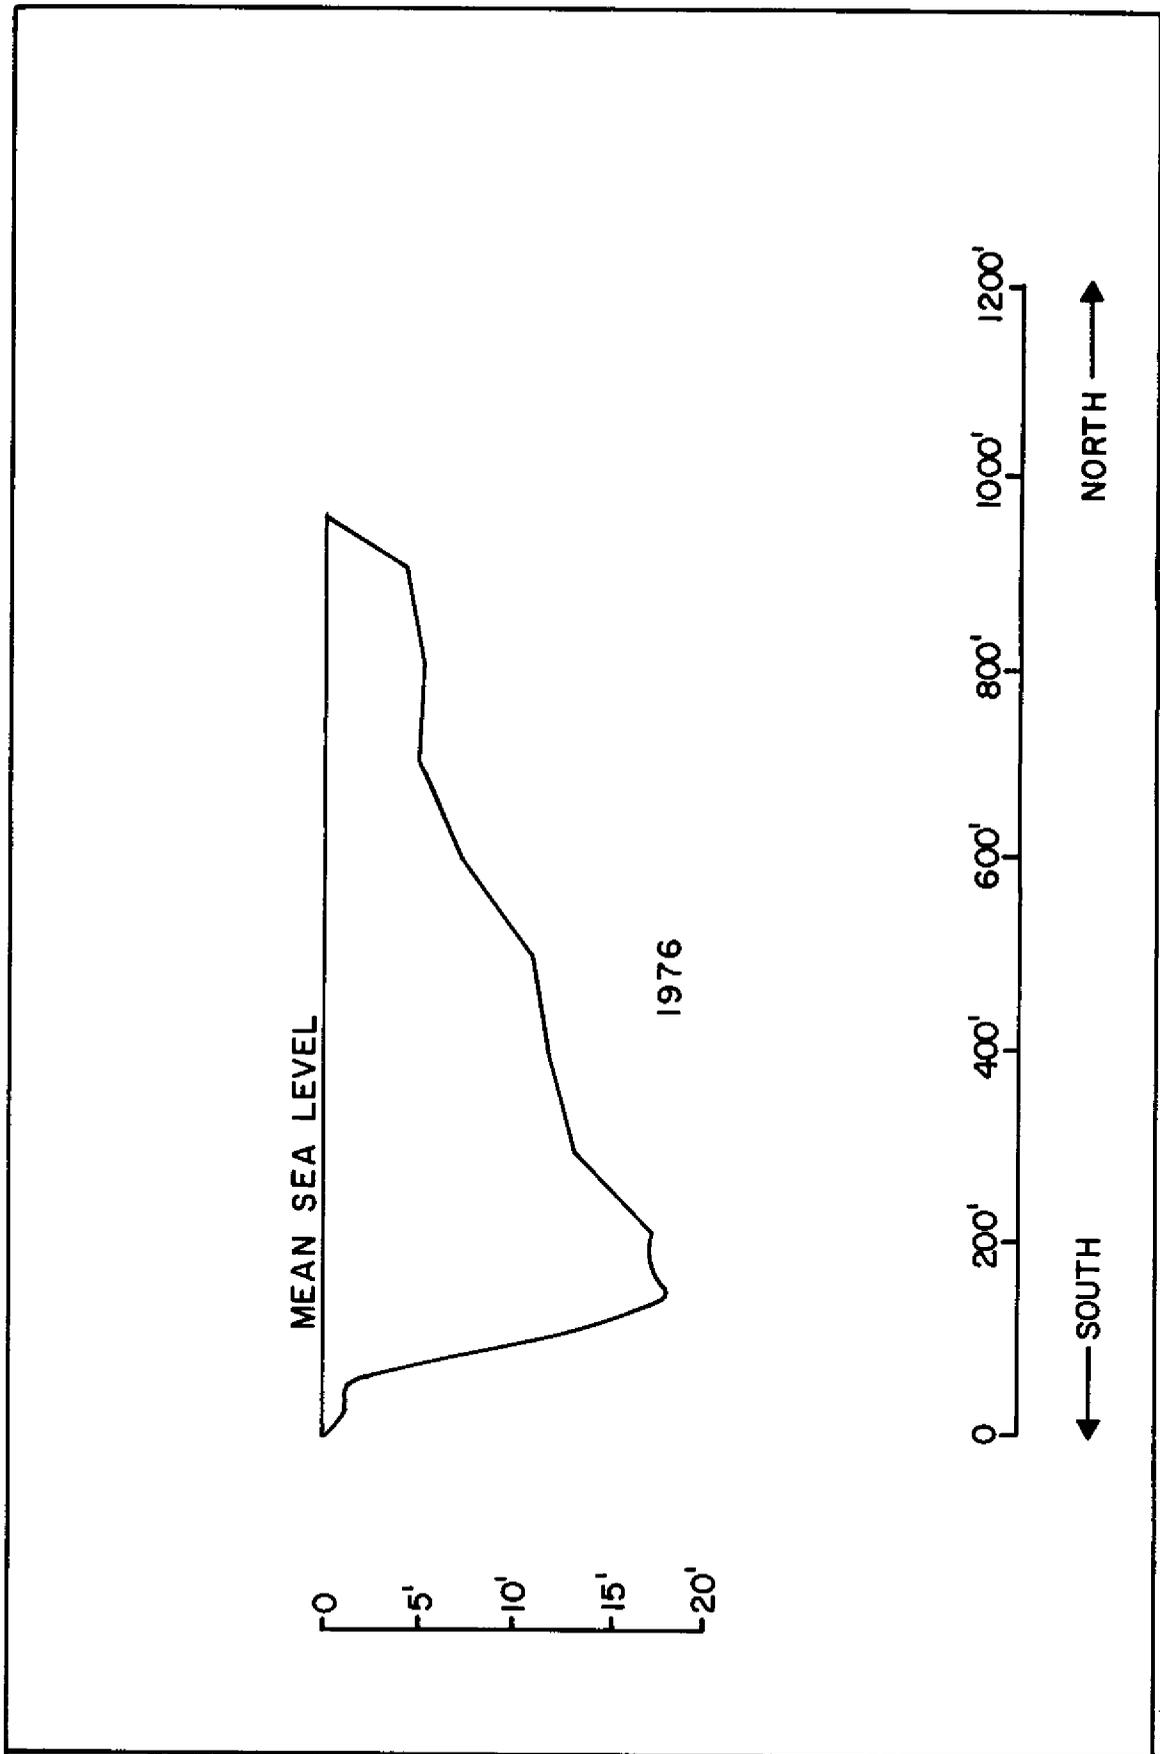
Fig. 6.11 Inlet Cross Sections.

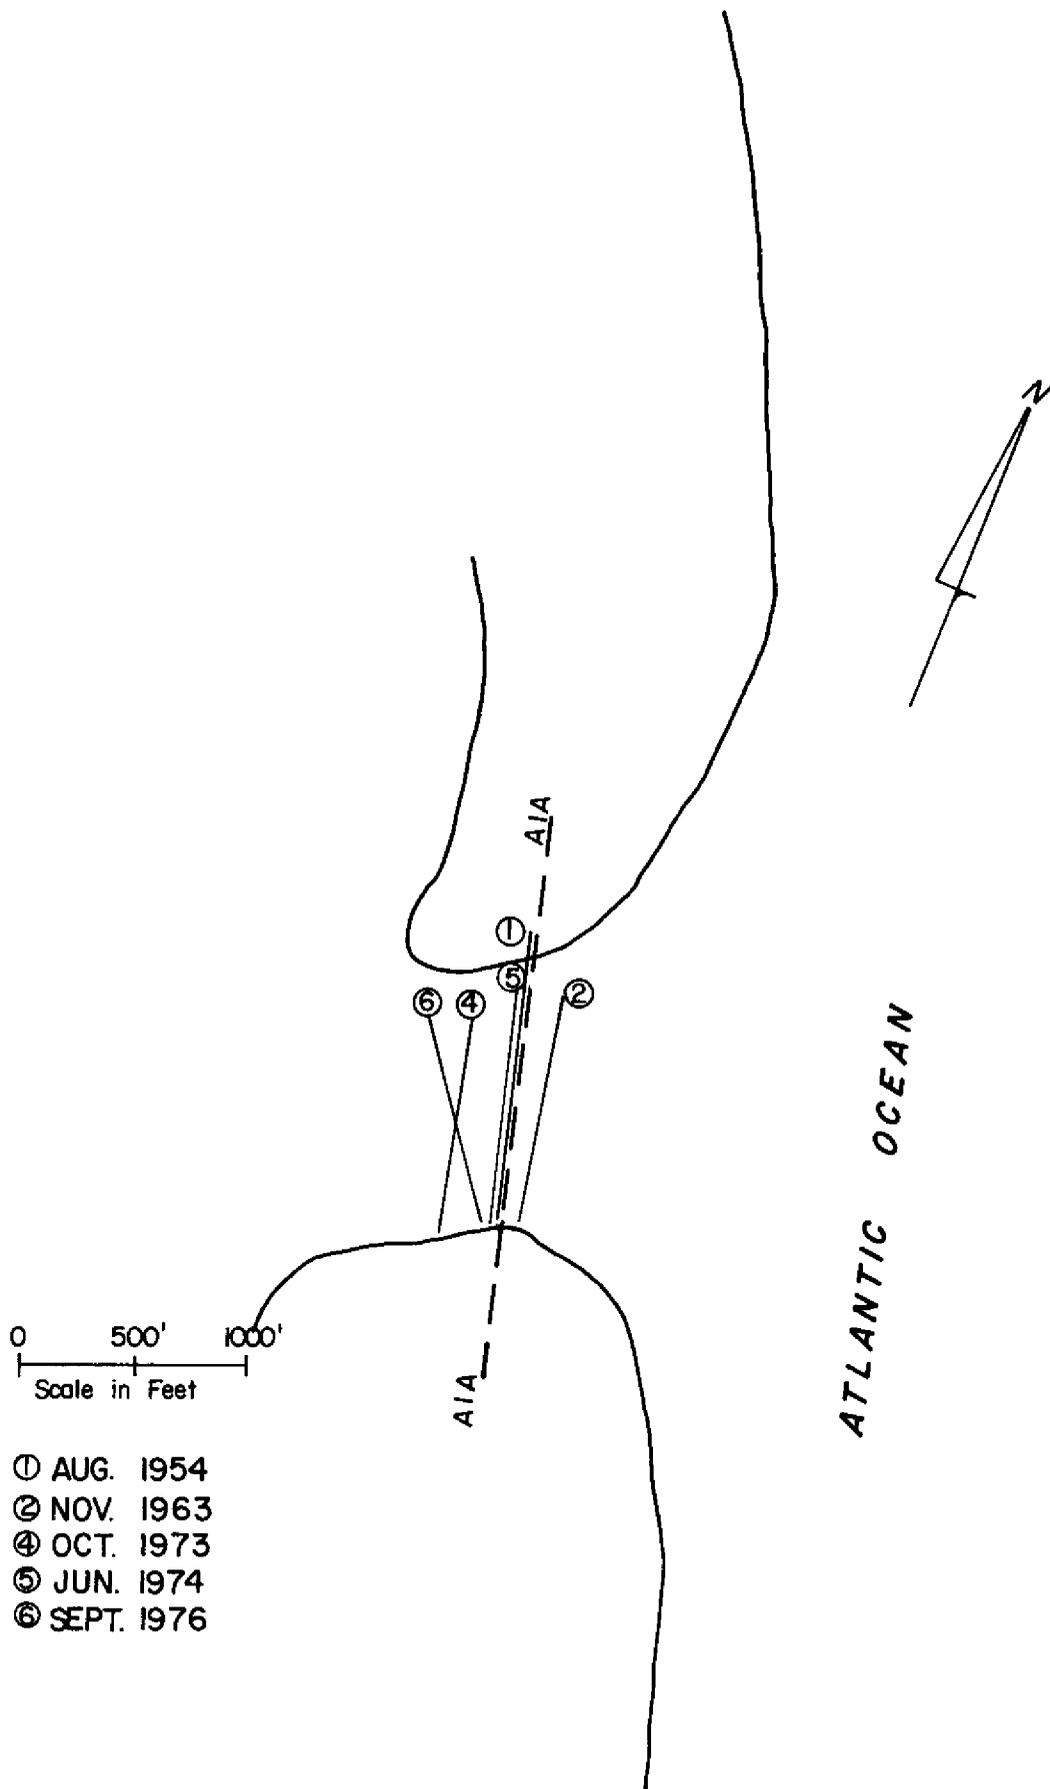
Fig. 6.12 Inlet Cross Section Locations. Exact Location of 1972 Cross Section is not Known.

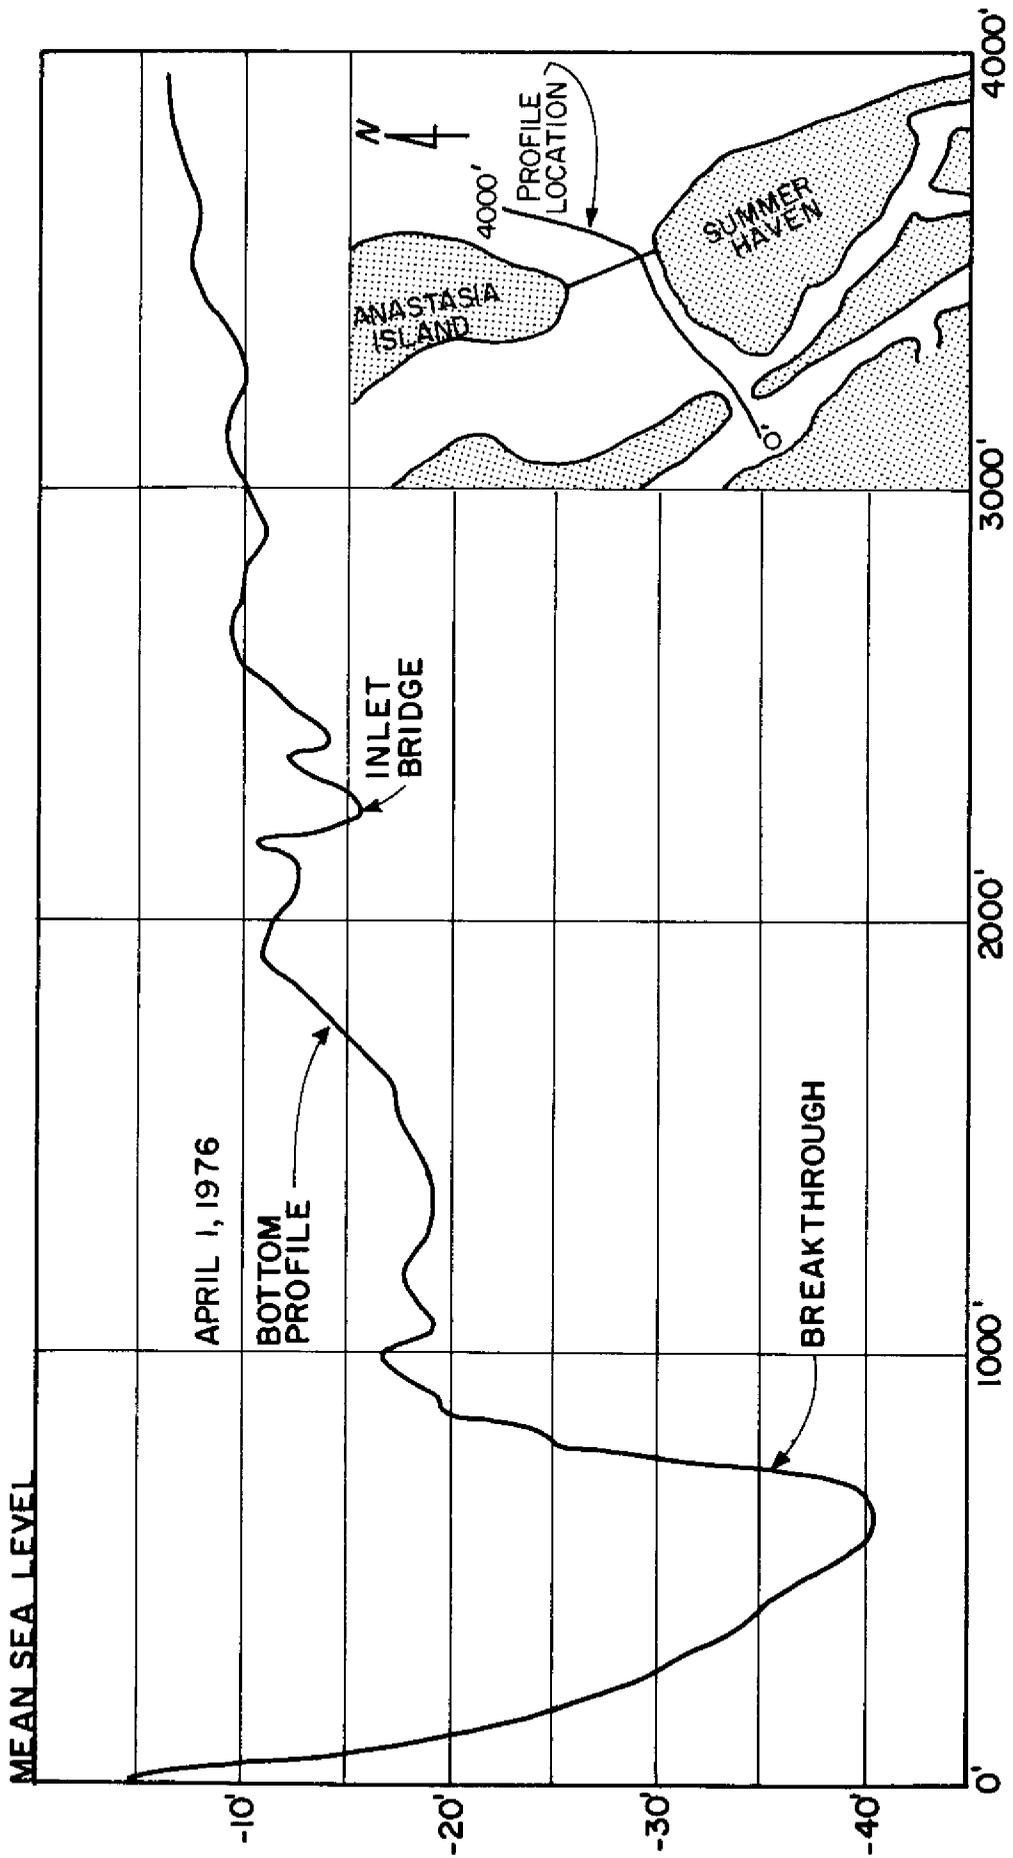
Fig. 6.13 Longitudinal Profile.

Appearing in Fig. 6.13 is the location of a longitudinal profile taken on April 1, 1976 (COEL) extending from the Intracoastal Waterway, through the breakthrough, under the inlet bridge and turning N-NE for a distance of approximately 1,800 ft. The total length of the section is approximately 4,000 ft.

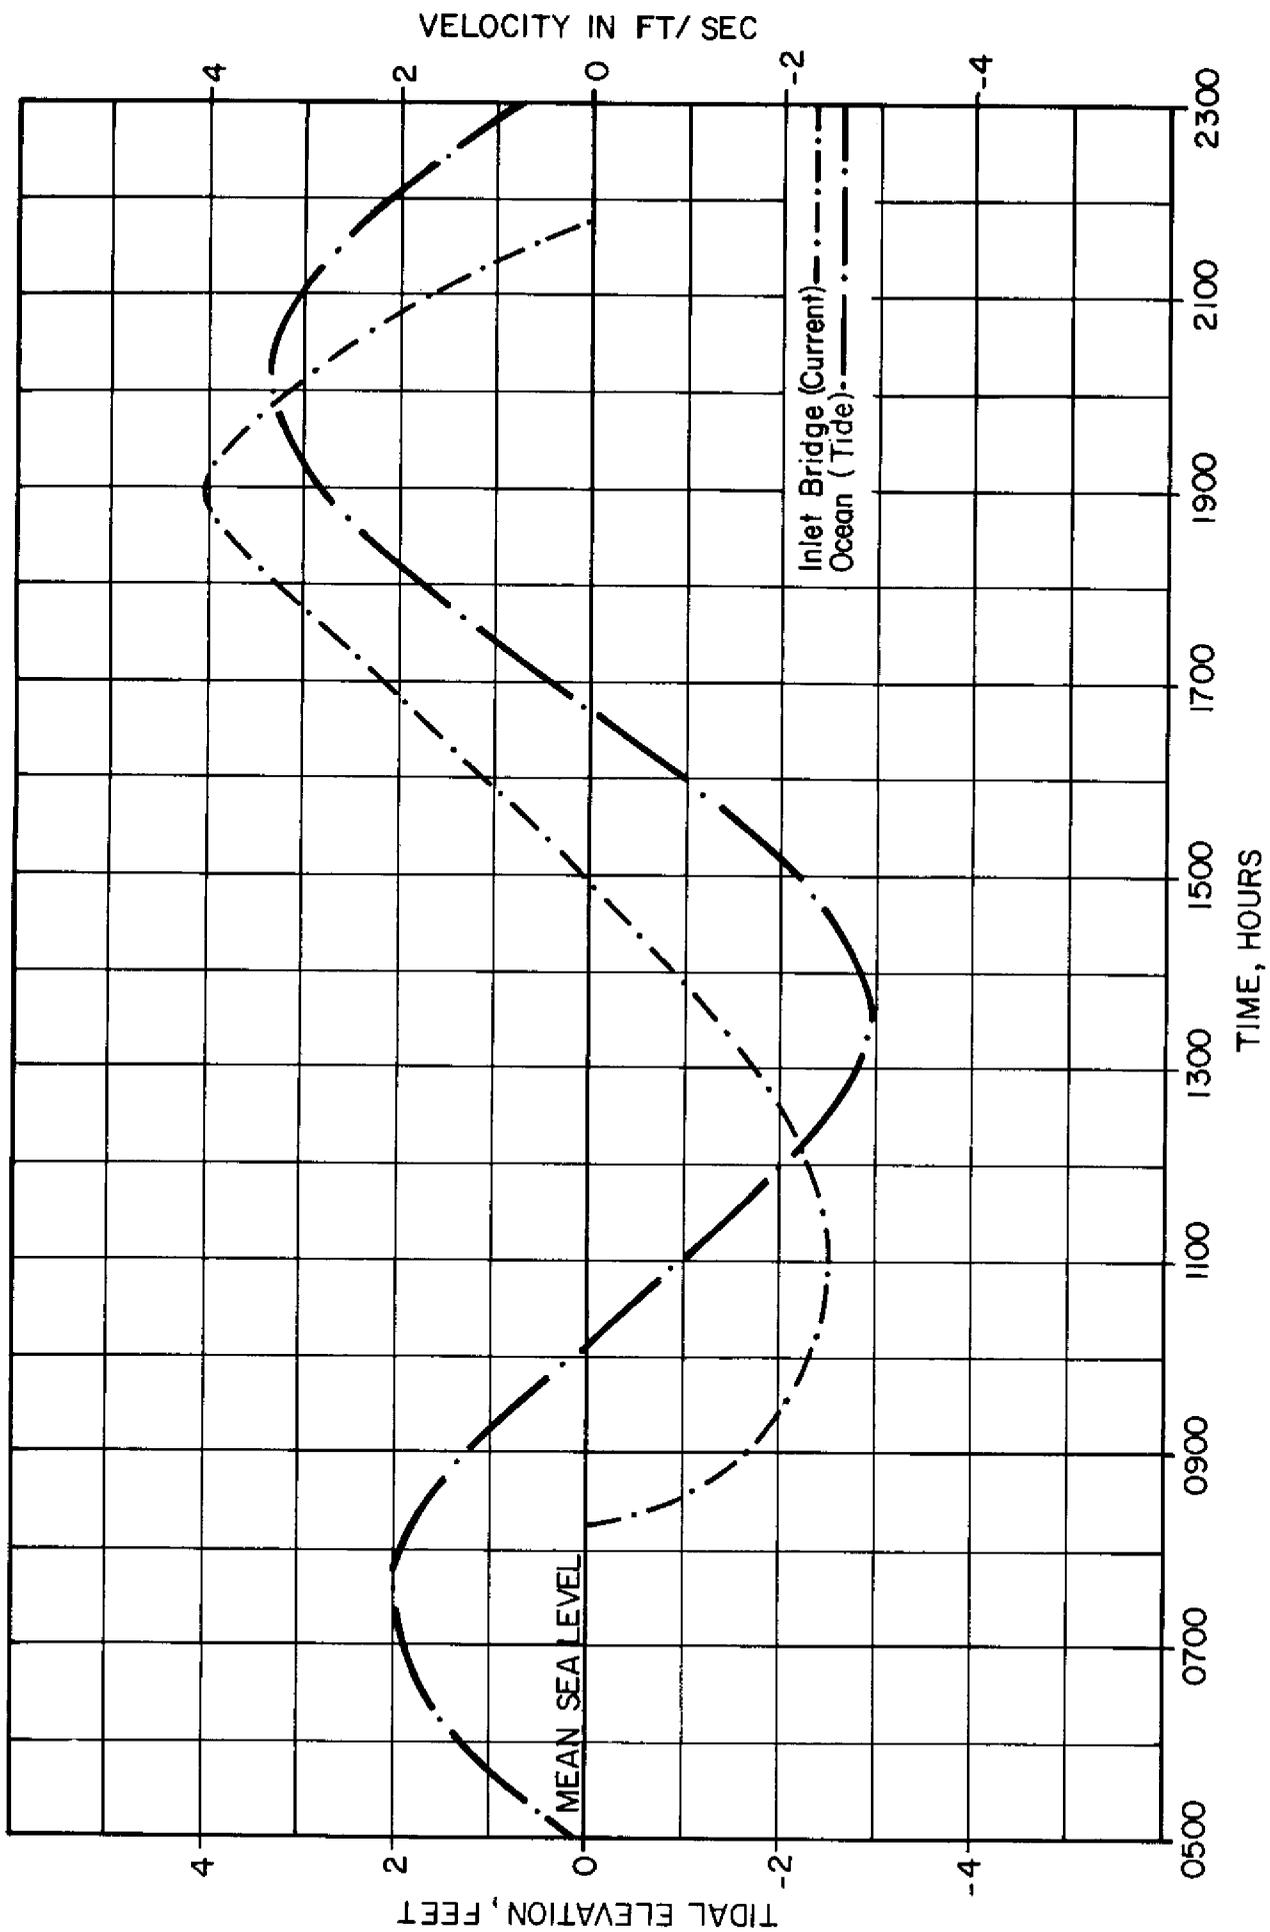
Fig. 7.3 Ocean Tide and Inlet Current (July 18, 1974).

The discharge curve for the inlet bridge in Fig. 7.1 may be divided by the 1974 cross section (From Table 6.2) to yield the corresponding velocity curve. This is plotted in Fig. 7.3 along with the ocean (Flagler Beach) tide record on July 18, 1974. It is observed that the maximum cross sectional average ebb velocity is 4.12 fps and the corresponding flood velocity is 2.39 fps. Note that the spring range of ocean tide is 5.69 ft.

It is observed from Fig. 7.3 that the time lag of slack water (zero current) after high water (HW) in the ocean is 45 minutes and the lag after low water (LW) is 110 minutes.
