MATANZAS INLET GLOSSARY OF INLETS REPORT #5

by A. J. Mehta and C. P. Jones

Report Number 21

May 1977

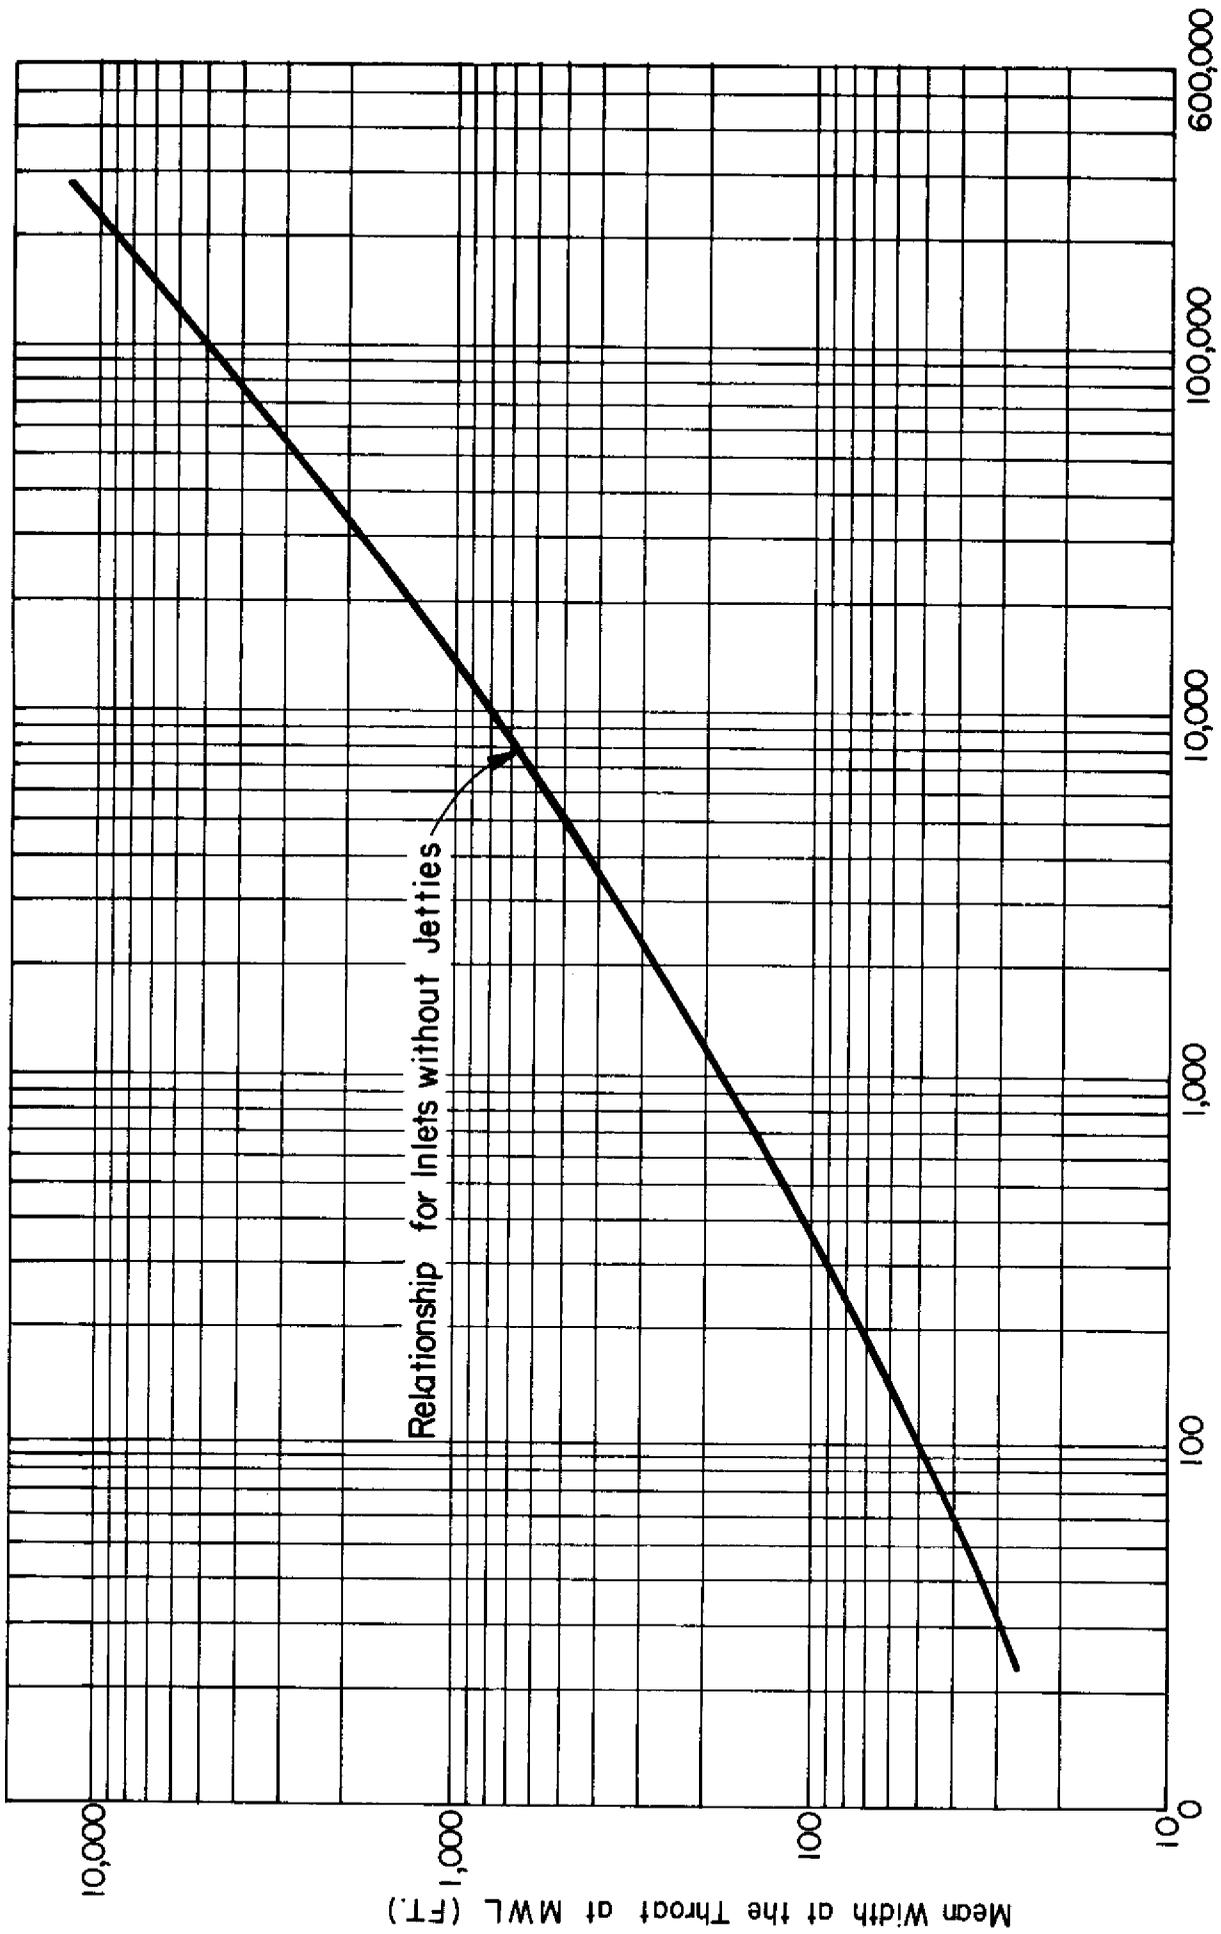
Area at the Throat at MWL (SQ. FT.)

Fig. 7.8 Throat Width-Area Relationship for Unimproved Inlets.

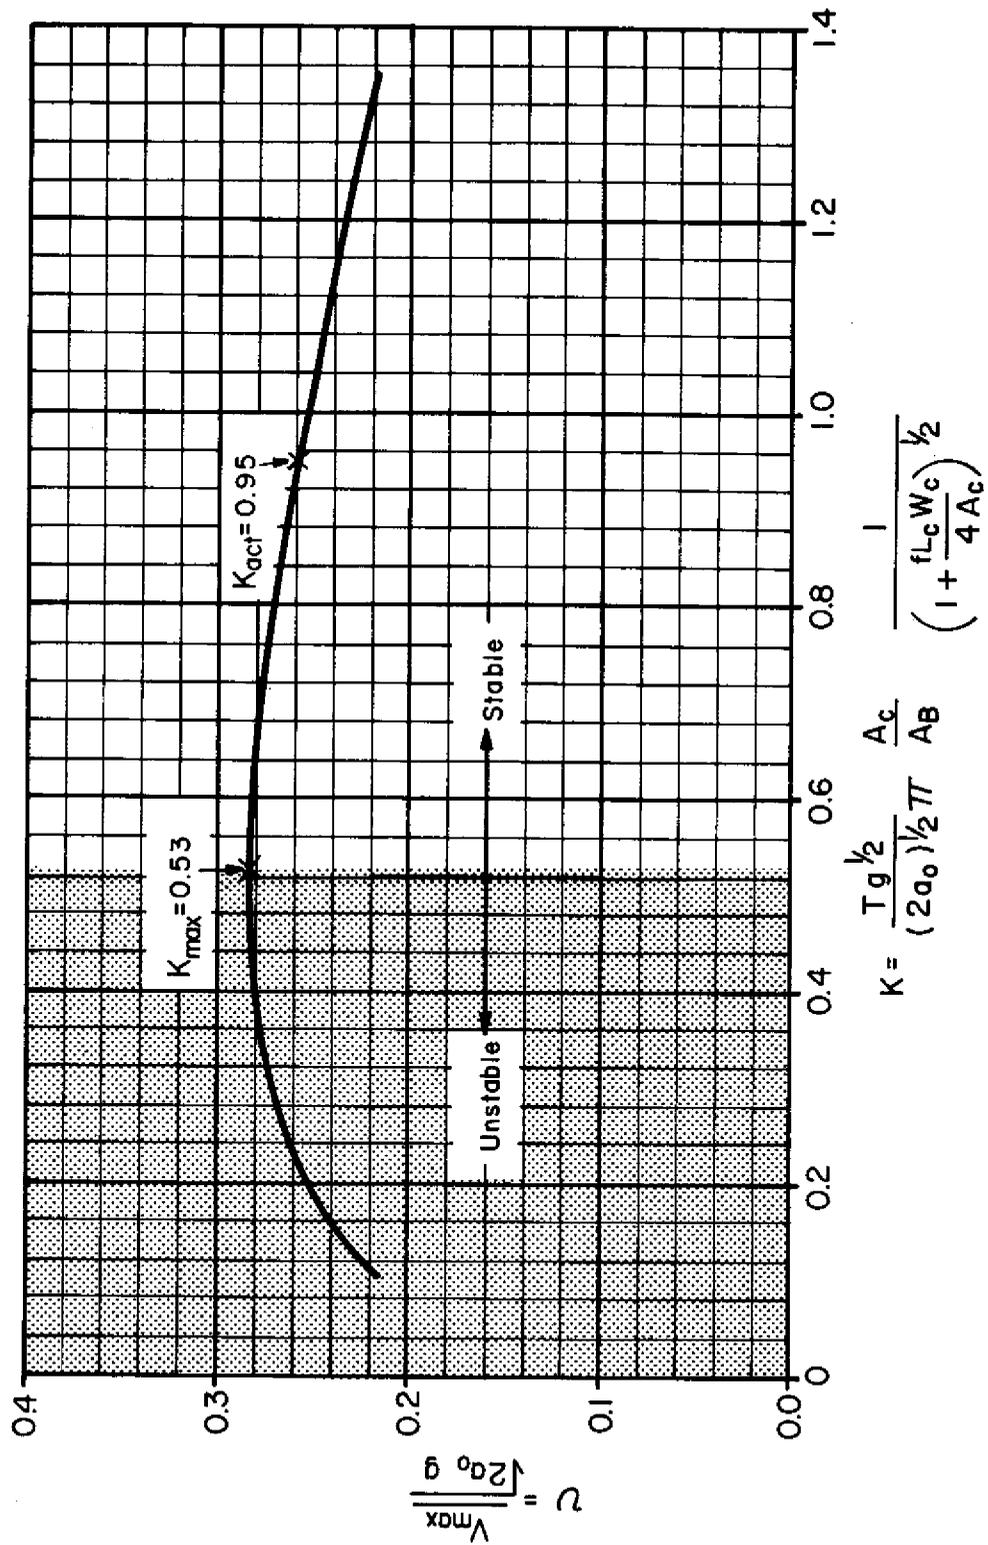
Fig. 7.9 Stability Curve for Matanzas Inlet.

From Fig. 7.9 it is observed that the value of K , i.e. K_{max} at the peak value of v is 0.53. It can be shown (Escoffier, 1940; O'Brien and Dean, 1972) that the case in which the actual value of K for the inlet, $K_{act} > K_{max}$ implies a hydraulically stable inlet and $K_{act} < K_{max}$ means that the inlet is unstable. From Section 7.4, $V_{max} = 3.6$ fps which yields $v = 0.24$. Also, the same V_{max} after converting to V'_{max} with $A_c = 9,766$ ft² corresponds to $K = 0.95$, which

is K_{act} . Thus $K_{act} > K_{max}$, which implies that Matanzas is a stable inlet, which confirms the known long-term stability of Matanzas Inlet.

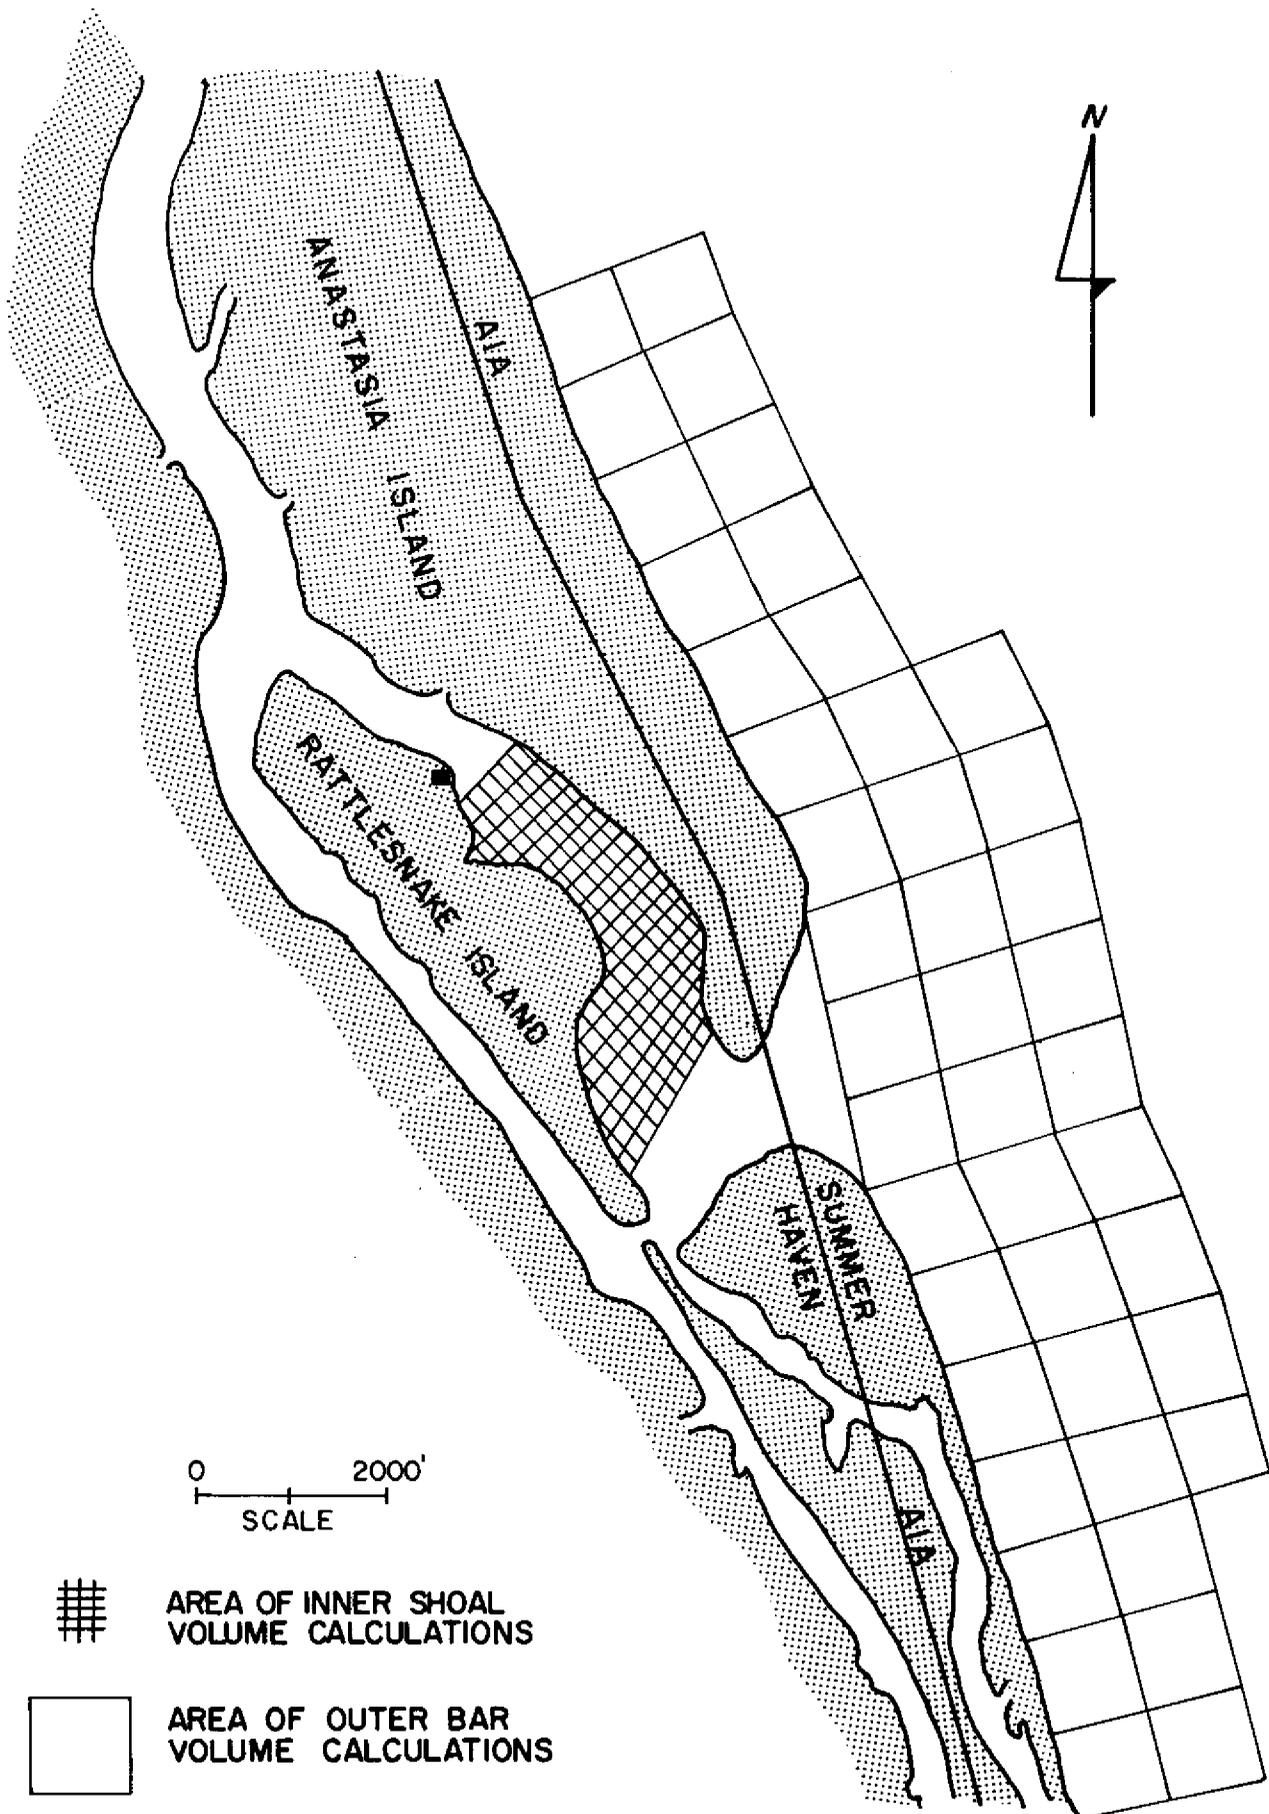
Fig. 8.2 Regions of Sand Volume Calculations.

The offshore bar volume at Matanzas Inlet was calculated from the 1963/64 Corps of Engineers survey map of the outer coast vicinity. Although the bathymetry was not indicated in the form of individual depth measurements, the contour lines enabled an approximate calculation to be made following the method developed by Dean and Walton (1975). The volume of sand estimated to lie in the outer bar for the 1963/64 survey was 4.4×10^6 cu. yds. This offshore bar volume calculation was made for that region shown in Fig. 8.2.

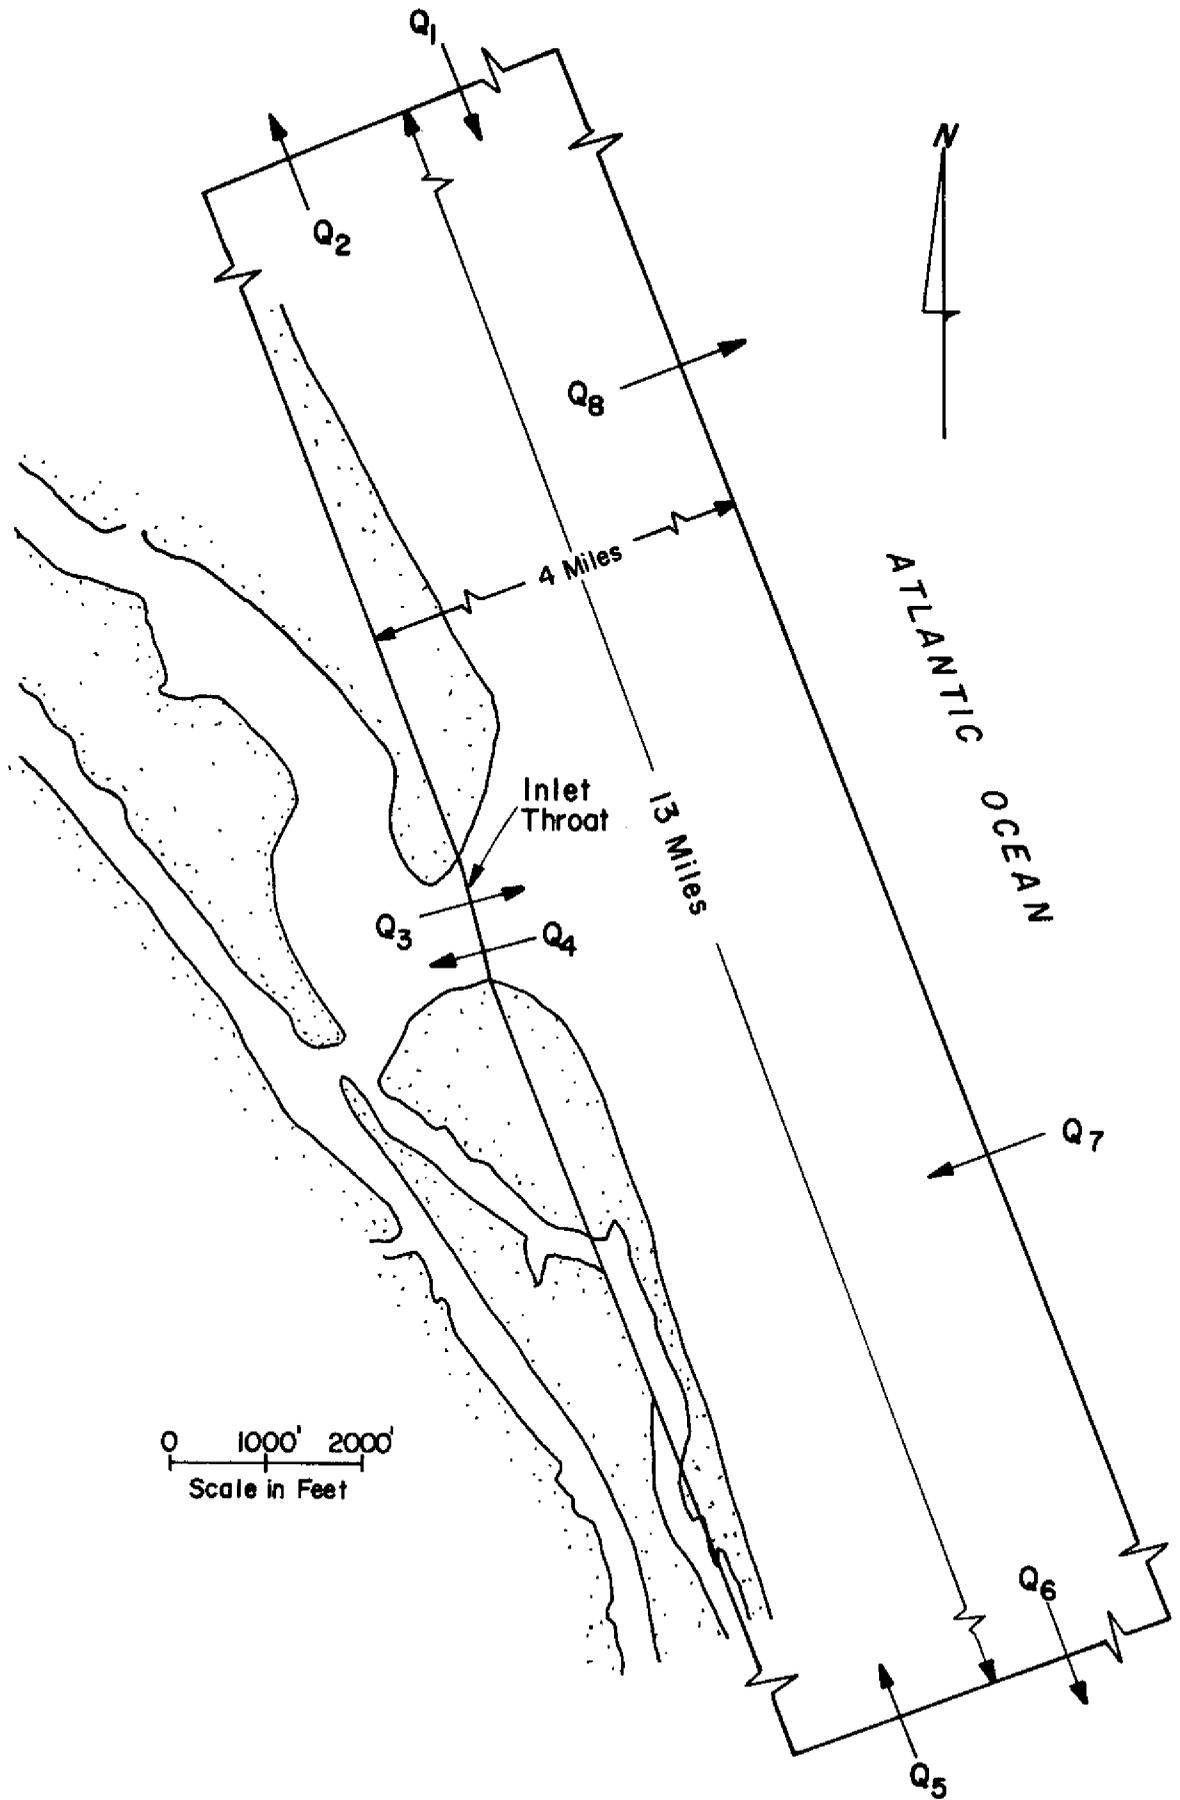
Fig. 8.3 Control Volume for Material Balance Calculations.

Fig. 8.3 shows a control volume encompassing the offshore region surrounding the inlet. The boundaries of the region have been selected as follows. The western boundary passes through the throat section of the inlet. The eastern boundary is in the offshore region parallel to the shoreline. The north and the south boundaries are normal to the beach at points 6.5 miles north and 6.5 miles south of the inlet. These boundaries are at sufficient distances from the inlet such that the influence of the latter on the beach configuration may be considered to be negligible. The stretch of the beach between the north boundary and the inlet is relatively straight and the normal to the beach subtends a 75° angle relative to the north, as observed in Fig. 8.4. The normal to the relatively straight beach south of the inlet subtends an angle of 69° .

With reference to the subscripted rate of littoral drift, Q , in Fig. 8.3, the following material balance may be expressed for the control volume.

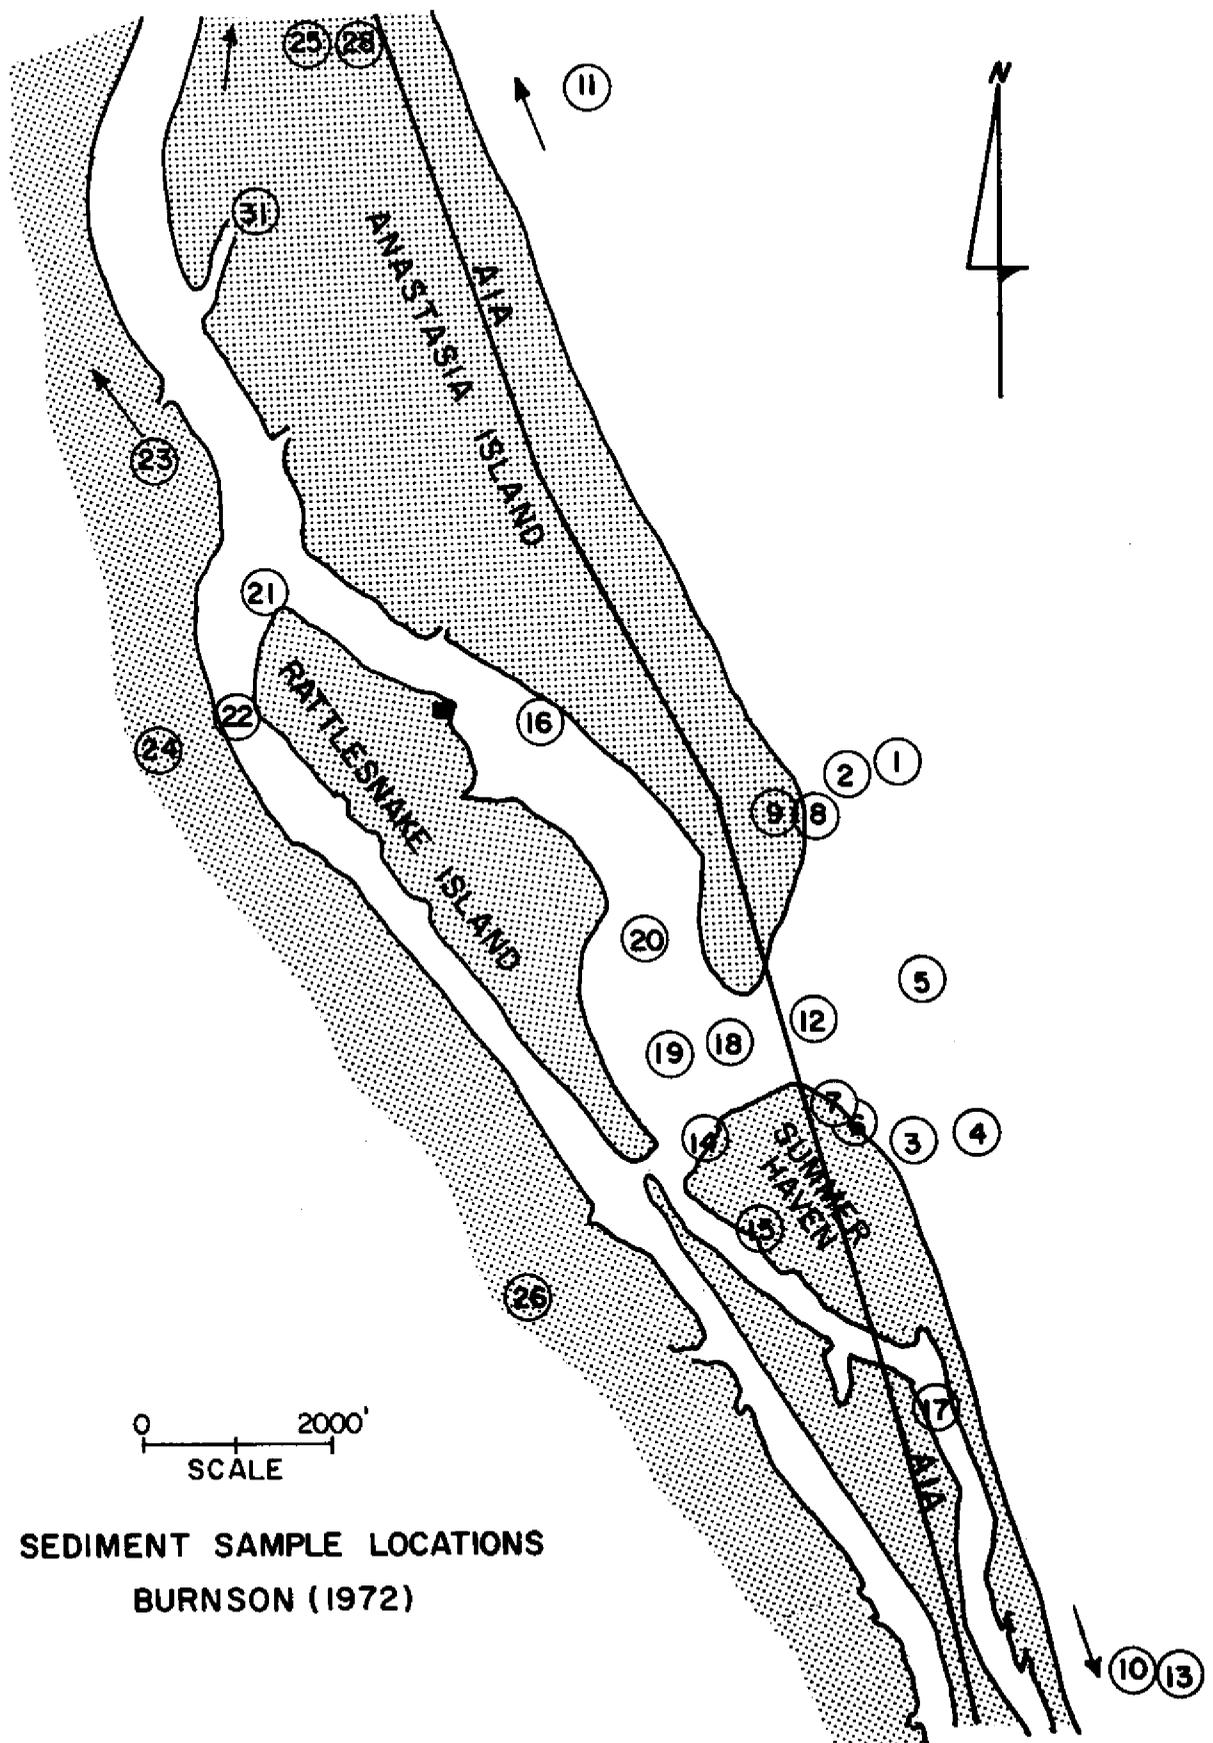
Fig. 8.5.

SEDIMENT SAMPLE LOCATIONS
 BURNSON (1972)

Between August 1971 and February 1972, Burnson (1972) collected sediment samples throughout the Matanzas Inlet area. Those sample points near the inlet are shown in Fig. 8.5 and combined results of his investigation are shown in Table 8.6. The average of the median diameters of the sediment samples was computed for those sample locations offshore, on the beaches, within the lagoon, and in the tidal marsh areas and is presented in Table 8.6 as average D_{50} . A sorting coefficient $S_0 = \sqrt{D_{75}/D_{25}}$ is also presented, as is the percent shell for selected samples. Several important results obtained from these data are discussed below:

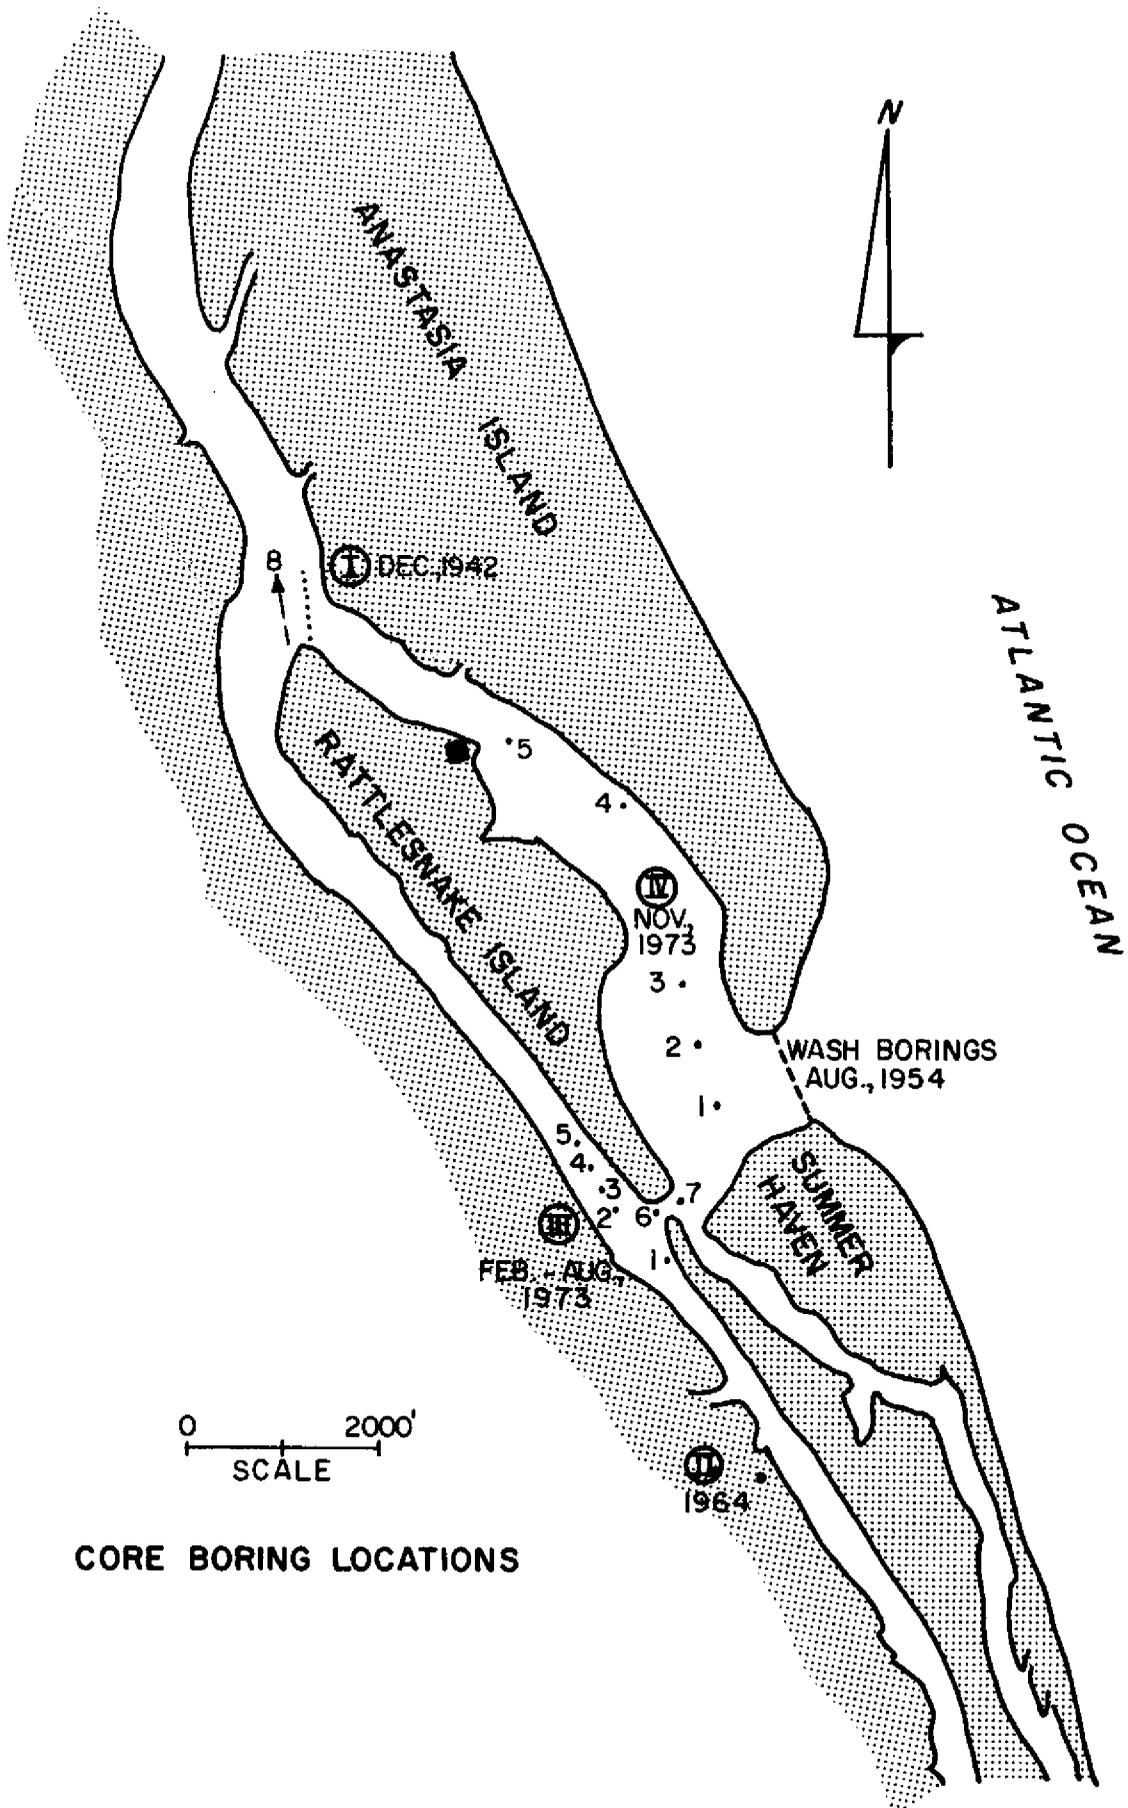
Fig. 8.6

CORE BORING LOCATIONS

Core borings in the area include those taken in 1942, 1965 and 1973. The first group, taken by the Corps of Engineers in December 1942, is designated "I" on Fig. 8.6. These borings were taken in conjunction with the current measurements mentioned in section 7.3. Along with other field work done by the Corps of Engineers in 1964, core borings were taken in the St. Johns County area to determine the availability of suitable material for beach renourishment purposes. One such boring was made in the Matanzas Inlet vicinity and is designated "II" on Fig. 8.6. Those borings designated as "III" on the figure were made by the Corps of Engineers in conjunction with the surveys of the breakthrough on Rattlesnake Island. Some borings were also taken at this time in the north arm of the Matanzas River, the proposed site for the dredging of a relief channel upon the planned closure of the breakthrough (Corps of Engineers, 1976). This group is designated "IV" on Fig. 8.6.

The borings at I indicate the presence of 4 to 14 ft. of sand mixed with some clay. Only boring 6 indicated the presence of shell (underlain by sand and clay). None of these borings penetrated beyond a depth of 20 ft. below MLW. The boring at II showed predominantly sand of median diameter 0.15 mm with some clay present. The Corps of Engineers study (1965) went on to conclude, "The materials penetrated by the one boring in the area contained a high percentage of unsuitable material. A dredged fill obtained from that area would probably contain at least 30 percent clay and silt." Boring 1 through 5 of group III indicate the predominance of fine sand mixed with some silt and shell to depths of 20 ft. below MLW. Borings 6 and 7, whose depths of penetration were 29.5 ft. below MLW and 41.5 ft. below MLW, indicate the presence of clay from 19.2 to 22 ft. and below 41 ft., respectively. The results of wash borings taken in 1954 prior to the construction of the new inlet bridge are presented in Fig. 8.7.

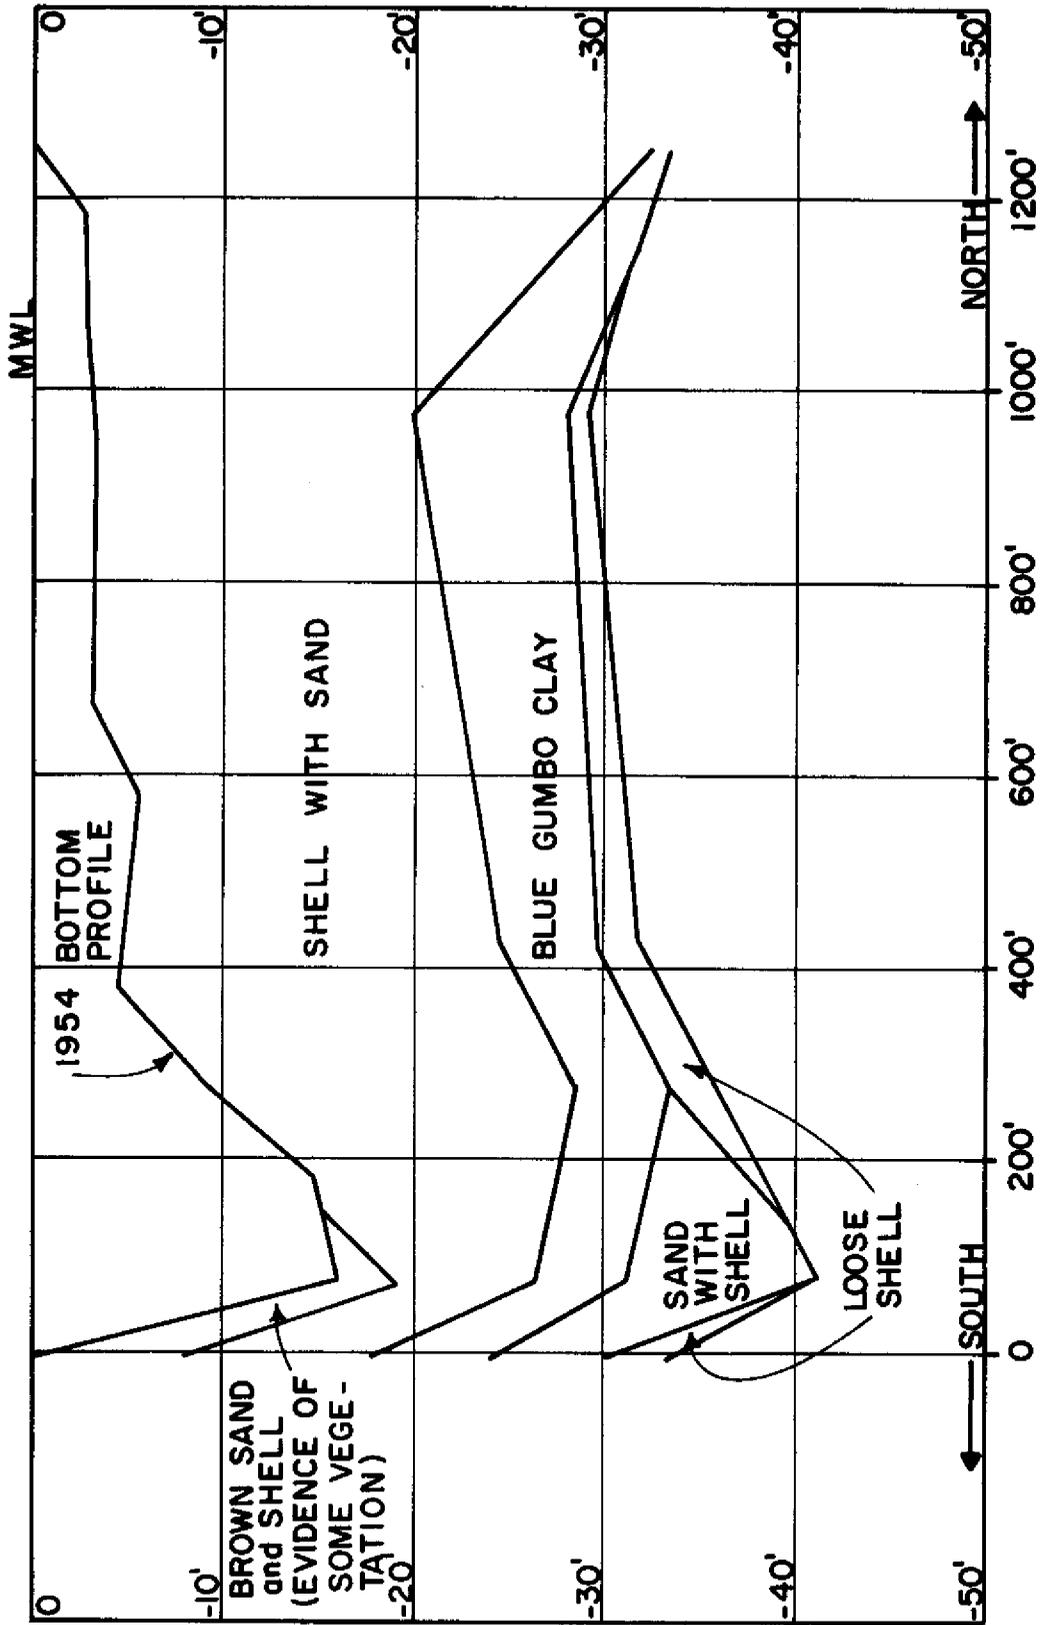
Fig. 8.7 1954 Wash Boring Results (SRD).
