NOAA *Okeanos Explorer* Program

MAPPING REPORT

CRUISE EX1101

Ship Shakedown and Patch Test

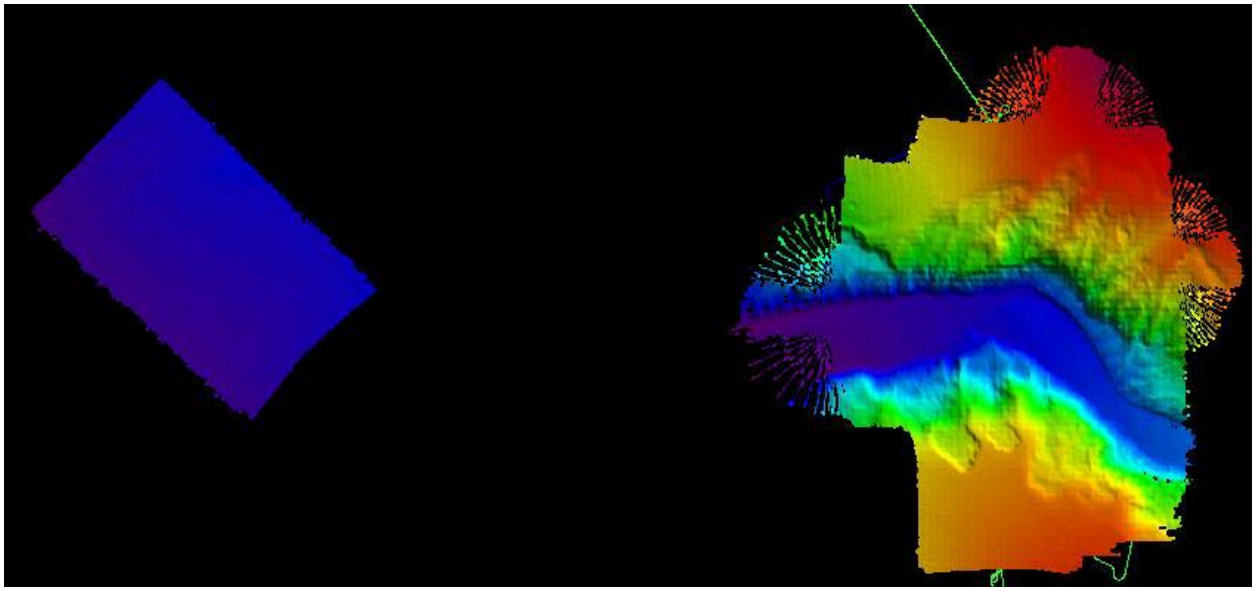
Figure 5. Screenshot of multibeam data collected over Monterey Canyon during patch test, shown in CARIS.

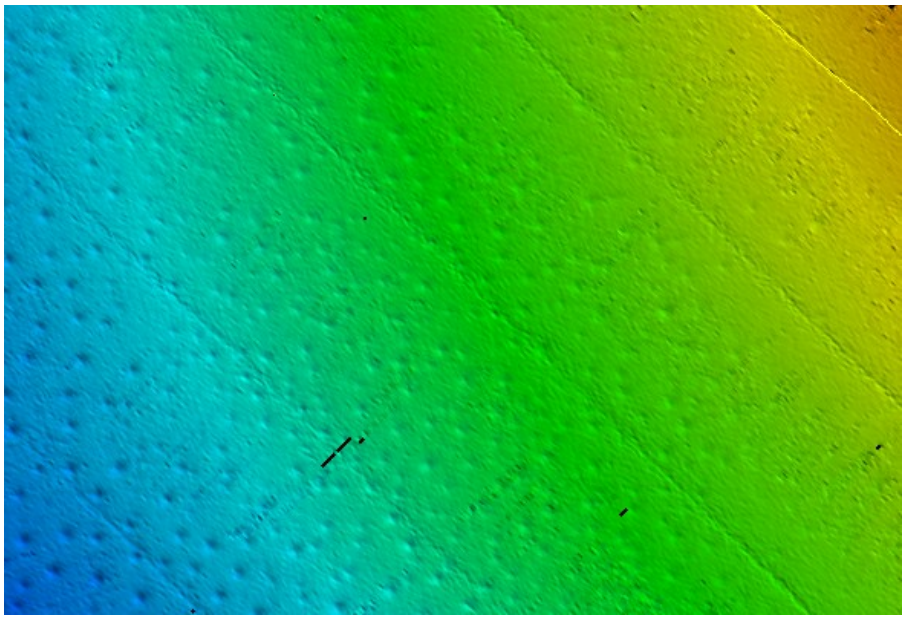
Interesting, previously known pockmarks of ~120 m in diameter and ~10 meters depth are prevalent in the southern section of Monterey Bay National Marine Sanctuary, and are shown in the screen capture below. Nadir penetration of a few meters below the seafloor occurred in this survey area in water depths of 700 meters to 1000 meters, seen as linear artifacts in the screen capture. Reducing to a shallower mode in SIS did not reduce this penetration. Changing the along direction angle to +2° worked best by reducing power hitting the seafloor directly below the transducer.

Figure 6. Pockmarks of 120 meter diameter observed near the southern border of Monterey Bay National Marine Sanctuary. Nadir penetration artifact at nadir also seen as parallel striping. Screen shot taken of gridded data (25 meter cell size, depths 600-800 meters) in CARIS.
