Western Washington University

Project Completion Report

Puget Sound Shore Erosion Protection Study

SHORE PROCESSES AND EROSION ABATEMENT ALTERNATIVES FOR PUGET SOUND

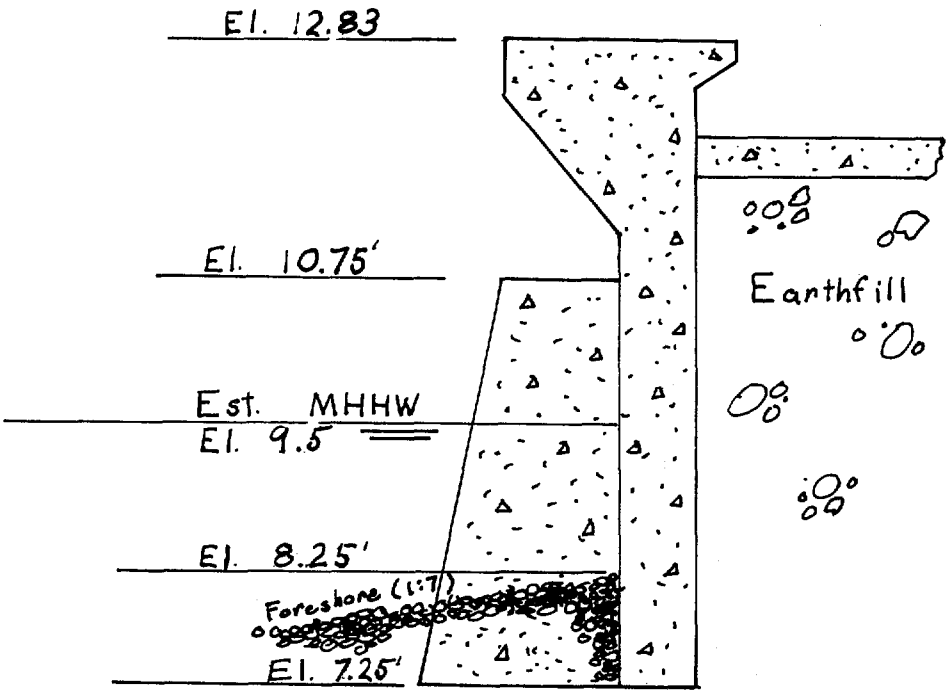
1. Structure Number: 1

This bulkhead appears adequately strong to resist the level of wave attack experienced at this site. There are no weepholes to provide drainage along the base of the structure, but since the backshore is impervious (concrete patio), none are needed. No tiebacks were incorporated in the bulkhead, a factor which could hasten overturning, should the beach lower more than 12 inches.

A 3-foot wide blanket of 20-50 pound rock at the toe would help to protect the footing from wave scour and reduce the possibility of bulkhead failure during a severe storm. Periodic placement of a fairly large quantity of sandy gravel at the bulkhead toe would also be a possible alternative should the beach lower more than 6 inches.

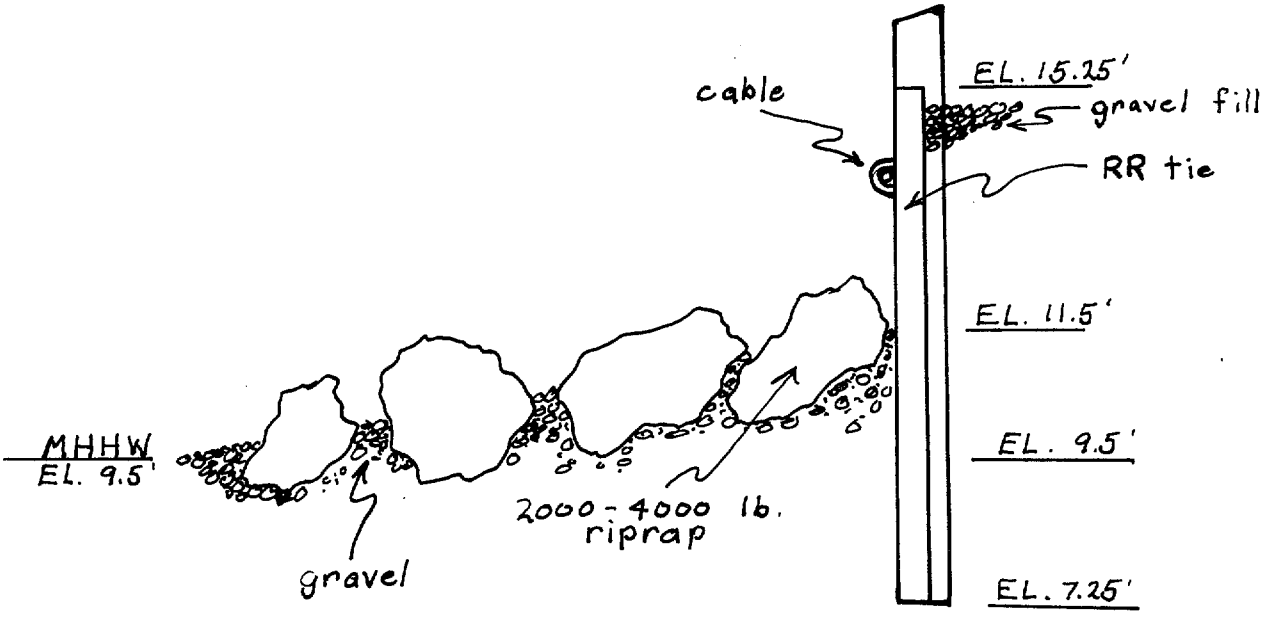
This bulkhead appears adequately strong to resist the normal level of wave attack experienced at this site. The riprap toe protection fronting the structure is adequate in size, but is subsiding because of a lack of proper bedding material. A horizontal cable which connects the railroad ties, probably lends little strength to the structure. Had tiebacks been attached to the cable every several feet, its usefulness would have been much improved. The bulkhead top elevation is sufficient to provide protection from wave overtopping and debris damage, except in the rare event of an exceptionally high tide occurring simultaneously with high winds from the northwest.

The structure could be improved by removing the existing riprap, placing an 18 inch thick by 8-foot wide blanket of quarry spalls (20-200

pounds) in front of the bulkhead, and then replacing the riprap on the blanket as close to the bulkhead as possible. This procedure would significantly reduct the rate of subsidence of the riprap. However, it should be noted that the recreational and scenic value of the beach has been lessened by the use of riprap.

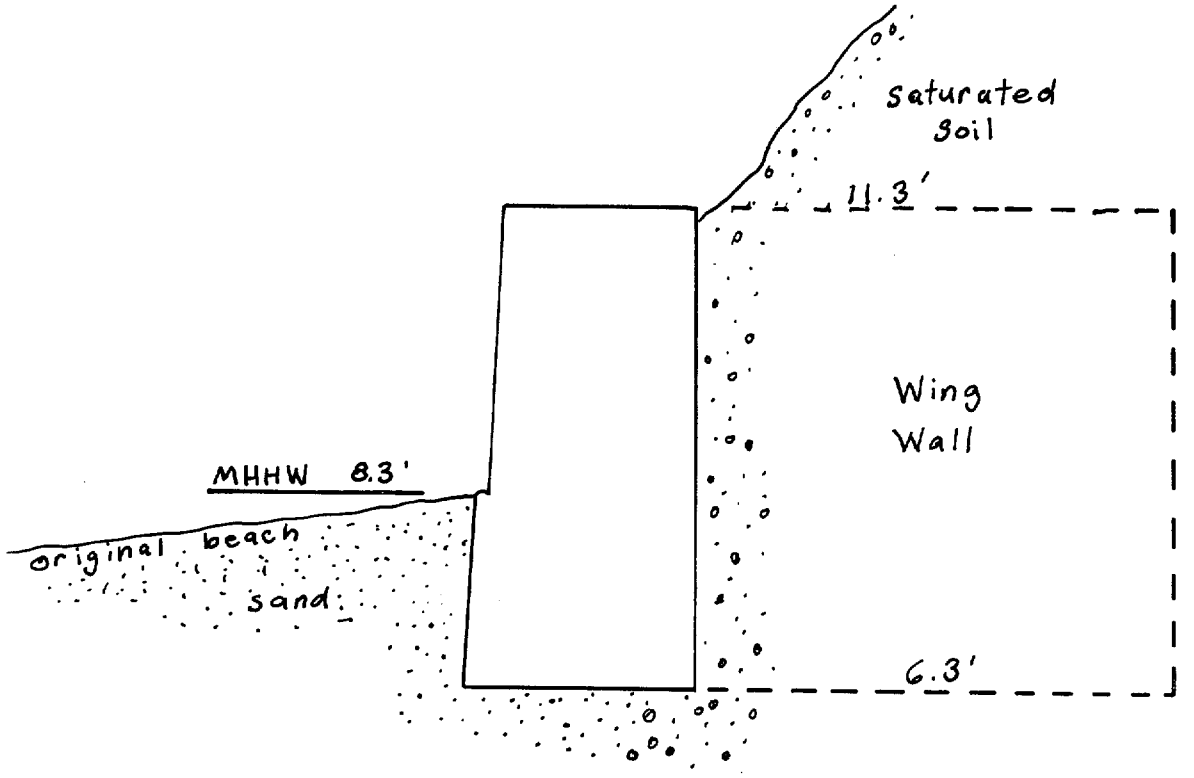
2. Structure Type: Concrete - vertical bulkhead (failed)

This site is exposed to wave attack primarily from the north. The net transport of beach material is from the northwest to the southeast, with eroding bluffs approximately 1/4 mile updrift of the site. Erosion of the beach appears to be a fairly slow process with the beach profile lowering at a rate of between 0.05 and 0.1 per year. This erosion contributed to, but does not appear to be, directly responsible for failure of this bulkhead. The primary cause for failure was probably the slumping of the bank which forced the bulkhead outward from behind.

This bulkhead, as originally constructed was adequately strong to resist the wave attack experienced at this site. However, the bulkhead was not a satisfactory bank retaining device. Lack of weep holes for drainage along the base of the bulkhead, compounded the bluff saturation problem. No tie-backs were incorporated in the original structure and the bulkhead had no rock toe protection. If toe protection or beach nourishment had been incorporated in the bulkhead maintenance, the 1-1/2-foot of toe scour which had occurred over the last 20 years could have been reduced. However, as discussed previously, toe scour is probably only a partial contributor to the problem. As constructed, the top elevation of this bulkhead was marginal. During extreme tides, there

was virtually no freeboard and any additional wave action probably caused overtopping, adding to the bluff saturation problem.

In this case, the lack of bank stabilization appears to be the primary cause of the bulkhead failure. If no solution is found for the bank foundation problem, the undestroyed portions of the bulkhead will probably fail in the near future. With no toe protection, the bank would be exposed to wave action, and the erosion rate could increase dramatically.

Solving the bank foundation problem could help to slow the rate of erosion at this site. Bank stabilization procedures could include resloping to a more stable angle, dewatering, and revegetation. In addition, a new means of protecting the bank toe should be provided. This could be a new bulkhead, either timber or concrete, or a revetment of some sort. In the event of further bank slumping, a "nonrigid" revetment of rock or gabions might prove less prone to catastrophic failure than a vertical bulkhead of wood or concrete.

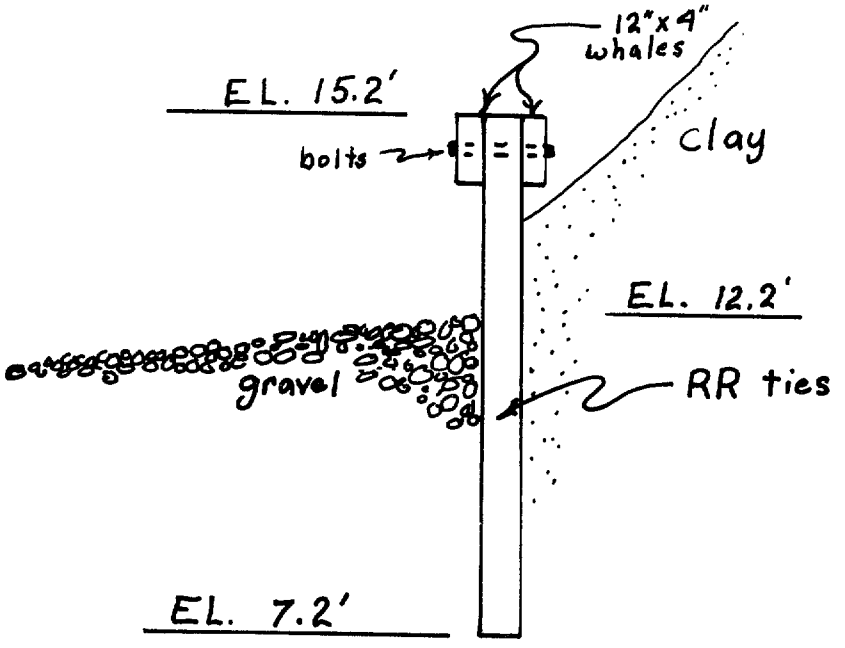
This bulkhead is adequately strong to resist the level of wave attack experienced at this site, but the structure is not designed to retain the high bluff behind it. The structure top elevation appears to be adequate, but high tides accompanied by moderate wave action may produce some overtopping. Since no filter material was provided behind the structure, fine material eroding from the bluff may continue to pass through the bulkhead. As of the inspection date, toe protection rock has only been provided along the eastern 25 percent of the structure. This rock is adequately sized but protection of the entire toe should be completed promptly. No tiebacks were included in this design, but the structure is only four feet high and, may be adequately strong to support the back fill behind it. However, a major bluff failure would overturn the bulkhead whether or not tiebacks were used.

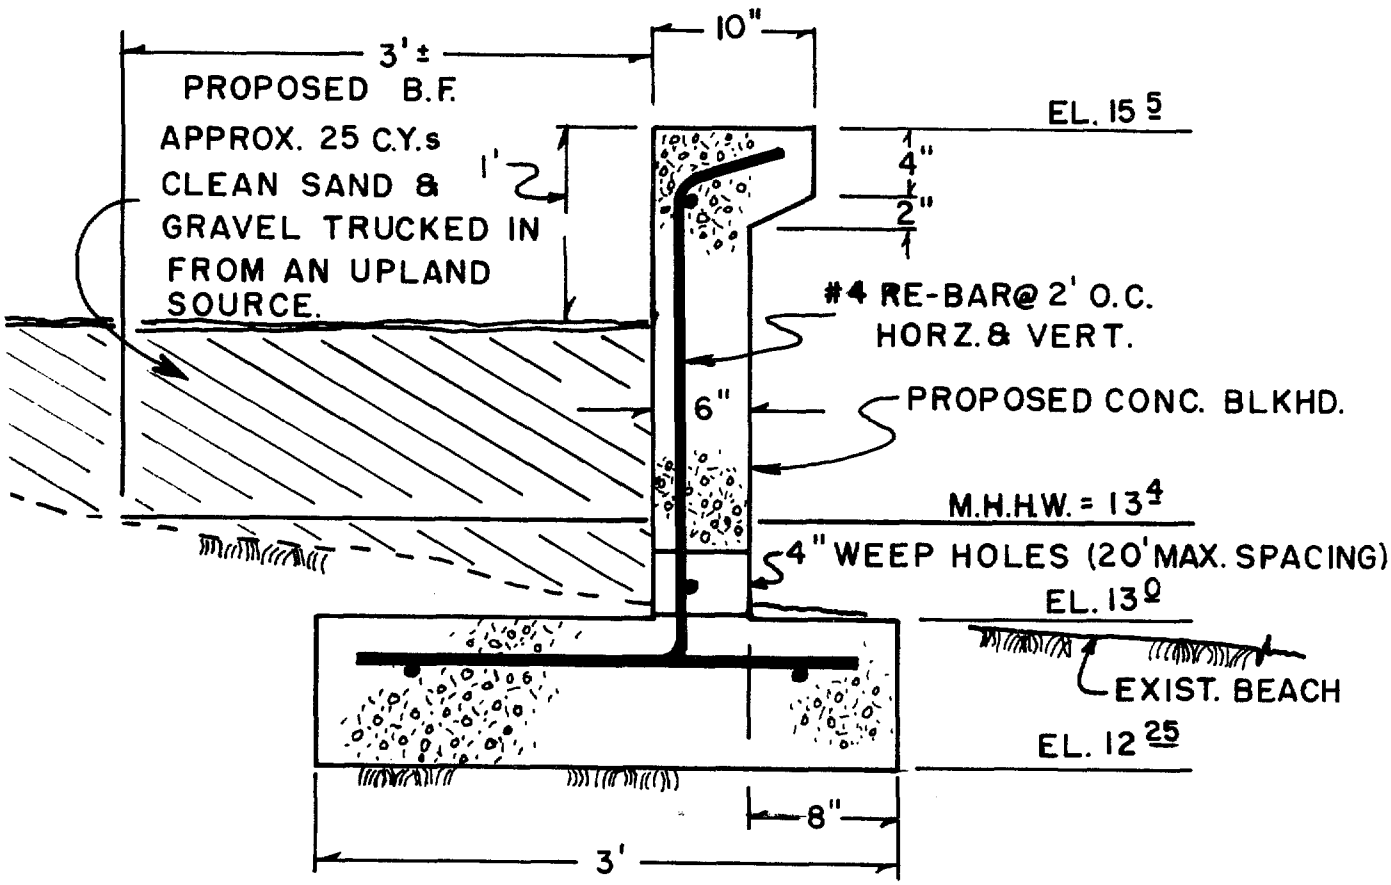
Proposed Design

The proposed bulkhead should be sufficiently strong for the wave climate at this site. However, the indicated bulkhead top elevation of 15.5 feet above mean lower low water (+15.5 mllw) is about 1.5 feet below the maximum estimated tide. At this elevation, the structure would probably be overtopped at least once annually. Since the proposed bulkhead does not completely enclose the backshore area and the foundation is extremely permeable, raising the top elevation by 1.5 feet or more would not insure that the backshore would remain dry. The plans for the proposed work show a backfill behind the bulkhead to an elevation of +14.5 mllw. This elevation probably will be surpassed by several tides each year. No toe protection is shown in the design plans, and without toe protection, the 9-inch deep footing is marginal.

This structure will probably do little to protect the backshore property from tidal flooding and could add to the problem by allowing the incoming tide into the backshore area and then retaining the water as the tide recedes. In addition, construction of the bulkhead may cause some increased erosion of the beach in the vicinity of the structure toe. The life of the bulkhead could be 20 years or more, depending on the toe scour rate and the degree of maintenance provided.

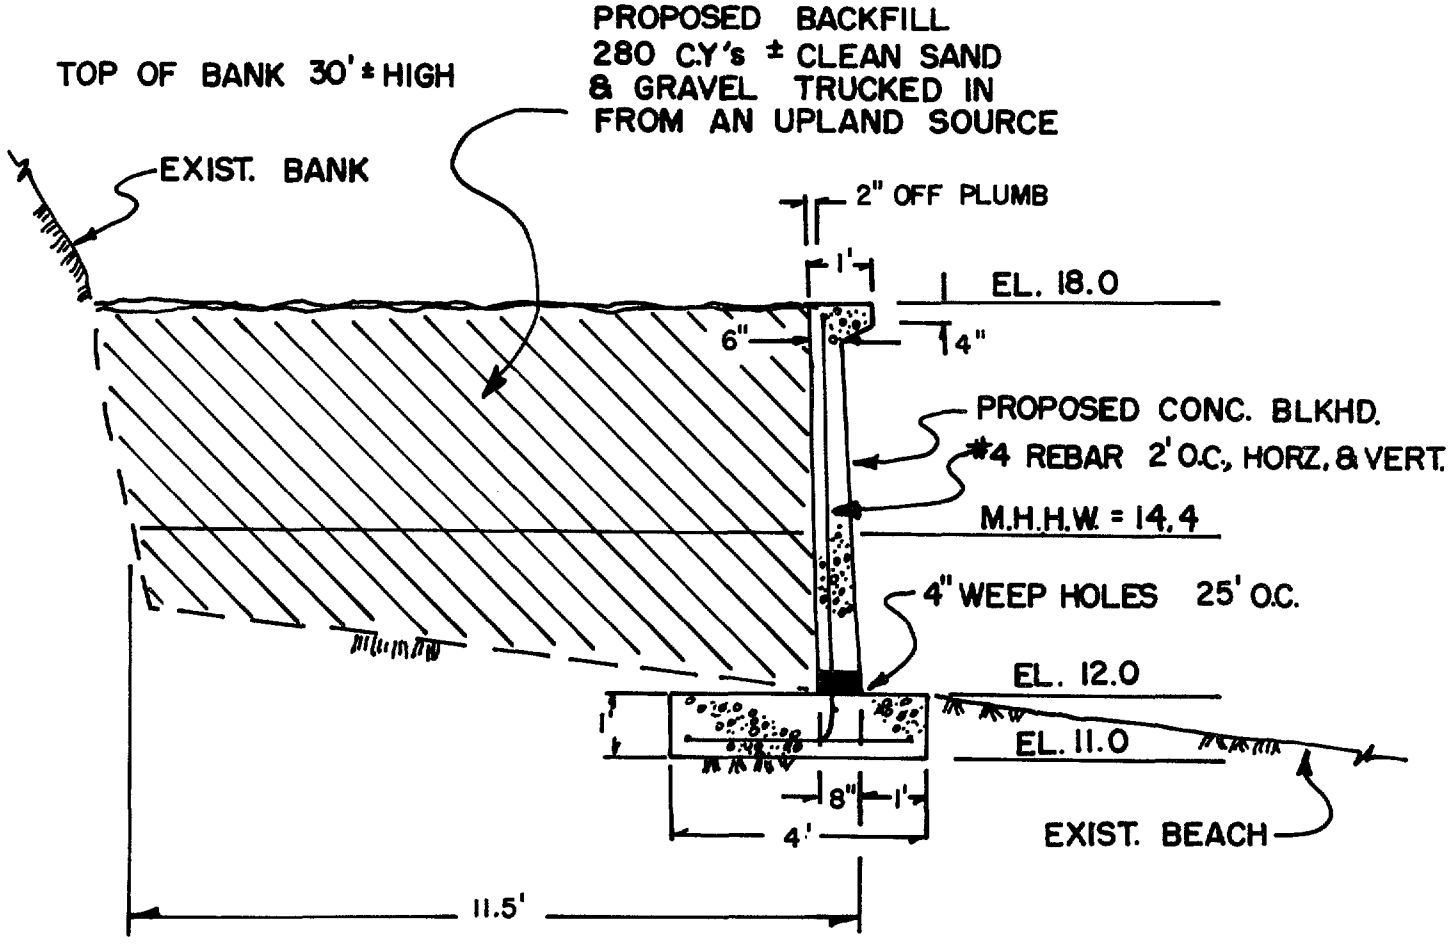
Proposed Design

The proposed bulkhead is sufficiently strong to resist waves which attack this site. The purpose of the bulkhead would be to retain the backfill material and additional bluff material which slumps onto the backfill and to prevent toe erosion. The top elevation of the bulkhead is satisfactory, but a footing depth of one foot may be marginal, particularly with no toe protection. No tiebacks are shown in the design, and with six feet of fill behind the structure, tiebacks may be desirable. The surface layer of beach material appears to be underlain by a clay-like material and attention should be paid to preparing a foundation for the bulkhead.

Two aspects of the geology and active geologic processes at this site relate to the design of any shore protection structures. A bulkhead could easily slide on the surface of the very hard impermeable silt underlying the gravels. Thus, it would need to be well "keyed" the silt surface but without disturbing it. Drainage would have to be carefully provided for as there would have to be no underflow. Secondly, superficial bank failure will continue but at a slower rate, even after construction. Thus, the bulkhead will need to perform some retaining wall functions as well as providing wave protection.

The life of this structure will depend primarily on its ability to resist overturning due to soil pressure. A high saturated bluff of clay and silt, and a clay-like foundation, will make the construction of a durable structure extremely difficult. Even if the bulkhead can resist overturning, the bluff will probably continue to slump until it reaches a stable slope.

d. Provide an adequate foundation

A riprap revetment is an alternative design which, if economically feasible, would be more flexible and might be less prone to catastrophic failure. Here again, foundation preparation would be critical. Another solution, if permits could be obtained, would be to construct an artificial beach of gravel and coarse sand. If graded to a 1:6 slope, such a beach fill would require about six cubic yards of material per foot of beach, in addition to the proposed backfill. This type of protection

would not be damaged by additional slumping of the bluff, and with periodic replenishment, would protect the bluff from wave action.
