NONPOINT SOURCE POLLUTION CONTROL PROGRAM

SEPTAGE DISPOSAL SITE INSPECTION

OCONTO COUNTY

1991 PROJECT REPORT

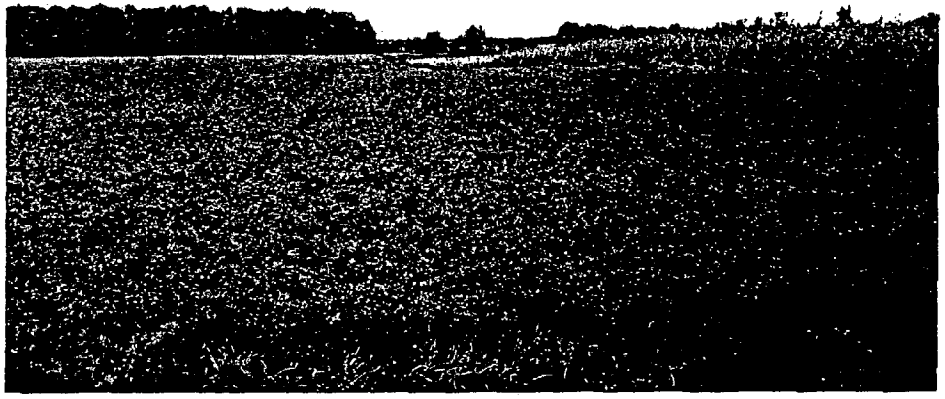
Took 5 borings, couldn't auger past 22 inches on any boring due to rocky conditions, indicative of glacial till.

Soil conditions indicate the potential for poor permeability. Site has some significant slopes forcing drainage to a low lying area which appears to be a seasonally wet area. Unless it can be shown that the soil will accept septage without any problems, I recommend withdrawing use of this site.

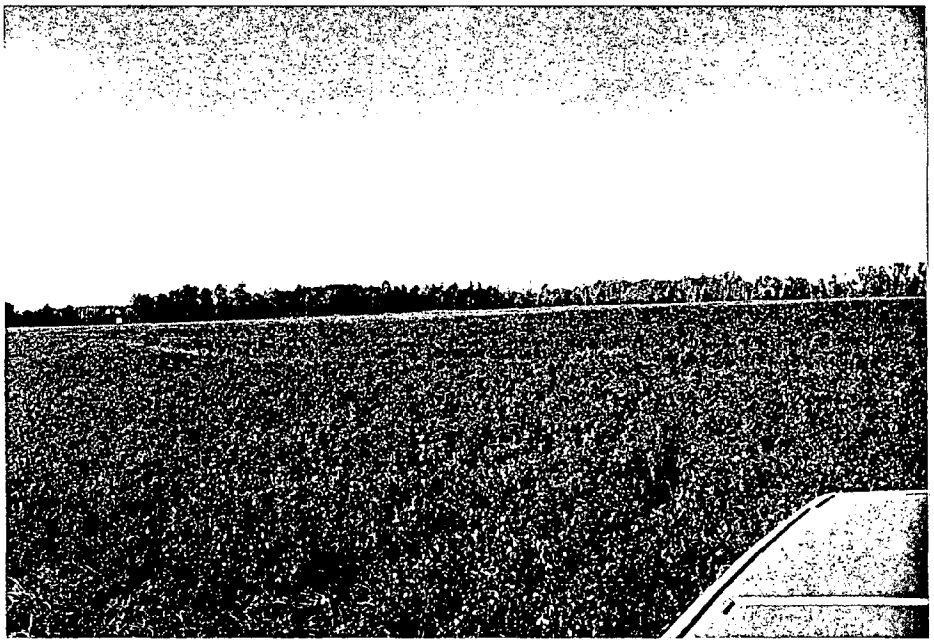
location of nearby residences: <1000 feet
location of nearby wells: >200 feet
low areas subject to flooding or ponding: low area in middle of field
location of surface waters: no nearby surface waters
evidence of rock outcroppings: no rock outcroppings
degree and extent of slopes: slope on north end of field,
drainage patterns: toward the north and toward the middle
condition of field: field is currently in alfalfa
truck ruts, burned vegetation, eroded gullies, dumping spots: no
evidence of septage application: no
public access: bounded on 2 sides by public road, no fences or signs
within 2000 feet of Morgan Marsh hunting area

DNR has no records of this site other than being on the list.

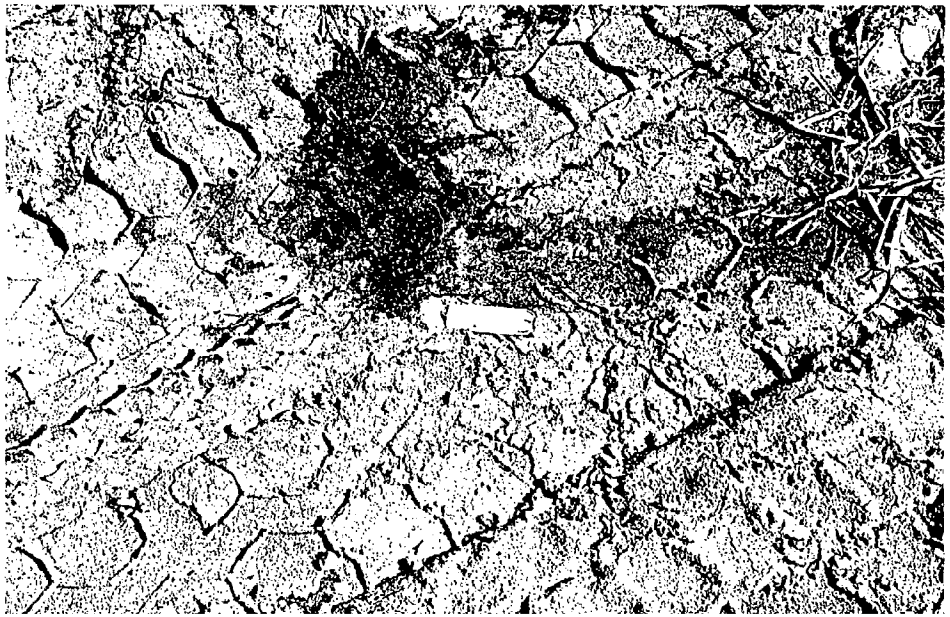
location of nearby residences: <1000 feet
location of nearby wells: >200 feet
low areas subject to flooding or ponding: fairly level
location of surface waters: Brehmer Creek
evidence of rock outcroppings: no rock outcropping
degree and extent of slopes: fairly flat area
drainage patterns
condition of field: dormant
truck ruts, burned vegetation, eroded gullies, dumping spots:
some truck ruts, no burned areas
evidence of septage application: litter from septage on field
public access: no trespassing signs, remote location

sawdust berm around area, there is a pit dug in the middle of the septic field which appears to be used for burning.

Soils are suitable for septage application. Make sure that the site cannot be accessed from the county forest.

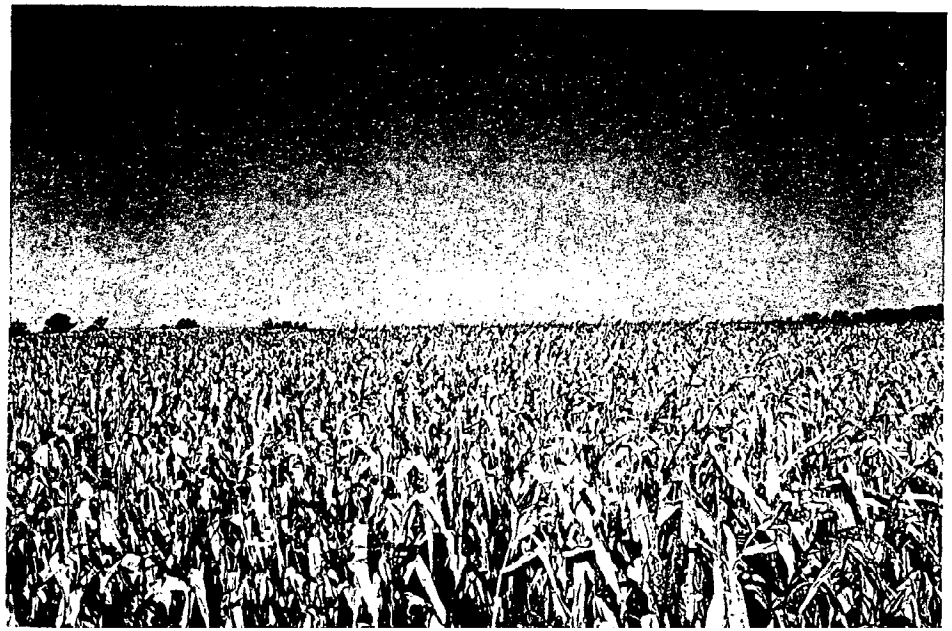
location of nearby residences: <1000 feet
location of nearby wells: >200 feet
low areas subject to flooding or ponding: no low spots
location of surface waters: Oconto River on south side of field
evidence of rock outcroppings: no rock outcrops
degree and extent of slopes: fairly level
drainage patterns: no distinct drainage patterns
condition of field: entire field in corn
truck ruts, burned vegetation, eroded gullies, dumping spots: no
evidence of septage application: no
public access: fronts Hwy 22, access by a private farm lane,

Soil borings inconclusive. First 2 borings indicative of slowly permeable soils due to glaical till. borings limited due to entire field being in corn. Recommend re-evaluation of field after the corn has been harvested.

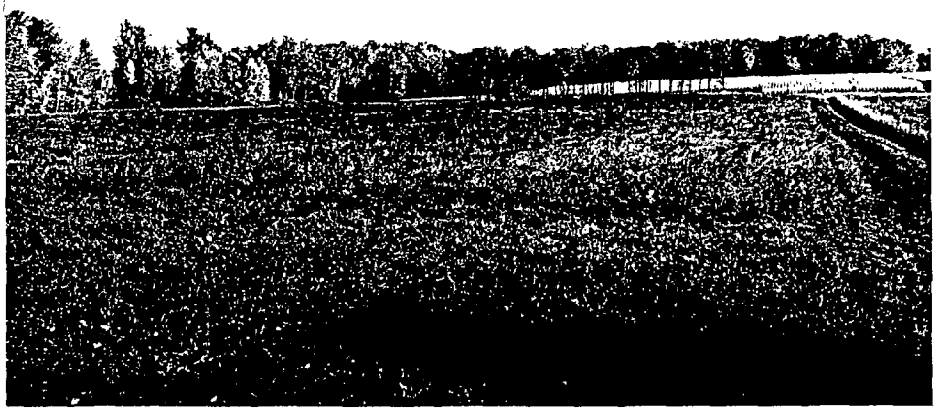
location of nearby residences: >1000 feet
location of nearby wells: >200 feet
low areas subject to flooding or ponding: sparse low areas
location of surface waters: Kelly Brook >1000 feet
evidence of rock outcroppings: no rock outcroppings
degree and extent of slopes: approx 2-12%
drainage patterns: drains from North end of field to south end
condition of field: alfalfa and hay
truck ruts, burned vegetation, eroded gullies, dumping spots: no
evidence of septage application: no
public access: remote location, not accessible to public

May continue use of this site.

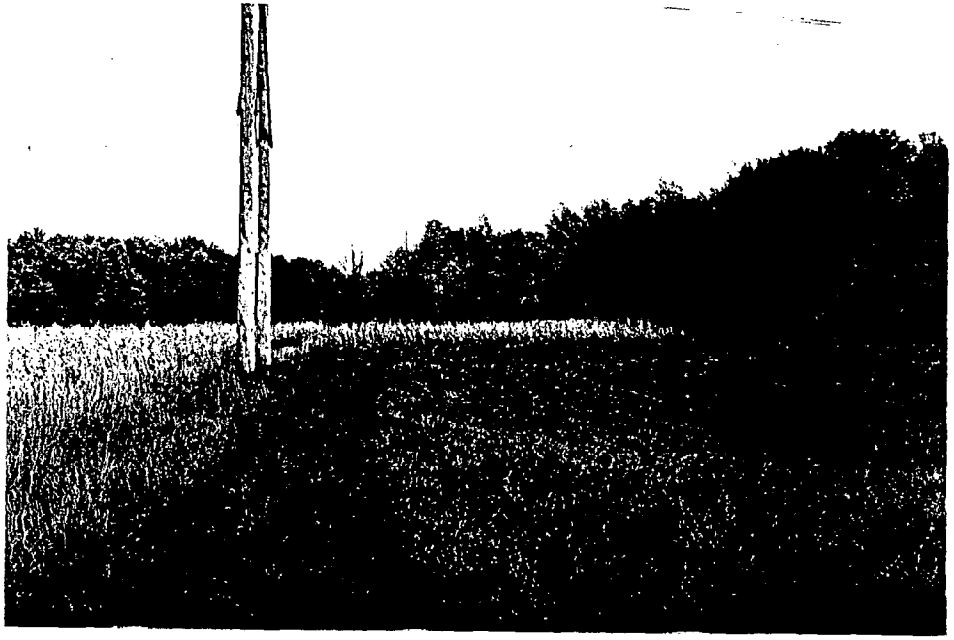
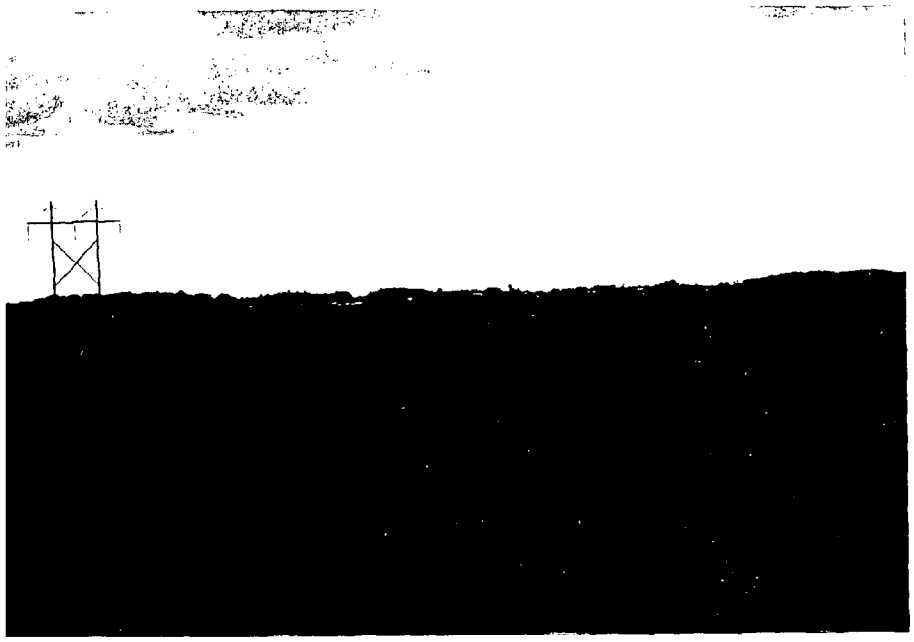
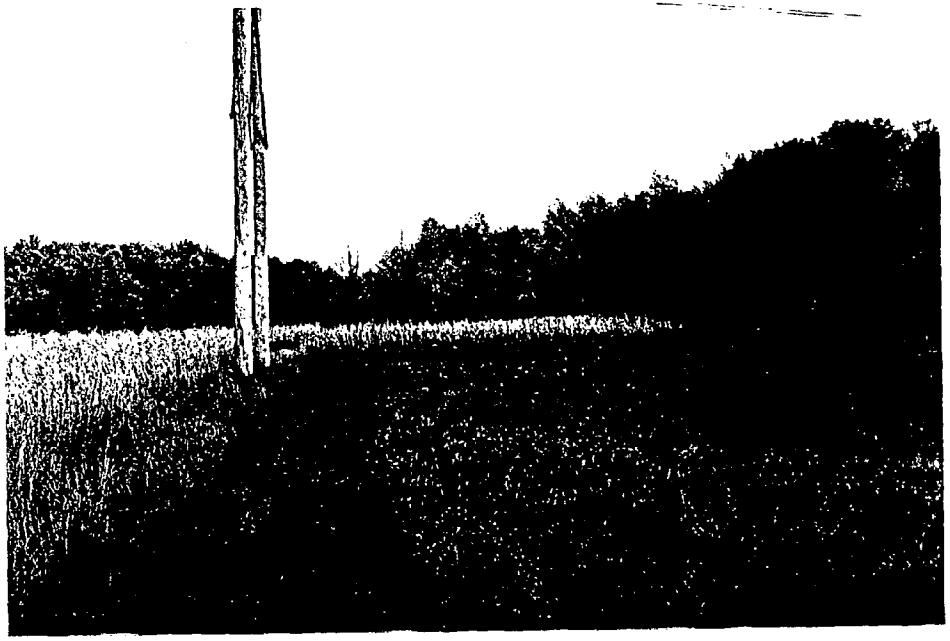
location of nearby residences: <1000 feet
location of nearby wells: >200 feet
low areas subject to flooding or ponding: several potholes
location of surface waters: no nearby surface waters
evidence of rock outcroppings: no rock outcroppings
degree and extent of slopes: very hilly area
drainage patterns: no distinct drainage patterns
condition of field: hay
truck ruts, burned vegetation, eroded gullies, dumping spots: no
evidence of septage application: no
public access: remote location, no public access

The very hilly terrain of this field with several potholes would severely limint use of this field. Potential for "dumping" as a result of getting stuck. Several potholes which could cause ponding. Recommend withdraw this site.
