Hope and Carton Hill Road Management Plan

January 2013

Horsley Witten Group

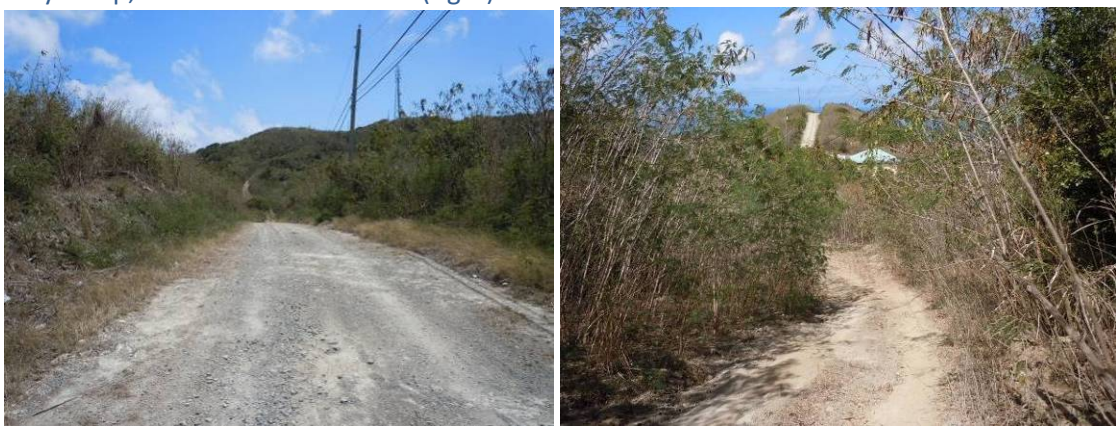
Figure 10. Coral Reef Trail in this area runs along the top of a ridge (left); this photo is looking down the extremely steep, eroded cell tower road (right).

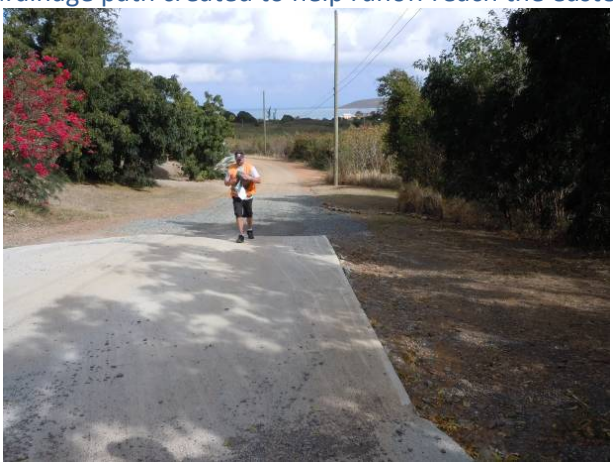
Figure 26. Some erosion is occuring at the edge of the paved intersection (left), and a manmade drainage path created to help runoff reach the eastern gut (right).

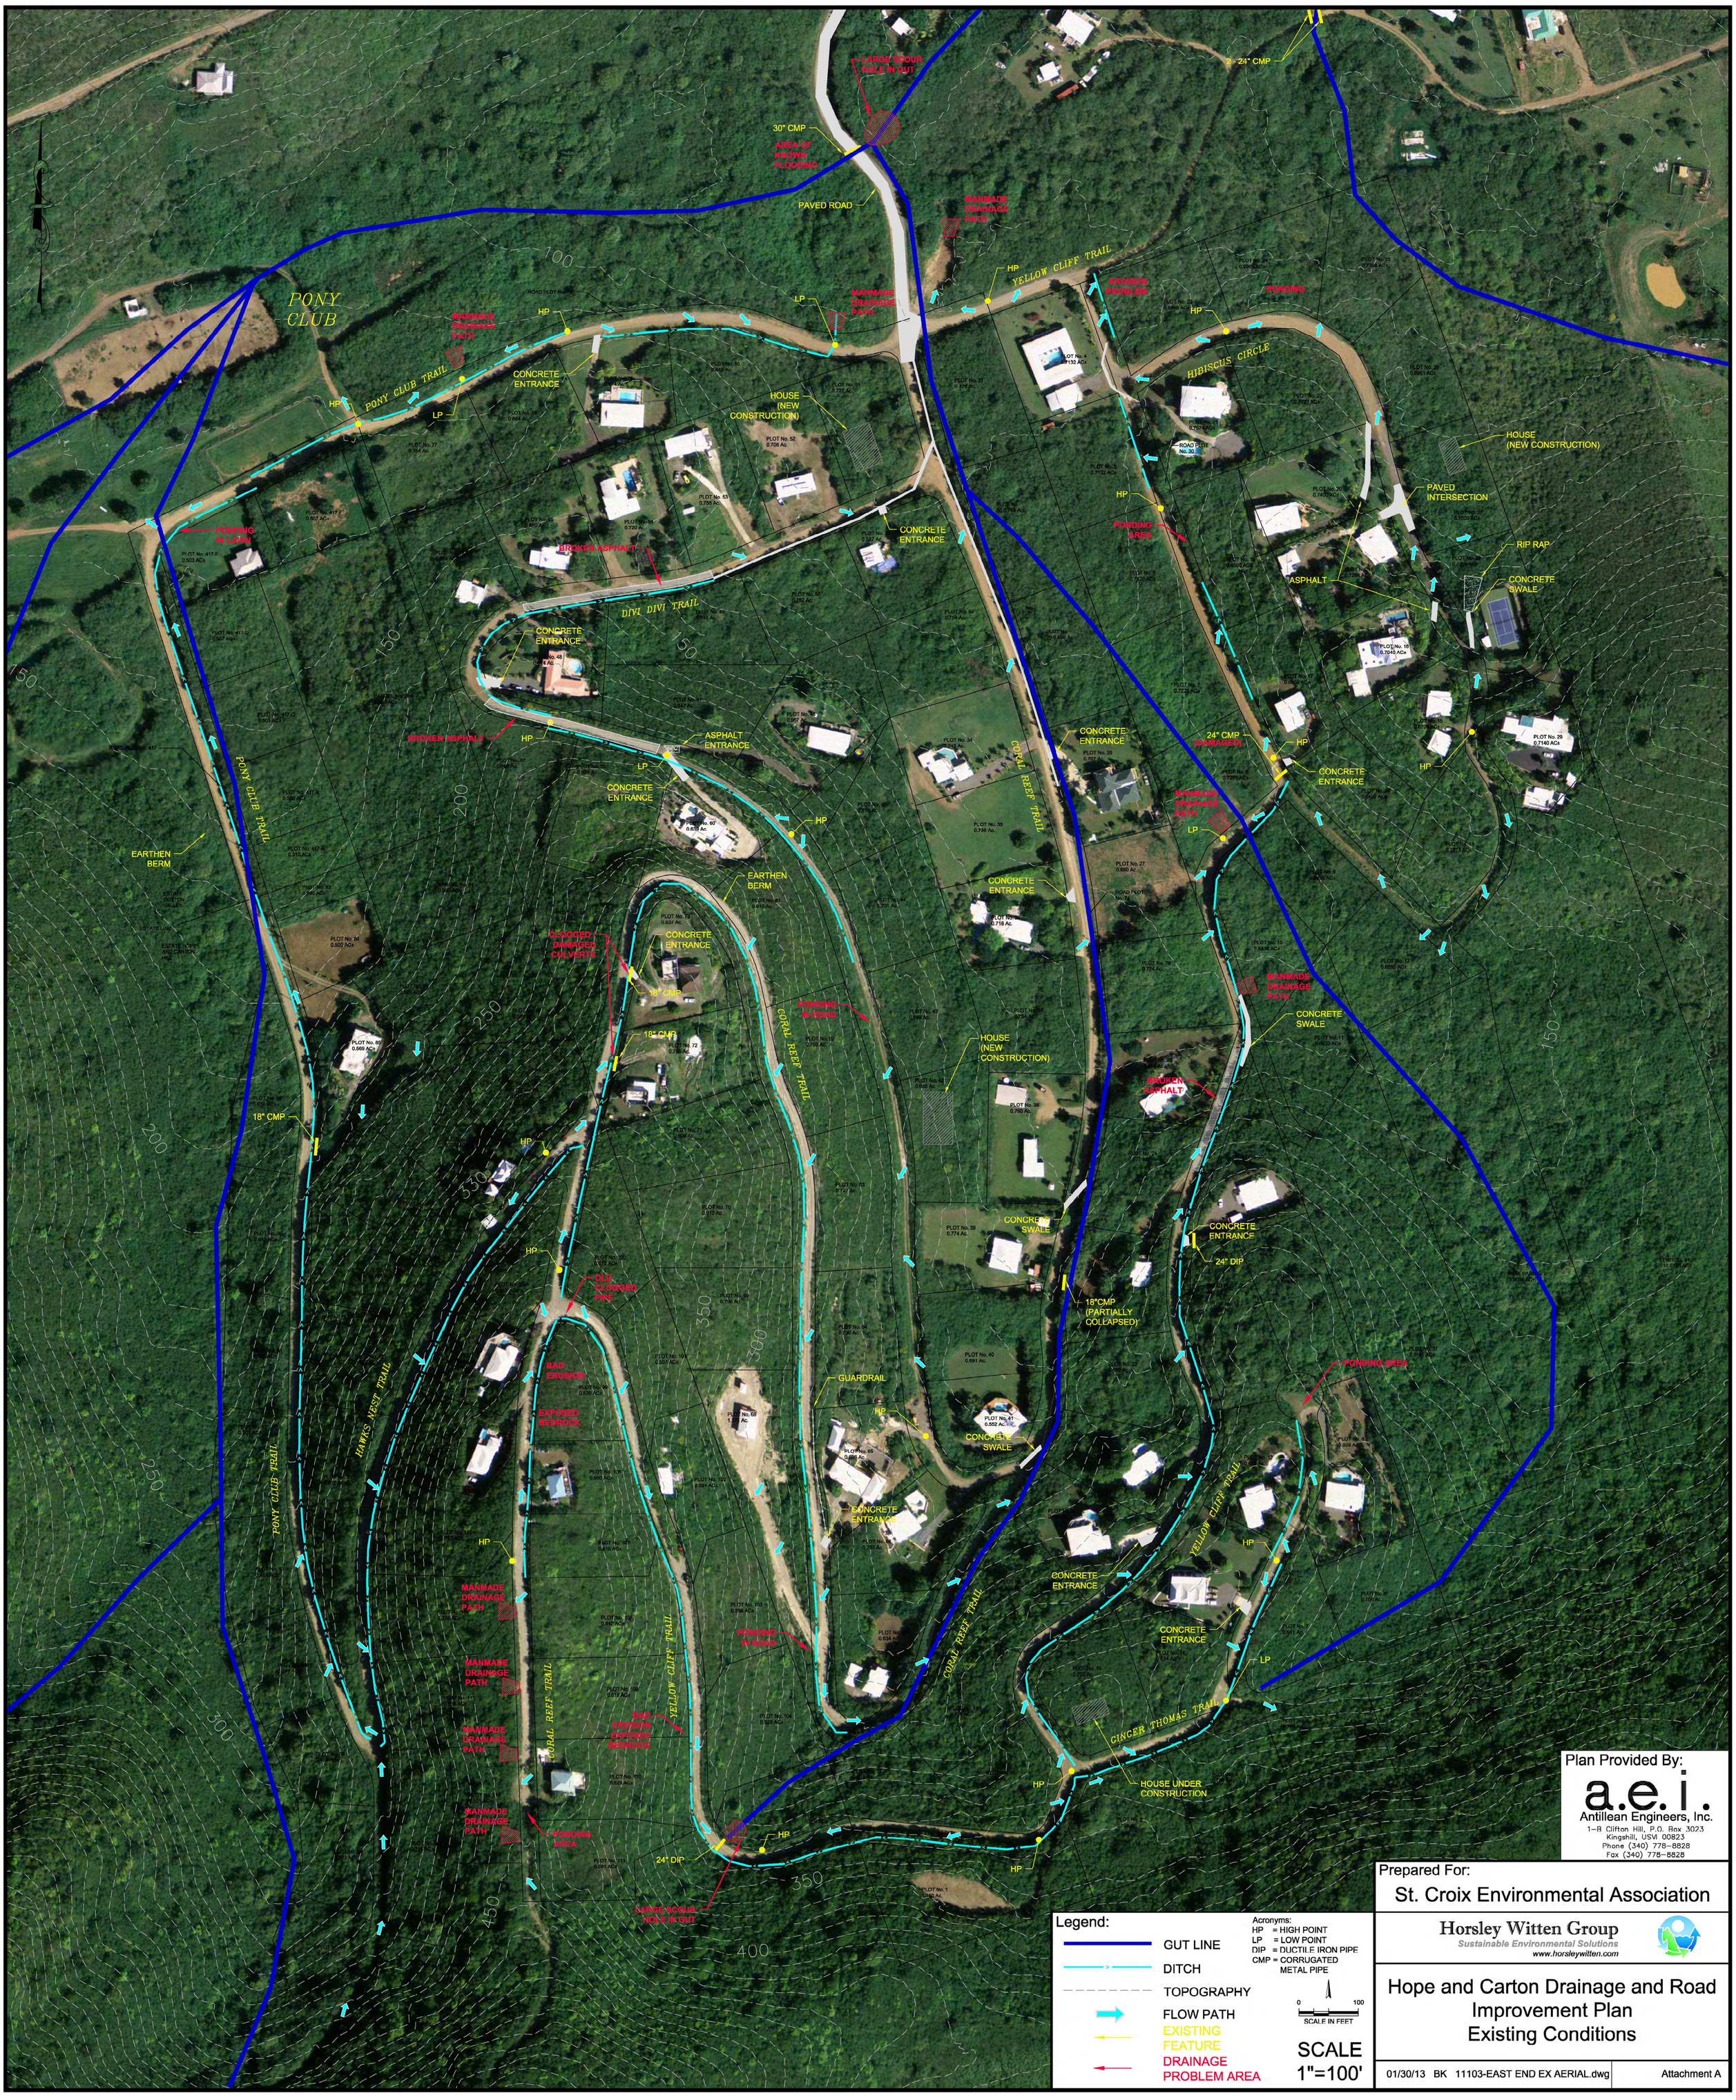
ATTACHMENT A: EXISTING CONDITIONS MAP

PONY CLUB
PONY CLUB TRAIL
DIVI DIVI TRAIL
YELLOW CLIFF TRAIL
HIBISCUS CIRCLE
CORAL REEF TRAIL
HAWKS NEST TRAIL
CINGER THOMAS TRAIL
LARGE SCOUR HOLE IN CUT
30" CMP
AREA OF KNOWN FLOODING
PAVED ROAD
MANMADE DRAINAGE PATH
EROSION PROBLEM
PONDING
HOUSE (NEW CONSTRUCTION)
PAVED INTERSECTION
RIP RAP
CONCRETE SWALE
ASPHALT
CONCRETE ENTRANCE
BROKEN ASPHALT
PONDING IN LAWN
PONDING AREA
ASPHALT ENTRANCE
24" CMP (DAMAGED)
EARTHEN BERM
CLOGGED / DAMAGED CULVERTS
18" CMP
PONDING IN ROAD
24" DIP
18"CMP (PARTIALLY COLLAPSED)
OLD CLOGGED PIPE
BAD EROSION
EXPOSED BEDROCK
GUARDRAIL
HOUSE UNDER CONSTRUCTION
HP
LP
Plan Provided By:
a.e.i.
Antillean Engineers, Inc.
1-B Clifton Hill, P.O. Box 3023
Kingshill, USVI 00823
Phone (340) 778-8828
Fax (340) 778-8828
Prepared For:
St. Croix Environmental Association
Horsley Witten Group
Sustainable Environmental Solutions
www.horsleywitten.com
Legend:
GUT LINE
DITCH
TOPOGRAPHY
FLOW PATH
EXISTING FEATURE
DRAINAGE PROBLEM AREA
