FEASIBILITY STUDY
FLOATING TIRE BREAKWATER
FOR
KOLLEN PARK

FEASIBILITY STUDY

FLOATING TIRE BREAKWATER

KOLLEN PARK

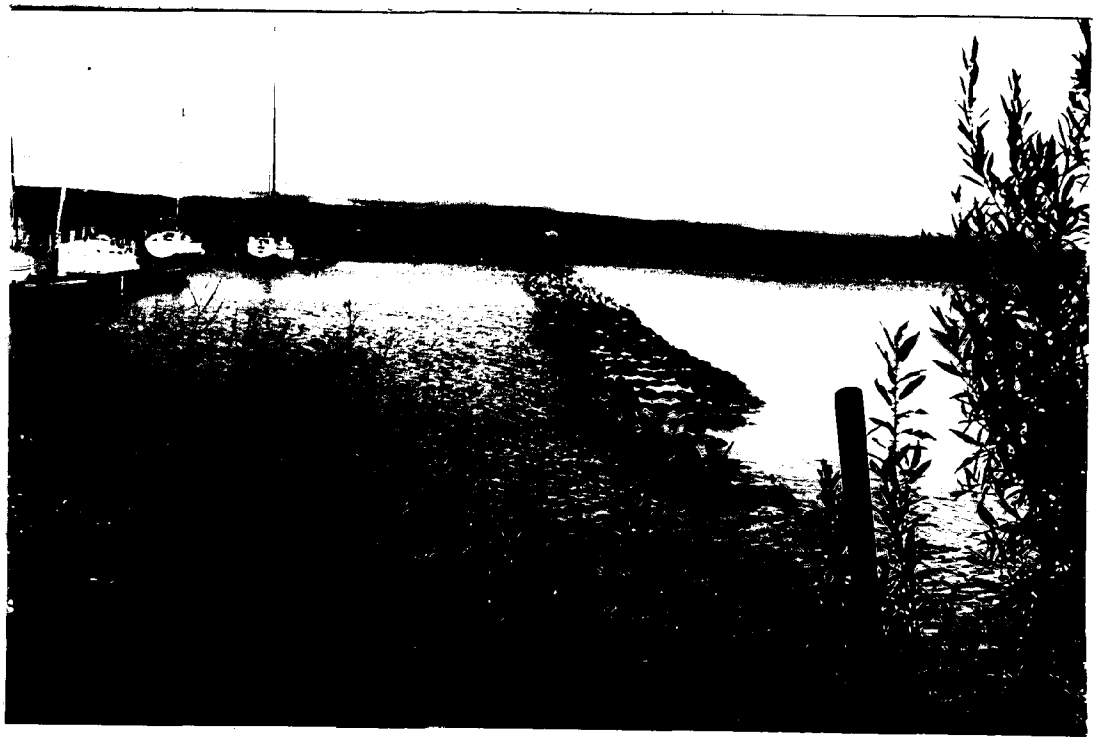
PHOTO LOOKING NORTH SHOWING EAST BREAKWATER FOREGROUND AND NORTHEAST BREAKWATER BEHIND.

PHOTO LOOKING EAST ALONG OUTER HEAD PIER - NOTE HOW SOME OF THE ORIGINAL TIRES INSTALLED ALONG PIER ARE PARTIALLY SUNK DUE TO LOSS OF FLOTATION

The breakwater is mostly constructed with truck tires. Tires are partially filled with a two-component polyurethane foam. The foam is not a closed cell foam and has gradually become saturated causing some of the tires to sink. In some time period, the amount of flotation lost will require a major rehab project.
