# MELVILLE CONDITION SURVEY

Rhode Island Port Authority and  
Economic Development Corporation

MAY, 1982

RE: Melville Condition Survey  
CEM No. 4001

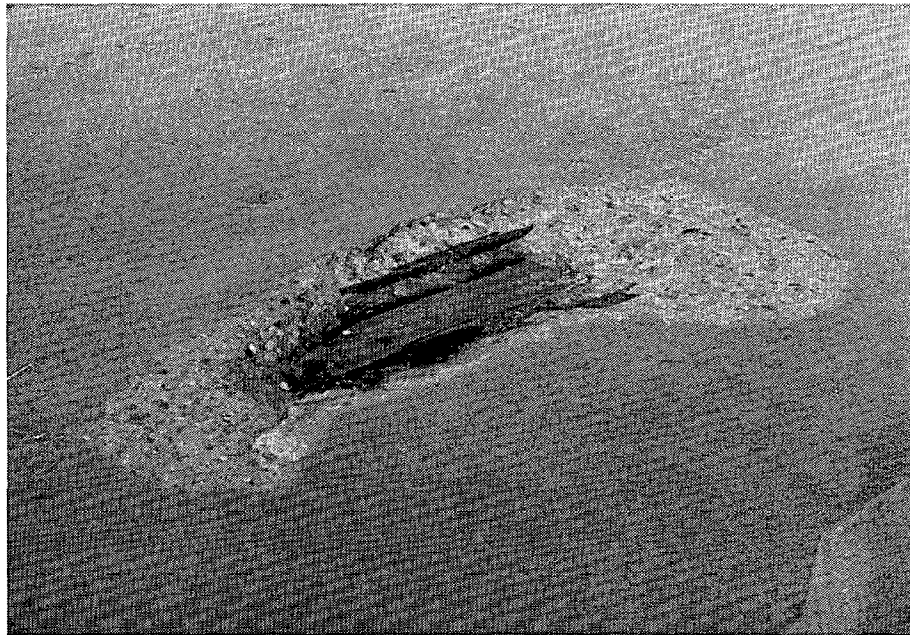
PHOTO 4 - SPALLED CONCRETE DECK AT THE FBM PIER  
NOTE SPLIT PIPE AT LOWER EDGE OF SPALL

FBM Pier & Access Trestle: The FBM pier appeared in excellent condition except for isolated damage as noted in the field notes. There are three small areas on the deck which require minor concrete repairs one of which was most probably caused by the freezing and expansion of an encased steel conduit. See photo 4.

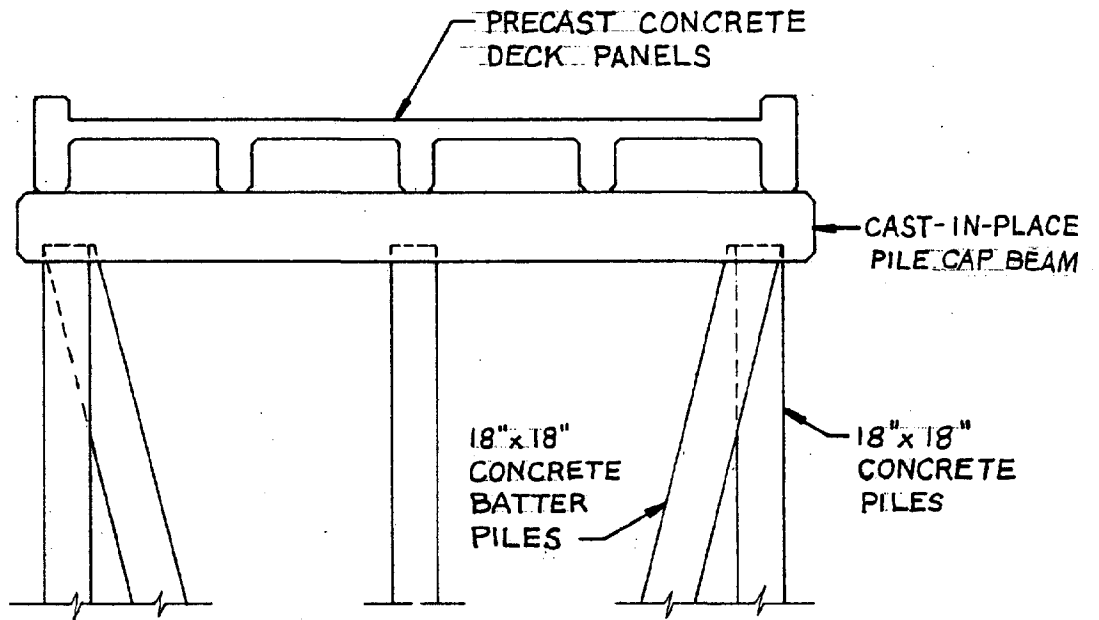
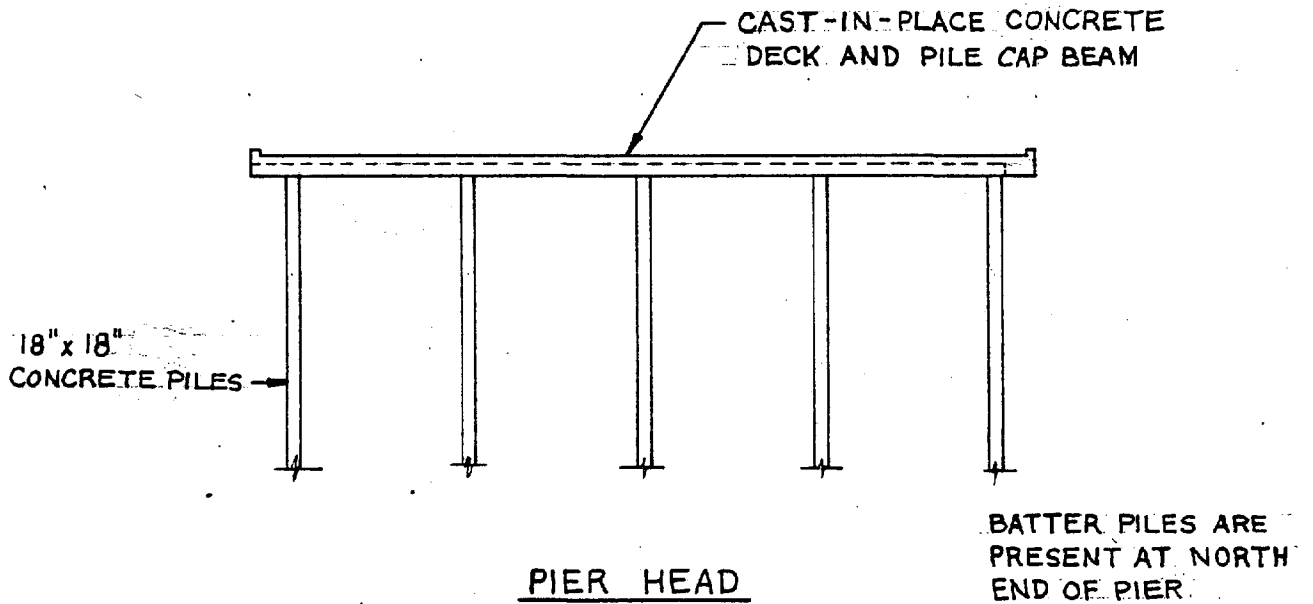
<b>MELVILLE CONDITION SURVEY</b>	
<b>F.B.M. REPLENISHMENT PIER TYPICAL SECTION</b>	
DATE MAY 1982	FIGURE NO. 5

directions at various locations to provide strength both laterally and longitudinally. All bollards and cleats were found to be in excellent condition. Figure No. 5 indicates the typical construction of the FBM pier. Approximately six structural piles were found to have sustained significant damage apparently from external impact. (See Photo 5) In these cases, the piles are broken at their connection to the pile cap, the concrete cover gone and the reinforcing exposed and corroded. On approximately eight other piles, cracking or spalling was noted and the reinforcing was exposed and corroded. With the exception of these piles, the remainder of the pier looked in excellent condition.

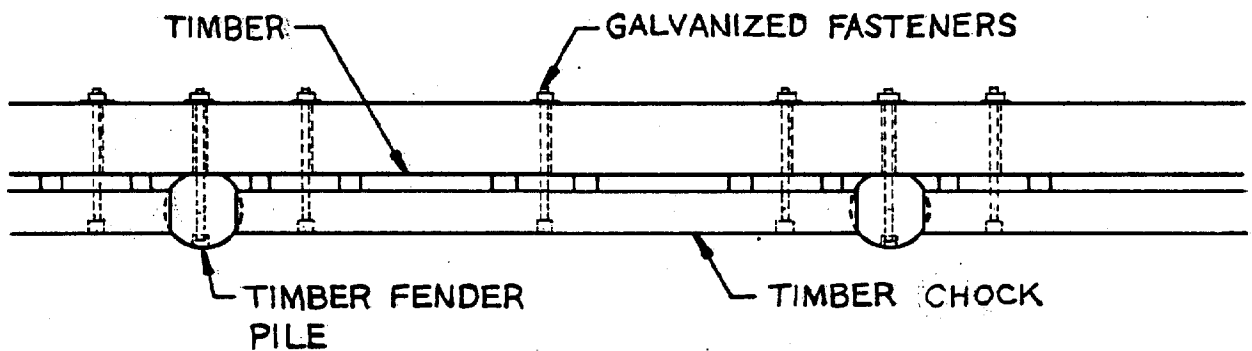
<b>MELVILLE CONDITION SURVEY</b>	
<b>TYPICAL FENDER SYSTEM &amp; SHEETPILE BULKHEAD</b>	
DATE	FIGURE NO.
MAY 1982	6

Sheetpile Bulkhead: The condition of the steel sheetpile bulkhead is typically poor. Figure No. 6 presents a typical section of the steel sheetpile bulkhead and concrete cap. The concrete curb topside has suffered moderate damage (cracking and spalling). In addition, the underside of the cantilevered deck slab shows signs of deterioration and stress (cracking and spalling). The fender system along the

bulkhead is almost non-existent and requires total replacement. Station 0+00 through 0+50 and station 3+50 through 5+75 were visually inspected during the diver inspection survey. Other bulkhead areas were blocked by berth vessels. The condition of the sheetpile bulkhead below water appeared to be fair with a light marine growth. Bottom conditions were somewhat steep at the base of the bulkhead with some light steel scrap scattered along the base of the bulkhead.

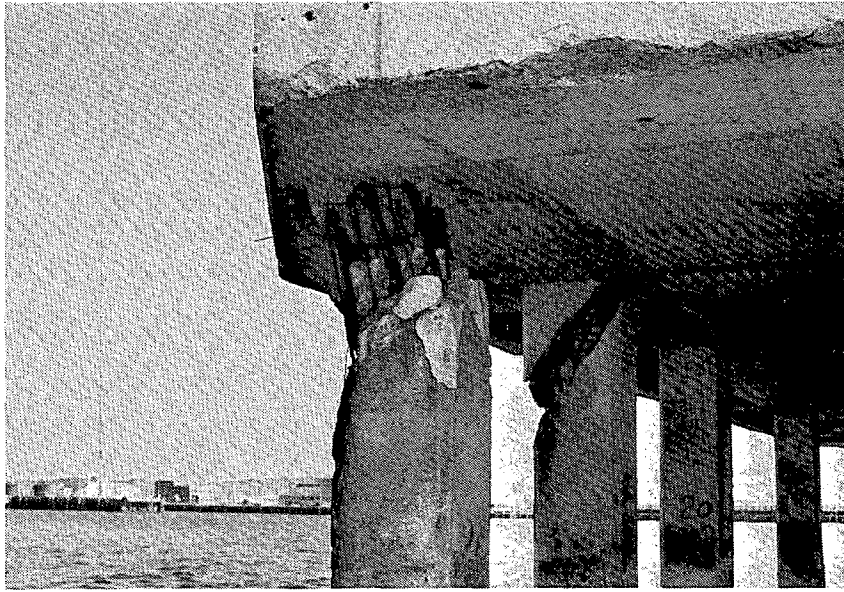
PHOTO 5 - DAMAGED CONCRETE PILES  
OF THE FBM PIER HEAD

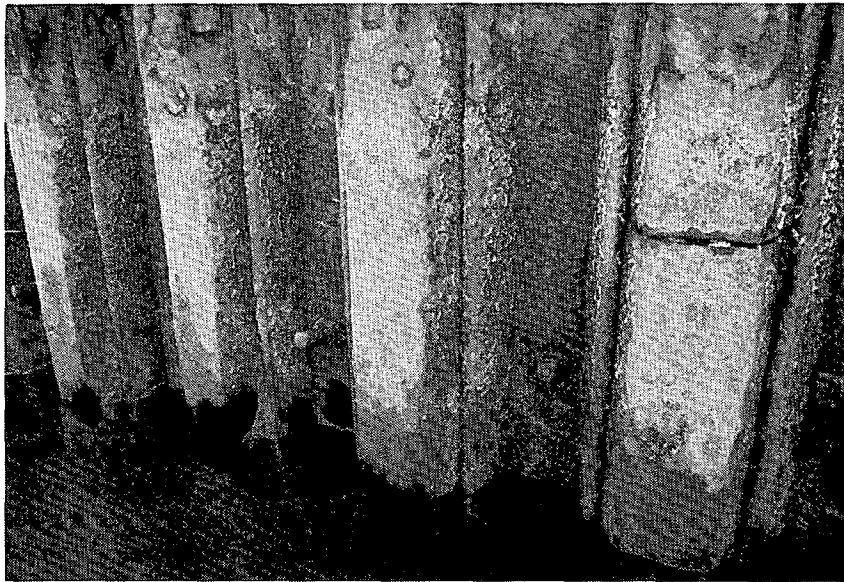
Inspection at the waterline (low tide) revealed a different set of conditions. The majority of the bulkhead exhibited advanced steel sheetpile deterioration with large holes in the outboard flange. See Photo 6. This common occurrence in older steel sheetpile bulkheads is caused by the continuous cyclic exposure to salt water and air (due to the continuous tidal fluctuations, wind and wave splash) which amplifies the oxidation (rusting) of the steel bulkhead. Deterioration of this type severely reduces the section modulus of the steel sheeting and therefore substantially reduces structural capability of the bulkhead. The few remaining fender piles revealed marine borer attack at the waterline. See photo 3.

PHOTO 6 - DETERIORATED STEEL SHEETPILE BULKHEAD  
NOTE HOLES AT THE WATERLINE  
(PHOTO TAKEN AT LOW TIDE)

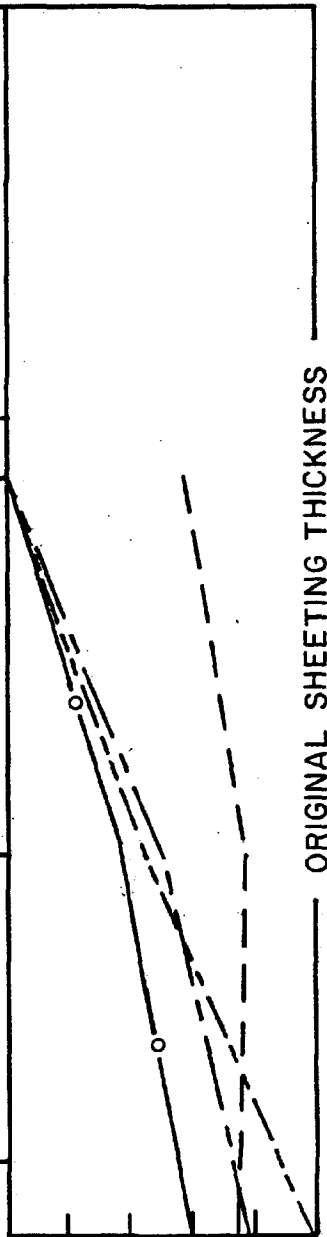
Ultrasonic testing was performed at several locations along the bulkhead. The test results and profile locations are shown in Figure No. 7. During preparation for the ultrasonic testing, the steel bulkhead was scraped of existing marine growth and rust. In addition, a thick layer of black tar-like material which was thought to be the original protective coating material was still intact at the lower elevations of

the bulkhead. The results of the testing revealed typical deterioration curves for coated steel in salt water. As shown in Figure No. 7 the most severe reduction of material (steel) was from elevation +6 to MLW, or what is called the splash zone. Thickness measurements taken at or near the mudline showed significantly less reduction of material thickness.

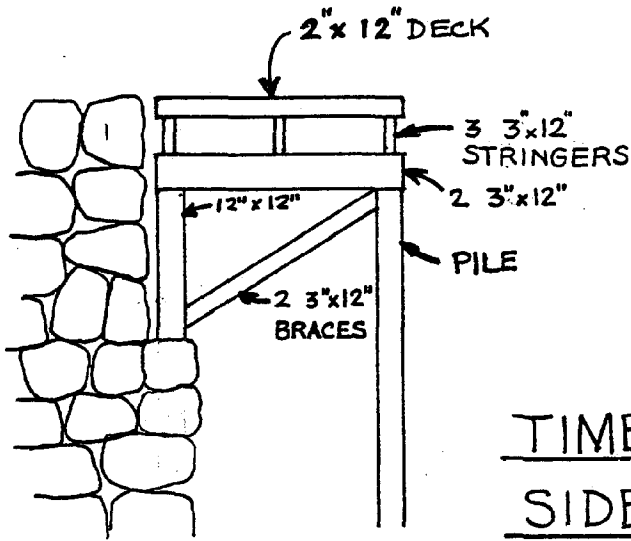
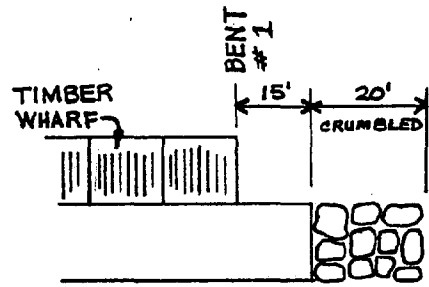
TIMBER DECK ON WEST  
SIDE (TYP.), STARTING  
AT NORTH END

<u>BENT #</u>	<u>PILE</u>	<u>VERT. 12x12</u>	<u>CAP</u>	<u>BRACES</u>	<u>STRINGERS</u>	<u>DECK</u>
1	ROTTED	GONE	GONE	GONE	GONE	GONE
2	ROTTED	GONE	GONE	GONE	GONE	GONE
3	✓	✓	✓	GONE	ROTTED	GONE
4	✓	✓	✓	✓	ROTTED	GONE
5	✓	ROTTED	✓	GONE	ROTTED	GONE
6	✓	ROTTED	✓	GONE	ROTTED	GONE
7	GONE	GONE	GONE	GONE	ROTTED	GONE
8		✓	✓	GONE	ROTTED	GONE
9	ROTTED	✓	✓	GONE	GONE	GONE
10	ROTTED	✓	ROTTED	ROTTED	ROTTED	ROTTED
11	✓	✓	✓	✓	ROTTED	GONE
12	✓	✓	✓	✓	ROTTED	GONE

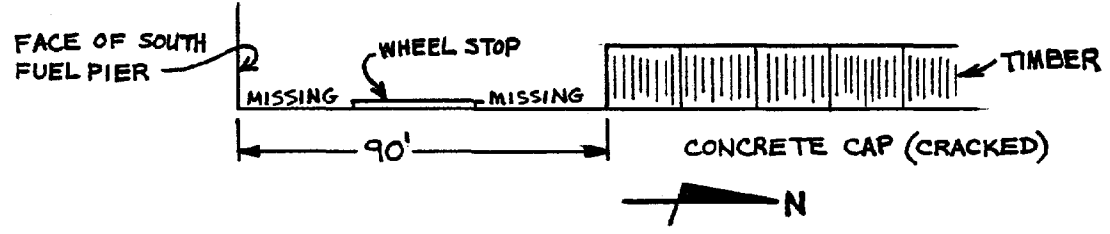
BENT#	PILE	VERT. 12x12	CAP	BRACES	STRINGERS	DECK
13	✓ FENDER PILE (ROTTED)	✓	✓	✓	ROTTED	GONE
14	ROTTED	✓	✓	GONE	ROTTED	GONE
15	ROTTED	✓	✓	GONE	ROTTED	GONE
16	✓ FENDER PILE ROTTED	ROTTED	✓	GONE	ROTTED	GONE
17	ROTTED	✓	✓	GONE	ROTTED	GONE
18	✓	✓	✓	GONE	ROTTED	GONE
19	ROTTED	✓	✓	GONE	ROTTED	GONE
20	ROTTED	ROTTED	✓	GONE	ROTTED	GONE
21	ROTTED	✓	✓	LOOSE	ROTTED	GONE
22	✓ FENDER PILE (ROTTED)	✓	✓	GONE	ROTTED	GONE
23	✓	✓	✓	✓	ROTTED	GONE
24	✓	✓	✓	✓	ROTTED	GONE
25	ROTTED	✓	✓	✓	ROTTED	GONE
26	✓	✓	✓	✓	ROTTED	GONE
27	✓	✓	✓	GONE	ROTTED	GONE
28	ROTTED	✓	✓	✓	ROTTED	GONE
29	ROTTED FENDER PILE	✓	✓	GONE	ROTTED	ROTTED
30	ROTTED & DISLODGED	✓	✓	✓	ROTTED	ROTTED
31	✓	ROTTED	✓	GONE	ROTTED	GONE

REMNANTS OLD FENDER SYSTEM

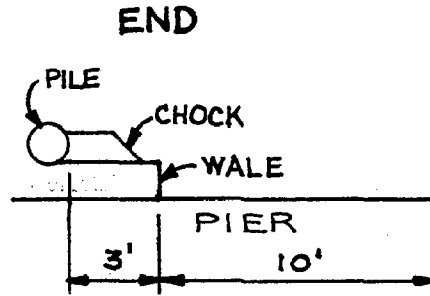
<u>FENDER #</u>	<u>PILE</u>	<u>CHOCK</u>	<u>WALE</u>
35	MISSING	ROTTED	✓
36	ROTTED @ TOP	✓	✓
37	MISSING (LEANING AGAINST 38)	✓	✓
38	ROTTED @ TOP

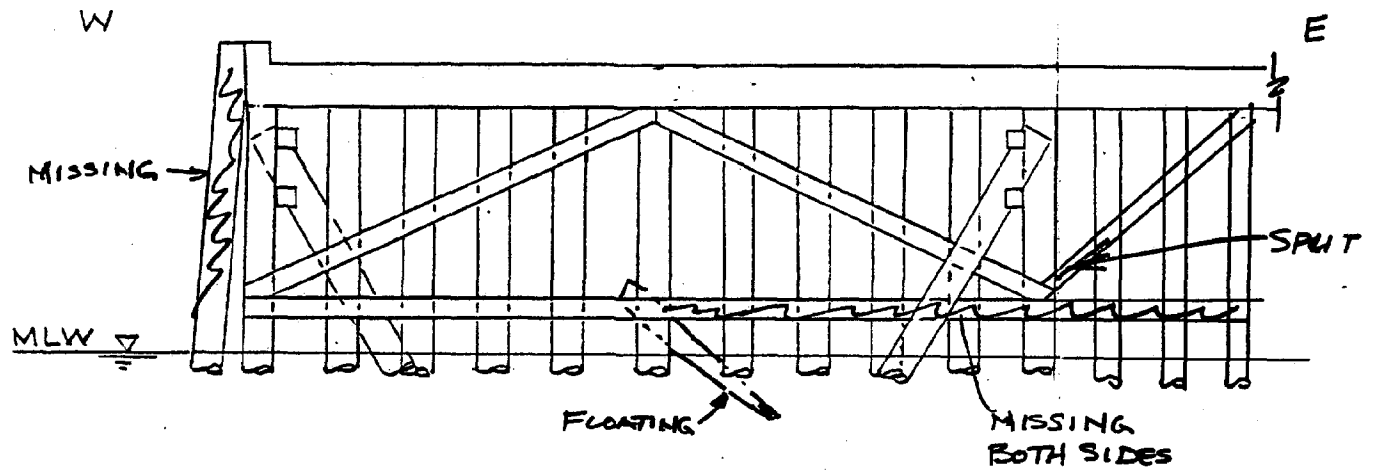
BENT NO. 43

CHOCK BETWEEN FBM PIER & FENDER PILE MISSING

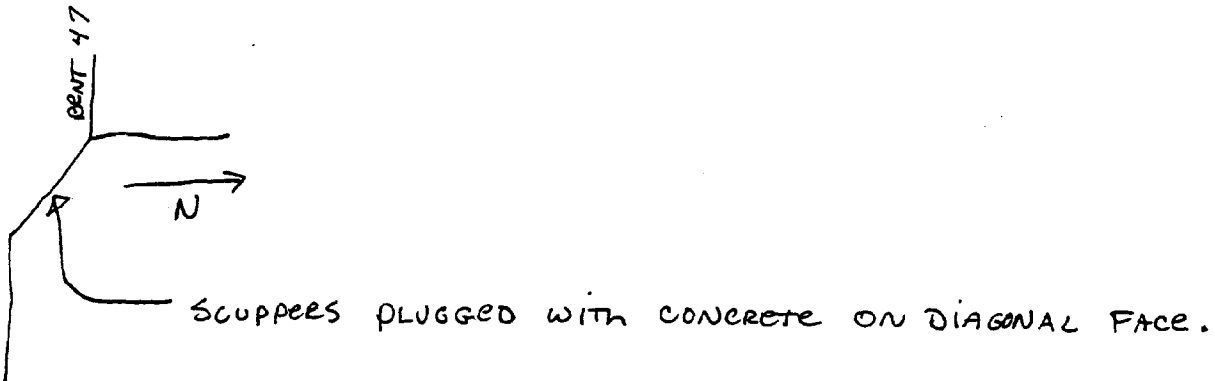
NOTE SCUPPERS ON WEST FACE OF PIER ARE PLUGGED WITH CONCRETE  
PILES SPLITTING ON FACE @ H.T.

END OF DIAGONAL START OF NORMAL BENTS

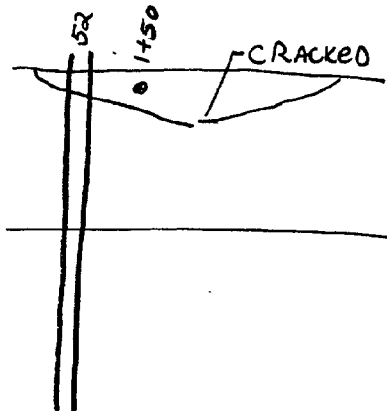
WEST FACE OF  
CONCRETE

SCUPPERS PLUGGED EAST FACE  
STA 1+50 TO 2+00

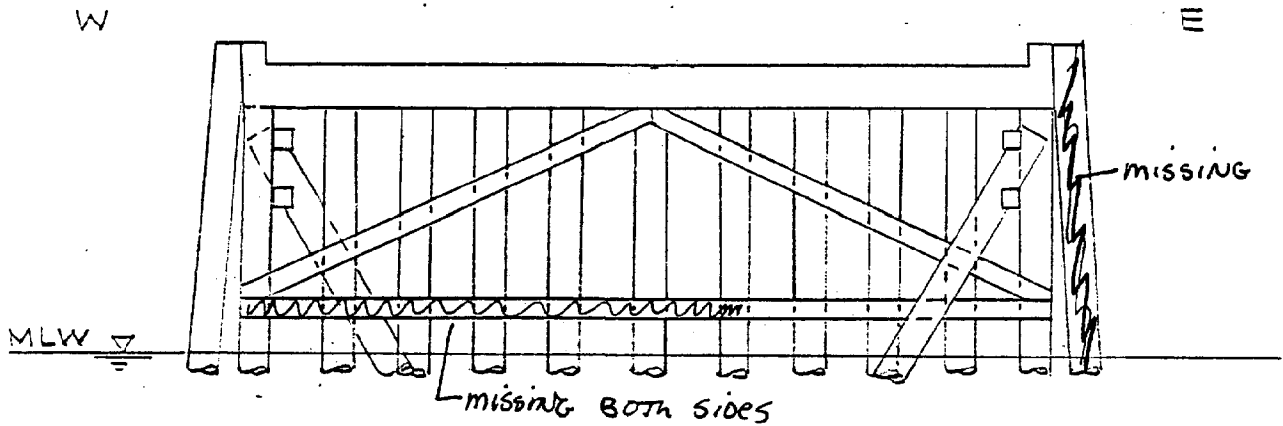
BENT NO. 57

CHOCK BETWEEN 55 & 56 ROTTED

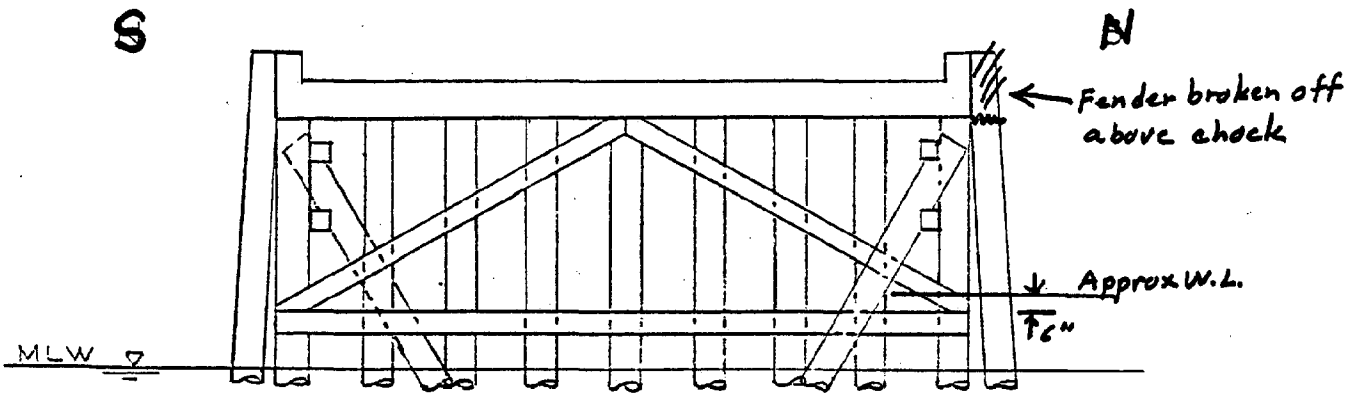
BENT NO. 1

ABUTMENT: Granite block courses (no mortar)  
 Blocks approx 33" high. One course above high tide then cone abutment to deck.  
 Condition good. Vertical crack in cone

Concrete Cap with steel form. Steel completely rusted away (Typ all bents)

Timber piles bear against cone cap. Not embedded. No sign of positive connection. (Typ all bents)

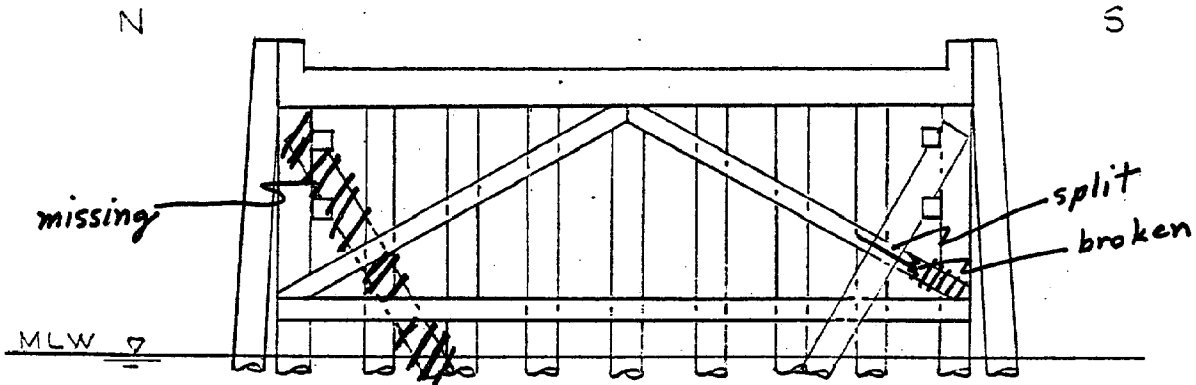
BENT NO. 2

*Piles show minor splintering in splash zone on face only. Probe with knife had little penetration (typical, except as noted, all bents)*

*Probed bracing with knife. Timber was solid. little penetration of knife. (Typical, except as noted)*

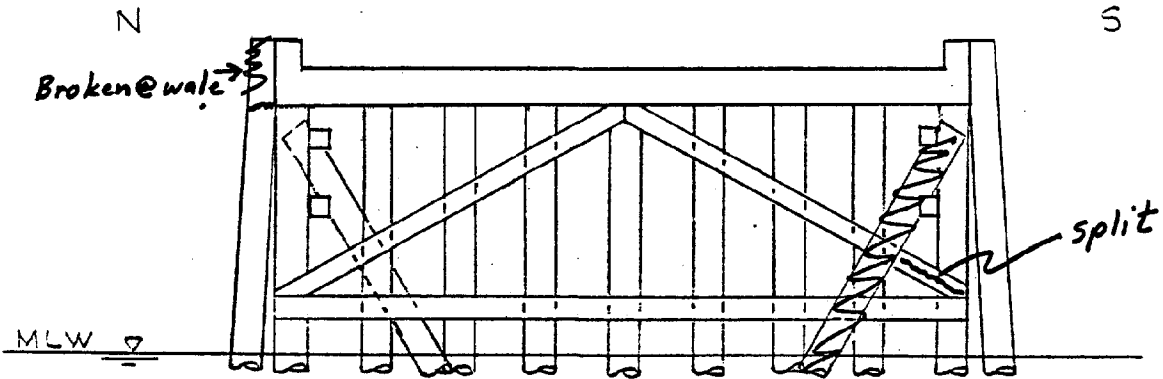
BENT NO. 7

Underside of conc deck looks good. Very little spalling, minor cracking (Typical except as noted)

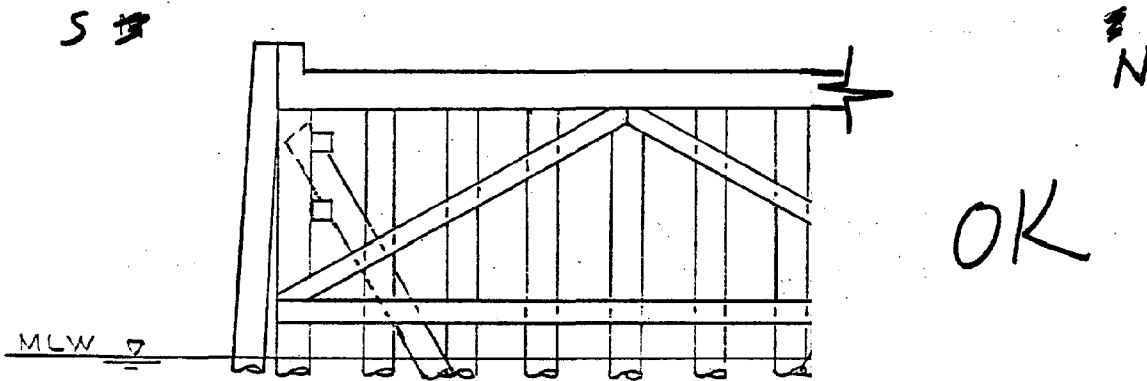
BENT NO. 36

Corner cluster split above wale. Cables loose. Piles wormy at W.L.

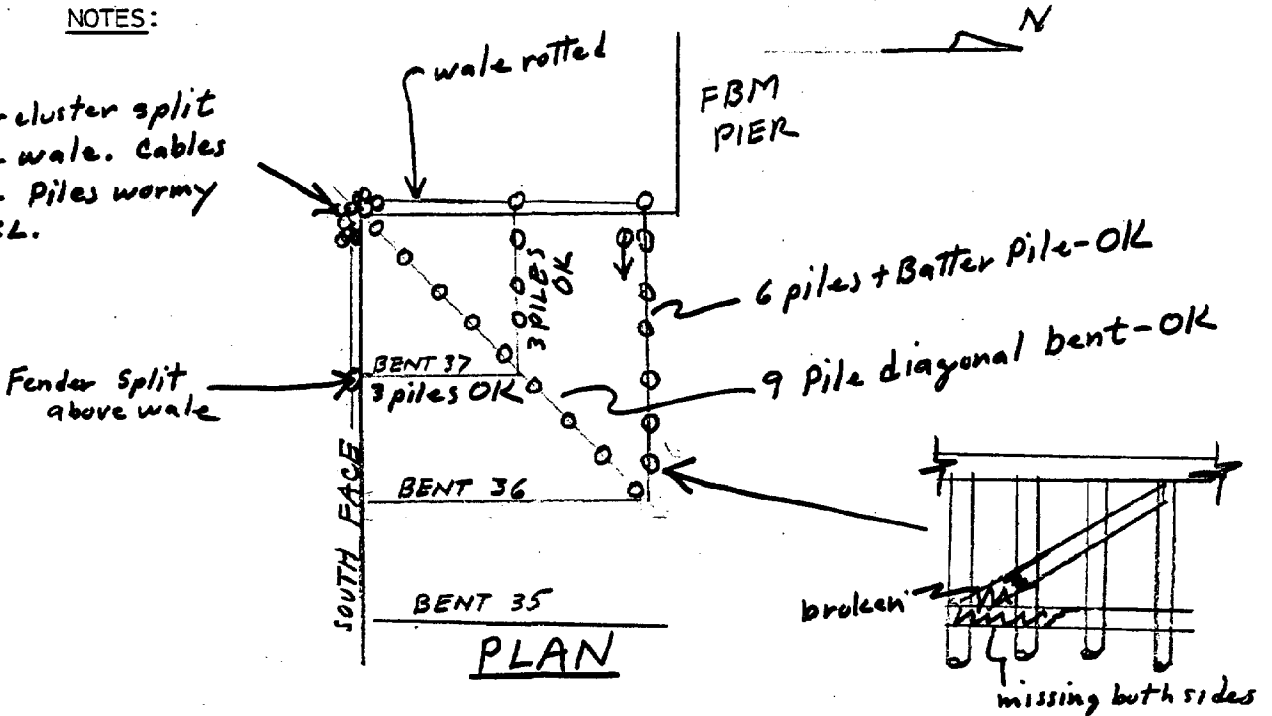
PROJECT MELVILLE CONDITION SURVEY  
SUBJECT FBM PIER

No batter piles bent 1  
Piles are 18"  $\square$  conc piles

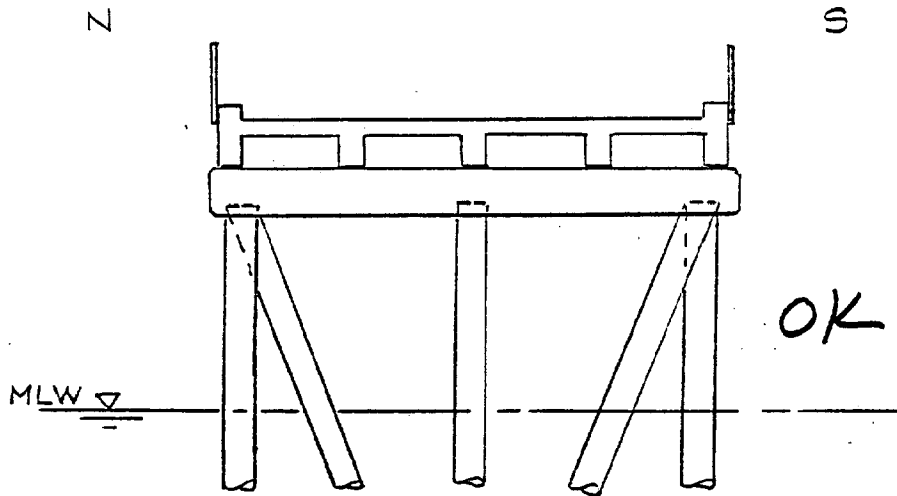
BENT NO.'S 30 Thru 32

Note: Light pole base bent 30. Pole missing

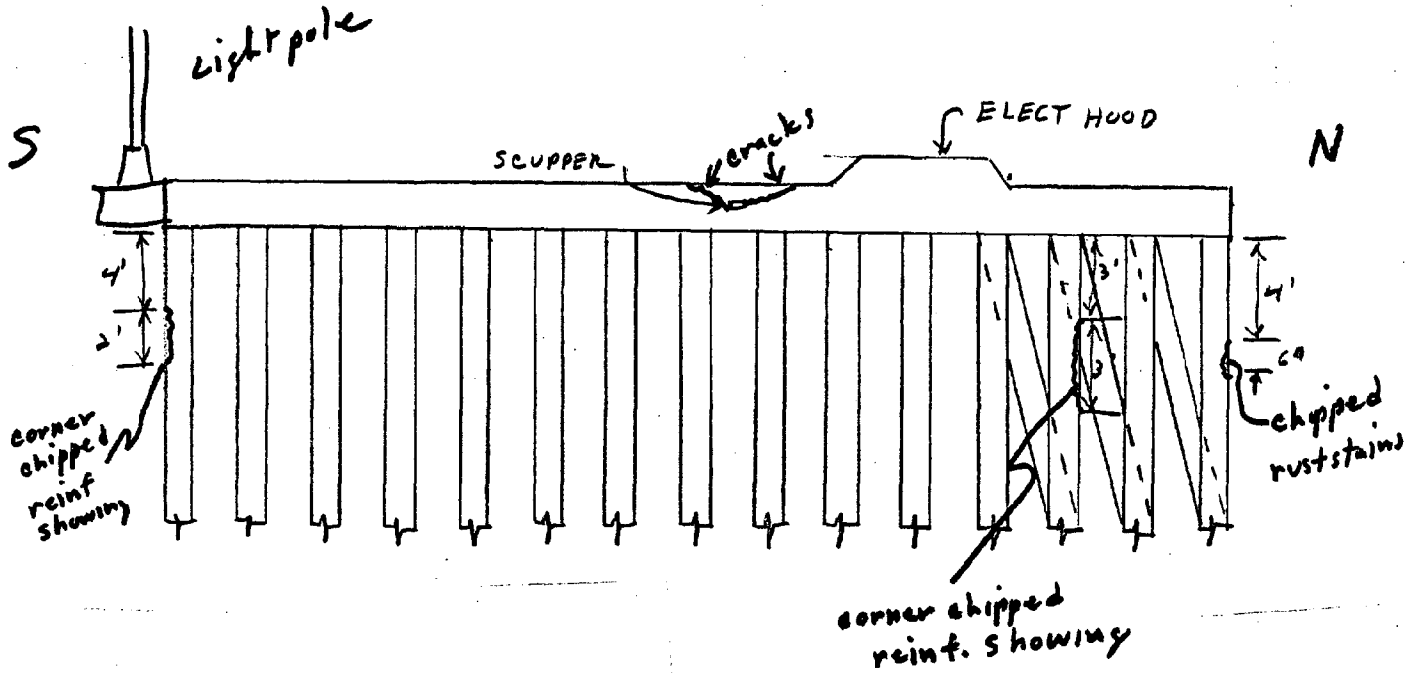
BENT NO. 60

damaged see next sh

vert piles

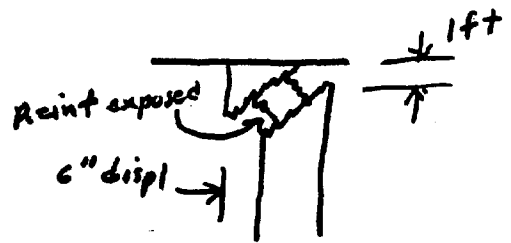
Pile Between Bents 63 & 64  
North Side  
(See previous sheet)

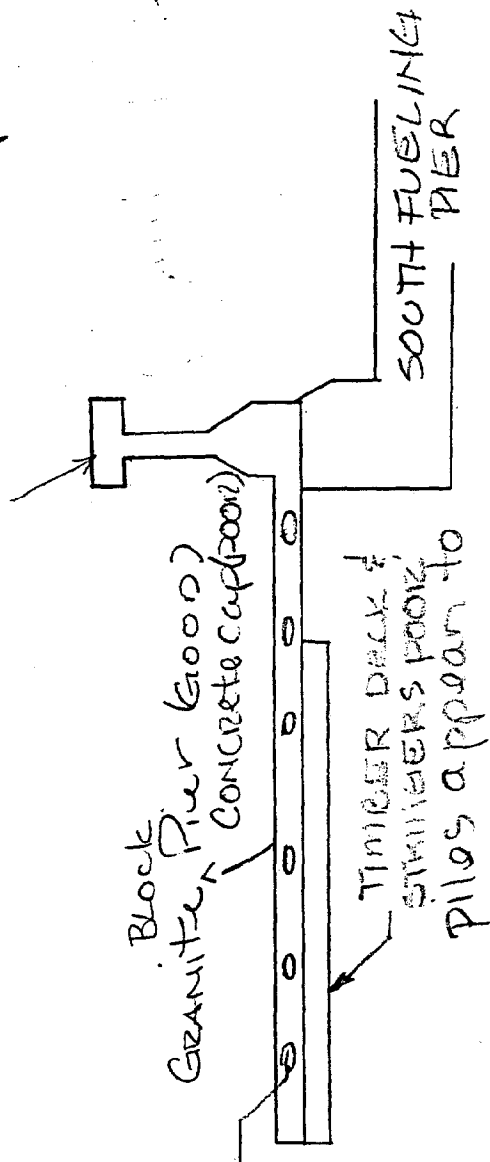
Granite pier (poor)  
 NUMEROUS MIS PLACED GRANITE  
 BLOCKS - NO CONCRETE CAP

Block Granite Pier (poor)  
 Concrete cap (poor)
