Preliminary Report:
Archeological and Engineering Expedition
Monitor Marine Sanctuary

August 1-26, 1979

U.S. National Oceanic and Atmospheric Administration
Office of Coastal Zone Management

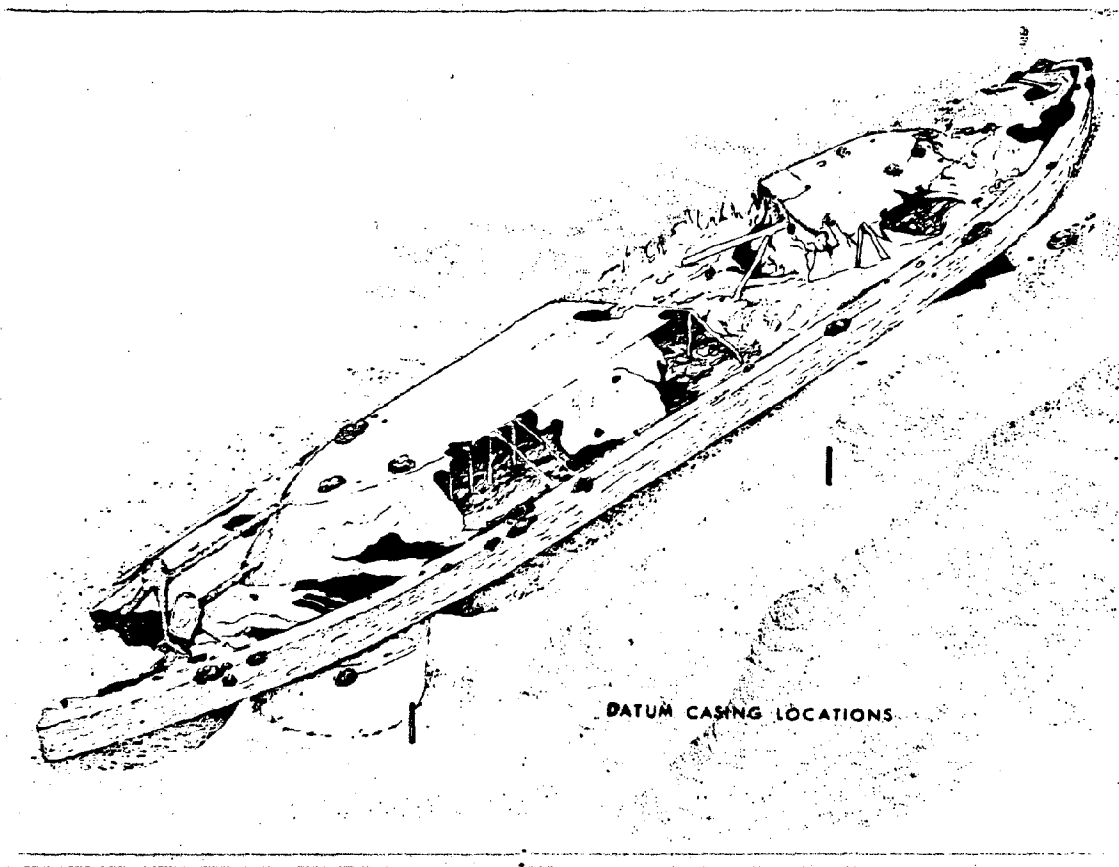
Figure 1.

The project began on August 1, 1979, with a non-lockout reconnaissance dive to examine the site. In the afternoon the first lockout was made to locate a positioning harness for the baseline datum stations and jet the first casing into the sediment adjacent to the amidships bulkhead. An electrically powered water pump mounted on the bow of the submersible provided water pressure sufficient to jet the first casing into a position identified by the harness. A leveling collar attached to the 3 inch casing provided the control necessary to assure a vertical orientation. While the first and second datum casings were easily jetted into the sediment to a depth of 5 feet, the remaining two located forward of the amidships bulkhead proved to be more difficult. At a depth of 3 feet an extremely compact stratum of sediment frustrated efforts to sink casings to the desired 5-foot depth. During the course of the project both of the forward casings were dislodged by the current. While it is possible that the stratum represents a natural formation, the discharge of calcareous material and black oxide from the casing indicated that the layer may be related to material associated with the Monitor (Figure 1).

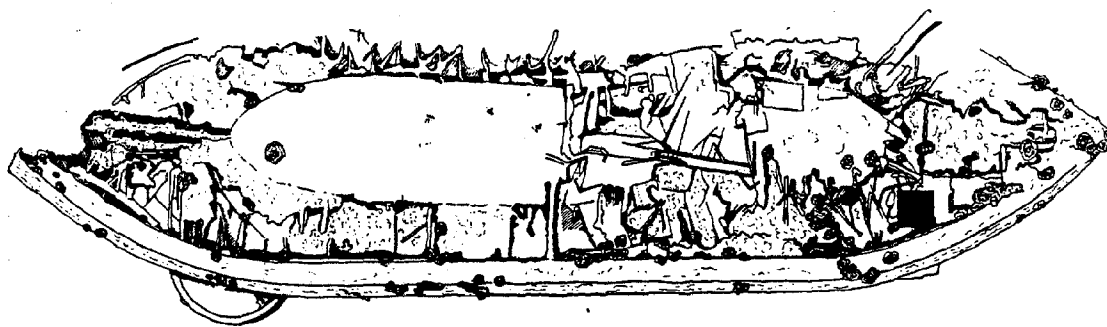
Figure 2.

inboard of the armor belt had been tentatively selected based upon an analysis of photographs taken from the ALCOA SEAPROBE in 1974 and the JOHNSON SEAL-LINK II in 1977. The reconnaissance confirmed the first choice as the best locations for an excavation (Figure 2). With the exception of a small area adjacent to the armor belt in the vicinity of the pilot house, most of the wreck is covered by large fragments of plating from the lower hull.

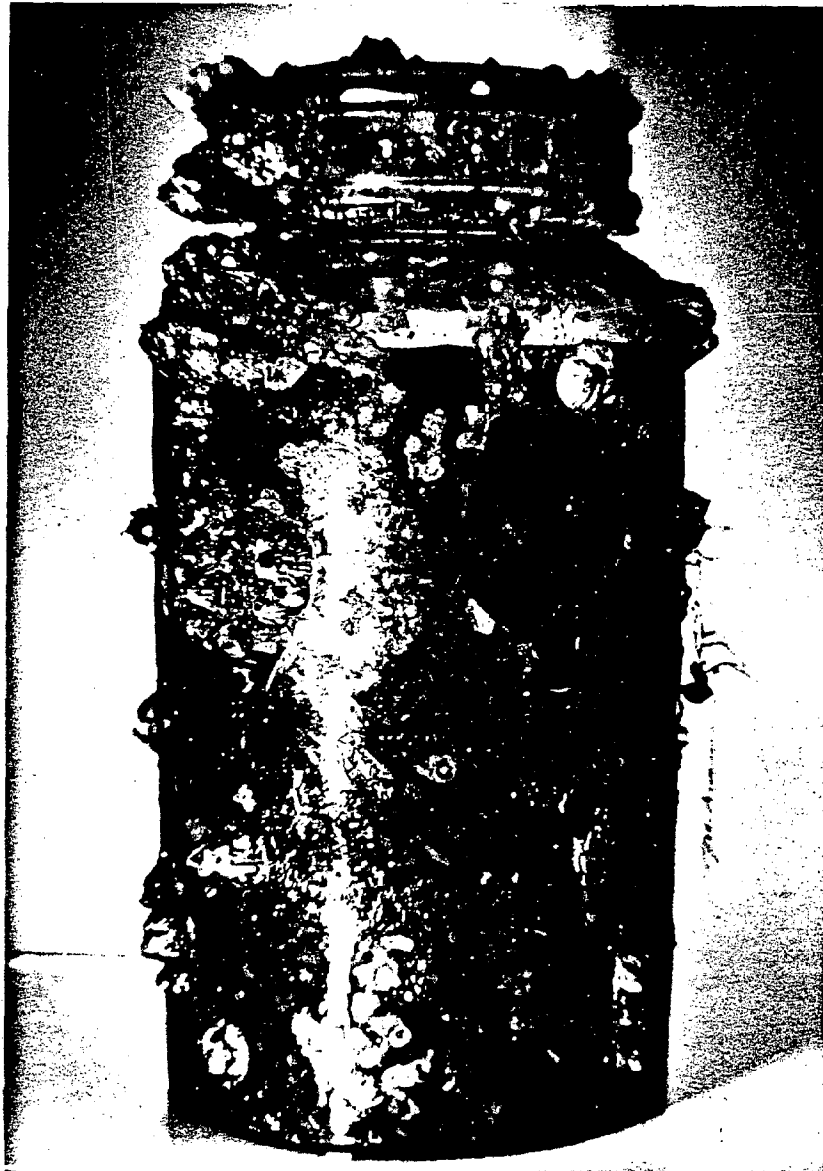
Analysis of the strata exposed during the test excavation revealed that the upper layer of the sediment was composed of sand and coarse shell hash. Modern debris found at the lowest level of this stratum confirmed that there has been considerable activity in the upper layer of sediment. At a depth of approximately 14 inches a transitional zone was identified. It consisted of larger shell and barnacle remains interspersed in sandy mud. With the exception of calcareous encrustations that had formed around the deteriorating remains of the vessel, no material associated with the ship was found in this stratum. Below this the sediment was composed of a very fine mud and silt that had come out of suspension in the water column. This stratum covered the structural remains of the deck and contained extensive fragments of non-structural wood bulkheads, cabinetry, and storage containers. All of the artifacts recovered during the project associated with the MONITOR, with the exception of a glass "U.S.S. NAVY/MUSTARD" bottle found on the surface of the grid area, were found in this layer. Immediately above the deck beams and planks, fragments of foul weather apparel, book binding, a ceramic soap dish, English walnuts, and a brass thimble were recovered. Although teredo damage to the wood was found to be extensive, the surfaces of deck beams and planks were crisp and undamaged, preserving all of the surface detail (Figure 6).

Figure 6. "Hartwell's Glass Jar Patented 1858, Guaranteed Air-Tight" was found to contain exceptionally well preserved relish that still retained its aroma.
