# GREEN CAY GUT HEADCUT STABILIZATION PROJECT Final Report

114-H Green Cay  
St. Croix East End, USVI

August 2017

## Purpose

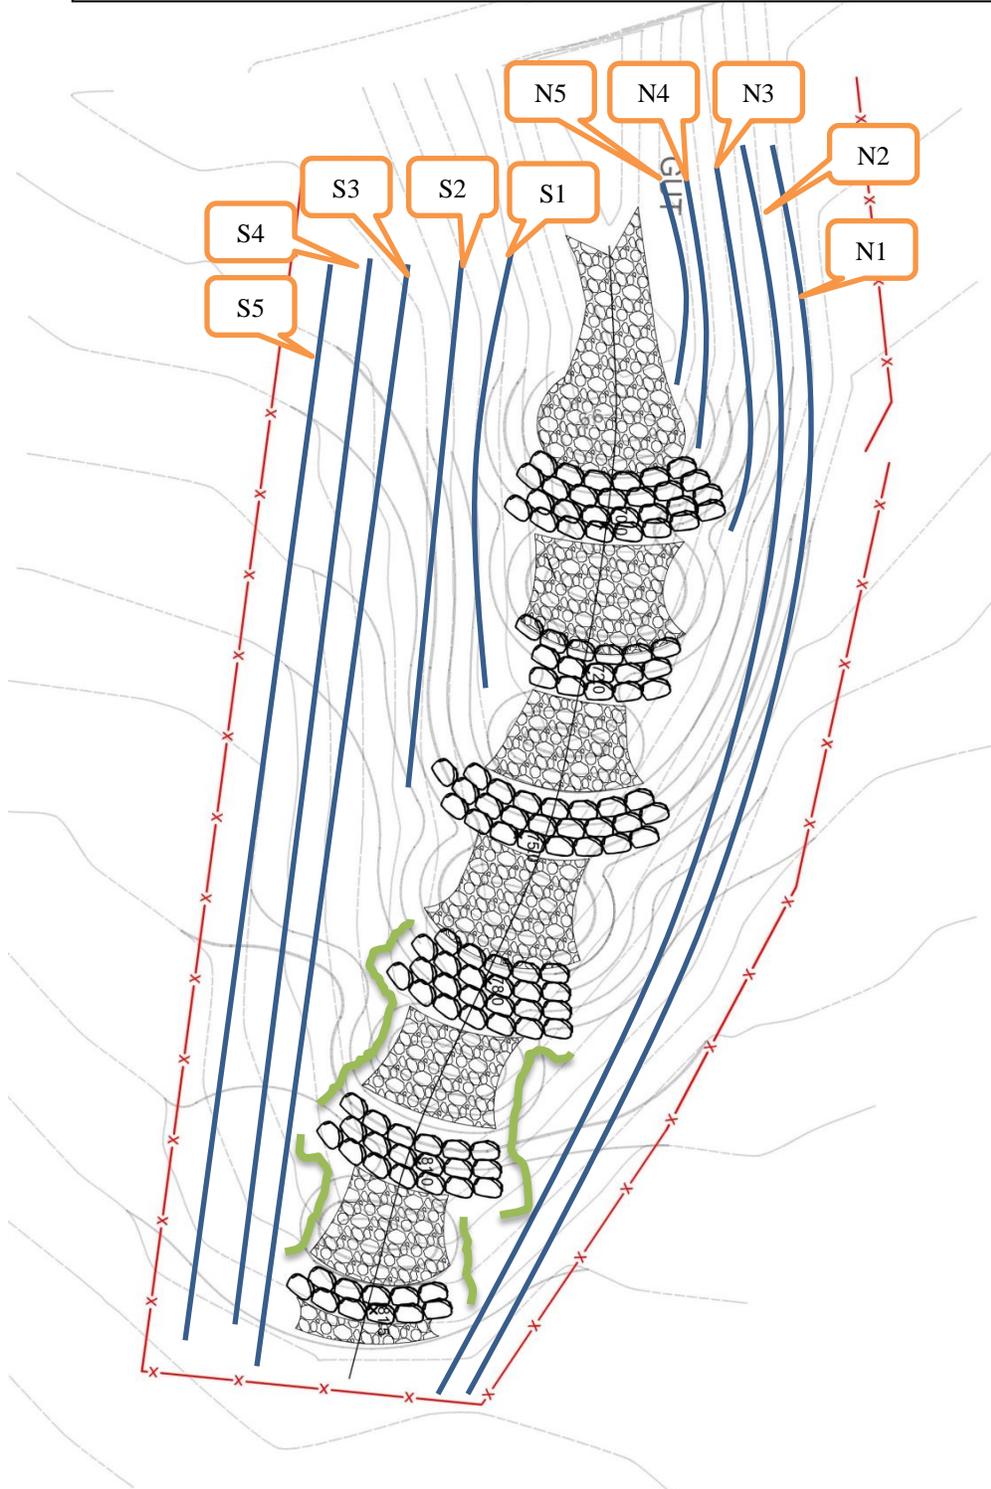
**Figure 1. Location and orientation of the 10 transects on which plants were established and Green Cay. Grasses for erosion prevention are depicted in green**

Native woody plants in one-gallon pots and extra-large grass plugs were established in linear transects on the North and South banks of the stream after construction. A mixture of grasses and native trees, shrubs and, vines was utilized in each transect. Plants were spaced at approximately 6 feet on center within rows. Rows are also spaced approximately 6 feet apart. There are 10 transects in total, oriented along the contour of the sloped banks. The transect locations are depicted in Figure 1. The number of plants in each transect is described in Table 2.

A variety of grasses was also planted. The 214 grass plugs have been effective in mitigating soil erosion. The grasses were installed within the rows described in Table 2, as well as erosion prone portions of the site. Large bunch grasses like guinea grass and stiff leaf Eustachy's grass were planted within the transects with the small trees and vines. Zoysia grass and other species were concentrated in areas most prone to soil erosion (Table 1 describes the quantities of grass plugs planted, by species). In particular, the upland portion of the site on the east side had areas of uneven terrain on relatively steep slopes. We planted the majority of our 4" grass plugs in this area because it could not easily be covered with erosion matting. The location of the grass plugs is depicted in Figure 1 with a broad green line.

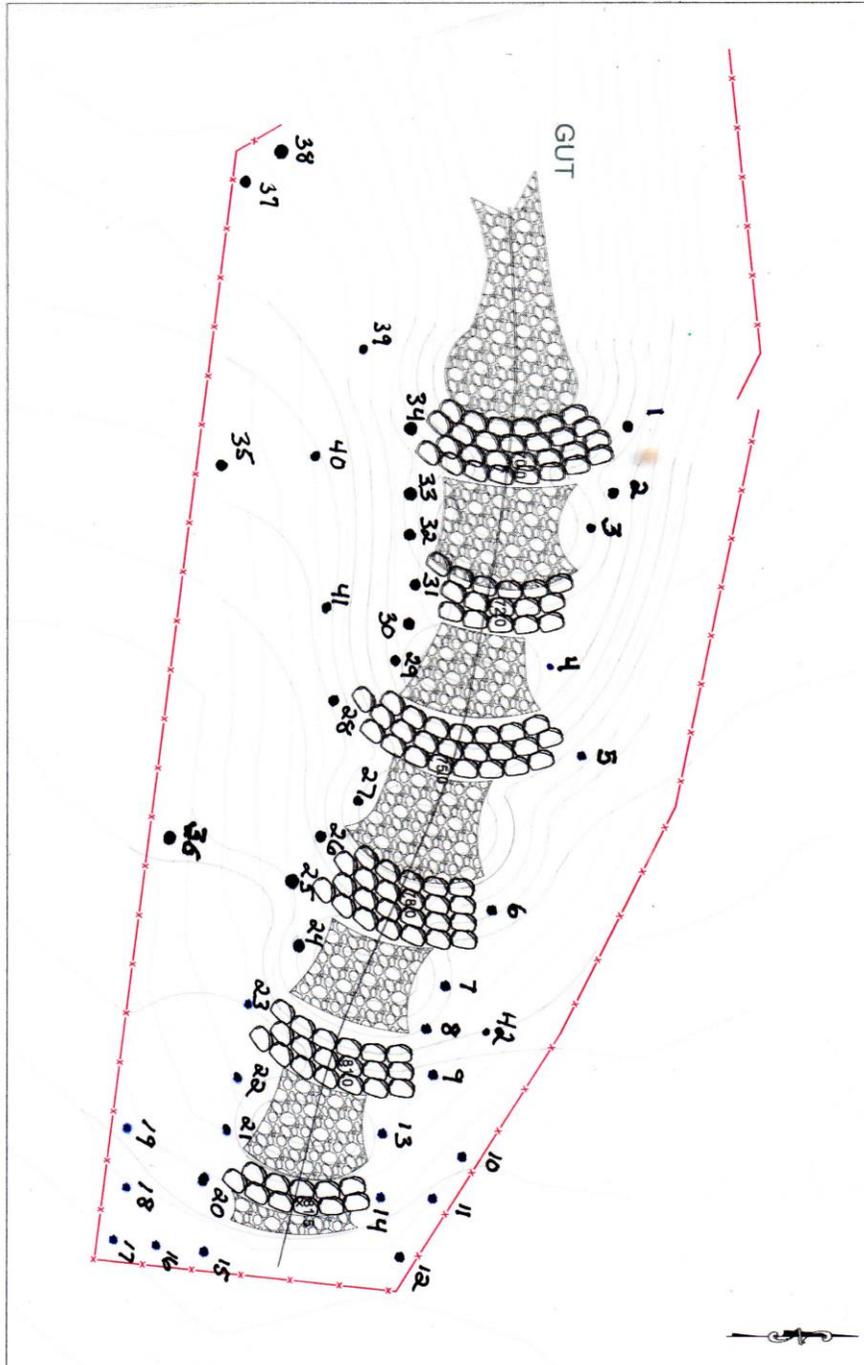
Figure 2 Locations of large plants in 3 gallon pots or greater. The numbers correspond with table 4

**Table 4 Plant number and species for the large plants installed at Green Cay. These numbers correspond to the numbers in the map in Figure 2.**
