# **SHORE EROSION STUDY**

SHORELINE EROSION AND BLUFF STABILITY ALONG LAKE MICHIGAN  
AND LAKE SUPERIOR SHORELINES OF WISCONSIN

### **RACINE COUNTY**

**FEBRUARY 1977**

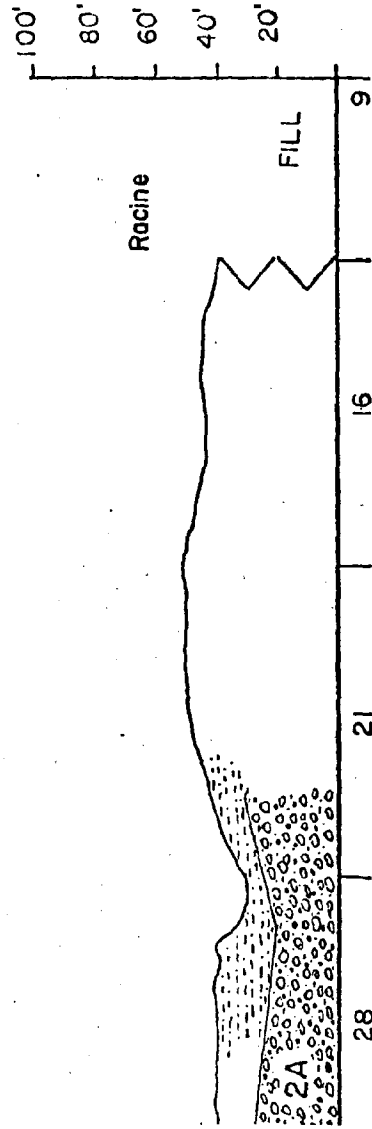
Generalized longitudinal section showing bluff stratigraphy in Reach 4. Numbers along base of diagram are geographic (1 mile) sections.

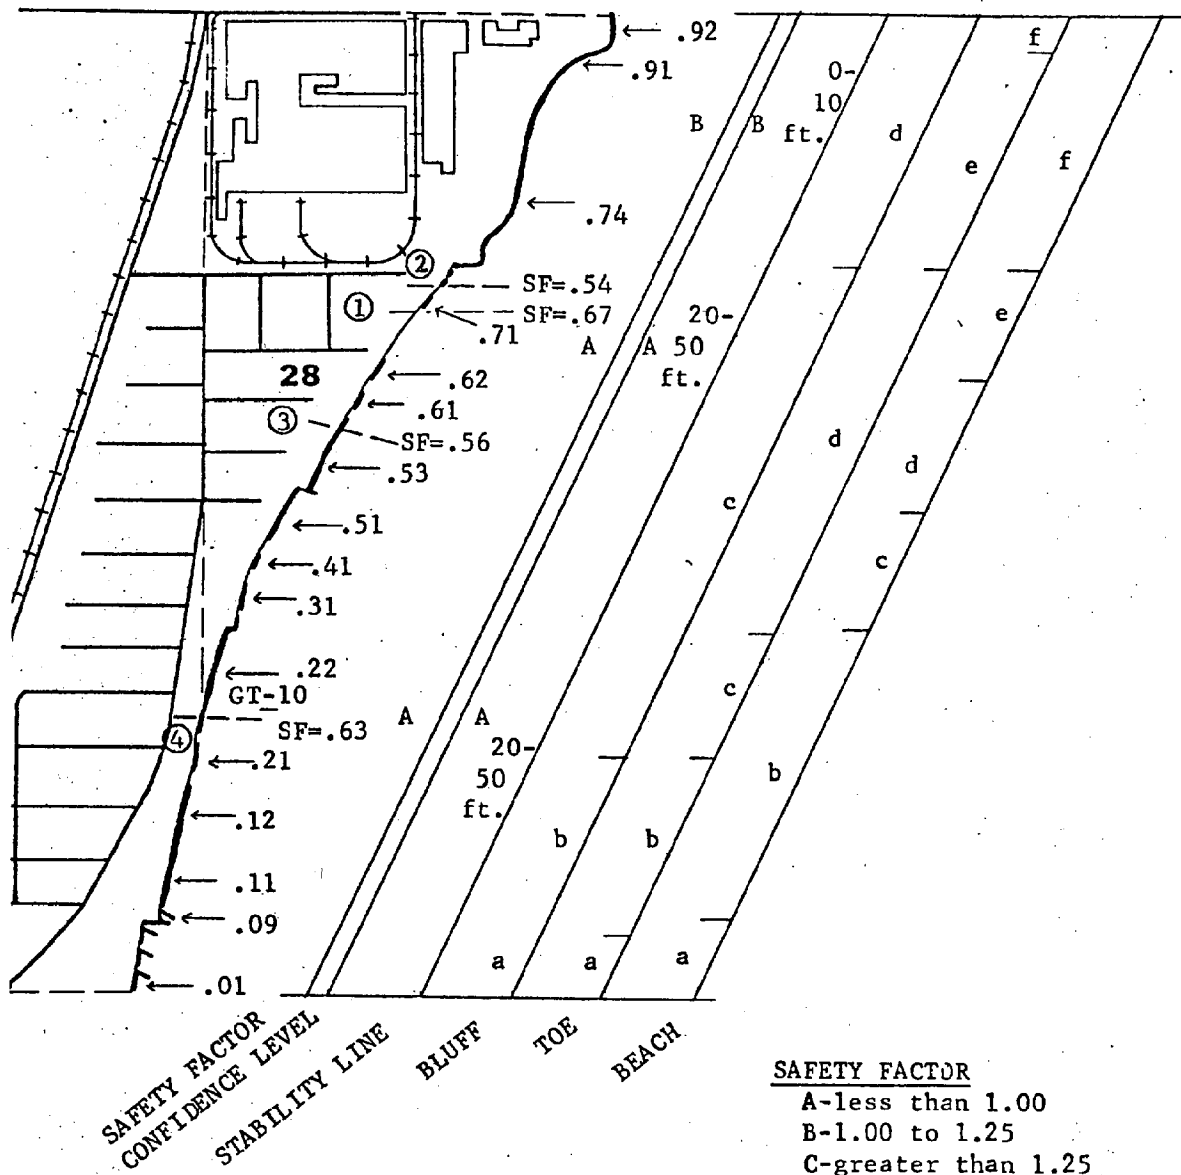
**T. 3 N., R.23 E., Sec. 28**

1. BLUFF	a-failure by slump	b-bluff consists of recent artificial fill	c-serious slope failure caused by slump, debris flow; also by the erosion, surface water coming over top of bluff, water issuing from seep zones in silt and sands above till. Foundations undercut and exposed. Scalloped bluff margin, slump scarps at top of bluff.	d-artificial fill; slope in back of revetment is vegetated and appears stabilized.

2. TOE	a-natural toe material is till, covered in most places by slump or artificial fill debris.	b-toe material consists mostly of artificial fill and debris dumped over top of bluff (broken concrete, slag, iron, bicycles, kitchen sinks)	c-dolomite blocks (revetment), with till behind	d-natural toe material is clayey till, till covered in many places by slag (at northern end), broken concrete, dolomite blocks and various types of debris
	e-dolomite blocks (revetment)	f-sheet-steel piling (bulkhead)

3. BEACH	a-0 to 5 ft., cobbles and pebbles	b-5 to 10 ft., pebbles and cobbles	c-no beach	d-0 to 8 ft., gravel, broken concrete, stone, wood, junk
	e-5 to 10 ft., beach is gravel, slag, bricks, junk and iron	f-no beach less than 5 ft., slag, pebbles, junk

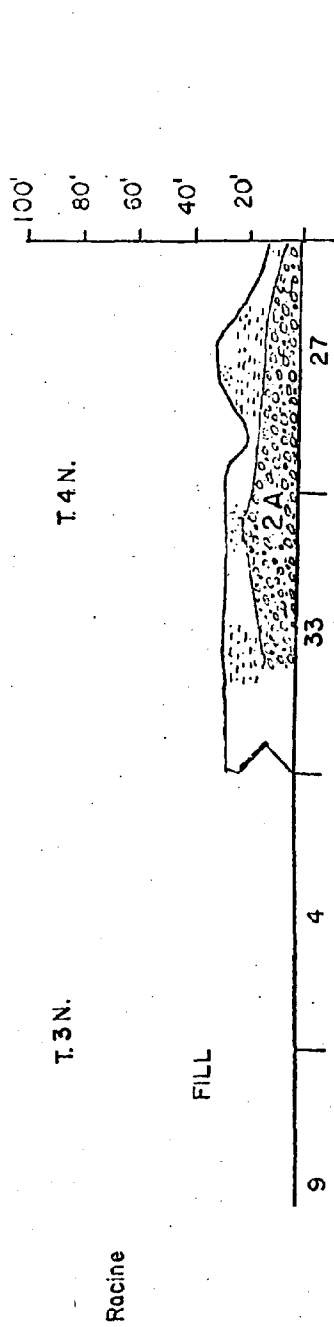
Generalized longitudinal section showing bluff stratigraphy in Reach 5. Numbers along base of diagram are geographic (1 mile) sections.

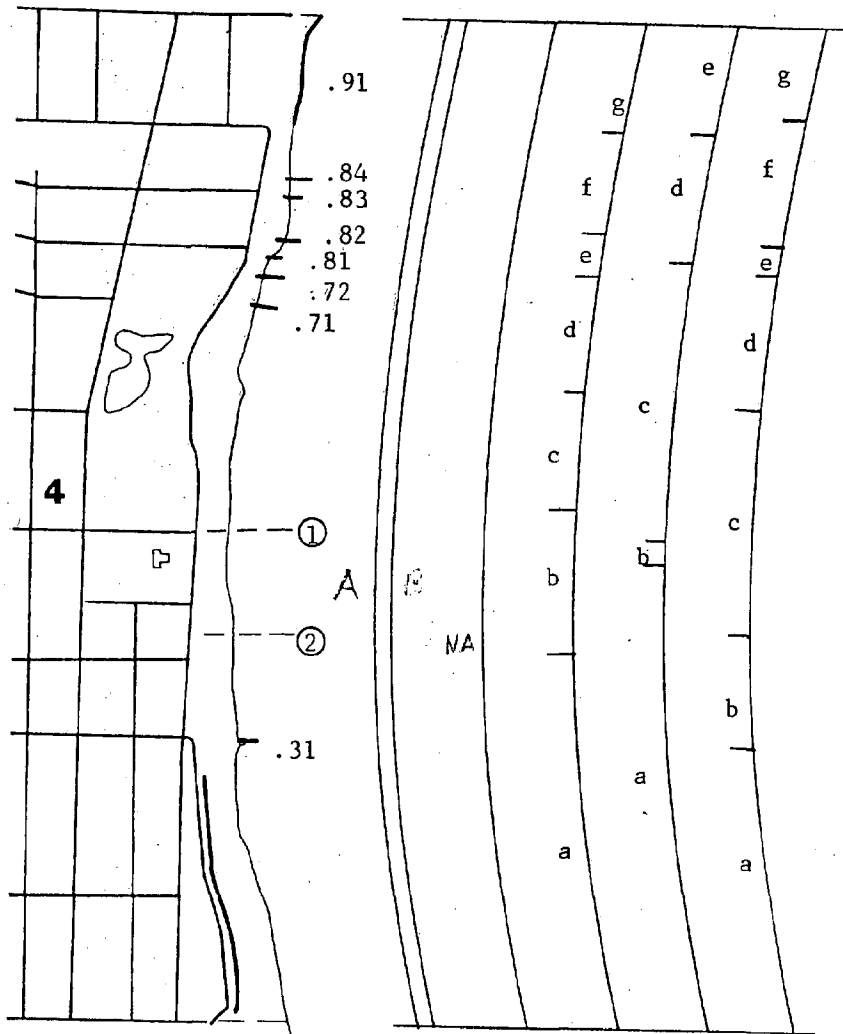
T. 3 N., R. 23 E., Sec. 4

1. BLUFF	a-bluff is fairly stable and concealed with vegetation	b-some slumping but not significant	c-concealed	d-fairly stable, vegetated
	e-slump, wave erosion of toe	f-fairly stable and concealed by vegetation	g-primary fill slumping, wave erosion of bluff, 30 ft.	
2. TOE	a-mostly sand where observable, dune formation in this area	b-some fill visible	c-concealed	d-mostly concealed, some gravel, till, fill visible
	e-till, filled materials			
3. BEACH	a-much accretion, 150 to 250 ft. sand beach	b-dunes, 150 ft. of sand	c-beach increases 25 to 150 ft. southward from structure 519	d-15 to 25 ft. sand
	e-no beach	f-37 ft. sand and gravel at north; widens southward	g-beach less than 5 ft., gravel

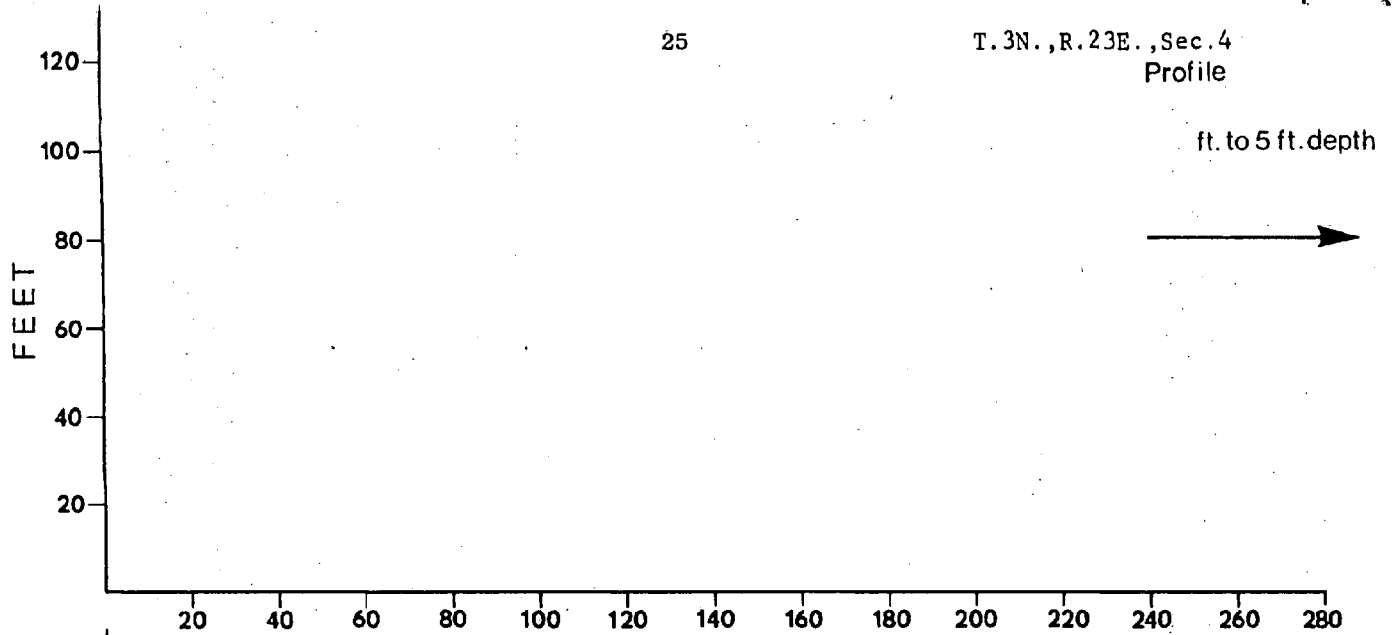
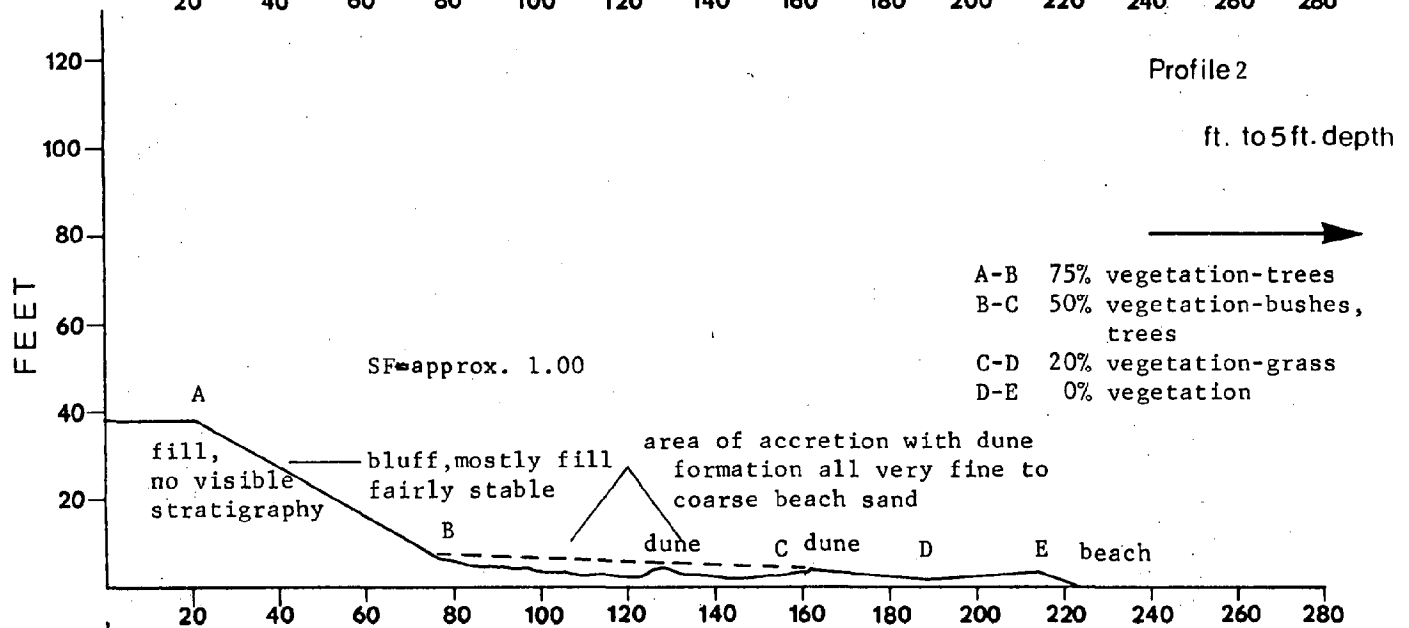
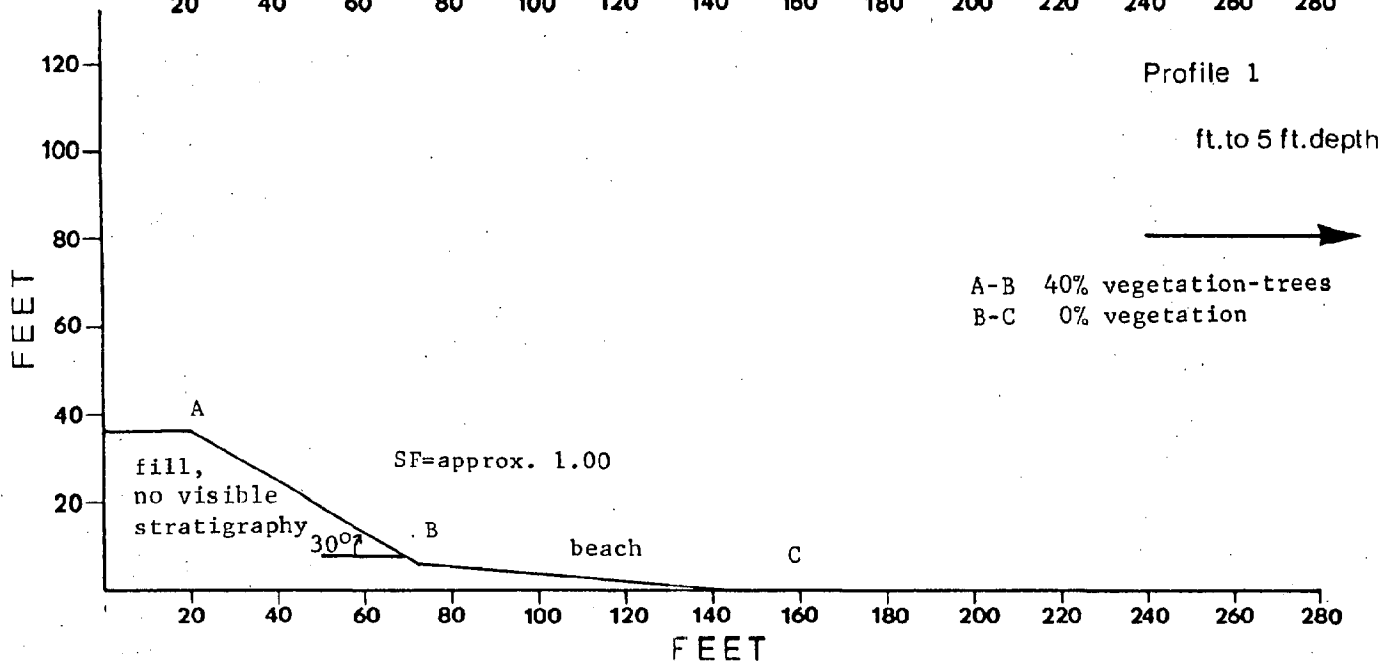
Much of the bluff is covered by vegetation, and in many places it is composed of artificial fill (see profiles 1 and 2, section 4). Where they are exposed, the natural sediments consist of calcareous gray (where unoxidized) or tan (where oxidized) silty clay till overlain by lacustrine deposits (see profiles 1, 2, and 3, section 27 and profile 1, section 33). At several places a thin layer of water-bearing sand or sand and fine gravel occurs slightly above mid-bluff height, between the till and pinkish-brown lake clay (see profiles 1, 2, and 3, section 27). Water seeping from this horizon, and also from other zones within the lacustrine beds, are undoubtedly a major cause of slope failure involving slump.

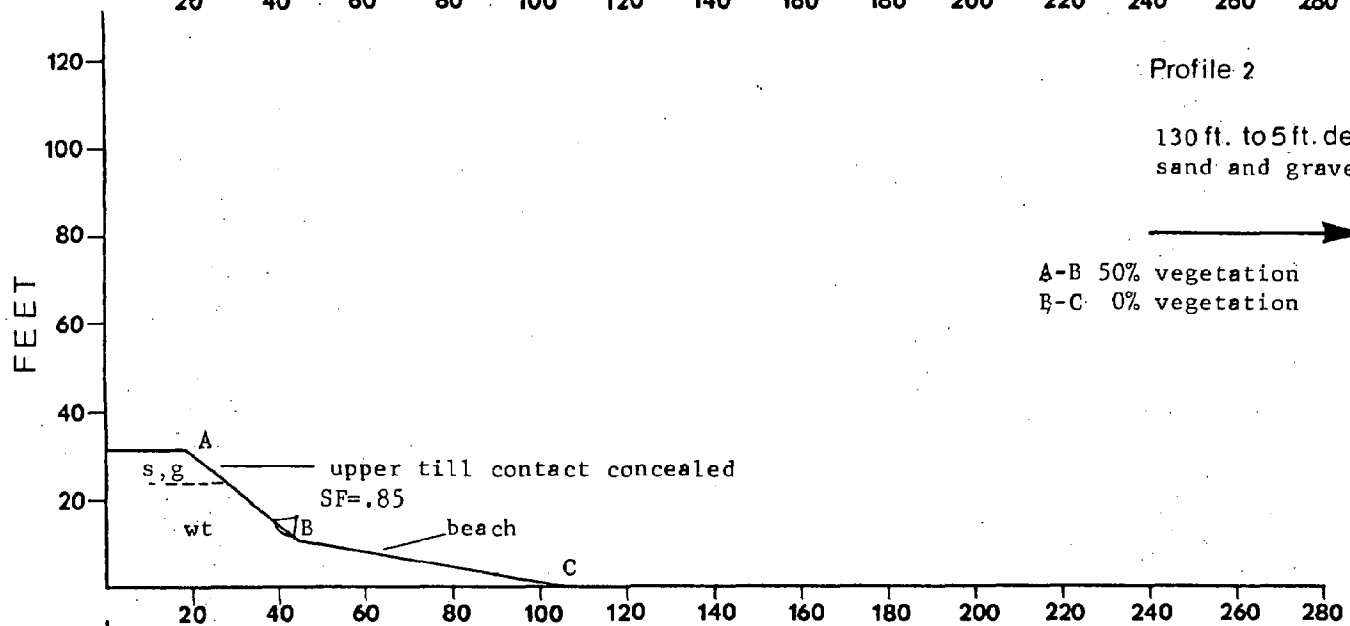
Profile 2

A-B 50% vegetation  
B-C 0% vegetation

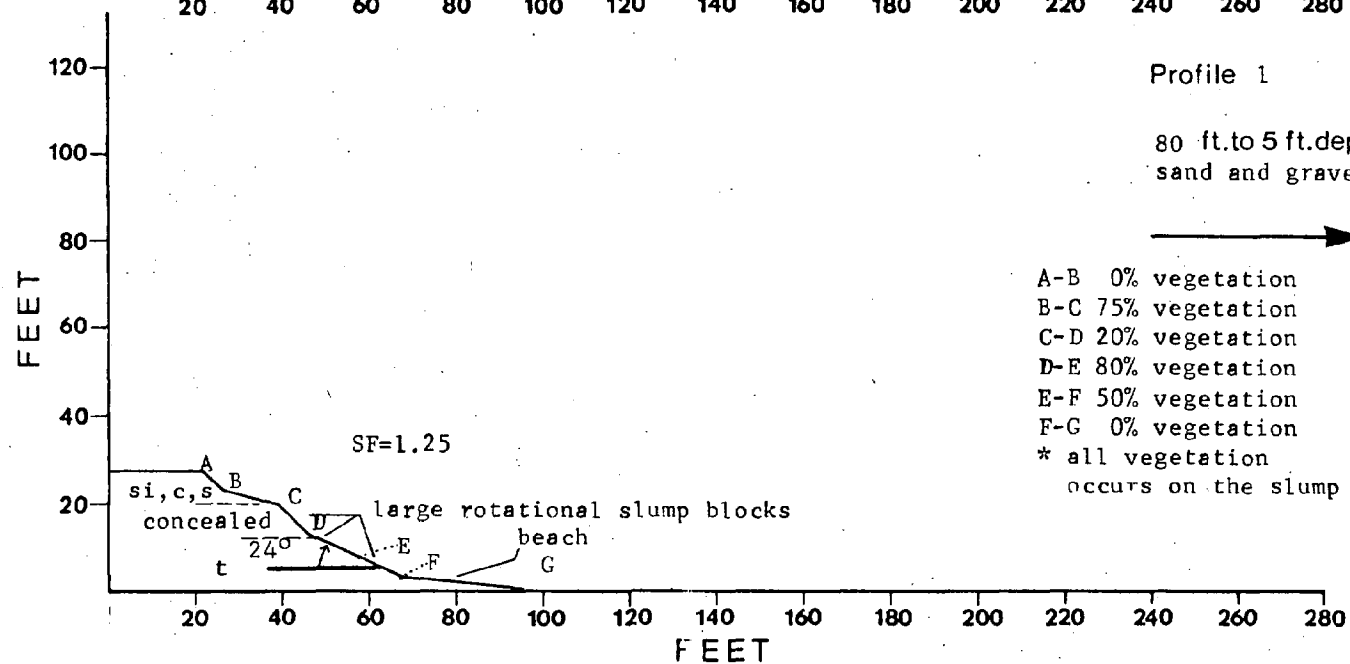
Profile 1

A-B 0% vegetation  
B-C 75% vegetation  
C-D 20% vegetation  
D-E 80% vegetation  
E-F 50% vegetation  
F-G 0% vegetation  
\* all vegetation  
occurs on the slump

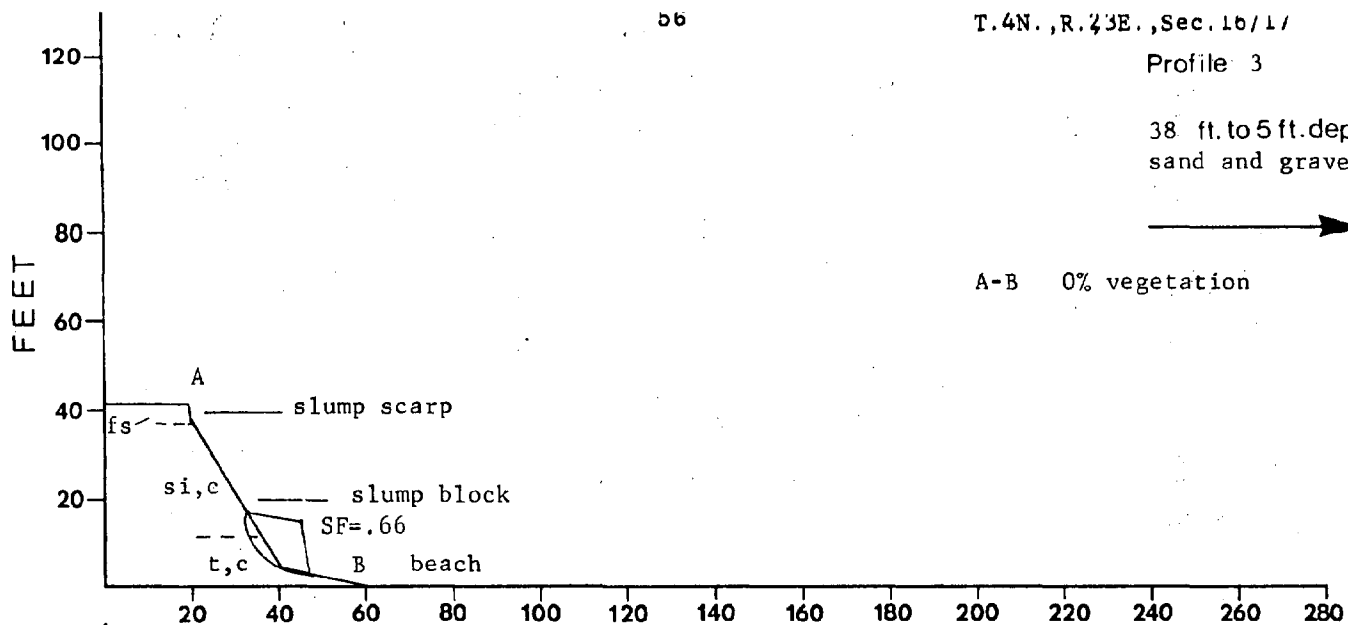
## Profile 3

38 ft. to 5 ft. depth  
sand and gravel

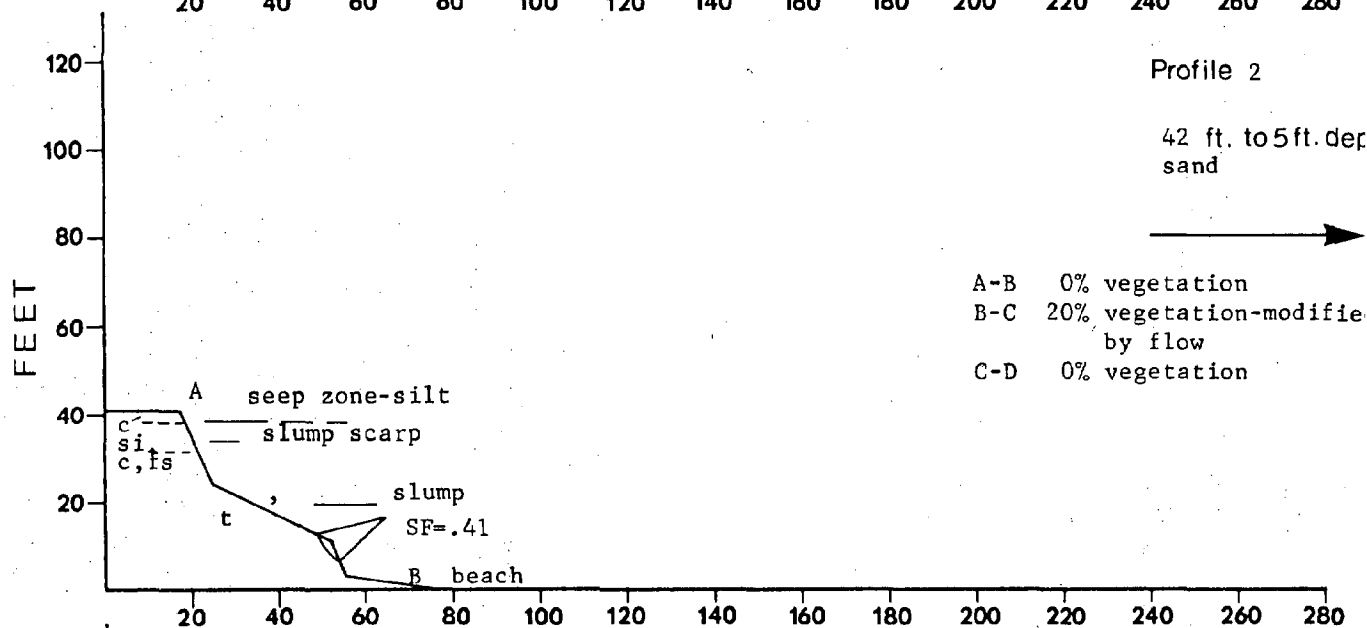
## Profile 2

42 ft. to 5 ft. depth  
sand

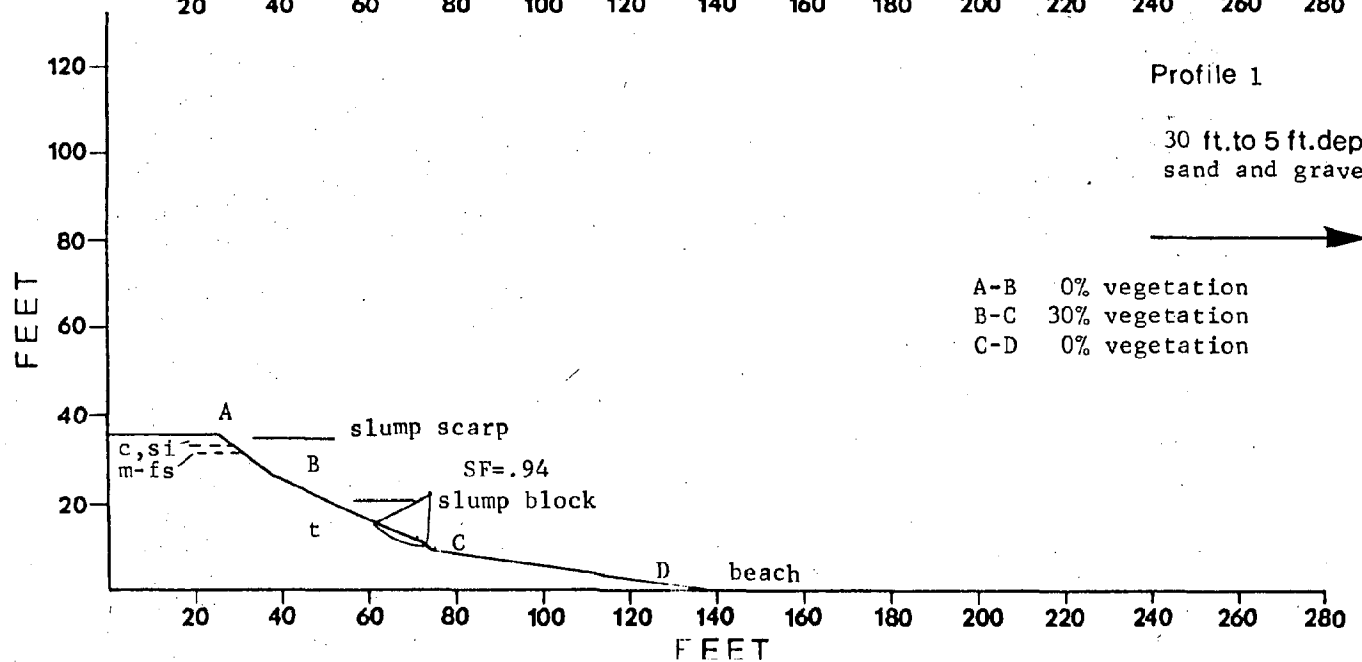
## Profile 1

30 ft. to 5 ft. depth  
sand and gravel

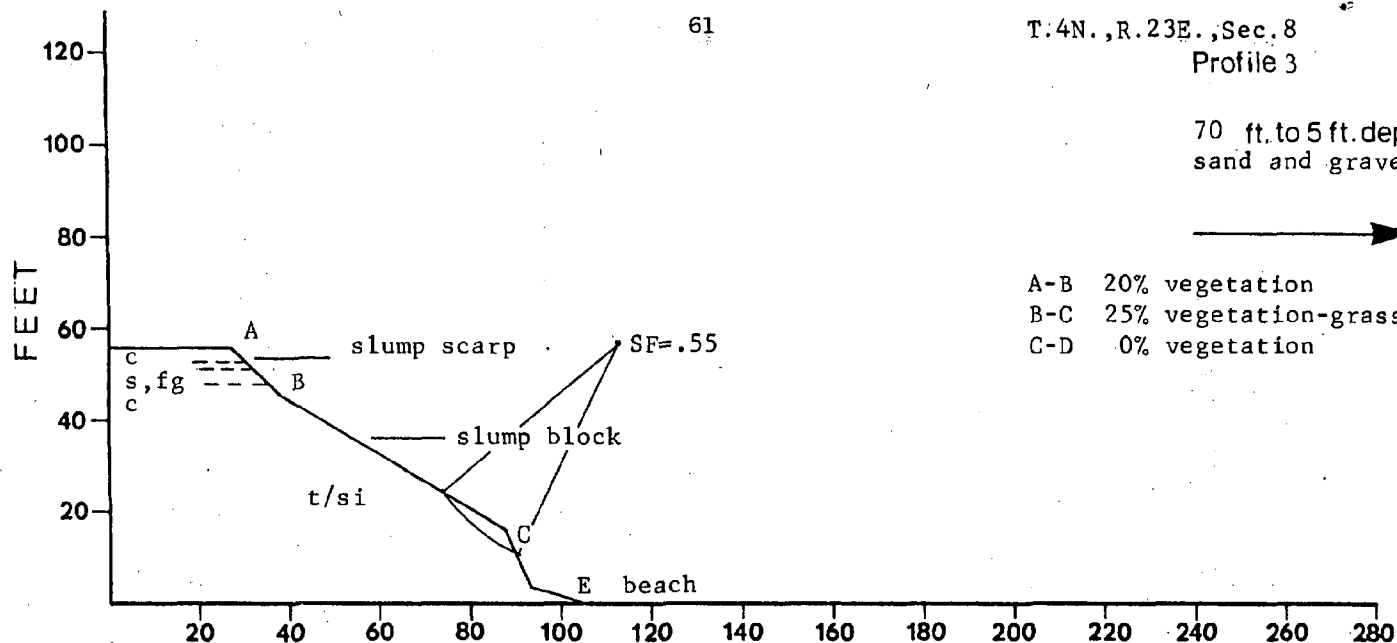
## Profile 3

70 ft. to 5 ft. depth  
sand and gravel

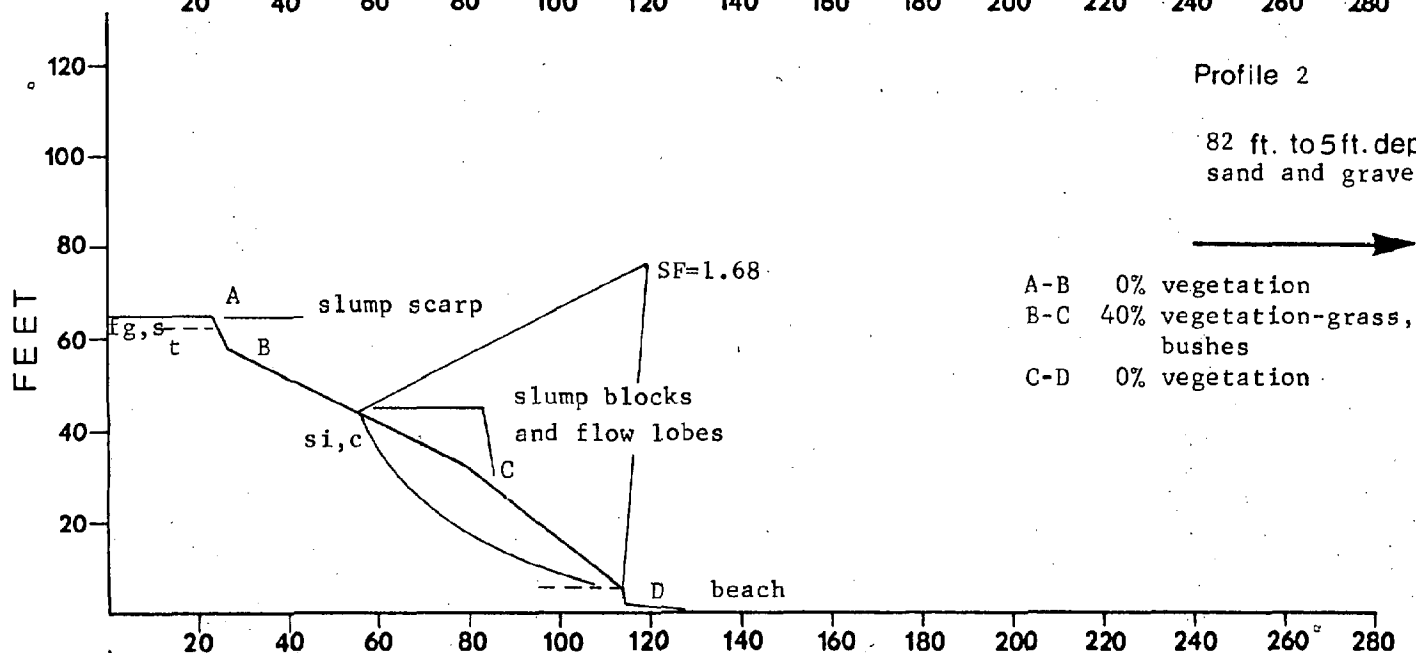
## Profile 2

82 ft. to 5 ft. depth  
sand and gravel

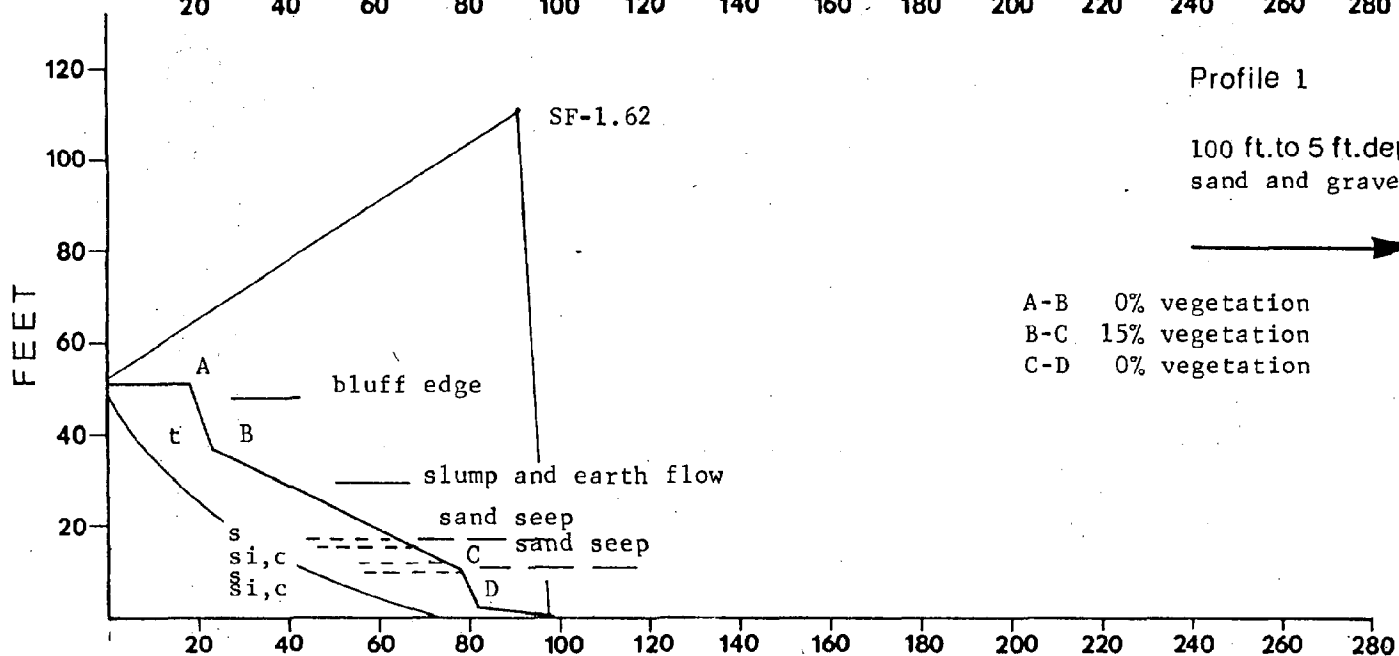
## Profile 1

100 ft. to 5 ft. depth  
sand and gravel

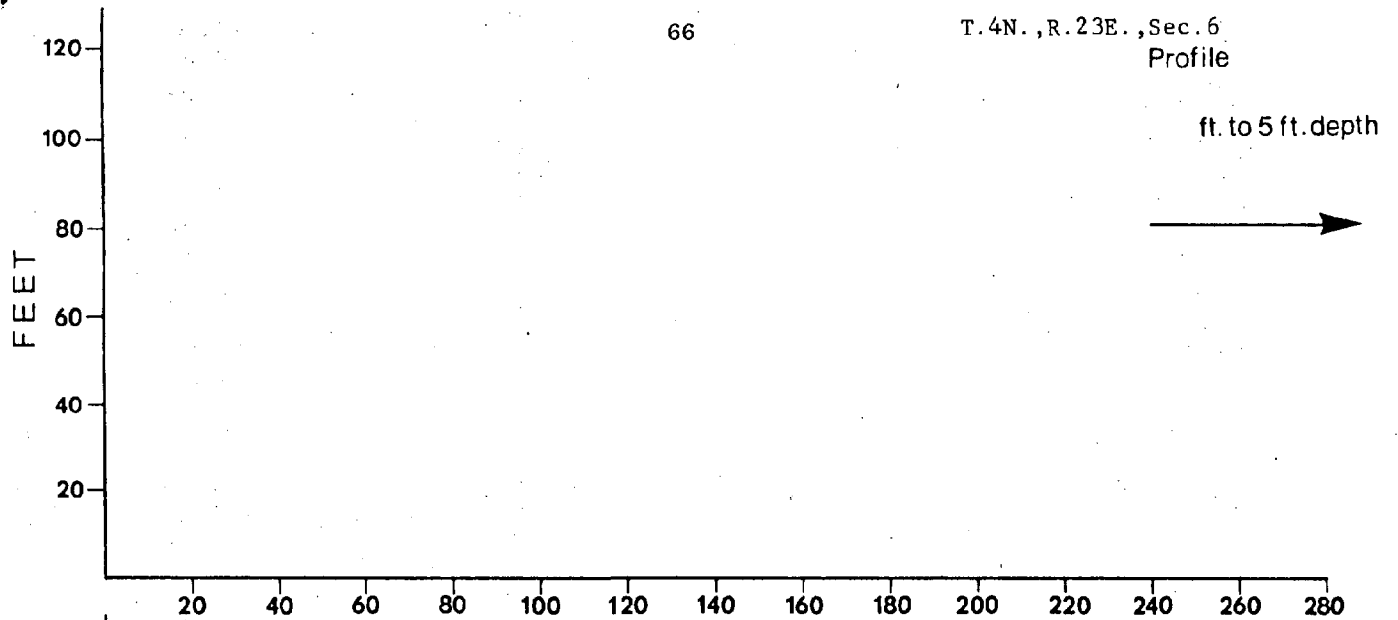
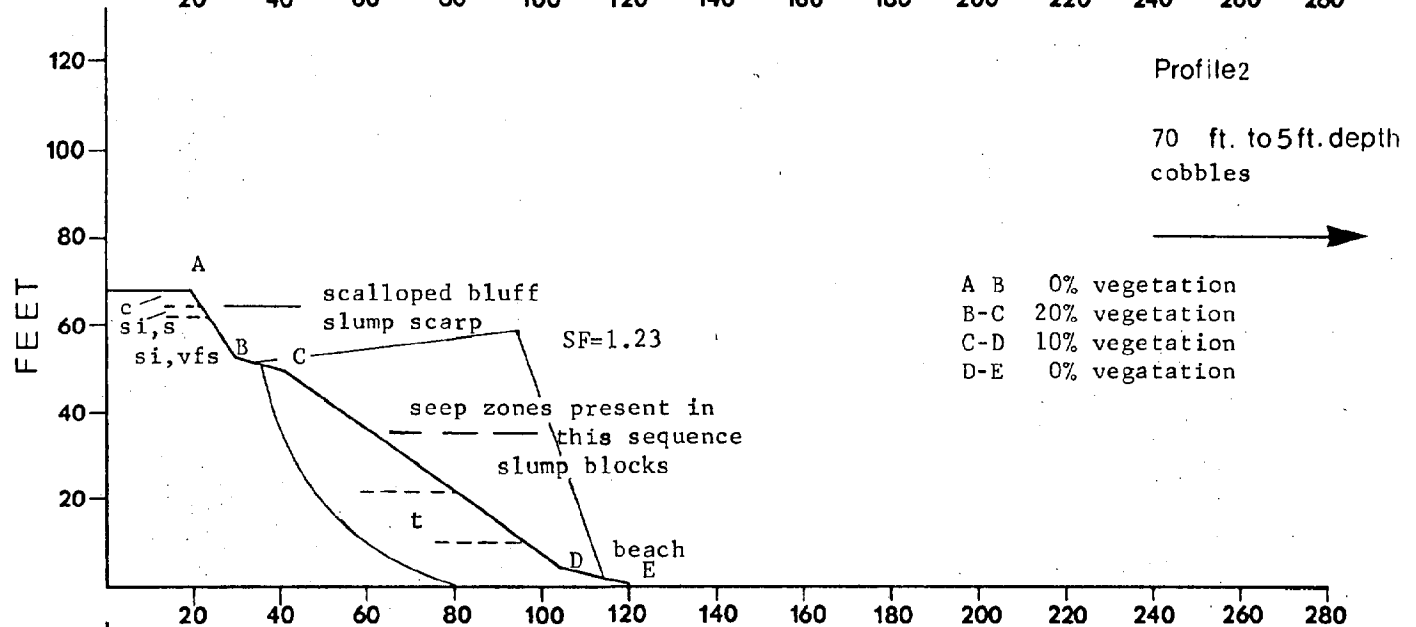
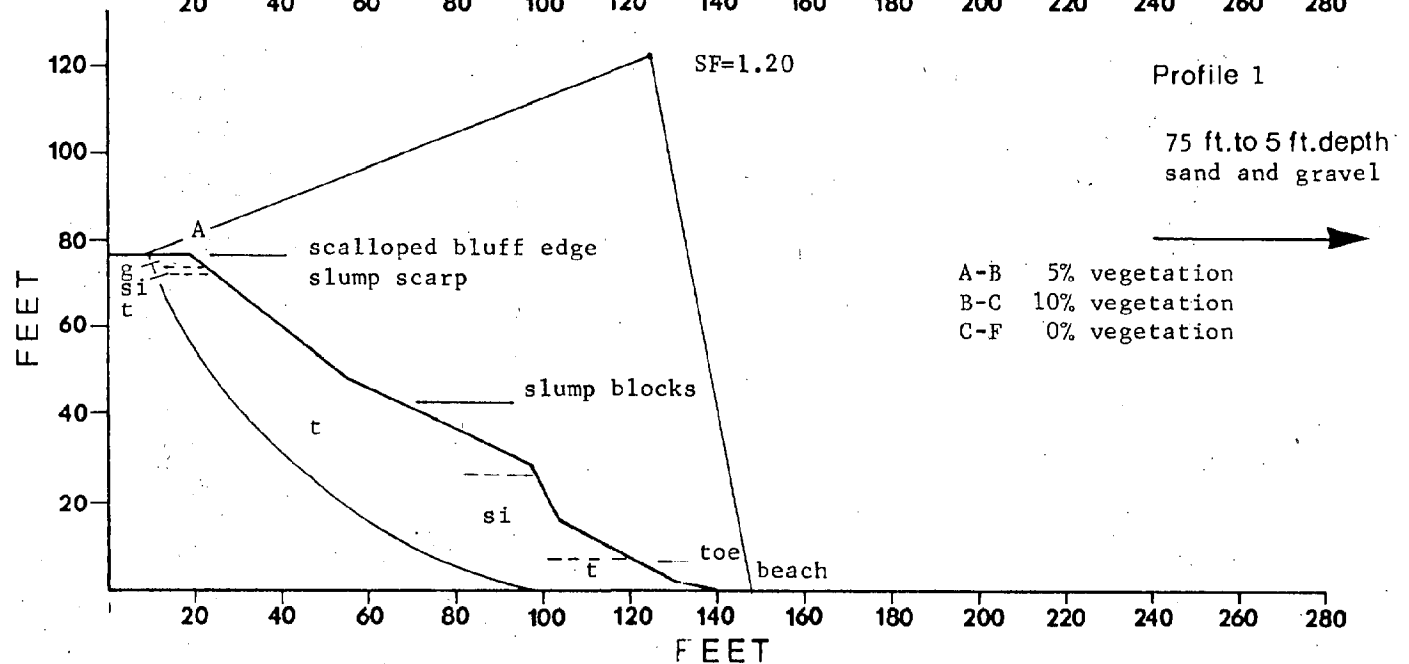
**T. 4 N., R. 23 E., Sec. 6**

1. BLUFF	a-entire bluff is unstable, lacks vegetation, and is subject to slope failure. edge of bluff distinctly scalloped throughout; upper part of bluff face marked by numerous slump scarps; middle part of bluff covered with simple and compound slump blocks, mainly of rotational variety; failure also taking place by toe erosion and consequent debris fall, particularly north of stream mouth near middle of section, where large debris falls are present; debris slides also present at several places.		b-bluff behind area of artificial fill is graded and sodded; appears fairly stable

2. TOE	a-till mostly in place, but also in slump blocks, also some lacustrine silts in slump blocks	b-till; some in place, some in slump blocks, some in debris falls	c-dolomite blocks (revetment)	d-dolomite blocks and corrugated sheet-steel piling (bulkhead)

3. BEACH	a-10 to 15 ft., sand and gravel	b-generally 5 to 10 ft., but less than 5 ft. in some places, sand and gravel	c-0 to 5 ft., except 10 to 15 ft. at mouth of stream, sand and gravel, boulders	d-no beach

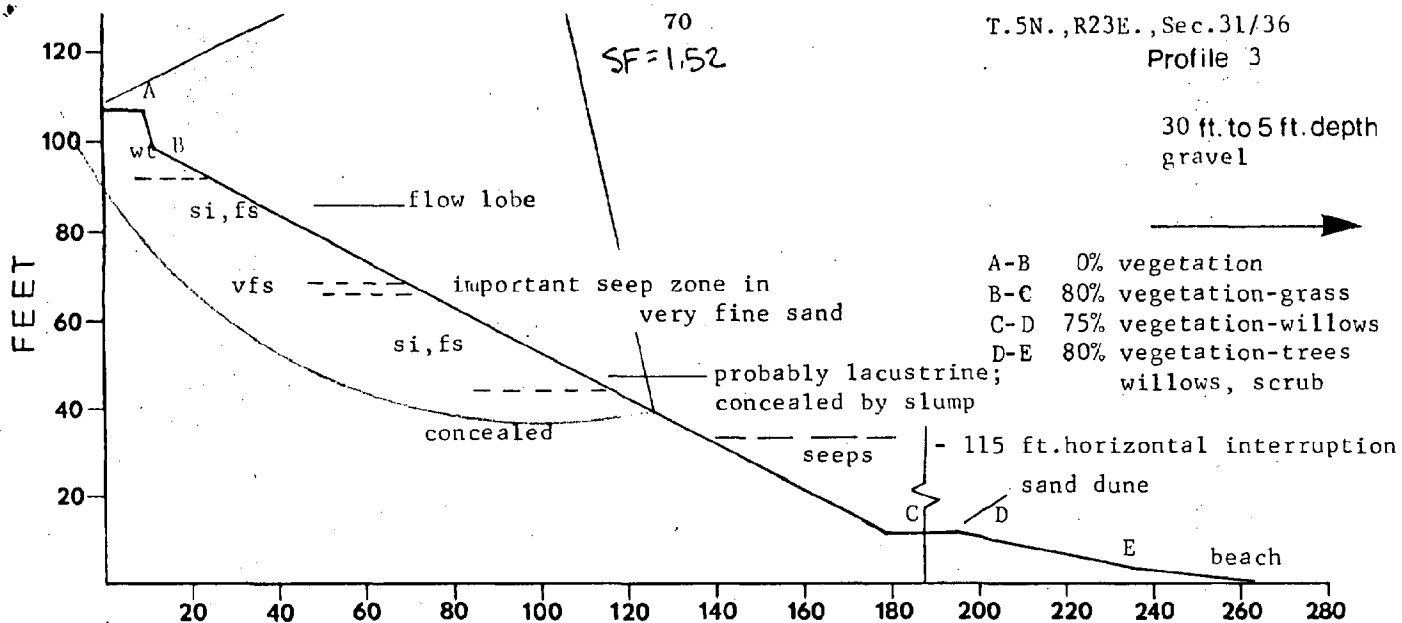
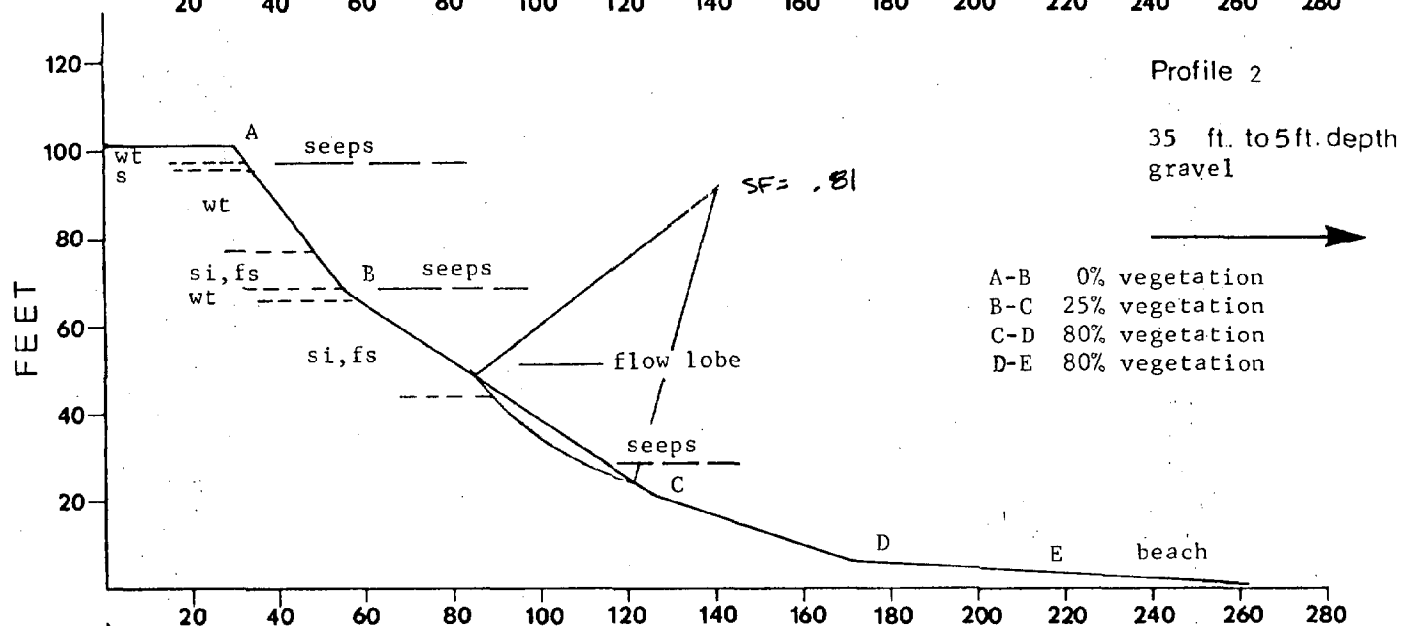
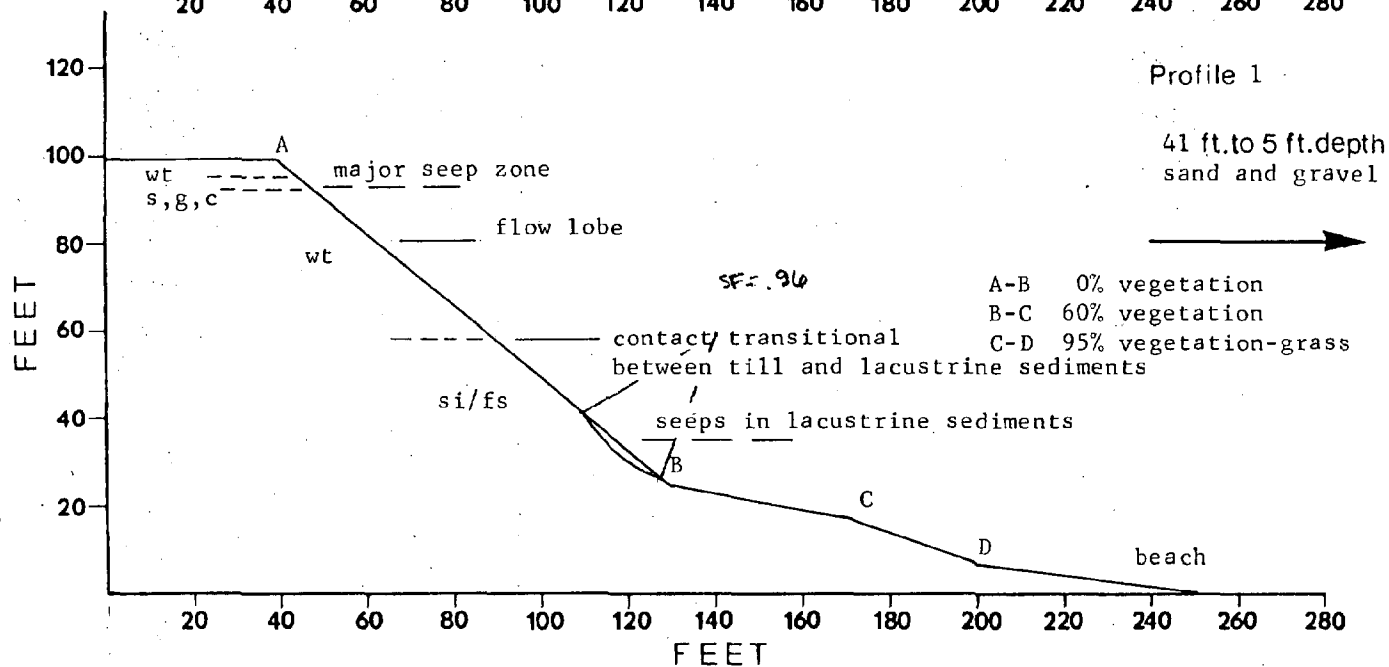
1. BLUFF	a-steeper slopes; middle portion of bluff less modified by flow units, smaller flow units	b-primarily earth flowage in two major recognizable episodes; tops of older flows form more or less continuous terrace, younger units cover lower 2/3 of bluff face	c-compound slope failure, slump debris fully modified by flowage
2. TOE	a-mostly consisting of slumped lacustrine sediments		
3. BEACH	a-less than 20 ft. sand and gravel	b-10 to 20 ft. sand and gravel, widens southward
