SHORE EROSION STUDY

APPENDIX 3

SHORELINE EROSION AND BLUFF STABILITY ALONG LAKE MICHIGAN
AND LAKE SUPERIOR SHORELINES OF WISCONSIN

MILWAUKEE COUNTY

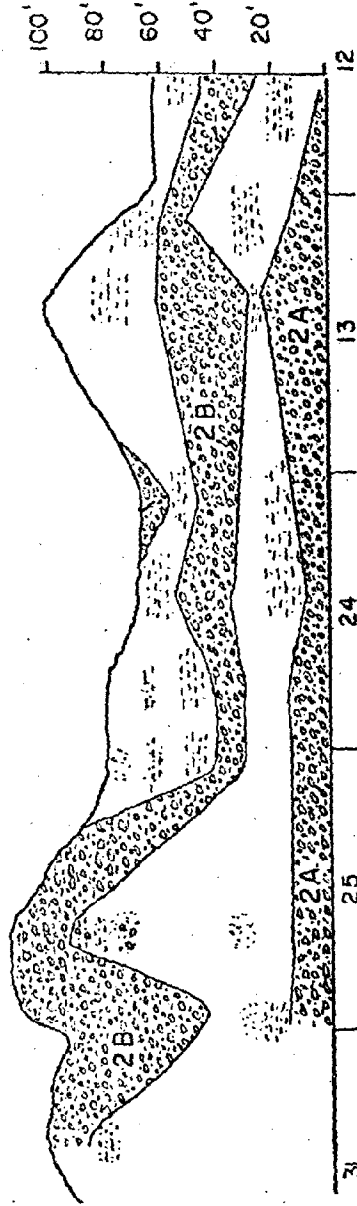
Generalized longitudinal section showing bluff stratigraphy in Reach 7. Numbers along base of diagram are geographic (1 mile) sections.

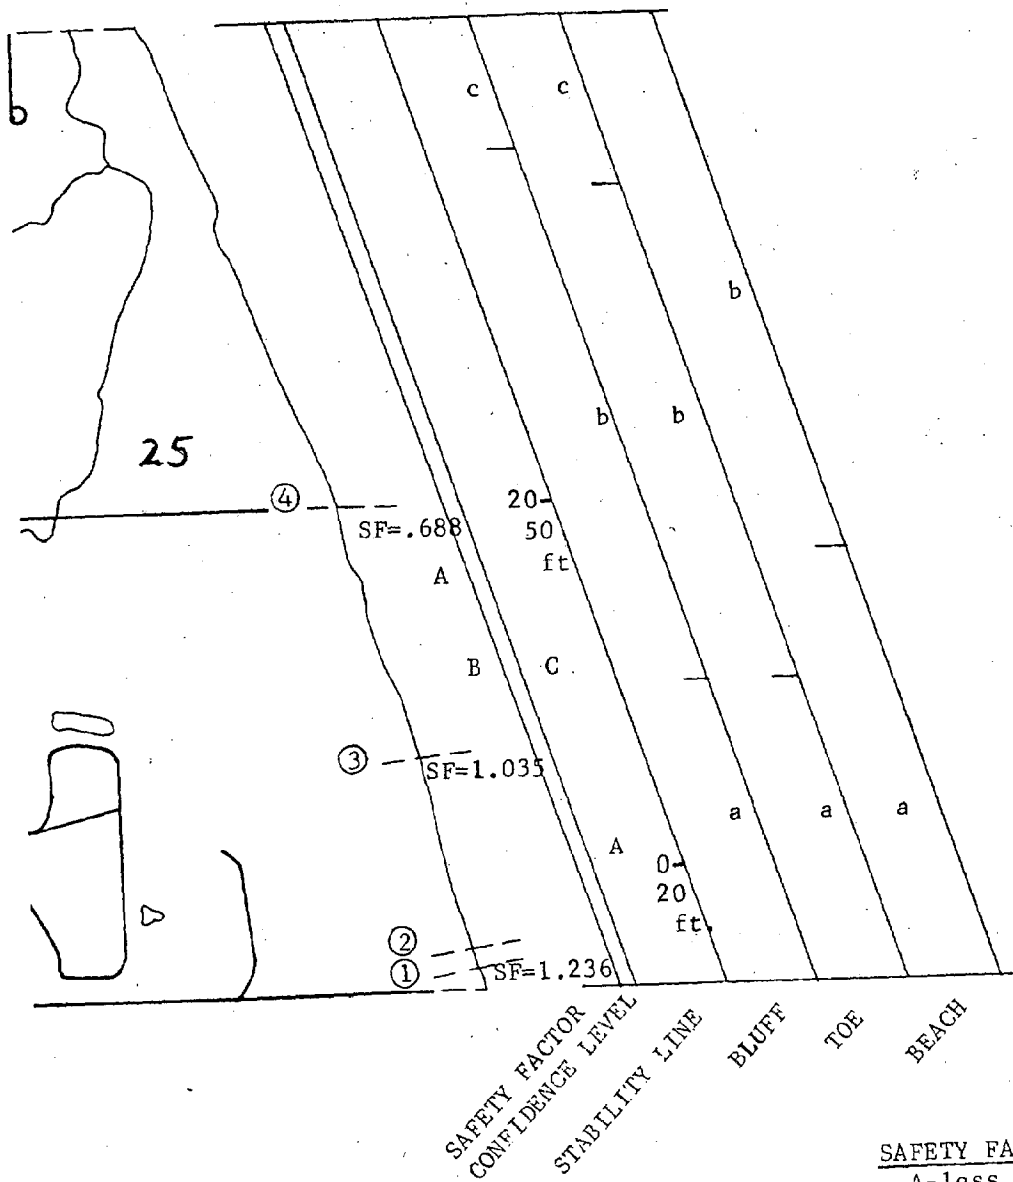
1. BLUFF	a-discrete slumps leaving concave cuts and scalloped bluff top	b-small slumps, lateral spreading without discrete large slump blocks	c-eroding bluff, no large recent slump blocks although older blocks probably being truncated, shallow slides
2. TOE	a-50% till in place 50% lacustrine silt and till slumped	b-slumped mixed lacustrine silts and till	c-till, most in place
3. BEACH	a-5 to 20 ft. beach pebbles with cobbles	b-less than 5 ft. beach, cobbles, otherwise no beach	
4. STRUCTURES-none in this section

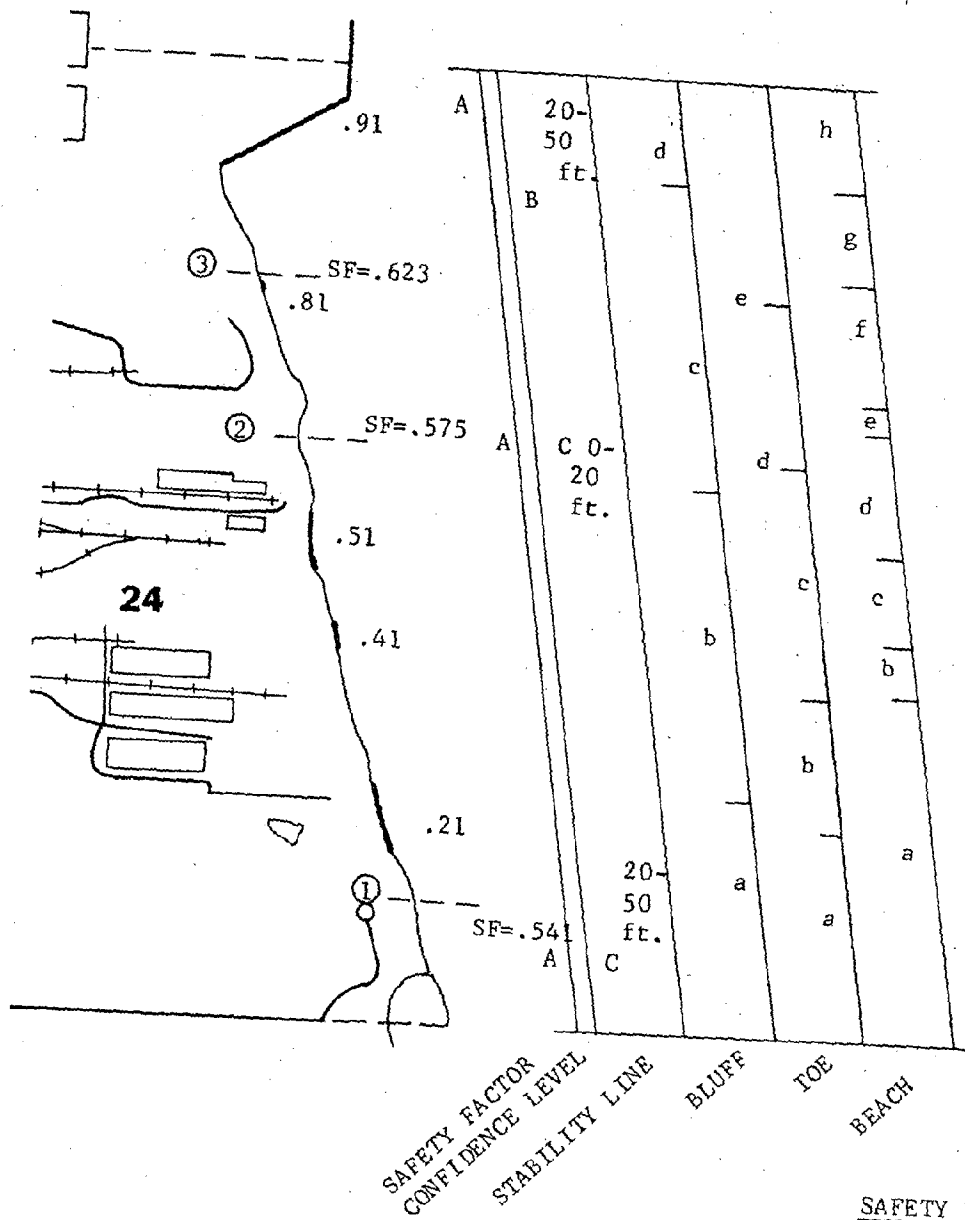
1. BLUFF	a-			
2. TOE	a-till in place e-slump debris	b-broken concrete	c-sheet piling fill behind	d-till in place
3. BEACH	a-no beach	b-less than 5 ft., boulders	c-no beach	d-greater than 20 ft., sand
	e-no beach	f-5 to 20 ft. wide, pebble and sand	g-no beach	h-5 to 20 ft. wide, pebbles and sand

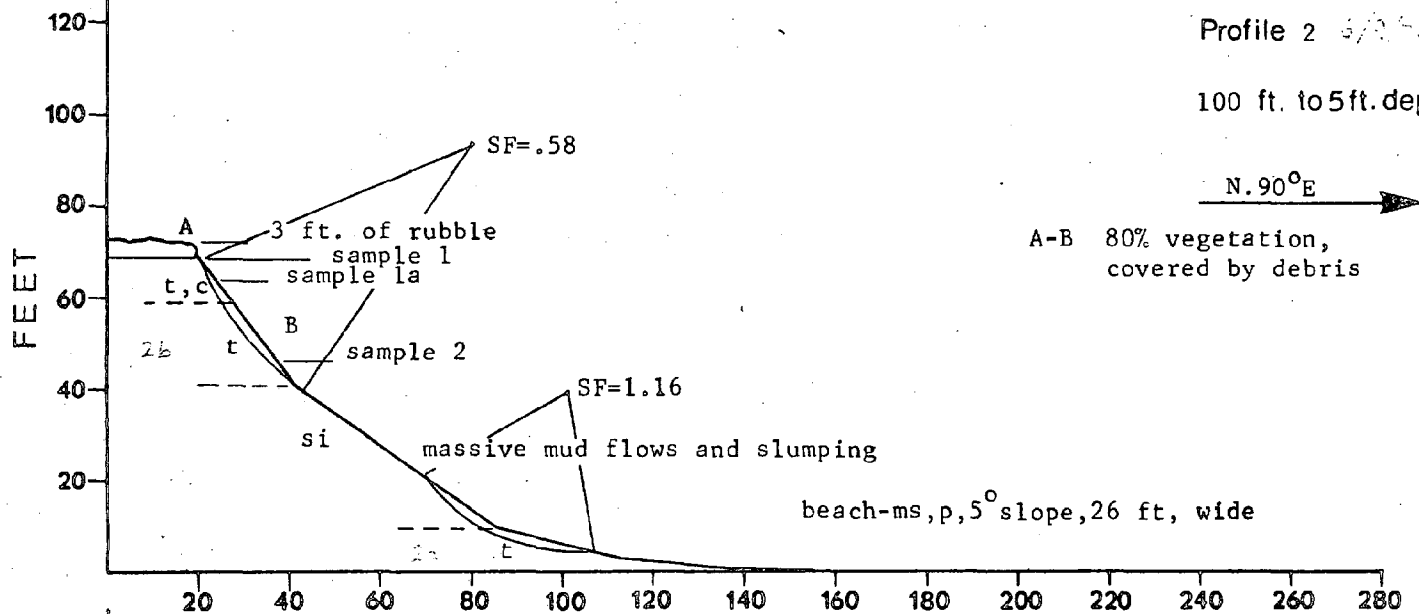
Profile 2 6/9/76

N. 90° E
A-B 80% vegetation,
covered by debris

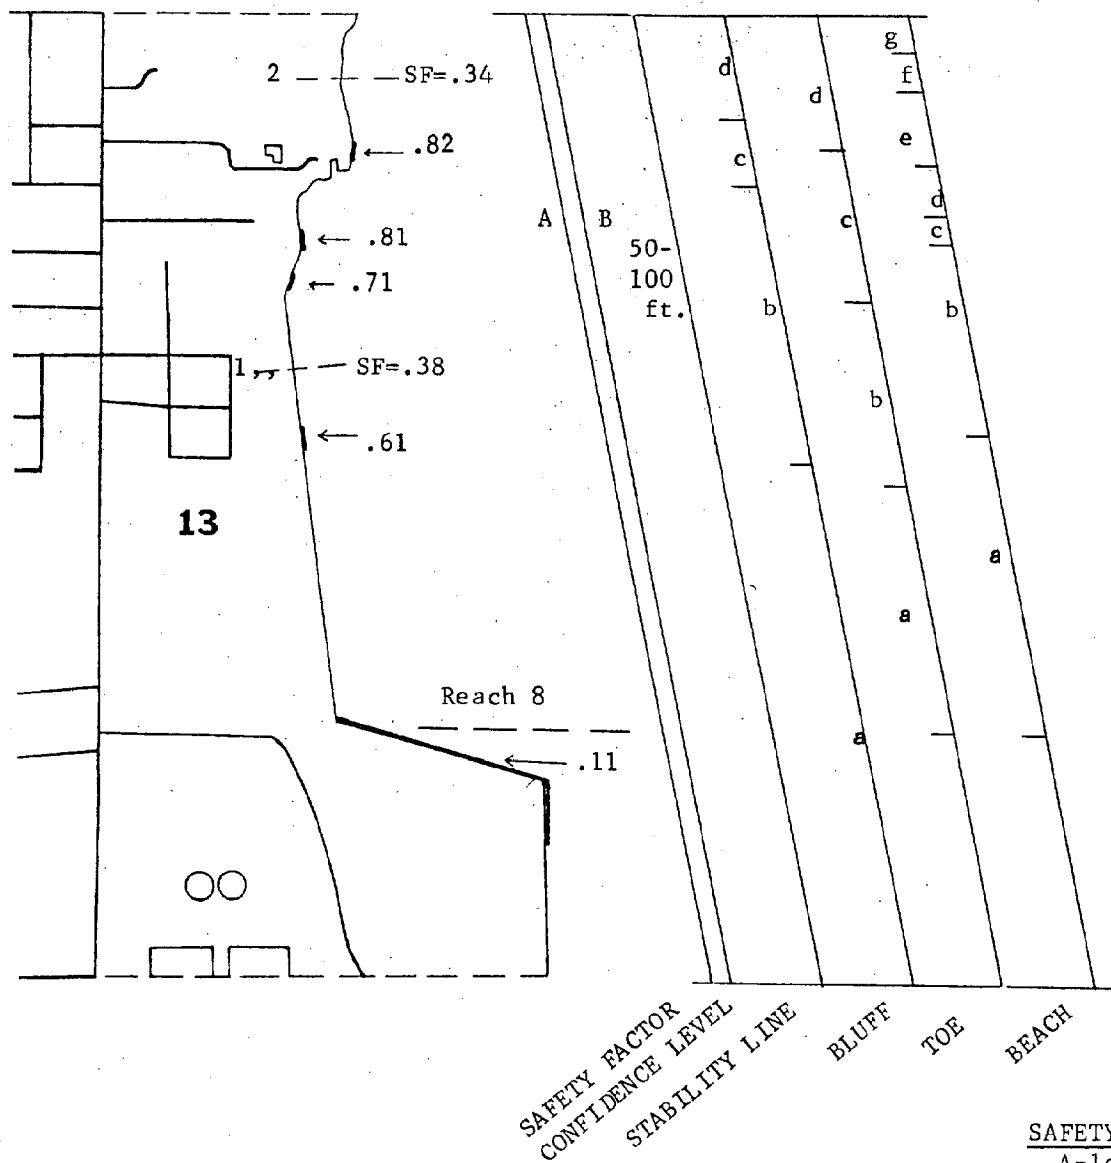
1. BLUFF	a-relatively stable, no recent failures, graded	b-shallow slides	c-protected, graded, relatively stable	d-shallow slides
2. TOE	a-slumped, vegetated, now graded	b-slumped, lacustrine silts	c-in place, till	d-flow, lacustrine silts
3. BEACH	a-sand, pebbles at water line, +20 ft. e-greater than 20 ft.	b-sand, pebbles at water line 5 to 20 ft. f-5 to 20 ft.,	c-boulders, broken concrete, no beach g-less than 5 ft.	d-sand, pebbles greater than 20 ft.

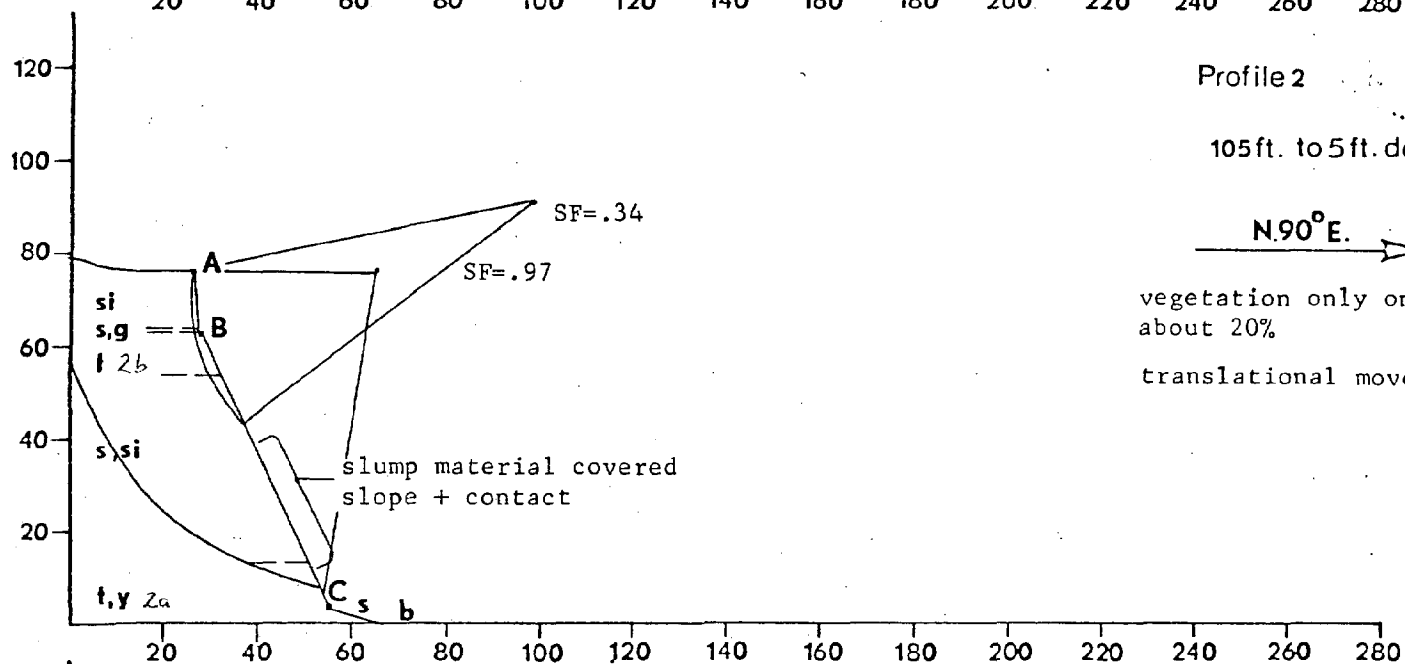
Profile 2

vegetation only on B-C
about 20%

translational movement

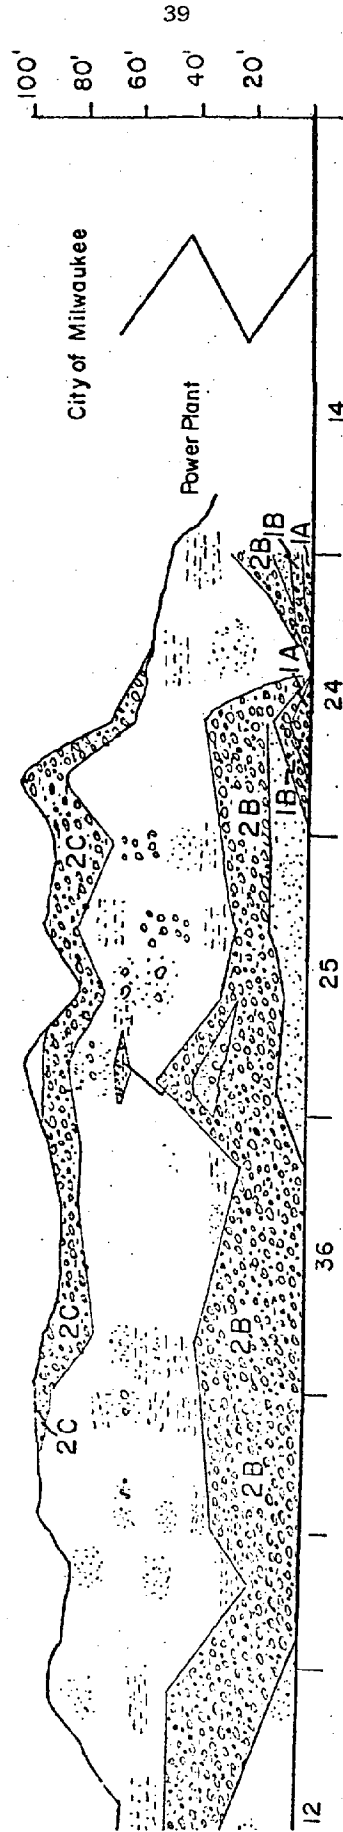
Generalized longitudinal section showing bluff stratigraphy in Reach 8. Numbers along base of diagram are geographic (1 mile) sections.

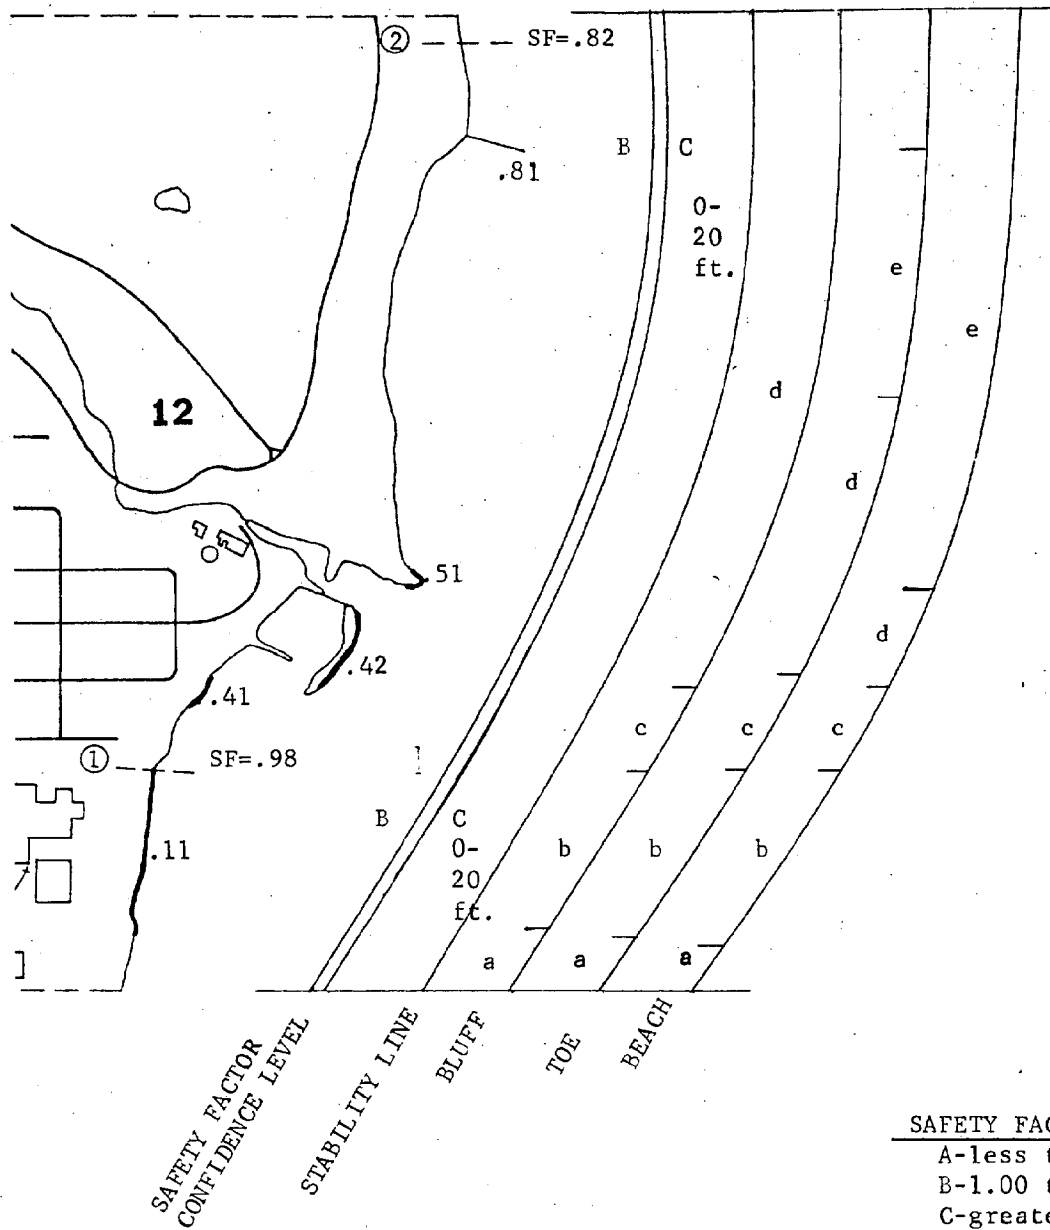
1. BLUFF	a-shallow slides	b-relatively stable - protected by revetment	c-shallow slides	d-relatively stable protective struc- ture and wide beach graded and wooded slopes responsible
2. TOE	a-in place	b-broken concrete nothing natural visible	c-toe material not visible slope graded	d-toe material not visible
	e-in place sand and boulder layer			
3. BEACH	a-5-20 ft. sand	b-concrete revetment no beach	c-+20 ft.	d-concrete revetment no beach
	e-+20 ft. sand

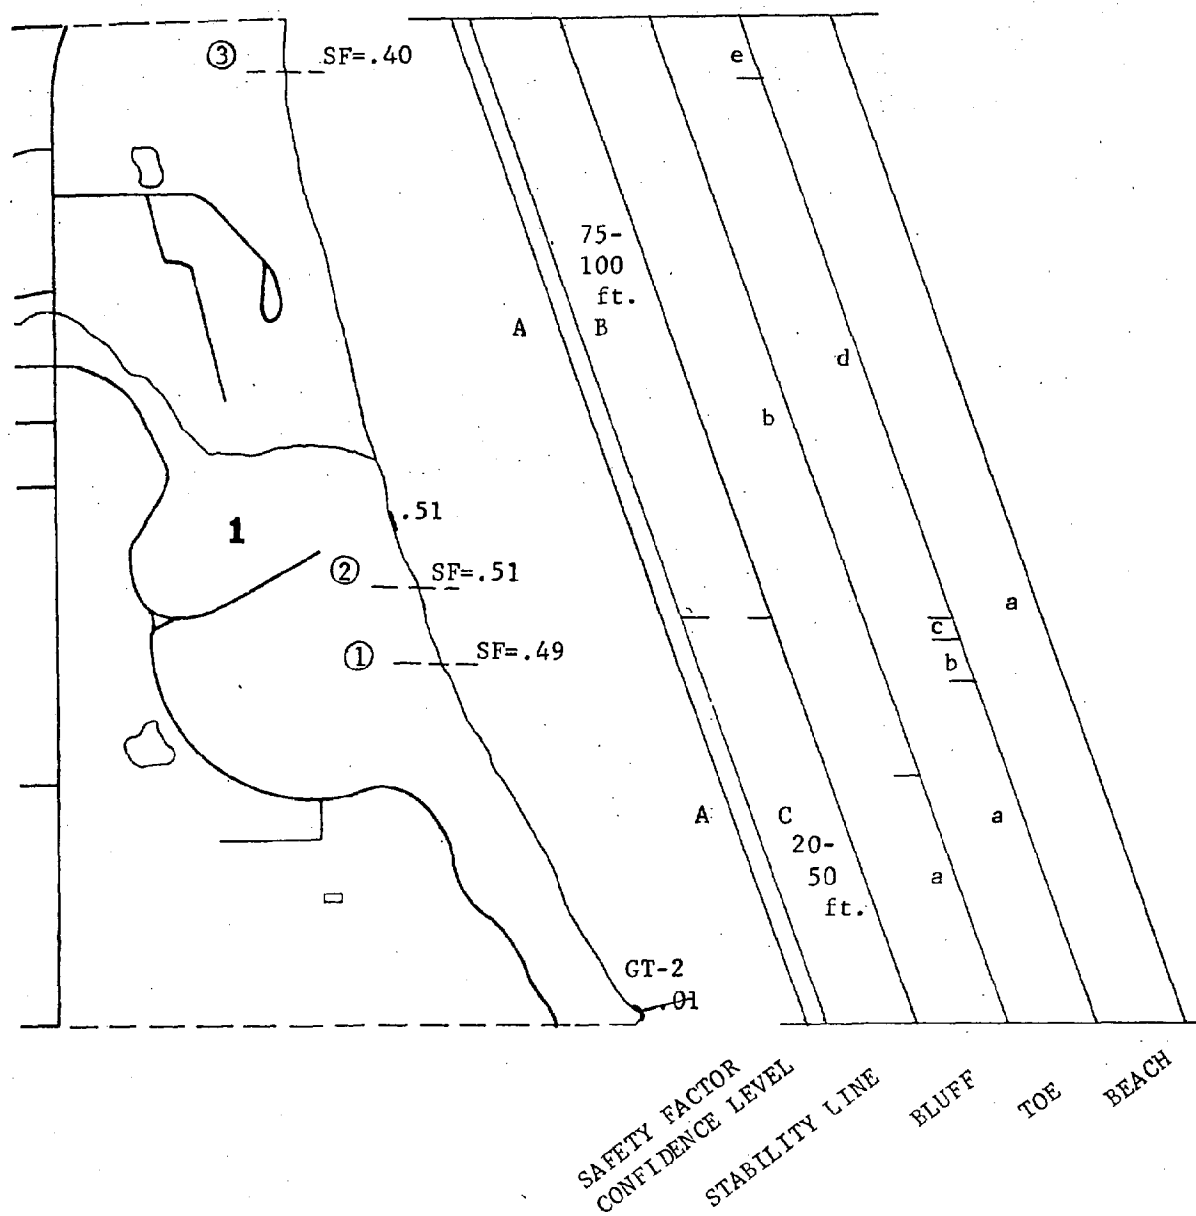
1. ELUFF	a-stable vegetated, no recent failures	b-primarily slides, several shallow slumps		
2. TOE	a-sand with a tree, bush and grass -cover in place	b-slumped silt, sand with pebbles, cobbles and boulders -mudflows throughout	c-sand, in place	d-slumped material
3. BEACH	a- +20 ft. cobbles and pebbles grading into sand

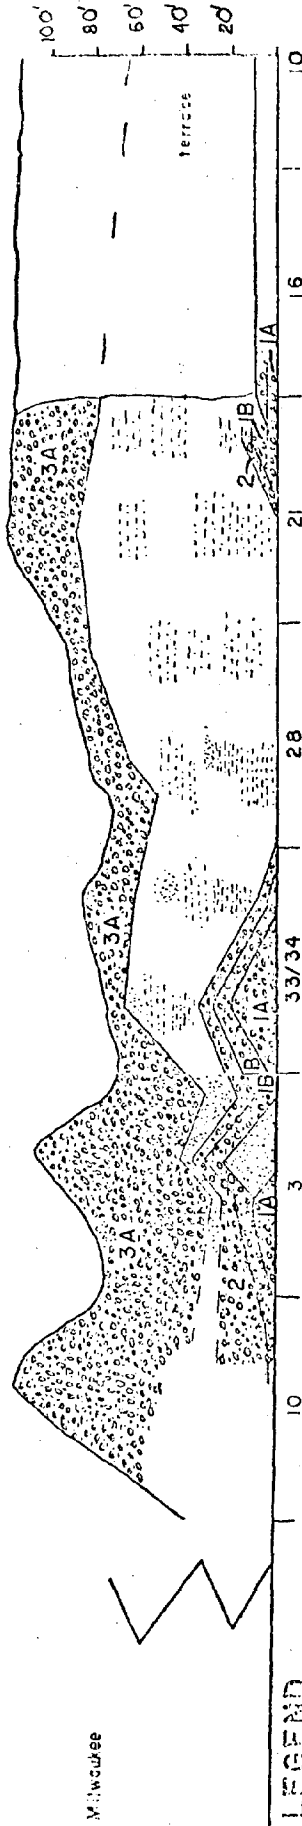
Generalized longitudinal section showing bluff stratigraphy in Reach 10. Numbers along base of diagram are geographic (1 mile) sections.

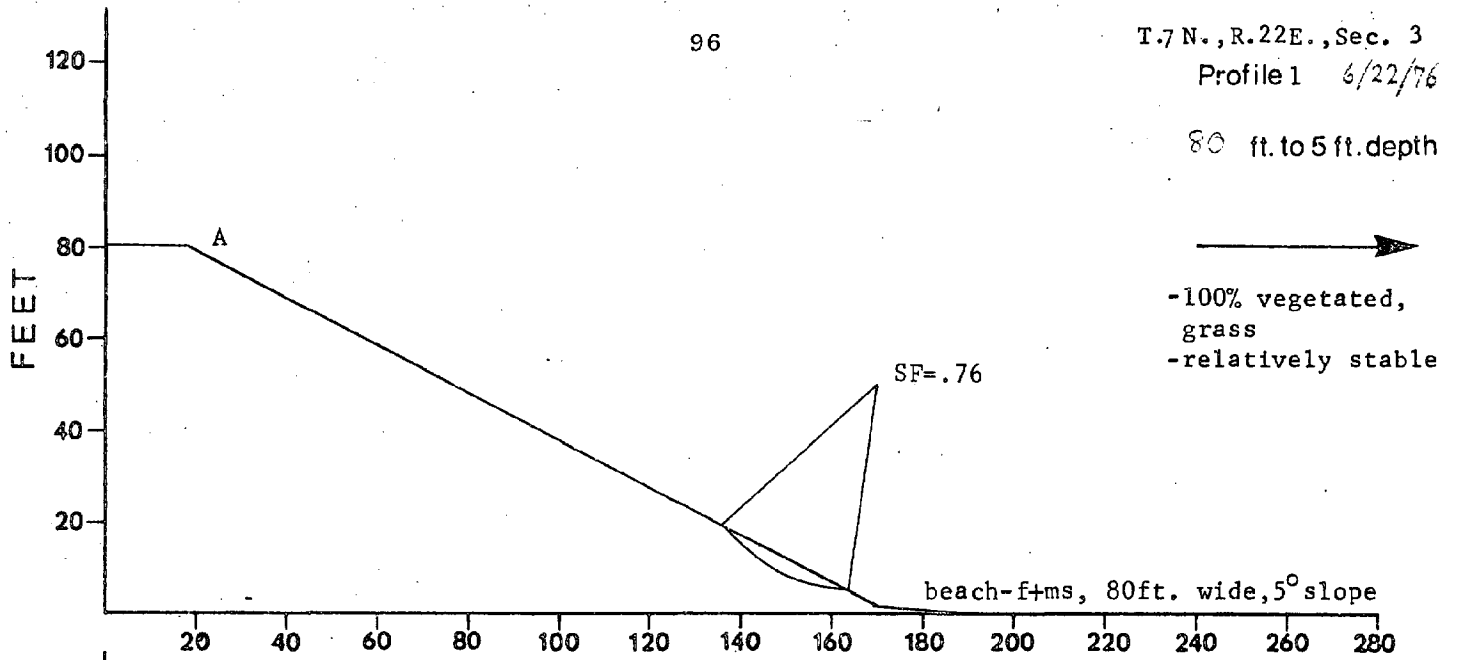
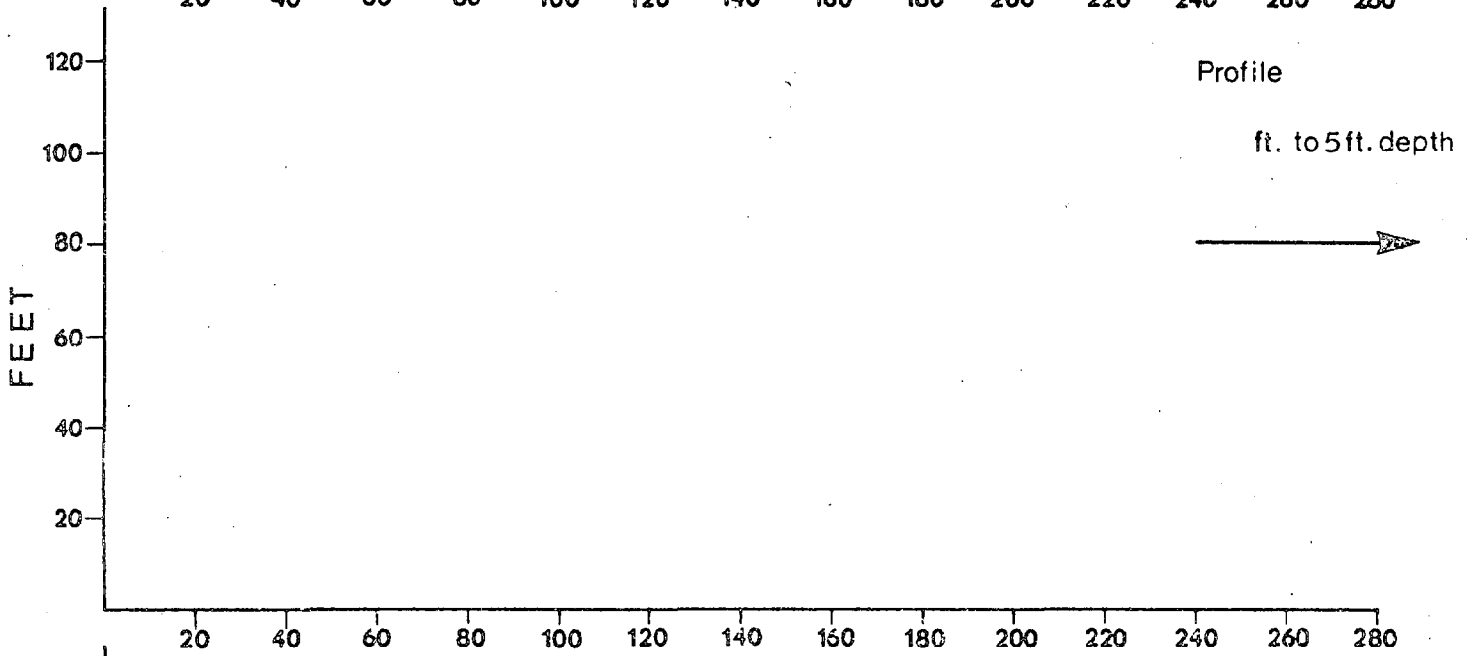
T.7 N., R.22 E., Sec. 3
Profile 1 6/22/76

A seawall partially protects the toe of the bluff at about 34.18 causing the slope to be more highly vegetated. The upper 2/3 is 100% covered while the lower 1/3 is bare of vegetation. The failing seawall extends in part to 34.2. It is here that profile 1 was drawn.

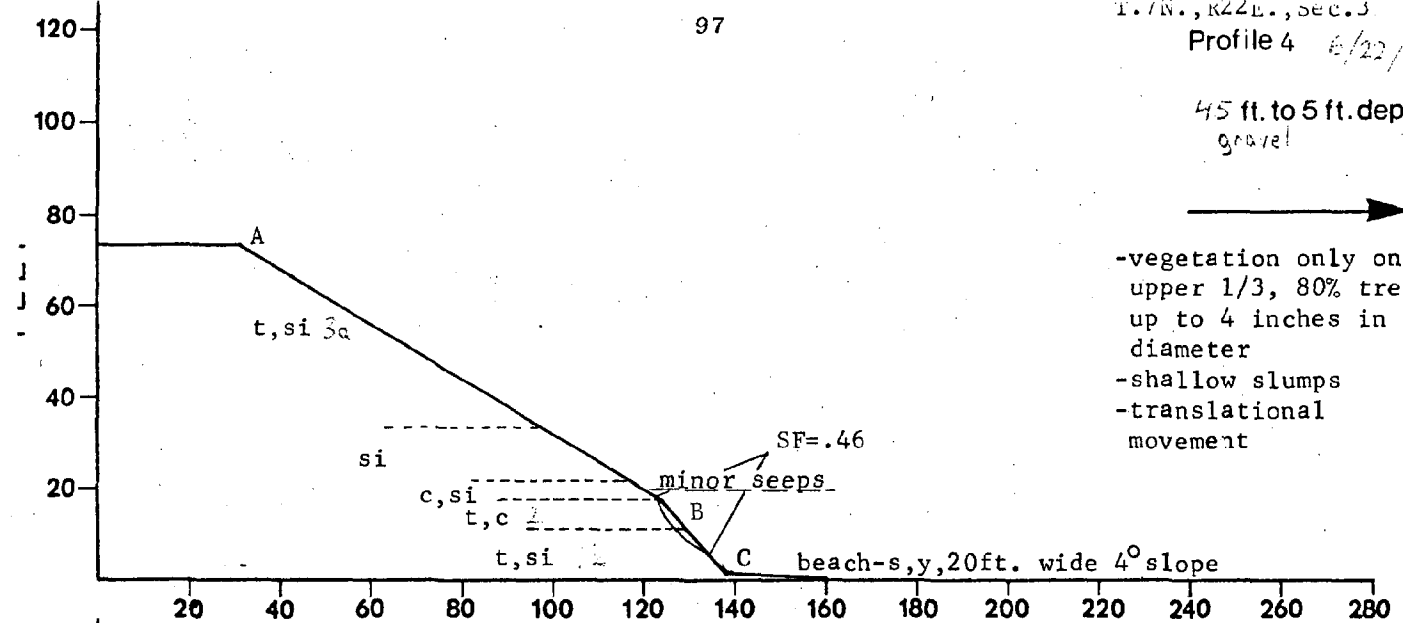
- vegetation only on upper 1/3, 80% trees up to 4 inches in diameter
- shallow slumps
- translational movement

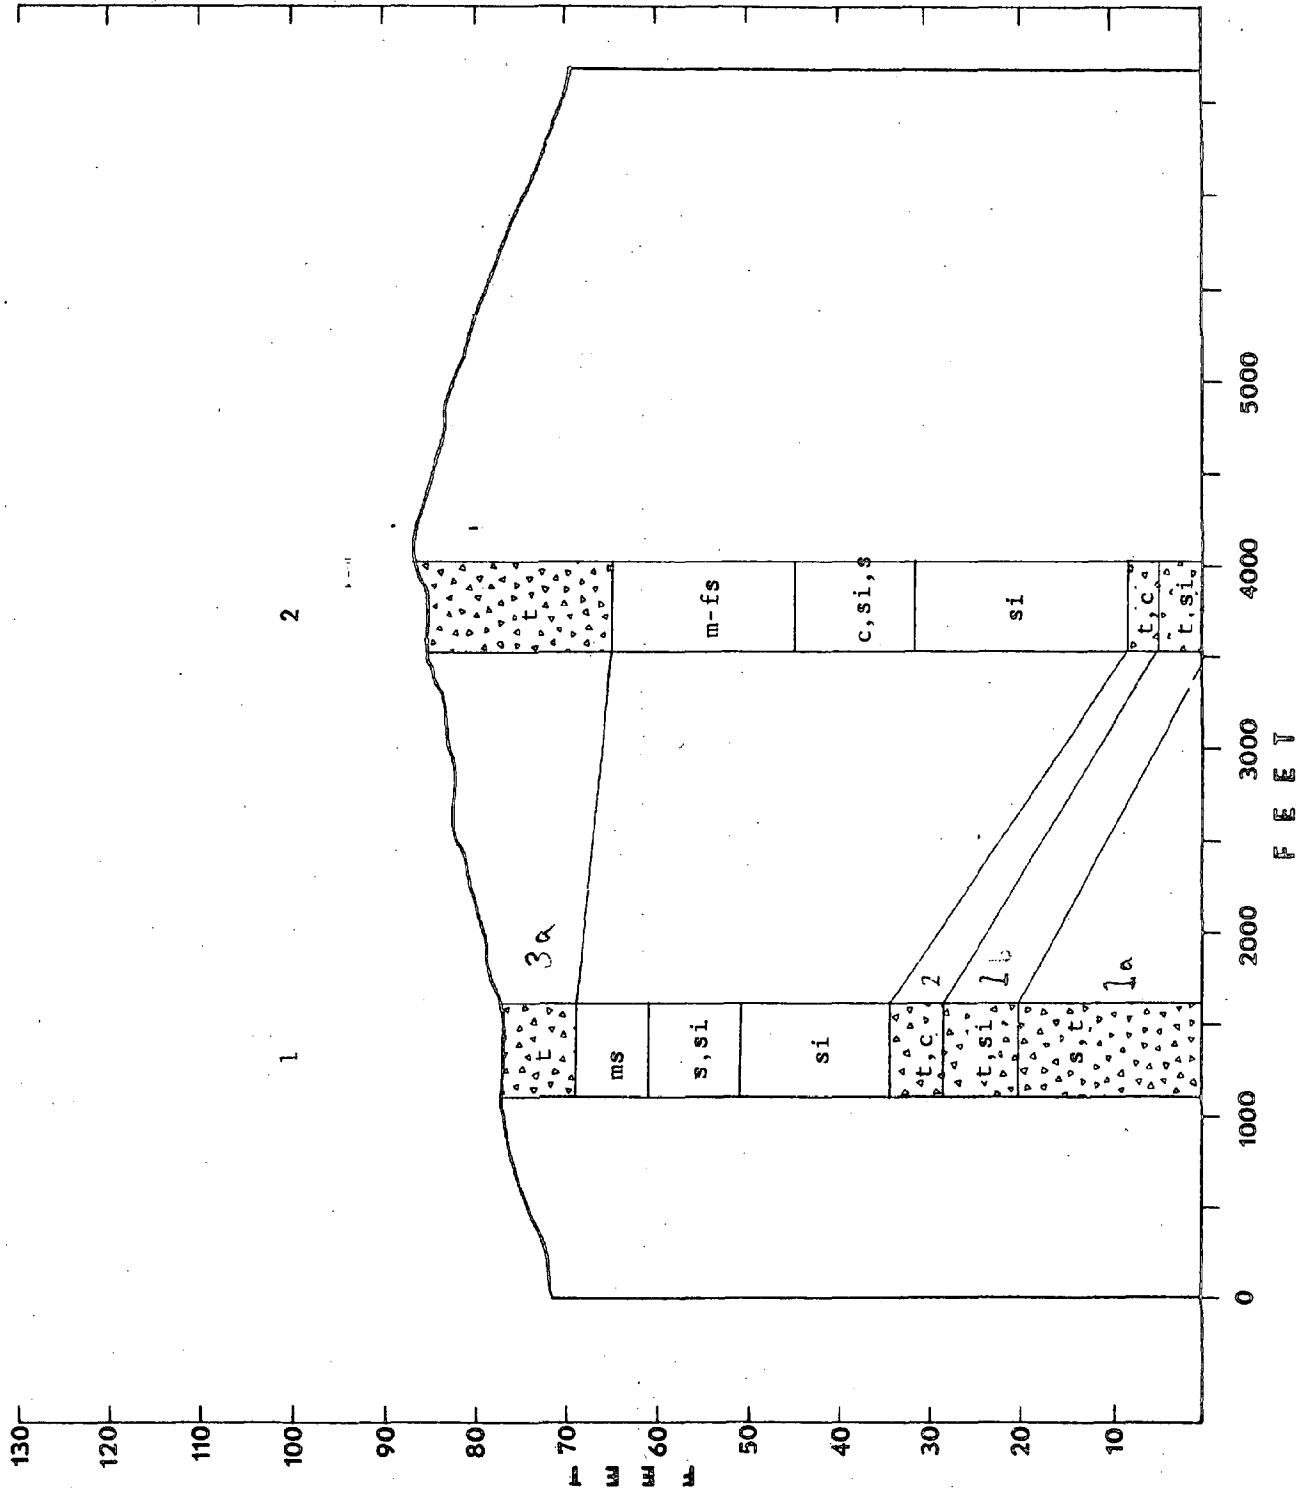
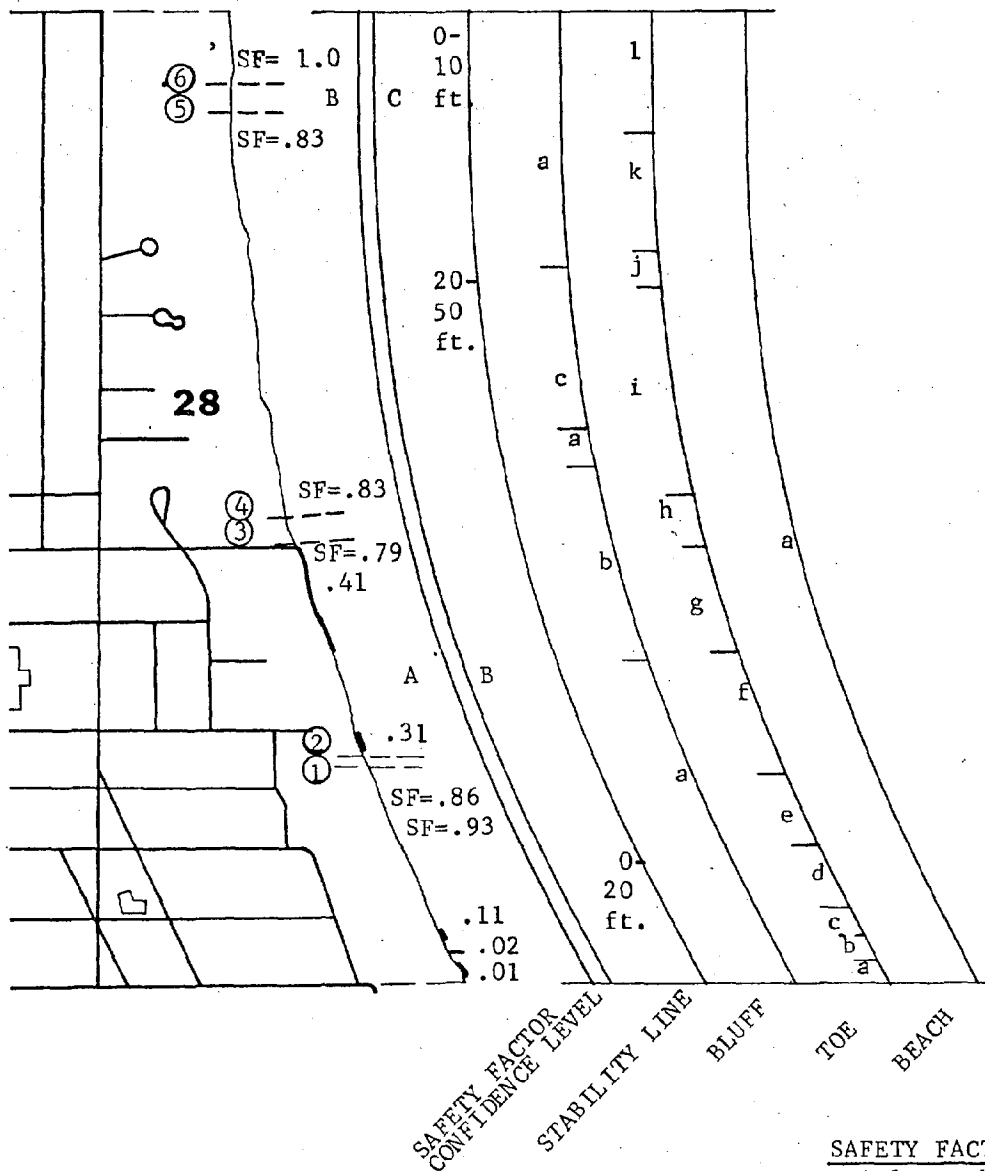
T. 8 N., R. 22 E., Sec. 33/34

1. BLUFF	a-A series of rotational slumps, as waves erode toe, bluff becomes unstable. Springs prevalent in the silt layer, standing water on the bottom most slump -possible impermeable layer below which a lubricated plane is produced for the faults to slump down. Vegetation is prevalent throughout most of slope. Slope angle seems to be approximately 40°. Scarp face evident at the top of the bluff.		b-fairly stable condition due to the seawall and sand build-up behind it which protects the toe of the bluff. Scarp face evident at the top of the bluff	c-in stable condition although the presence of slumps, possibly due to the sand build-up at the toe from an old beach deposit which protects the toe. Heavily vegetated. Scarp face evident at the top of the bluff.
	d-same as a- above.

2. TOE	a-slumped till	b-debris	c-slumped sand and silt	d-slumped till
	e-slumped silt	f-slumped till	g-sand resulting from waves overtopping seawall	h-slumped silt
	i-sand, possibly an old beach deposit	j-part of soil profile	k-slumped silt	l-slumped till

3. BEACH	a-greater than 25 ft.; approximately 10 ft. from the water's edge-pebbles and cobbles; to toe of bluff-medium sand.

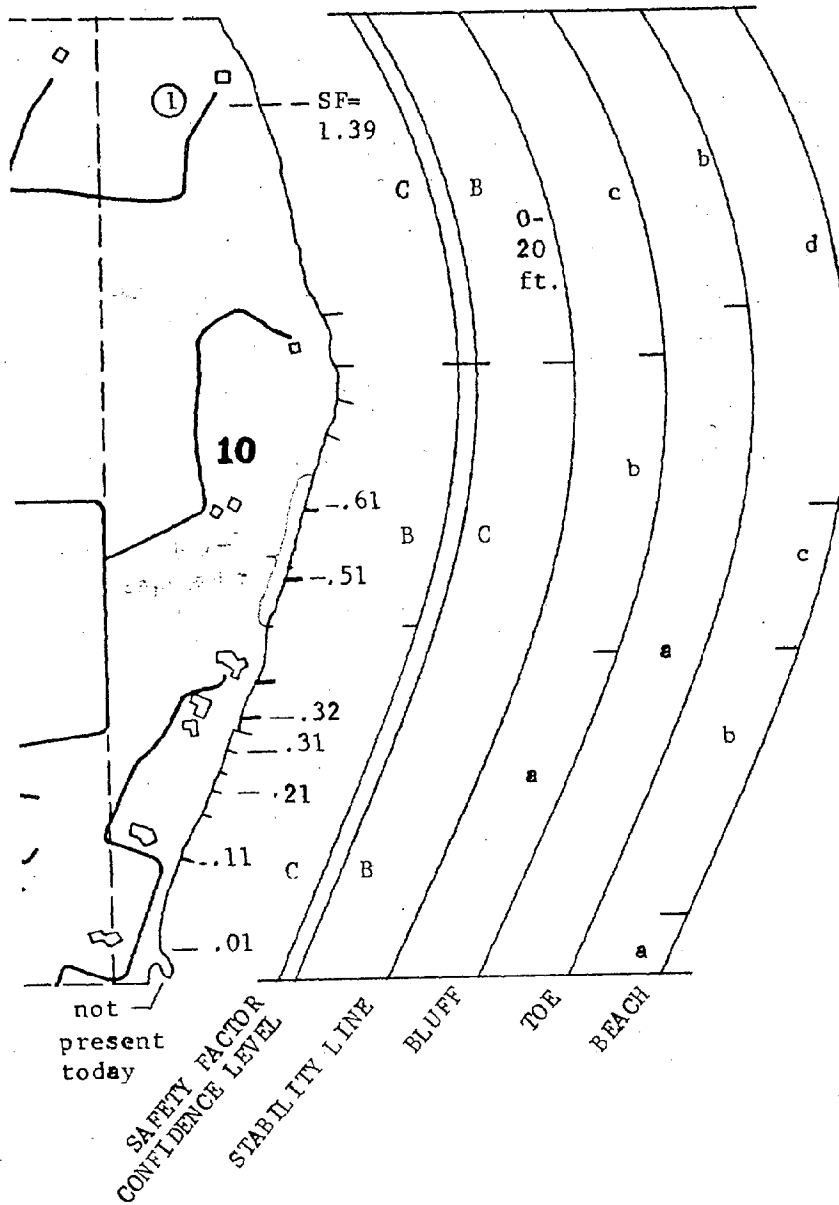
1. BLUFF	a-relatively stable, several slump scarps noted.			
2. TOE	a-in place paleo lake terrace, till and beach sand, gravel, cobbles			
3. BEACH	a-less than 5 ft. sand, revetment, seawall	b-less than 20 ft., sand	c-less than 5 ft., sand,revet- ment,seawall	d-less than 20 ft., sand
