**WET-PIT MINING IMPACT ASSESSMENT:
COASTAL ZONE OF PUERTO RICO**

Andrea Handler Ruiz and Rojeanne Salles O'Farrill

Office of Coastal Resources Management (OCRM)
National Oceanic and Atmospheric Administration (NOAA)

Task 7.2
May 1988

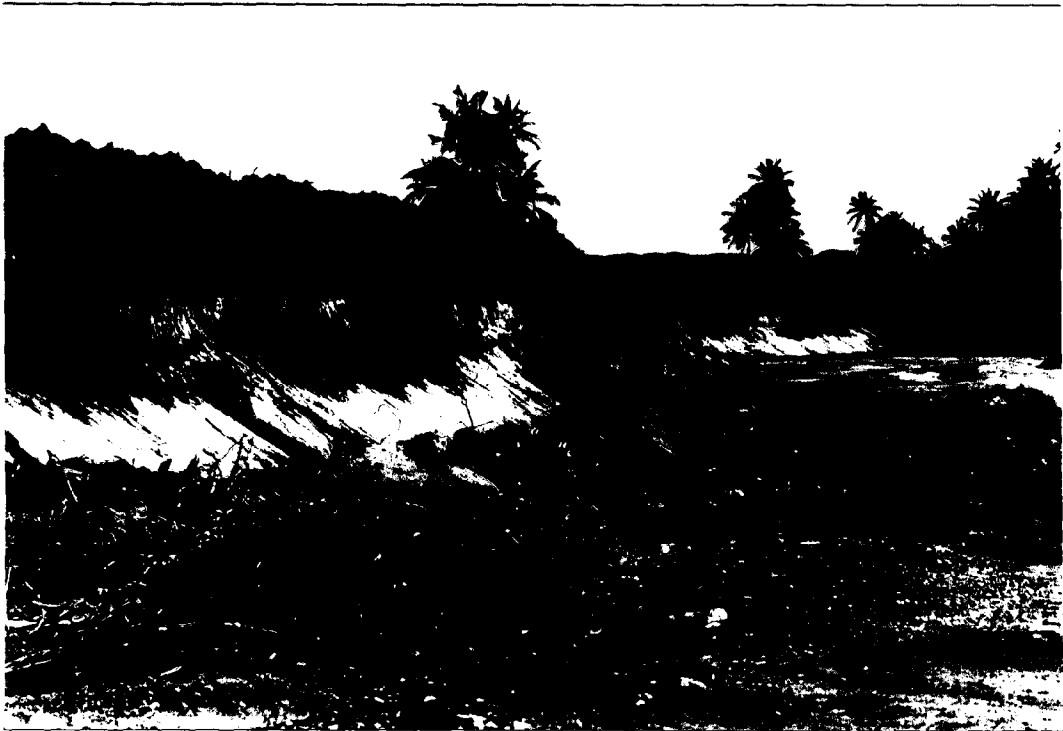
Photo 2e - Partial view towards the east.
Scraped backdune.
