**EVALUATION OF GREAT LAKES  
SHORE PROTECTION STRUCTURES**

**PROJECT REPORT**

**Michigan Department of Natural Resources  
Coastal Management Program  
Land and Water Division**

**December, 1988**

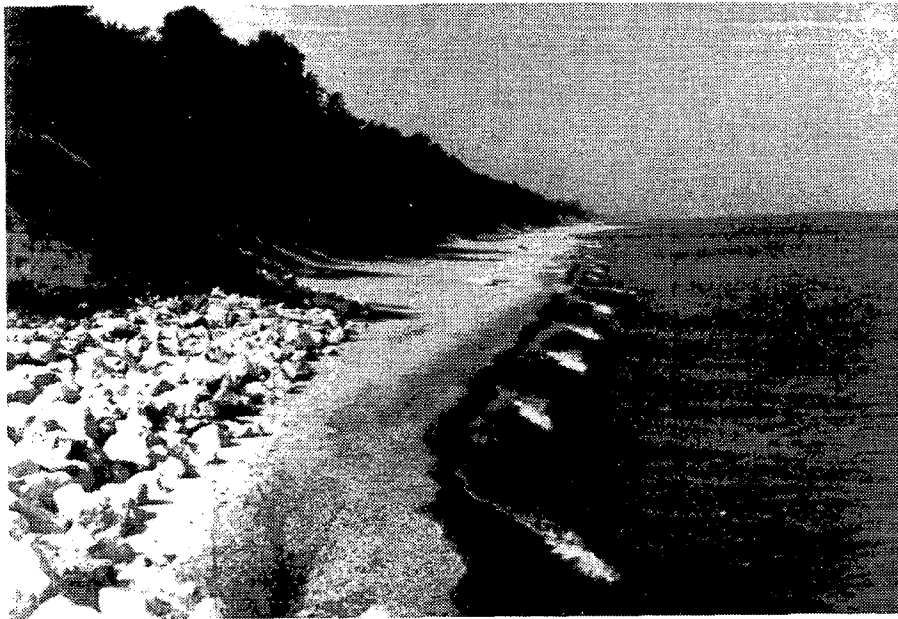
**Figure B2.** Site A: Looking along beach in a southerly direction from revetment just north of property. What appears to be groin ends is actually the end of the second tier of bags and groins extend into the water.

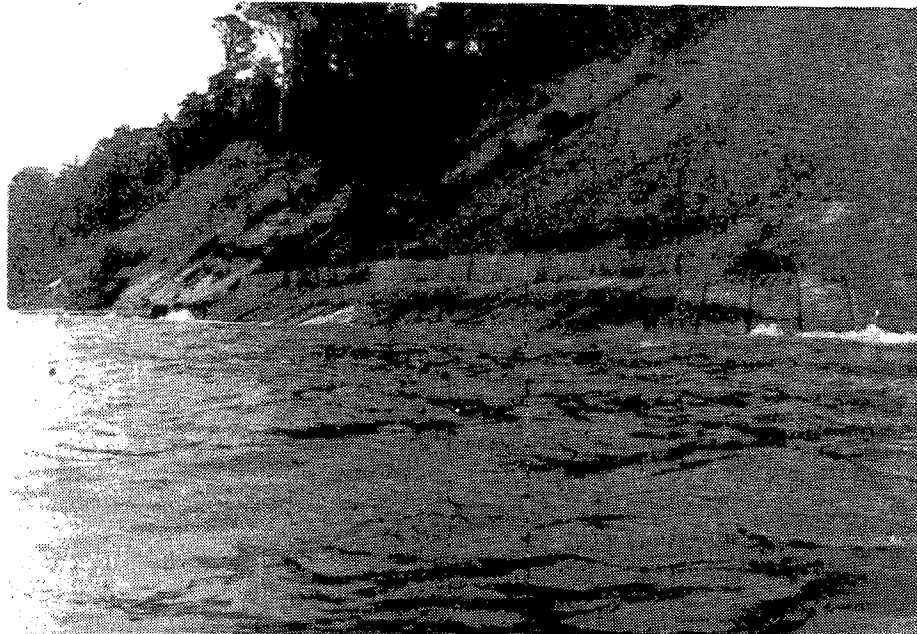
**Figure B7.** Site C: View of modular units looking from offshore onto the structure.

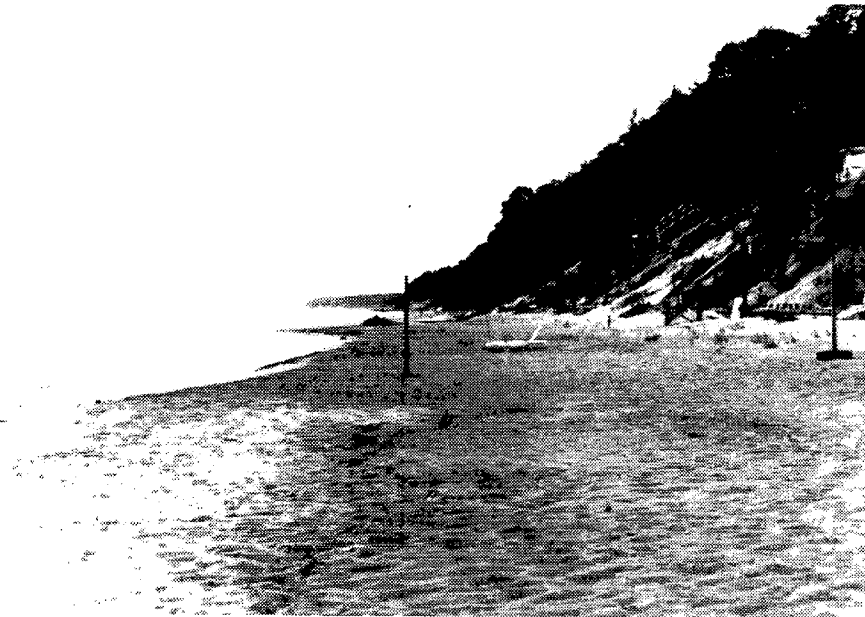
**Figure B12.** Site E: Looking to the north from southern edge of site. Shoreline is more visible in this photograph. Top of retaining wall is barely visible at right center of photo.

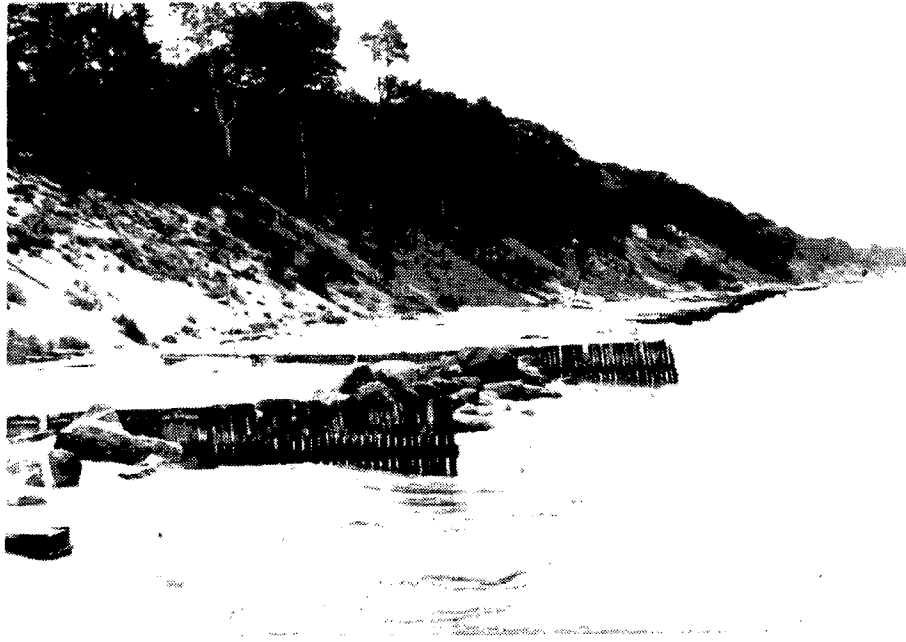
**Figure B14.** Site F: Looking south towards site from two properties to the north. Top of buried groin is immediately behind stone filled groin compartment in foreground.

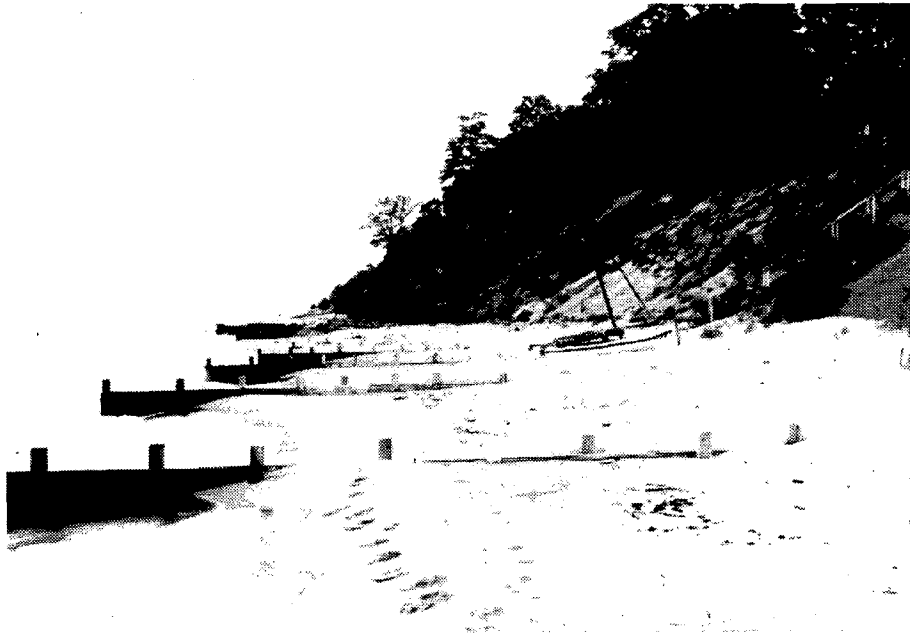
**Figure B15.** Site F: Looking north towards the site. Buried groin is to the north of the four groins in the foreground. Note longer and higher groins on either side of property.

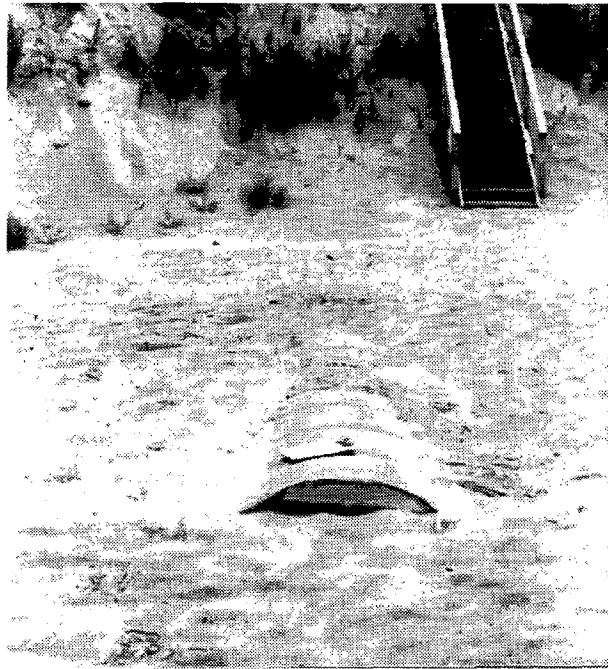
**Figure B16.** Site G: Looking directly onshore from beyond end of groin, Note that groin is almost completely buried with no beach elevation difference across groin.

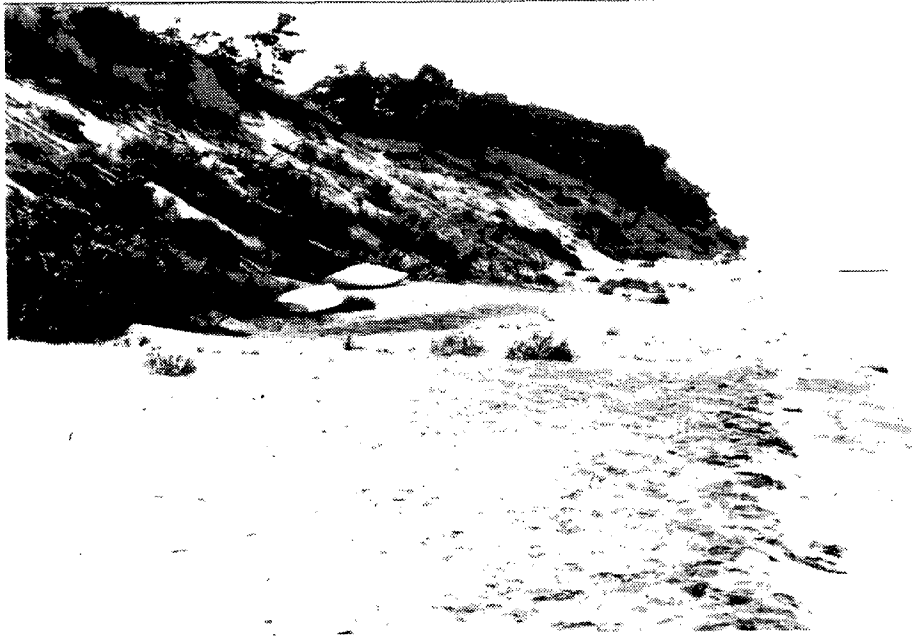
**Figure B17.** Site G: Looking south at groin. Both end of groin are visible in center of photograph.

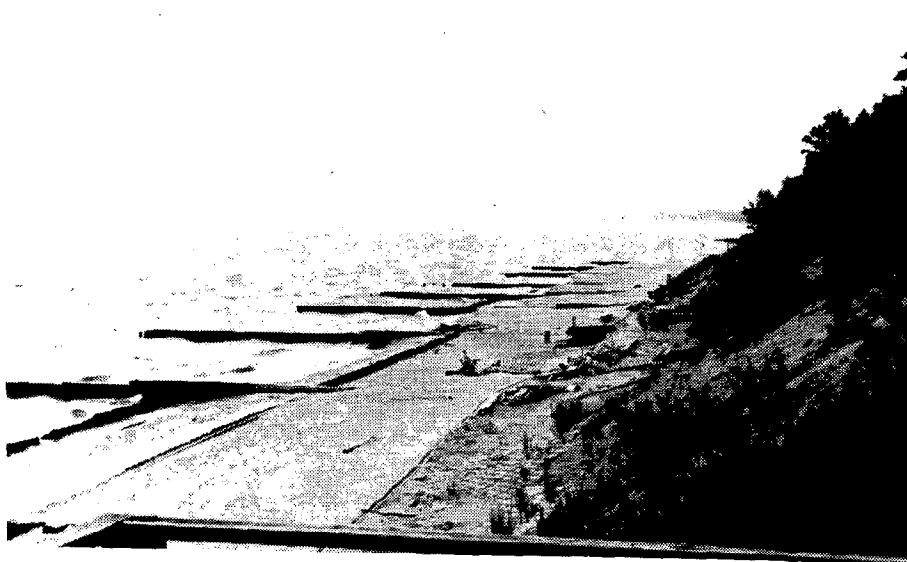
**Figure B19.** Site H: View towards the north of the last eight groins at the northern side of the system. Tops of wavebusters are visible at lower left side of photograph. Flex-blocks are visible in foreground at toe of bluff.

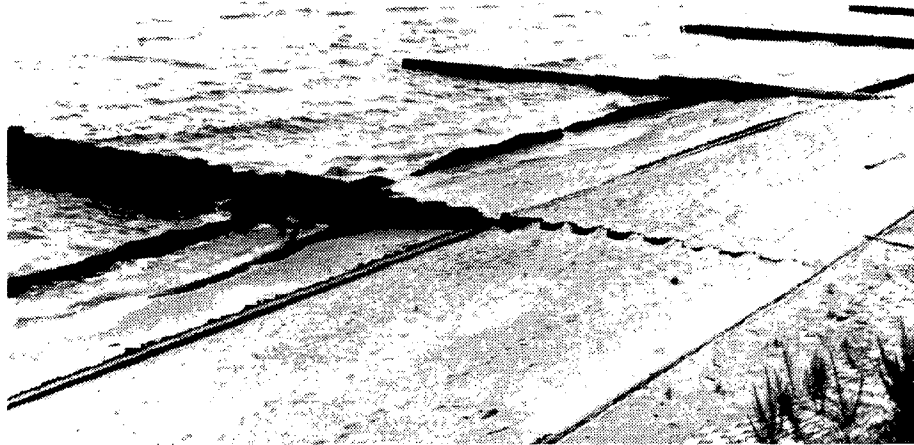
**Figure B20.** Site H: View of tops of wavebusters between groins 8 - 10 from north end of site. Wavebusters in center are also visible in Fig. B19. Note sills onshore from wavebusters.

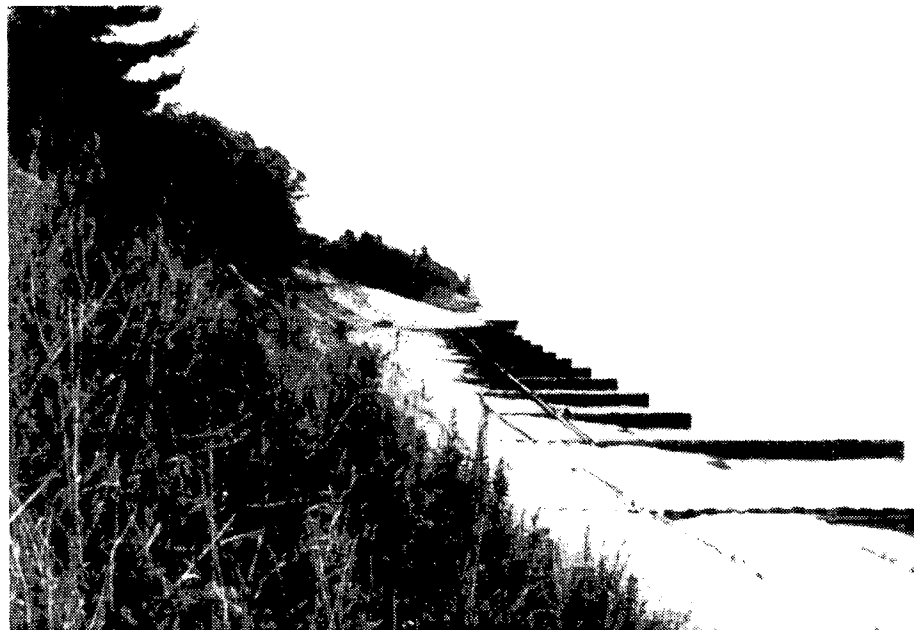
**Figure B21.** Site H: Looking towards southern end of property from approximately the middle of the groin system. Note that southernmost groins are shorter than the two closest ones. Wavebusters are present in lower right of photo.

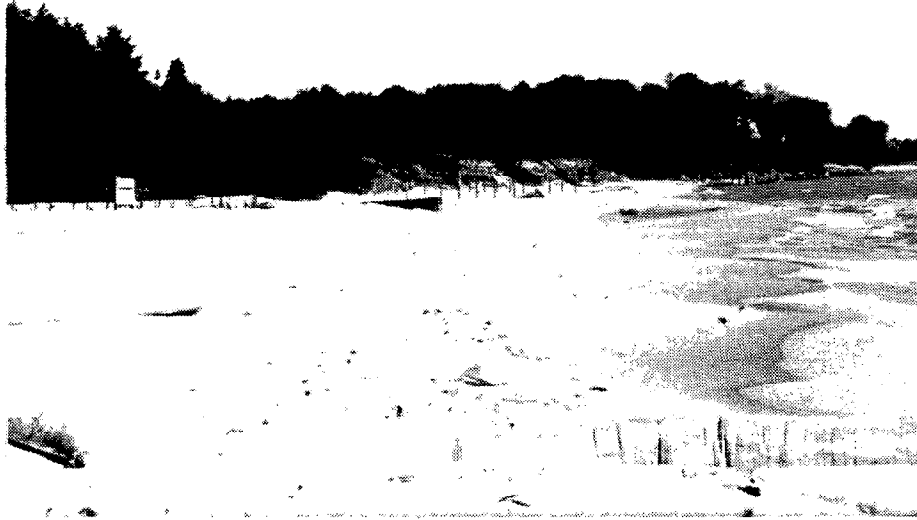
**Figure B22.** Site I: Looking south across Reid property, standing on Epworth property (site J). Tube groin on south side of Epworth property is in foreground, Light colored tube groin at center of property is barely visible below and right of sign. Timber groin at south side of property is also visible and note lack of beach farther o south.

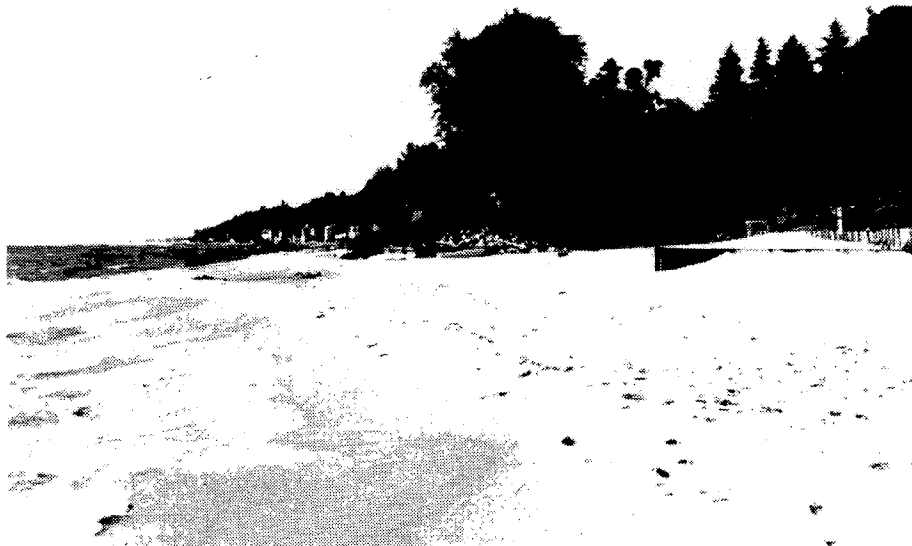
**Figure B23.** Site I: Looking north across property. Timber groin at south property boundary is present at center right and end of tube groin on Epworth property is also visible below edge of line of trees. Epworth property is on other side of sailboat.

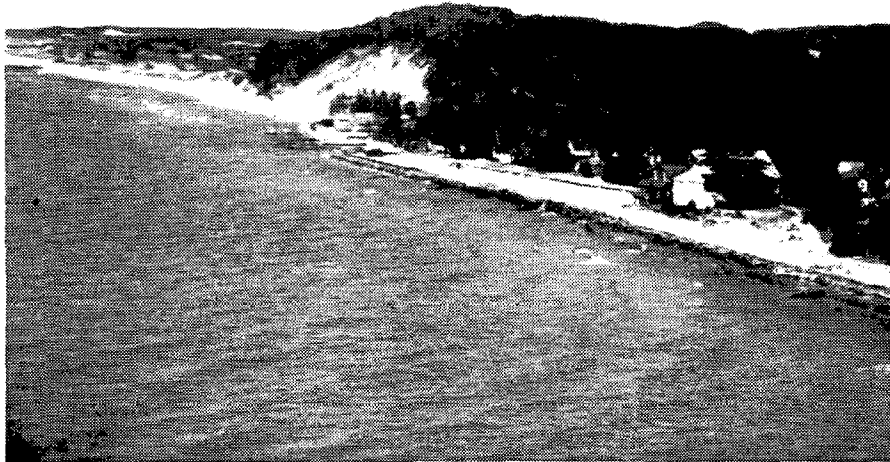
**Figure B26.** Site J: Aerial view of northern part of Epworth property. Revetment is visible along shoreline with remnants of old shore protection systems.

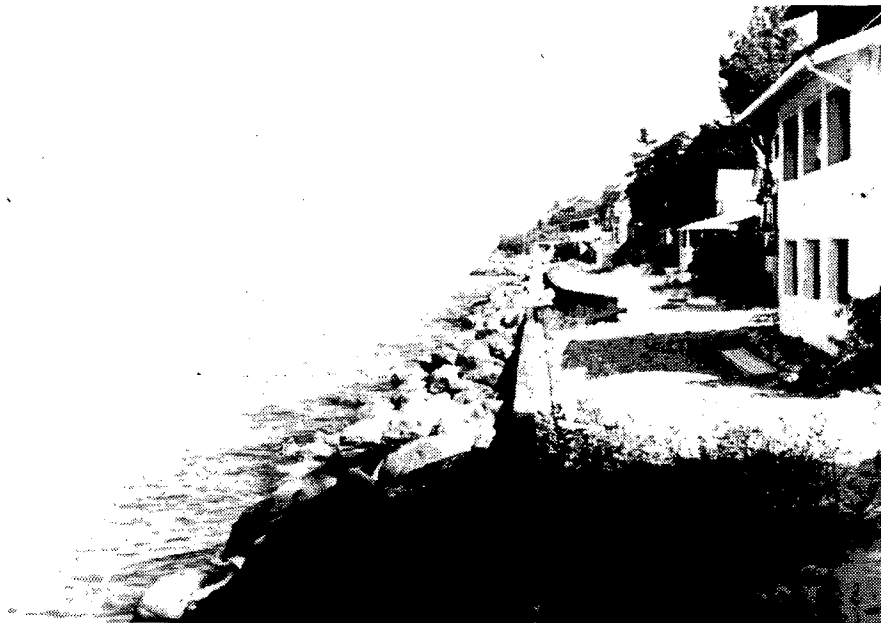
**Figure B27.** Site J: Closer view of revetment at location where it is backed by a retaining wall.

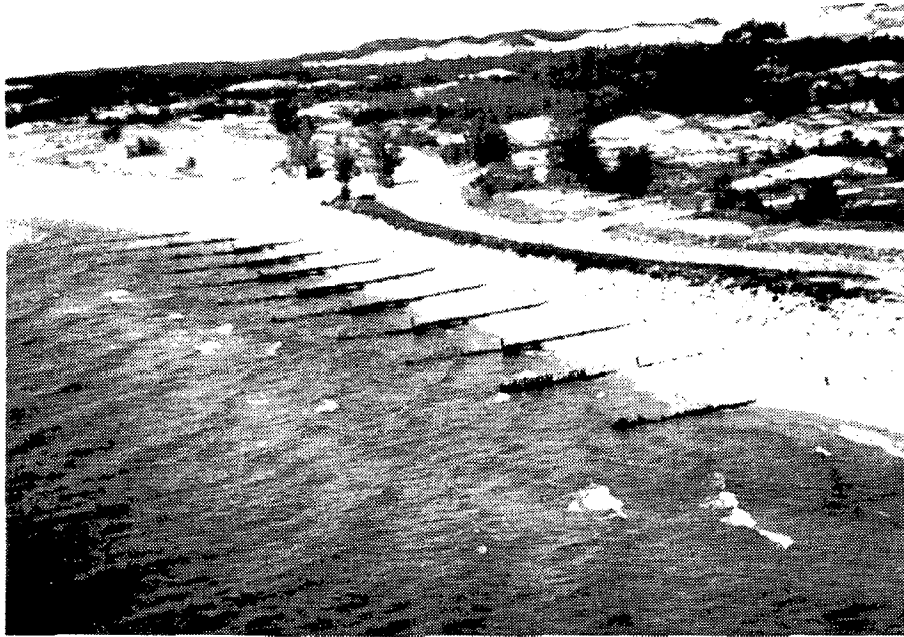
**Figure B28.** Site K: Aerial view of 13 groin field. Note remnants of old groin system.

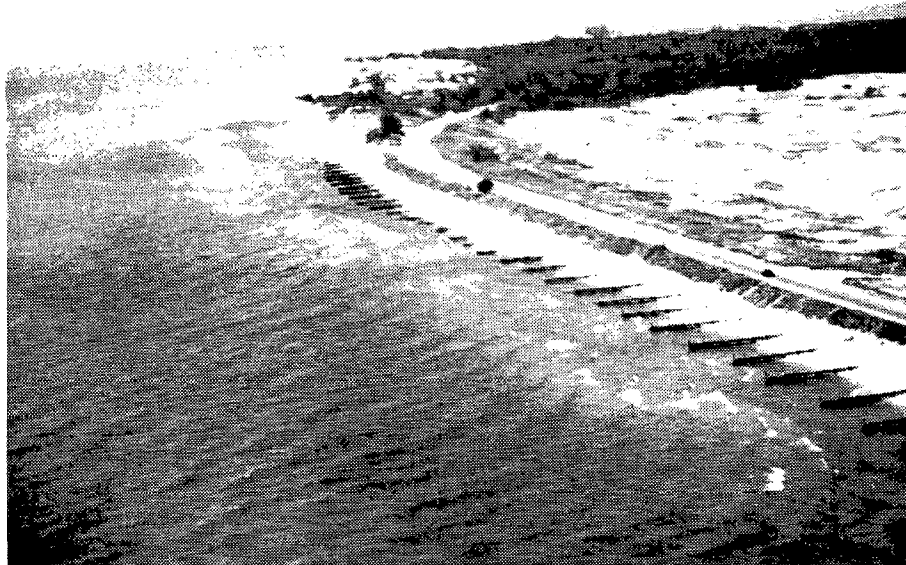
The above interpretation would be more or less consistent with the observations in the long (58 groins) groin field north of Ludington (site K) in which it is observed that the compartments within the groin field are filled more towards either end than in the center (Figs. B29 and 30). Since the original groin system also never filled at the center in the 25-plus year period of time after it was constructed, it would support the general conclusions drawn above. All of the other groin systems (including the 13 groin system just to the south) investigated were considerable shorter and the same features were not observed and conclusions are more difficult.

**Figure B30.** Site K: Aerial view somewhat to the north of Figure B29. Northern end of groin field only is visible. Note that some groins are almost completely filled.

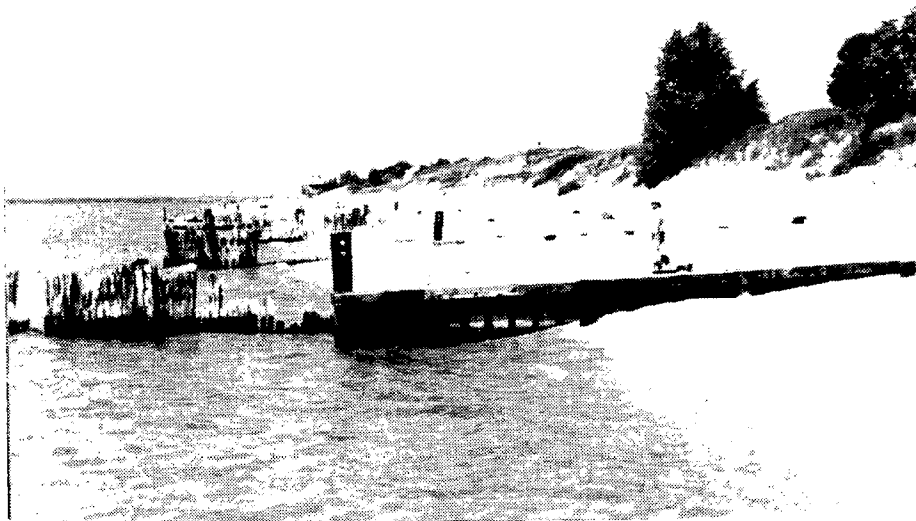
**Figure B31.** Site K: Looking north across southerly groin field. First groin is the seventh one from south side. Note that new groins are shorter than remnants of old system.

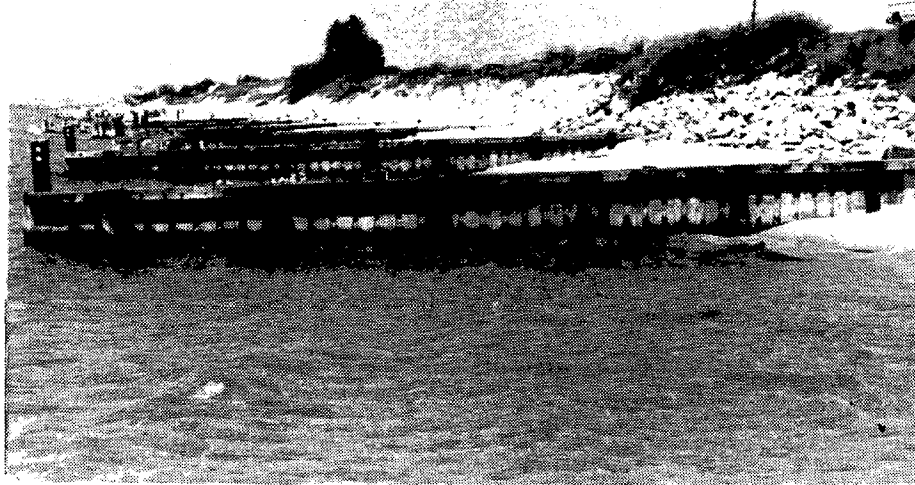
**Figure B32.** Site K: Looking north across long groin field. Groin in foreground is 50th from southern end of system or close to northern end.

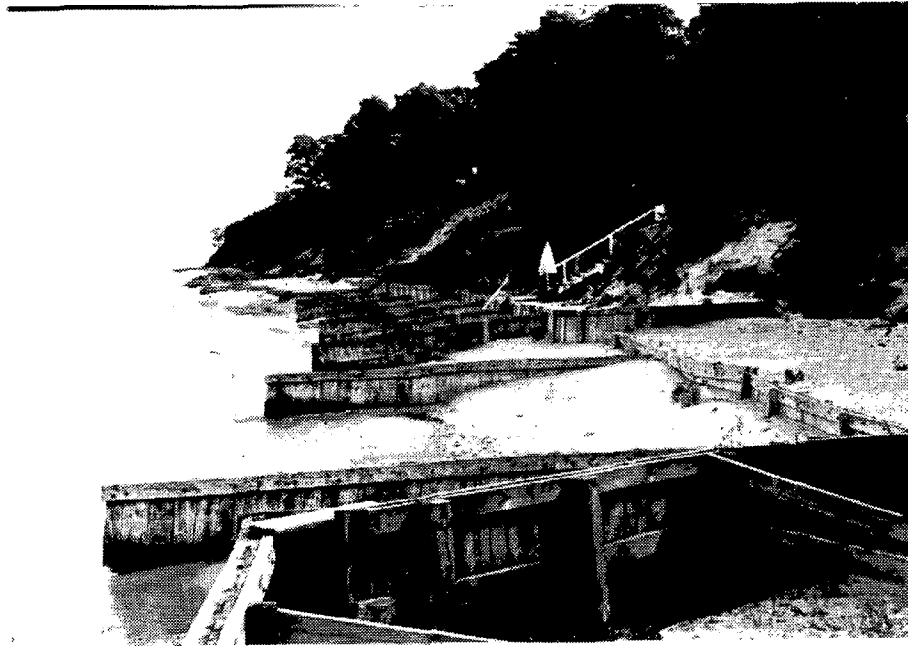
**Figure B34.** Site L: Looking north across site from the property to the south. Two groins and low retaining wall beyond high retaining wall are part of this system. Note other shore protection along shoreline.

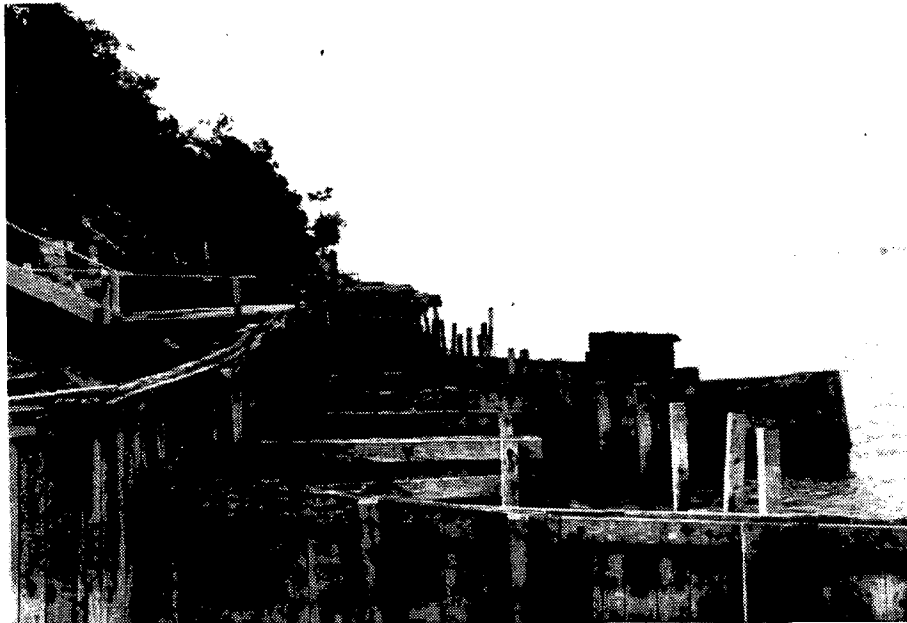
**Figure B35.** Site L: property just to south of site. Note closely spaced short timber groins projecting from retaining wall.

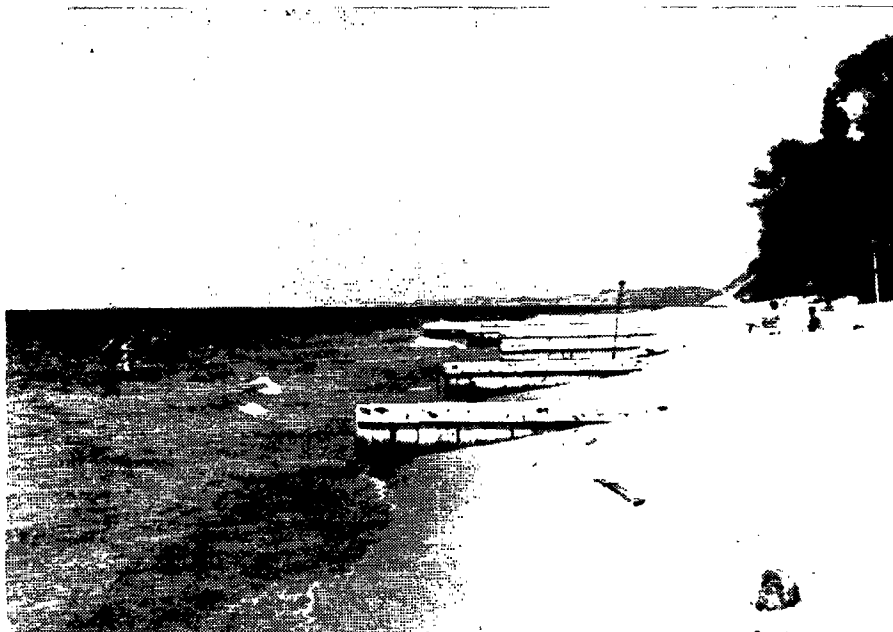
**Figure B37.** Site M: Looking northwards from beyond southern edge of groin system.

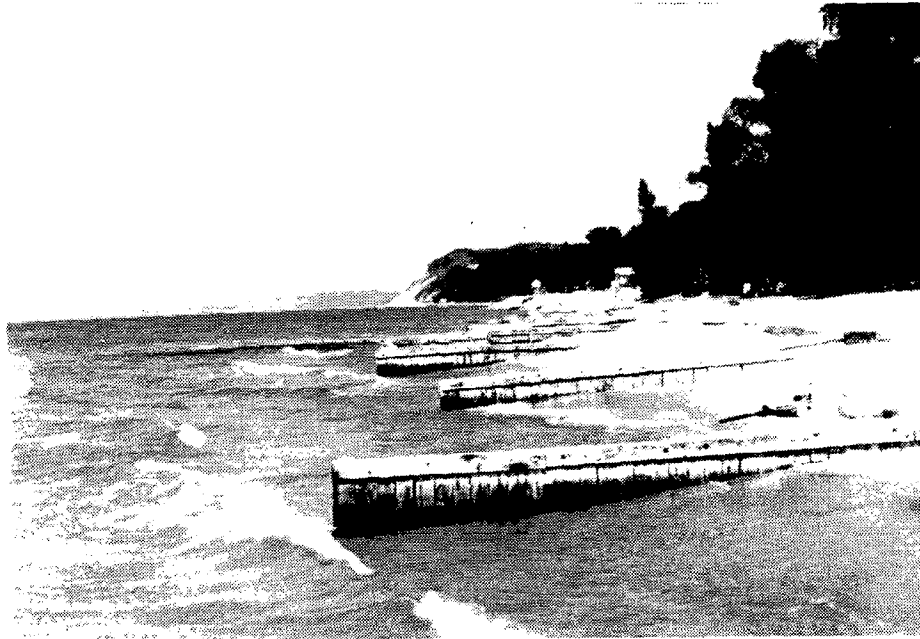
**Figure B38.** Site M: Looking north from southernmost long concrete groin, second one is visible parallel to horizon.

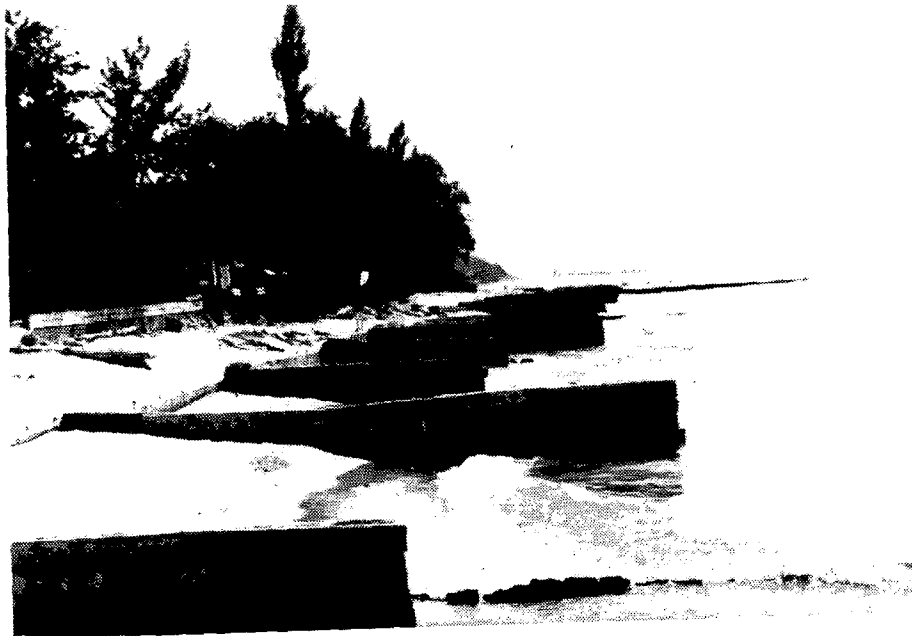
**Figure B39.** Site M: Looking south from 8th groin north of second long concrete groin.

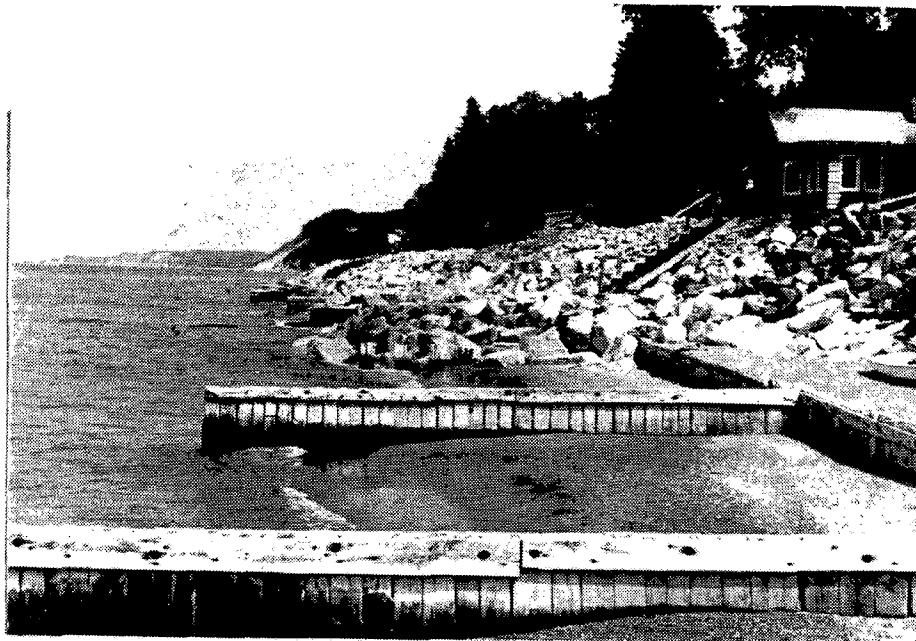
**Figure B40.** Site N and O: Looking north towards the long revetment on site O from Site M and N property. Revetment on site N is just visible to the right and well up above the existing water level. Also groin and sill system exists between revetment and shoreline. Note old groins within revetment on site O.

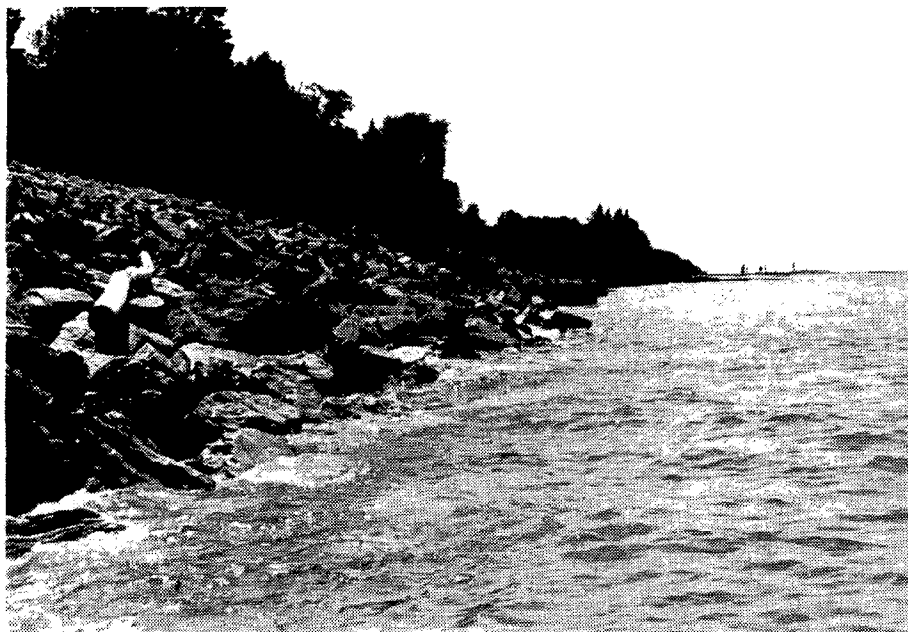
**Figure B41.** Site O: Looking south along revetment from location in Fig. B36 where abrupt turn in shoreline occurs.

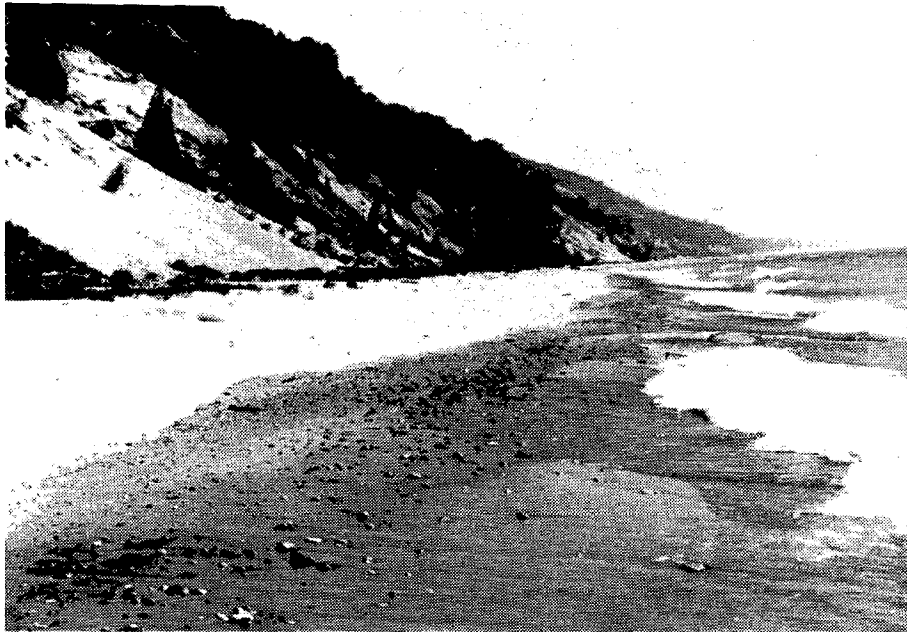
**Figure B45.** Site P: Looking to south across site. Beach becomes narrower to the south. Also note groin end at water's edge,

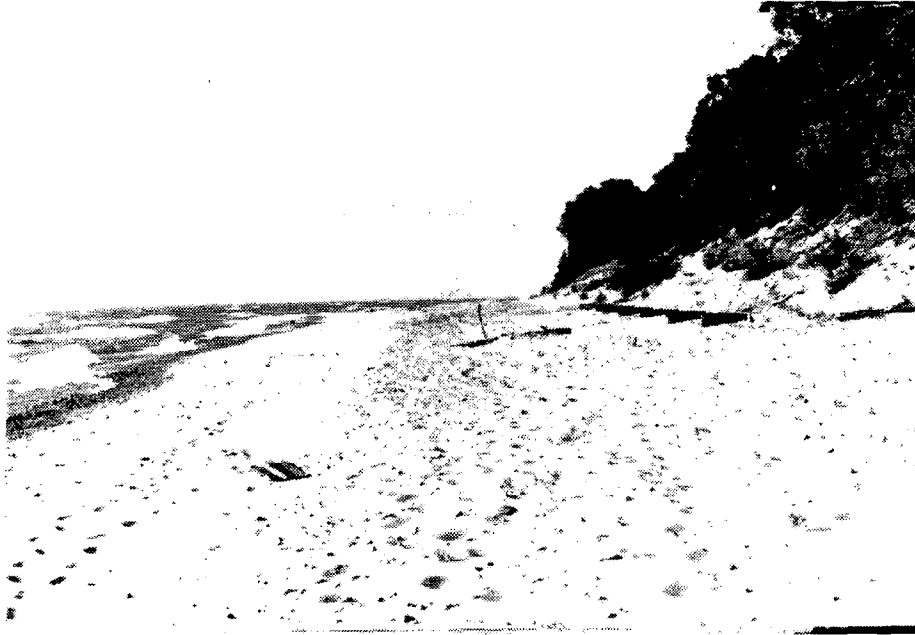
**Figure B48.** Site S: Looking north at retaining wall just visible at toe of bluff.

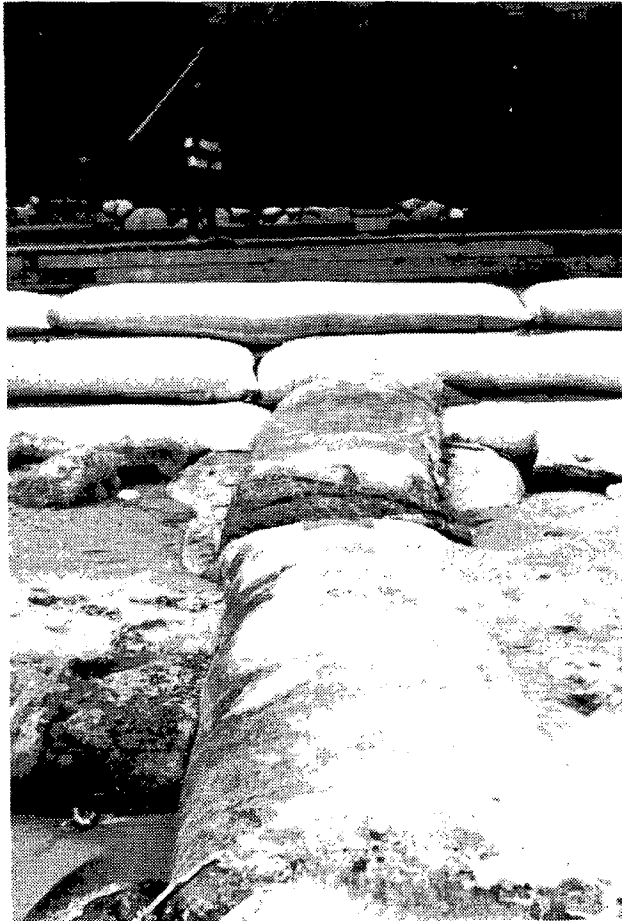
**Figure B50.** Site U: Looking onshore from third groin from southwest end. Note higher filling on right side of groin

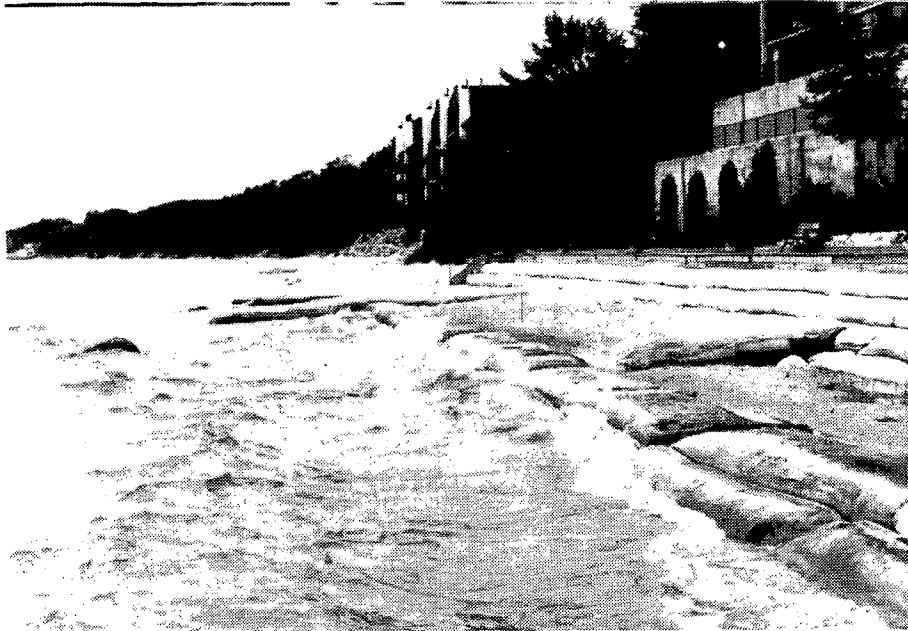
**Figure B51.** Site U: Looking northeasterly from same point as Fig. B50. Note sand filling behind offshore sill. Beach is beyond sill to the south of this location.

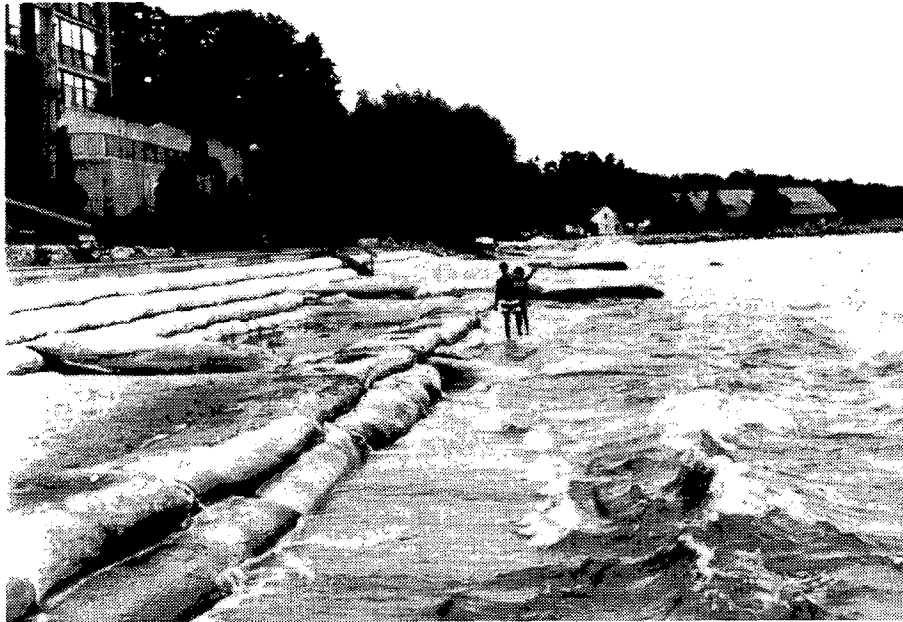
**Figure B52.** Site U: Looking towards the southwest from the most northerly groin in the system. Beach is higher behind bathers, may be due to artificial filling or littoral drift from the southwest.

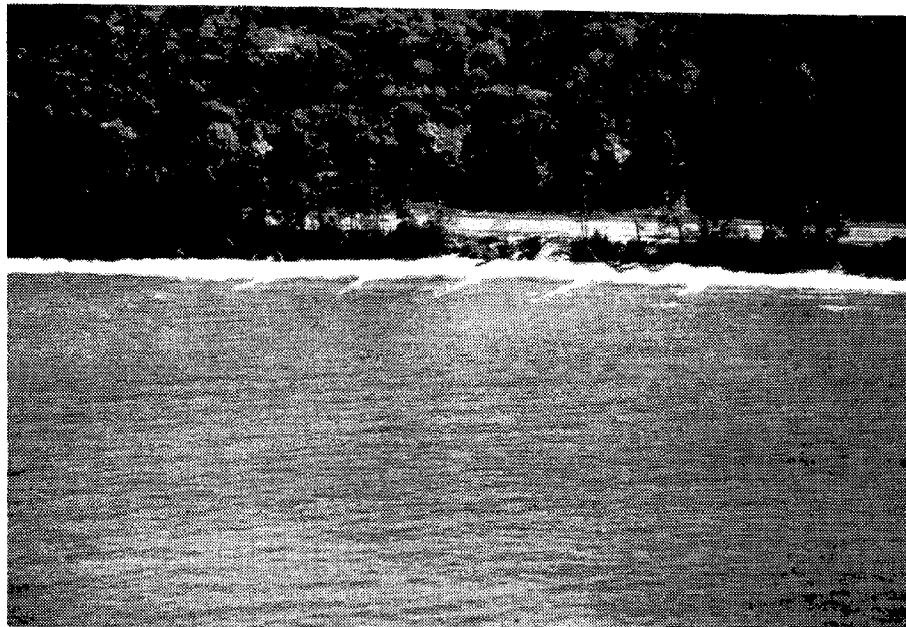
**Figure B53.** Site V: Aerial view of 5 groin system.

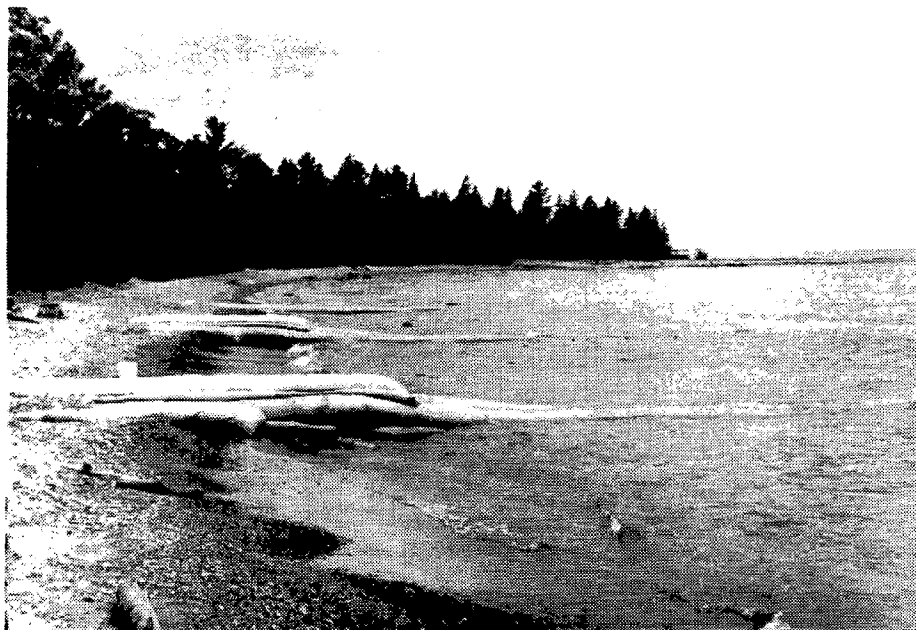
**Figure B54.** Site V: View looking towards the southwest over the top of the 5 groin system.

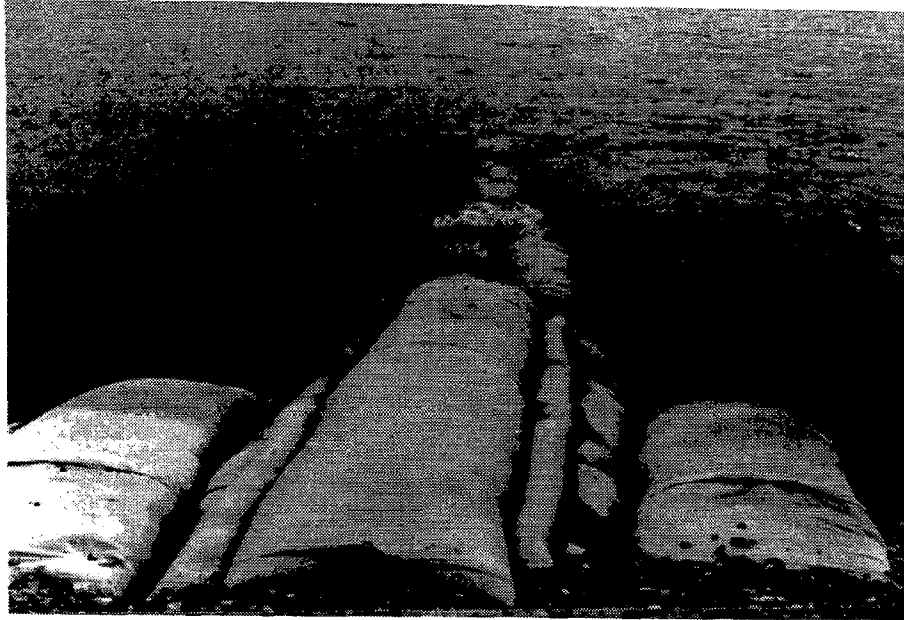
**Figure B55.** Site V: Same location as Fig. B54 except looking offshore along tube groin.

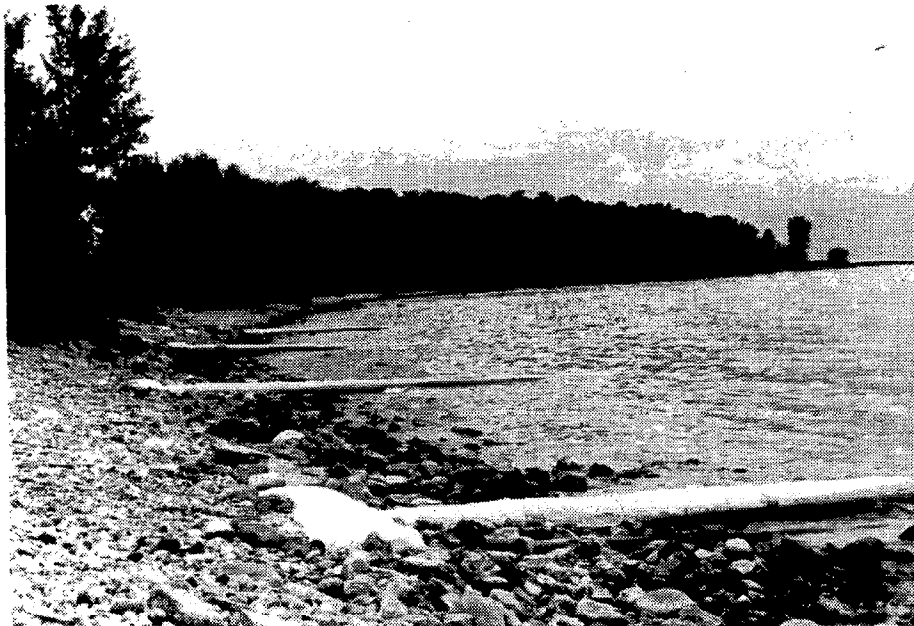
**Figure B56.** Site V: Four groin system, looking southwest. Note coarse beach material at this site.

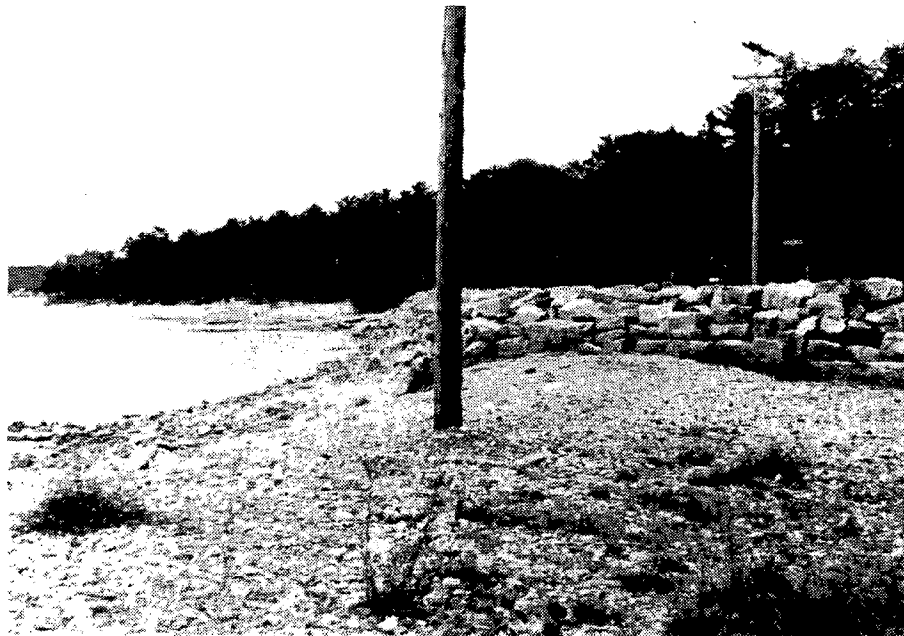
Figure B58. Site W: looking at southwestern side of revetment.

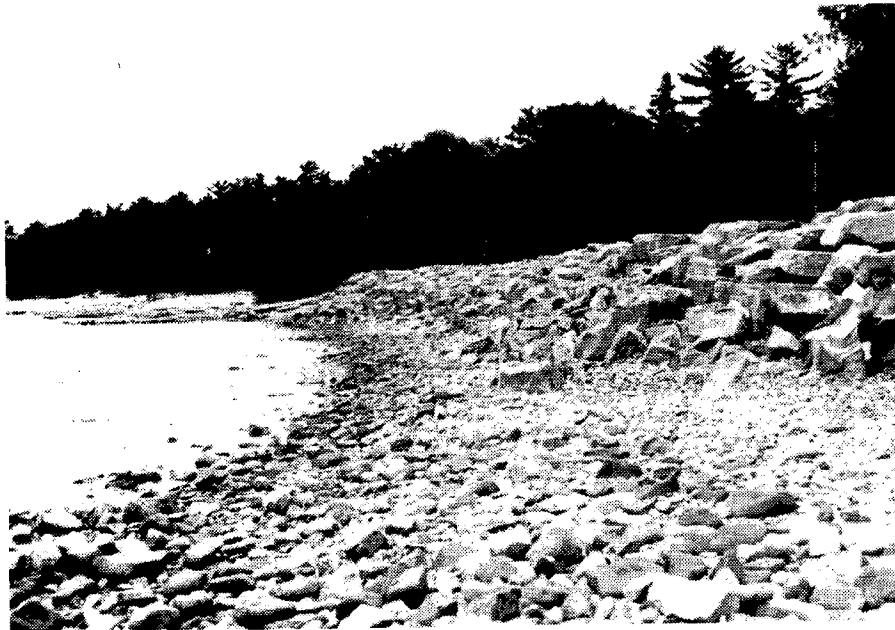
**Figure B59.** Site W: Looking at coarse beach in front of revetment.

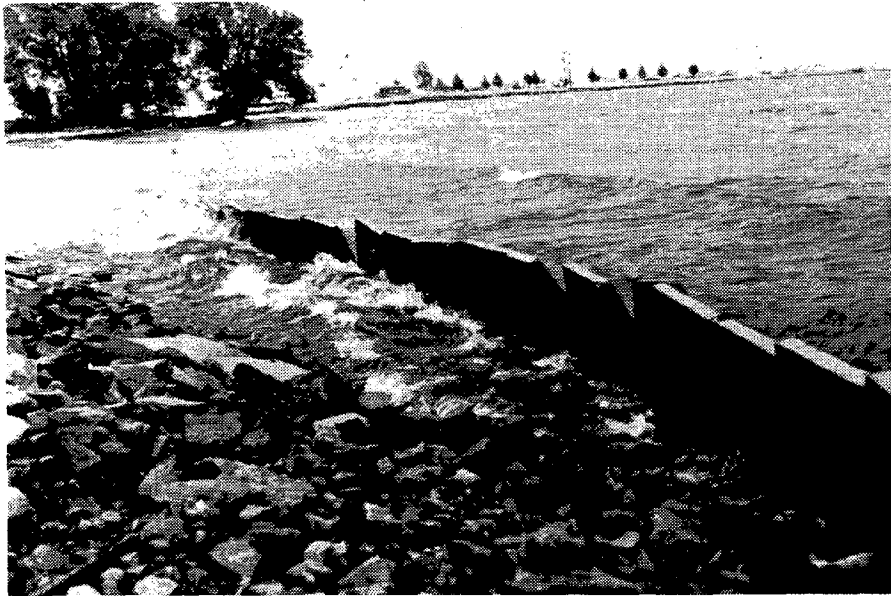
**Figure B60.** Site X: Normandy type wavebusters in front of 240 S. State. Note revetment almost immediately behind wavebusters.

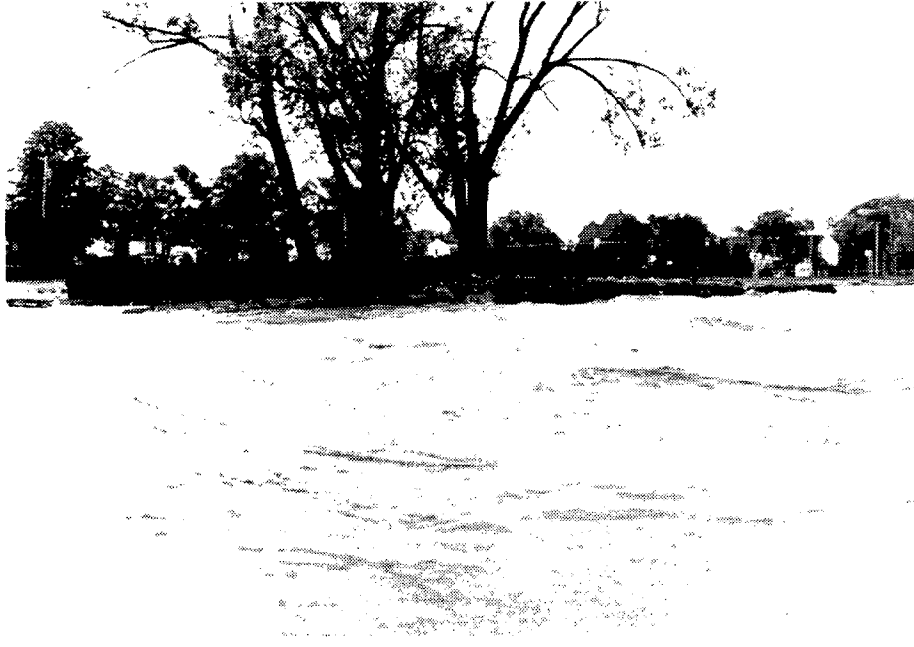
**Figure B61.** Site X: Looking generally onshore towards 240 S. State (right) and 250 S. State (left). Trees, seawall, etc. are on 240 S. State property.

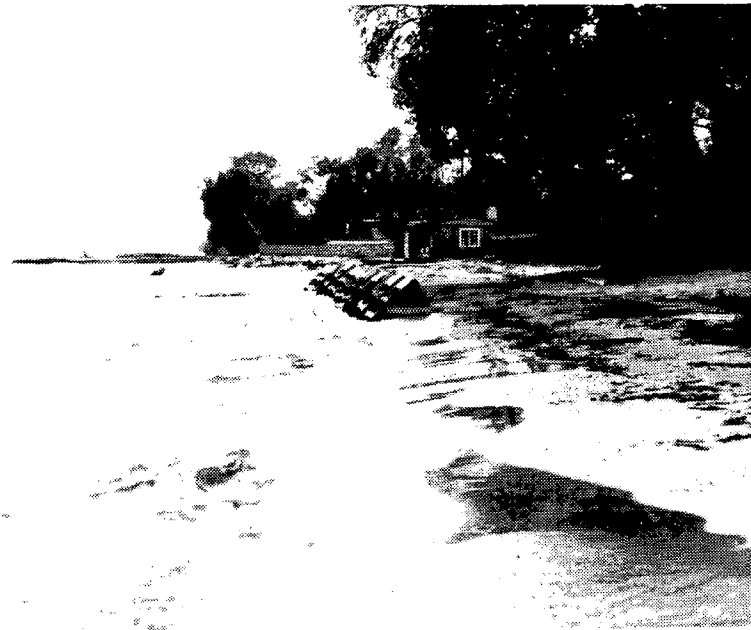
**Figure B62.** Site X: Looking south at wavebusters at 430 S. State. Note shore protection allows property to south to project farther lakeward.
