**EVALUATION OF GREAT LAKES  
SHORE PROTECTION STRUCTURES**

**PROJECT REPORT**

**Michigan Department of Natural Resources  
Coastal Management Program  
Land and Water Division**

**December, 1988**

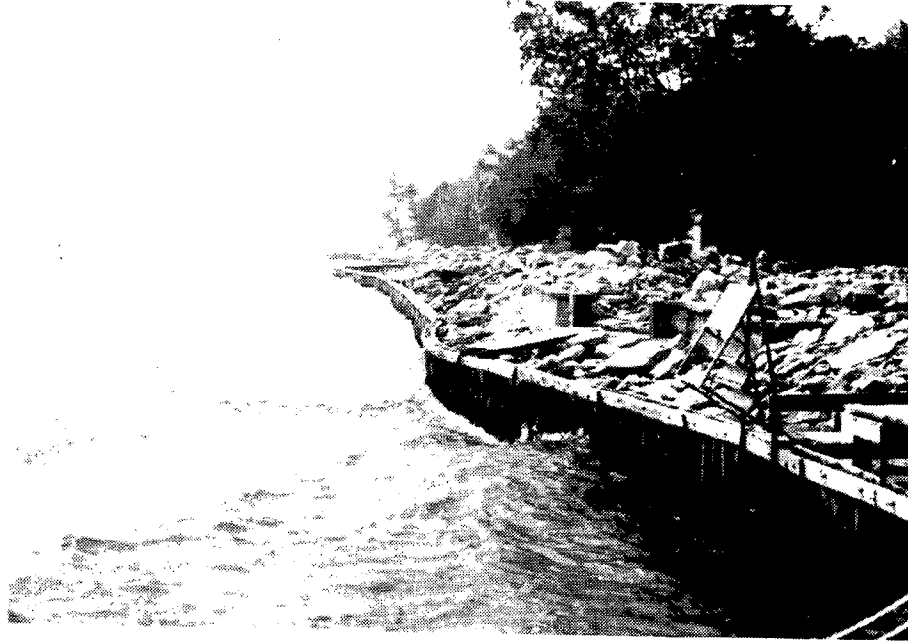
The site is characterized by existing structures similar to that described above (Fig. B63), except that the existing pole wall is in fairly poor condition. An additional problem is that the previous construction was undertaken in a piecemeal fashion with some walls extending farther lakeward than others. The plan as presented in the permit application proposed to tie the whole lakeshore together in a more continuous fashion with an overall plan presented for a whole stretch of shoreline. However, it appears that a good number of the property owners will not be participating in the project and the shore protection will again be undertaken in a piecemeal fashion here. The existing wall is about sixteen years old at present and appears to have been reasonably stable although there is no beach in front of the wall and water depths are typically 3-5 feet at the walls.

Figure B63. Site Y: Looking south from Philip's property.

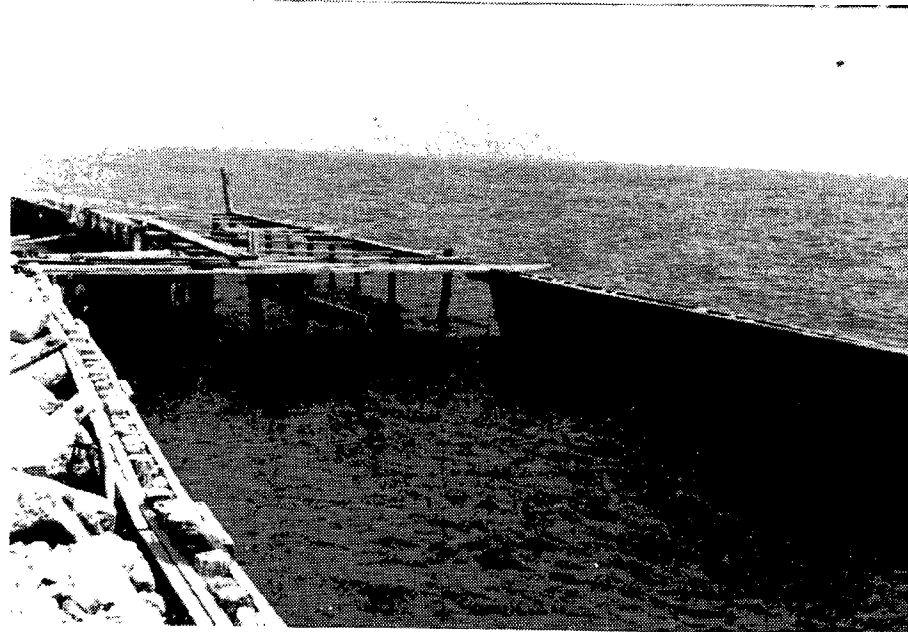
Figure B64. Site Y: New wall construction at Heller property.

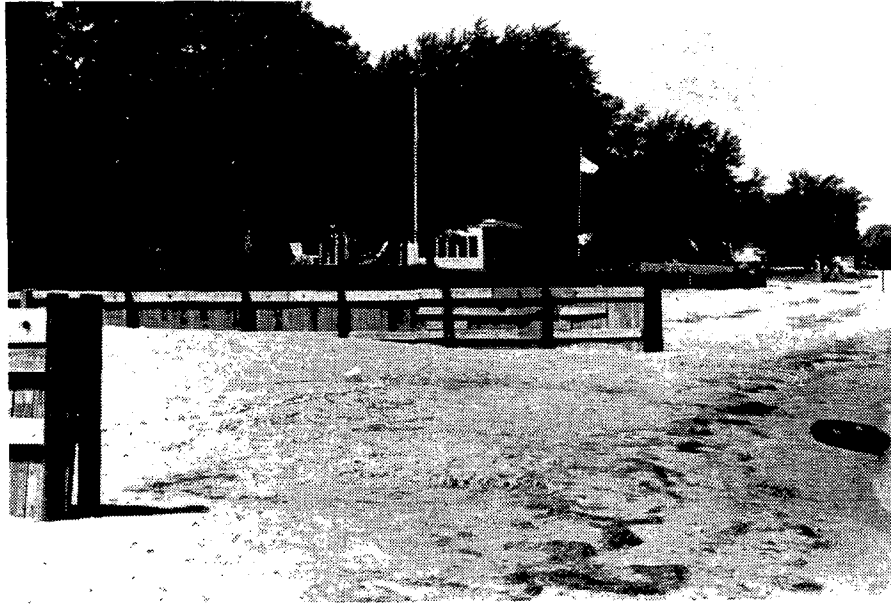
**Figure B67.** Site AA: Looking north towards groin. Note shoreline considerably beyond end of groin. Also note similar structure to south at left side of photo.

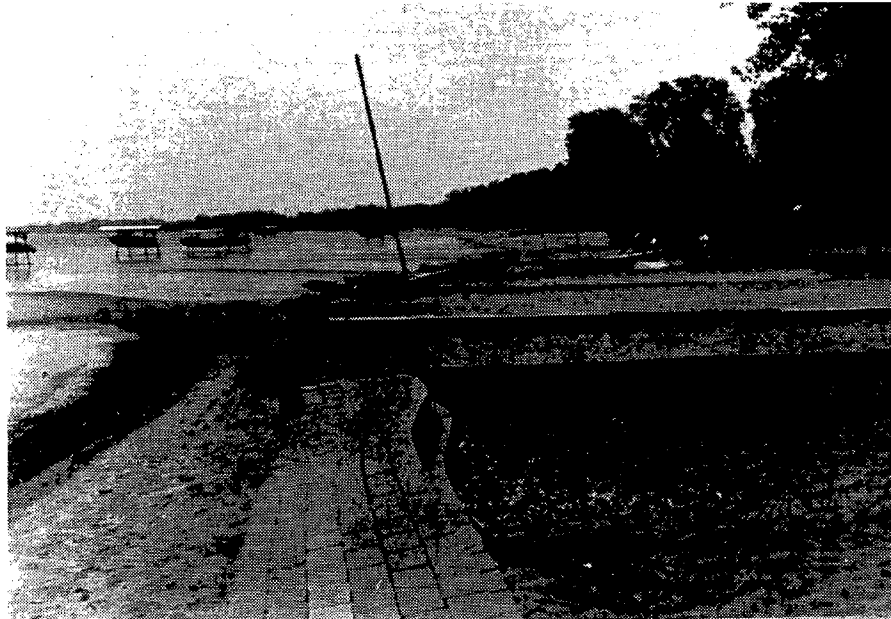
At this site, as in the two previous ones, there is a lot of sand in the offshore region (Fig. B68) and the water depths are fairly shallow for a considerable distance offshore. It seems likely that it was only the problem of the extremely high water and the wind seiche on Saginaw Bay that may have caused problems at these sites. A very broad beach naturally exists to the south of the site in locations where little, if any, shore protection is present. It is concluded that most of the changes at this site are associated with changes in lake levels and not the effectiveness of a particular shore protection system.

**Figure B68.** Site BB: Looking south towards site. Property is between two groins between catamaran and sandgrabber wall in foreground. Note sand spit offshore.

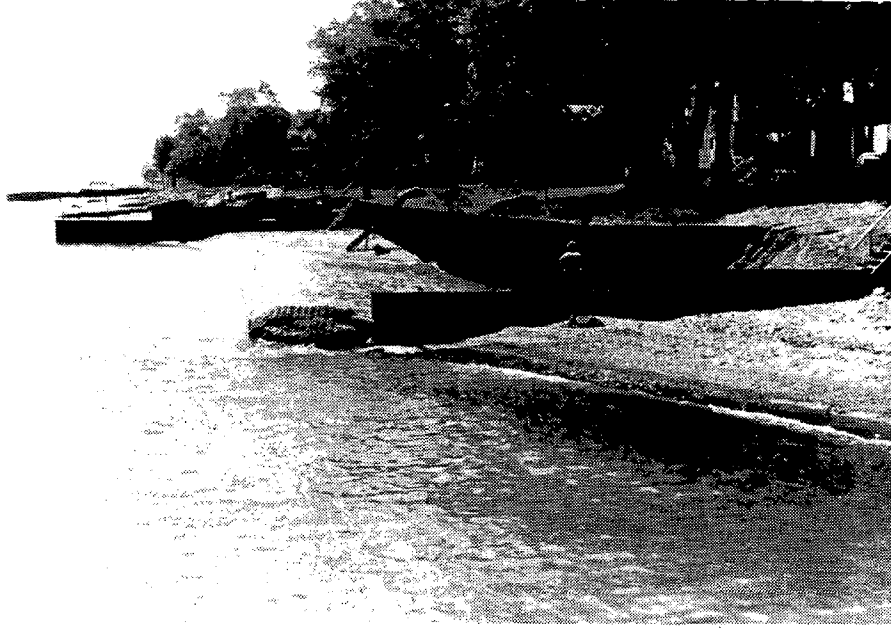
**Figure B69** Site DD: Looking south across Sharpe property. Existing groin with large boulder in front is their groin. Note small sand fillet in corner of seawall-groin system immediately to the south. Also note that Sharpe groin does not project as far lakeward as the groin to the south or the groin from which the photo was taken.

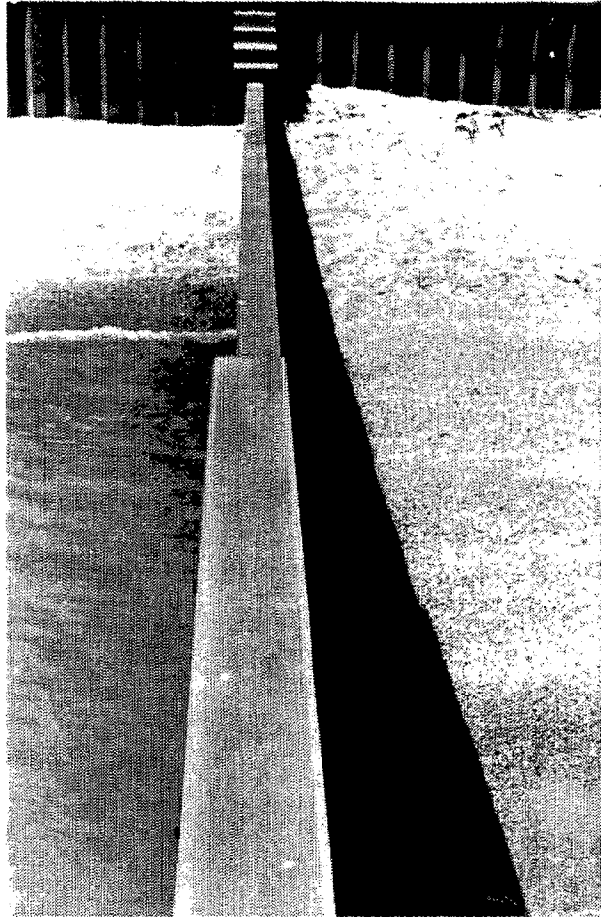
**Figure B70.** Site DD: Looking shoreward along groin on north side of Sharpe property. Littoral drift is right to left. Total groin length is about 50 feet.

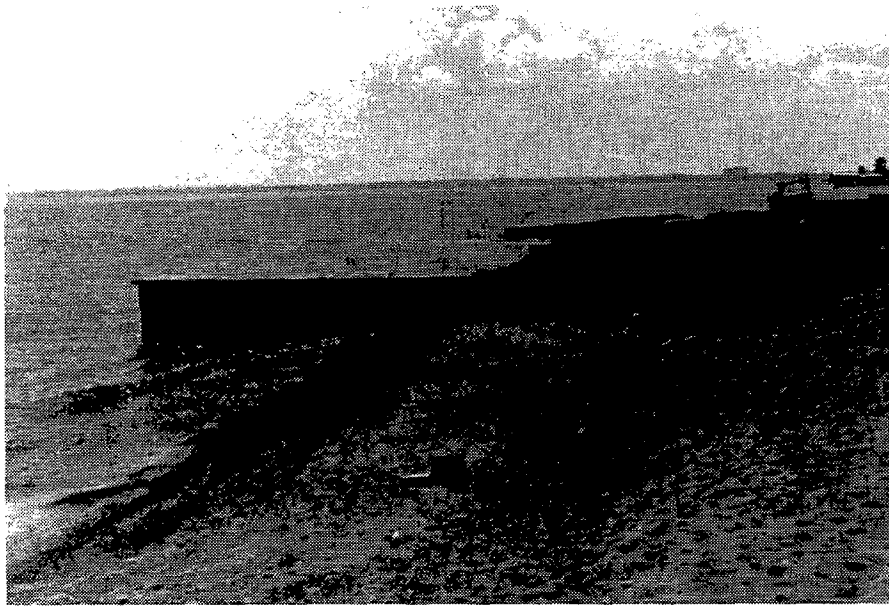
**Figure B71.** Site GG: Looking south at Durand groin. Sand on beach is just a fine layer with coarse cobbles underneath.

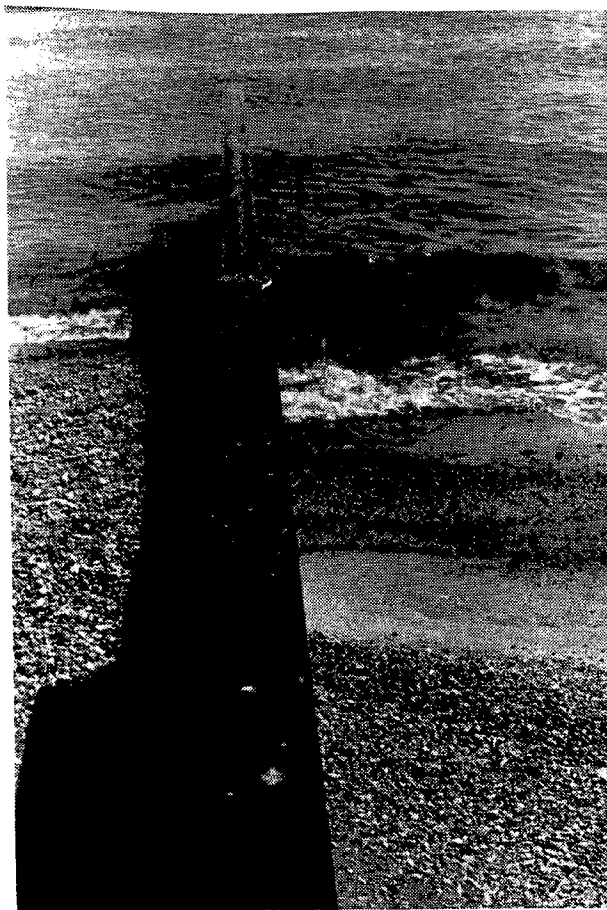
**Figure B72.** Site GG: Looking offshore along Durand groin. Littoral drift is left to right.

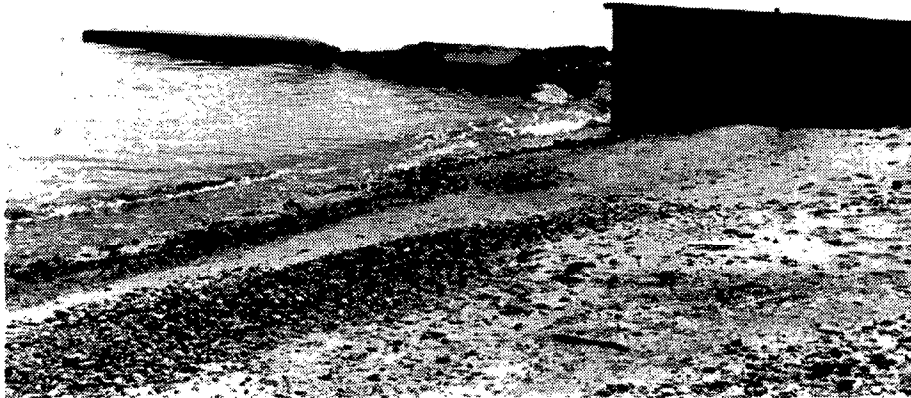
**Figure B73.** Site HH: Looking towards the southeast from north corner of Wines' beach. Remnant of old concrete groin extends beyond steel groin.

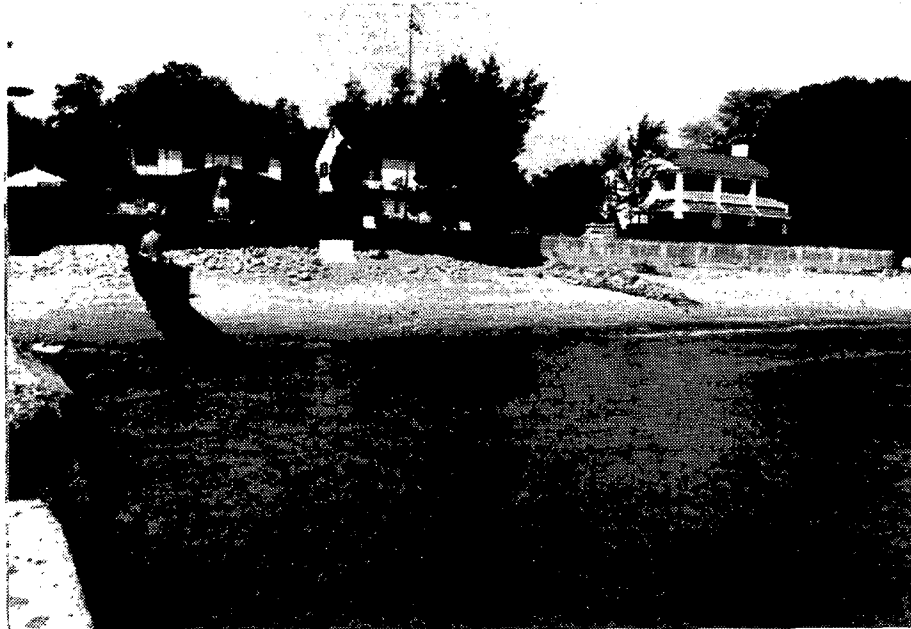
**Figure B74.** Site HH: Looking onshore from end of old concrete groin (Fig. B73) towards new steel groin and beach.

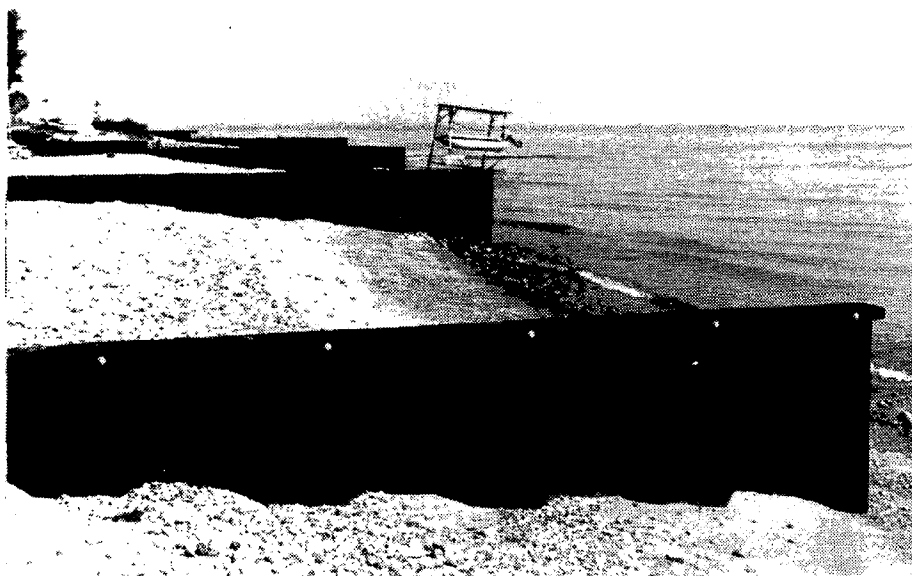
**Figure B75.** Site II: Looking north across system of groins from just south of property. Note beach nearly fills groin compartments and general coarse littoral material.
