Service Assessment

Super Typhoon Paka December 2 thru 21, 1997

U.S. DEPARTMENT OF COMMERCE
National Oceanic and Atmospheric Administration
National Weather Service
Honolulu, Hawaii

June 1998

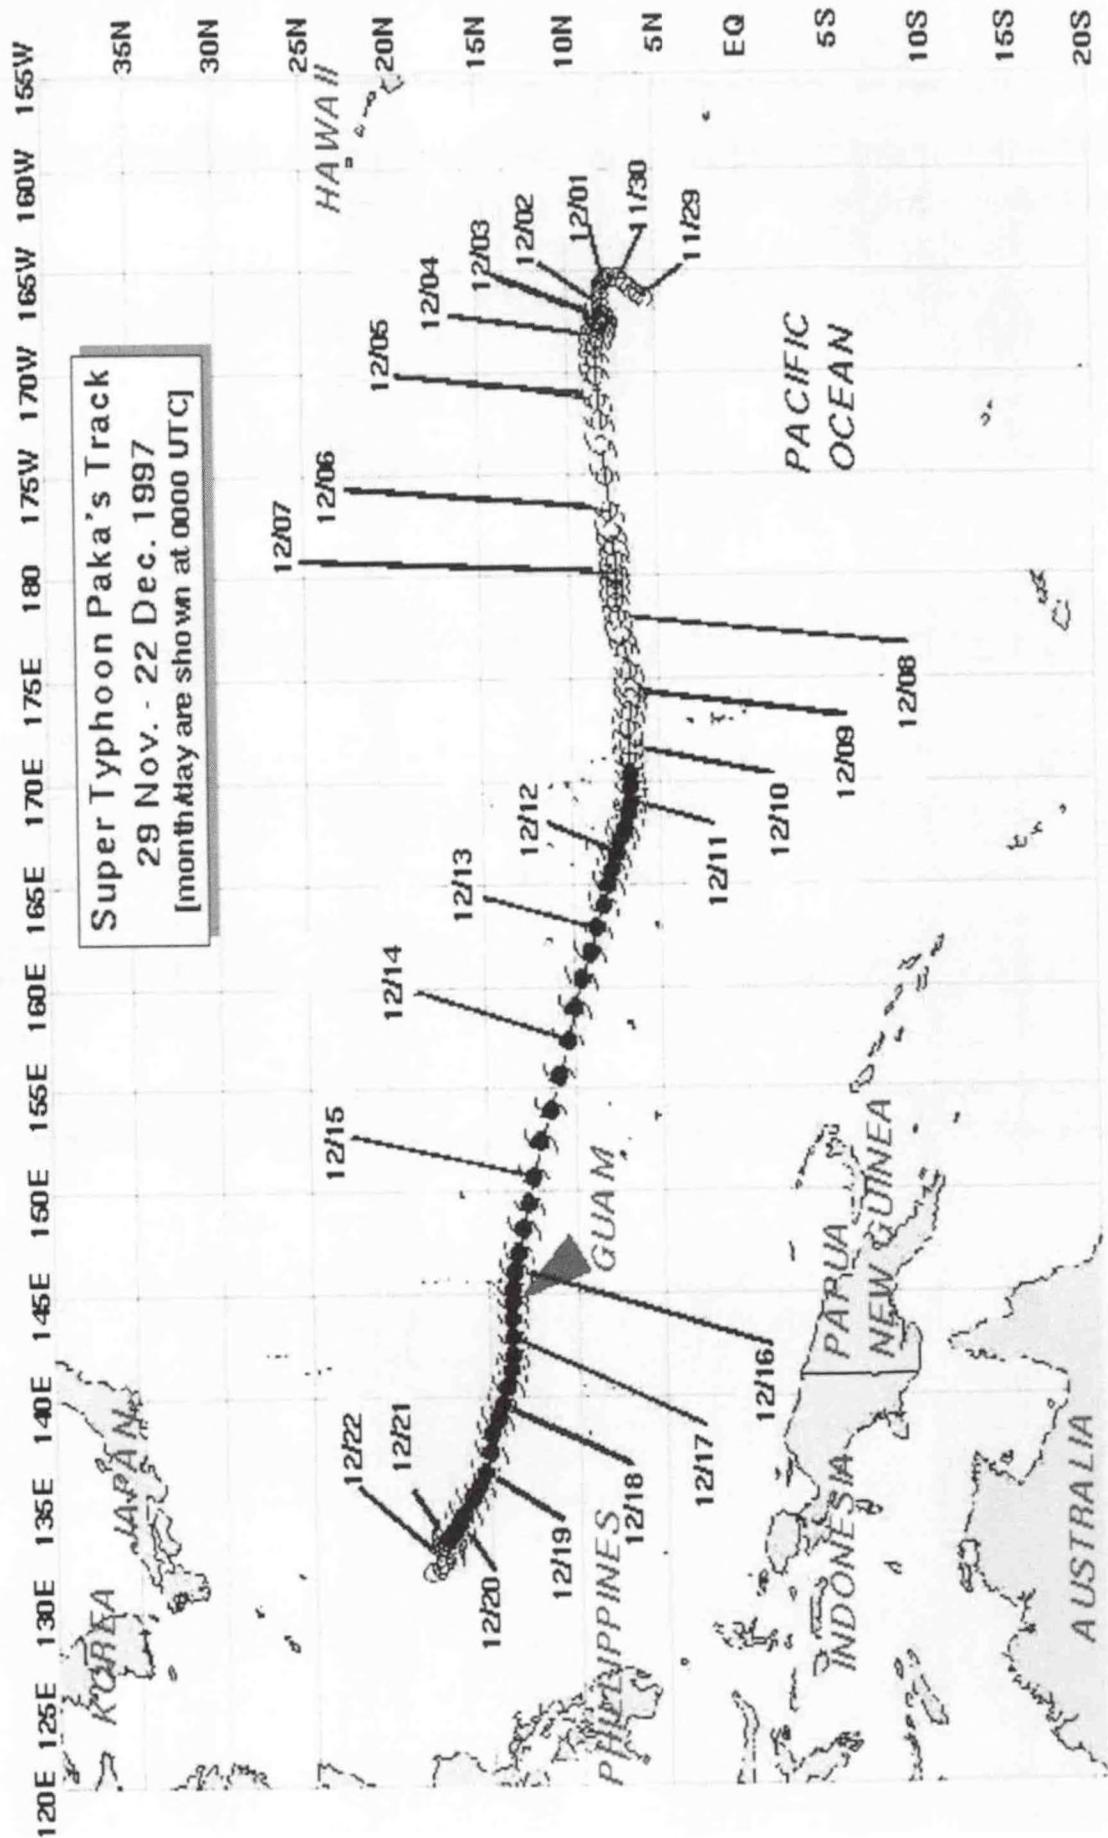
Figure 1: Track of Super Typhoon Paka Courtesy of Joint Typhoon Warning Center

However, Paka's more west to west-southwest track through the eastern Marshall Islands (before exiting on a more northwest track) encountered less shear and warmer SST (2 degrees C) that was just enough to overcome an earlier sheared upper level environment, and resulted in a more favorable outflow pattern that led to rapid intensification on December 11 (see Figure 1).

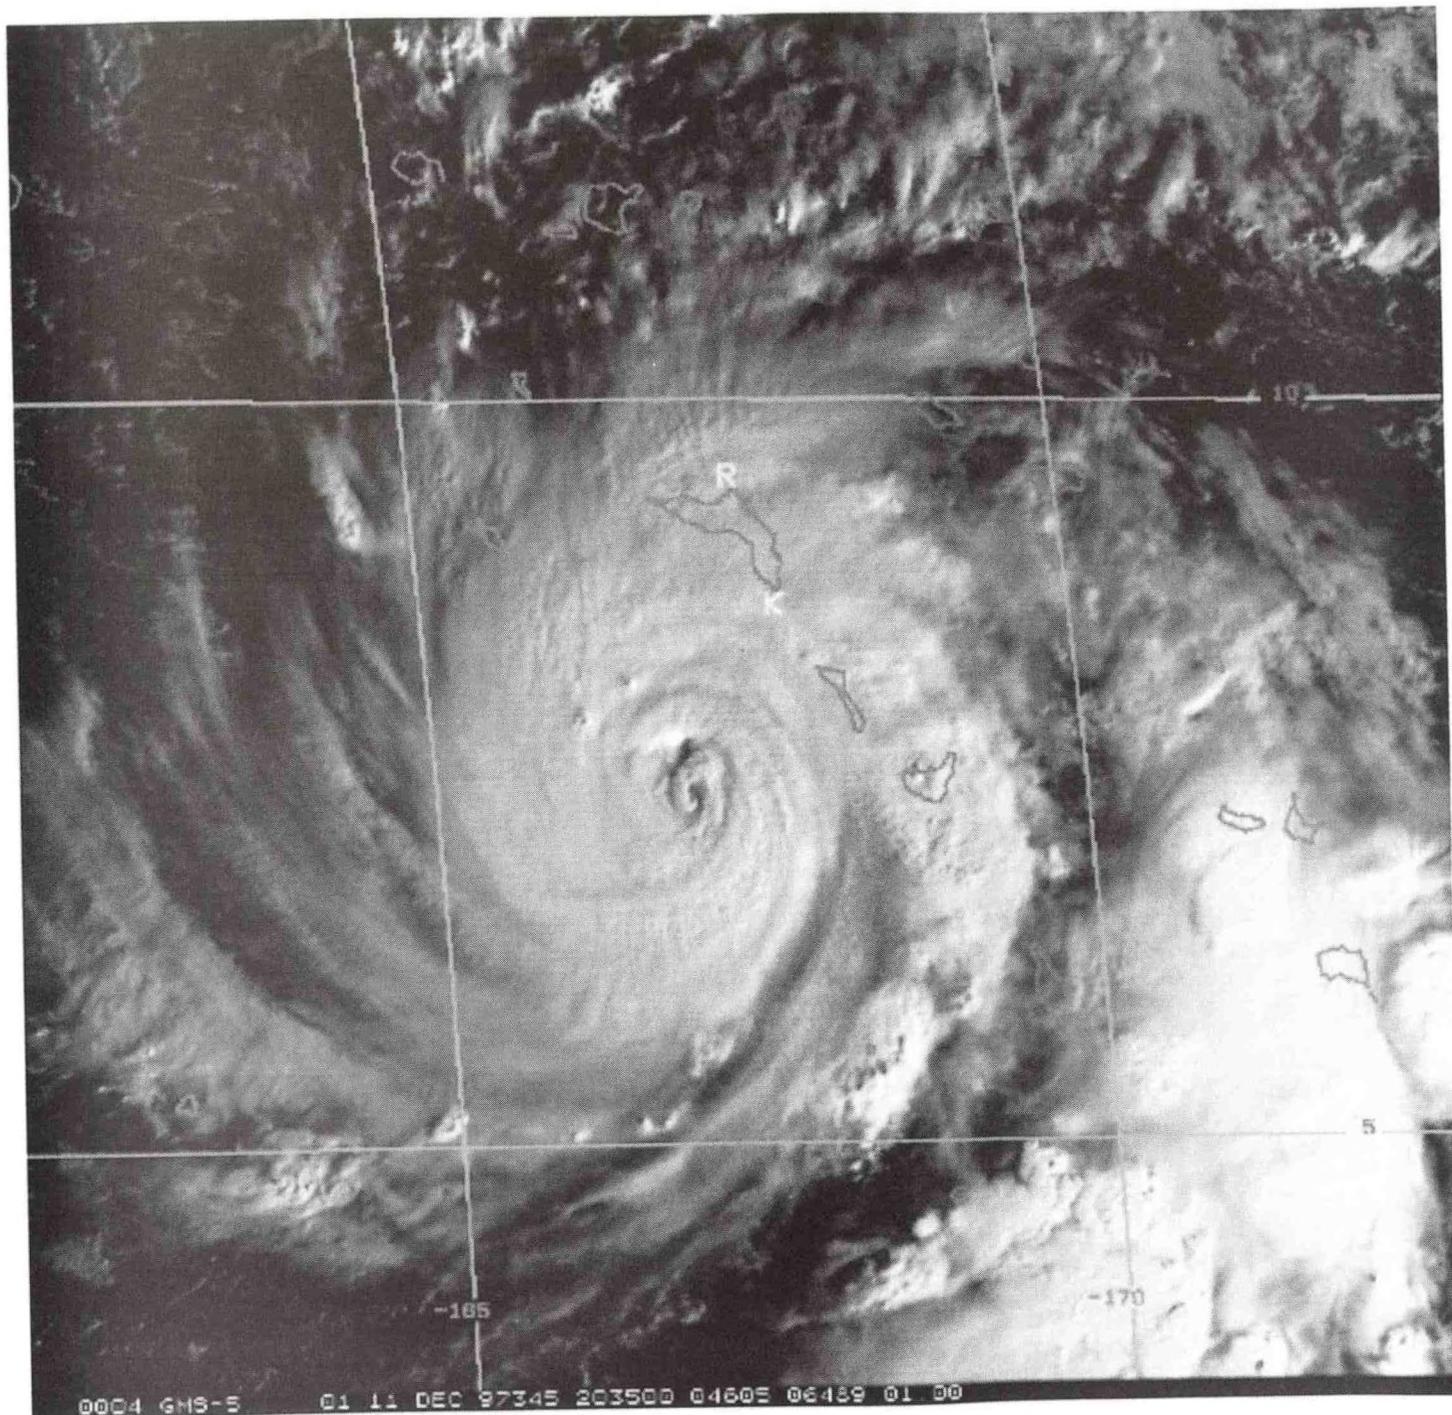
Figure 2: GMS visual picture (1.25 km resolution) at 2035 UTC on December 11,1997 (8:35 am LST December 12th) Courtesy of Aeromet, Inc. Kwajalein Atoll

Tropical Storm Paka reached typhoon strength in the Marshall Islands on December 11 at 0600 Local Standard Time (LST) (1800 UTC). Typhoon Paka continued to intensify as it tracked northwest into the FSM on December 12, with Typhoon Watches issued for Kosrae, Pingelap, Mokil, and Ujelang. Paka came within about 40 nm of Ujelang Atoll, the extreme western atoll of the Marshall Islands. Because Ujelang is believed to be uninhabited, the extent of damage is unknown (see Figures 2 and 3).

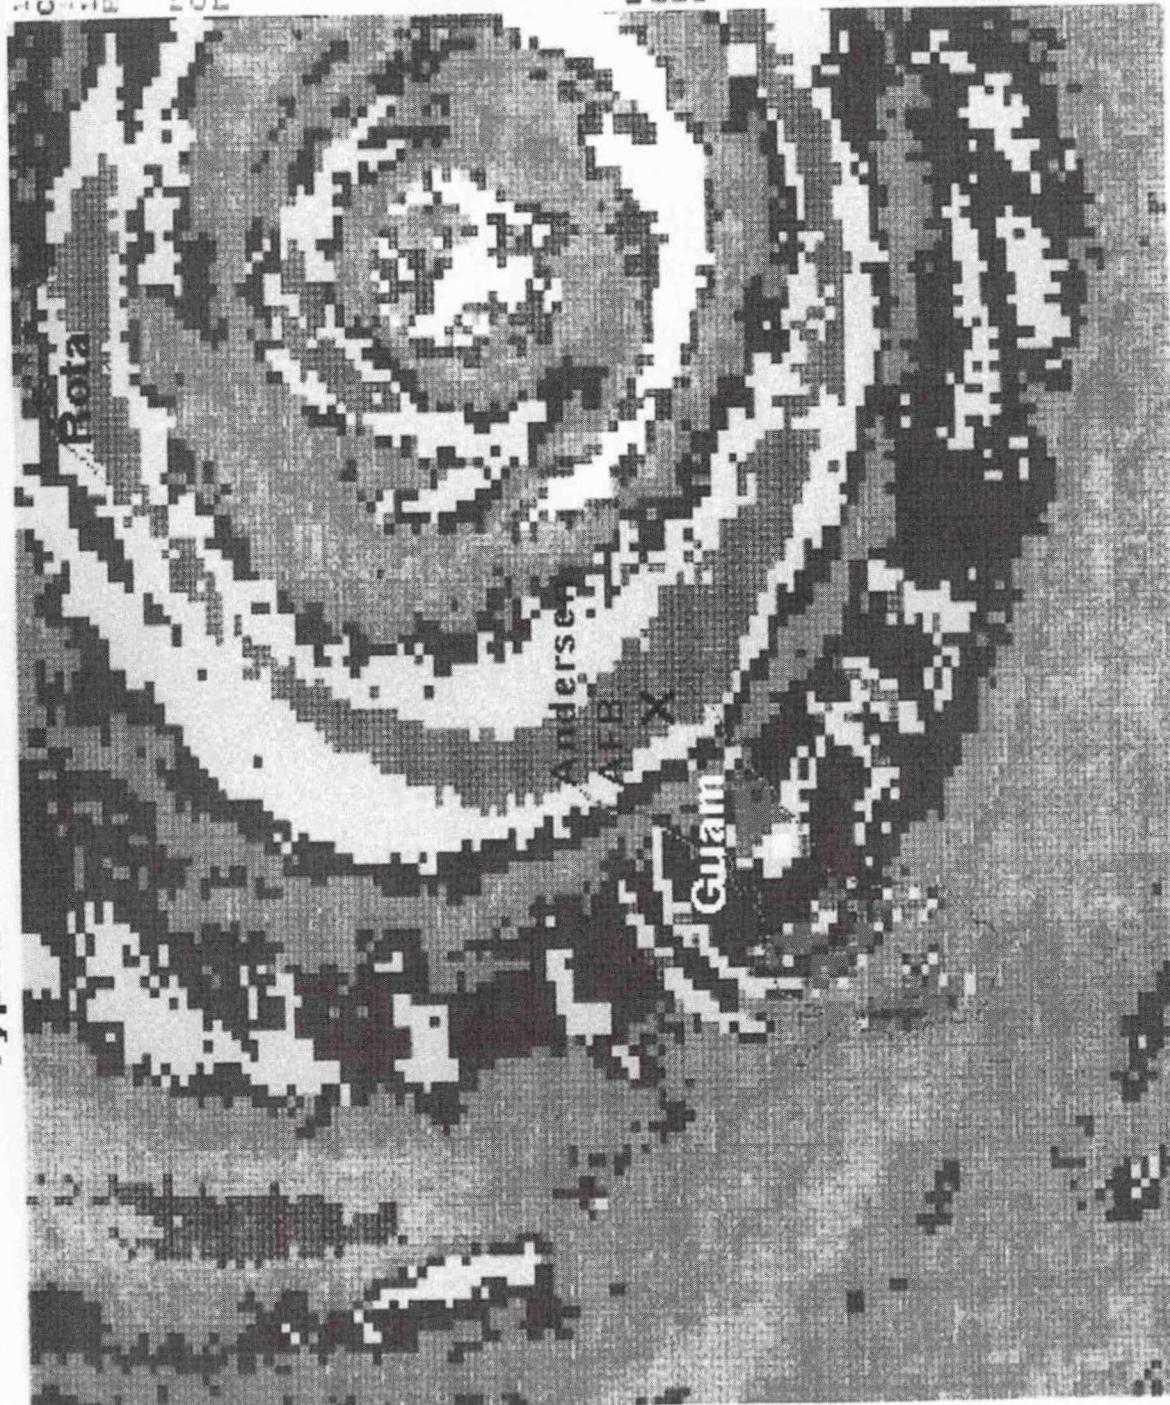
Figure 4

WSR-88D reflectivities (dBZ) showing eyewall over Andersen AFB at time of peak gust (X indicates the location of the wind instrument)

At the AAFB, located on the northeast end of the island, winds were at first northerly then turned to southerly as the outer eyewall moved across the island. A hot wire anemometer, an FMQ-13, located at the southwest end of the runways recorded a gust of 205 kts, but this is not supported by post-analysis (Forbes, et al., 1998). The incomplete inner eyewall stayed offshore. The island of Rota was north of the eye and thus received strong easterly winds from the outer eyewall. Rainfall reached 20 inches for Guam over 48 hours (see Figure 5).

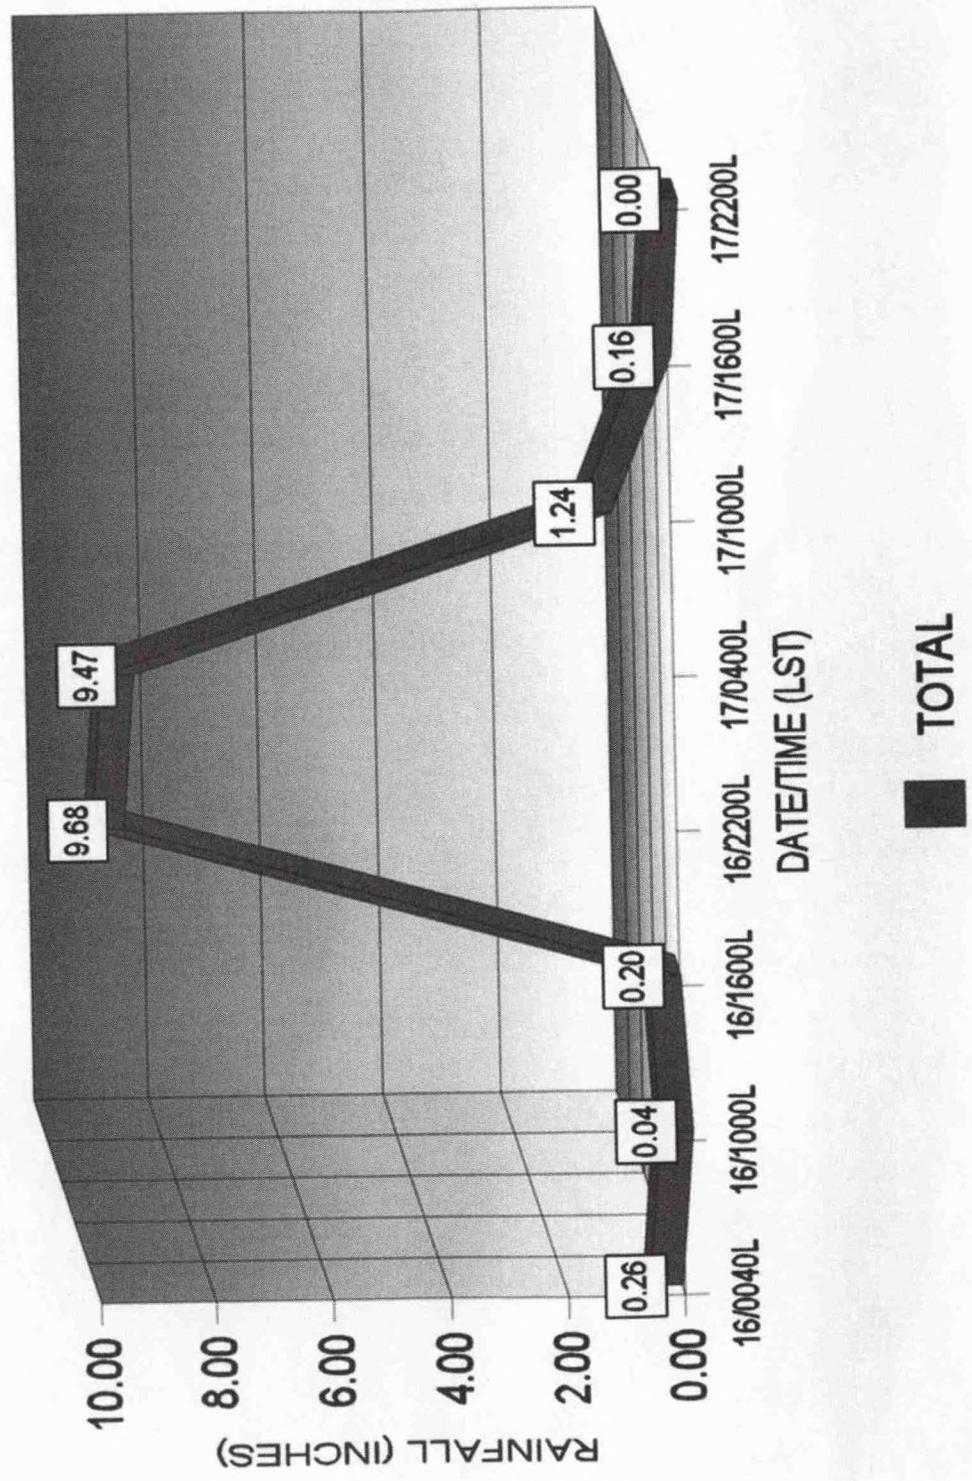
Figure 5

TYPHOON PAKA, GUAM MI, DEC. 16-17, 1997
 BASED ON 6-HOURLY RAINFALL MEASUREMENTS

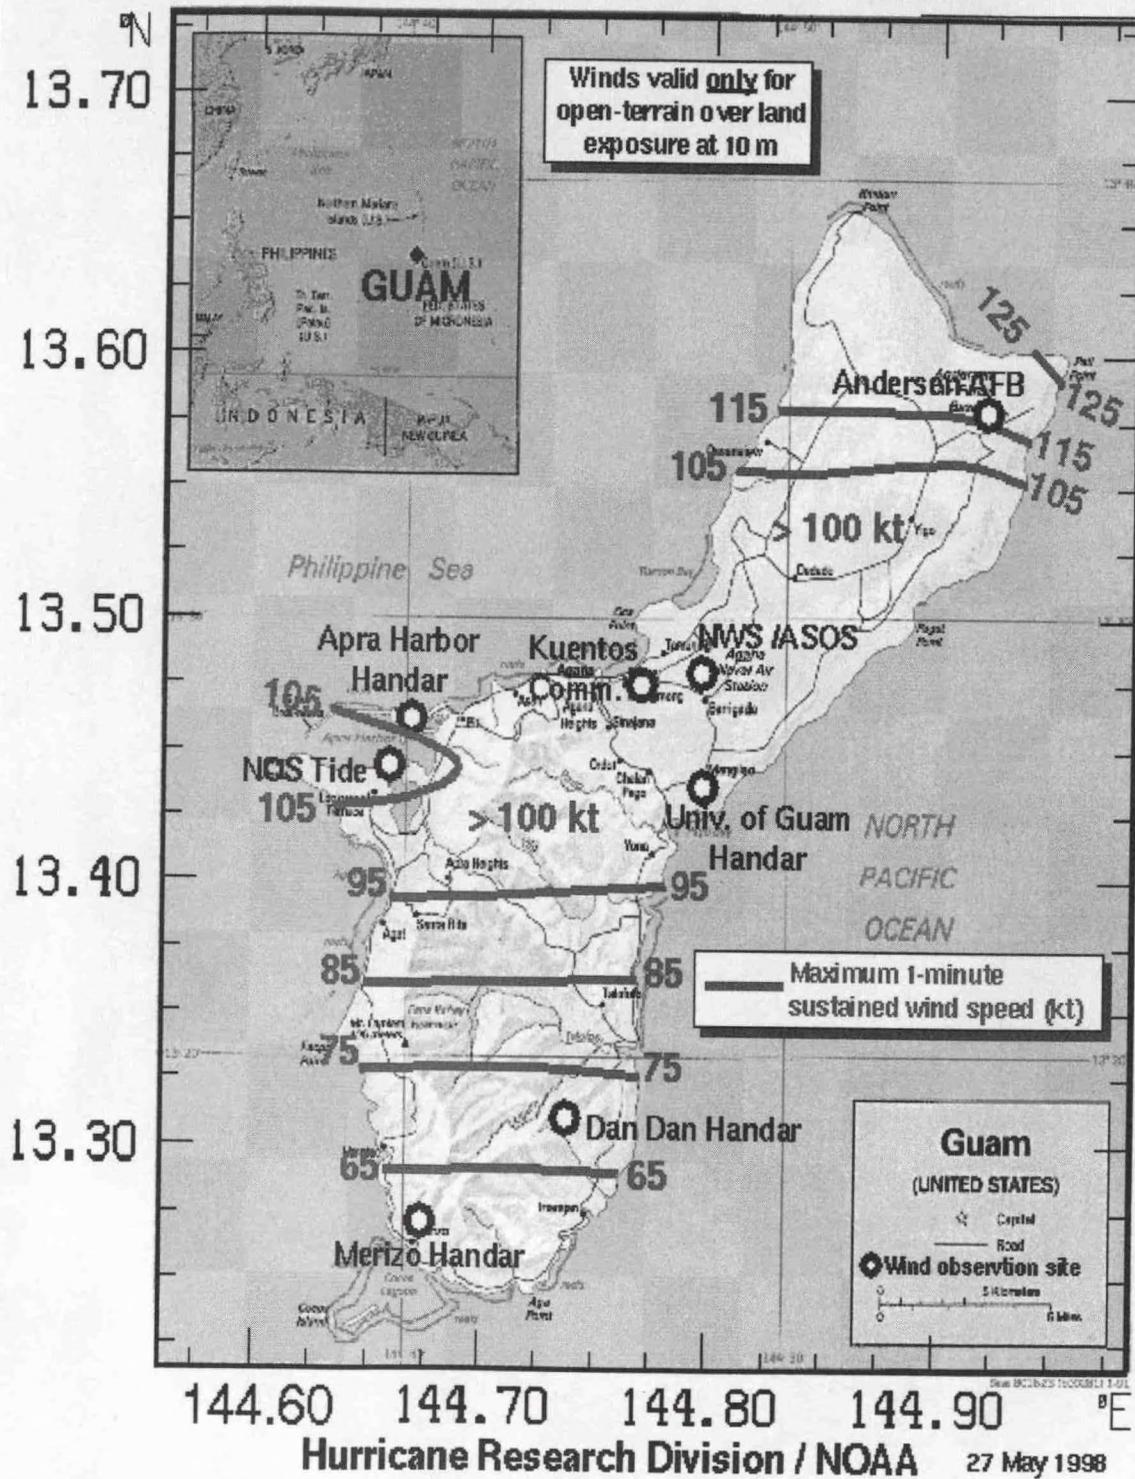
Figure 12

Interviews with the public demonstrate that the duration (8-10 hours of greater than 64 kts sustained) of the destructive winds, in conjunction with an evening and night passage, gave them the perception that Paka was the worst of the typhoons in the last 25 years (see Figure 12). This includes Omar (1992) and Pamela (1976). Vegetation damage was impressive due to the duration of the winds and the heavy rains. Damage estimates ranged upward of 600 million U.S. dollars (GOV Guam, Super Typhoon Paka, 1998) (see Figure 13).

Swath map of maximum 1 minute sustained wind speeds over Guam during Super Typhoon Paka on 16 December 1997. These peak wind speeds (units = knots) are based on advecting surface wind fields along Paka's track. These wind speeds are valid only for open terrain over land exposure at 10 meter height. The wind observation stations used to produce the swath are also shown (NOAA 1998).
