COASTAL EROSION ALONG OCEANSIDE LITTORAL CELL,
SAN DIEGO COUNTY, CALIFORNIA

Gerald G. Kuhn
Geological Research Division
Scripps Institution of Oceanography
University of California, San Diego
La Jolla, California 92093CIRCULATING COPY
Sea Grant Repository

Abstract

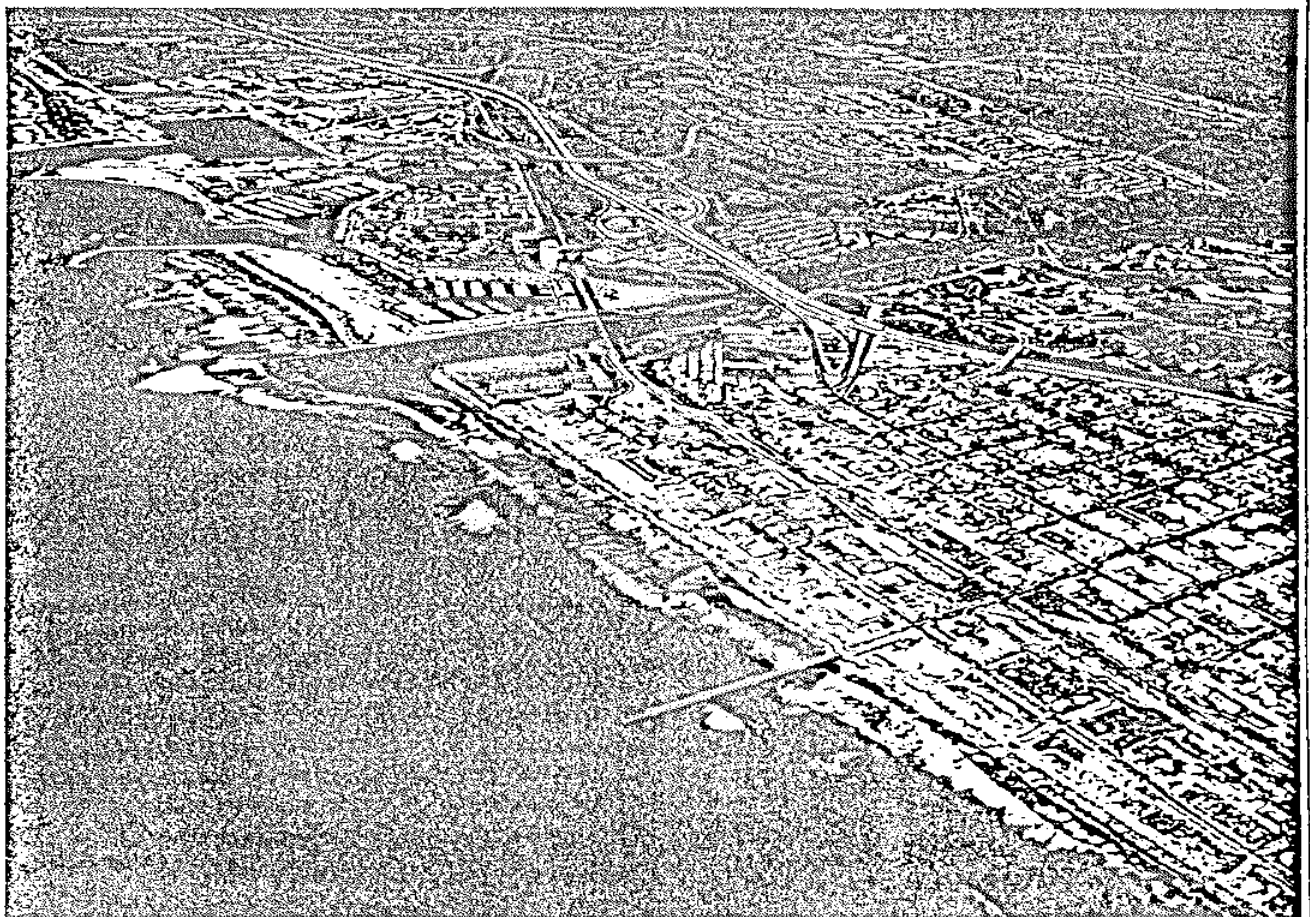
B. 1980 aerial view looking north across City of Oceanside toward the Camp Pendleton Boat Basin and Oceanside Harbor. Note that the width of beaches markedly decreases to the south of the harbor. Photo: Sea Grant/G. Kuhn, February 23, 1980.

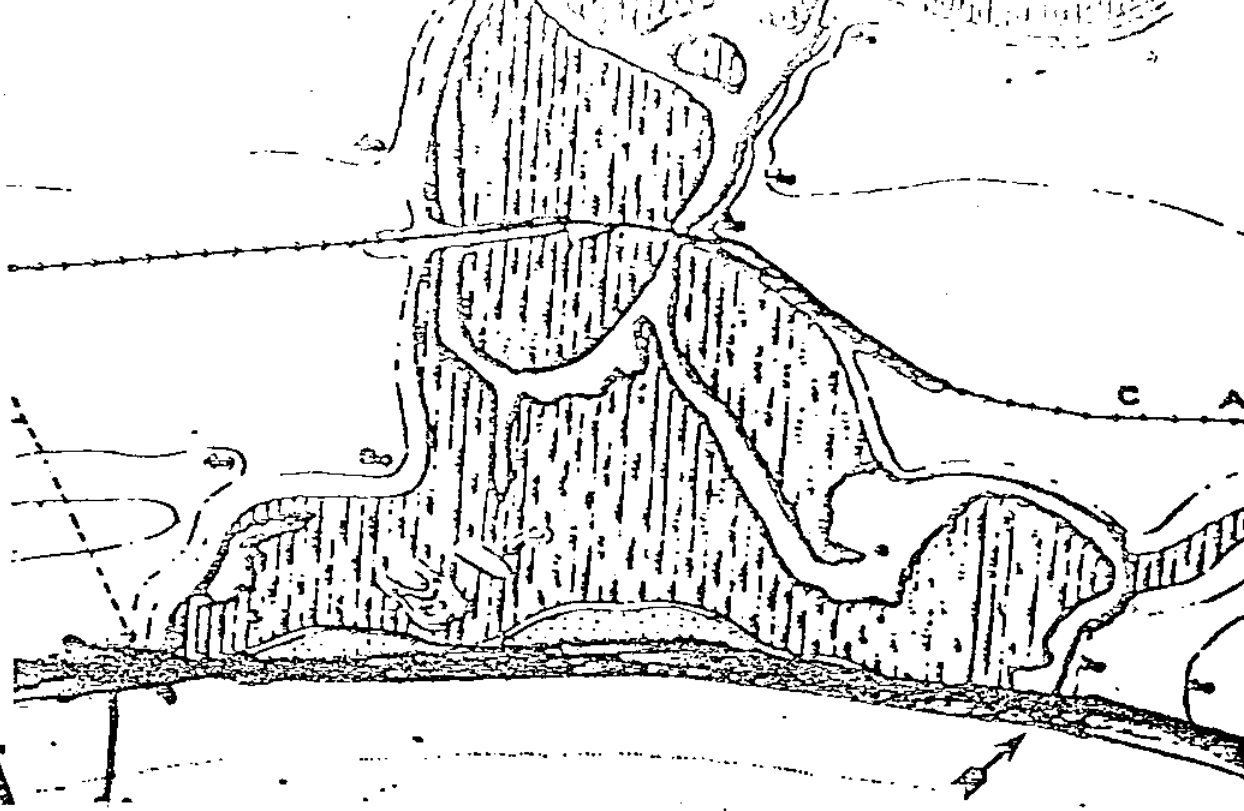
An interesting observation is noted in that from 1889 until development of the surrounding area, the inlet mouth of Agua Hedionda Lagoon was located on the south (Figure 8.A). Following severe floods and storms from the south during the 1880's and 90's the mouth shifted to the north, where it is today (Figures 8.B & C). Dredging of the lagoon is necessary periodically as sediment is trapped there. In 1954 approximately 5 million cubic yards of sediment was dredged from the lagoon and placed on the beach (Figure 8.D).

Figure 8. A. 1889 map of Agua Hedionda Lagoon, Carlsbad, California.
 Note: Arrow points to the lagoon entrance inlet.
 Courtesy of U.S. Coast & Geodetic Survey.

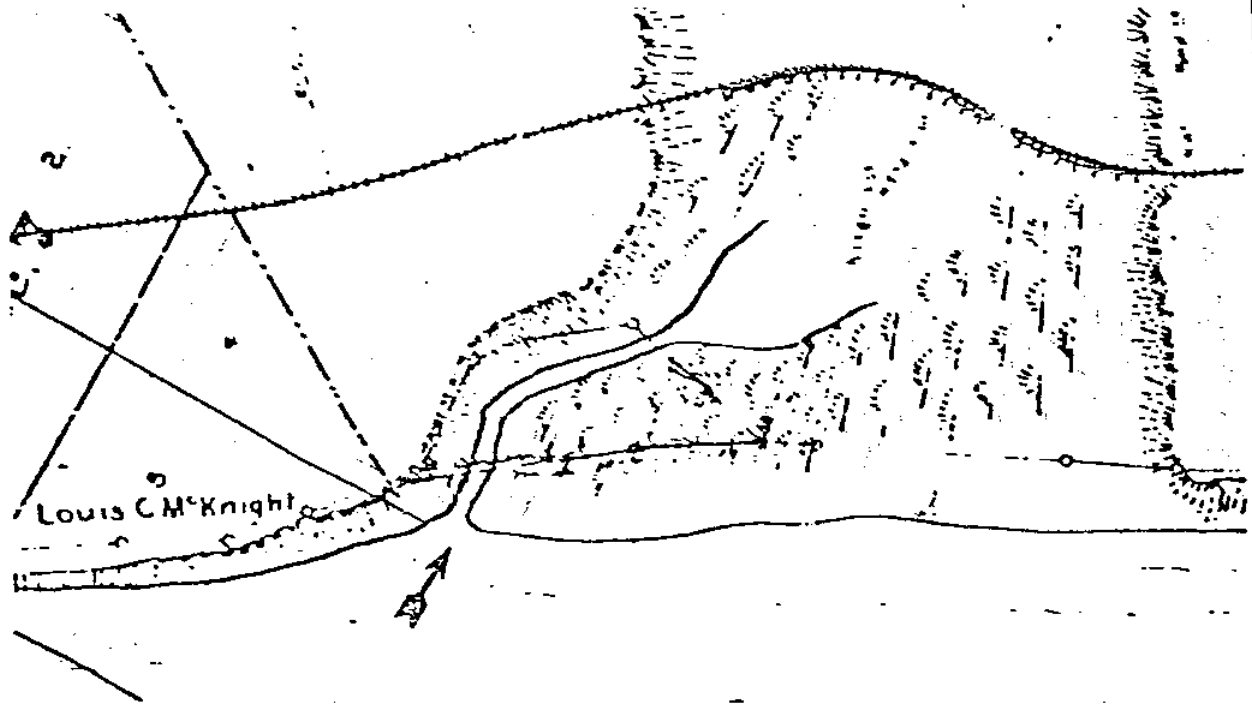
B. 1898 map of same site as Fig. B.A. Note lagoon north opening has relocated from south to north since 1889.
 Courtesy San Diego County Road Survey, 1898.

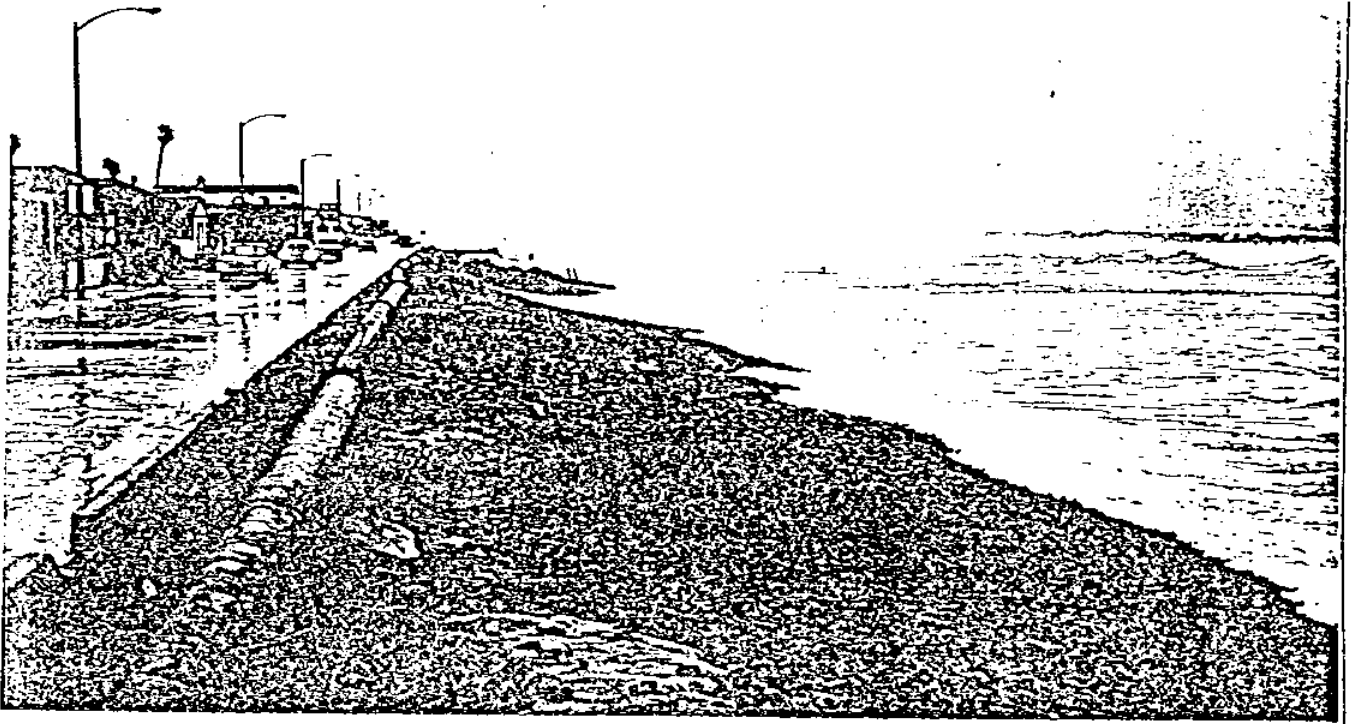
Figure 9. A. January 1978. Winter view looking south along "The Strand", Oceanside, California. Note: Arrow points to end of conduit pipe used to transport sand dredged from Oceanside Harbor to rebuild the beaches. Photo: Sea Grant/G. Kuhn, January 14, 1978.

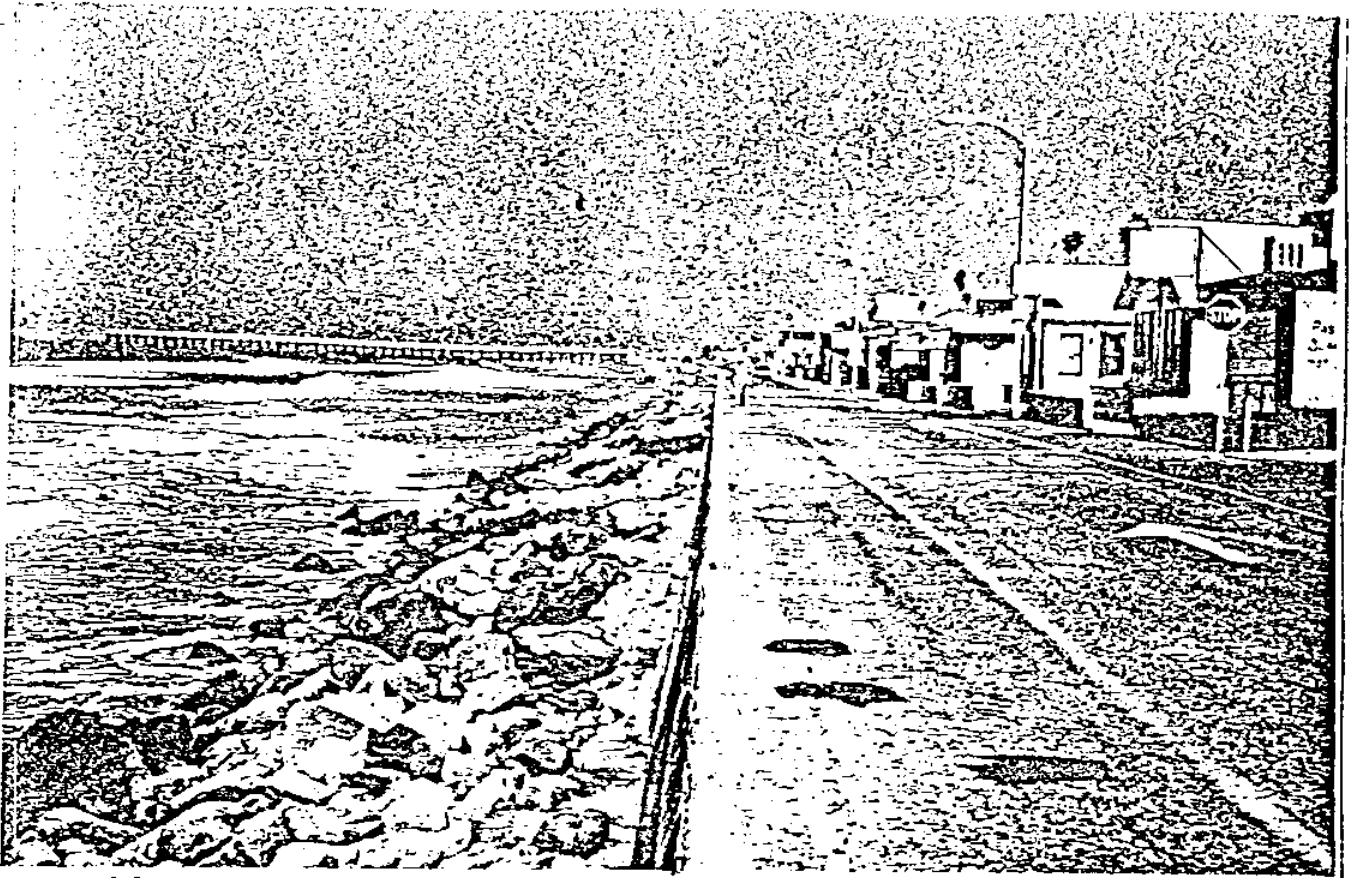
Figure 10. A. (Before) September 1979. View looking north along "The Strand" at Oceanside, Calif. Building and road were constructed on former beach. Riprap fronts and protects concrete seawall and road. Photo: Sea Grant/G. Kuhn, Sept. 22, 1979.

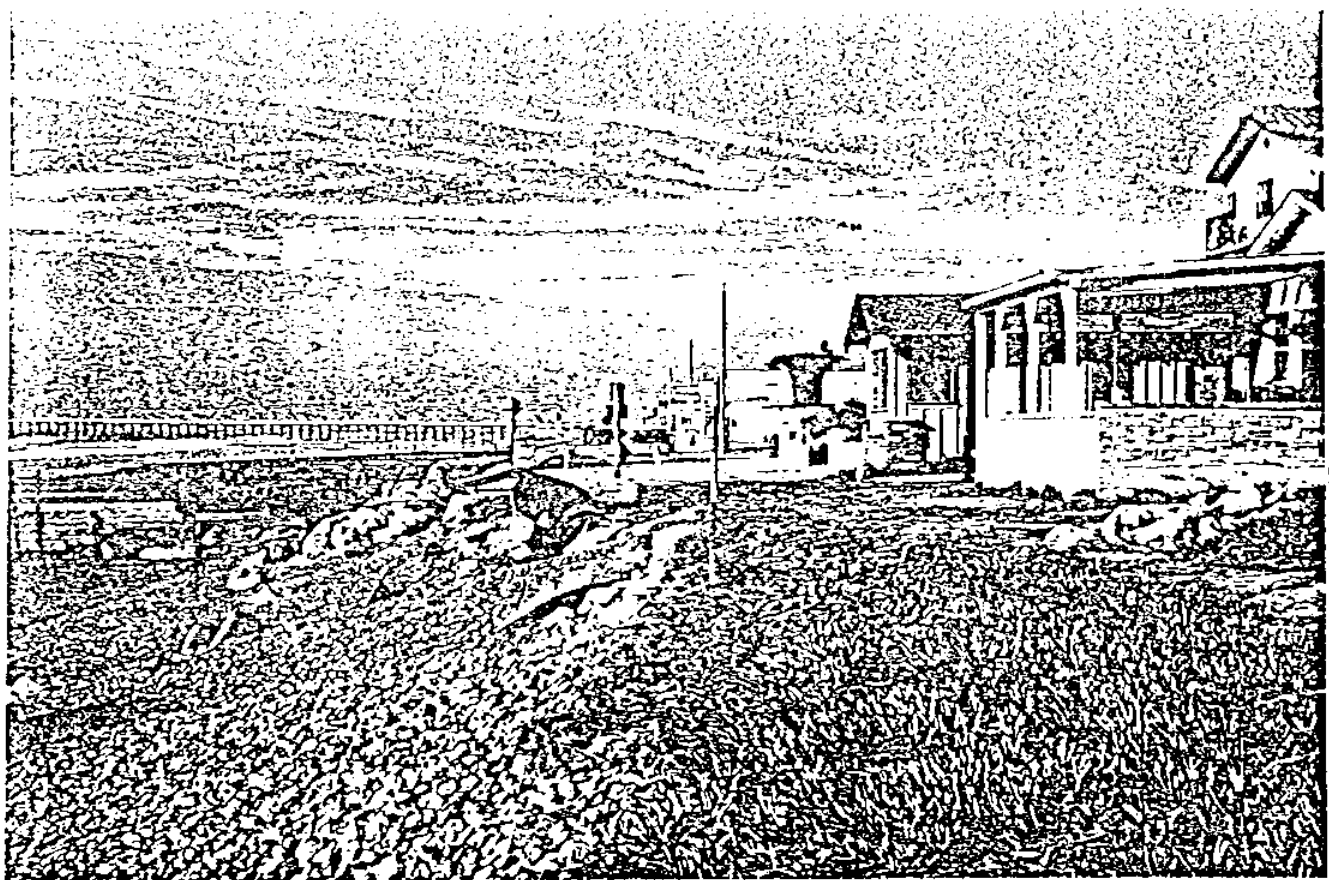
Figure 12. A. (Before) 1978 photo of beach cottages located south of Wisconsin Street in Oceanside, Calif. Photo: Sea Grant, Jan. 4, 1978.

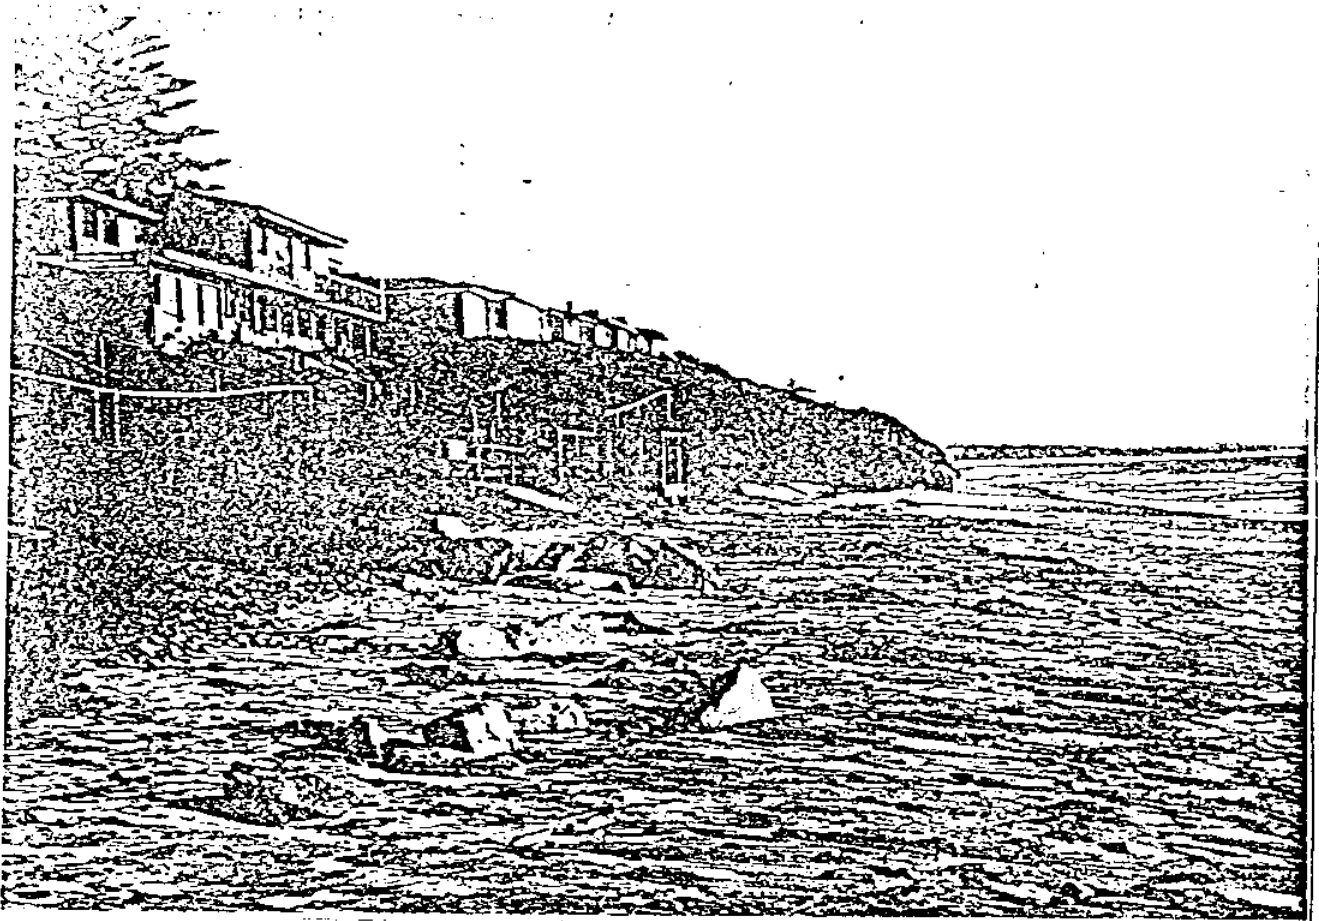
Figure 13. A. December 1977. View along the shore at Carlsbad, Calif.
Photo: Sea Grant/G. Kuhn, Dec. 17, 1977.

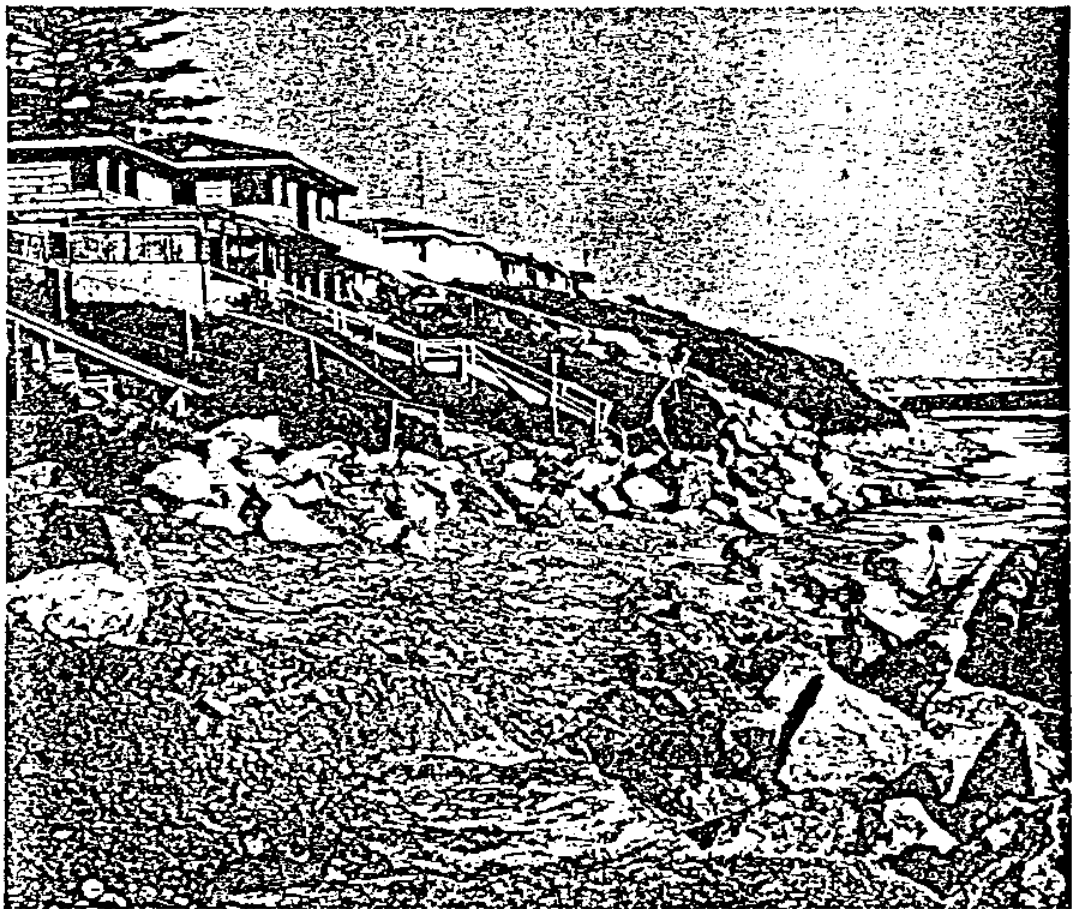
D. June 1978 view of same site. Riprap was placed in front of all houses at this site. Photo: Sea Grant/G. Kuhn, June 3, 1978.

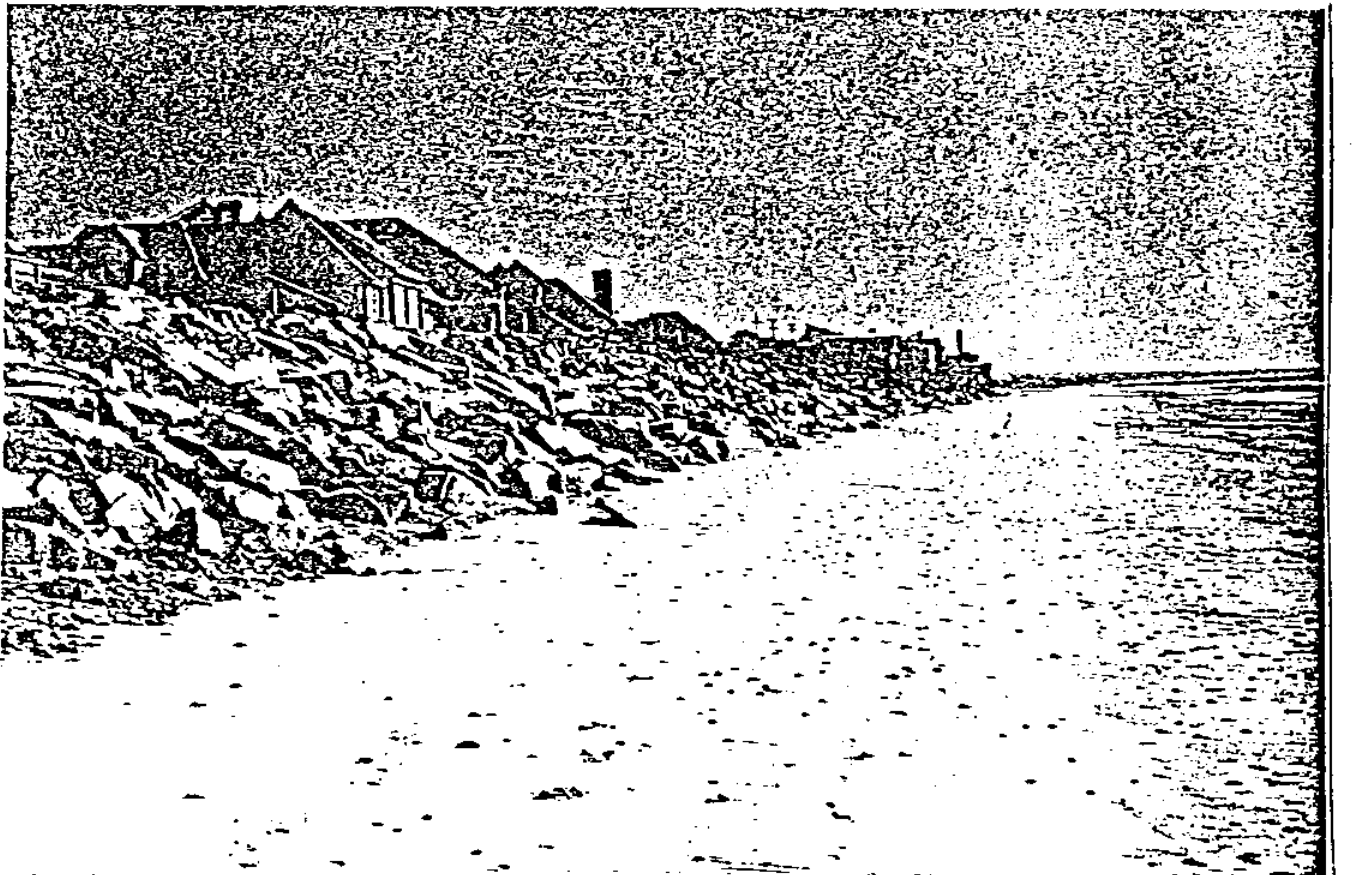
B. (After) Same view at South Oceanside in June, 1978. Only remnant pockets of cobbles remain. Photo: Sea Grant/G.G.Kuhn, June 20, 1978.

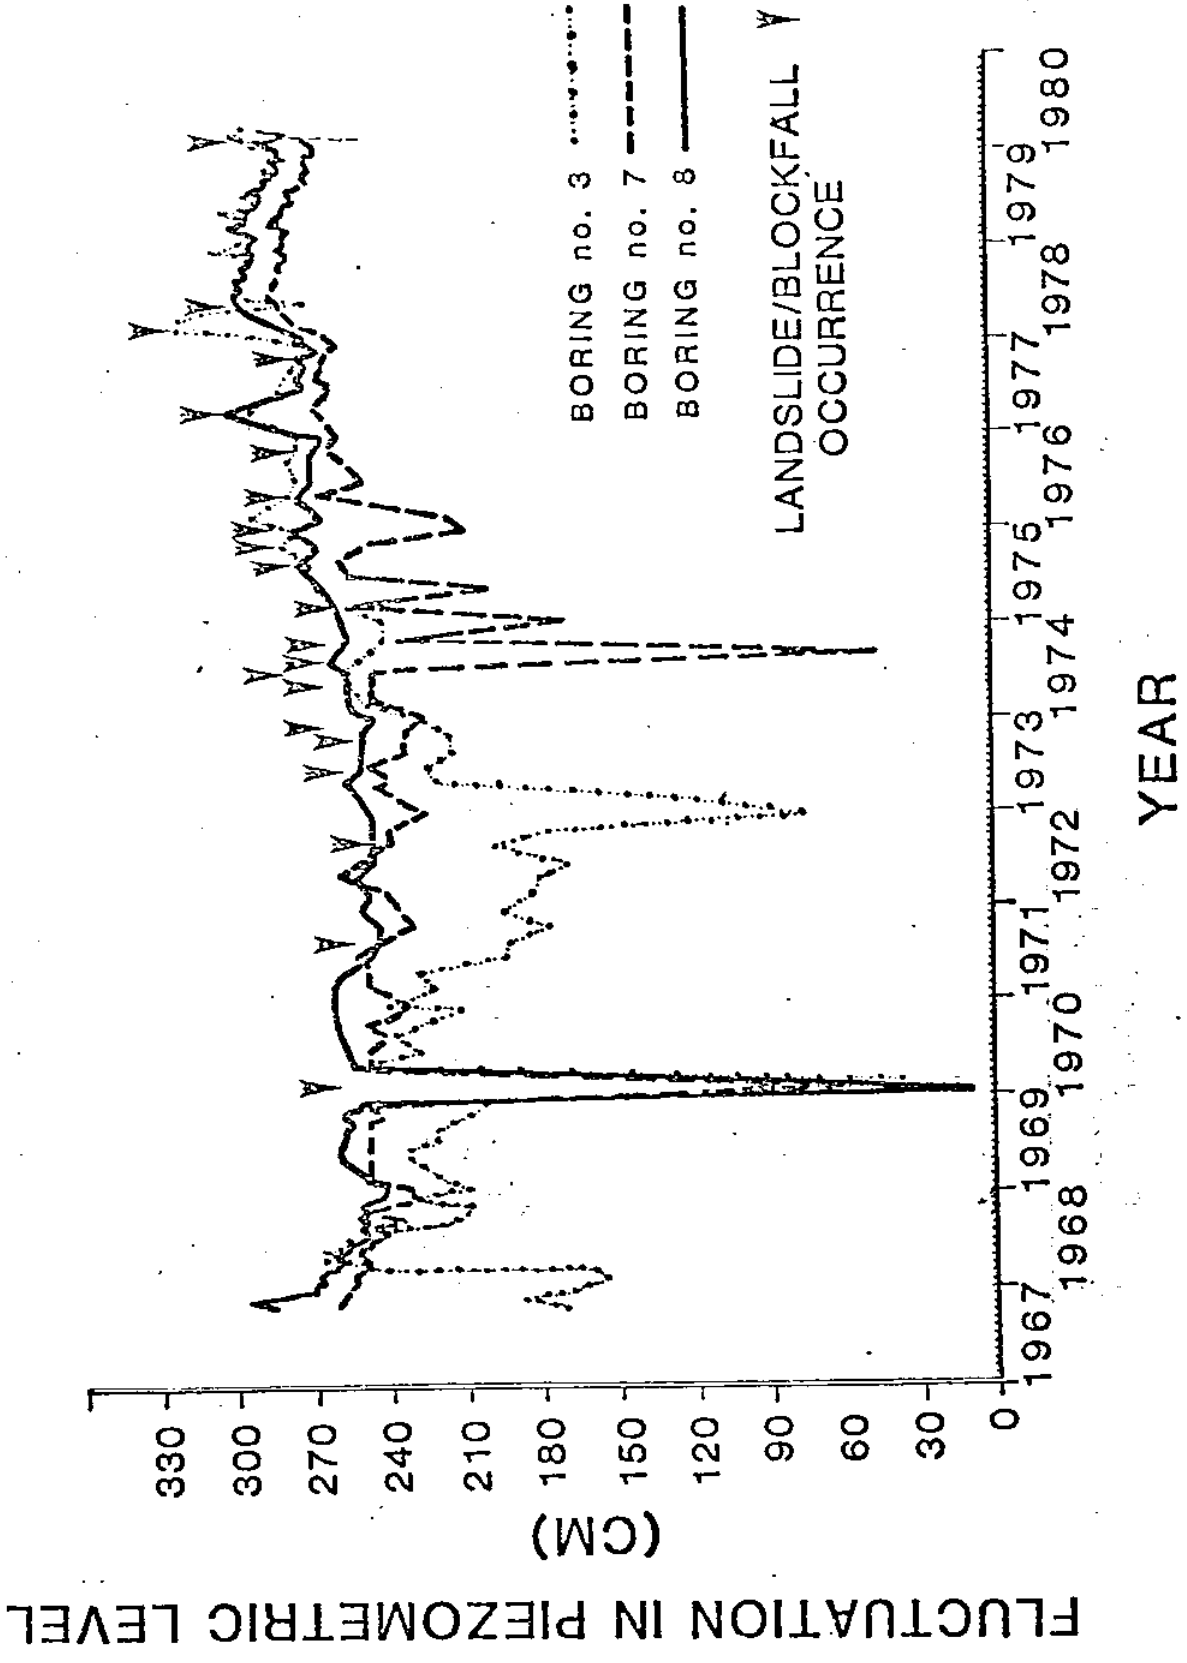
This extensive watering has lead to at least three important effects: It has caused a slow but steady increase in the water table, even during the dry period which preceded the rains of 1978. This has added weight to the cliff material which contributes to development of landslides. It has lubricated surfaces along which slides and block falls are initiated, and in some cases has greatly increased solution in the underlying rocks. specific sites that evidenced erosion during the drought years prior to 1978 are continuing to collapse. Large sections of cliff face have separated along parallel joint sets (Figures 19-21).

Figure 18. Graph showing piezometer well-level ground water table data at the Self Realization Fellowship property, Encinitas, California. Photo: G.G. Kuhn.

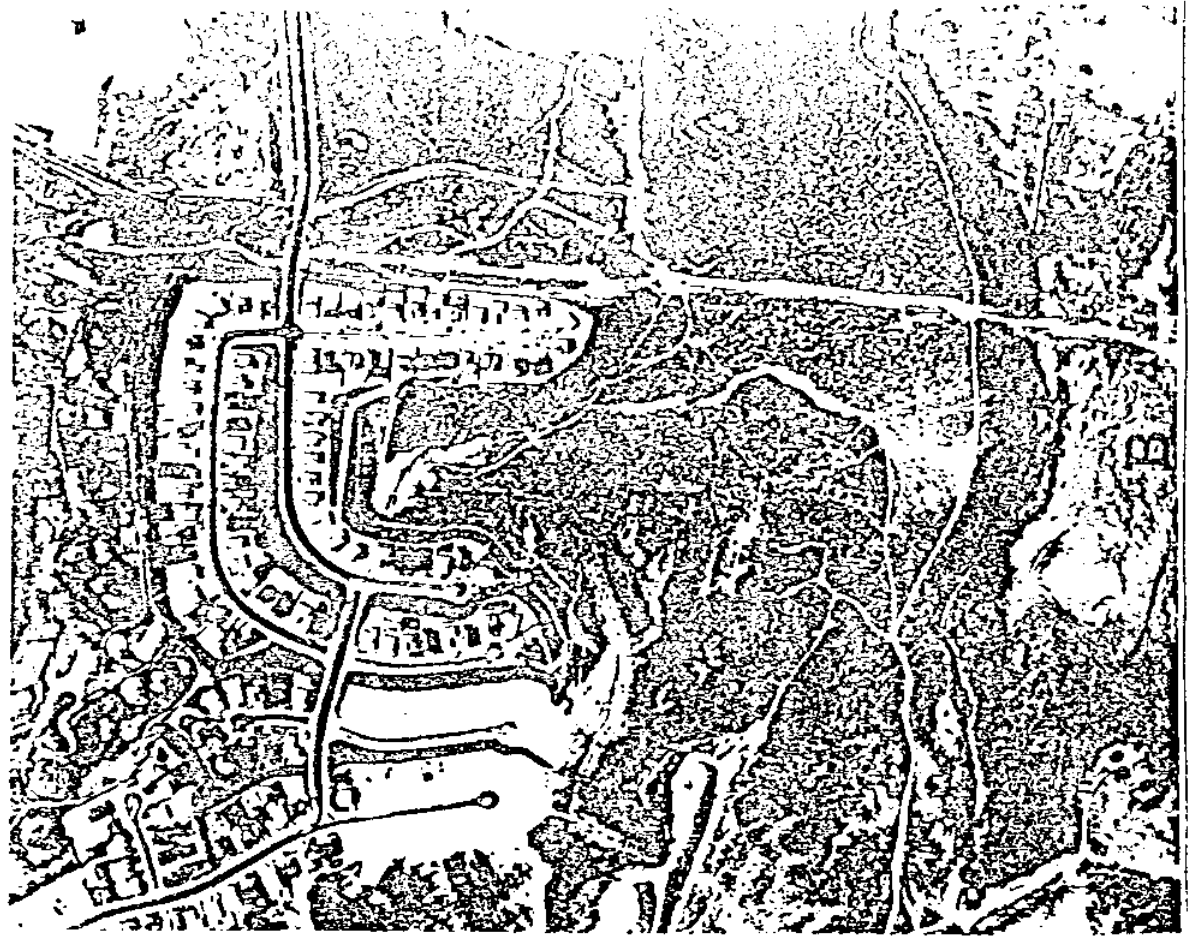
B. 1974 Vertical Aerial Photo of same location as 27A. Note: The large alluvial fan that was developing at this time (denoted by arrow). Photo: Sanitation and Flood Control, County of San Diego., 1974.

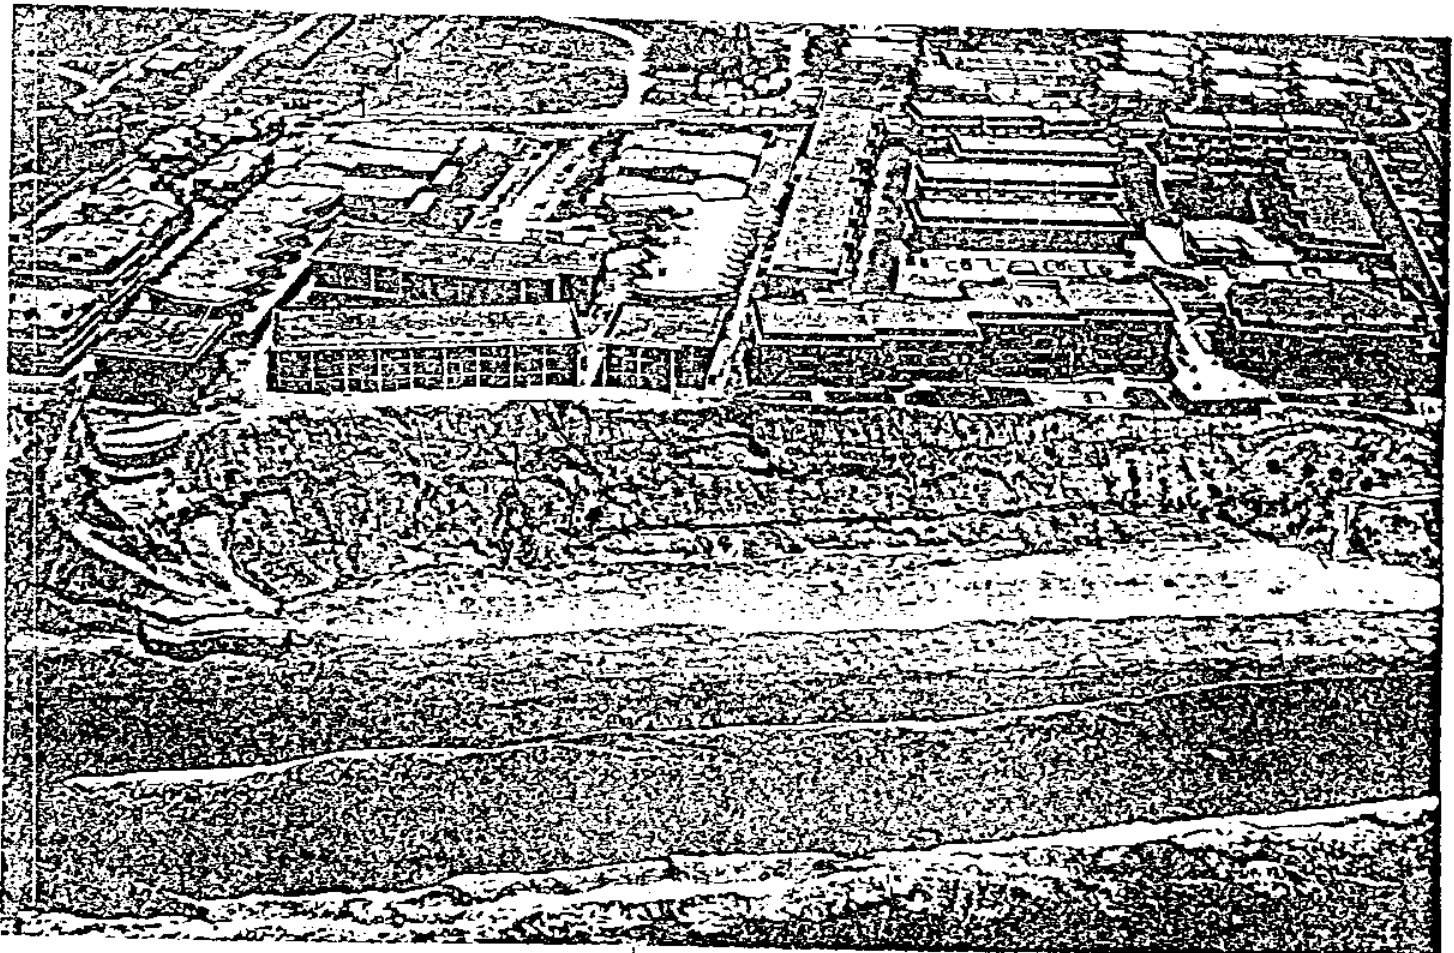
B. (After). Same view in 1974 after development. Photo: B and A Engineering, June 1974.

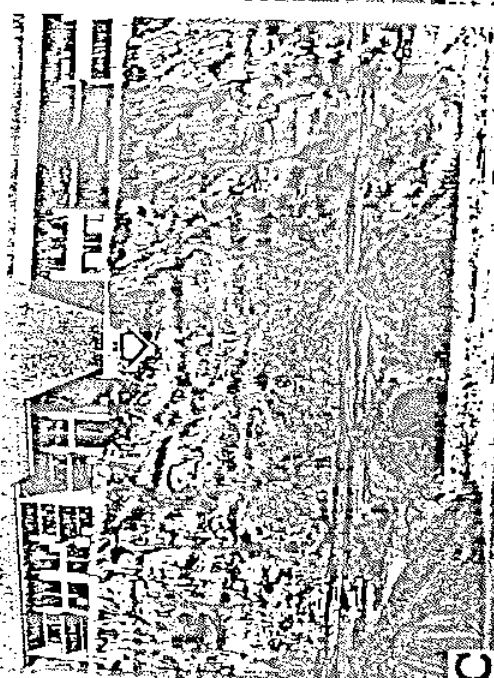
Figure 31.

The grading of the bluff tops, in many cases to the edge of the slope, initiates slope failures in the sea bluff and creates drainage avenues along which further surface runoff erodes the bluff face. It has been observed that where existing bluff terrace deposits and soil profiles are left intact, and surface drainage diverted, the bluff edge appears to erode very slowly (Figure 30.A), whereas following development the bluff face is seen to erode (Figure 30.B). In 1972 along South Solana Beach, the bluff top was lowered about 15-18 ft by excavation and surface water was allowed to run over and down the bluff face (Figure 31.A). The upper bluff face and slope continued to collapse during and following heavy rainfall in subsequent years (Figures 31.B, 31.C). The base of the cliff along this site eroded a maximum of 8-10 ft between 1972 and 1978.

1972 oblique view looking East along the bluffs at South Solana Beach, California., taken during the grading of the bluff top. Note: Prior to grading, surface drainage was directed away from the bluff face. In 1972, 15-18 feet of the bluff top was excavated, surface drainage patterns were altered, and numerous slope failures occurred. Photo: California Coastal Commission, 1972.

Slope failure which initially occurred in October, 1972. View looking East. Same location indicated by arrow. Photo: A.P.M. Cochrane, March 1973.

Same site as 31C. April 1979 view of concrete "cribwall" being installed on bluff face at Solana Beach, California. Photo: Sea Grant/ G.G. Kuhn, April 23, 1979.

E. May 1979 view of same site as 31C. Note: The cribwall completed before it was completed. Photo: Sea Grant/ G.G. Kuhn, May 4, 1979.

F. Same site as 31D. View of eroded bluff face following removal of collapsed "cribwall". Photo: Sea Grant/ G.G. Kuhn, May 19, 1979.

the entire structure rotated and collapsed, leaving debris and sediment resting on the seawall below (Figure 31.E). Within a week following the collapse the debris was removed and sections of the sidewalk along the bluff top collapsed. Surface water was seen to flow down the bluff face (Figure 31.F).
