COASTAL PROTECTION STRUCTURES AND THEIR EFFECTIVENESS

**KIM FULTON-BENNETT
AND GARY B. GRIGGS**

UNIVERSITY OF CALIFORNIA AT SANTA CRUZ

1986

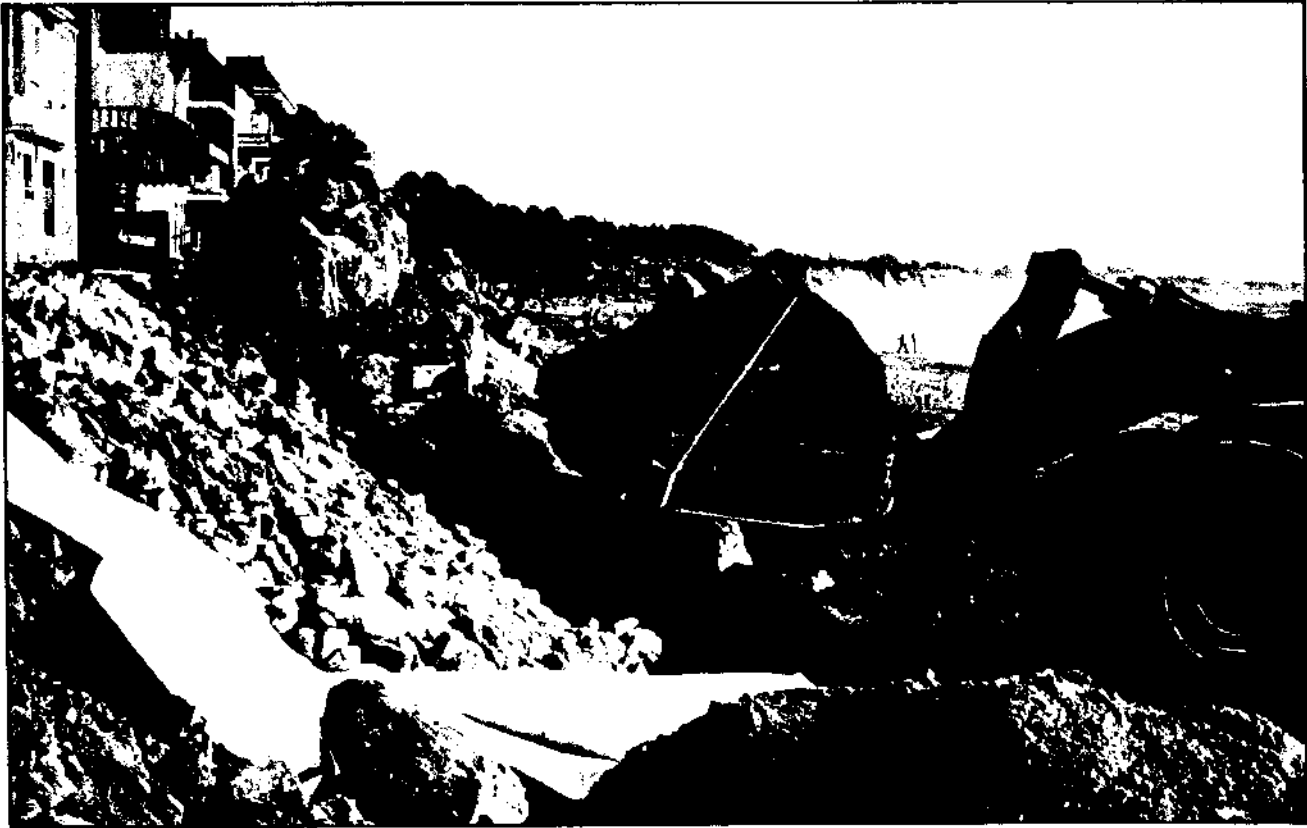
Figure 9

Emplacement of an engineered revetment using filter cloth, covered by small core stone, and larger cap rock (Site 24).

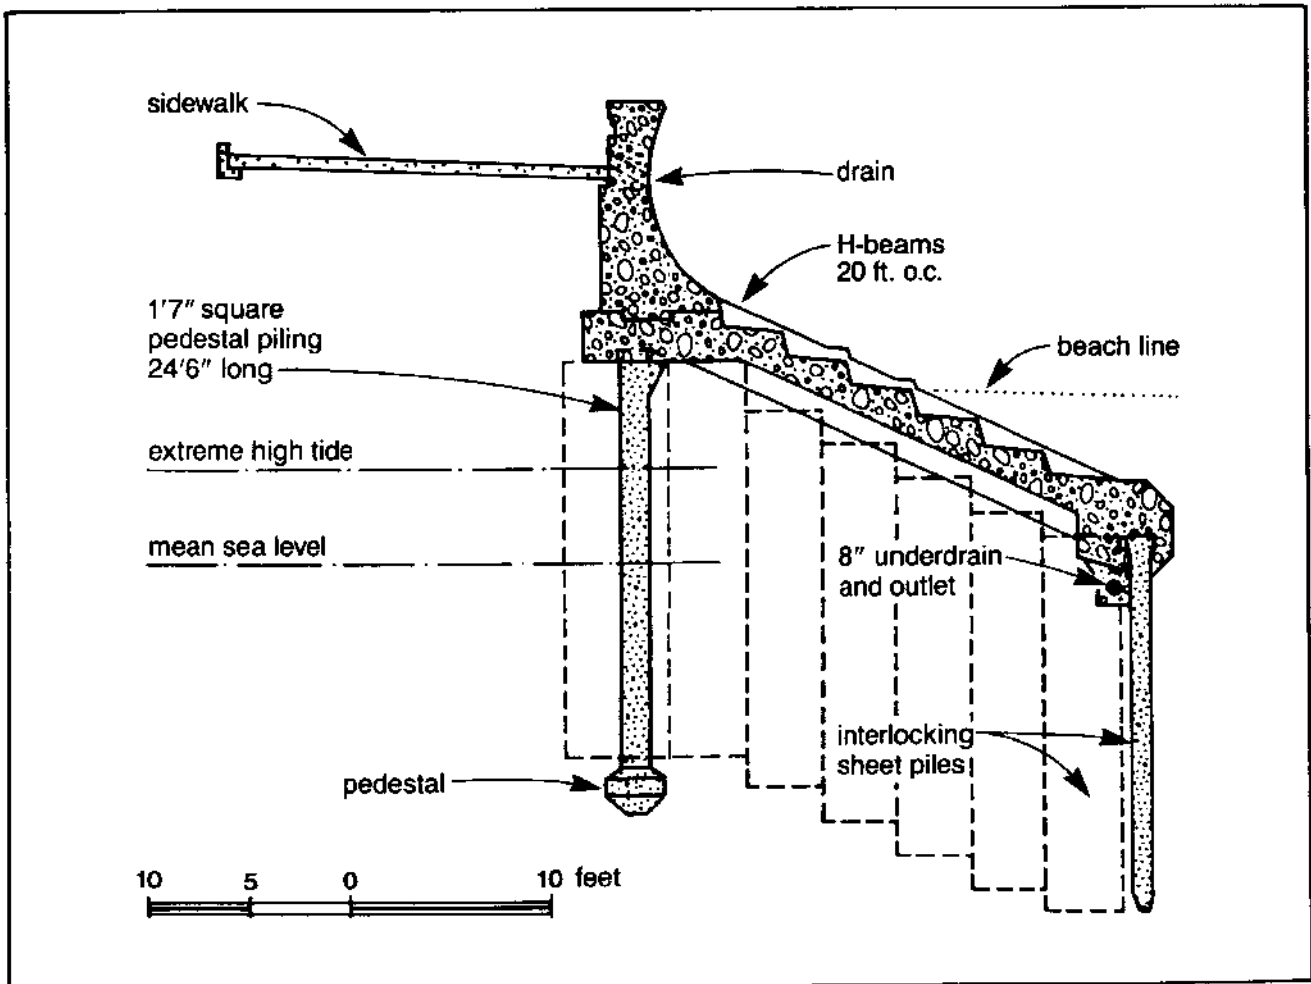
\$575,000, is the single most successful protective structure within the study region. This massive concrete wall has survived the test of time because it incorporates design and construction elements that prevent each of the typical causes of failure. At present day costs of approximately \$4000 per linear foot, this wall would be economically impractical for most property owners today, but its design elements are still highly relevant.

Figure 15
The O'Shaughnessy seawall in cross-section (Site I- see also Figure 16).

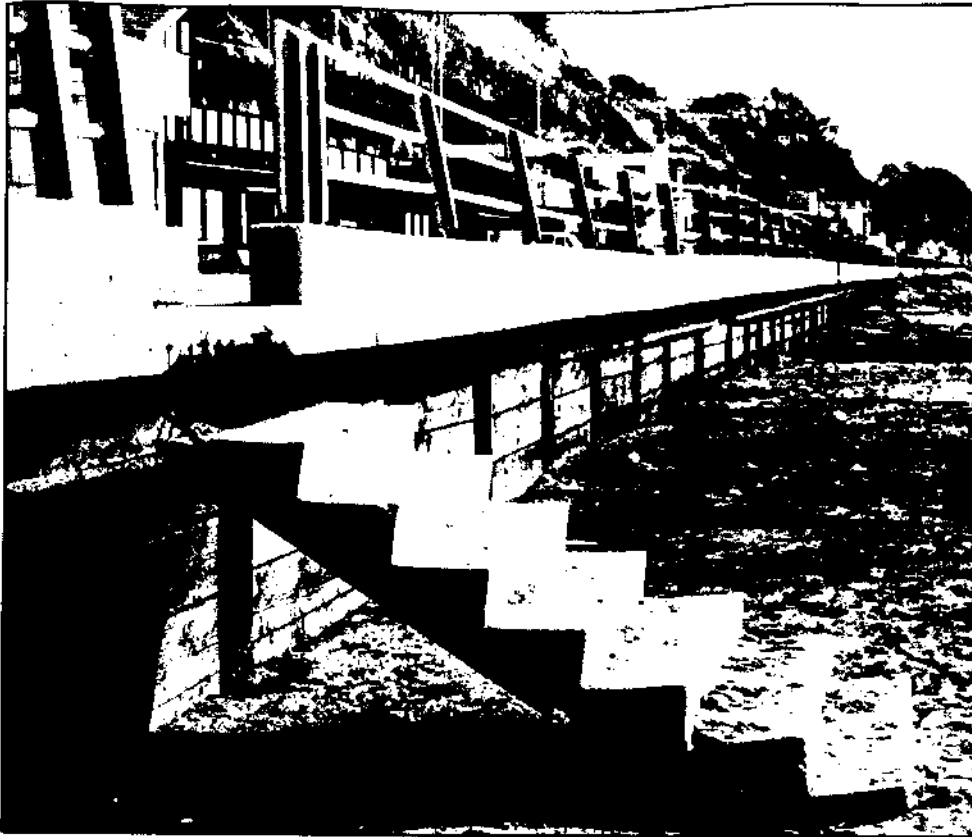
Figure 36

Seawall consisting of steel I-beams, 6 inch thick timber lagging and curved concrete cap withstood overtopping during 1983 storms (Site No. 25). The failure of the stairway at several locations was caused by wave uplift on the stairway and repeated deflection of the wall during extreme wave conditions.

The utilization of Epoxy-coated steel I beams (which constrain the lagging) and 6-inch-thick timbers (Figure 36—Site No. 25) proved far more able to withstand the wave and debris impact during the 1983 storms than did wood pilings with 2 to 3 inch timber lagging (Figures 30 and 32, Site No. 22), although loss of fill behind the wall at Site No. 25 was still a problem.

Vertical Forces: Both greenwater and wave splash can exert strong upward, vertical forces on structures and materials near the crests of seawalls, especially those with vertical faces (Figure 36). Where moderately deep water lies in front of a vertical seawall, even relatively small (3 to 4 foot high) breaking waves can send jets of water up to twenty feet in the air. In high-surf conditions, the vertical forces exerted by such jets have destroyed overhanging decks and floors of ocean-front homes.

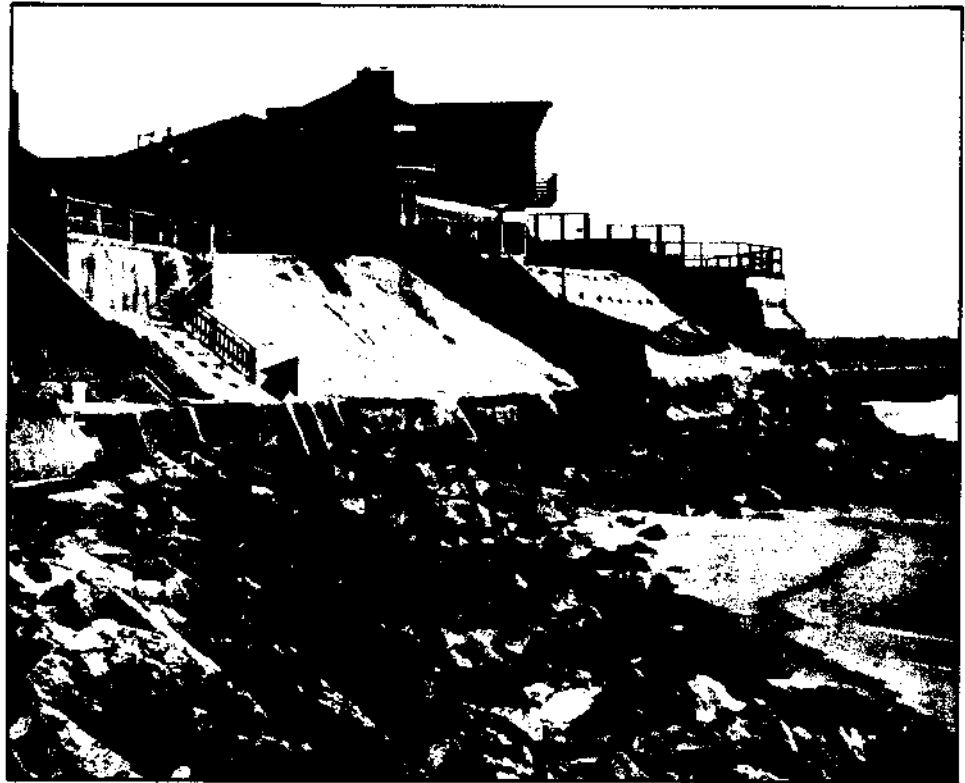
Figure 37
Concrete seawall fronted by rip rap in foreground and gunnite protected slopes in background (arrow) (Site 16).

Gunnite consists of viscous concrete sprayed or trowelled over a steel mesh and/or reinforcing rod framework, and is often laid over relatively steep, erodible slopes (Figure 37). It has most commonly been used to protect terrace deposits and erodible bedrock from erosion by wave splash and spray, as well as by surface runoff. The coastal protection literature seldom mentions gunnite, probably because it is not viewed as a stable long-term solution to erosion problems. However, with continued maintenance and patching, gunnite at some sites (Site No. 16 for example) has lasted for 10 to 20 years. At each of these sites, waves only reach the gunnite during the highest tides and most severe storms. Along San Francisco's Great Highway, a low, engineered, steel wall coated with gunnite has survived from 1941 to the present, although it has been buried by sand much of that time.

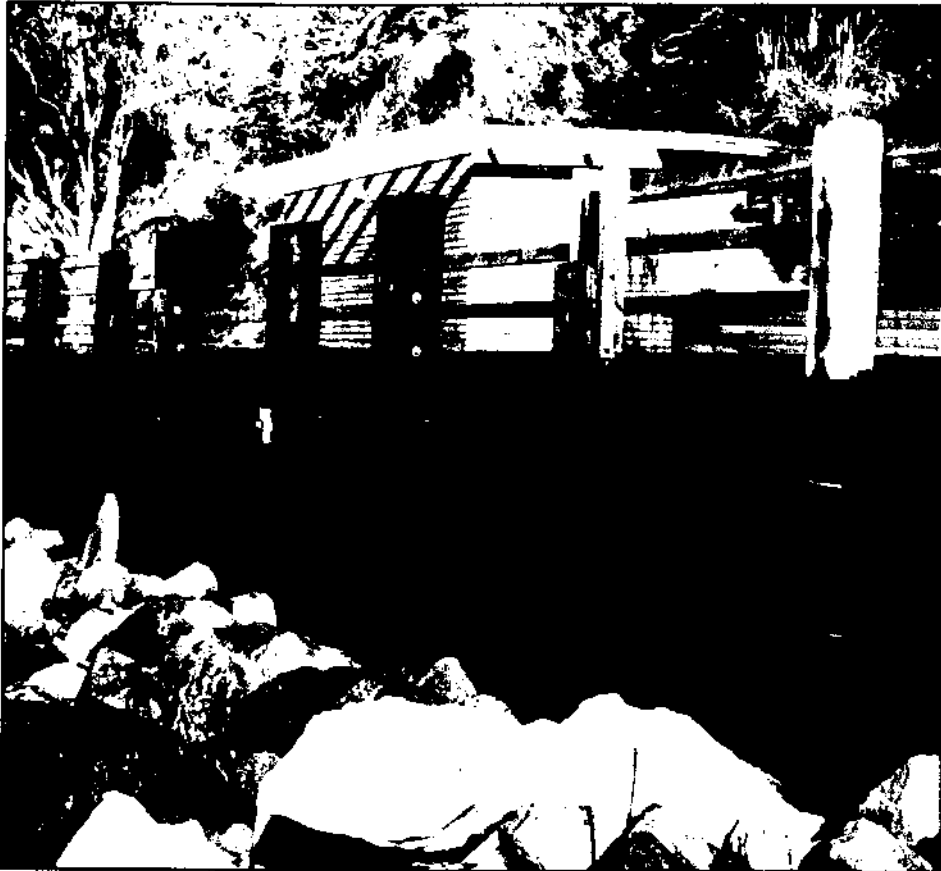
Figure 43

"Sacrificial" lagging was added to the front of this timber seawall in an effort to prevent damage to the wall from wave and debris impact.
