# Benthic Morphology and Marine Life Assessment for the Siting of Ocean Outfalls on South Tarawa

The South Tarawa Sanitation Improvement Sector Project, Tarawa Atoll, Kiribati

March 2015

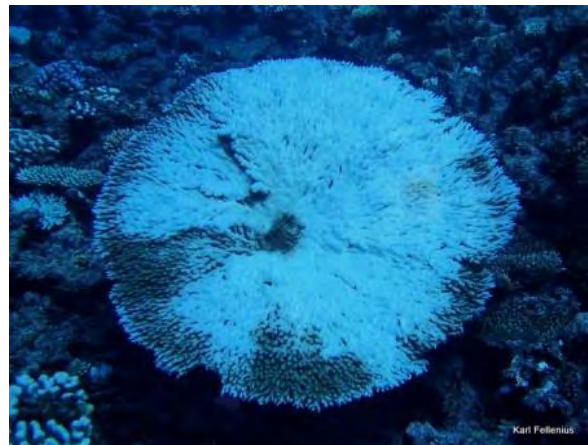
Fig. 2.23 Bleached table coral

Despite a few examples of coral mortality from bleaching, most of the coral along the existing ocean outfalls in South Tarawa at the time of this survey did not display significant thermal stress. However, the Western Gilbert Islands have been on a bleaching alert level 2 since December 2014 with the outlook for 2015 for continued elevated sea surface temperatures (fig. 2.24, NOAA Coral Watch 2014). The overriding point is that even pristine reefs cannot escape these global killers. Practically it means that even the outwardly intact reefs in Kiribati are already under threat and therefore survive somewhat precariously. Seemingly benign impacts can have serious consequences because the reef immune system is already under stress. Moreover, reefs already under threat from local impacts are less capable of embracing the adaptation needed to dampen the effects of global climate change.

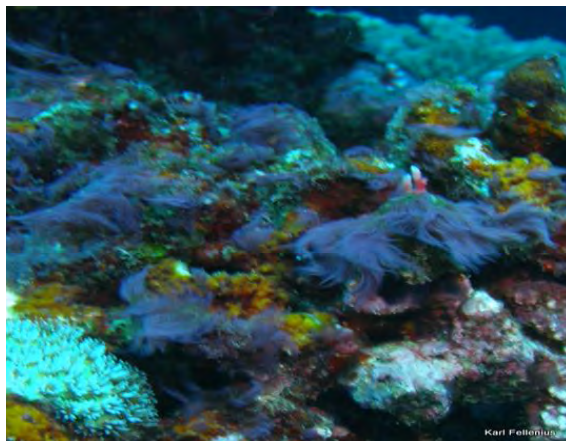
Beyond the physical impact of sedimentation in run-off is the nutrient nature of the material. Ground coral rock contains phosphates and nitrates that act as liquid fertilizer in the marine environment. While nutrients in the marine environment are normal, the excessive rates at which they enter South Tarawa's waters from excavated shorelines, road works, sewage leakage, open defecation on reef flats, and animal husbandry areas in particular cause eutrophication. Coral reefs are gradually being replaced by algae.

Fig. 2.25 Stringy Black Cyanobacteria

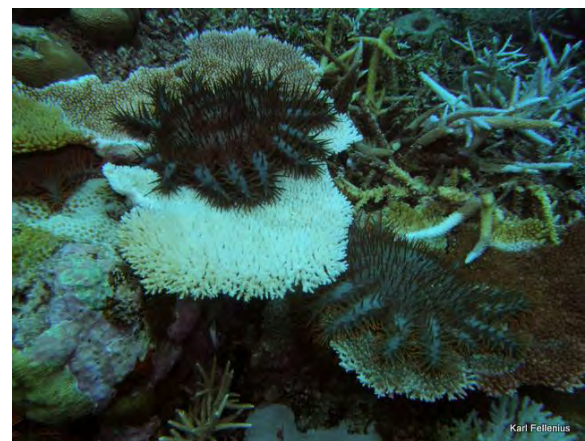
Fig. 2.26 COTs on table corals

South Tarawa, and especially Bairiki, continues to have infestations of the Crown-of-Thorns (COTs) sea star *Acanthaster planci* beyond the 2009 outbreak (KIR PWU 2013, items 42-91). It is a growing problem all over the world. Numerous animals and feeding scars were seen on this survey (discussed further in section 3.3). COTs eat stony coral (fig. 2.26). Much research has been done in this area and the consensus is that COTs thrive in polluted, nutrient-rich areas. There are also outbreaks in pristine areas so there is some indication that COTs control fast-growing coral from taking over a reef. Nonetheless, they are considered to be pests and the best management practice is to remove them from the water and to avoid the high nutrient water quality conditions in South Tarawa that attract them in the first place.

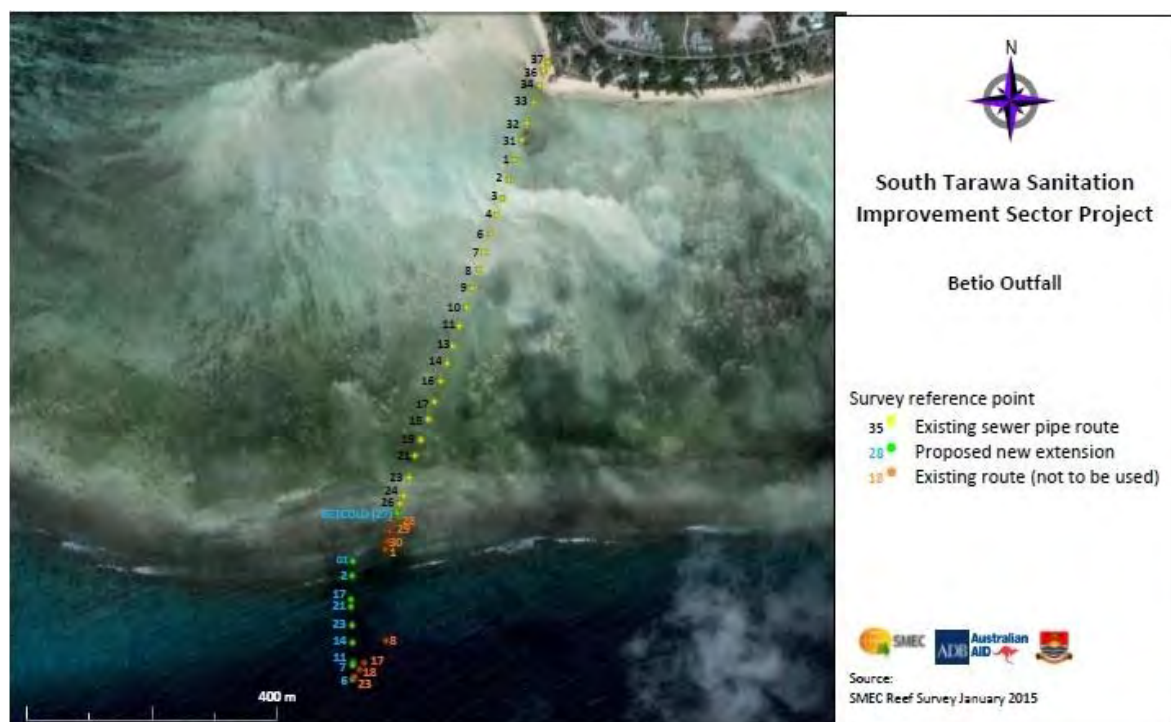
Fig. 4.1.1a Location of Existing and Proposed Betio Outfall Route

Terminating the outfall within 2m south of point 7 (see fig. 4.1.1a p22) is warranted because it achieves the desired 30m depth, and keeps the diffuser and the immediate area of discharge away from the blue coral *Heliopora coerulea* that is on the upper reef slope. If the diffuser is 10m long and ends at this location, it would be 47m south of the shallower *H. coerulea*. It is expected but not confirmed via surveying, that the reef conditions on the slope are similar 25m east and west of the outfall location based on the visibility at the time.

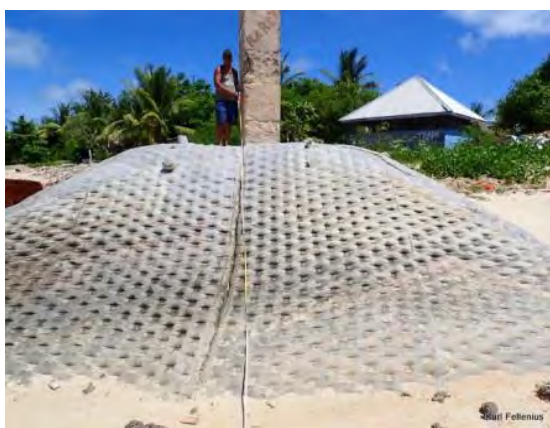
Fig. 4.1.3 Betio vent looking North

Figures 4.1.3 and 4.1.4 of the vent location on the shoreline show point 37 as the 0m chainage point.

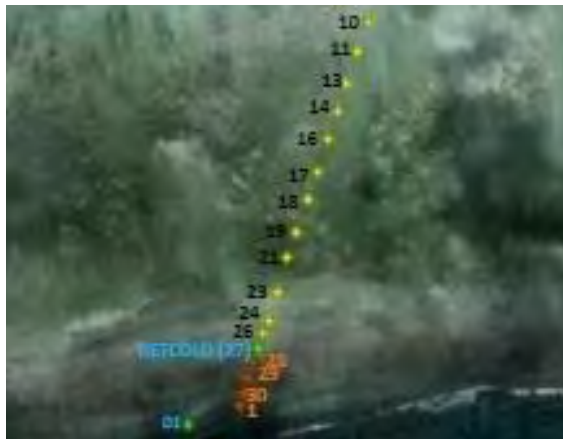
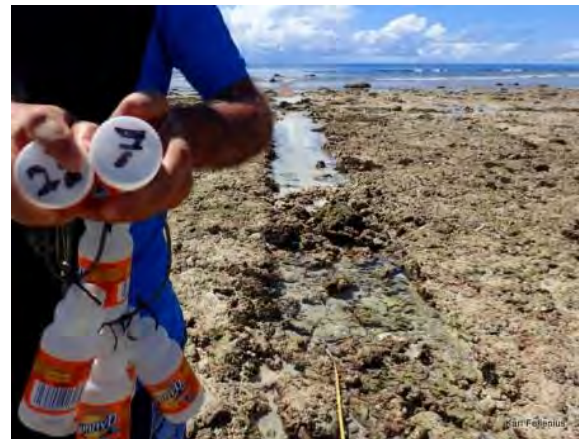
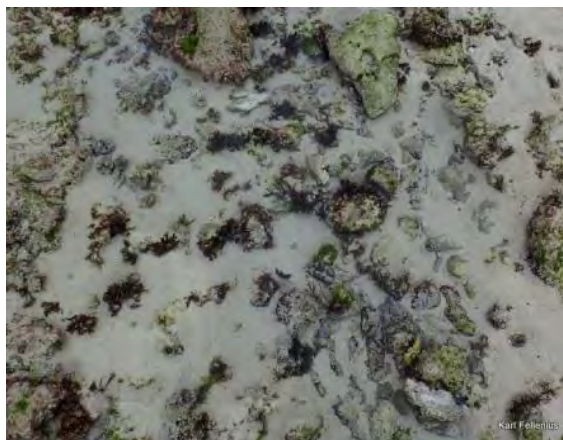
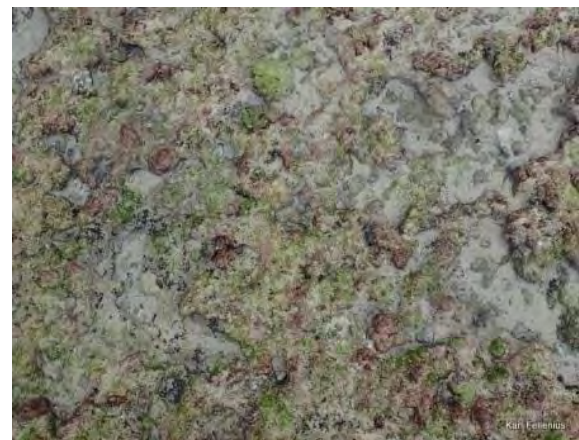
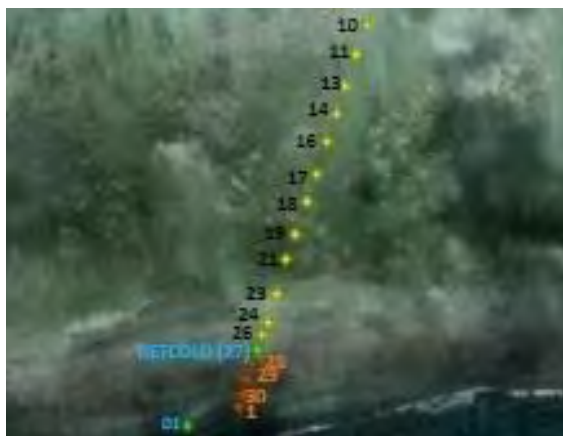
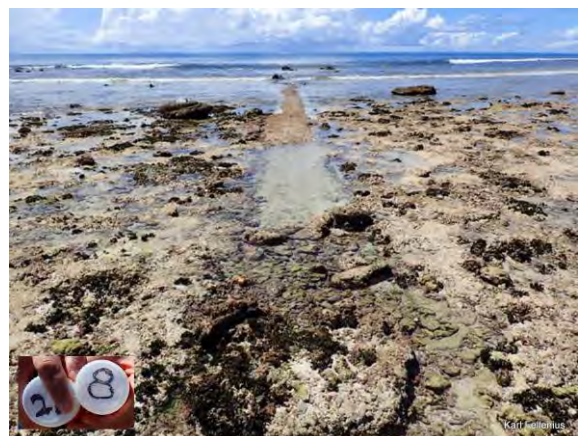
Figures 4.1.58 to 4.1.69 show the substrate and algae that is representative of the outer 100m of the intertidal reef flat. There is negligible sand outside the trench with about 70% cover of turf algae. Roughly half of the turf algae are red cyanobacteria microalgae, and half are fleshy green microalgae. Both arise from high nutrient and high energy conditions with enough sunlight. Within the green varieties there are the thicker-branched algae that are not palatable for herbivorous fishes, and therefore spread quickly. Others known as sea lettuce (*Ulva* sp.) have soft sheet-like leaves that do get eaten, or quickly disintegrate. Because of the high amount of turf algae, there are less than 5% crustose coralline algae and no green-segmented coralline algae (*Halimeda* sp.) that are normally associated with good water quality on outer intertidal reef flats.

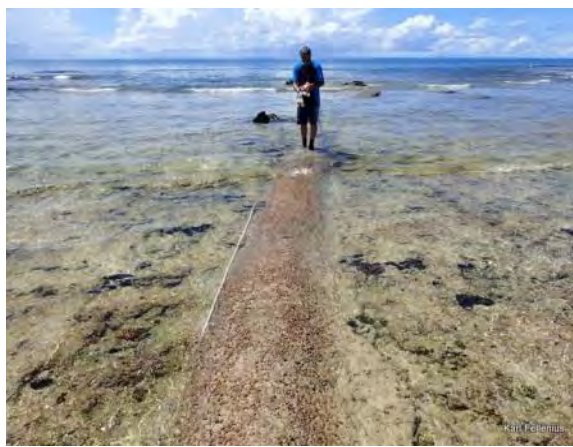
Figures 4.1.66 and 4.1.67 show a 20m section of the existing outfall pipe encased in concrete from approximately point 29 to point 30.

Fig. 4.1.66 Betio reef flat from point 29 looking South

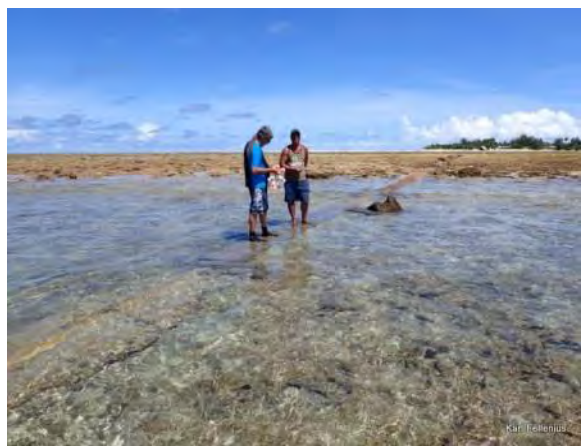
Fig. 4.1.67 Betio reef flat at point 30 (people) looking NW

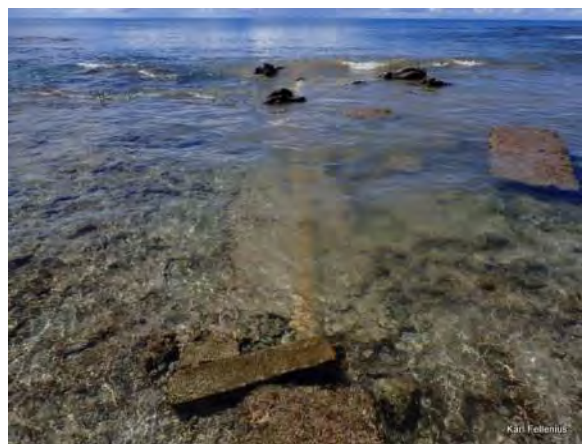
Figure 4.1.69 shows the last 13m section of the existing outfall pipe exposed from approximately point 30 to the end.

Fig. 4.1.69 Betio reef flat from point 30 looking South, 20 min. after low tide of +66cm

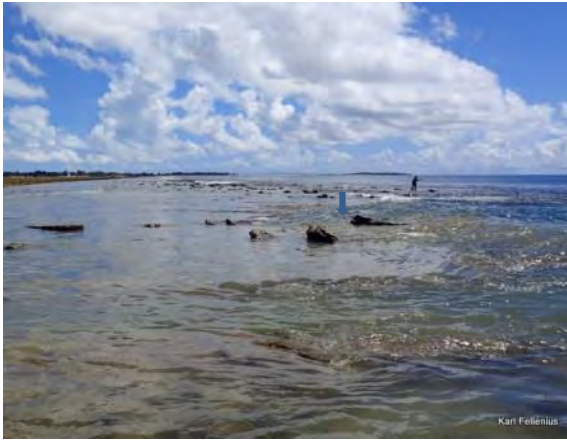
Figures 4.1.70 and 4.1.71 are views in both the east and west direction from opposite sides of the end of existing pipe.

Fig. 4.1.70 Betio outfall looking East with point 1 (end of pipe) at ↓ 20 min. after low tide of +66cm

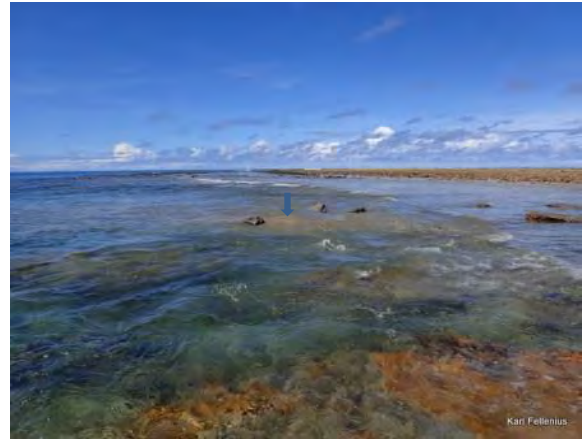
Fig. 4.1.71 Betio outfall looking West with point 1 (end of pipe) at ↓ 20 min. after low tide of +66cm

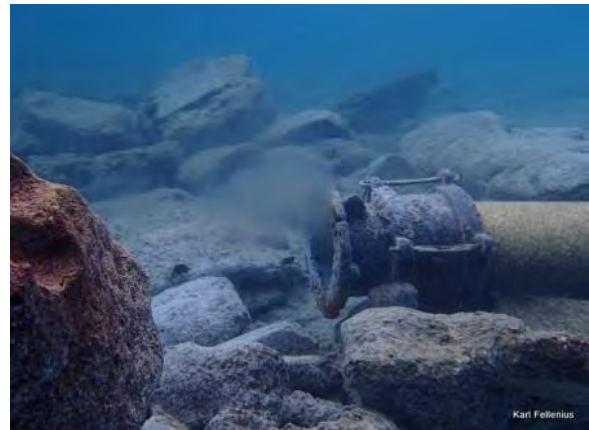
The existing end of the outfall pipe at Betio is shown in figures 4.1.72 and 4.1.73. The pipe itself appears in good condition except the portion that was attached from this point south has broken off. The broken pipe was not located on the reef flat, crest, or slope. The presence of dozens of concrete anchor blocks (CABs) strewn across the subtidal reef flat suggests that it has completely broken up into pieces and has washed away in recent years.

Fig. 4.1.73 From Betio end of existing pipe, looking West, corrected height +0.8m

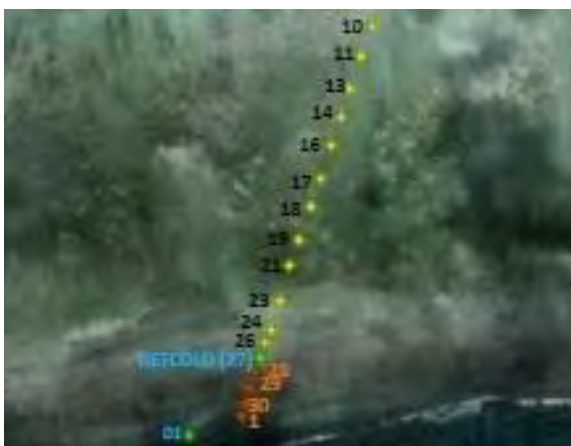
Fig. 4.1.74 Betio outer intertidal reef flat

Directly south of the end of existing pipe at point 1 (fig. 4.1.74 in orange) is not the proposed extension route for reasons that are outlined in the subtidal reef flat section in 4.1.3. Therefore, an alternative route is proposed to the west of the current end of pipe through point 01 (fig. 4.1.74 in blue). The chainage for this point is listed along with the subtidal points in section 4.1.3. The proposed extension would connect to the existing pipe and trench at BETCOLD (27).

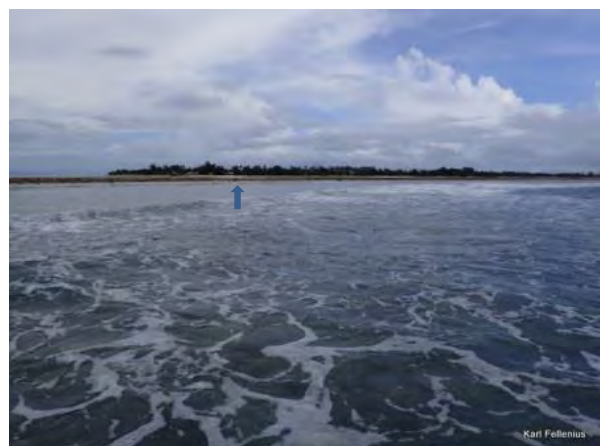
Fig. 4.1.75 Betio proposed route from point 01 to 27 at ↑ looking Northeast, 30 min. after low tide of +99cm

Figures 4.1.75 to 4.1.77 suggest that point 01 is not exposed on a moderate-to-high low tide. This will need to be factored in for the excavation of the new trench. The spur-and-groove morphology south of this point is also discussed in section 4.1.3.

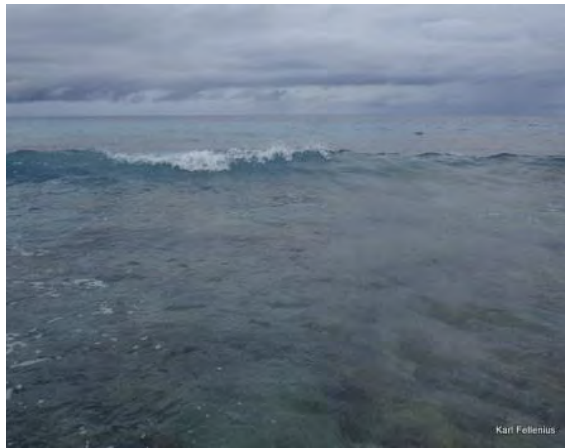
Fig. 4.1.76 Betio proposed route looking South from point 01, 30 min. after low tide of +99cm

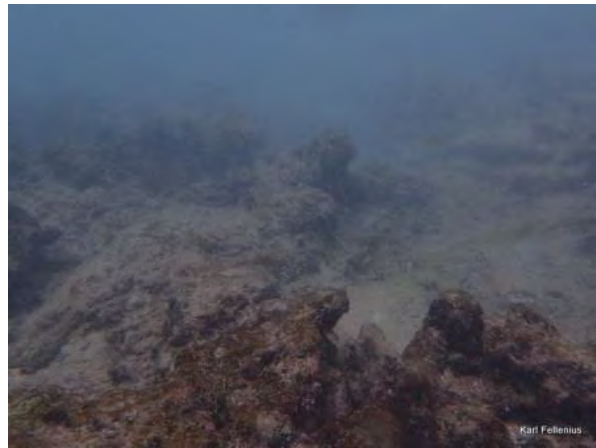
Fig. 4.1.77 Betio proposed route looking South from point 01, 30 min. after low tide of +99cm, 50cm depth

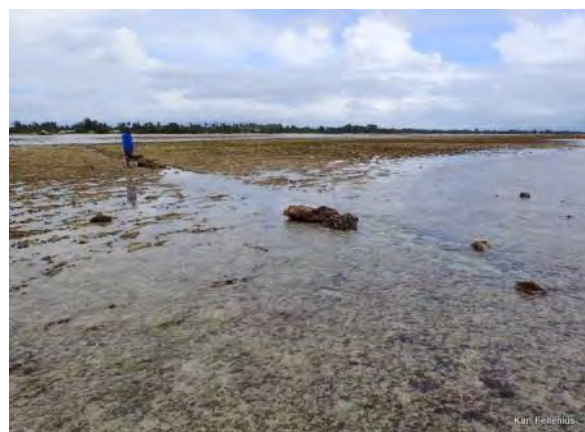
Fig. 4.1.81 Betio reef flat proposed route, from 20m Southwest of point 27 (BETCOLD), at person

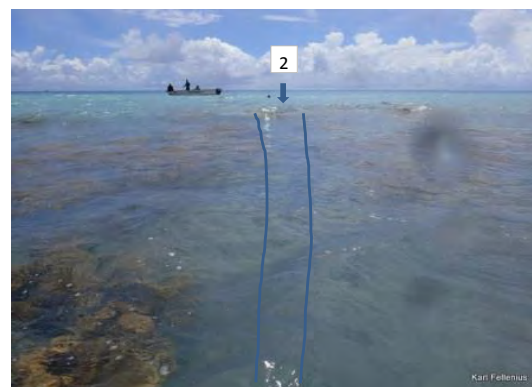
Most of the 9m long channel is therefore subtidal, with three rocky features crossing the proposed trench (fig. 4.1.86). The width is the 1m width required for the trench, and the length is 1.5m in one case (foreground 2m south) and 0.5m for each of the others (background 6m south). It is estimated to be total 2.5m<sup>3</sup> of rock. The outer 4m section is relatively open, although some shaving of rock surfaces to achieve an approximate level surface will be needed. These features are part of the spur of the reef, and need to be excavated by machine. Refer to channel part of video: *Betio 5 new route S to N vid 3m (pt17) to 0m* from 2:45 onwards. Figures 4.1.87 and 4.1.88 show the proposed outer section of the channel, and figures 4.1.89 and 4.1.90 look to the east and west of point 2.

Fig. 4.1.86 Betio proposed channel access, half-way between points 01 & 2 with terminus at 2

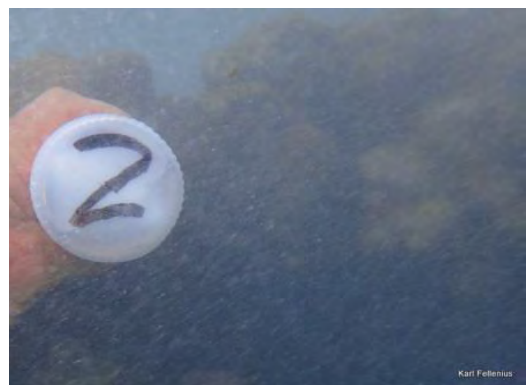
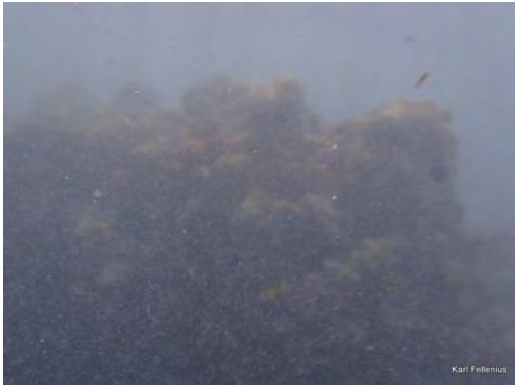
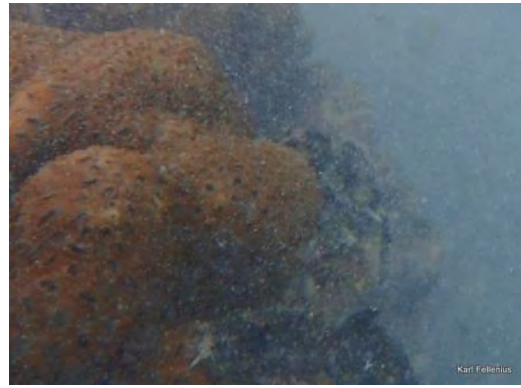
The 1.5m channel entrance is illustrated in figures 4.1.91 and 4.1.92. The channel is largely bare rock with only the outer portion having about 30% cover of zooanthids, commonly found in shallow spur-and-grooves (figs. 4.1.94 to 4.1.96). The zooanthid *Palythoa* sp. thrives under high nutrient conditions. It is possible its abundance is in response to the COTs outbreak in South Tarawa in 2009 (Houke 2015), which reduced coral cover throughout all three outfall areas.

Fig. 4.1.94 Betio point 2 rocky outcrop

Fig. 4.1.95 Betio rocky outcrop at point 2

Fig. 4.1.96 Betio rocky outcrop detail of the common zooanthid *Palythoa* sp., corrected depth 0.15m

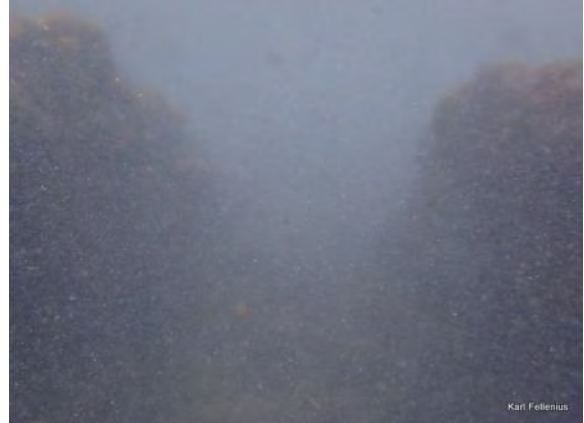
Obstruction 1: Beyond the channel 1-3m south of point 2 are two adjacent rocks obstructing the route that are each 0.75m in diameter for a total of 0.5m<sup>3</sup> that need to be removed. They are separate from the channel spur and are therefore not as solid. They are listed as an obstruction but it may be possible for the excavator to reach from the channel area. The reference is Betio video 5 at 1:27 and one rock is shown in figure 4.1.98. Each rock has about 10% cover of the same zooanthid noted for the channel. For most of the 33m route between point 2 and 17 the bottom is unobstructed and typical of figure 4.1.99. [dive team estimate 6 hrs.]

Fig. 4.1.99 Betio typical of route between point 2 & 17, corrected depth 1.8m

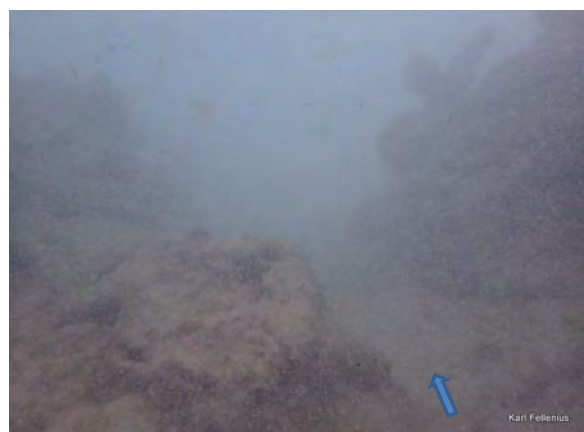
For the remainder of the subtidal reef flat refer to video: *Betio 6 new route N to S vid 3m (pt17) to 11m (pt14)*. Figure 4.1.101 shows the route at point 17 passing between two rocky outcrops 1m apart. There is no coral or other marine life in this heavily-silted area.

Fig. 4.1.101 Betio point 17 looking South, corrected depth 2.3m, route passes along ↑

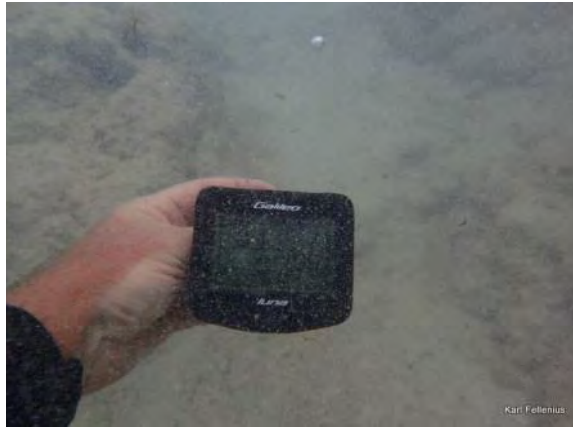
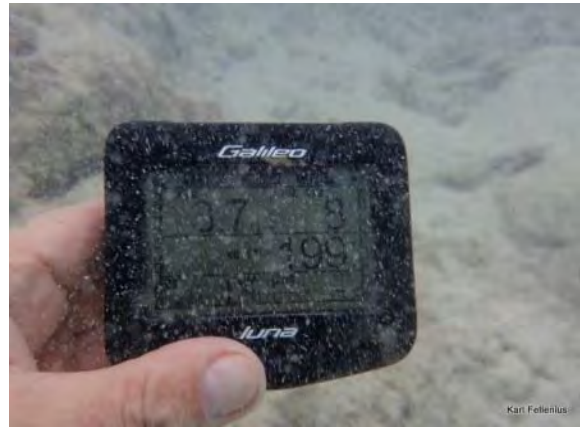
The 10m of substrate between points 17 and 21 is silt, rubble, and debris at a slope of 3° (figures 4.102 and 4.103). There are no coral or other marine life present other than about 70% cover of turf algae.

Fig. 4.1.102 Betio typical substrate south of point 17, corrected depth 2.3m

Fig. 4.1.103 Betio typical substrate north of point 21, corrected depth 2.9m

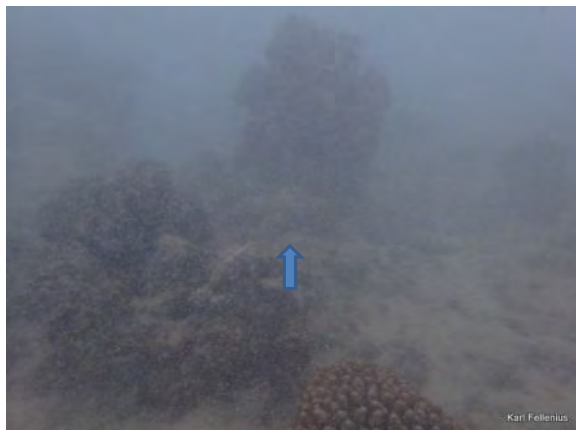
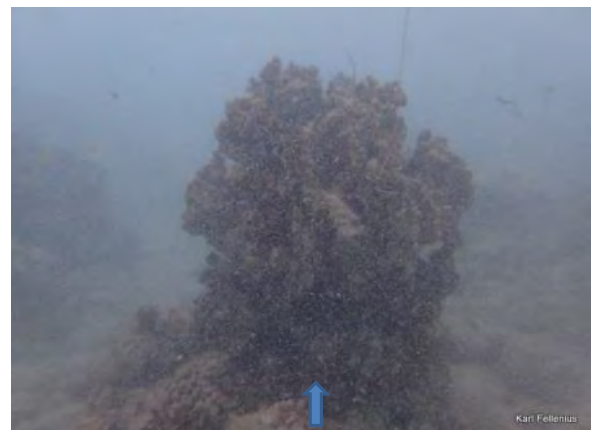
**Obstruction 4:** Figures 4.1.104 and 4.1.105 show a 0.75m wide and 1m high *Porites* sp. coral bommie at point 21 with the proposed outfall route through the bommie (reference at 0:40 in Betio video 6). Immediately north is a 0.5m wide rocky outcrop and an *Acropora* sp. digitate coral colony. These need to be removed because the channel to the left in figure 4.1.105 is not wide enough. Effort to relocate *Acropora* sp. is recommended, although this is not needed for the abundant and habitat-poor *P. rus*. [dive team estimate 3 hrs.]

Fig. 4.1.104 Betio coral bommie at point 21 looking South, route marked ↑ corrected depth 2.9m

Fig. 4.1.105 Betio coral bommie at point 21 looking South, route marked ↑ corrected depth 2.9m

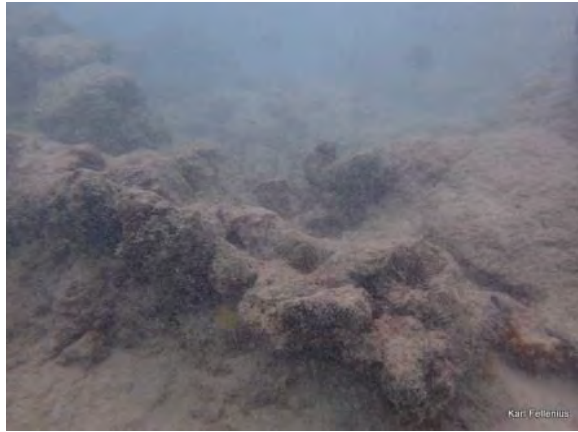
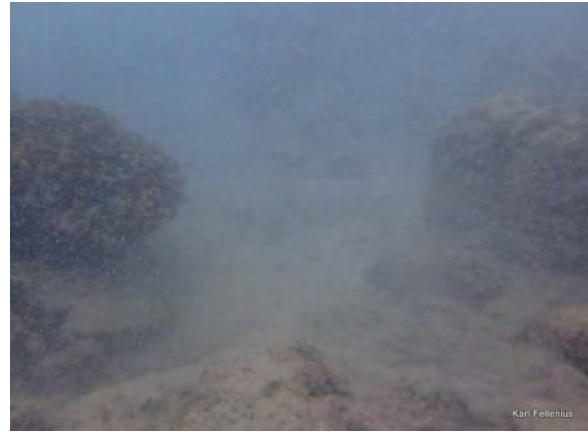
Obstruction 9: Figures 4.1.106 and 4.107 show the rocky and silt-laden substrate about half-way between points 21 and 23. The reference at 1:23 in Betio video 6 does not clearly show the area but there is some levelling needed for the bottom, and relocation of the left submassive coral colony. There is only a 0.75m wide space between the submassive and massive coral colonies, which are typical of the 10-15% coral cover in the area. [dive team estimate 2 hrs.]

Fig. 4.1.106 Betio 13m South of point 21 looking South, corrected depth 3.4m

Fig. 4.1.107 Betio 15m South of point 21 looking South, corrected depth 3.6m

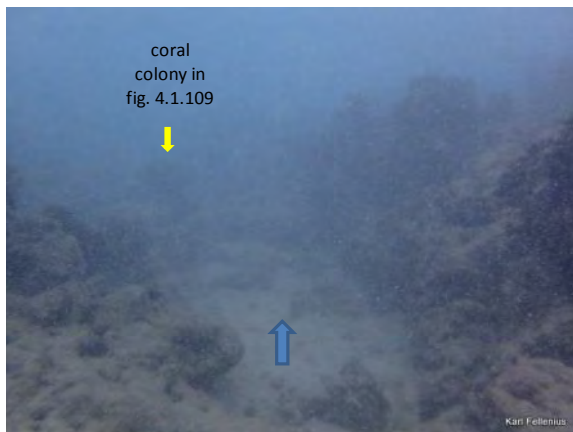
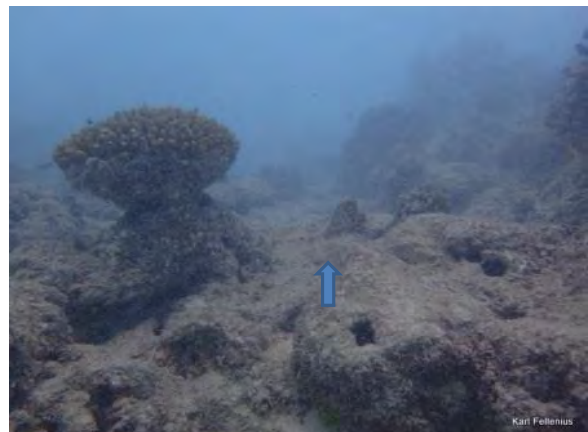
There are a few *Acropora* sp. digitate coral colonies starting at 5-8m north of point 23 (figs. 4.1.108 and 4.1.109 and reference from 1:38 to 1:52 in Betio video 6). Coral cover remains at 10-15%.

Obstruction 11: The uneven slope immediately north and right of the coral colony in the foreground of figure 4.1.109 needs to be levelled. The amount is less if the coral colony can be relocated. However, effort should be put to only relocating *Acropora* sp. where absolutely necessary.

Fig. 4.1.108 Betio 8m North of point 23 looking South, route marked ↑ corrected depth 4.2m

Fig. 4.1.109 Betio digitate coral colony 5m North of point 23 looking South, route marked ↑ corrected depth 4.2m

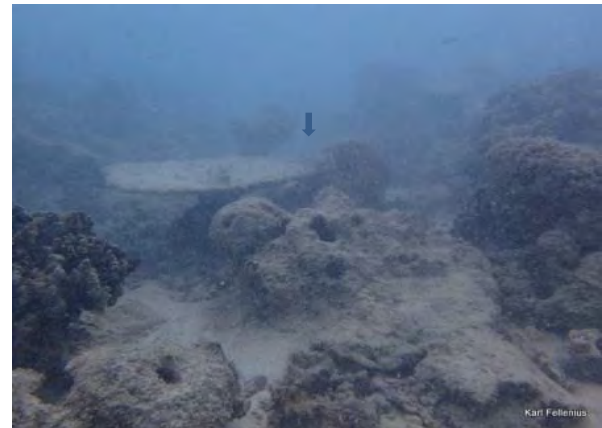
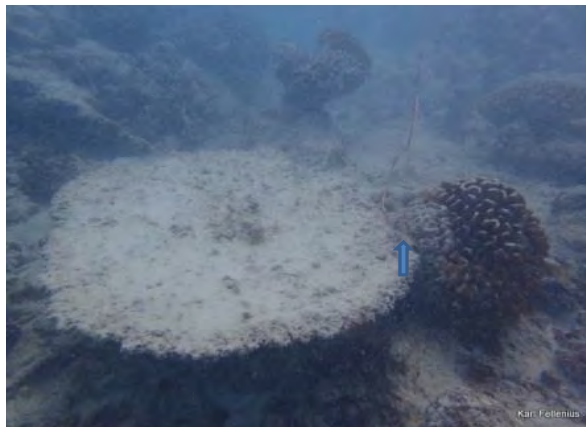
Obstructions 13-16: Point 23 lies on a dead table coral structure 1.5m in diameter (fig. 4.1.111 and reference at from 1:56 to 2:08 in Betio video 6). The structure has a very solid base and is adjacent to rock to the north, coral to the west, and coral to the south (fig. 4.1.112). The outfall route is proposed to be at this point as opposed to directly east to avoid significant curvature south of this point. It cannot sit on top so the table structure must be removed. The base of the structure can be pulled out from the substrate given significant floatation via lift bags (est. at 100L lift). The protruding edge north of the table needs to be shaved off, although the coral to the west can remain. The small live portion of the rock making up the *Acropora* sp. digitate coral colony to the south should be relocated. Immediately to the south of that point is a 0.3m diameter dead coral colony, which needs to be removed to allow the outfall pipe to pass unobstructed. [dive team estimate 3 hrs.]

Fig. 4.1.111 Betio point 23 looking South, route passes along ↑ corrected depth 4.6m

Fig. 4.1.112 Betio point 23 looking South, route passes along ↑ corrected depth 4.6m

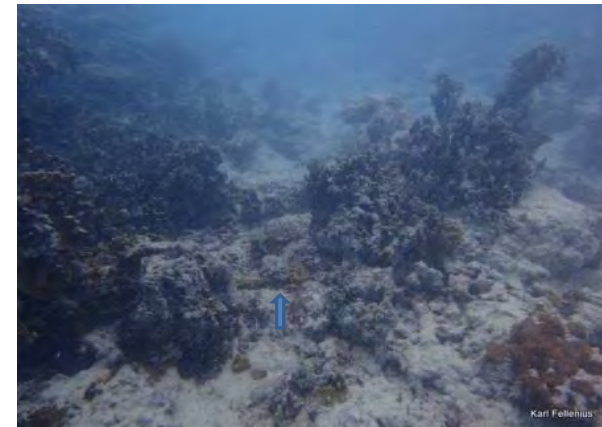
Fig. 4.1.113 Betio 5m South of point 23 looking South, route passes along ↑ corrected depth 5.2m

The slope almost doubles to 7° over the next 5m south to a coral patch dominated by submassive *P. rus* and *H. coerulea* (reference at 2:16 in Betio video 6 and fig. 4.1.113). *Pocillopora* sp. also present, although no live *Acropora* sp. This point marks the beginning of significant rubble and debris for the remainder of the subtidal reef flat.

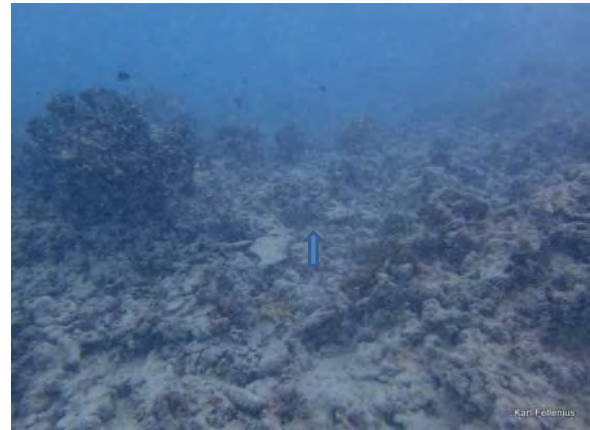
The 26m of substrate between points 23 and 14 is silt, rubble, debris, and coral at a slope of 11° (figures 4.114 and 4.115, reference at 02:32 and 02:26 respectively in Betio video 6). There is 10% coral cover across similar genus and growth forms identified closer to point 23, although colonies are in a more degraded state due to heavy siltation and about 45% cover of turf algae. There is no obstruction along this part of the outfall route, although there is significant rubble and debris present.

Fig. 4.1.115 Betio 14m South of point 23 looking South, route passes along ↑ corrected depth 7.2m

The proposed route passes adjacent to the coral bommie in figure 4.1.115 and through figure 4.1.116 (reference 02:53 in Betio video 6). At that point the video goes slightly off course to the east (in grey), while the proposed route follows as shown in figures 4.1.116 and 4.1.117. The arrow in figure 4.1.117 is point 14. Note that Betio video 6 from 02:54 to 03:34 informs the typical substrate for the area although it terminates about 5m east of point 14 instead of at point 14.

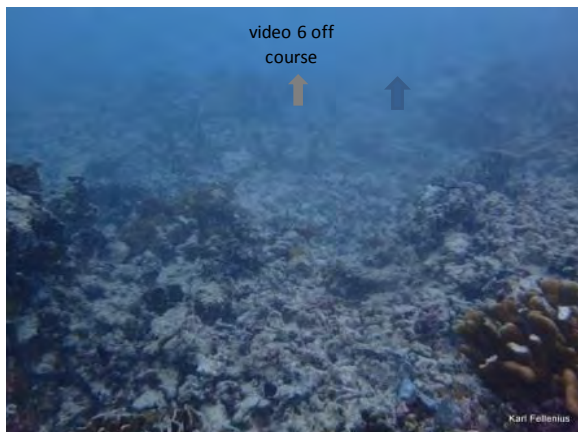
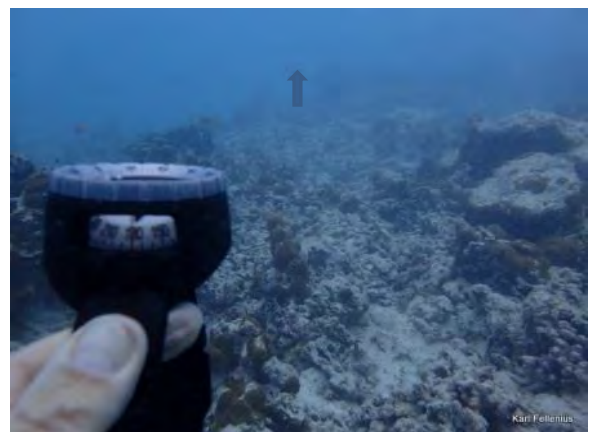
Fig. 4.1.116 Betio 16m South of point 23 looking South, route passes along ↑ corrected depth 7.7m

Fig. 4.1.117 Betio 20m South of point 23 looking South, route passes along ↑ corrected depth 8.2m

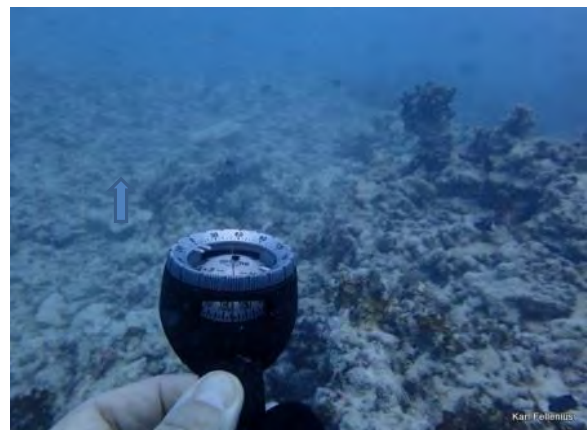
Fig. 4.1.123 From Betio 3m North of point 14, looking South, route passes along ↑ corrected depth 9.9m

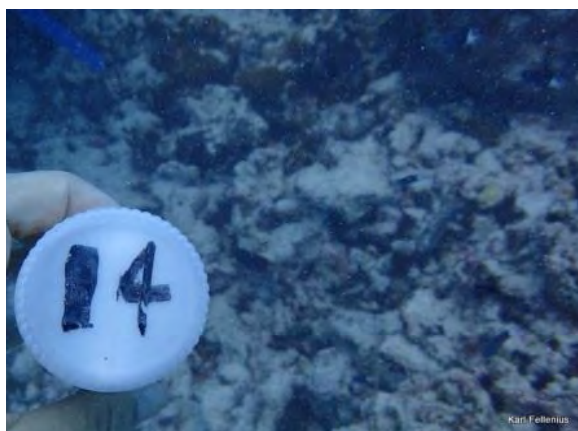
Fig. 4.1.124 Betio rubble substrate at point 14

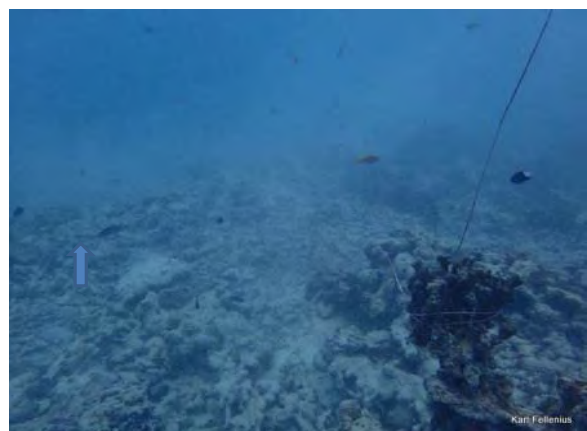
Fig. 4.1.125 From Betio point 14, looking South, route passes along ↑ corrected depth 9.9m

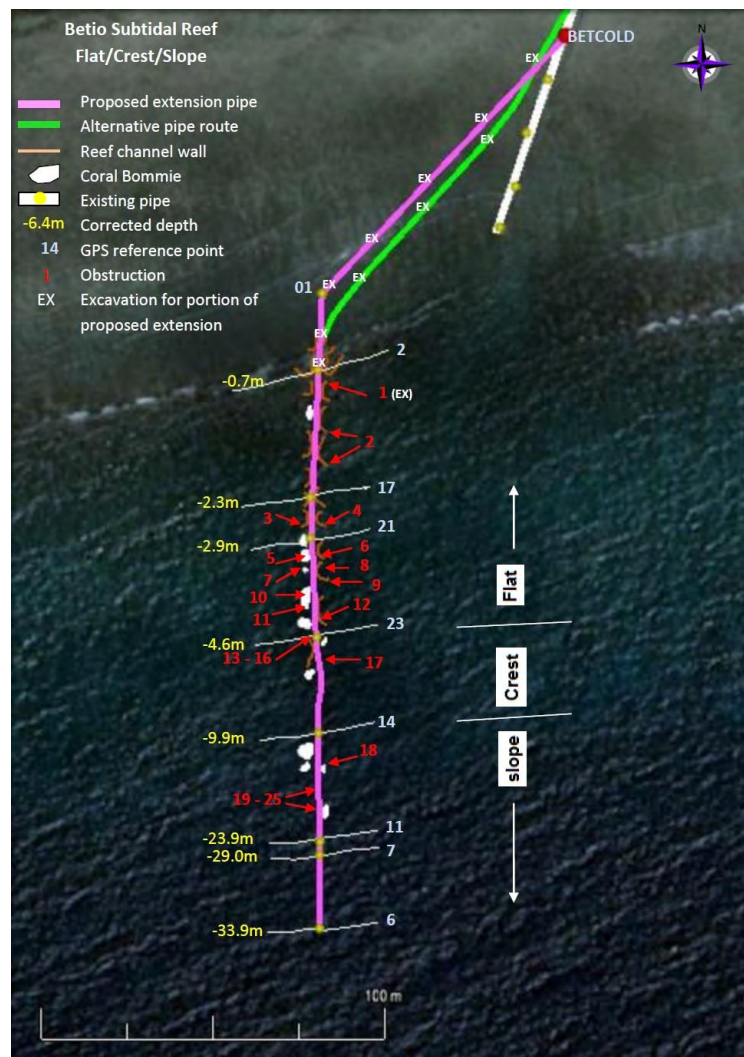
Fig. 4.1.128 Features and Obstructions along the Existing and Proposed Betio Outfall Route (digitized by SMEC)

The 29m of substrate between points 14 and 11 is rubble, debris, with silt and minor coral at a slope of 26° (reference from 0:11 and 01:16 in Betio video 7 and from 1:05 to 2:25 in Betio video 8). Figure 4.1.128 re-displays the proposed outfall route and the various features and obstructions found along the length of the proposed extension.

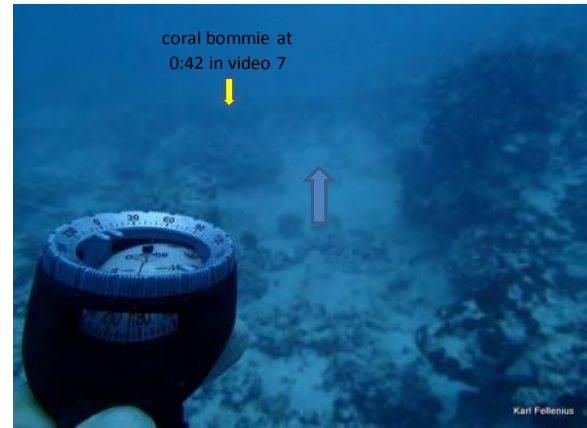
**Obstruction 18:** There is a collapsed dead table coral structure 1.5m wide and 2.5m long that is loose and needs to be removed from the outfall route (figure 4.1.129). There is some minor adjacent debris as well. The route is relatively clear for about 6m beyond that point as shown in figure 4.1.130. The reference is from 0:35 to 0:42 in Betio video 7. The corresponding reference is from 1:58 to 2:05 in Betio video 8. Note however that there are issues with both video segments. Video 7 stays right after heading south from point 14 from 0:20 to 0:35, when it should have stayed left. Video 7 (descending) at 0:35 is to the right of the arrow in figure 4.1.129, and video 8 (ascending) is to the left of the coral bommie noted in figure 4.1.130. [dive team estimate 1 hr. at 14m depth]

Fig. 4.1.130 Betio 10m South of point 14 looking South, route passes along ↑ corrected depth 13.5m

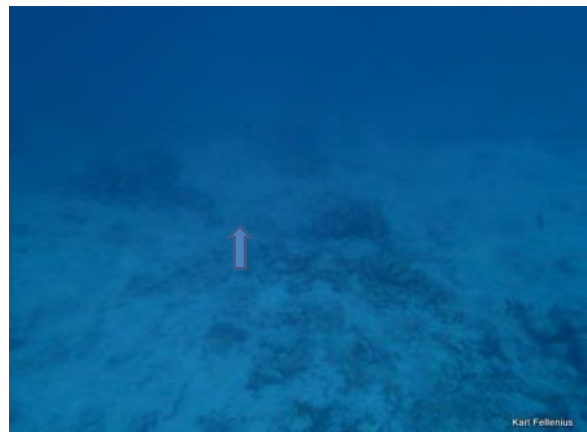
Figure 4.1.132 shows no obstructions beyond point 11 at 24m depth.

Fig. 4.1.132 From Betio at point 11, looking South, route passes along ↑ corrected depth 23.9m

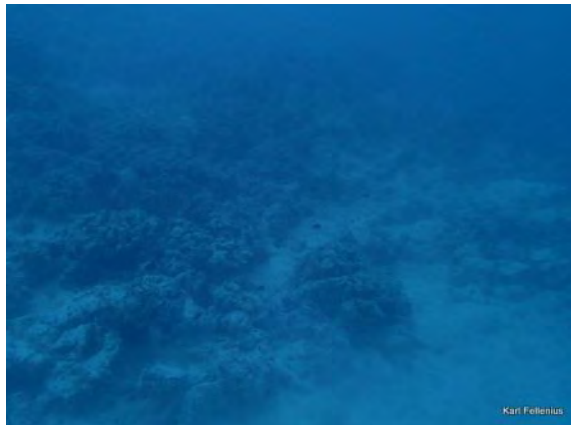
There is no coral on the middle reef slope, neither immediately east nor west of point 11 (figs. 4.1.133 and 4.1.134). Dead coral structures are remains of *P. sinuosa*, likely killed off during the COTs infestation of 2009 with contributing stressors related to sedimentation and nutrient loading from the sewage outfall over the years.

Fig. 4.1.133 From Betio point 11 looking East, corrected depth 23.9m

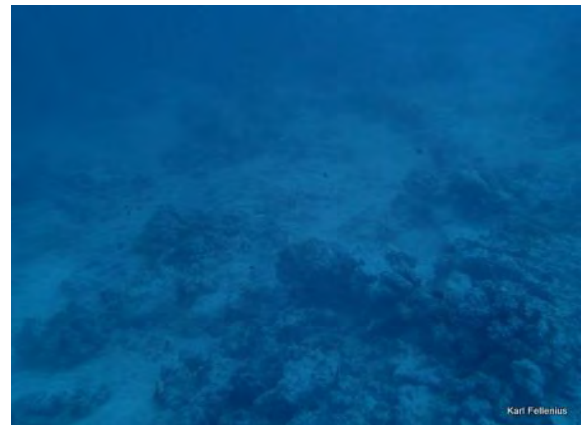
Fig. 4.1.134 From Betio point 11 looking West, corrected depth 23.9m

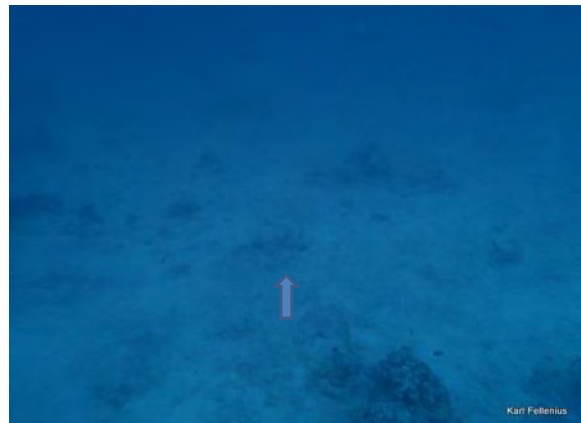
Figures 4.1.136 shows no obstructions beyond point 7 at 29m depth.

Fig. 4.1.136 From Betio at point 7, looking South, route passes along ↑ corrected depth 29.0m

Note that terminating the outfall within 2m south of point 7 (reference at 2:15 in Betio video 7 and 0:38 in Betio video 8) is warranted because it achieves the desired 30m depth (corrected), and keeps the diffuser and the immediate area of discharge away from the *H. coerulea* that is on the upper reef slope. If the diffuser is 10m long and ends at this location, it would be 47m south of the shallower *H. coerulea*. It is expected but not confirmed via surveying, that the reef conditions on the slope are similar 25m east and west of the outfall location based on the visibility at the time.

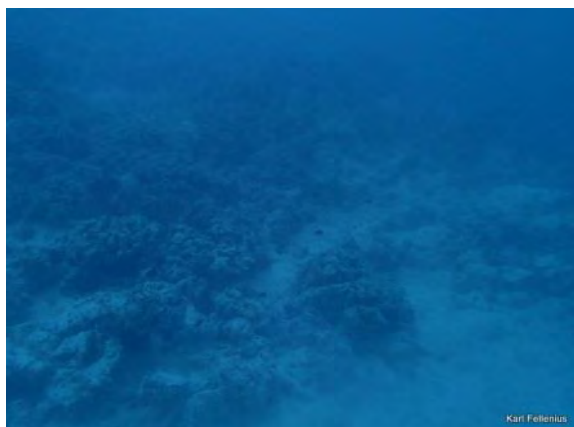
There is no coral on the lower reef slope, neither immediately east nor west of point 7 (figs. 4.1.137 and 4.1.138). Dead coral structures are remains of *P. sinuosa*. There are about 40% cover of turf algae, and no fleshy or crustose coralline algae.

Fig. 4.1.137 From Betio point 7 looking East, corrected depth 29.0m

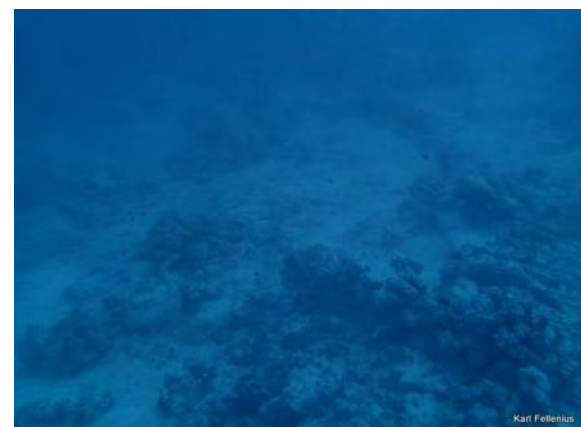
Fig. 4.1.138 From Betio point 7 looking West, corrected depth 29.0m

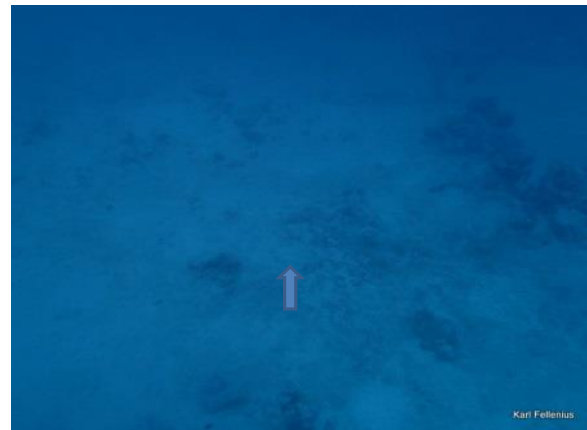
Figures 4.1.140 shows no obstructions beyond point 6 at 34m depth.

Fig. 4.1.140 From Betio at point 6, looking South, route passes along ↑ corrected depth 33.9m

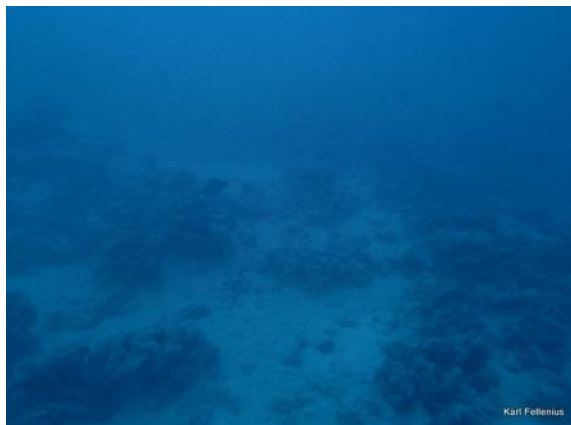
There is no coral on the lower reef slope, neither immediately east nor west of point 6 (figs. 4.1.141 and 4.1.142). Dead coral structures are remains of *P. sinuosa*, and there is 10% blue-green algae.

Fig. 4.1.141 From Betio point 6 looking East, corrected depth 33.9m

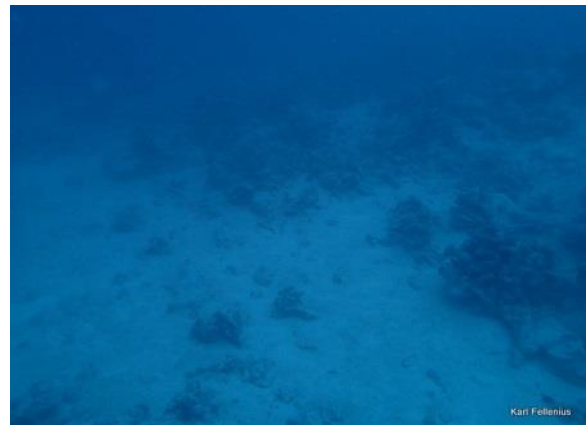
Fig. 4.1.142 From Betio point 6 looking West, corrected depth 33.9m

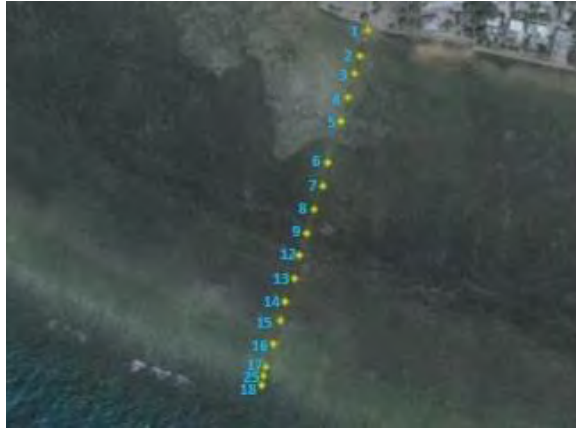
Fig. 4.2.6 Bairiki intertidal reef flat

Approximately the first 60m of the inner intertidal reef flat is rubble with no algae, followed by 25% cover of turf algae for about 30m, dropping off to 10% near the end of existing pipe. The odoriferous and fast-growing red macroalgae, *Hypnea* sp. starts at about 150m from the shoreline and persists at 75% cover for about 30m, dropping off to 5% at 40m before the end of existing pipe. At that point (15) through to 20m before the existing end of pipe there flourishes a 60% cover of *Caulerpa* sp. sea grape algae, albeit with a few patches of cyanobacteria mat macroalgae. The overriding point is that there is a dominance of fleshy and other undesirable algae across the intertidal reef flat, with no presence of any calcifying algae.

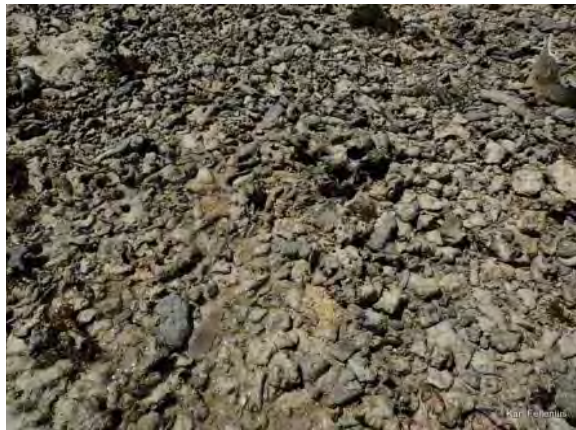
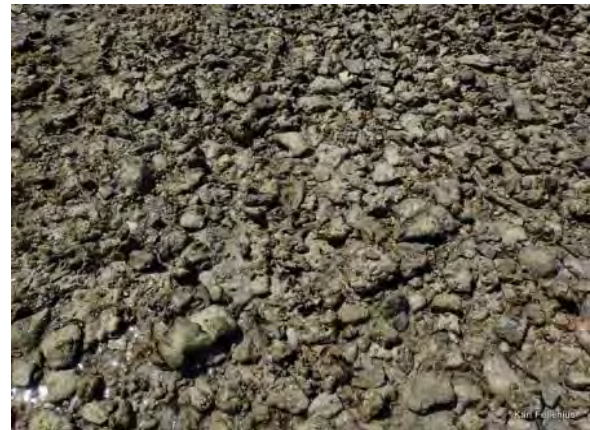
Fig. 4.2.8 Bairiki reef flat point 4 rubble

Fig. 4.2.9 Bairiki reef flat point 4 rubble

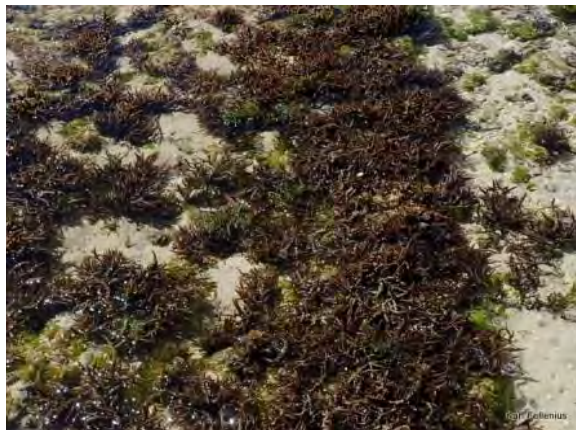
Fig. 4.2.16 Bairiki reef flat at point 12, *Hypnea* sp. algae

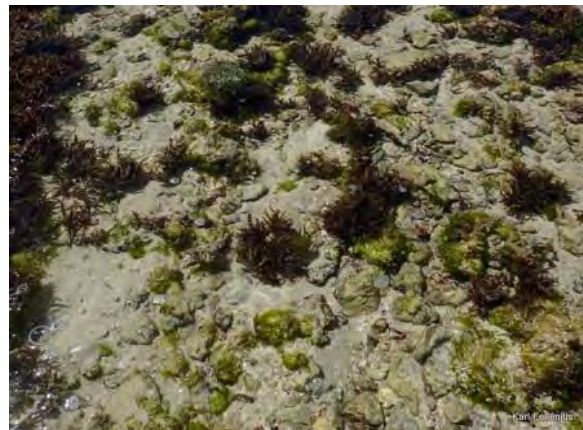
Fig. 4.2.17 Bairiki reef flat at point 12, green turf algae

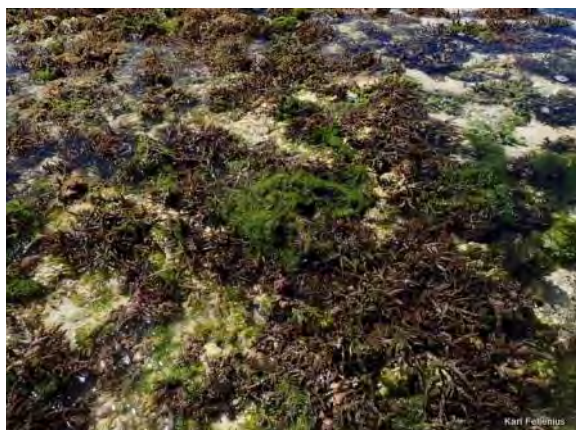
Fig. 4.2.20 Bairiki reef flat at point 13, *Hypnea* sp. and stringy green algae

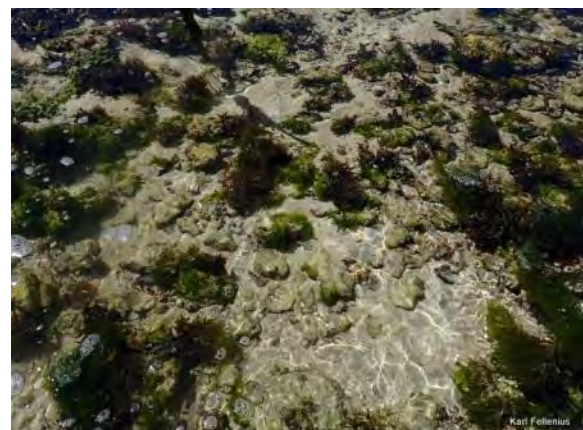
Fig. 4.2.21 Bairiki reef flat at point 13, green turf algae

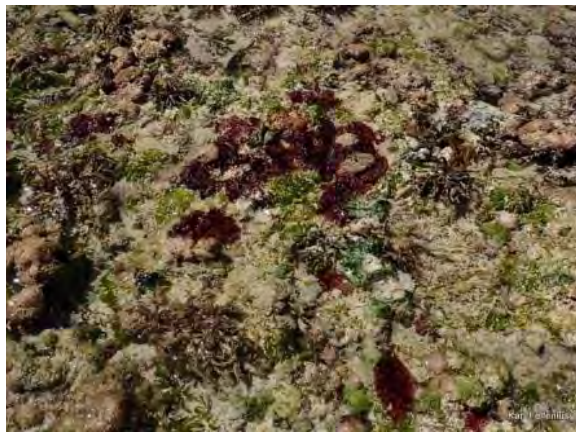
Fig. 4.2.24 Bairiki reef flat at point 15, Cyanobacteria mat algae
