# Benthic Morphology and Marine Life Assessment for the Siting of Ocean Outfalls on South Tarawa

The South Tarawa Sanitation Improvement Sector Project, Tarawa Atoll, Kiribati

March 2015

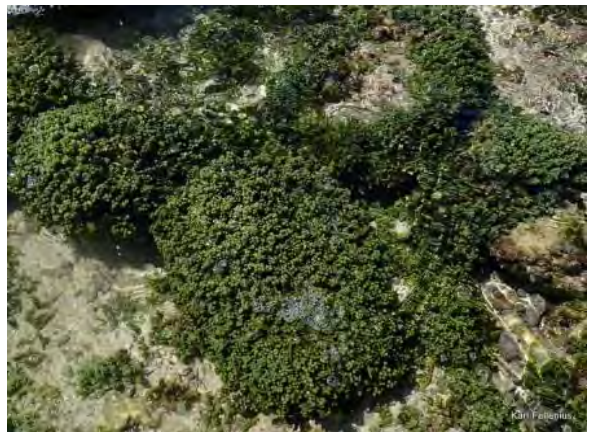
Fig. 4.2.25 Bairiki reef flat at point 15, *Caulerpa* sp. sea grape algae

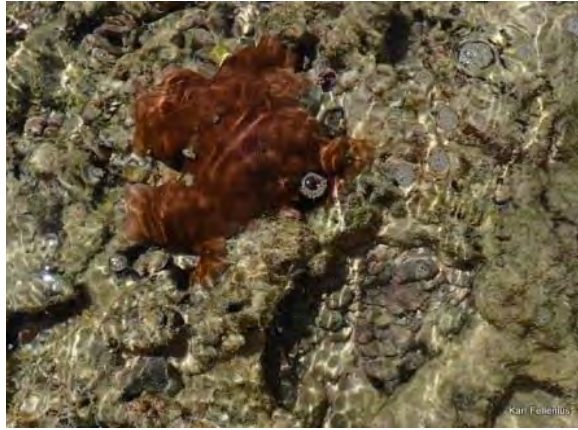
Figures 4.2.28 and 4.2.31 show the only coral presence within 10m of the outfall pipe in both directions. There is effectively no coral cover on the intertidal reef flat.

Fig. 4.2.28 Bairiki reef flat at point 16, encrusting coral patch

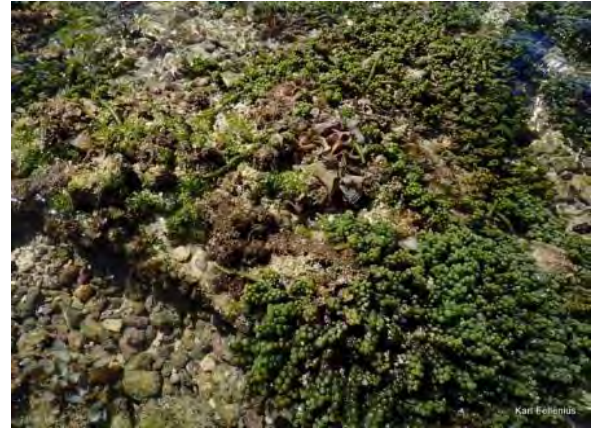
Fig. 4.2.29 Bairiki reef flat at point 16, *Padina* sp. funnelweed and *Caulerpa* sp. sea grape algae

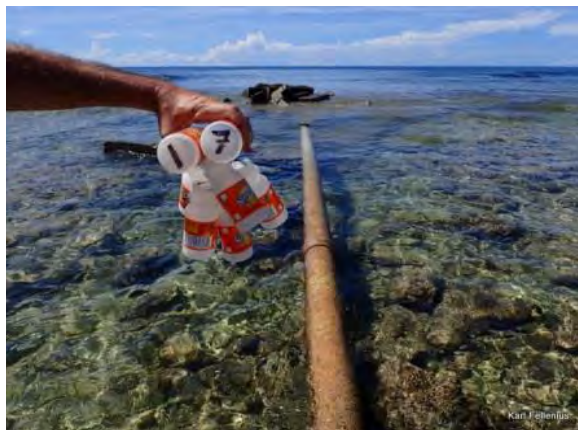
Fig. 4.2.30 Bairiki reef flat at point 17, exposed outfall pipe, looking South

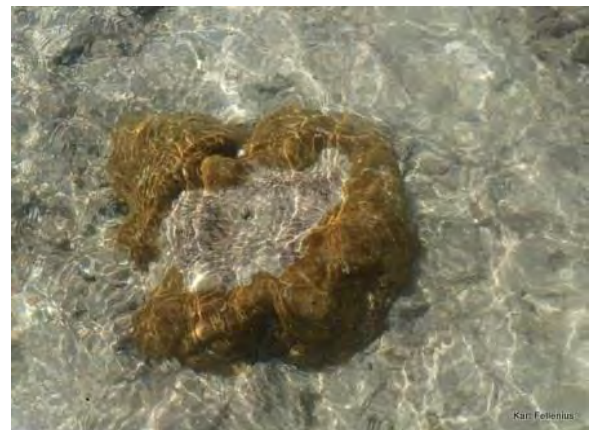
Fig. 4.2.31 Bairiki reef flat at point 17, palm-sized massive coral

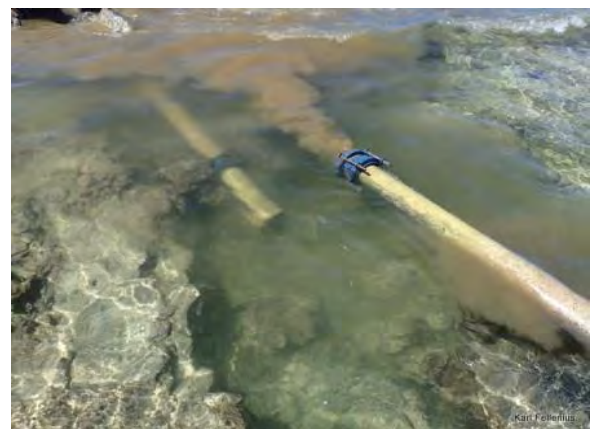
Fig. 4.2.33 Bairiki reef flat at point 25, end of existing pipe

The end of existing pipe during active pumping is shown in figures 4.2.32 and 4.2.33. The pipe itself appears in good condition except the portion that was attached from this point south has broken off. There is a significant pile of CABs immediately south of the end of existing pipe, and these are discussed along with excavations and obstructions in section 4.2.3.

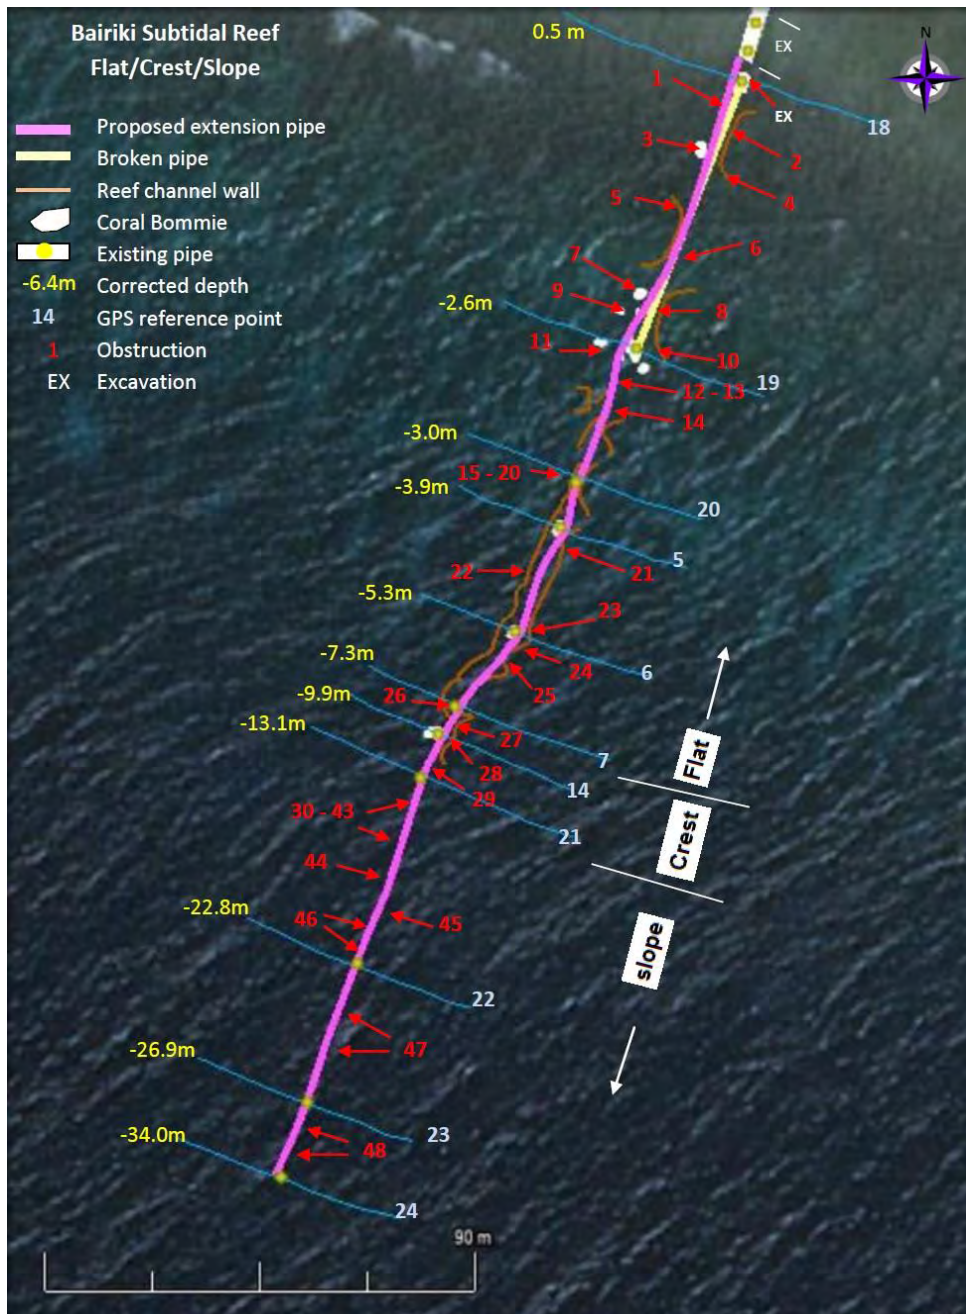
Fig. 4.2.41 Features and Obstructions along the Existing and Proposed Bairiki Outfall Route (digitized by SMEC)

Figure 4.2.41 shows the proposed outfall route and the various features and obstructions found along the length of the proposed extension.

The existing outfall pipe needs to be cut approximately 10m north of the end of the existing pipe, and the trench excavated (figs. 4.2.42 and 4.2.43, reference from 2:00 to 2:40 in video). A 10m<sup>3</sup> pile of small and large CABs at point 18 from 1-7m south of the end of existing pipe also needs to be removed via excavation (figs. 4.2.44 and 4.2.45, reference from 2:50 to 3:15 in video). There is about 20m<sup>3</sup> of CABs present, but no more than half are along the outfall route.

The entire length of the broken pipe from point 25 to 19 (66m) and its still-attached 22 CABs need to be removed (reference from 2:50 to 5:12 in video).

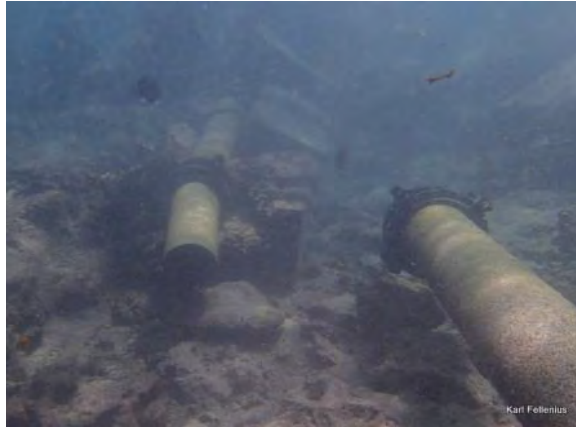
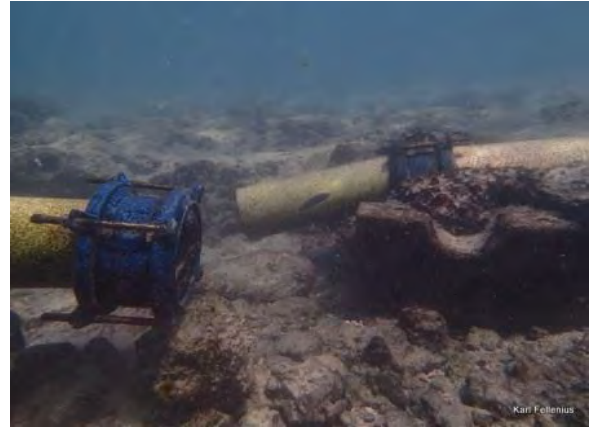
Fig. 4.2.42 Bairiki reef flat from 1m South of end of existing pipe, looking South, corrected height +0.1m

Fig. 4.2.43 Bairiki reef flat from 1m West of end of existing pipe, looking East, corrected height +0.1m

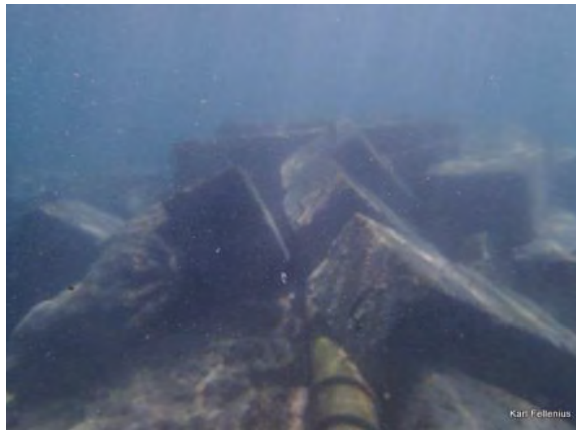
Fig. 4.2.44 From Bairiki end of existing pipe, looking South across point 18, corrected height +0.6m

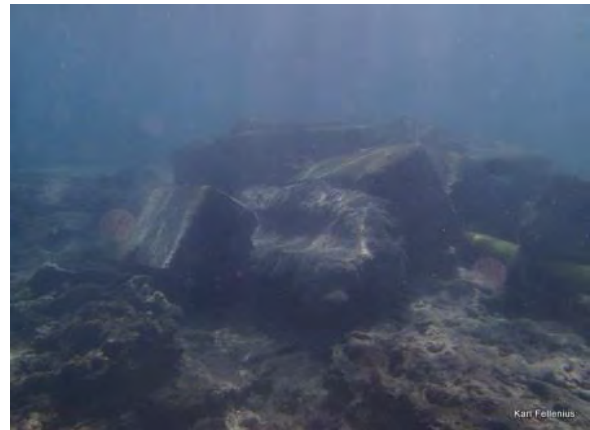
Fig. 4.2.45 From Bairiki end of existing pipe, looking Southwest to point 18, corrected height +0.6m

Obstruction 2: One rock 3m long, 1m wide, and 0.5m high obstructs the route 9m south of point 18 (video capture fig. 4.2.45 and reference at 3:34 in video). It is solid reef foundation and at best can be shaved down as needed as it would be very difficult to remove. A trench 0.5m wide is sufficient for the pipe, but this means that the position of adjacent CABs may need to be adjusted. [dive team estimate 1.5hrs.]

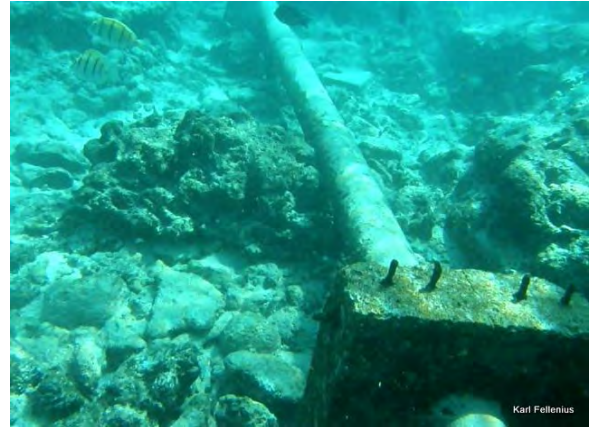
Fig. 4.2.46 Bairiki 12m south of point 18, looking South, corrected depth 1.0m

Obstruction 3: One loose rock 1m long along with miscellaneous debris 12m south of point 18 needs to be removed (video capture fig. 4.2.46 and reference at 3:43 in video). [dive team estimate 0.5hr.]

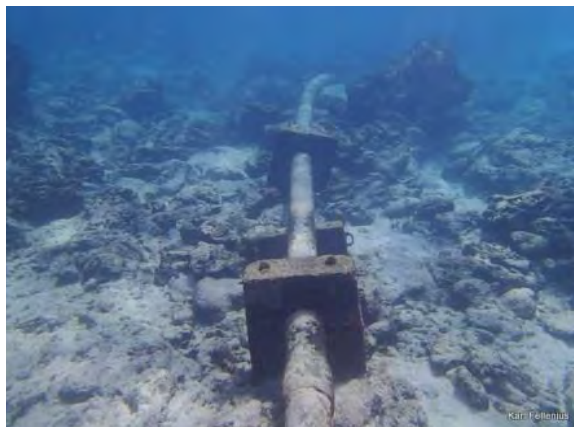
Fig. 4.2.47 Bairiki 23m south of point 18, looking South, corrected depth 1.4m

Obstruction 5: Miscellaneous debris needs to be removed from 23-27m south of point 18 (figure 4.2.47 and reference from 4.08 to 4:11 in video). [dive team estimate 0.5hr.]

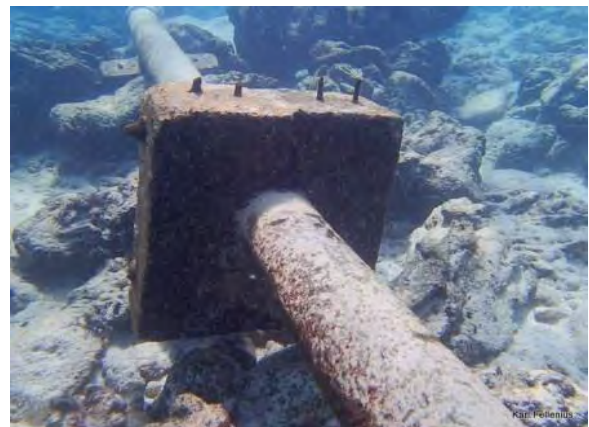
Fig. 4.2.48 Bairiki 26m south of point 18, looking South, corrected depth 1.4m

Figure 4.2.48 is a typical CAB attachment from along the broken pipe at this location. It also shows heavier siltation than at the end of existing pipe, which is expected with decreasing wave energy away from the immediate discharge area in the shallows. There are slightly less turf algae at 50% cover, and no coral.

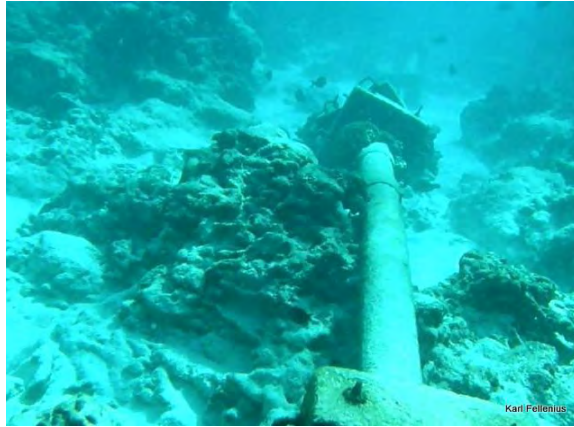
Fig. 4.2.49 Bairiki 9m North of point 19, looking South, corrected depth 2.0m

Obstruction 7: One rock 1.5m long, 0.75m wide, and 0.5m high obstructs the route 11m north of point 19 (video capture fig. 4.2.49 and reference at 4:39 in video). It is solid reef foundation and at best can be shaved down into a trench 0.5m wide, and requires that any adjacent CABs be adjusted. [dive team estimate 1 hr.]

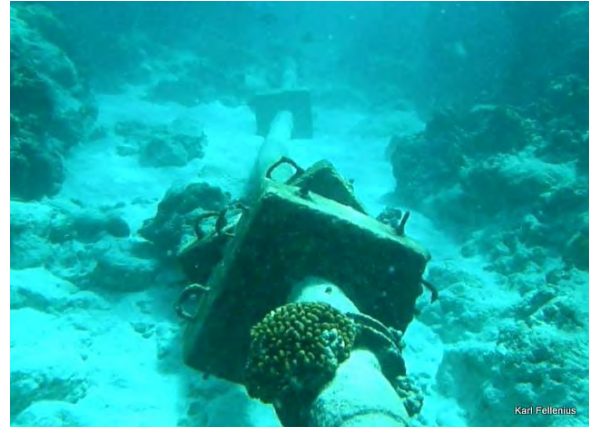
The first coral colony on the subtidal reef flat is 9m north of point 19, growing on the broken outfall pipe (fig. 4.2.50). This *Pocillopora* sp. coral can easily be relocated.

Fig. 4.2.50 Bairiki 9m North of point 19, looking South, corrected depth 2.0m

**Obstruction 8:** One loose rock 1m long along with minor debris 9m north of point 19 needs to be removed (video capture fig. 4.2.50 and reference at 4:43 in video). [dive team estimate 0.5hr.]

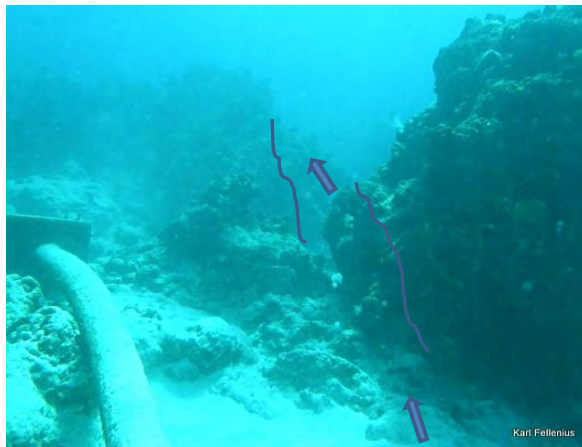
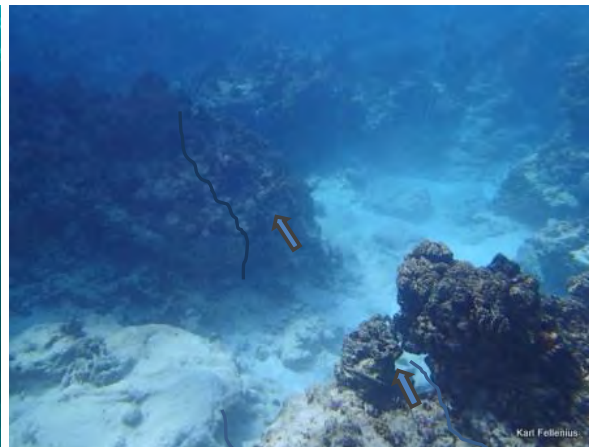
At 5m north of point 19 (reference at 4:53 in the video), the outfall route shows the proposed alignment as indicated in the video capture in figure 4.2.51. The video proceeds to show the end of the broken pipe before re-aligning with the route at 5:04 and again at 5:18.

Fig. 4.2.51 Bairiki 5m North of point 19, looking South-Southwest, route through ↑ corrected depth 2.5m

Fig. 4.2.52 Bairiki 3m Northwest of point 19, looking Southwest, route through ↑ corrected depth 2.7m in channel

**Obstruction 9-10:** The right foreground edge and left background edge of rock in figures 4.2.51 and 4.2.52 need to be removed as shown to accommodate the proposed outfall route at point 19. The portion of the right foreground edge to be shaved is 1m long, 0.5m wide, and 0.75m high. Conversely, the shaving of the left background edge needs to be 1.5m long, 1m wide, and 1m high. There is also miscellaneous debris on the bottom that needs to be removed and levelled in both the foreground of figure 4.2.51 and background of figure 4.2.52. It will require that any adjacent CABs be adjusted. There are 2 small *Pocillopora* sp. and 2 *H. coerulea* colonies on the left background edge. The former can easily be relocated, and the latter with some effort. [dive team estimate 5hrs.]

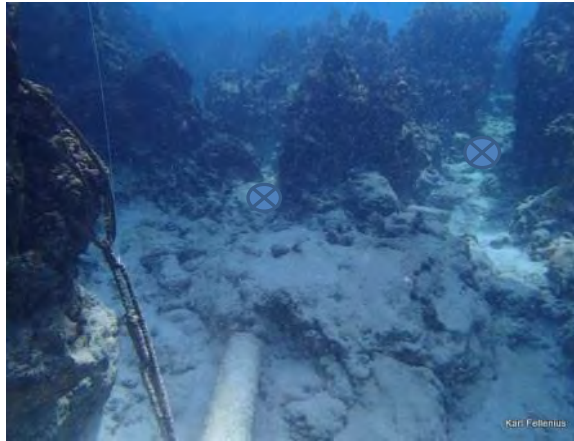
Figure 4.2.53 emphasizes that there is no route option directly south of the broken end of pipe. There would be more reef rock to remove in that direction than described in obstruction 9-10. Figure 4.2.54 shows obstruction 10 from the northwest looking southeast, with the proposed route along the side of the 5m long and 2-3m wide coral bommie.

Fig. 4.2.53 From Bairiki point 19, looking South, no route through

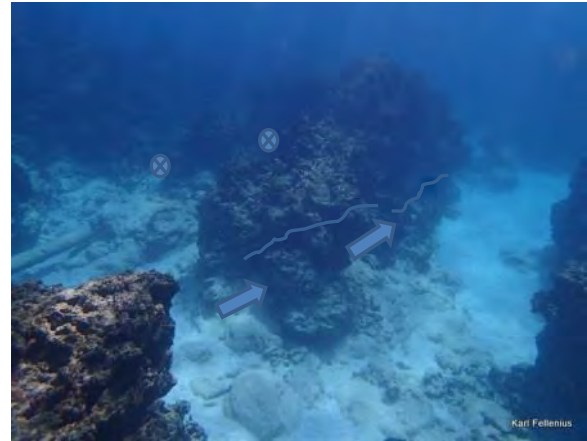
Fig. 4.2.54 Center at 3m West of Bairiki point 19, looking Southeast, route along

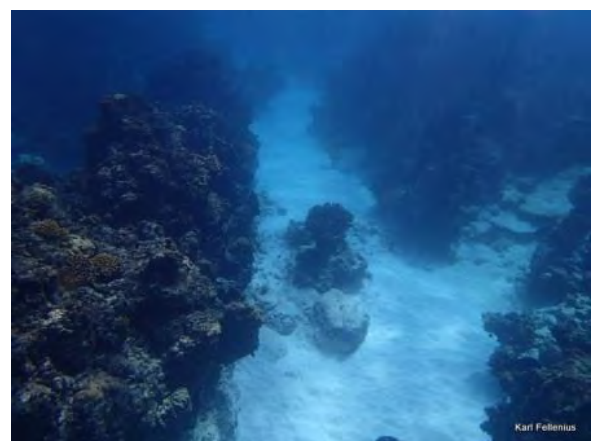
Figure 4.2.56 shows the proposed outfall route heading south from the area of point 19, with the coral bommie in the center making up obstruction 12.

Fig. 4.2.56 From Bairiki 4m West of point 19 looking South, corrected depth 3.7m (foreground channel)

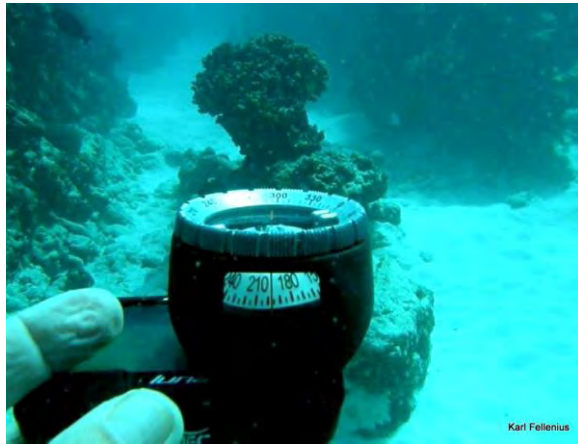
Fig. 4.2.57 Bairiki 6m South of point 19, looking South, coral colony on base, corrected depth 3.8m

Obstruction 12-13: One *Pocillopora* sp. coral colony on a solid rock base 1.5m long and 0.75m width, with some debris 6m south of point 19 needs to be removed (video capture figs. 4.2.57 and 4.2.58, and reference from 5:42 to 5:52 in video). [dive team estimate 1.5 hrs.]

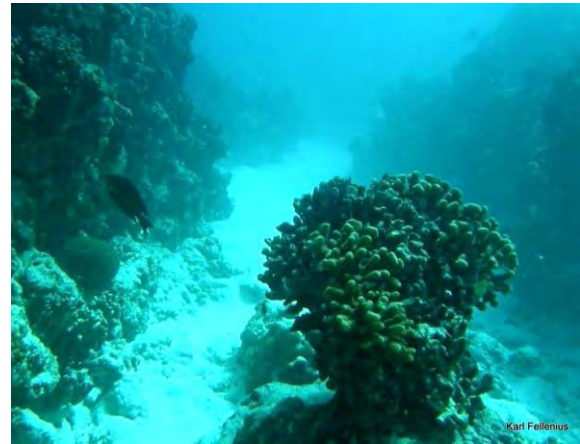
Fig. 4.2.58 Bairiki 6m South of point 19, looking South, debris in background behind coral colony, corrected depth 3.8m

Obstruction 14: One *H. coerulea* coral colony with rock base on an edge 0.75m wide and 0.5m long 12 m south of point 19 needs to be removed (video capture figs. 4.2.58 and 4.2.59, and reference at 6:07 in video). [dive team estimate 1hr.]

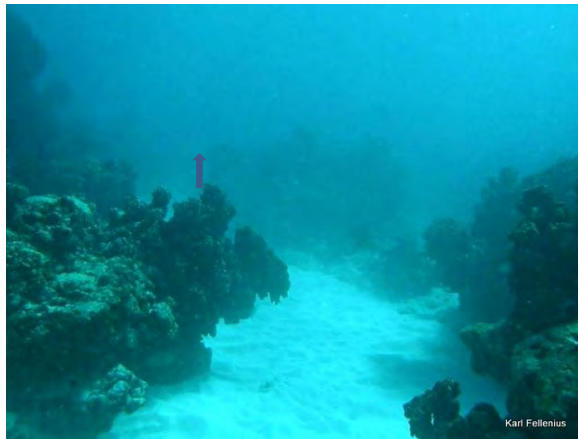
Fig. 4.2.59 Bairiki 14m South of point 19, looking South, route follows ↑ corrected depth 3.6m

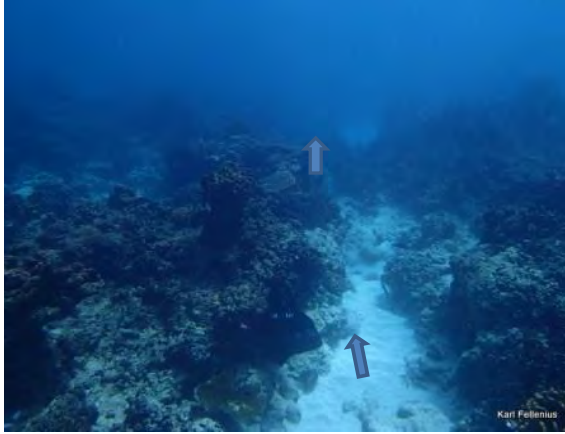
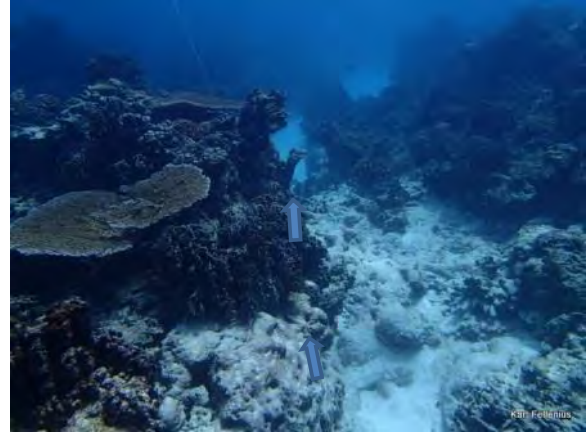
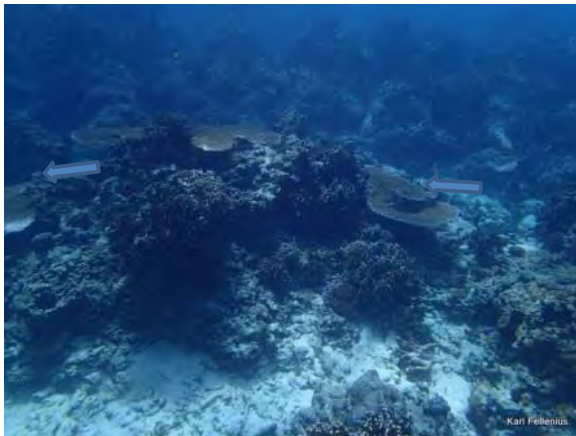
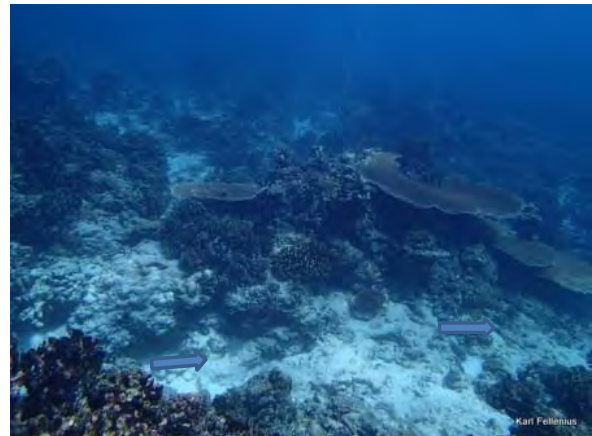
Figures 4.2.61 through 4.2.65 give an overview of an area of obstruction from 2m north to 3m south of point 20 that requires careful levelling, shaving, and infilling to accommodate the proposed outfall route while protecting all *Acropora* sp. table corals. The first two figures are along the south route while the latter ones are side and top views.

Fig. 4.2.61 From Bairiki point 20, looking South, route follows ↑ corrected depth 3.0m

Fig. 4.2.62 From Bairiki point 20, looking South, route follows ↑ corrected depth 3.0m

Fig. 4.2.63 From Bairiki 3m East of point 20, looking West, route follows ↑ corrected depth 3.0m

Fig. 4.2.64 From Bairiki 3m West of point 20, looking East, route follows ↑ corrected depth 3.0m

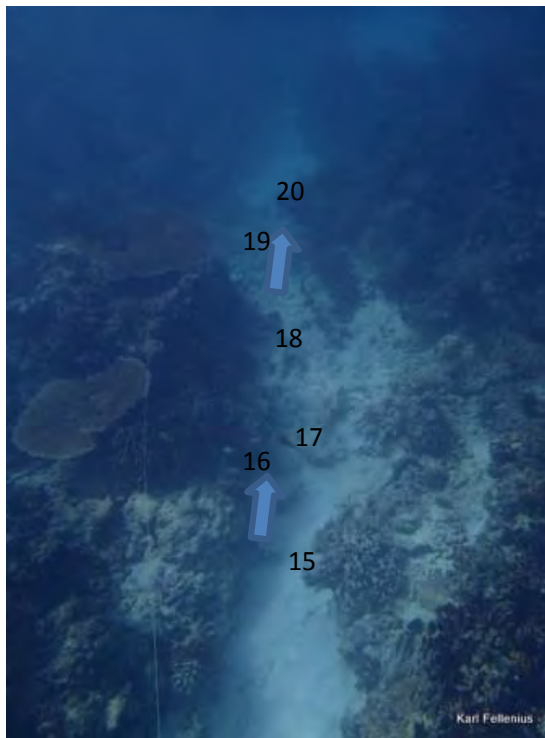
Fig. 4.2.65 From surface at Bairiki point 20, looking South, route follows ↑ corrected depth 3.0m

Obstruction 15: The edge on the right side of the channel needs to be shaved by 0.75m (figs. 4.2.65 and video capture fig. 4.2.66, and reference at 6:30 in video). [dive team estimate 0.5hr.]

Obstruction 19-20: Levelling down and infilling of 0.4m height on the downward slope with removal of 0.3m on the right side edge (figs. 4.2.65 and video capture fig. 4.2.69, and reference at 6:38 in video). [dive team estimate 1.5hrs.]

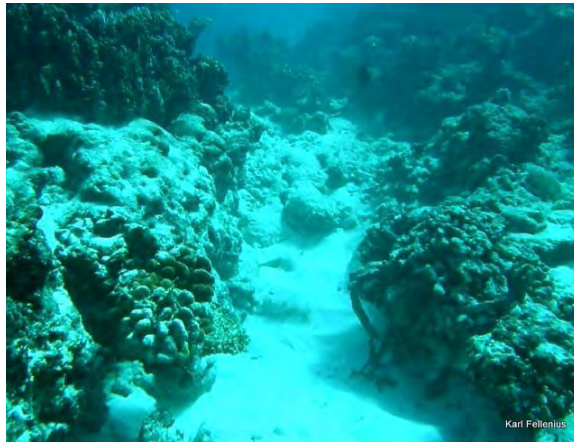
Fig. 4.2.66 From Bairiki 2m North of point 20, looking South, corrected depth 3.0m

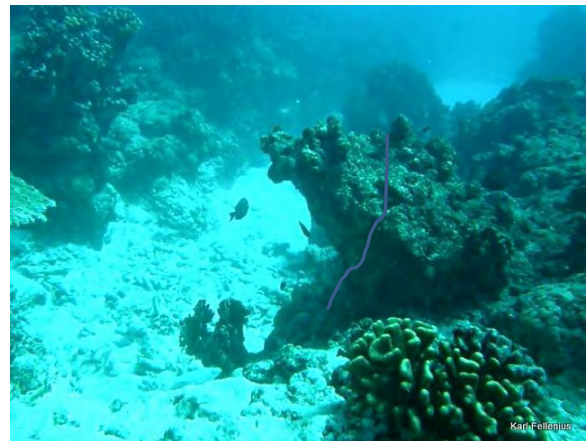
Fig. 4.2.69 From Bairiki 2-3m South of point 20, looking South, corrected depth 3.0-3.4m

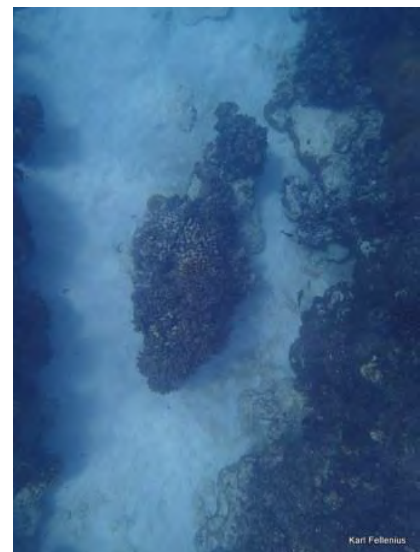
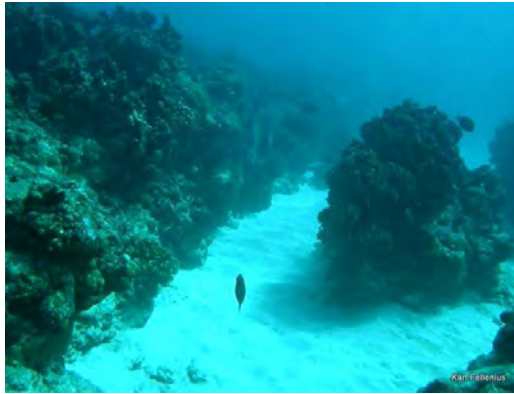
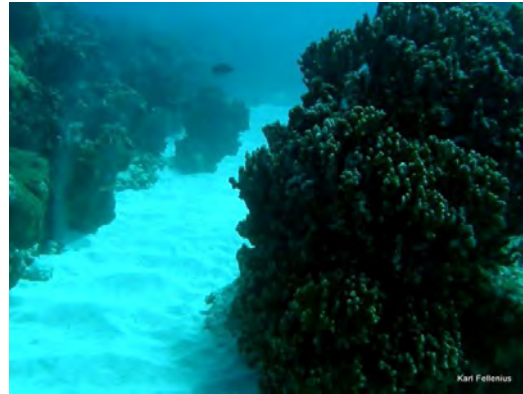
A 3m long and 1m wide *H. coerulea* bommie at point 5 is shown in figure 4.2.71 and video capture figures 4.2.72 and 4.2.73 (reference from 6:45 to 6:57 in video). This is not an obstruction as the proposed route passes to the left.

Fig. 4.2.71 From surface at point 5, South at top, corrected depth 3.9m

Fig. 4.2.72 From Bairiki 4m North of point 5, looking South, corrected depth 3.7m

Fig. 4.2.73 From Bairiki point 5, looking South, corrected depth 3.9m

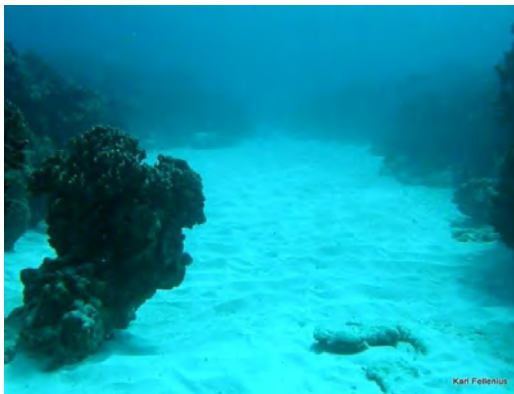
Fig. 4.2.74 From Bairiki 3m South of point 5, looking South, corrected depth 4.2m

Obstruction 21: The 0.75m diameter and 1m high *H. coerulea* bommie 3m south of point 5 may need to be removed (figs. 4.2.74 and reference at 7:02 in video). [dive team estimate 0.5hr.]

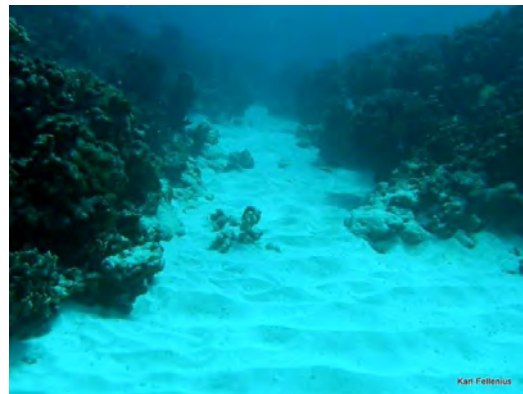
Fig. 4.2.75 From Bairiki 10m South of point 5, looking South, corrected depth 3.6m

Obstruction 22: The channel narrows to 0.9m 10m south of point 5 (figs. 4.2.75 and reference at 7:26 in video). The edge at the right needs shaving by 0.3m [dive team estimate 0.5hr.]

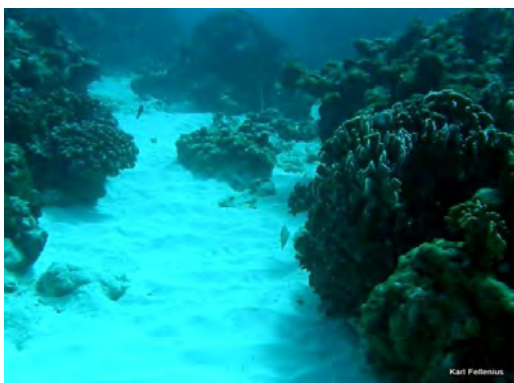
Fig. 4.2.76 From Bairiki 4m North of point 6, looking South, corrected depth 5.2m

Obstructions 23-24: :The 0.75m diameter rock just north of point 6 partially covered with encrusting *Porites* sp. in the channel in video capture figure 4.2.76 needs to be removed, along with 0.2m of shaving necessary on the left channel edge. (reference at 7:37 and 7:43 in video). The 1.5m diameter *H. coerulea* colony at point 6 can largely be left in place as the channel passes to the left (video capture figure 4.2.77 and reference at 7:47 in video). However, the 0.75m wide rock base with 0.3m of the coral to the left needs to be removed. [dive team estimate 1hr.]

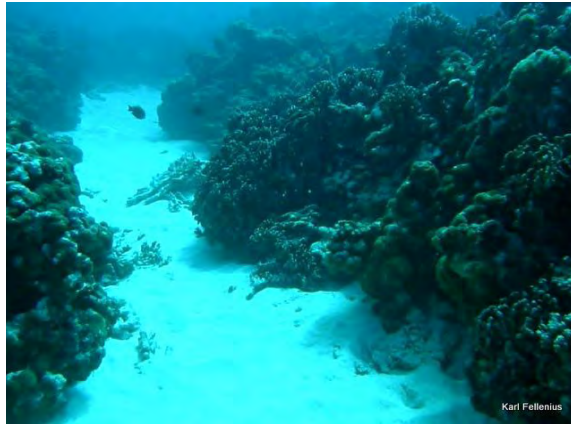
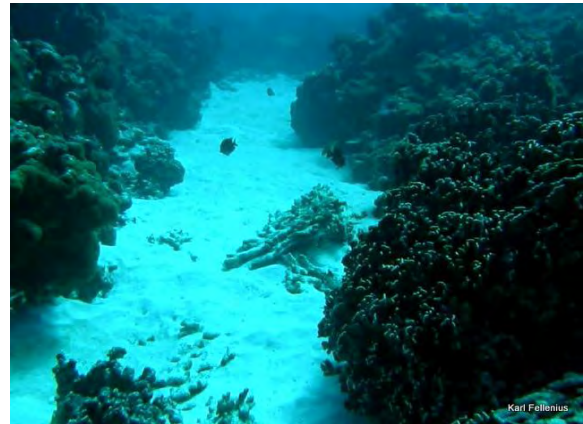
Fig. 4.2.78 From Bairiki 3m South of point 6, looking South, corrected depth 5.7m

Fig. 4.2.79 From Bairiki 5m South of point 5, looking South, corrected depth 5.8m

Obstruction 25: Between 3-5.5m south of point 6 the channel narrows to 0.7m wide. The left side needs shaving of 0.5m through partial cover of encrusting *Porites* sp. coral. (video capture figures 4.2.78 and 4.2.79, reference from 7:57 to 7:59 in video). The right side is to be left intact. There is also some debris immediately to the south. [dive team estimate 1.5hr.]

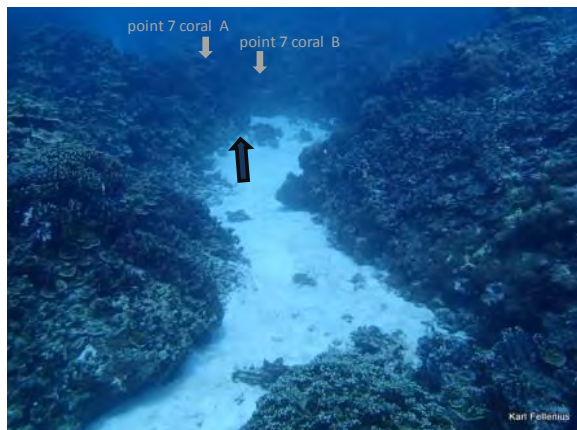
Fig. 4.2.85 From Bairiki 4m South of point 6, looking South to point 7, route along ↑ corrected depth 5.7-7.3m

Figure 4.2.85 shows part of obstruction 25 (from the end of the subtidal reef flat section) at the bottom left, and the channel heading south towards point 7 (reference from 8:00 to 8:21 in video). Two coral colonies are noted as coral A and B at point 7 in figures 4.2.85 and 4.2.86 (reference for coral B at 8:22 in video).

**Obstruction 26:** The 4m long and 0.5m wide channel running between coral A and B needs to be widened to 2.5m to account for the slight bend in the alignment of the proposed outfall route. The edge on both sides, as well as the overhang on the left side needs to be removed. It requires that any adjacent CABs be adjusted. Moreover, the cut needs to include 1m north (on the left) and 1m south (on the right) of the channel for a total distance of 6m. (reference from 8:21 to 8:34 in video). One quarter of the area to be removed is covered in *H. coerulea* and *P. rus* and three-quarters is rock and debris. The former is able to be partially relocated. [dive team estimate 5hrs. at 7m depth]

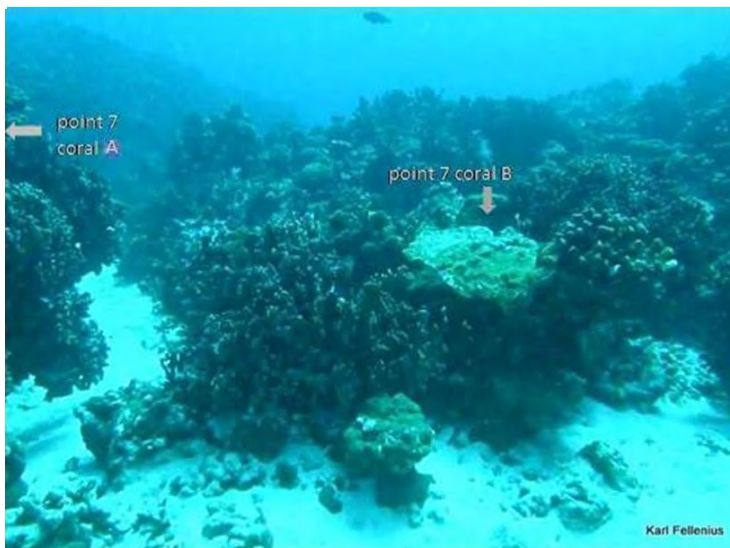
Fig. 4.2.87 From Bairiki point 7, looking South, corrected depth 7.3m

These same coral colonies are noted in figures 4.2.87 and 4.2.88, from the side and top view respectively (reference from 8:22 in the video for both figures, and through to 8:32 for figure 4.2.88).

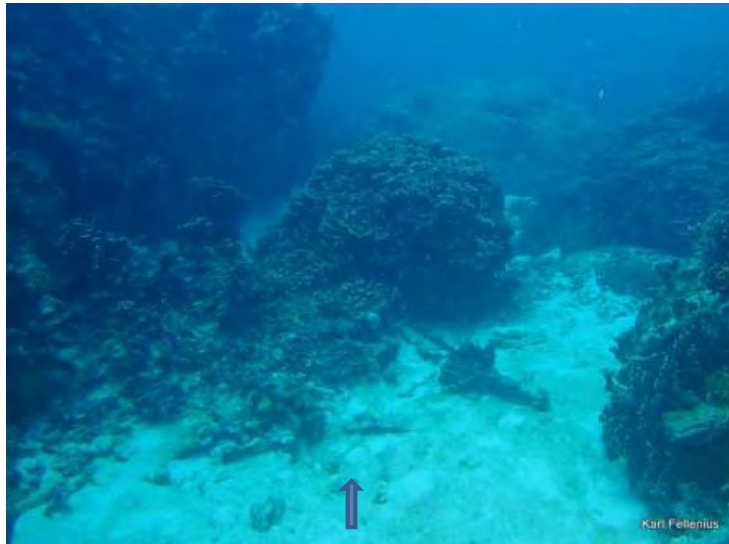
Fig. 4.2.89 From Bairiki 5m north of point 14, looking South, route along ↑ corrected depth 9.4m

**Obstruction 27:** The 1.5m diameter common *P. rus* coral bommie in figure 4.2.89 and the bottom of figure 4.2.90 needs to be removed and relocated. (reference at 8:47 in video). The base cuts in underneath so it may loosen with effort. There is also some miscellaneous debris to be removed immediately north. [dive team estimate 2hrs. at 9m depth]

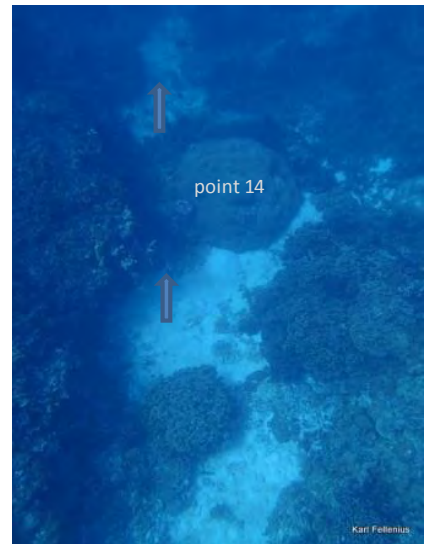
Fig. 4.2.90 From surface at point 14, South at top, route along ↑ corrected depth 9.9m

There is a 6mm diameter *Lobophyllia* sp. coral bommie at point 14 in figures 4.2.90 through 4.2.92 (reference at 8:56 in video). It cannot be moved for both environmental and technical reasons. Moreover, the outfall route cannot be placed on top (OOE 2015). Therefore, the route must pass to the east at the left shown in the three figures.

**Obstruction 28:** There is miscellaneous debris to be removed and levelling needed along a 4m long and 1.2m wide area immediately to the east of point 14. It requires that any adjacent CABs be adjusted. Effort should be put to limit damage to the adjacent *Acropora* sp. coral colony, which can otherwise be relocated (yellow arrow). Therefore, the left side edge of this proposed route may need to be shaved by 0.2m [dive team estimate 2.5hrs. at 10m depth]

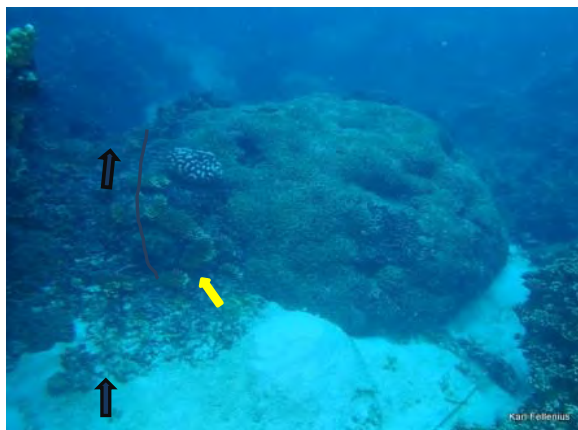
Fig. 4.2.91 From Bairiki 3m North of point 14, looking South, route along ↑ corrected depth 9.9m

It appears on figure 4.2.91 that immediately south of the upper arrow is another obstruction on the downward slope. This is not the case.

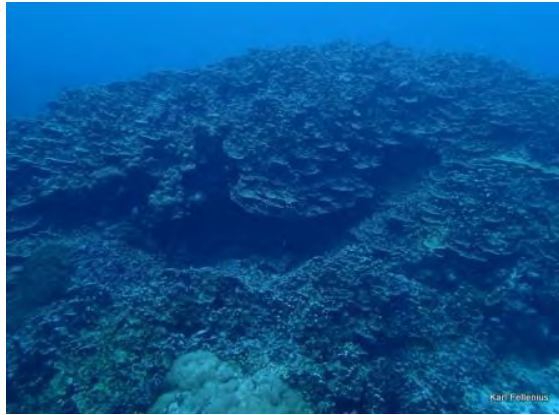
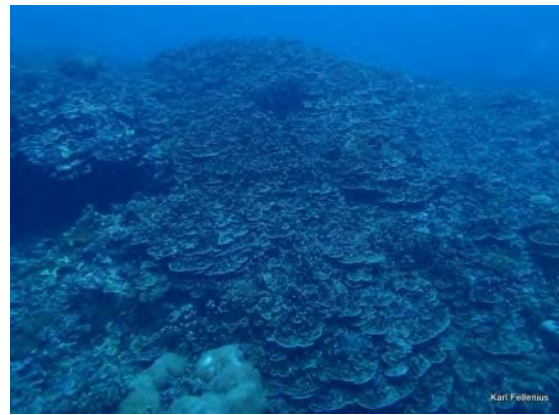
Figures 4.2.93 and 4.2.94 are reefscape views of the crest and upper slope on either side of the proposed outfall route looking back towards shore. They emphasize that the proposed route is the only option for the area, in the valley channel in between (not shown).

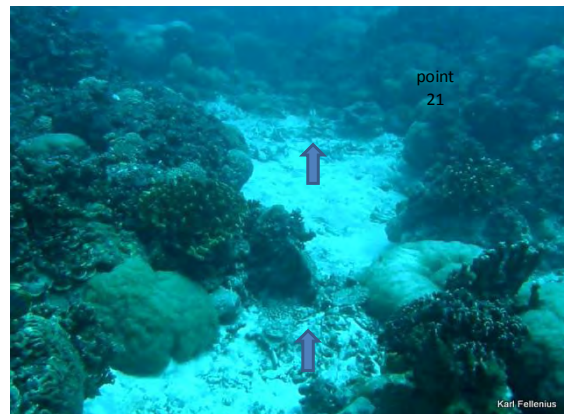
Fig. 4.2.96 From Bairiki 5m North of point 21, looking South, route passes along ↑ corrected depth 12.8m

**Obstruction 29:** The 0.2m wide space for the route 4m north of point 21 needs to be widened to 1.2m via removal of miscellaneous debris on both sides (video capture figure 4.2.96 and reference at 9:10 in the video). There is also one *Pocillopora* sp. and the edge of one *P. sinuosa* colony on the left that need to be removed and relocated. The *P. sinuosa* grows in distinct columns, which are visible when the polyp retreats on disturbance. Therefore, these dislodge with relative ease and relocate with reasonable effort. [dive team estimate 2hrs. at 13m depth]

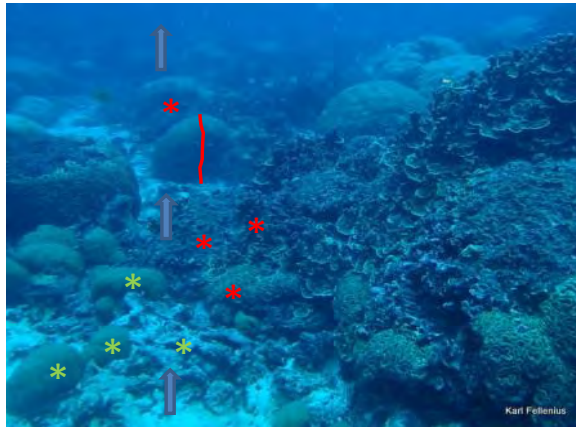
Fig. 4.2.99 From Bairiki 2-7m South of point 21, looking South, route along ↑ corrected depth 13-15m

The first 15m south of point 21 is a concentrated live *P. sinuosa* coral field with numerous obstructions (fig. 4.2.99 and reference at 09:45 in the video). It is nonetheless narrower than on both sides of the proposed route. Deeper than about 16m the *P. sinuosa* continue but obstructions are minimal. The entire area has a patchwork of COTs feeding scars on the *P. sinuosa* (fig. 4.2.100). This suggests that the 2009 infestation continues, albeit at a more subtle rate as only one animal was seen deeper at 20m (see transect sections following this section).

**Obstruction 30-43:** There are three partial (red line) and one complete (red \*) 1.5m diameter *P. sinuosa* colonies that need to be relocated between 2-17m south of point 21 (video capture figures 4.2.99, 4.2.101 and 4.2.102, reference from 09:45 to 10:38 in video). Within this stretch there are three patches of miscellaneous debris (green \*) to be removed, four areas of rock to be levelled or removed (red \*), and a rocky outcrop 0.5m wide to be shaved (red line). Figure 4.2.99 shows a number of small and loose *P. sinuosa* outcrops (green \*) and figure 4.2.101 has a small *Pocillopora* sp. colony in the foreground that should also be relocated [dive team estimate 7hrs. at 15m depth]

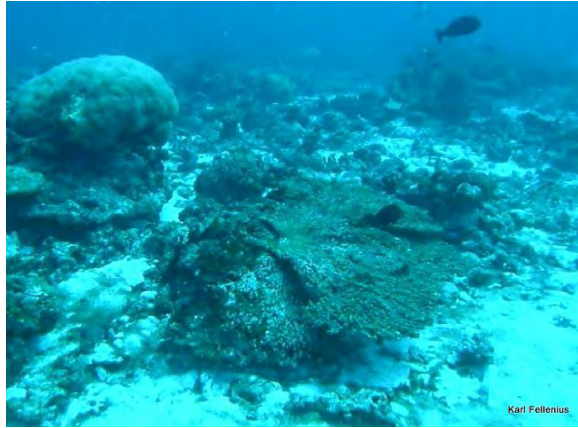
Fig. 4.2.103 From Bairiki 22m South of point 21, looking South, corrected depth 18m

**Obstruction 44:** A dead table coral 2m in diameter 22m south of point 21 needs to be removed (video capture figure 4.2.103 and reference at 10:51 in the video. The proposed route runs down the middle of the table. [dive team estimate 1hr. at 18m depth]

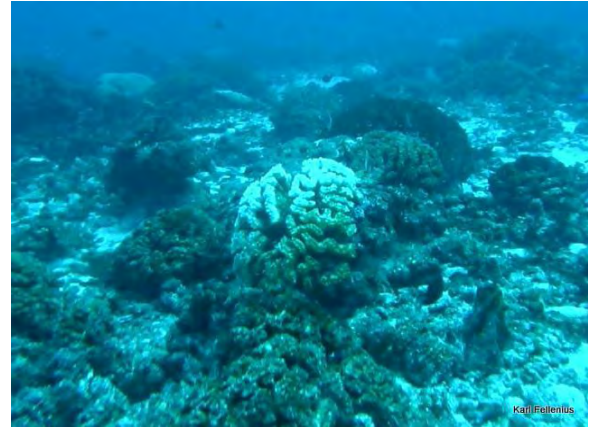
Fig. 4.2.104 From Bairiki 7m North of point 22, looking South, corrected depth 21.5m

**Obstruction 46:** Up to 3 coral rock structures 1m in diameter for the last 7m north of point 22 need to be removed (video capture figure 4.2.104 and reference from 11:17 to 11:31 in the video. The route is not marked because the distance from the previous obstruction gives flexibility in exact placement of the outfall pipe. [dive team estimate 2.5hrs. at 21m depth]

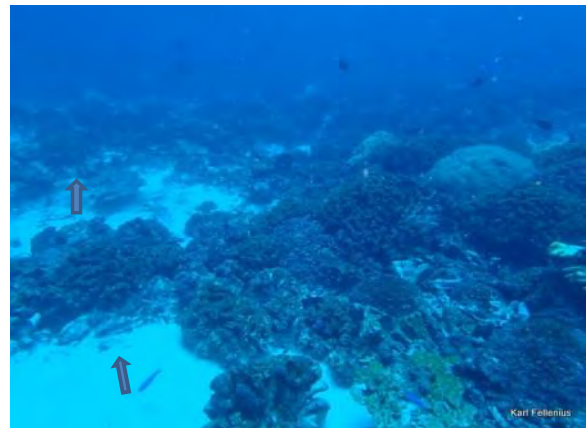
Fig. 4.2.106 From Bairiki at point 22, looking South, route along ↑ corrected depth 22.8m

The 31m of substrate between points 22 and 23 is rubble, debris, and 5% coral cover at a slope of 8°. Coral cover is only massive *P. sinuosa*. COTs feeding scars are present, but the low cover suggests this area has been largely depleted. There is about 15% cover of blue-green algae but no turf or coralline algae (reference from 11:42 to 12:29 in video). Figures 4.2.106 to 4.2.108 show the area around point 22.

**Obstruction 47:** There is low-lying debris along the entire route from points 22 to 23, but especially for the first 10m stretch south of point 22 (video capture figure 4.2.106 and reference from 11:45 to 12:15 in the video). The depth below 20m suggests that there is more flexibility for CABs to sit on top of low relief structures than at shallower depths. Therefore, a generalized obstruction for the route is noted. [dive team estimate 2hrs. at 25m depth]

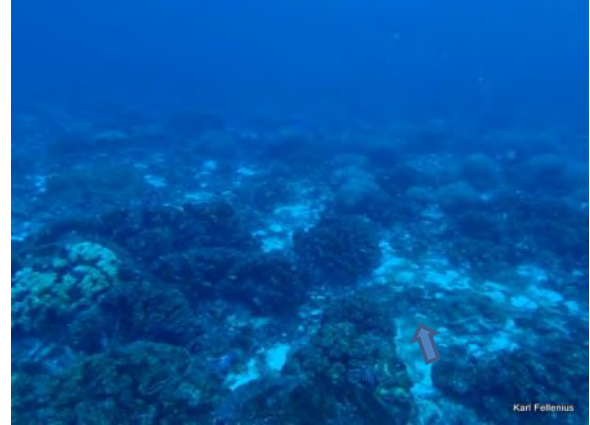
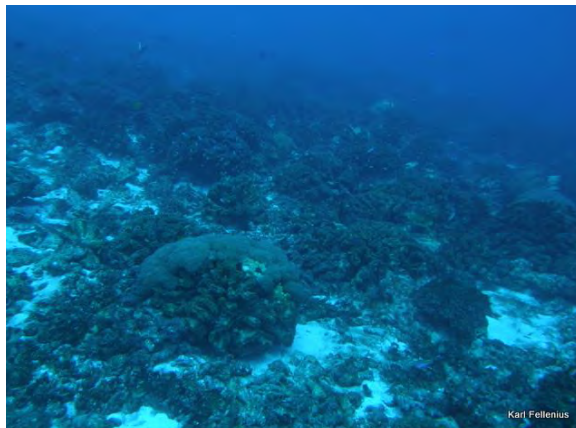
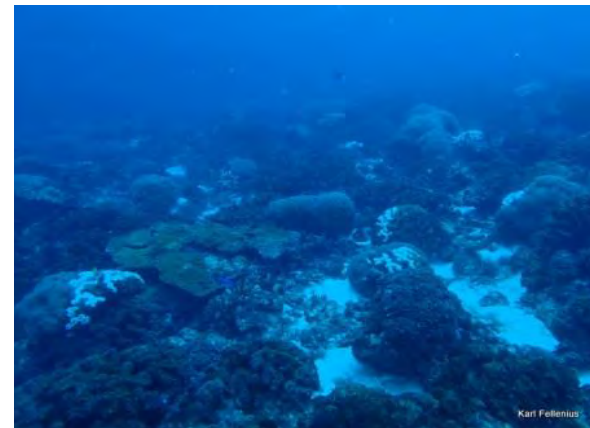
The 16m of substrate between points 23 and 24 is rubble, debris, and back up to 15% coral cover at a slope of 24°. Coral cover is only massive *P. sinuosa* and one highly algae-impacted *Acropora* sp. table coral. The average of 15% represents 5% for the first 8m south of point 23 and 25% for the last 8m north of point 24. Recent COTs feeding scars are especially prevalent along this section, which suggests that the proportionately higher coral cover maybe short-lived. There is about 5% cover of blue-green algae but no turf or coralline algae (reference from 12:56 to 13:26 in video). Figures 4.2.110 to 4.2.112 show the area around point 23.

**Obstruction 48:** There is low-lying debris along the entire route from points 23 to 24. A generalized obstruction for the route is noted. [dive team estimate 1hr. at 30m depth]

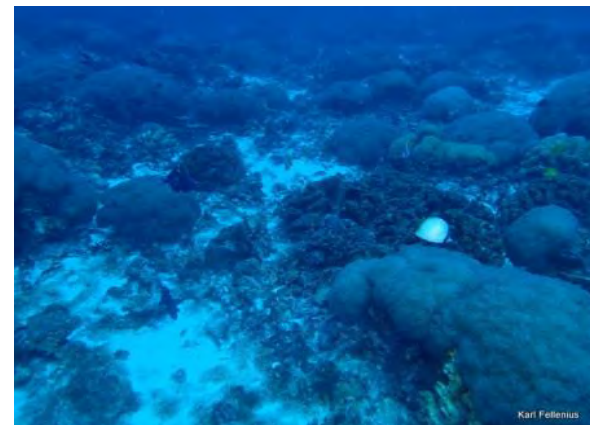
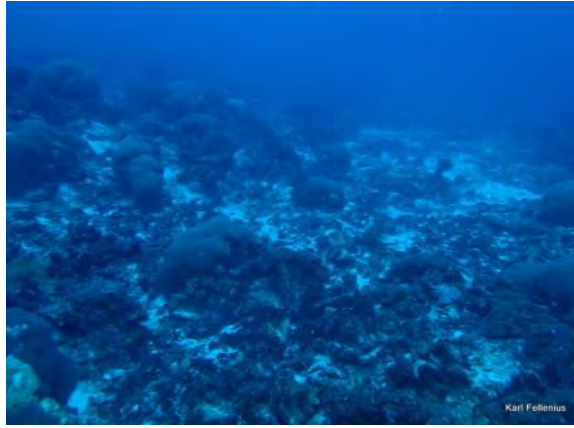
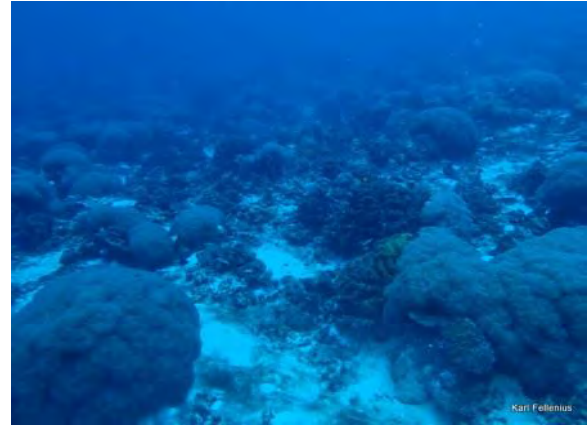
Figures 4.2.114 to 4.2.116 show the area around point 24, with *P. sinuosa* well beyond 34m depth.

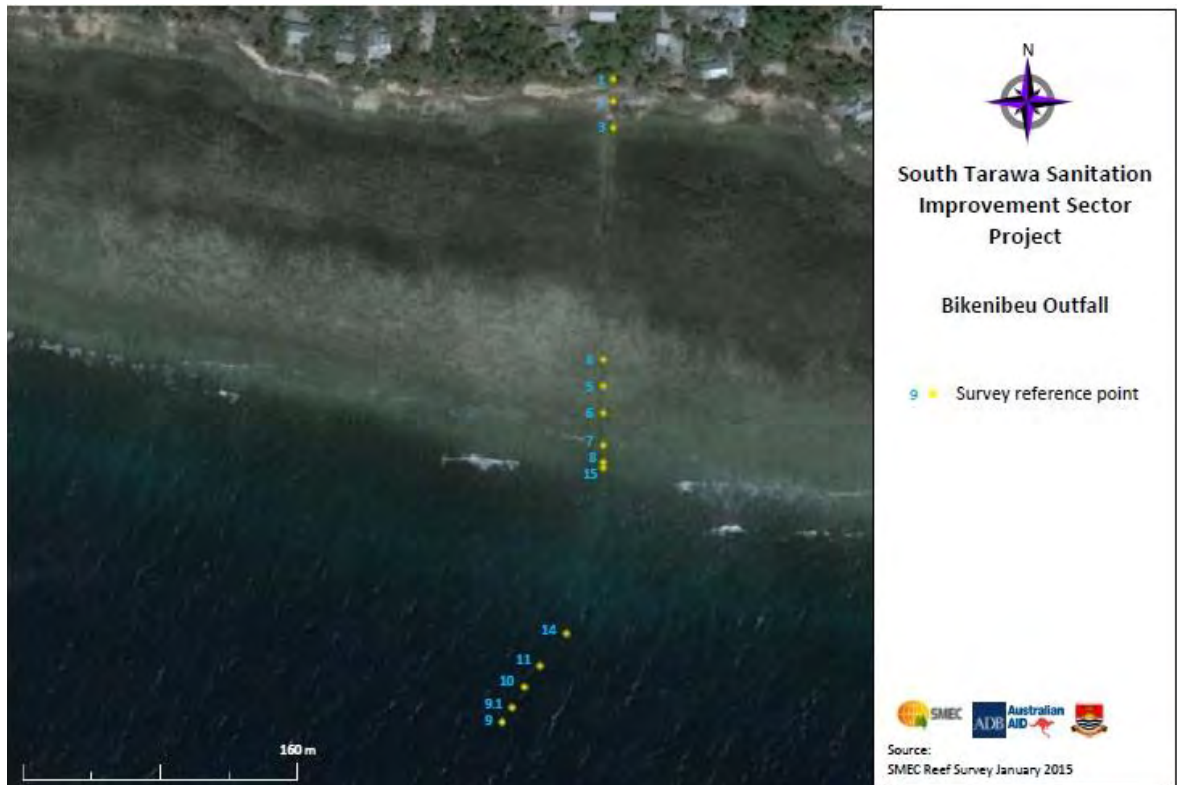
Fig. 4.3.1 Location of Existing and Proposed Bikenibeu Outfall Route

Each section begins with a description of the chainage with photos referenced accordingly. Figure 4.3.1 shows the distribution of GPS positions taken along the existing and proposed outfall route.

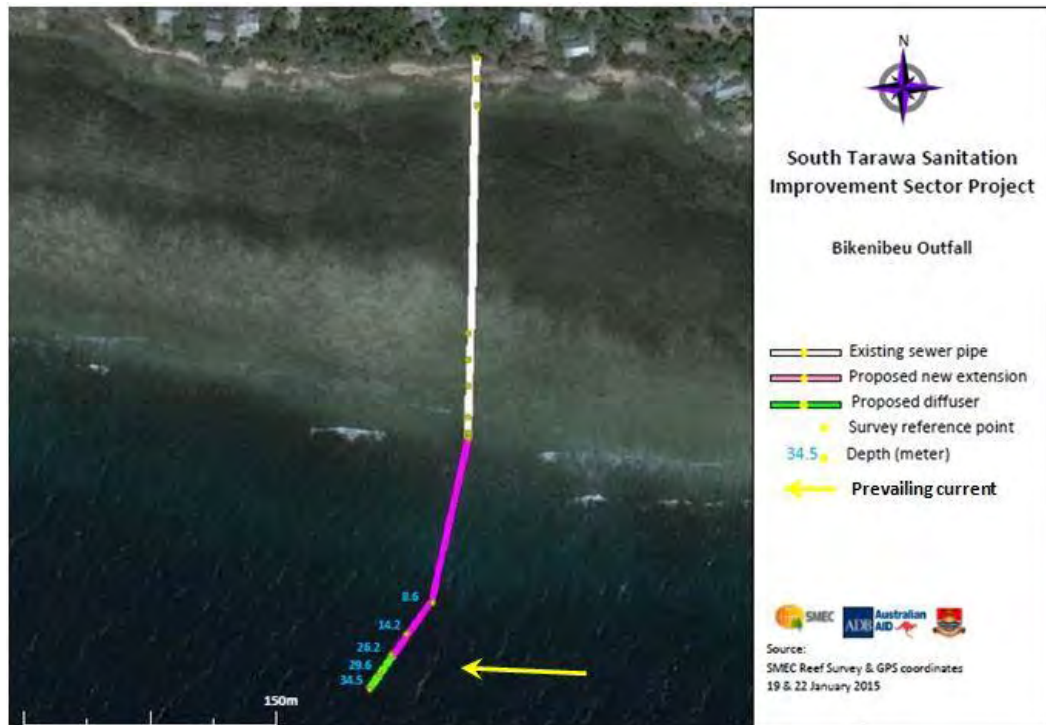
Fig. 4.3.2 Existing Outfall Pipe and Proposed Extension at Bikenibeu  
(note: reference depths not corrected for 0 datum)

Figure 4.3.2 shows the pipeline route that was derived from the GPS points.
