# Benthic Morphology and Marine Life Assessment for the Siting of Ocean Outfalls on South Tarawa

The South Tarawa Sanitation Improvement Sector Project, Tarawa Atoll, Kiribati

March 2015

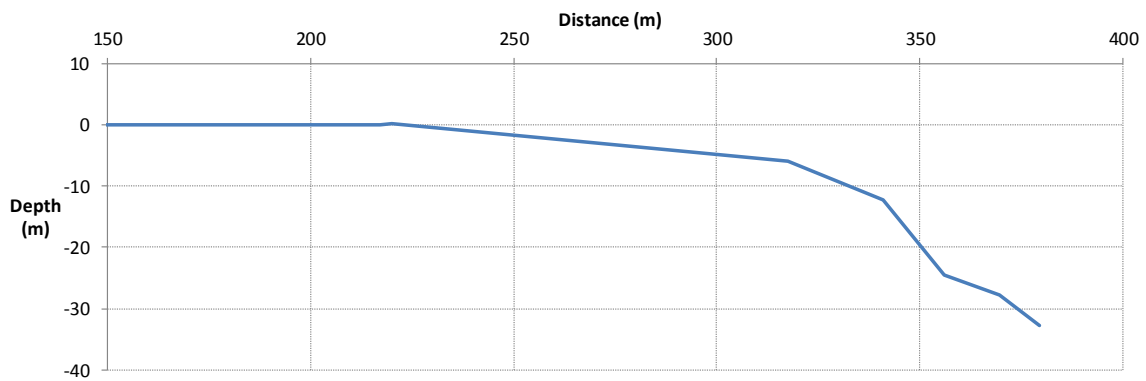
Fig. 4.3.2 Reef Depth Profile along the Existing Bikenibeu Outfall Route and Proposed Extension

Figure 4.3.2 is the depth profile for the existing wastewater line and proposed extension from point 1 at the vent on the shoreline to point 9 at 33m depth on the reef slope. Total distance covered is 379m. Note that GPS points on the intertidal reef flat to end of pipe are all displayed as 0m.

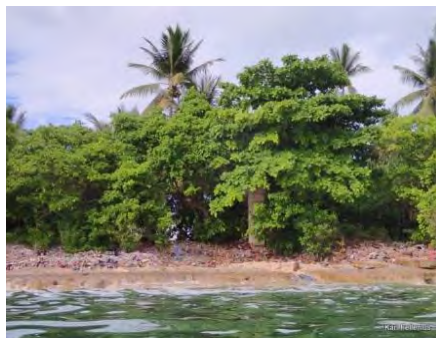
Fig. 4.3.3 Bikenibeu vent looking North

Figures 4.3.3 and 4.3.4 of the vent location on the shoreline show point 1 as the 0 chainage point.

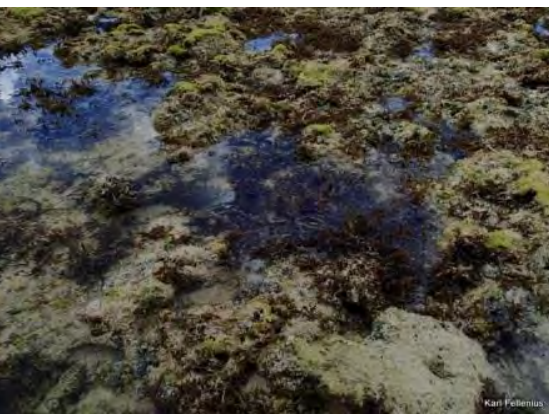
Fig. 4.3.12 Bikenibeu reef flat point 4, macroalgae

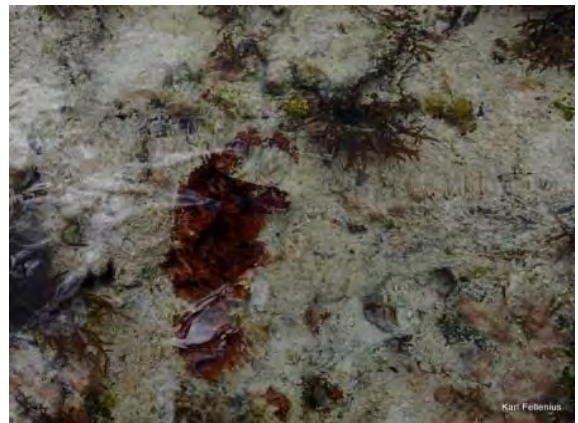
Fig. 4.3.17 Bikenibeu reef flat point 5, cyanobacteria mat algae (blue-green algae)

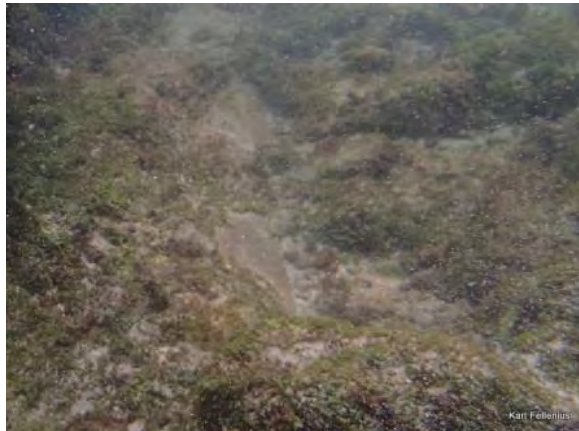
The area at the end of existing pipe during is shown in figures 4.3.30 and 4.2.31. Algae cover appears low right at the outfall because the energy of discharge at that point prevents it from attaching. The pipe itself appears in good condition except the portion that was attached from this point south has broken off. There are some CABs immediately north of the end of existing pipe, and these are discussed along with the excavation of the last section of pipe and removal of obstructions in section 4.3.3.

Fig. 4.3.30 Bikenibeu reef flat point 15, turf and sea grape algae near end of existing pipe

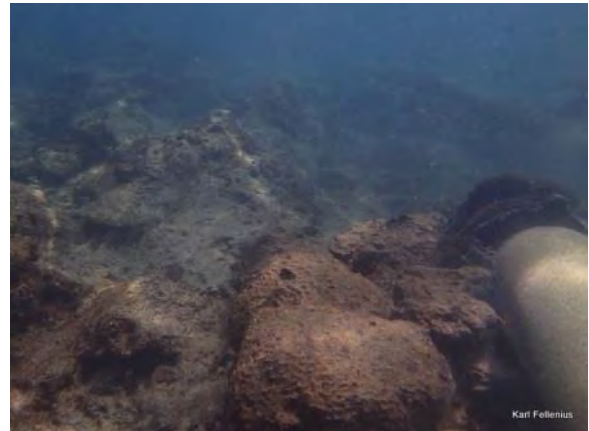
Fig. 4.3.31 Bikenibeu reef flat point 15, end of existing pipe

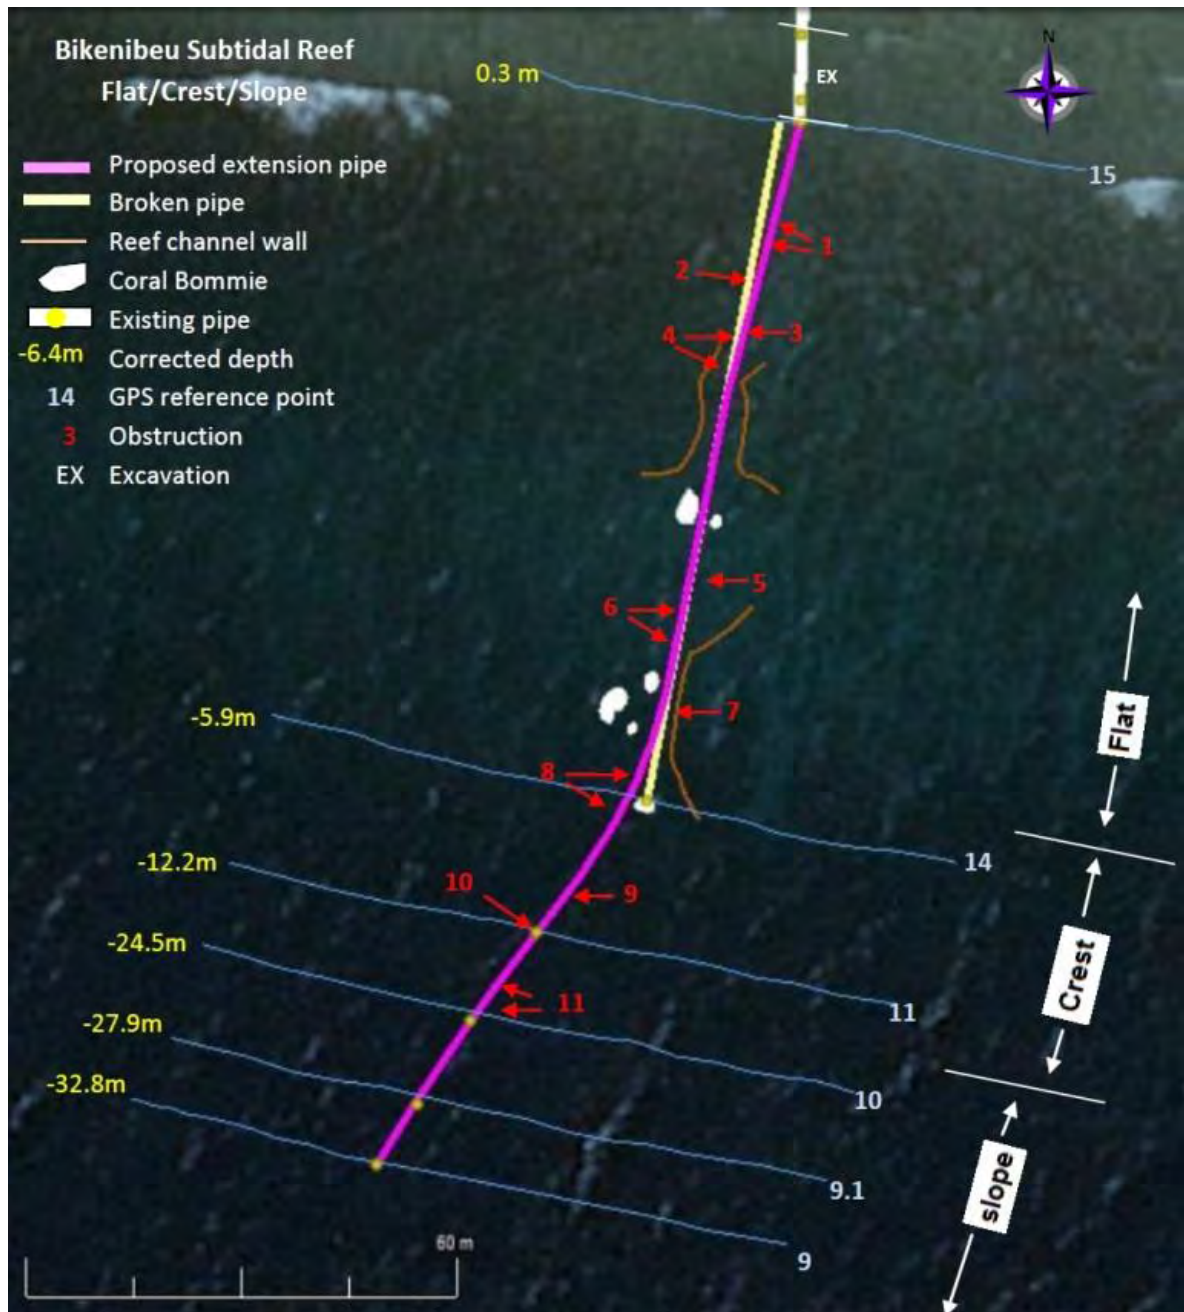
Figure 4.3.35 shows the proposed outfall route and the various features and obstructions found along the length of the proposed extension. In contrast with Betio and Bairiki, there are fewer obstructions. However, significant coral obstructions are concentrated on the reef crest.

Fig. 4.3.35 Features and Obstructions along the Existing and Proposed Bikenibeu Outfall Route (digitized by SMEC)

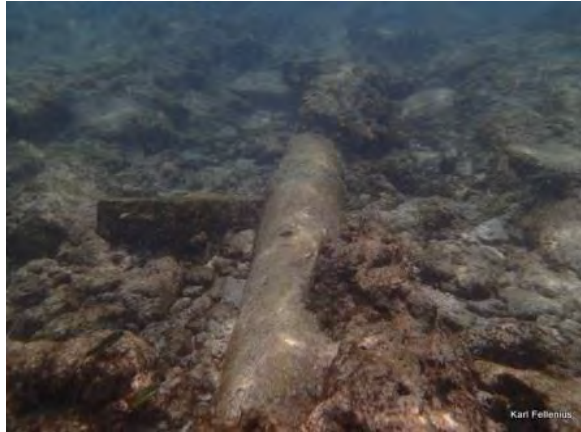
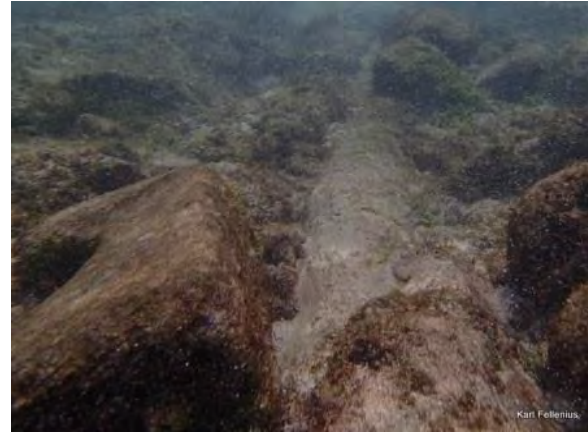
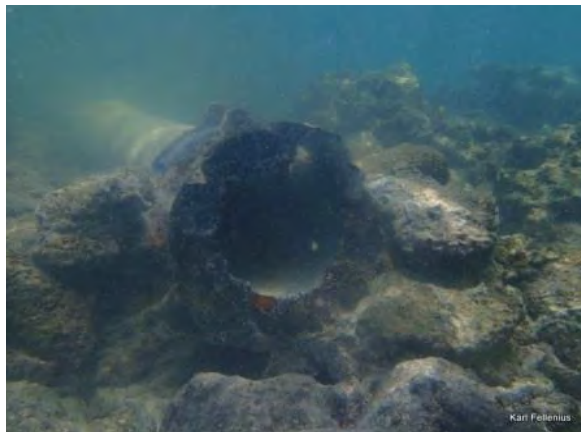
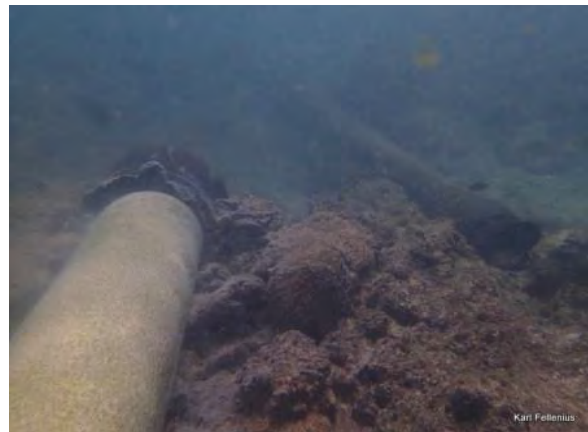
Fig. 4.3.36 From Bikenibeu 5m North of end of existing pipe, looking South, corrected height +0.4m

Fig. 4.3.37 From Bikenibeu 9m North of end of existing pipe, looking South, corrected height +0.4m

Fig. 4.3.38 From Bikenibeu end of existing pipe, looking Northeast, corrected height +0.3m

Fig. 4.3.39 From Bikenibeu end of existing pipe, looking South, corrected height +0.3m

The existing outfall pipe needs to be cut approximately 13m north of the end of the end of the existing pipe, and the trench excavated. A few small CABs are strewn along this length, and along with some small and a few large rocks (up to 0.7m diameter) need to be removed (figs. 4.3.36 to 4.3.39, reference from 6:00 to 6:53 in Bikenibeu video 2).

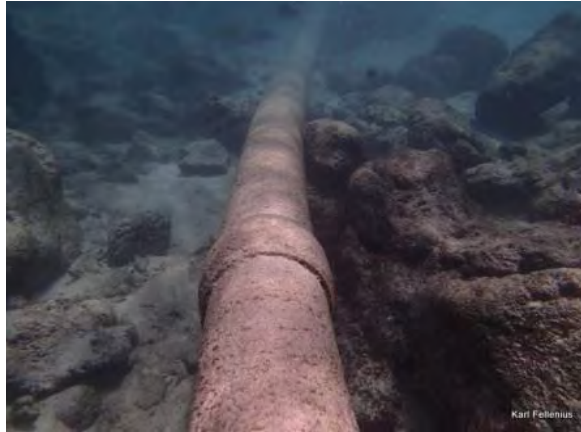
Fig. 4.3.40 From Bikenibeu 15m South of end of existing pipe, looking South, corrected depth 0.6m

Obstruction 1: There are 5 loose rocks up to 1m in diameter for a 7m stretch that need to be removed (reference from 4:46 to 5:05 in Bikenibeu video 2). Some levelling is required for 2 solid rock areas. One of the loose rocks is shown in figure 4.3.40 (reference at 4:50 in Bikenibeu video 2). [dive team estimate 2hrs.]

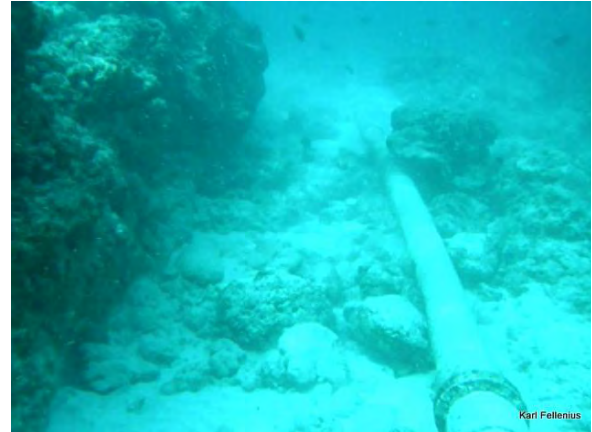
Fig. 4.3.41 From Bikenibeu 22m to 18m South of end of existing pipe, looking North, corrected depth 1.0m

Obstruction 2: There is miscellaneous debris and 1 loose rock 1.2m in diameter for a 4m stretch that need to be removed (video capture fig. 4.3.41 and reference from 4:32 to 4:42 in Bikenibeu video 2). Some levelling is required for 1 solid rock area. [dive team estimate 1.5hrs.]

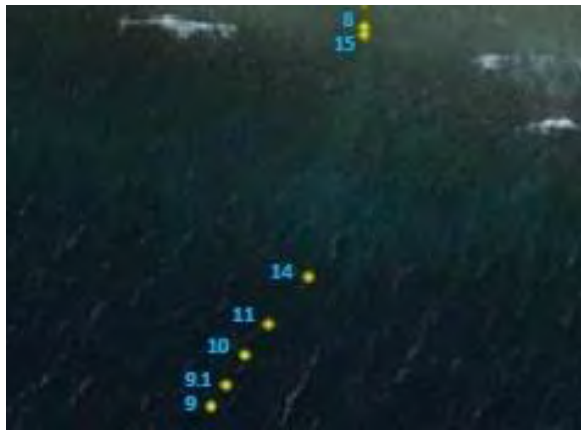
Fig. 4.3.42 Bikenibeu subtidal reef flat, crest, and slope

**Obstruction 3:** Levelling and infilling is required over a 3m stretch (video capture fig. 4.3.42 and reference from 4:12 to 4:19 in Bikenibeu video 2). Note that the broken pipe has moved to the right away from the proposed outfall route [dive team estimate 2hrs.]

**Obstruction 4:** Levelling and infilling is required over a 6m stretch (video capture fig. 4.3.42, fig. 4.3.45, and reference from 3:58 to 4:10 in Bikenibeu video 2). Note that the broken pipe has moved to the right away from the proposed outfall route, and that the figures show the route from different directions. [dive team estimate 3hrs.]

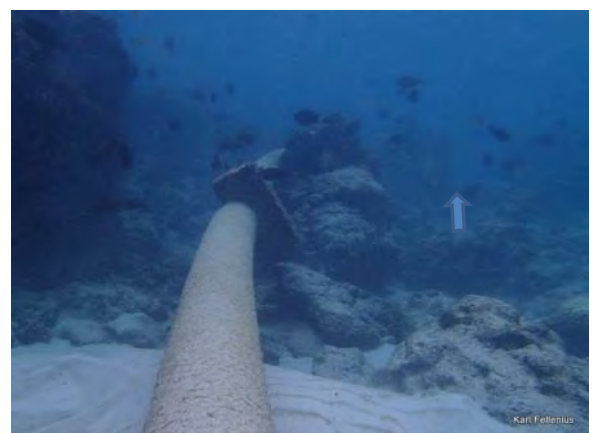
Fig. 4.3.45 From Bikenibeu 26m South of end of existing pipe, looking South, route along ↑ corrected depth 1.9m

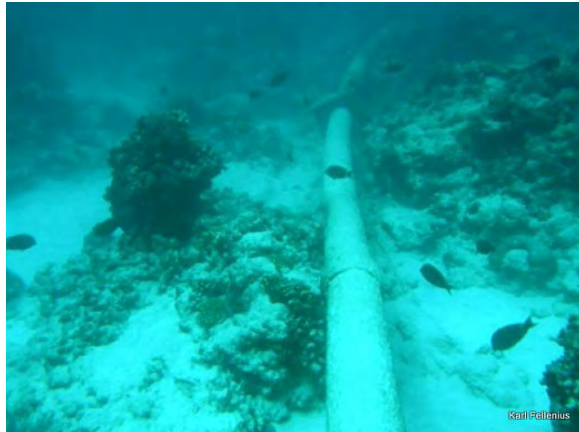
Fig. 4.3.46 From Bikenibeu 27m North of point 14, looking North, corrected depth 1.6m

Obstruction 5: The 2m side of a large coral bommie needs to be shaved by 0.5m (video capture fig. 4.3.46, and reference from 3:49 in Bikenibeu video 2). There is no coral in the affected area. [dive team estimate 3hrs.]

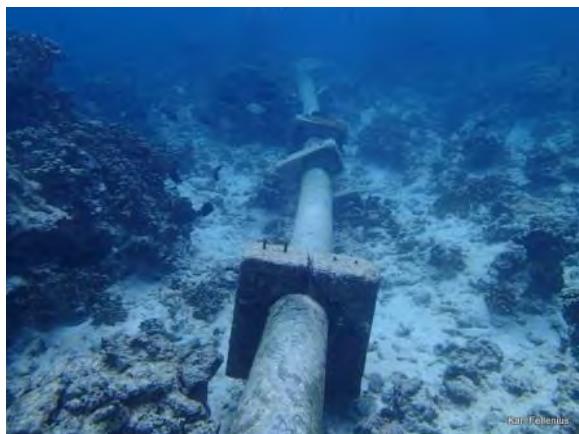
Figure 4.3.48 shows a series of three CABs just over half-way along the subtidal reef flat (reference at 3:16 in Bikenibeu video 2). One of the CABs has a patch of the same common zooanthid *Palythoa* sp. that is present in the spur-and-groove channels at Betio. The amount of silt and algae in this area is less, with 40% turf algae and coral cover increases to about 10%, dominated by *p. rus*.

Fig. 4.3.48 From Bikenibeu 19m North of point 14, looking South, corrected depth 3.8m

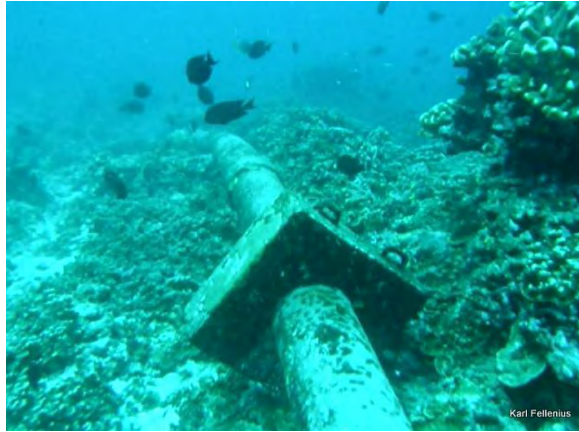
Fig. 4.3.50 From Bikenibeu 10m North of point 14, looking North, corrected depth 3.6m

Obstruction 7: Levelling is needed along a 3m stretch of a low relief coral bommie (video capture fig. 4.3.50, and reference from 3:05 to 3:11 in Bikenibeu video 2 and 0:00 to 0:08 in video 1). Immediately south at 2:58 in the video are 3 CABs that need to be removed. The affected surface of the bommie is covered in *P. rus* and very little of it can be relocated. [dive team estimate 2hrs.]

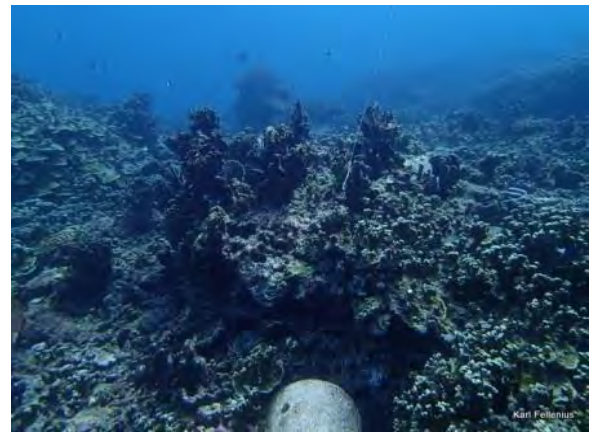
Obstruction 7 is precisely 10m north of point 14, where the proposed outfall route turns slightly right (west-southwest) over the reef crest (reference at 0:14 in Bikenibeu video 1). Figure 4.3.53 shows the end of the broken pipe at point 14, and the coral rise of *P. rus* and *H. coerulea* that prevent this from being a viable route.

Fig. 4.3.53 From Bikenibeu point 14, looking South, corrected depth 5.9m

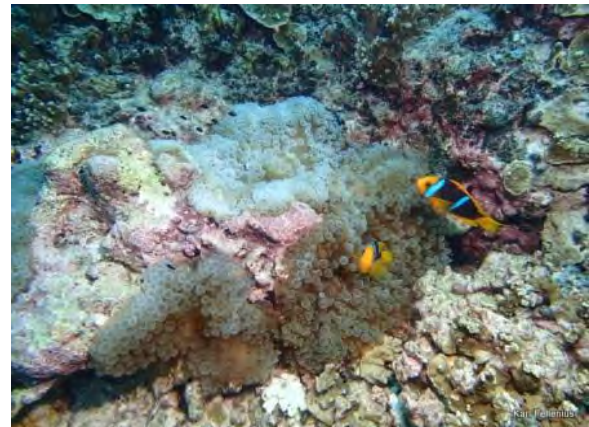
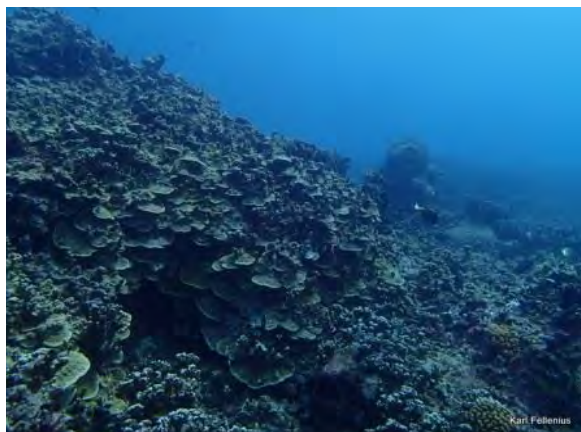
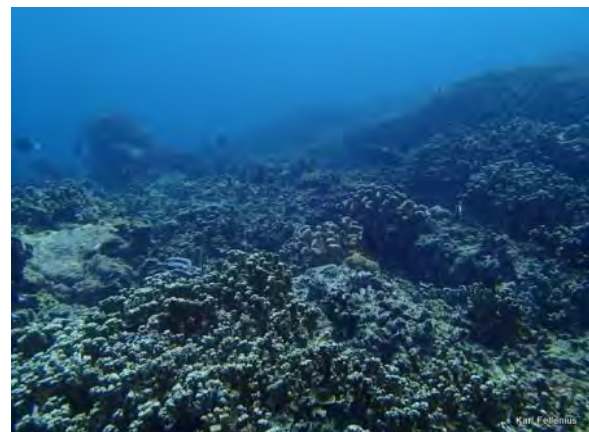
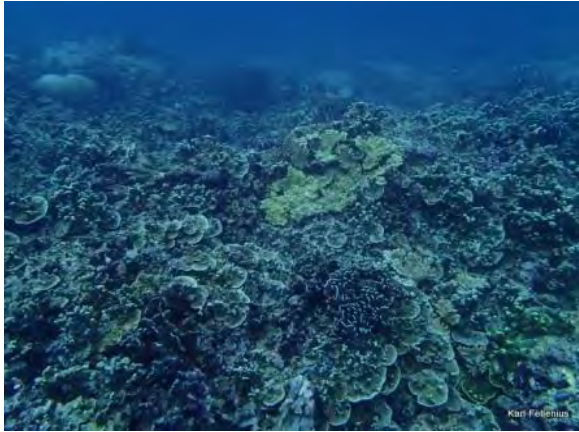
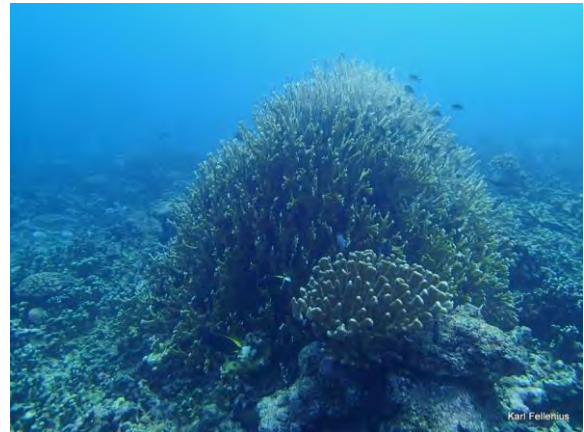
Figures 4.3.59 through 4.3.63 show the reef crest environment between points 14 and 11. They do not specify the proposed outfall route, which is to the right beyond figure 4.3.61. The figures emphasize that the upper reef crest has significantly high coral cover at over 80% with modest rugosity limiting the options of a viable route across the reef.

Fig. 4.3.59 Bikenibeu vicinity of point 14, anemone with Orangefin anemonefish - *Amphiprion chrysopterus* corrected depth 7.5m

Fig. 4.3.60 From Bikenibeu vicinity of point 14, looking East, corrected depth 6.5m

Fig. 4.3.61 From Bikenibeu vicinity of point 14, looking South, route to the right beyond rise, corrected depth 6.5m

Fig. 4.3.62 From Bikenibeu vicinity of point 14, looking South, corrected depth 11.0m

Fig. 4.3.63 From Bikenibeu vicinity of point 14, looking West, Fire coral - *Millepora* sp., route in background, corrected depth 8.5m

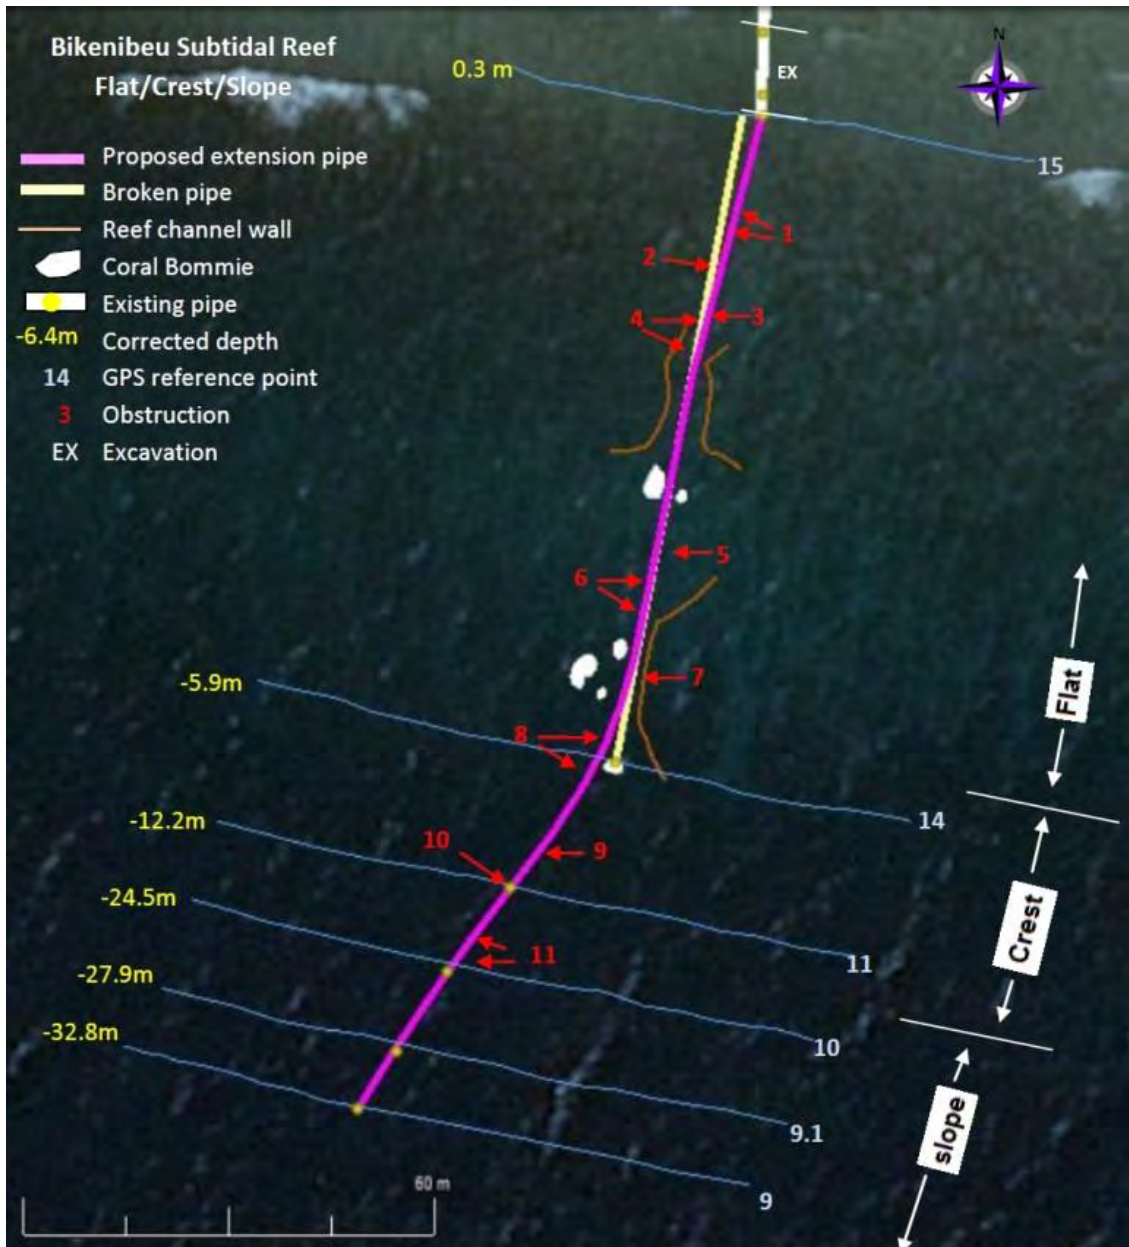
Fig. 4.3.64 Features and Obstructions along the Existing and Proposed Bikenibeu Outfall Route (digitized by SMEC)

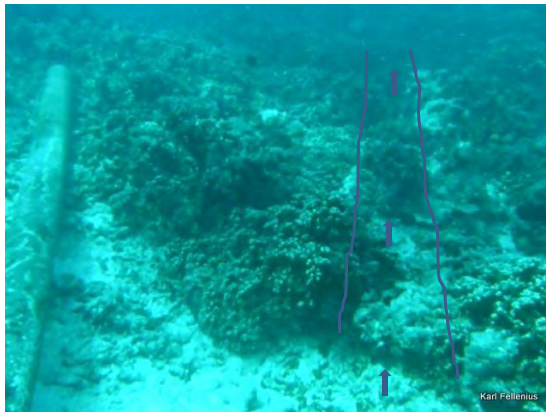
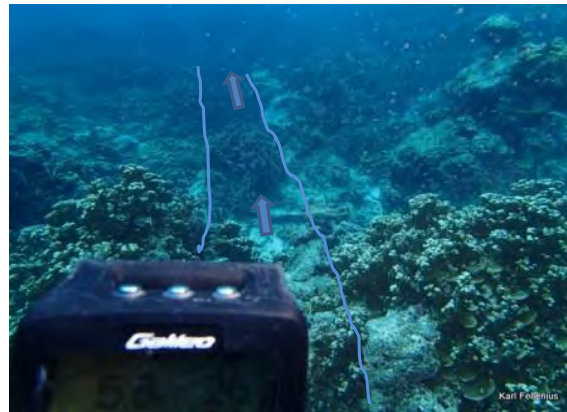
Fig. 4.3.65 From Bikenibeu 3m North of point 14, looking South, route along ↑ corrected depth 5.5m

Fig. 4.3.66 From Bikenibeu 2m North of point 14, looking South, route along ↑ corrected depth 5.6m

**Obstruction 8:** Removal and partial relocation of coral 1.2m wide and 0.8m high along a 5m stretch (video capture fig. 4.3.65 and fig. 4.3.66, and reference from 0:14 to 0:35 in Bikenibeu video 1). Within the sand and rubble patch identified above there is a 0.3m edge of a coral bommie that also needs to be removed (video capture fig. 4.3.67 and fig. 4.3.68, and reference Bikenibeu video 1 at 0:22 and video 2 at 2:32). The affected corals are almost entirely *P. rus* with some *H. coerulea* and *Pocillopora* sp. Some additional 0.3m diameter solid rock and miscellaneous debris to be removed as well [dive team estimate 6hrs. at 6m depth]

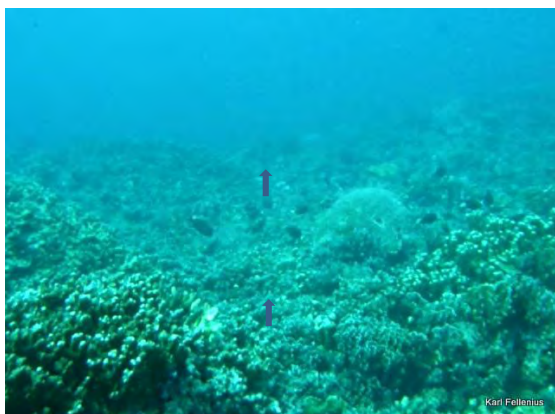
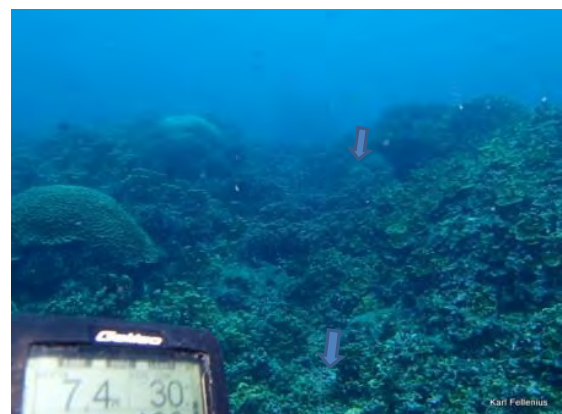
Fig. 4.3.69 From Bikenibeu 8m Southwest of point 14, looking South, route along ↑ corrected depth 5.8m

Fig. 4.3.70 From Bikenibeu 11m Southwest of point 14, looking North, route along ↑ corrected depth 7.2m

Figures 4.3.69 and 4.3.70 are of the reef crest directly south of the obstruction (reference from 0:35 to 0:44 in Bikenibeu video 1). They show there to be no obstructions and that the outfall pipe can sit on top of the low relief reef, which is less than 20% coral cover dominated by *P. rus*.

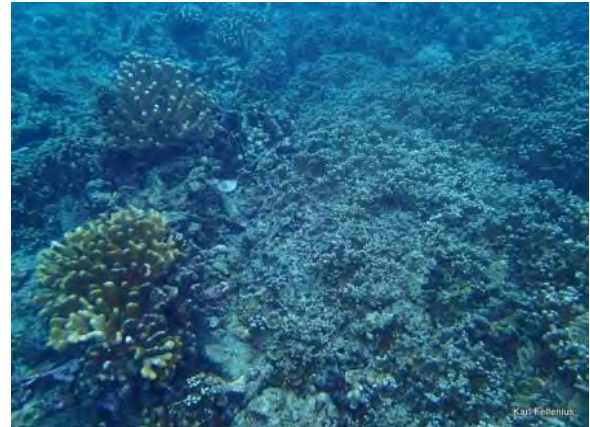
Obstruction 9: Removal and relocation of up to half a dozen mostly *Pocillopora* sp. coral colonies 0.2-0.4m diameter along a 10m stretch ending 6m north of point 11 (fig. 4.3.72 and reference from 0:54 to 1:14 in Bikenibeu video 1). [dive team estimate 2hrs. at 8m depth]

Fig. 4.3.72 From Bikenibeu 6m North of point 11, corrected depth 9.0m

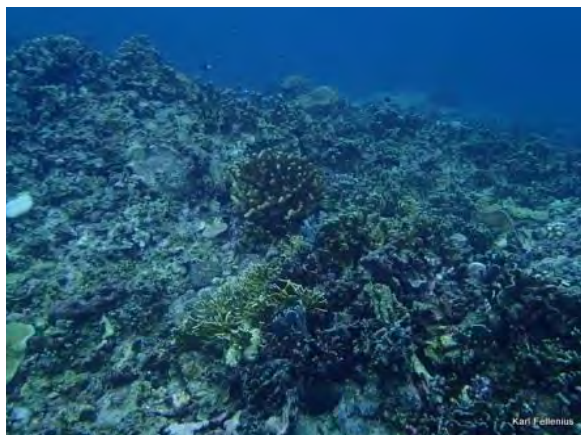
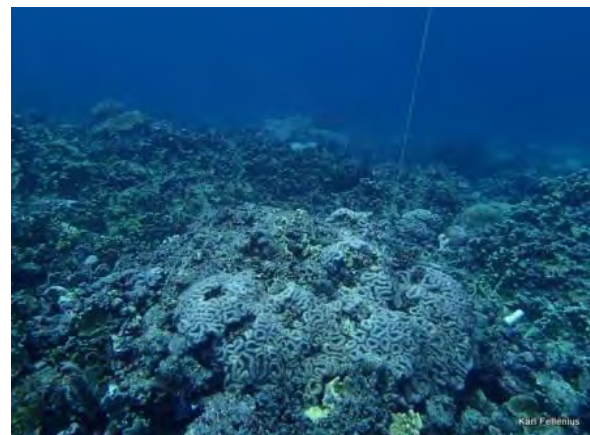
The 15m of substrate between points 11 and 10 is debris and 15% coral cover at a slope of 40°. Coral cover is mainly massive *P. sinuosa*, some massive *Lobophyllia* sp. and submassive *P. rus* and *H. coerulea*. Minor *Pocillopora* sp. and encrusting *Porites* sp. are also present but no *Acropora* sp. The debris is mainly dead and scattered *P. sinuosa* colonies. There are about 5% turf algae, 5% fleshy coralline algae, 20% of the more desirable crustose coralline algae. The upper slope at point 11 is shown in figures 4.3.73 and 4.3.74 (video reference from 2:02 to 3:02 in Bikenibeu video 1).

Fig. 4.3.73 At Bikenibeu point 11, looking West, *Millepora* - *Heliopora* - *Pocillopora* sp., corrected depth 12.2m

Fig. 4.3.74 At Bikenibeu point 11, looking South, *Lobophyllia* sp., corrected depth 12.2m

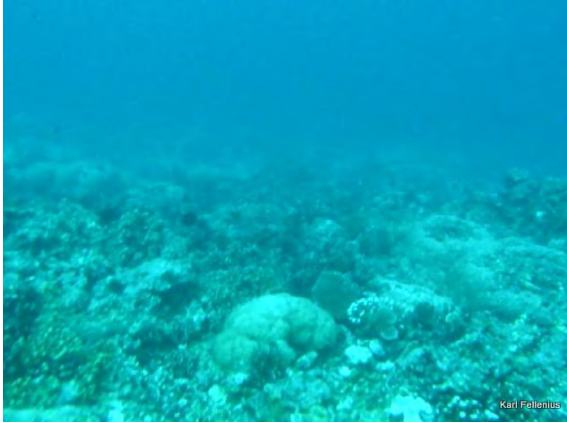
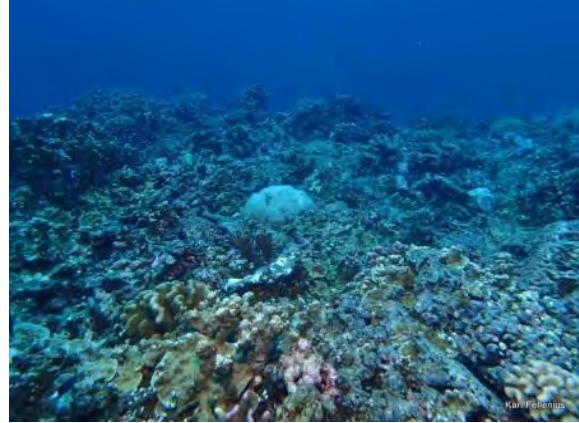
Obstruction 10: Levelling of debris and possible removal and relocation of small coral colonies along a 4m stretch ending at point 11 (video capture fig. 4.3.75 and fig. 4.3.76, reference from 1:19 to 1:27 in Bikenibeu video 1). [dive team estimate 1hr. at 12m depth]

Fig. 4.3.75 At Bikenibeu 2m North of point 11, looking South, corrected depth 12.0m

Fig. 4.3.76 At Bikenibeu point 11, looking North, corrected depth 12.2m

From a few meters south of point 11 to just north of point 10 the *P. sinuosa* is relatively concentrated. The relief is not as high as it is on the upper slope at Bairiki, and the outfall pipe can likely be placed on top of the live bubble coral field. However, it is recommended that some effort be placed on relocation of the affected colonies.

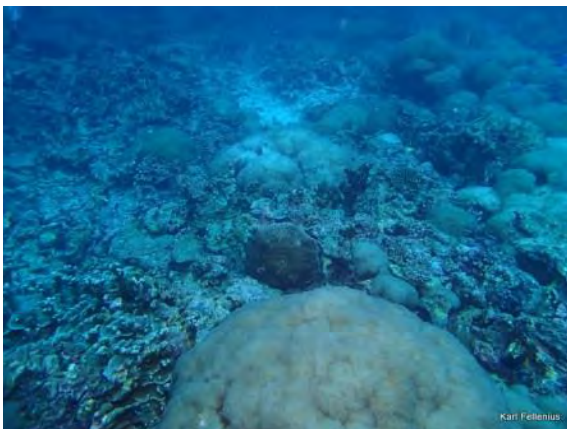
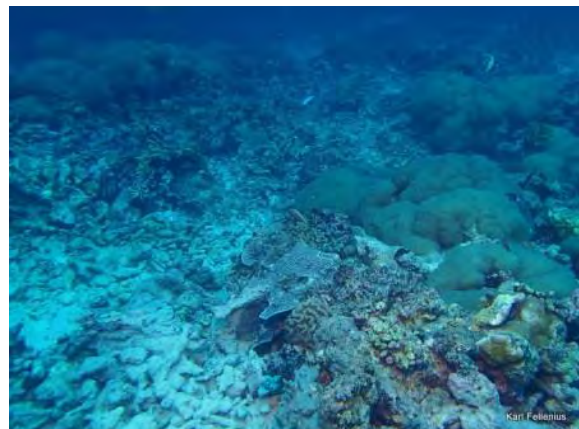
Obstruction 11: The middle slope north of point 10 has numerous patches of debris and up to a dozen 0.8-1.2m diameter *P. sinuosa* colonies that should be relocated. (figs. 4.3.77 and 4.3.78, reference from 2:23 to 2:55 in Bikenibeu video 1). [dive team estimate 4.5hrs. at 20m depth]

Fig. 4.3.77 From Bikenibeu 7m South of point 11, looking South, corrected depth 18.5m

Fig. 4.3.78 At Bikenibeu 12 m South of point 11, looking South, corrected depth 22.5m

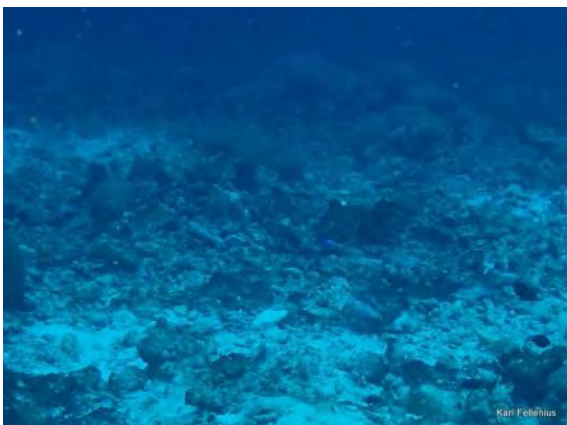
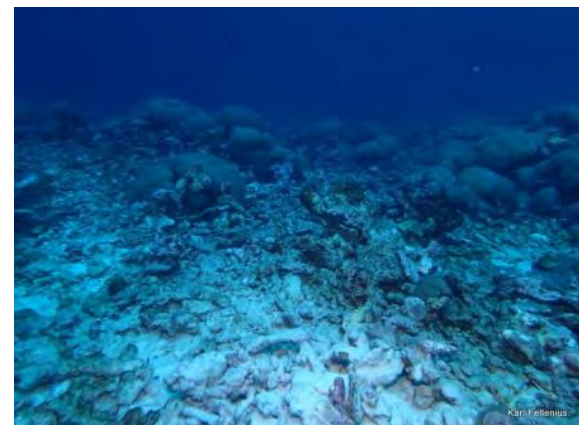
The 14m of substrate between points 10 and 9.1 is largely sand, silt, rubble, and debris at a slope of 14°. Coral cover is reduced to 5%. Blue-green, turf, and fleshy coralline algae are present at 5% each, although there is still 15% crustose coralline algae. The upper and middle slopes are shown in figures 4.3.79 and 4.3.80 (video reference from 2:57 to 3:19 in Bikenibeu video 1).

Fig. 4.3.79 From Bikenibeu point 10, looking South, corrected depth 24.5m

Fig. 4.3.80 From Bikenibeu point 9.1, looking South, corrected depth 27.9m

Note that terminating the outfall 2m south of point 10 (reference 3:00 in video 1) is warranted because it achieves a 25m depth (corrected), and keeps the diffuser and the immediate area of discharge away from the *P. sinuosa* that is both shallower and deeper but not in the debris field in the middle. If the diffuser is 10m long and ends at this precise location, it would be 10m north of the deeper *P. sinuosa*. This is not significant, but it is better than terminating it in the deeper coral patch, which would necessitate further obstruction work, damage coral from both removal of obstructions and from more concentrated effluent plume discharge, and therefore not yield the perceived benefits that a deeper outfall might suggest.

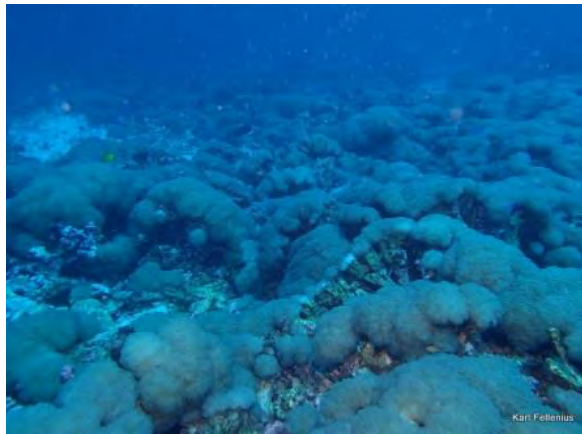
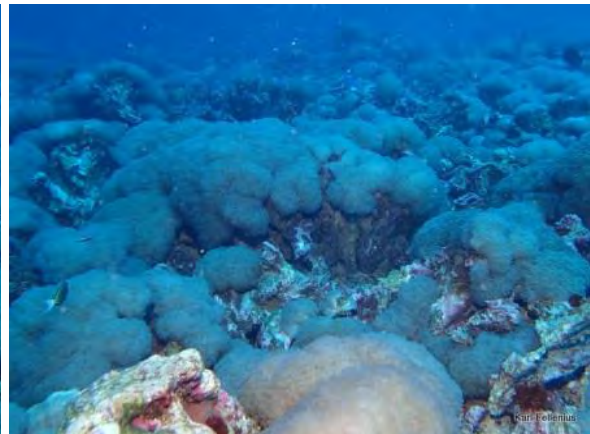
The 10m of substrate between points 9.1 and 9 is debris and 80% coral cover at a slope of 26°. Coral cover is almost exclusively massive *P. sinuosa*. The debris is mainly dead and scattered *P. sinuosa* colonies. Crustose coralline algae is back up to 20%. The lower slope at point 9 is shown in figures 4.3.81 and 4.3.82 (video reference from 3:19 to 3:50 in Bikenibeu video 1).

Fig. 4.3.81 From Bikenibeu 3m South of point 9.1, looking South, corrected depth 29.0m

Fig. 4.3.82 From Bikenibeu 3m North of point 9, looking South, corrected depth 31.5m
