ASSESSMENT OF THE BREAKWATER  
STRUCTURES AT CLINTON REEF MARINA,  
PORT CLINTON, OHIO

Charles E. Herdendorf  
Center for Lake Erie Area Research

Clinton Reef Marina  
Port Clinton, Ohio 43452

June 1987

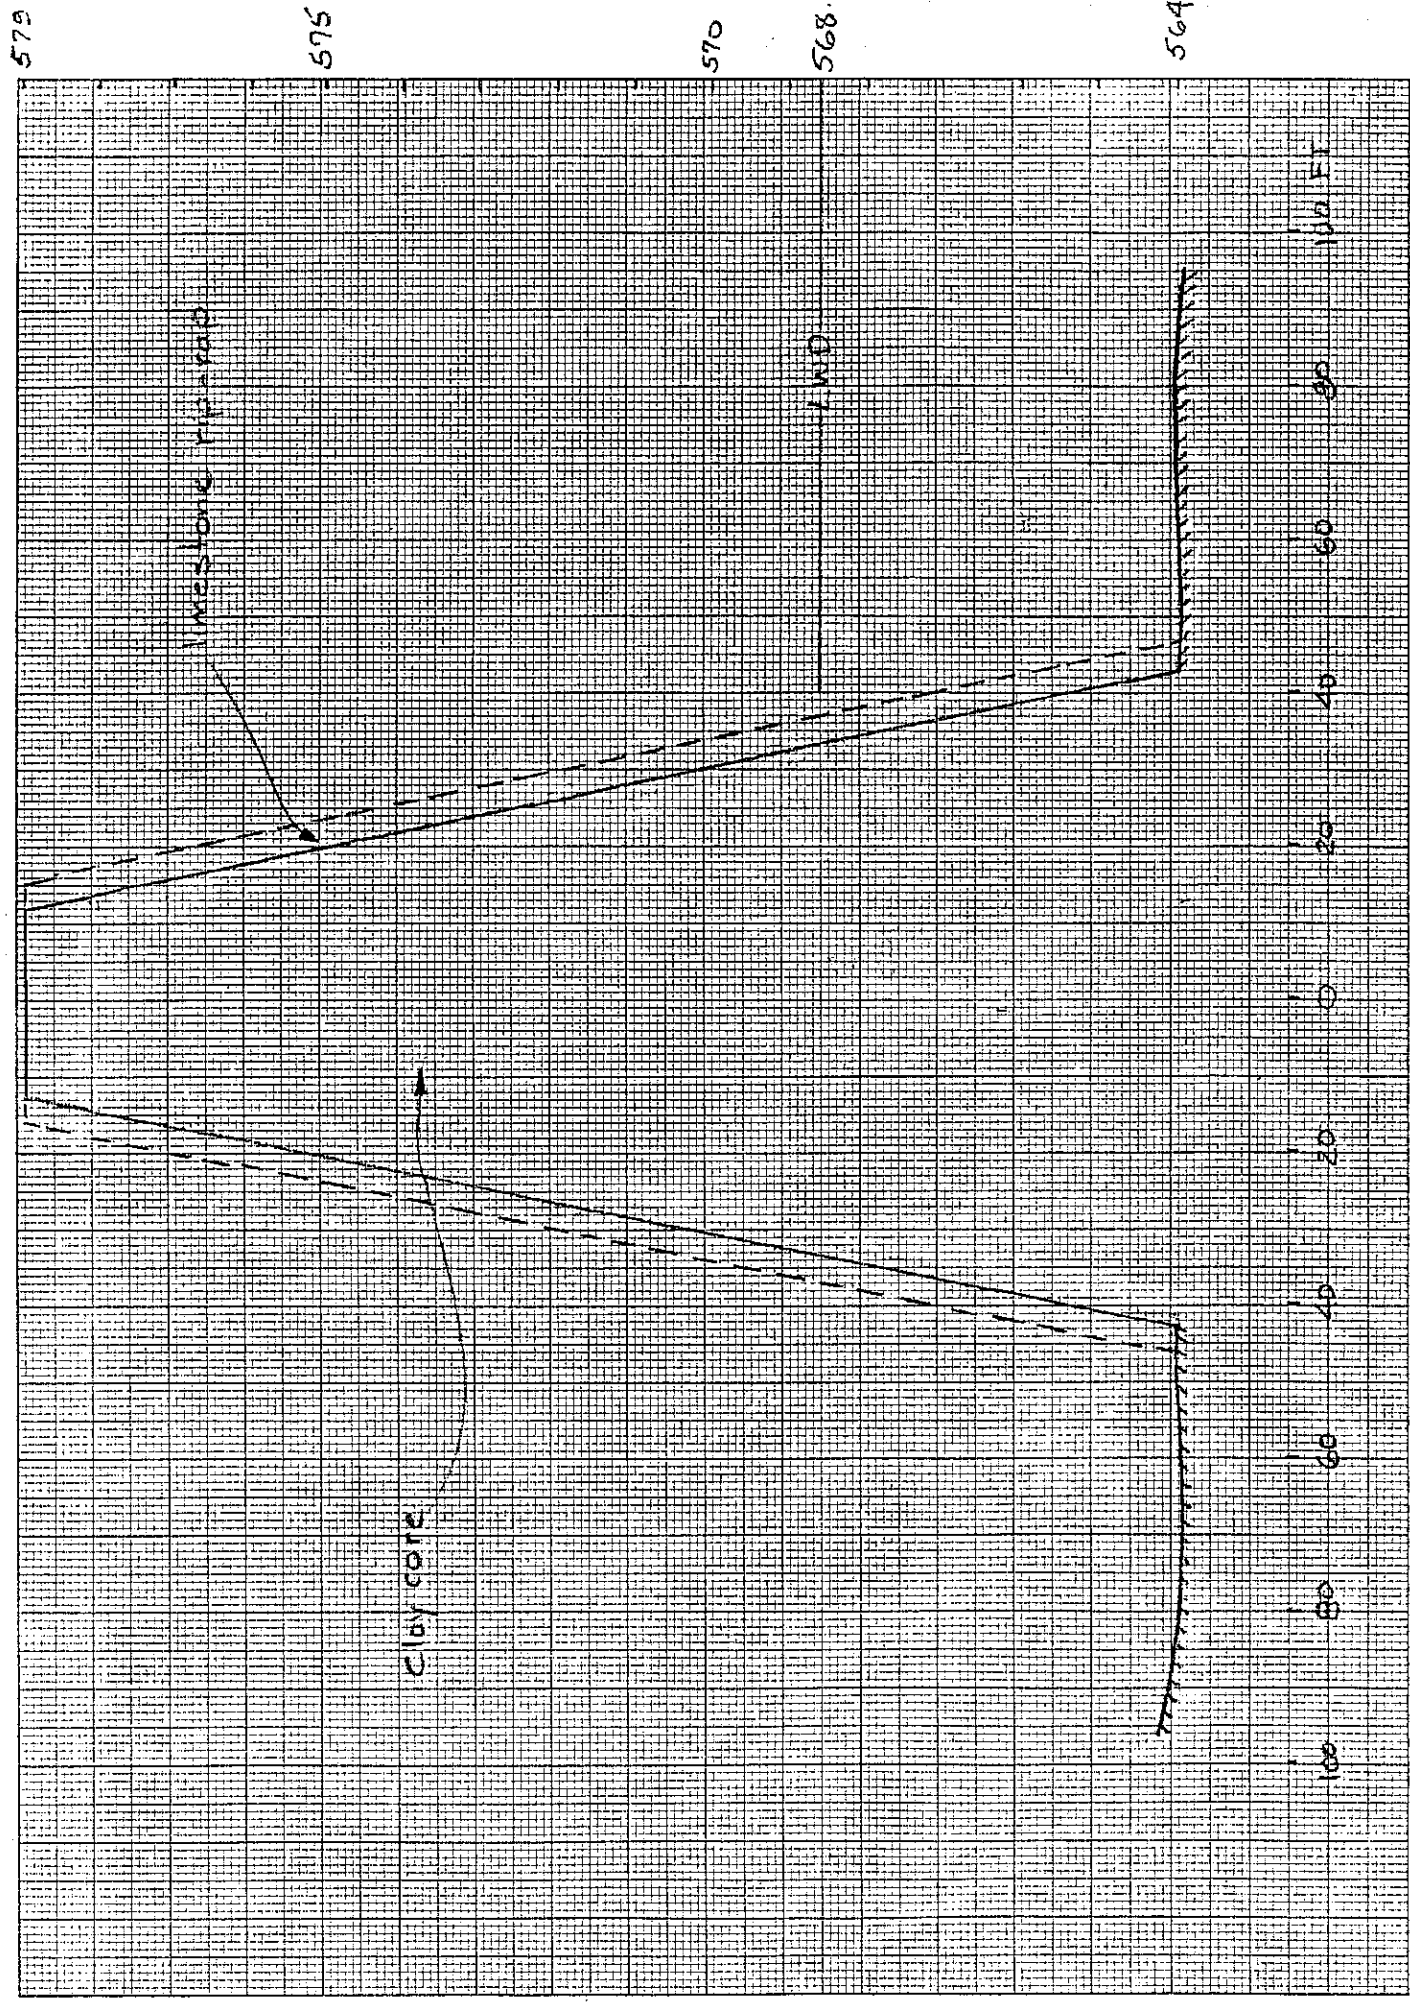
Figure 3. Typical Section B-B (South Breakwater).

The typical sections described in the permit were plotted on graph paper with a 10:1 vertical exaggeration. Figure 3 shows the configuration for typical section B-B. There appears to be some inconsistency in the permit drawings concerning the overall width of the sections. The drawings label the top of the clay core with a width of 25 ft, then show a 3 ft wide limestone rip-rap cap on both sides of the core. However, the bar scale does not agree with these dimensions. For the purposes of the assessment I have used 25 ft as the width of the core and 31 ft
