SURVEY OF SHORELINE STRUCTURES POPPONESSET BEACH, MA

M. R. Goud
and
D. G. Aubrey

May 1983

Technical Report

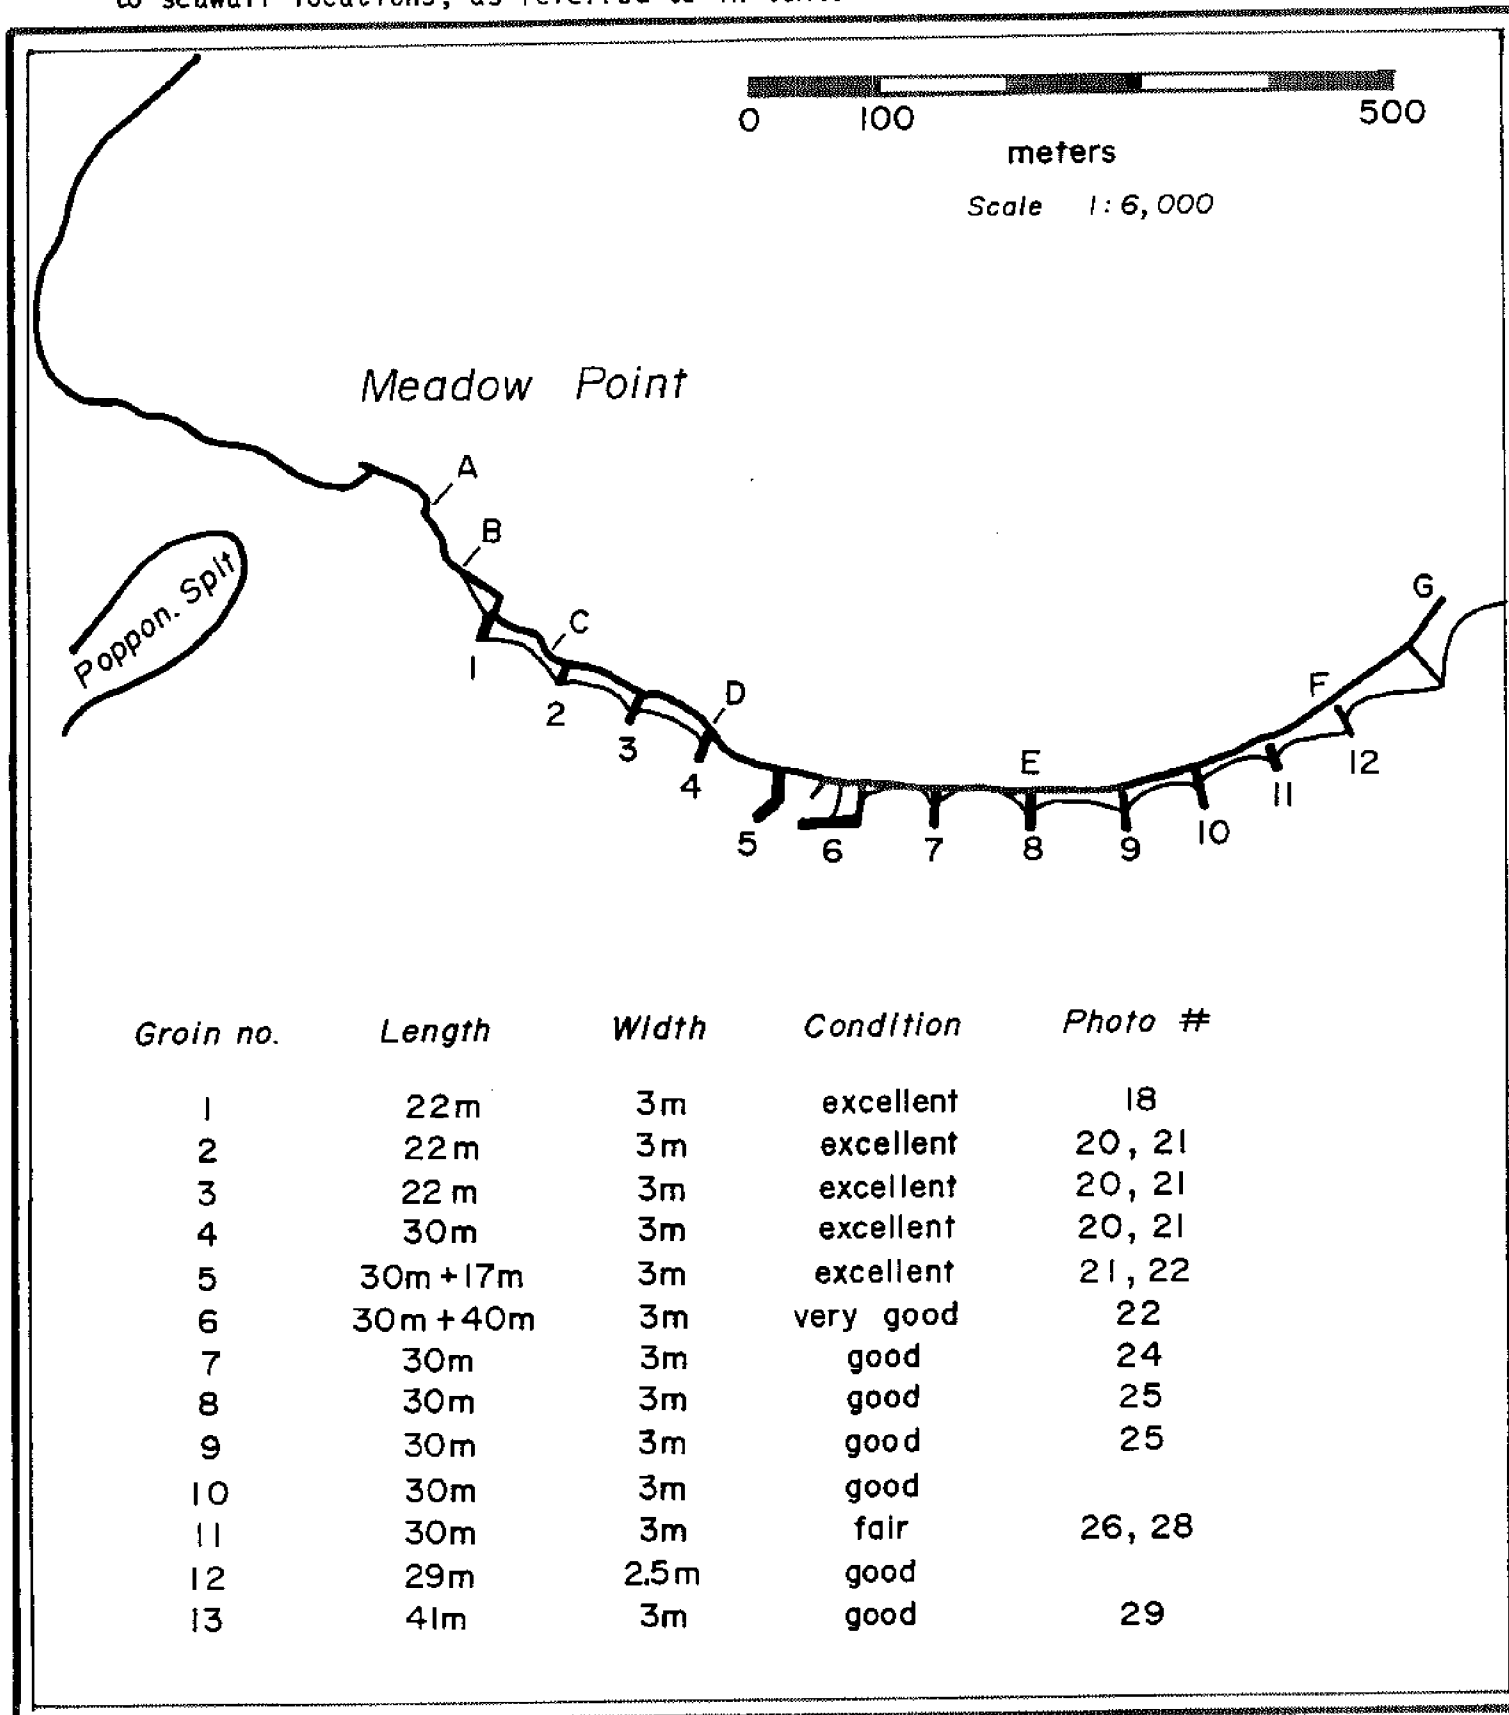
Figure 3. Detail of Station VI, showing locations of groins as well as construction parameters, conditions, and photo references. Letters refer to seawall locations, as referred to in text.

GROINS (see Figure 3 for locations, construction parameters, conditions and photo references)

Seawalls of various sorts extend northeast from 100m south of groin 1 to groin 13. They vary in effectiveness and condition, and are described individually, with reference to the letters on Figure 3.

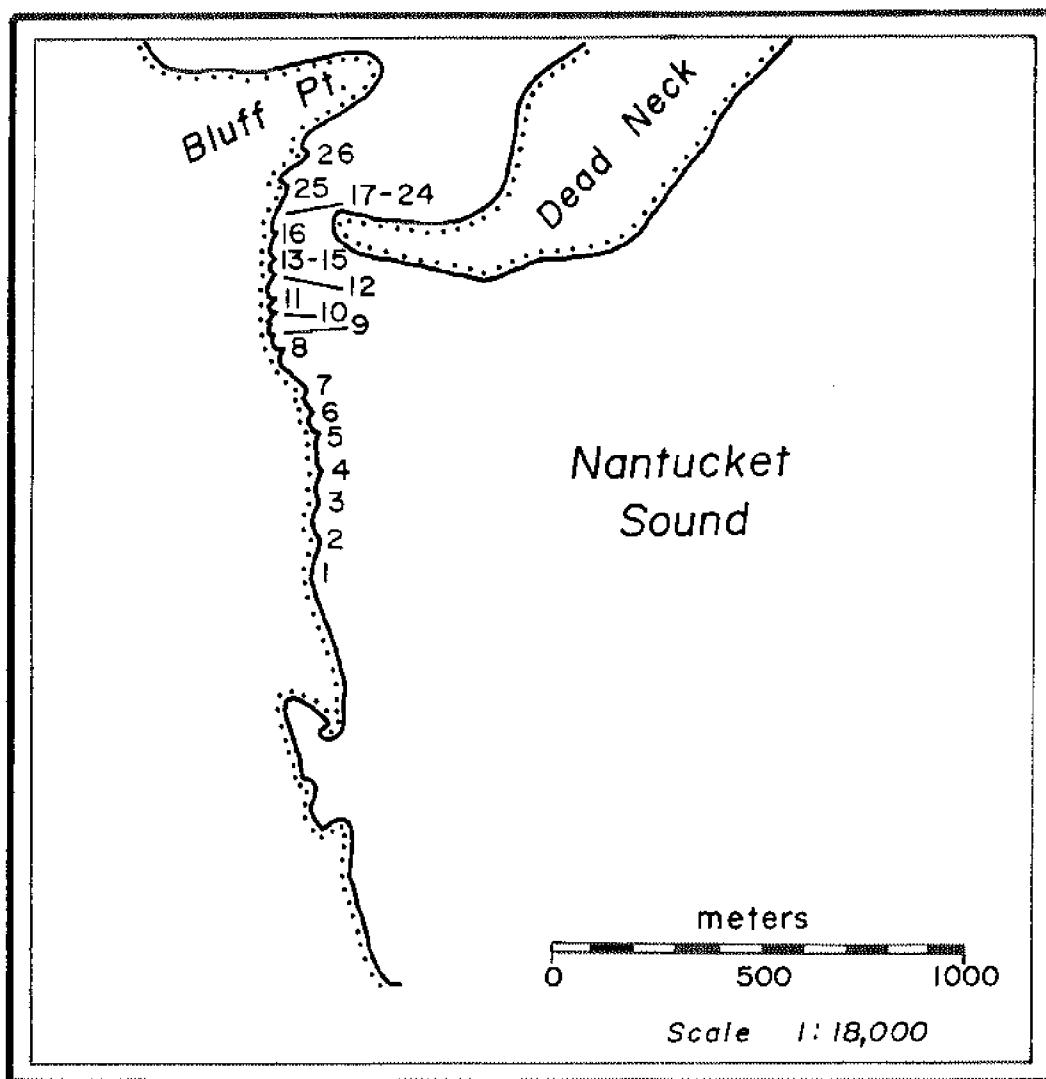
Figure 4. Detail of Station VIII, showing locations of groins from Rushy Marsh Pond to Bluff Point.

Station 8 extends from the sand spit near Rushy Marsh Pond to the last groin on the approach to Bluff Point (Figure 4). It consists of 26 groins of loose boulder construction, in poor to excellent condition, for the purpose of trapping sand. In a few locations there are seawalls between the groins.

Effectiveness: almost none; onshore migration of sand from the northeast limb of Popponesset Spit has made the stabilizing structures unnecessary. A wall which formerly prevented bluff erosion (photo 35) is likewise a vestige of the previous shoreline configuration.
