**THE MICHIGAN DEMONSTRATION EROSION CONTROL PROGRAM IN 1976**

**Prepared by the University of Michigan Coastal Zone Laboratory**

**Michigan Sea Grant Program  
Technical Report No. 55**

**February 1977**

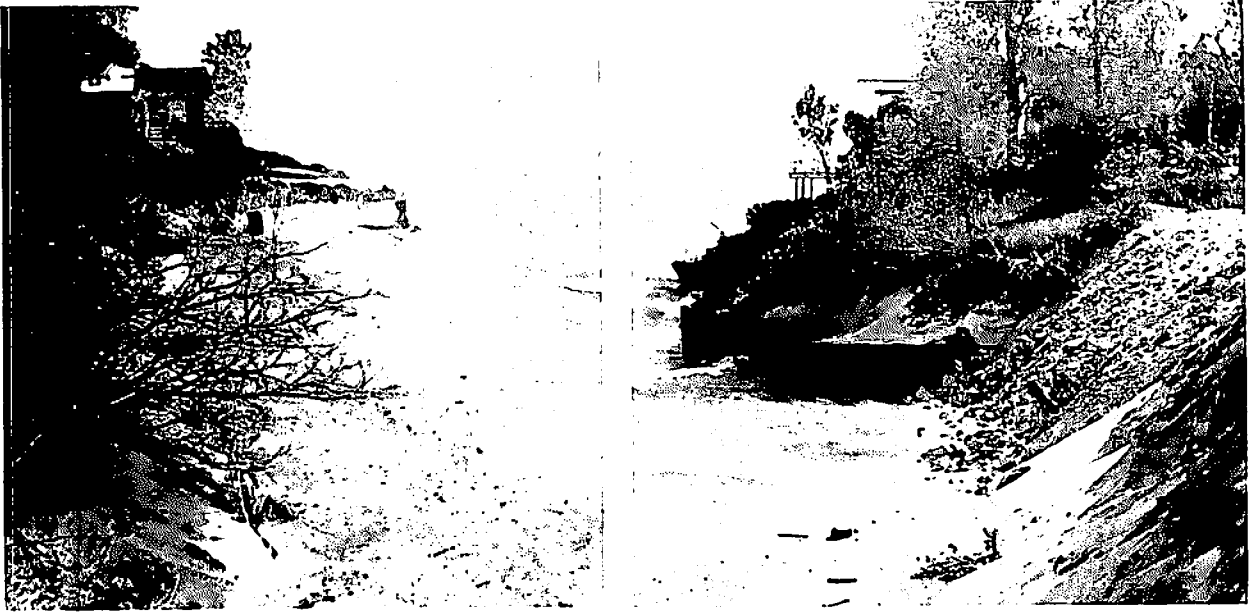
Figures 2 (left) & 3 (right). Michiana, August 1, 1973

These photographs show the Michiana site prior to construction. The seawalls evident at the ends of the beach mark the limits of the project area. The Village's major utilities and road are located at the top of the sand bluff.

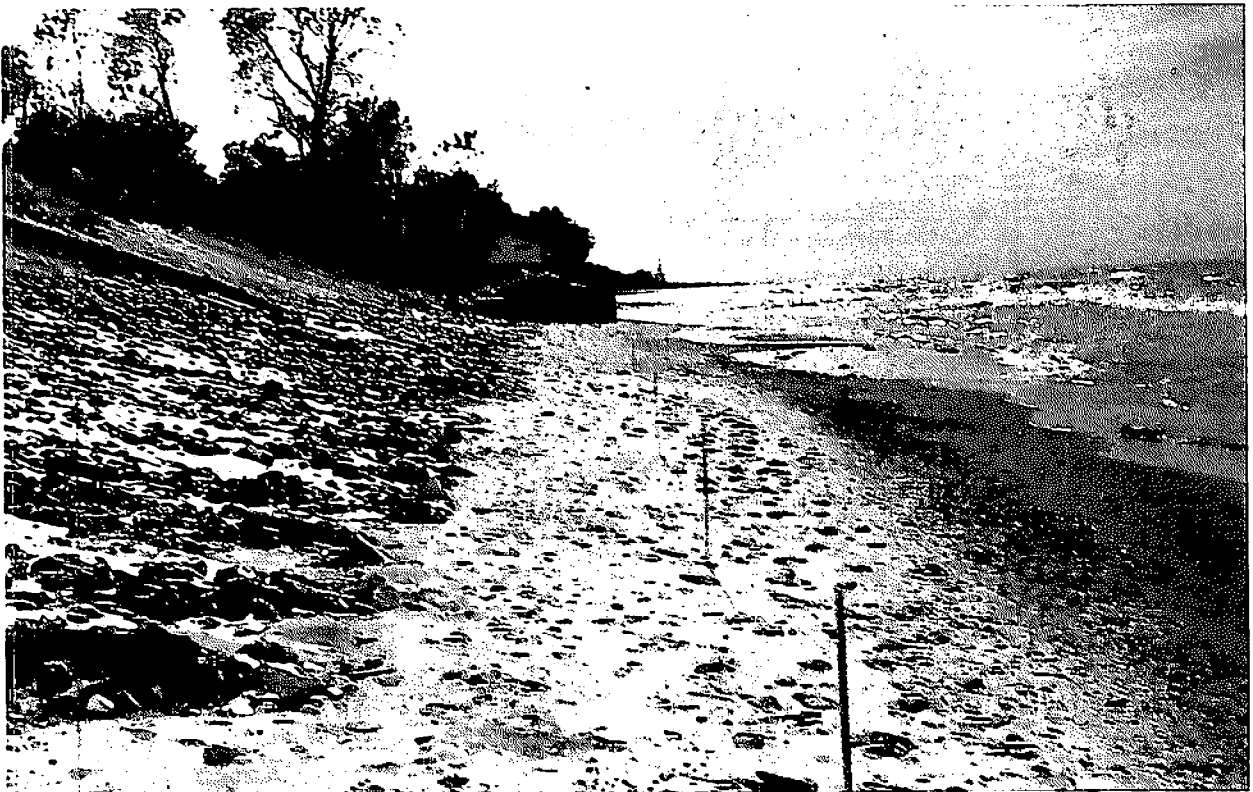
Figure 4. Michiana, September 23, 1973.

The revetment can be seen one week after construction. The stakes mark the lower edge of the structure.

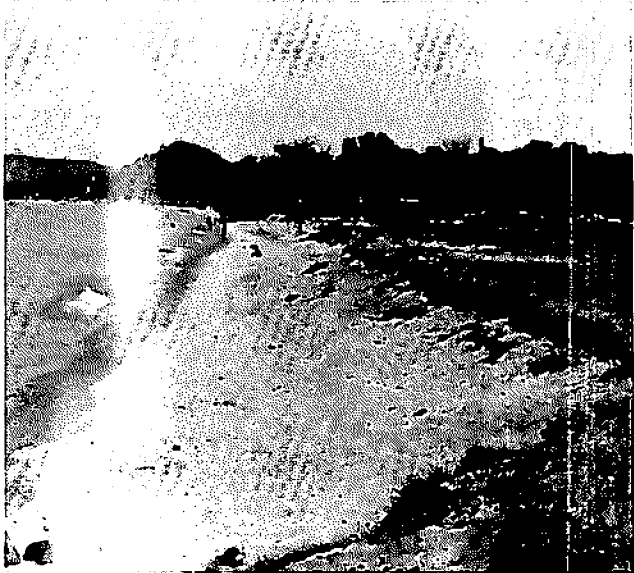
Figure 10. Empire, October 23, 1973.

The condition of the site immediately after construction was completed is shown. The 40-inch (101.6 cm) diameter tube has been placed on a layer of filter cloth. The low sand bluff is particularly evident in this photograph.

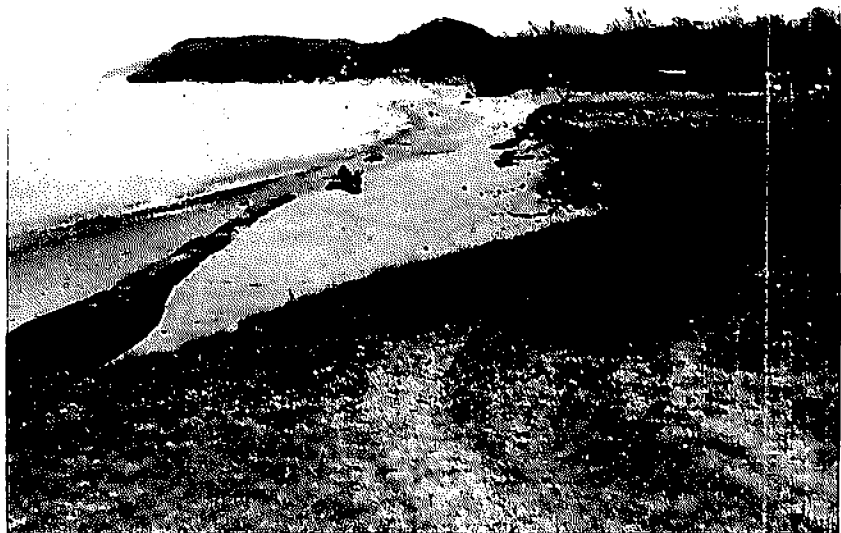
Figure 12. Empire, June 15, 1974.

This photograph shows a portion of the tube which was ripped after the initial damage experienced in the fall.

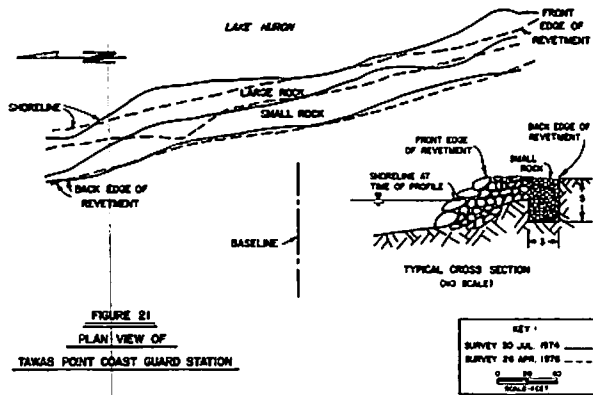
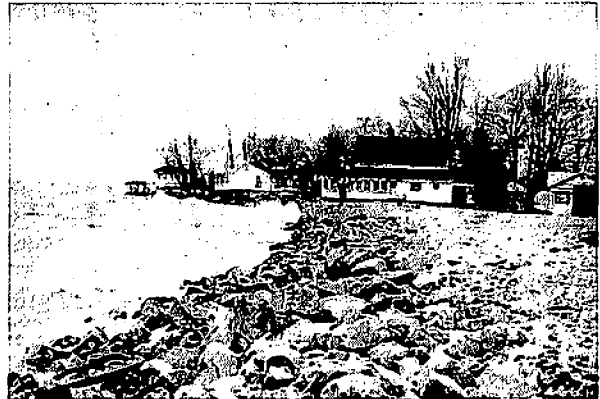
Figure 22. Tawas Point Coast Guard Station, April 25, 1976.

Taken in the spring of this year, this photo shows the rock revetment at Tawas Point Coast Guard Station. There has been some very minor shifting of rocks used to construct this revetment but on the whole this structure has performed very well.

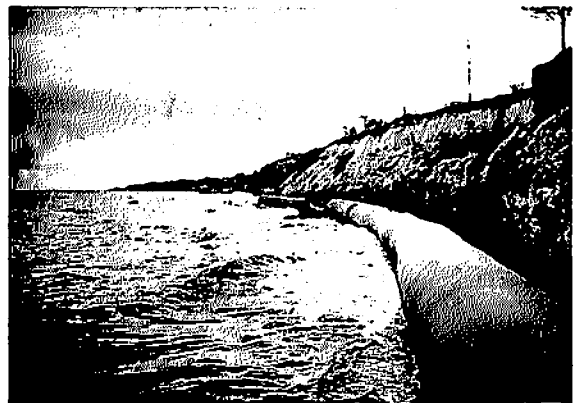
Figure 23. Sanilac-Section 11, October 20, 1974.

This photo was taken during the first survey of this site. At that time the filling operation of the tube was still underway. The hopper which is used to fill the tubes is evident in the background of the picture. The background tube is yet to be filled completely. The very steep, actively eroding, clay bluffs typical of this area can also be seen.

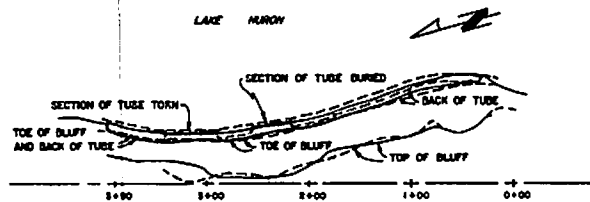
FIGURE 26  
PLAN VIEW OF 69" DIA. LONGSHORE TUBE  
SECTION 11 - SANILAC TWP., MICHIGAN

The survey made in the spring of 1976 revealed that this structure had been severely damaged; see Figure 25. This damage probably occurred during a critical storm experienced in late April 1976. Portions of the tube have collapsed and the entire structure has rolled toward the lake. Photographic records show that during the past two years the bluff recession rates to the north and south have been greater than at the site of this installation. It appears that these tubes have reduced the erosion rate to the land area behind them. Figures 26 and 27 show the movement of the tube.

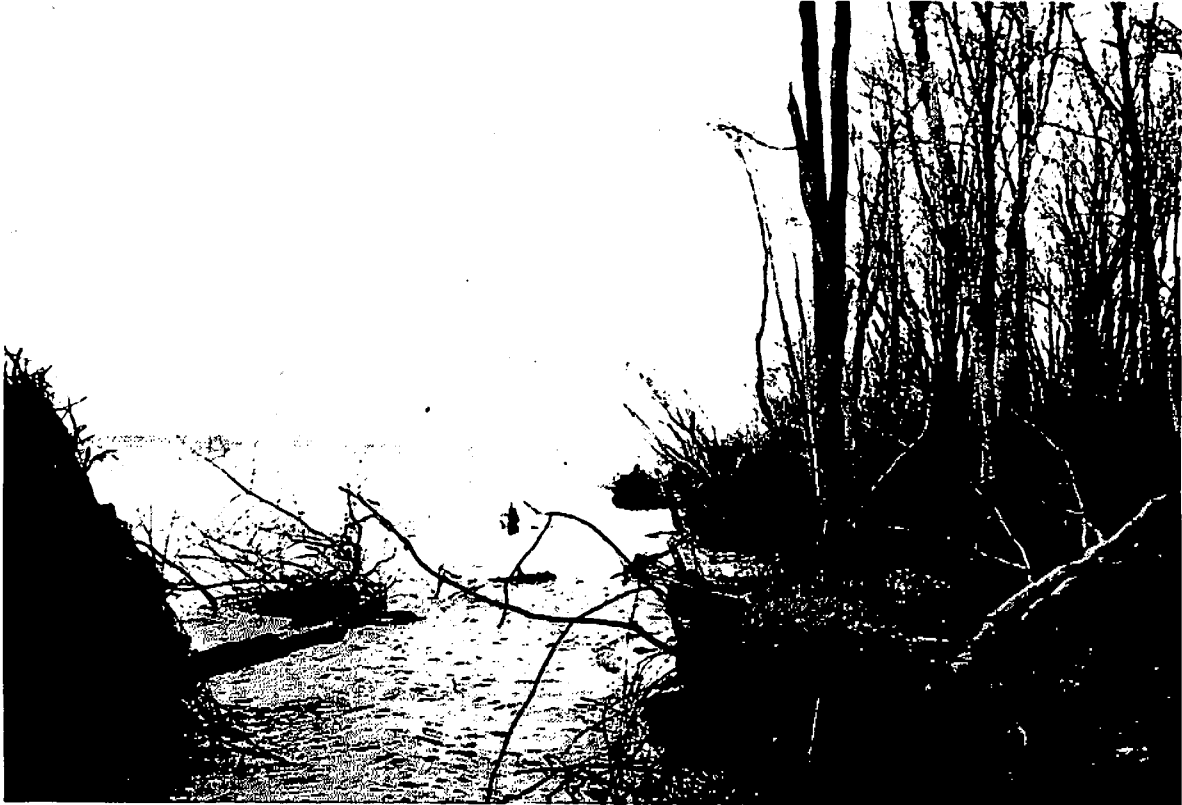
Figure 28. Whitefish Township, Summer, 1973.

This photo was taken in the summer before construction of the shore protection system was completed. As is readily apparent, erosion damage was active at this site and many trees and other valuable park land were being lost.

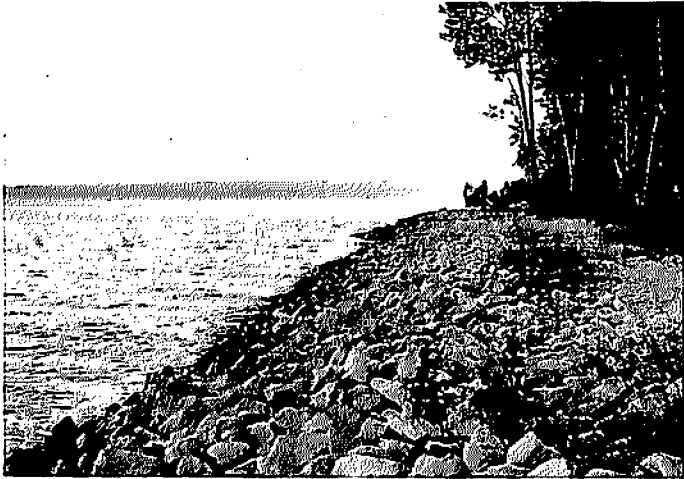
Figure 29. Whitefish Township, May 18, 1975.

There are no obvious changes after the revetment's first year in place.

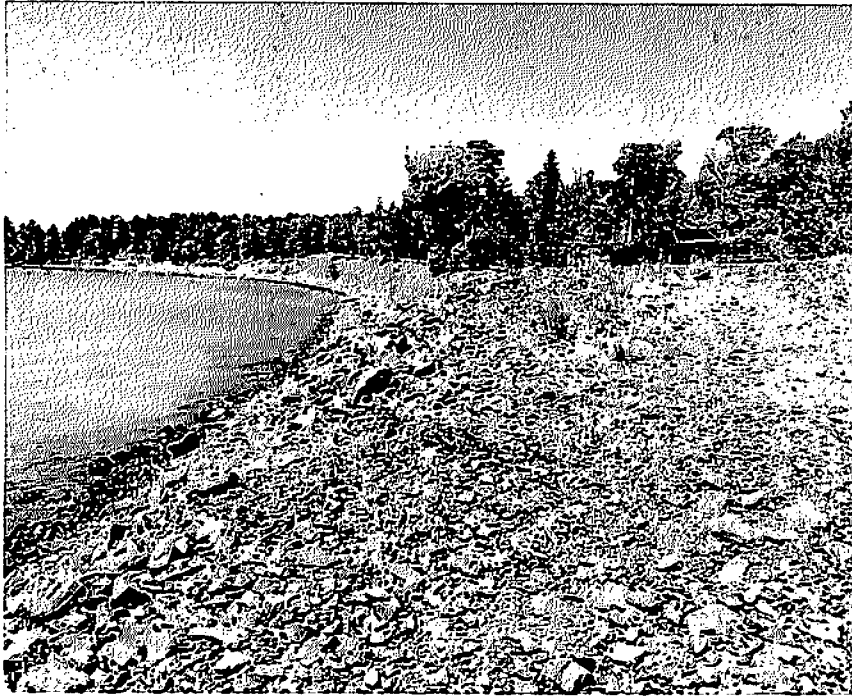
Figure 30. Keweenaw Peninsula, June 30, 1976.

The highway which was being threatened by severe erosion can be seen at the top of the bluff. Note the varying sizes of rock used in the revetment.

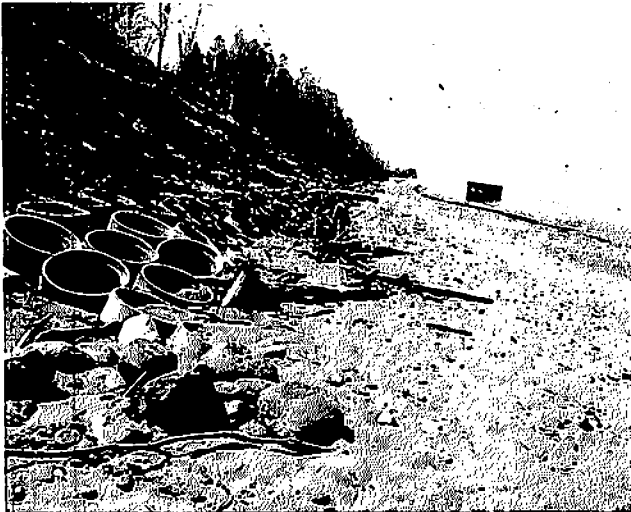
Figure 32 (left). Little Girls Point, May 21, 1975.

foundation. Some of the rings were tied together with steel rods. It had been planned to grade the bluff to a slope of 1 to 1 1/2 and install the revetment at the base of the bluff. Instead, the bluff was not graded and the revetment was installed along the upper portion of the beach next to the base of the bluff in the fall of 1974. Therefore, the slope of the revetment was about 10 to 1; see Figure 32.

The Nami rings can be seen after the first year of service. For the most part the rings have remained stable except for some shifting due to the slumping bluff. Many of the rings had filled with sand by the time of this photograph.

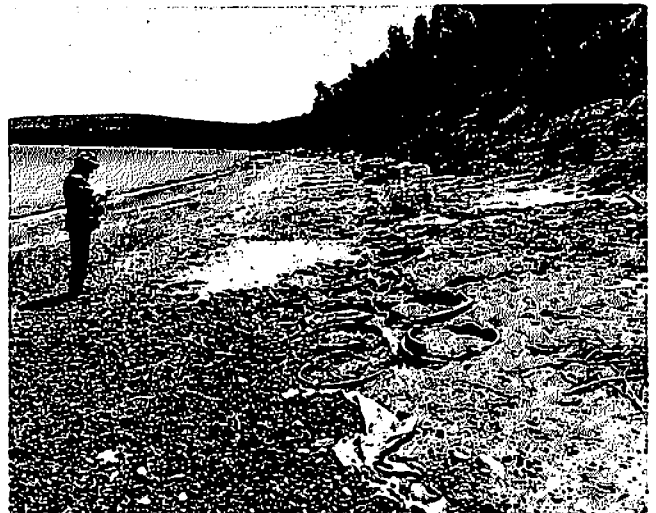
Figure 33 (right). Little Girls Point, June 30, 1976.

Many of the Nami rings have settled and/or been broken since installation. This view shows the ongoing recession of the bluff behind the revetment.

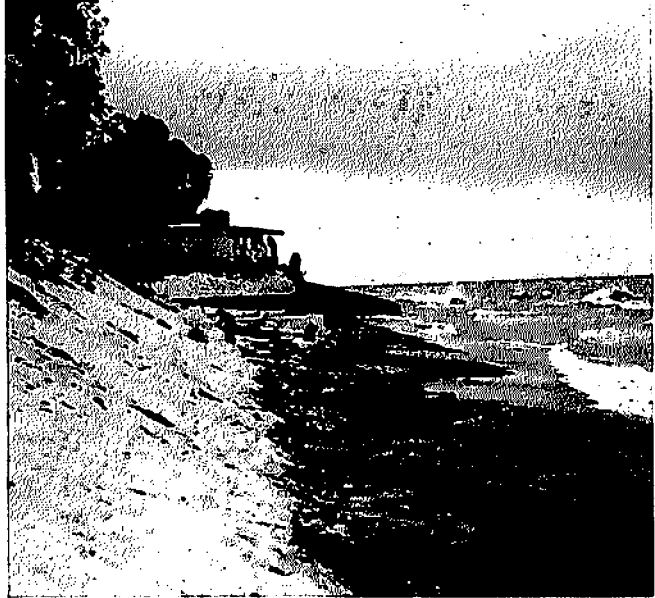
Figure 36. Lincoln Township,  
August 11, 1973.

The narrow beach and the vulner-  
able sand bluffs at this site can  
be seen. The steel seawall marks  
the southern limit of the project  
area.

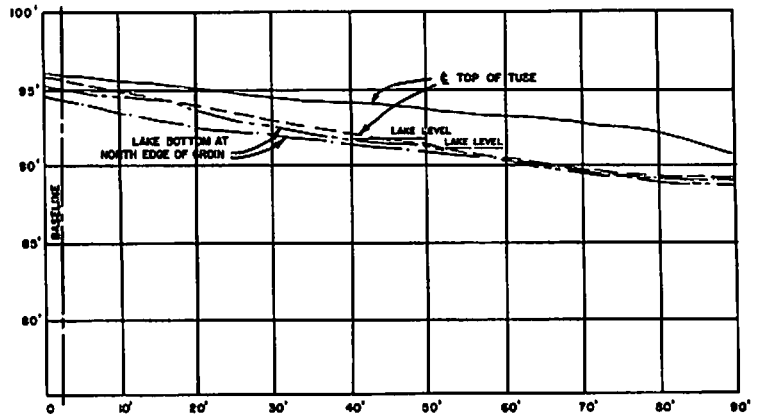
FIGURE 38  
PROFILE OF LONGARD TUBE  
LINCOLN TWP., MICHIGAN

The Longard tube was the first structure installed at this site in the fall of 1973 at a cost of \$30 per foot (\$98 per meter). This tube was also installed without a foundation to test the effectiveness of setting such a structure on a sand lake bottom. The Longard tube has suffered moderate damage. Approximately 30 feet (9.1 m) of the lake end of the tube has been lost and the whole structure has settled about 3 feet (.9 m) along the centerline (see Figure 38). The rate of settlement increased again in the fall of 1975 after remaining relatively stable for about a year. It has not been determined if this is due to sand washing out of the tube from the lakeward end or by sinking. The tube still acts successfully as a groin in trapping sand which helps to protect the bluff though some bluff recession has been recorded near this structure. However, after less than three years its effectiveness has been greatly reduced.

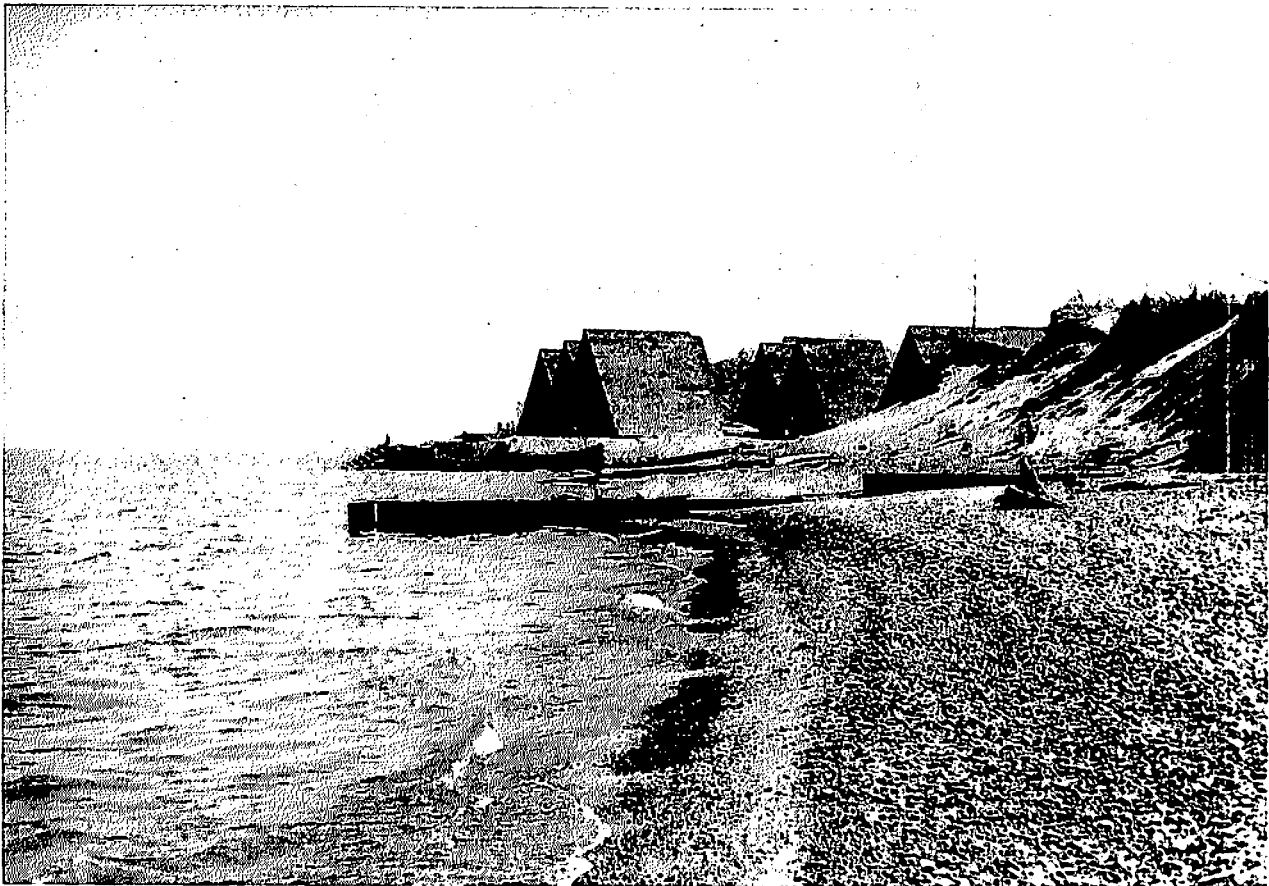
Figure 40. Lincoln Township, May 1, 1976.

The wide spacing between groins has proven quite successful and the entire system has worked very effectively in protecting the site by trapping sand and raising the beach profile. Both structures are still stabilizing the bluff although there has been minor slumping (see Figure 40). This slumping is probably due to factors other than simply wave attack, such as wind erosion or heavy human traffic on the bluff.

This is a view of the site in the spring of 1976 looking to the north. The wood pile groin is evident in the foreground and close observation will reveal the 40-inch (101.6 cm) diameter Longard tube in the background. Some bluff recession/stabilization is evident as documented by the flattened slopes on the bluff.

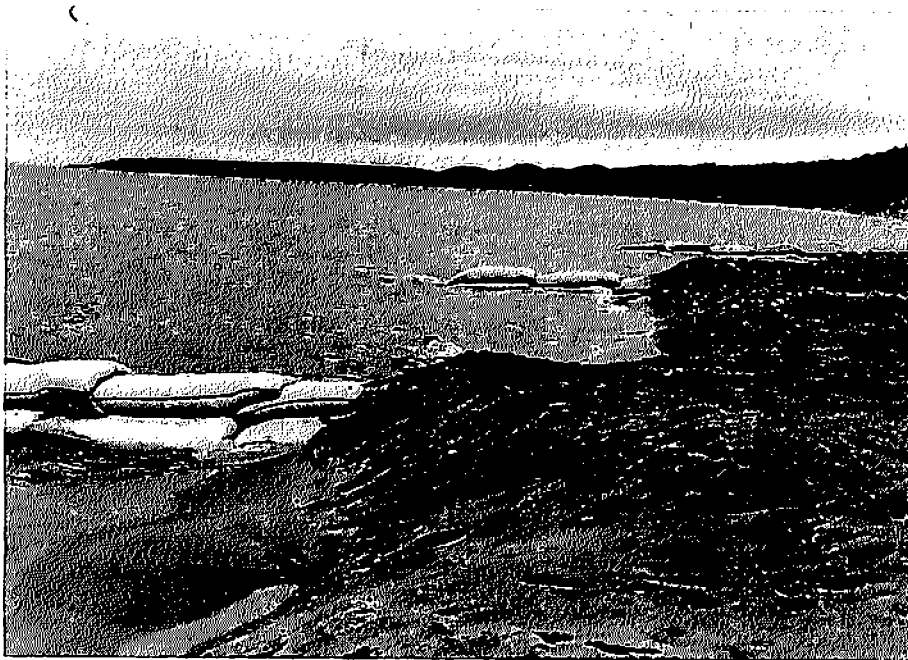
Figure 41. Charles Mears State Park, April 27, 1976.

This photo was taken shortly after sandbags were used to replace the lakeward end of each groin. Buried under the piled sand is the remaining original gabion system.

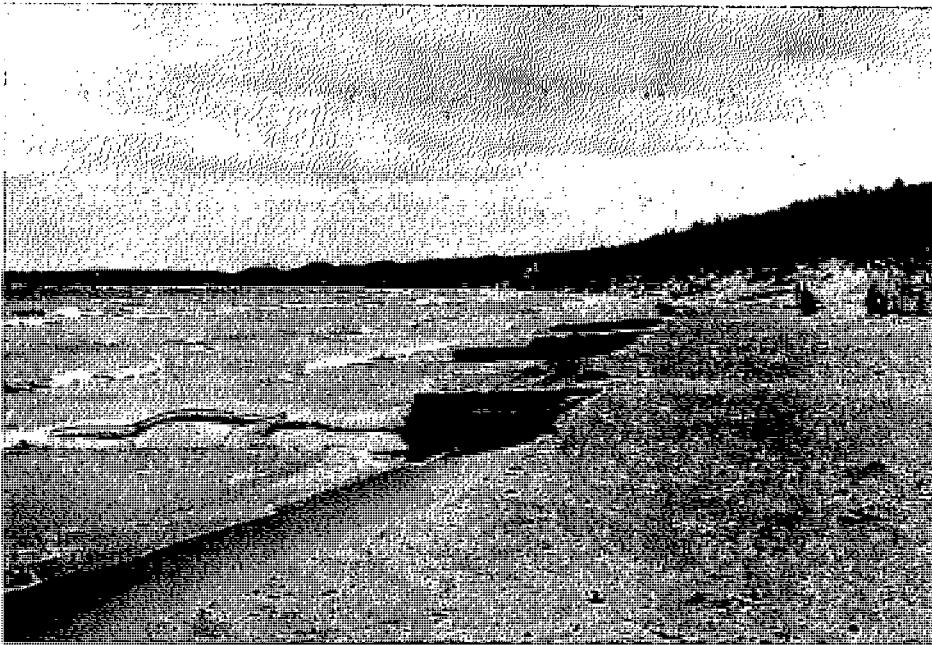
Figure 42. Charles Mears State Park, June 15, 1974.

It is evident that some of the sandbags were either lost or displaced at the extreme lakeward end of the groins. Some of the beach sand has been eroded to expose parts of the original gabions.

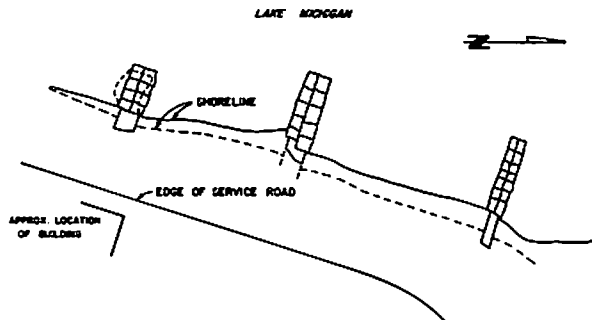
**FIGURE 43**  
**PLAN VIEW OF CHARLES MEARS STATE PARK**  
**PENTWATER, MICHIGAN**

To date there have been only moderate changes in these structures (see Figures 42, 43, 44, 45, and 46). All the groins have been lowered, particularly at their lakeward end. This lowered profile is partly due to settling of the structures and partly due to bag loss. Because of periodic nourishment, it is difficult to evaluate their effectiveness.

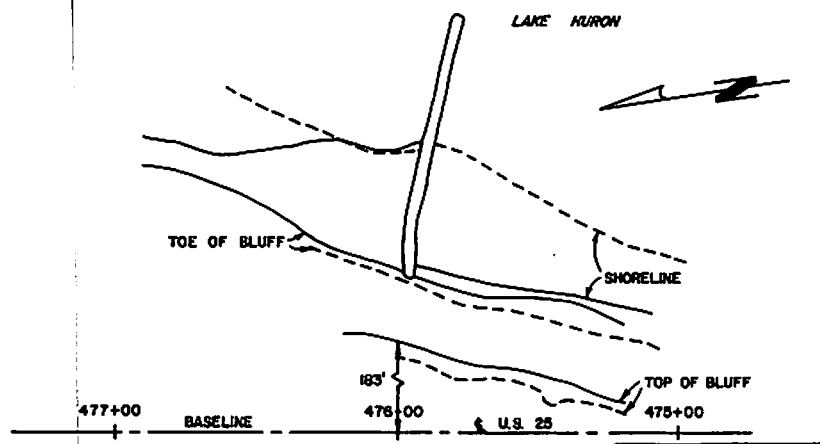
**FIGURE 48**  
**PLAN VIEW OF 40\"/>
**SECTION 26 - SANILAC TWP., MICHIGAN****

Two 40-Inch (101.6 cm) Diameter Longard Tubes. Two 40-inch (101.6 cm) diameter Longard tubes were installed side-by-side in the fall of 1973. The tubes are 100 feet (30.5 m) long and were installed at a cost of \$30 per foot (\$98 per meter) of shoreline. It was planned to stack a third tube on those two in pyramid style. A storm occurred during construction which prevented placement of the third tube (see Figures 48, 49, and 50). This groin appears to be working well; although some settlement has occurred along both tubes, particularly the southern tube. The groin is still trapping sand. The tubes have helped to build up the beach and thus resist wave attack. Recession at the top of the bluff has been about 10 feet (3 m) since installation in the immediate vicinity, and some slumping has occurred due to rain and frost action.

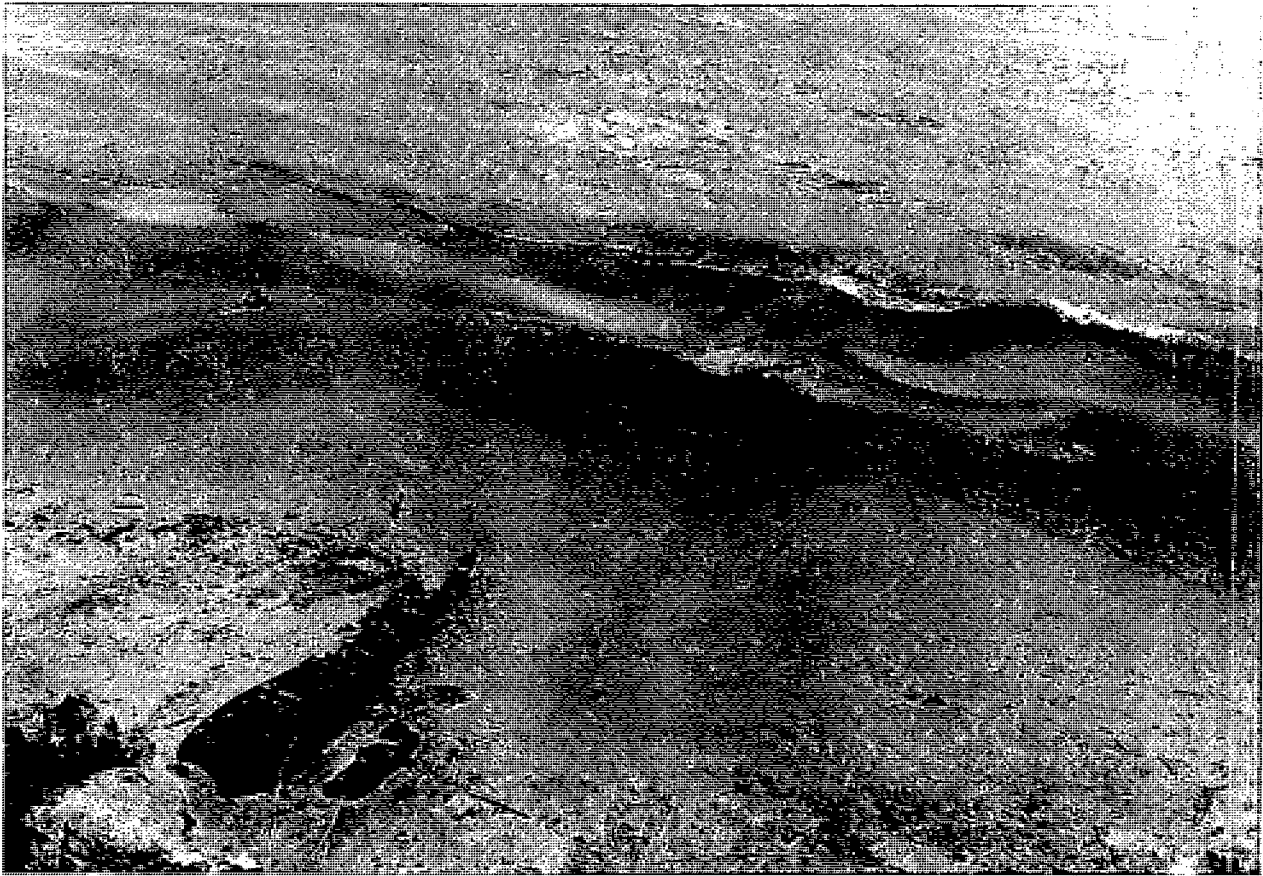
Figure 50. Sanilac-Section 26, May 19, 1976.

The two 40-inch (101.6 cm) diameter Longard tubes can be seen used as a groin. It is evident that a large amount of beach has been trapped as the tubes are buried. The south tube which can barely be seen is lower than the north tube. It has settled about 1 foot (.3 m).

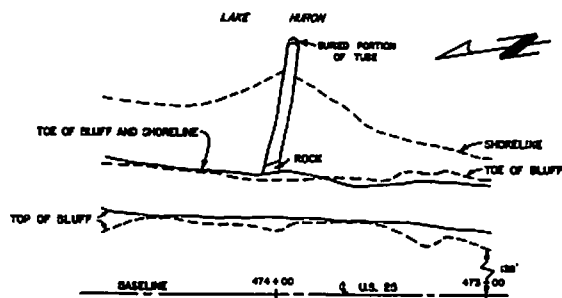
**FIGURE 61**  
PLAN VIEW OF 69" DIA. LONGARD TUBE  
SECTION 26 - SANILAC TWP., MICHIGAN

One 69-Inch (175.3 cm) Diameter Longard Tube. The 69-inch (175.3 cm) diameter Longard tube was installed in the spring of 1974. This tube is 50 feet (15.2 m) long and cost \$25 per foot of shoreline (\$82 per meter) to install. It was expected to trap sand more effectively than the 40-inch (101.6 cm) diameter tubes because it has more freeboard. However, as of the last survey, both groins have performed equally well. Only minor settlement was experienced with this tube (see Figures 51 and 52). The lack of settlement indicates that a structure of this type can be placed directly on the lake bottom (without a supporting foundation) in areas where the soil is clay. This tube has effectively trapped sand and prevented direct wave attack on the bluff, although minor recession of the bluff has been recorded in the immediate area.

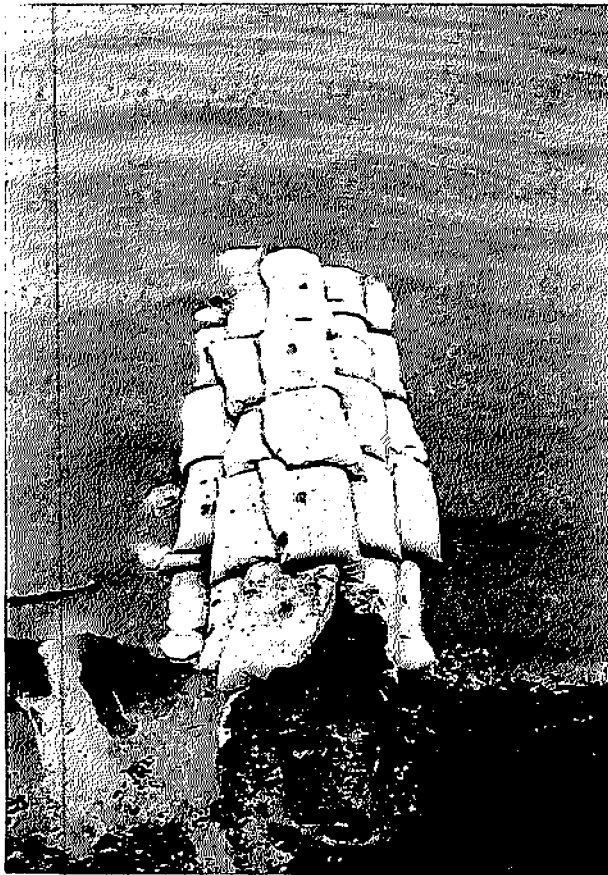
Figure 56. Sanilac-Section 26,  
March 9, 1974.

This photo was taken in the spring after construction was completed the previous fall. The sandbags withstood the effects of the winter ice. Some of the clay till bluff has slumped onto the end of the groin.

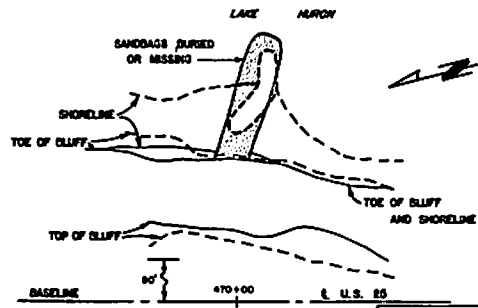
**FIGURE 58**  
**PLAN VIEW OF SANDBAG GROIN**  
**SECTION 26 - SANILAC TWP., MICHIGAN**

Giant Sandbag Groin. The giant sandbag groin was installed in the late fall of 1973 and suffered major damage in the first year. The length of the groin is 60 feet (18.2 m.) and it cost \$30 per foot (\$98 per meter) to install. Nearly 15 feet (4.6 m) of sandbags were lost at the lake end of the groin. Vandalism is probably not the cause since the missing bags were from the lakeward end of the structure which is submerged. Bags are continuing to deteriorate, rip open, and become lost; other bags are being displaced from their original positions; see Figures 56 and 57 for changes. The structure appears to be trapping some sand despite the damage (see Figures 58 and 59). Preliminary conclusions as to effectiveness and durability indicated that sandbag groins offer temporary protection. They do not seem as durable as other structures and should not be considered permanent protection. With annual replacement of damaged bags and protection against tearing, sandbag groins could function effectively for several years.

The condition of the groin is shown two years later (than Figure 56). Sand has been trapped by the groin but a large number of bags have been lost or have shifted. As is apparent, sandbags are not a permanent means of shore protection.

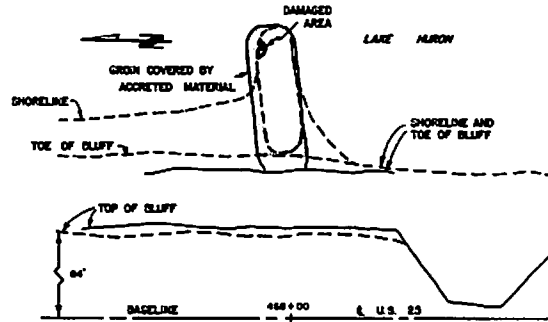
**FIGURE 60**  
**PLAN VIEW OF ROCK MASTIC GROIN**  
**SECTION 26 - SANILAC TWP., MICHIGAN**

Rock Mastic Groin. The rock mastic groin was completed in the fall of 1973. Design and construction supervision of this groin was provided by The University of Michigan's Coastal Zone Laboratory. The successful installation of this structure demonstrated that it was possible to pour mastic through 7 feet (2.1 m) of water. Prior to this successful application, the existing literature had reported that mastic should not be poured through water of more than 1 foot (.3 m). The rock mastic groin is 60 feet long (18.3 m) and was installed at a cost of \$45 per foot (\$146 per meter) of shoreline. Large amounts of sand have been trapped providing a protective beach. No movement of the groin has been visible. However, there has been minor damage to the north edge (see Figures 60 and 61). A section of the mastic and underlying rock was broken off at the lake edge. Minor recession and slumping of the bluff has occurred, probably due to slope adjustment. This type of structure has proven stable and effective although it lacks the aesthetic qualities of other methods. The lack of maintenance requirements indicates that only an initial expense for building will be incurred. This structure has performed well thus far and is a good example of successful low-cost shore protection.

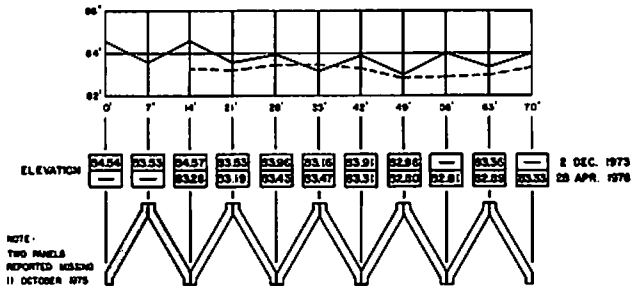
FIGURE 67  
 PLAN VIEW AND LONGITUDINAL PROFILE OF WALL #2  
 BUTTERSVILLE PARK - PERE MARQUETTE TWP., MICHIGAN

The breakwater system performed quite effectively in building up a beach and preventing bluff recession for the first year. A major storm with 6- to 10-foot (1.8 to 3.0 m) waves during the winter of 1975 caused extensive damage to this protection system and the bluff. Walls 2 and 3 have been damaged by settlement and panel breakage (see Figures 65, 66, 67, and 68). Wall 3 lost two entire panels and settled about 3 feet (.9 m). It is now completely submerged. One panel was lost off wall 2 which also settled and tilted radically. The remaining panels in walls 2 and 3 are chipped and cracked and have tilted toward shore. Wall 1 has remained largely unchanged except for some tilting. Major bluff recession has continued, up to 30 feet (9.1 m) in some locations during the past three years. The bathhouse has been completely destroyed.

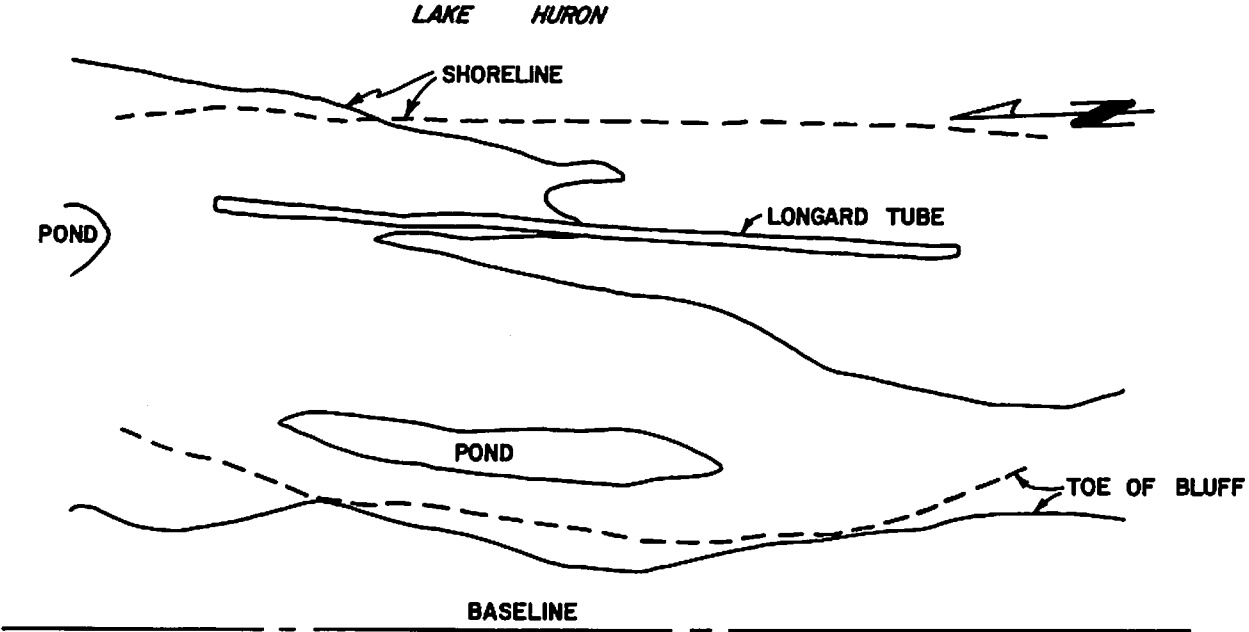
**FIGURE 69**  
**PLAN VIEW OF LAKEPORT STATE PARK**  
**LAKEPORT, MICHIGAN**

foredunes, and a beach area. In the spring of 1974 a 40-inch (101.6 cm) Longard tube was placed on a partly submerged sandbar to form an offshore breakwater. For some unexplained reason unrelated to the installation of this structure, sand began to accrete in this general area. This tube is now well back from the shoreline (see Figure 69). This site is not now being actively monitored. This site is visited several times a year to determine if conditions have changed. Should this accreted sand erode, the project will again be included in the monitoring program.

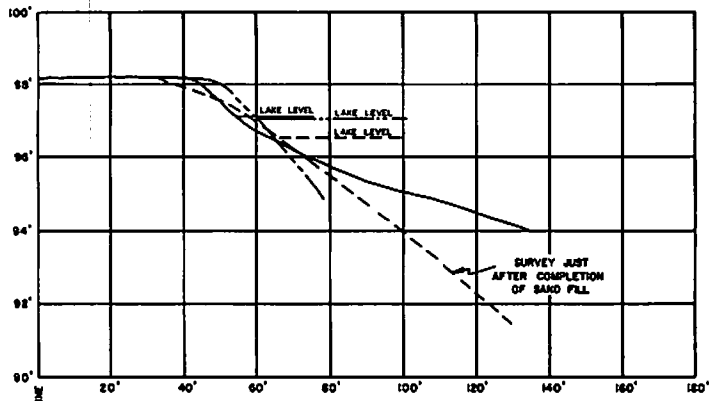
**FIGURE 70**  
**PROFILE AT STATION 3+00**  
**TAWAS CITY, MICHIGAN**

Tawas City Park was selected for the examination of a nourishment project. The site is sheltered by Tawas Bay and has a sand shoreline with no bluff. Sand nourishment was the selected method of shore protection in order to maintain the site as a bathing beach and because of the site's sheltered location. There is an existing pier (jetty) at the southwest end of the project area. Tawas City installed a timber crib groin at the northeastern limit of the site. Installation of the sand fill began in the fall of 1973 and was completed by the spring of 1974. Four hundred linear feet (122 m) of shoreline (between the groin and jetty) was protected with 4,350 cubic yards (3,328 m<sup>3</sup>) of sand fill. The fill sand used had a size distribution similar to the natural beach sand. The nourishment project cost \$20 per foot (\$66 per meter)\*. After some initial shifting the sand remained relatively stable through the spring of 1975. Minor shifting was again detected through this year. See Figure 70 for further details. The timber crib groin and pier have helped to hold the fill sand in place as well as trap additional sand. However, only minor storm activity has been experienced, so further evaluation of this project is required to determine overall effectiveness. To date, this nourishment project has been very successful and inexpensive.

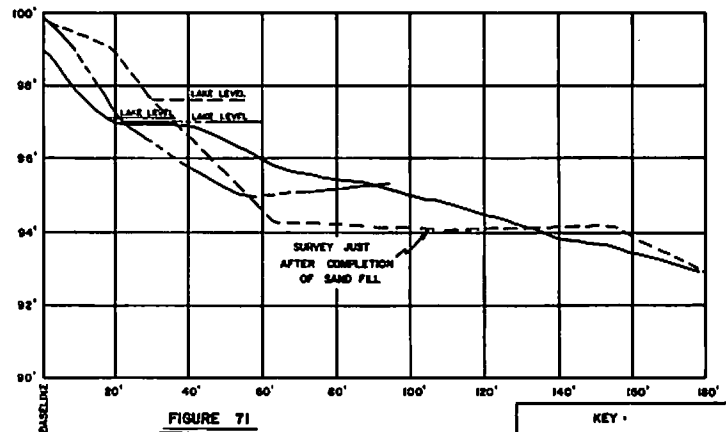
**FIGURE 71**  
**PROFILE AT STATION 3+00**  
**EAST TAWAS, MICHIGAN**

East Tawas City Park in Tawas Bay was selected as another test site. This site is similar to the one at Tawas City as it is in a bay and is heavily used as a bathing beach. Sand nourishment was used, but without any groins or jetties for protection, at a cost of \$15 per foot (\$48 per meter). Three thousand cubic yards (2,295 m<sup>3</sup>) of sand fill were placed along 400 feet (121.9 m) of shoreline in the spring of 1974. For nearly a year the sand nourishment remained stable. During the winter of 1974-75 much of the sand was dispersed. By the fall survey of 1975, some sand had shifted back into the area of the original nourishment. See Figure 71 for current conditions. This site experienced the same storm activity as Tawas City, yet had much sand movement. This helps confirm the observation that stabilization of sand nourishment by a groin system will maintain the initial fill over a longer period of time.

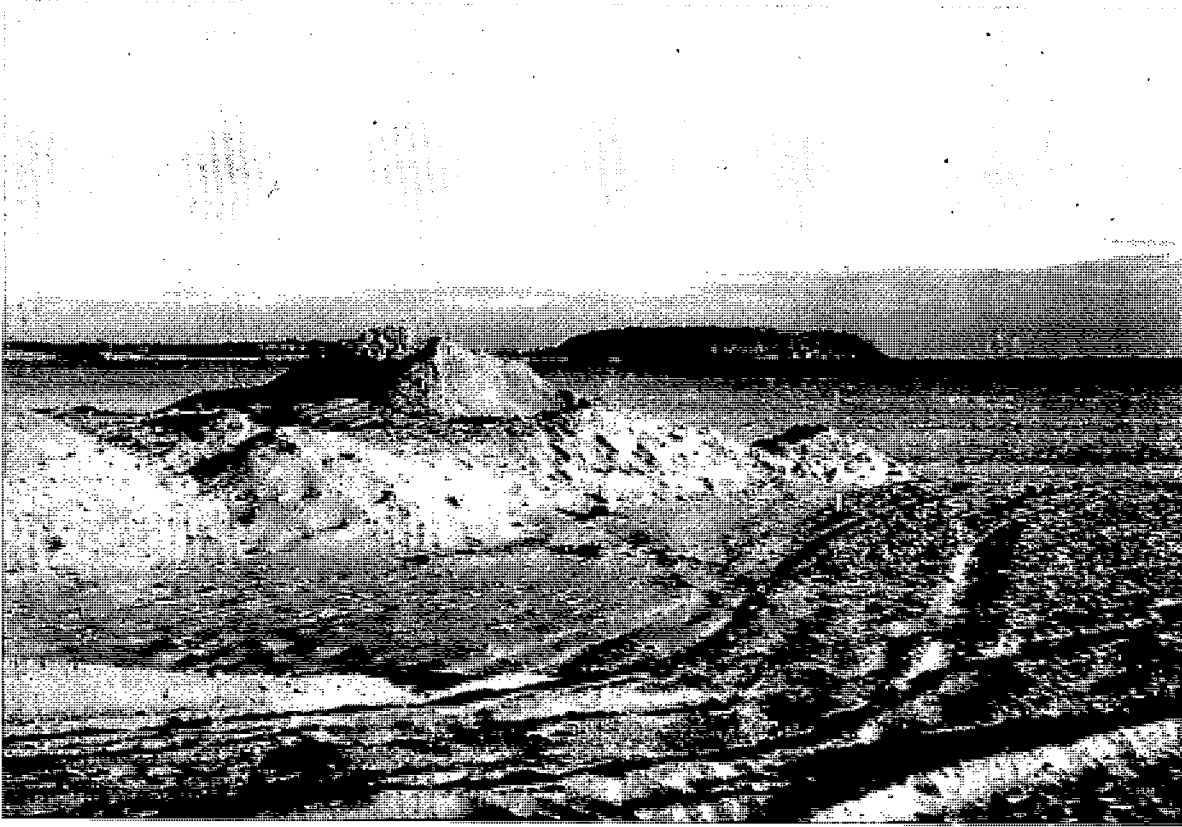
Figure 72. Marquette, Summer 1973.

This site is located at Shiras Park in a partially sheltered coast area with low sand bluffs and little to no beach. Broken concrete had been previously placed here in an attempt to protect the shoreline. In the fall of 1973 sand was placed over the concrete and out into the lake as a nourishment project. This sand was donated by a local power company from a dredging operation. The sand contained a large amount of fine material which was not expected to stay in place for very long (see Figure 72). However, since the sand was free, it was of interest to determine how much protection this kind of sand would provide. A steel sheet pile groin was installed in the fall to help stabilize the sand. This groin was added because the city had the steel available.

Fill sand dumped over broken concrete and rubble is evident at this site. This method of shore protection maintained the use of the beach for bathing.

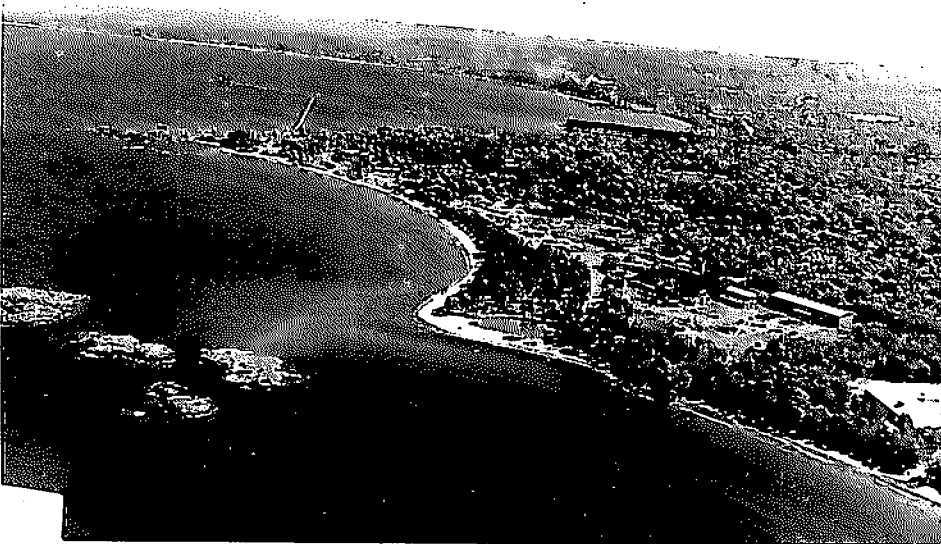
Figure 73. Marquette, June 30, 1976.

Much of the sand has been lost. The groin which had originally been covered with sand is now exposed. However, the removal of the sand has not yet exposed the original rubble which was buried by the sand fill. Therefore, the fill is still providing protection. The rate of erosion will be determined when surveys which have been made by associates in Marquette become available. A view of the area is shown in Figure 73.

This aerial view shows the project site at the point in the center of the picture. There appears to be a substantial amount of fill sand remaining in place.
