Evaluation Of Tying Materials For Floating Tire Breakwaters

University of Rhode Island
Marine Technical Report 54

Marine Technical Report No. 54

April, 1977

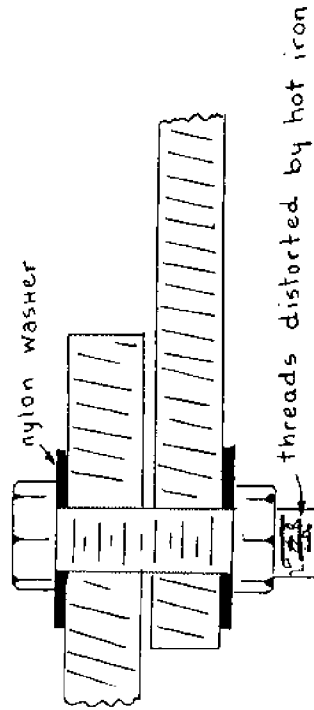
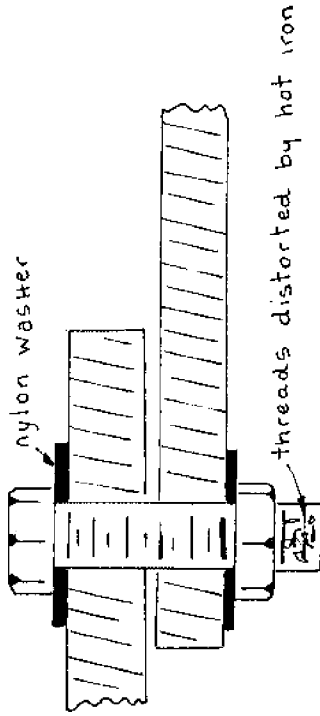
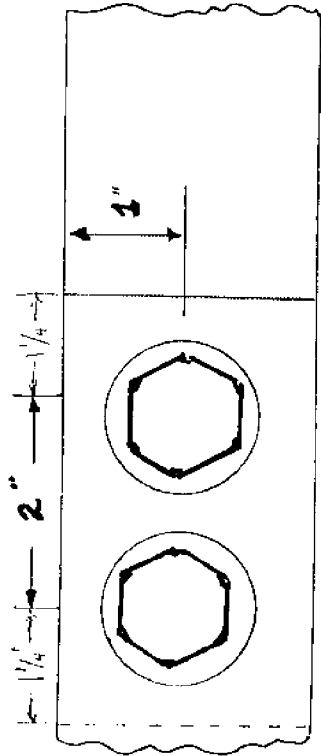
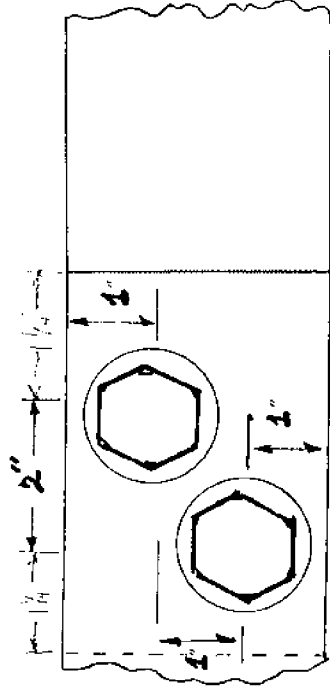
Diagram #1 Bolt pattern for 2 bolt system employing $\frac{1}{2}$ -13 nylon bolts for belt fastening.

System 2. The use of two 1/2-13 bolts per tie as indicated in Diagram 1. The belt width used should be no less than 2.00 inches, and preferably 3.00 inches, to prevent belt tearing. The average strength of this pattern is 2,150 pounds. In this system the bolts do not fail: They pull through the rubber belting, or the belting tears. These bolts differ from the 3/8-16 in that they are manufactured from cast nylon bar stock on a screw machine and do not have the voids that are present in the 3/8-16 bolts. The strength of this system tends to be more predictable. From a design point of view, it is the better system.

Second Bolt omitted in this view

minimum distance for this configuration

- (a) When tightening the nuts, torque limits should be maintained. These will vary with the size of the bolt being used. A good method is to watch the nylon washer for cupping as the nut is tightened (only flat washers are recommended, i.e., no lock washers). A slight cupping indicates that the nut is tight enough.
- (b) Bolts should be purchased long enough to permit at least 1/4" of thread to protrude through the nut. Allowance for varying belt thicknesses and the two flat washers should be made accordingly.
