U. S. DEPARTMENT OF COMMERCE . NATIONAL OCEANIC AND ATMOSPHERIC ADMINISTRATION

# NATIONAL OCEAN SURVEY NATIONAL DATA BUOY CENTER

## EXAMINATION OF SEA LANES MOORING E AFTER TWO YEARS ON STATION

NATIONAL DATA BUOY CENTER JULY 1972 MISSISSIPPI TEST FACILITY BAY ST. LOUIS, MISS. 39520

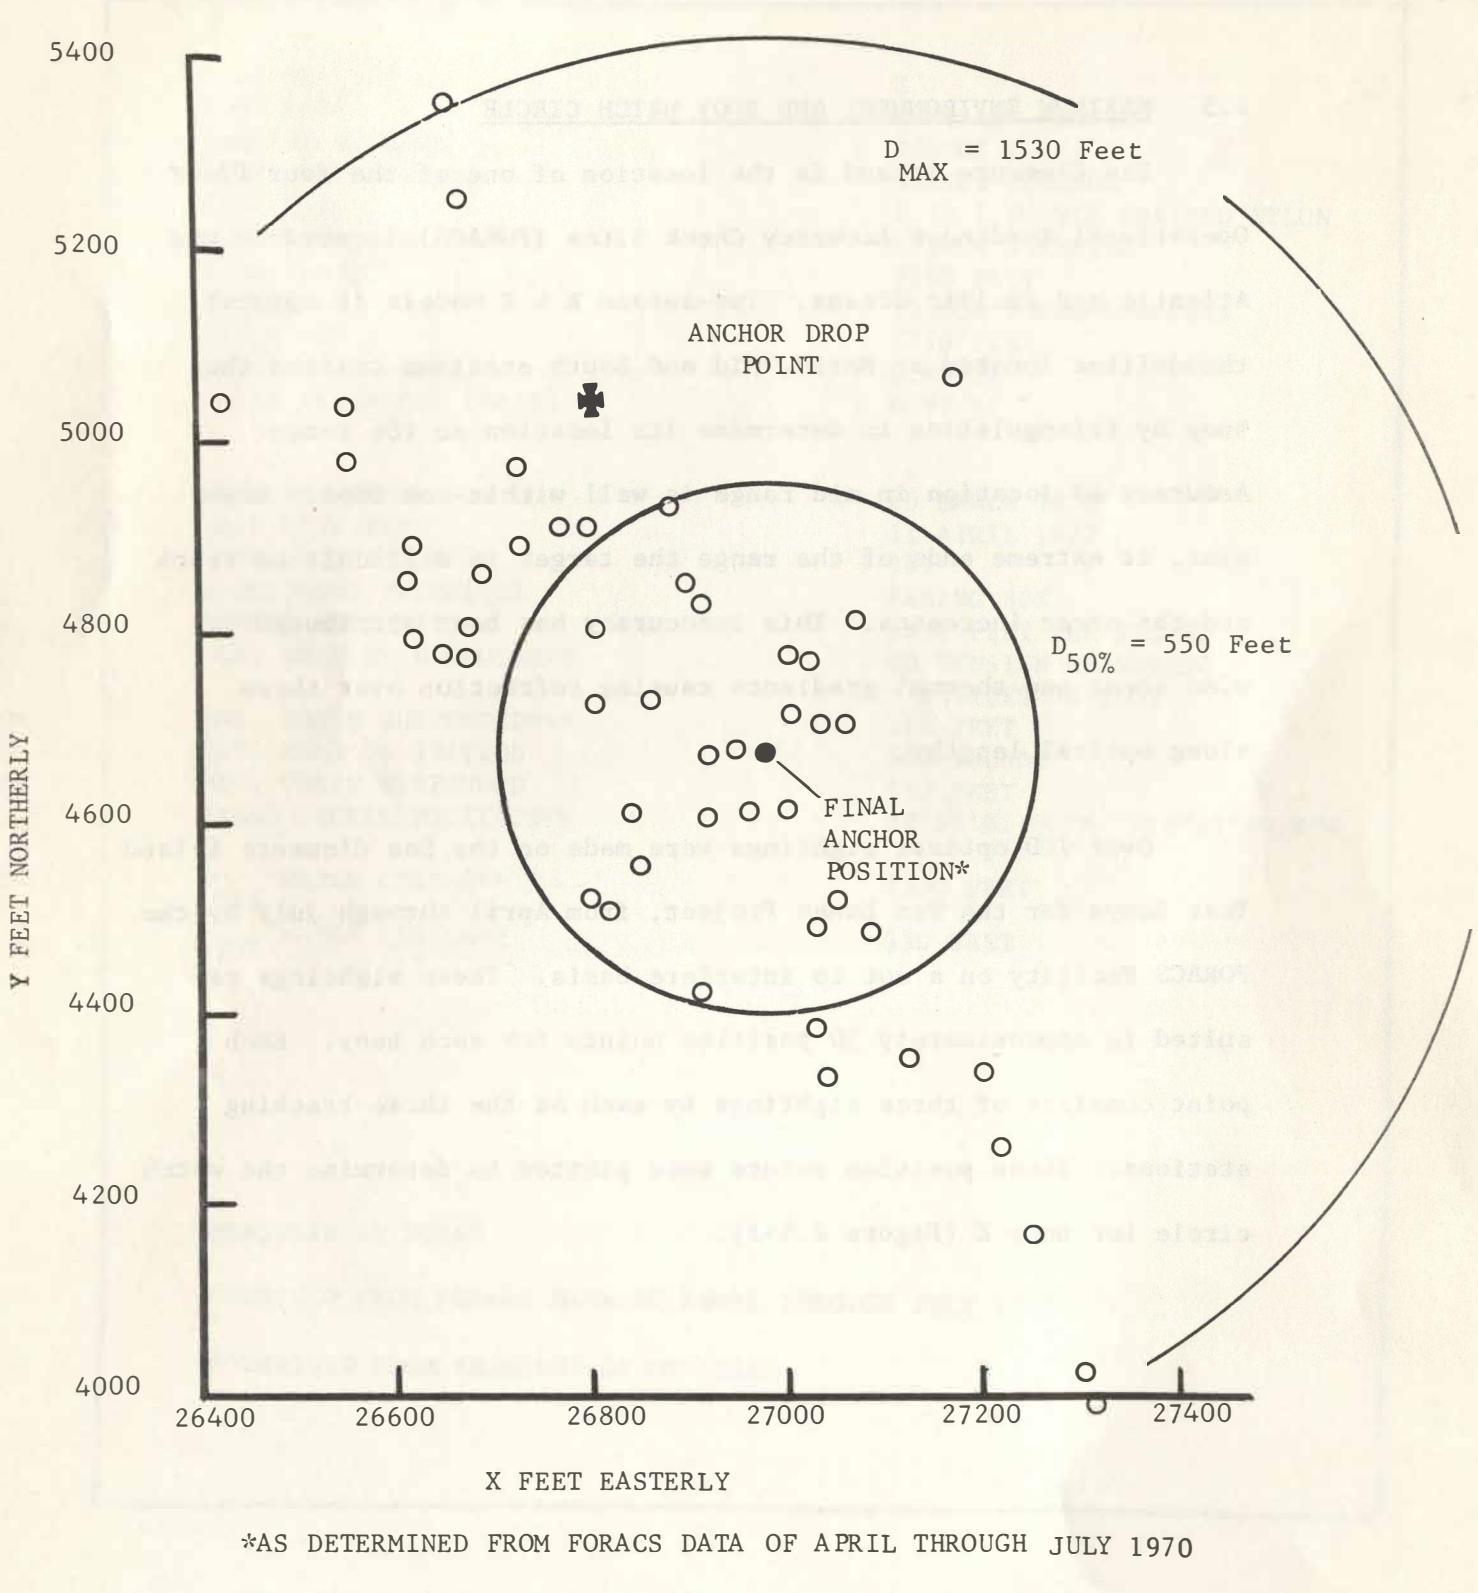
FIGURE 2.5-1 BUOY E LOCATIONS FROM FORACS DATA

Over 700 optical sightings were made on the San Clemente Island Test Buoys for the Sea Lanes Project, from April through July by the FORACS Facility on a not to interfere basis. These sightings resulted in approximately 50 position points for each buoy. Each point consists of three sightings by each of the three tracking stations. These position points were plotted to determine the watch circle for Buoy E (Figure 2.5-1).
