SUSF-SG-77-002

Floating Tire Breakwaters

Charles A. Gifford, Jeffrey A. Fisher, and Todd L. Walton, Jr.

FLOATING TIRE BREAKWATERS - A CASE STUDY OF A POTENTIAL LOW COST SHORE
PROTECTION STRUCTURE FOR FLORIDA'S PROTECTED MARINE WATERS

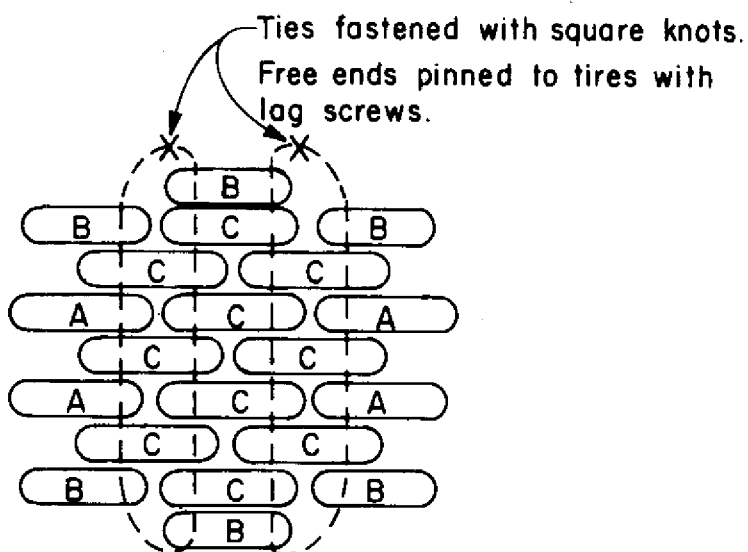
- A - 15" Tires
- B - 13" Tires
- C - 14" or 15" Tires

Figure 1. Top view of modified scrap tire module showing tire pattern and fastening ties. After Kowalski and Ross, 1975.

In our configuration, a modification of the Rhode Island prototype (see Figure 1), which was found to be both easy to construct and inexpensive, 20 tires are bound together in a module which floats with the tires vertical in the water, supported by the air trapped in each tire crown. The modules were built on a pier, then tipped over into the water and connected together to form a breakwater unit. This construction method permits building the breakwater wherever it is cheapest or most convenient and towing it to its point of use.

Instead of fastening the ties with nylon bolts, as was done in Rhode Island, the ties were fastened by tying them in square knots. After approximately 10% of the knots worked loose during severe storms the decision was made to pin the ends of the ties beyond the knots to the tires with lag screws. This stopped both knot failure and tire rotation. Module heavy galvanized construction and knot tying are shown in Figure 1.

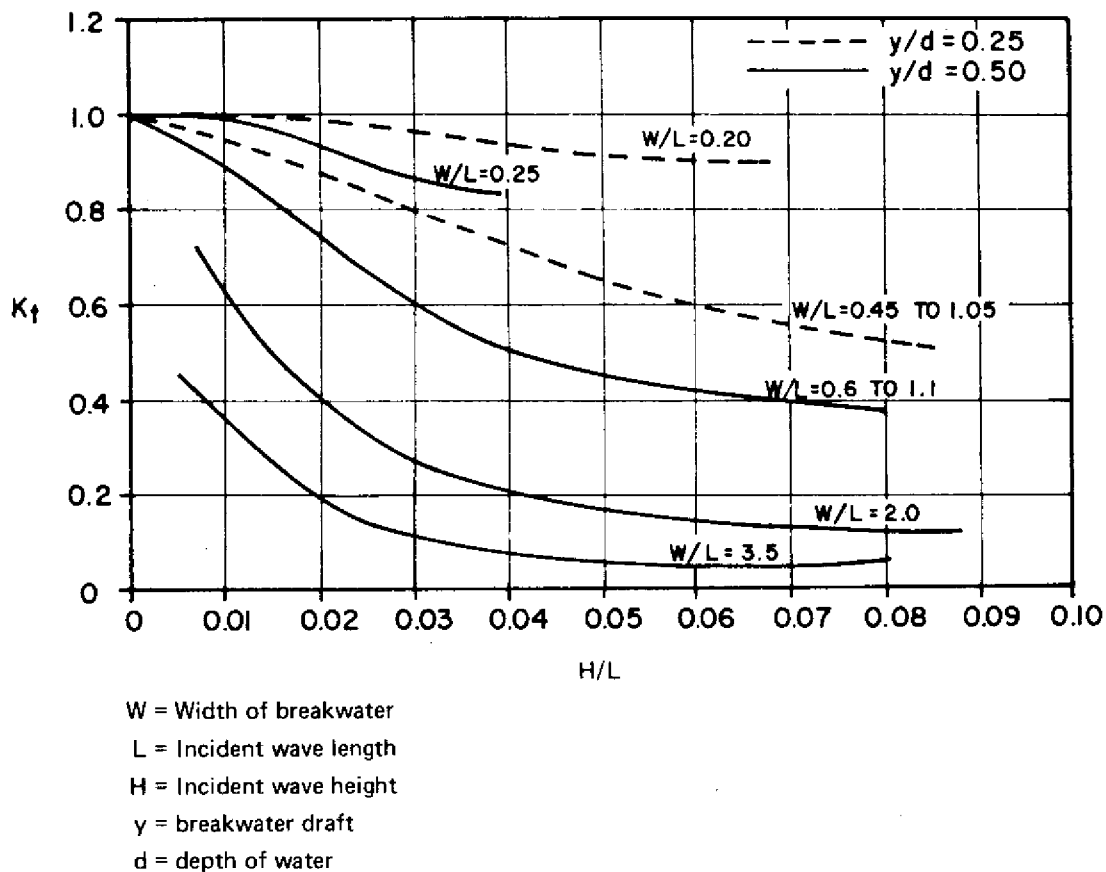
Figure 3. Wave Transmission Characteristics of "Maze" Type Floating Tire Breakwaters. After WES, 1968.

A floating tire breakwater with a somewhat different tire configuration has been tested in wave tank experiments (U.S. Army Waterways Experimental Station, 1968). For the same incident wave conditions as the Rhode Island prototype breakwater experienced, a transmission coefficient of $K_t = 0.4$ would be found. The results of these tests are shown in Figure 3. Figure 3 shows that K_t is dependent on both the width to wavelength ratio w/L , as well as the incident wave steepness H/L .
