RISK ASSESSMENT AND EVALUATION OF SELECTED VIRGINIA SITES WITHIN THE COASTAL ZONE

FINAL REPORT

(SE-VDWM-4222-89)

The Center for Risk management of Engineering Systems
University of Virginia
Charlottesville, Virginia

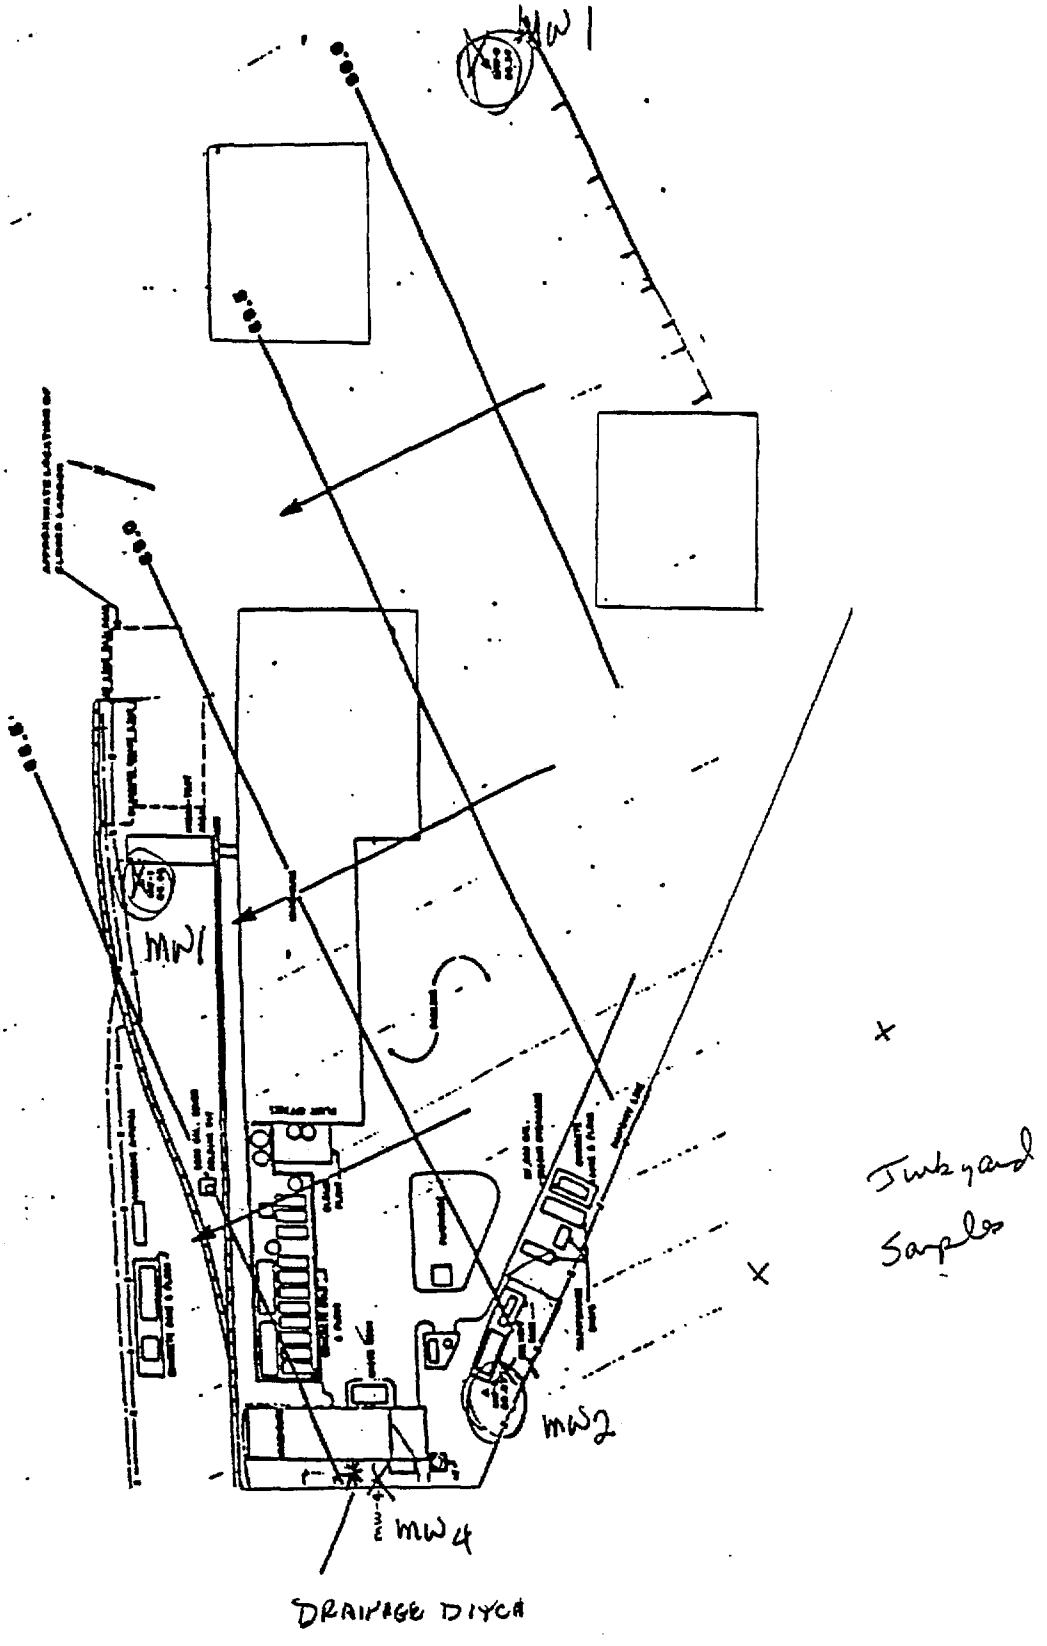
FIGURE # 3 SITE MAP - SUFFOLK CHEMICALS

Only three wells could be sampled. Well #3 (furthest upstream) was below surface water level, making sampling impossible. The other three wells, numbers 1,2, and 4, were all analyzed for Primary Drinking Water metals, several targeted inorganics, and acid-base/neutral extractable organics (GC/MS).

Preliminary assessment of the results shows well #2 to have the greatest inorganic contamination, low pH, high chloride, nitrates, and sulfates, as well as trace amounts of 4-chloro-3-methylphenol, 12,4-trichlorobenzene, and butyl benzyl phthalate. (Phthalates are used as plasticizers and under different solvent conditions, or acid environments, etc., they could have leached from the PVC well casings.) Well #2 is approximately 20 feet away from the sulfuric acid tank (probably the source of the low pH and sulfates observed).

Well #4 is unique, showing relatively high levels of copper, zinc, and chromium. Well #4 also showed 20 to 60 ppb levels of bis(2-ethylhexyl) phthalate and Poly Aromatic Hydrocarbons. (Since these are commonly found in fuel oils, they may be a result of run-off from the nearby parking lot.) (Note: Well #4 was partially filled in with sludge and bailing the well out only made the sludge contamination worse.)

The analytical data is summarized in Tables 1-12. Locations of samples are shown in Fig. 3. New data are given in Appendix 1. Each type of sample will be discussed below.

2. Two of the four wells need repair. Well #3 needs to be evaluated to remove the possibility of surface water contamination. Well #4 has been partially filled in and needs to be repaired.

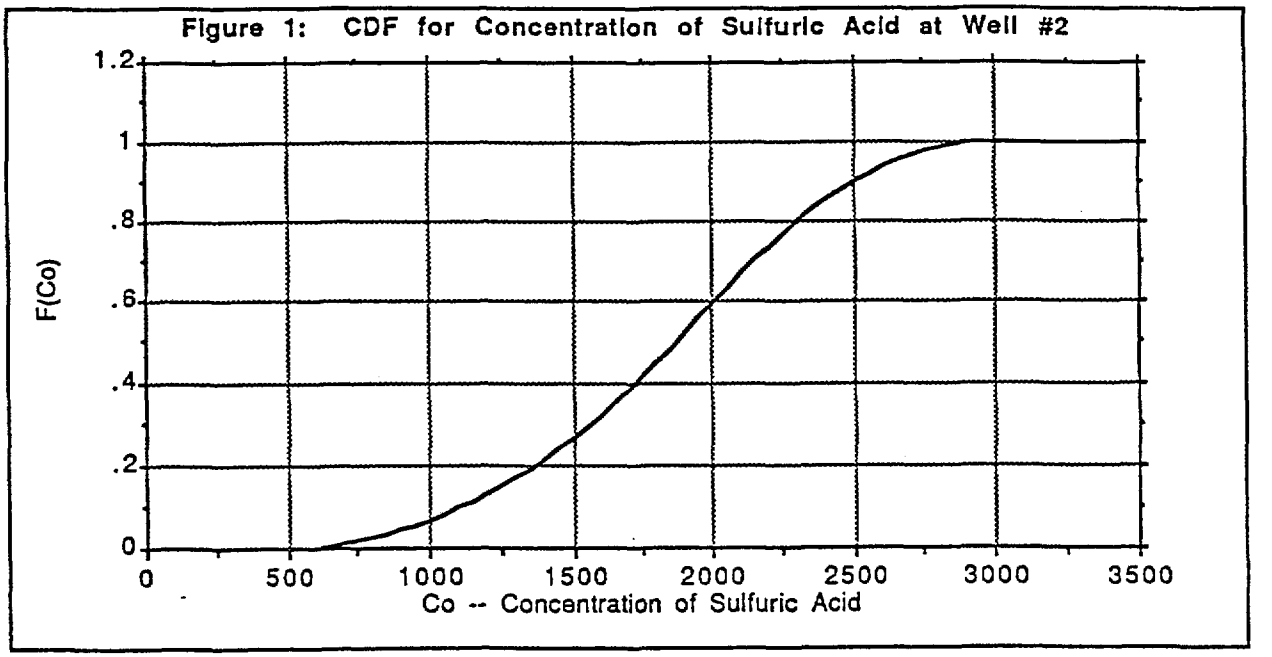
Figure 1: CDF for Concentration of Sulfuric Acid at Well #2
F(Co)
1.2
1
.8
.6
.4
.2
0
0
500
1000
1500
2000
2500
3000
3500
Co -- Concentration of Sulfuric Acid

Parameters required for the model are given in Appendix 4 were estimated as shown in Table 13. Assume that at well #2 a sulfuric acid source is located which injects 100,000 gallons of sulfuric acid at the present time. The concentration of the acid has a distribution function which must be assessed. In the absence of appropriate data, the distribution can be assumed to be of a triangular form (Kelton and Law, 1982):

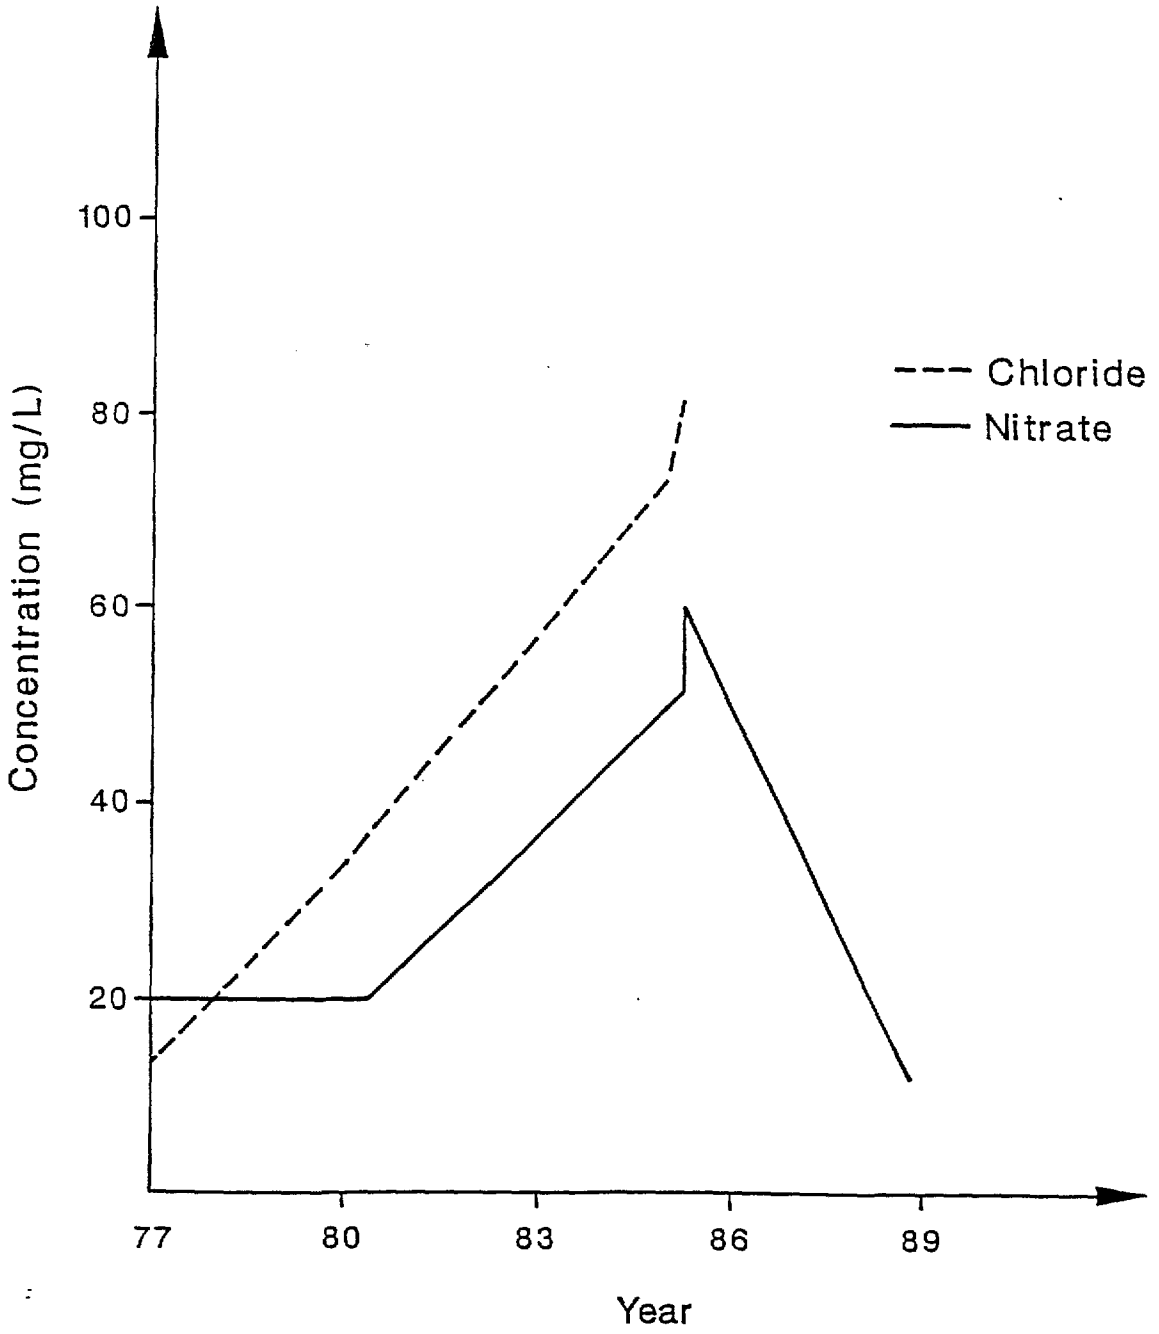
Figure 10: Concentration of chemicals in the Davis Well

3. A massive spill with concentrations of 1000 parts per million in the soil would be unlikely to be able to contaminate the Davis Well at the identified levels (It may be a contributing factor). Models of these types do not take into consideration specific molecular characteristics, like hydrophobicity, ionic strength, etc. They treat all contaminants as similar agents. There are differences between organics and inorganics migration/transportation mechanisms (the oil industry is spending fortunes evaluating these conditions) in terms of adsorption/asbsorption partition coefficients and many other liquid medium interactions.

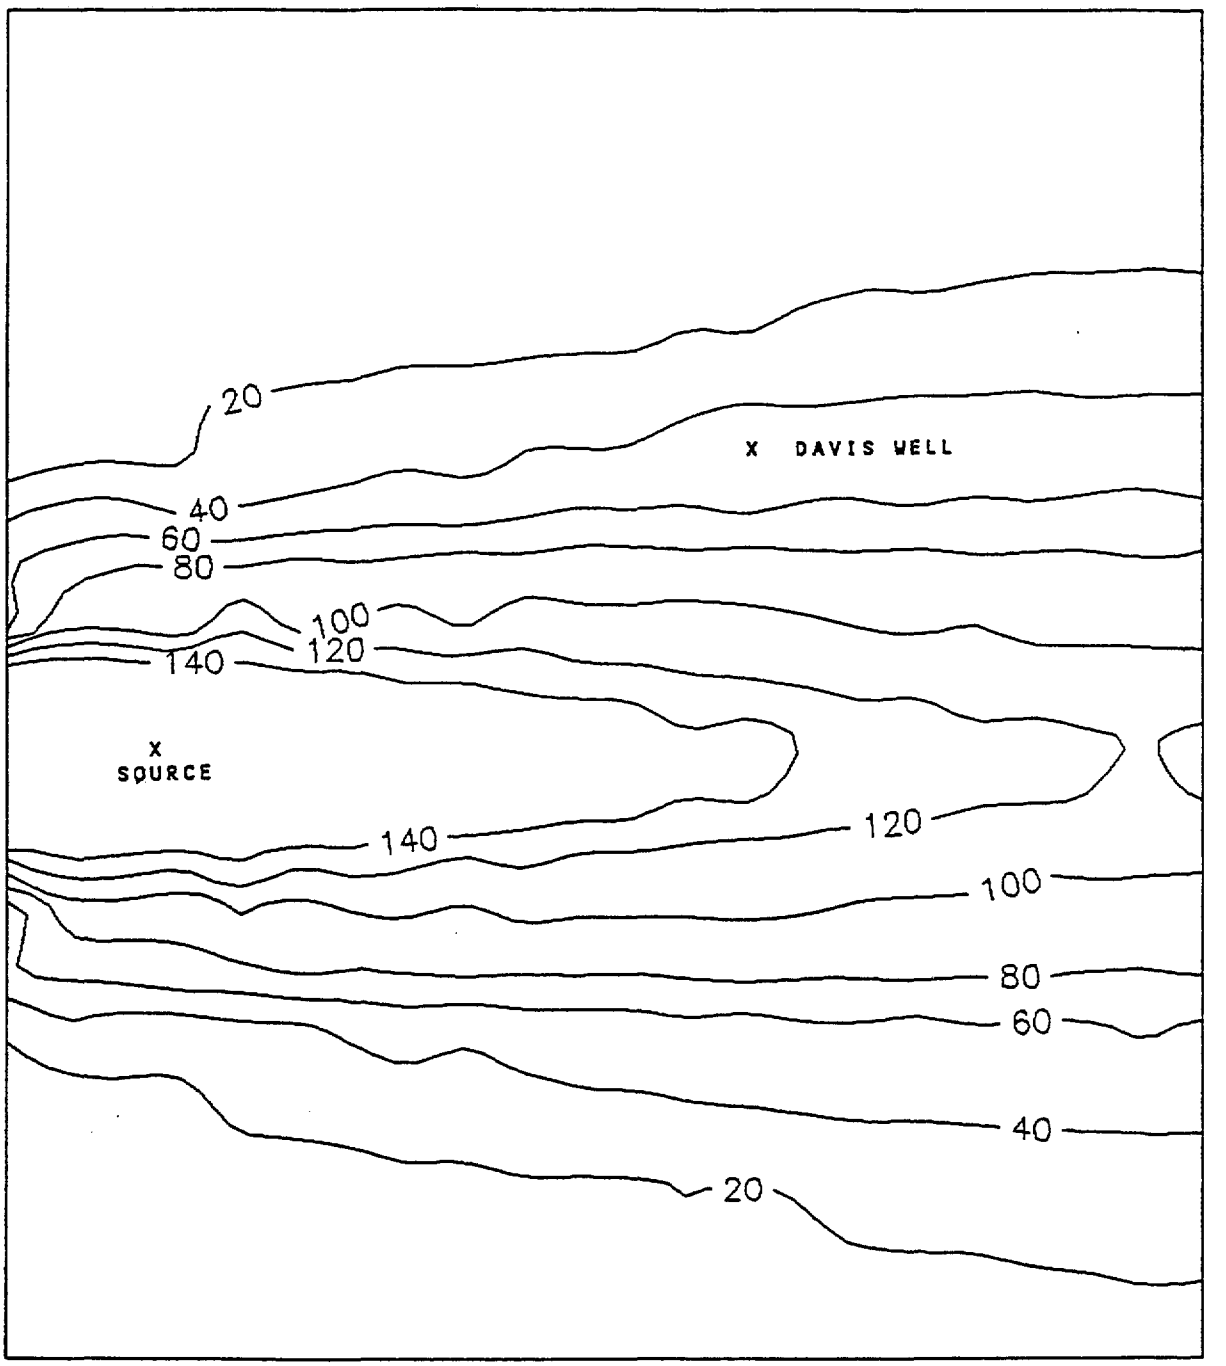
Figure 12: CONMIG results for NO_3^- migration from the Alliance site. Contours are in mg/L NO_3^-.

feet), flow velocity (3.5 - 10ft/yr), and transmissivities (0.000521 - 0.0490 ft_2/s). There is some question as to the validity of the flow velocities quoted in the report. A conservatively large value (40 ft/yr) was used in the simulations. Transmissivities were determined by slug tests and showed considerable variability. A reasonably conservative value of 0.02 ft^2/s was used. A typical porosity for unconsolidated sand deposits was employed (0.3). In order to be conservative, large values for dispersivities, contaminant injection rate, and an initial nitrate concentration of 1000 mg/L were used at the source. Using these values, a steady-state nitrate concentration of approximately 11 mg/L is attained in the Davis well after about 14 years (Figure 12). Large nitrtate concentrations can be attained if smaller velocities are used. This allows greater spreading of the plume in a lateral direction because the containment is not allowed to migrate away from the source as rapidly. On the other hand, the amount of time for the plume to reach the Davis well greatly increases. For example, if a nitrate concentration of approximately 20 mg/L reached in the Davis well using a velocity of 1ft/yr is considered, a steady-state nitrate concentration in the Davis well greater than 100 mg/L is attained after 100 years. (At 50 years, the concentration is less than 10mg/L.)

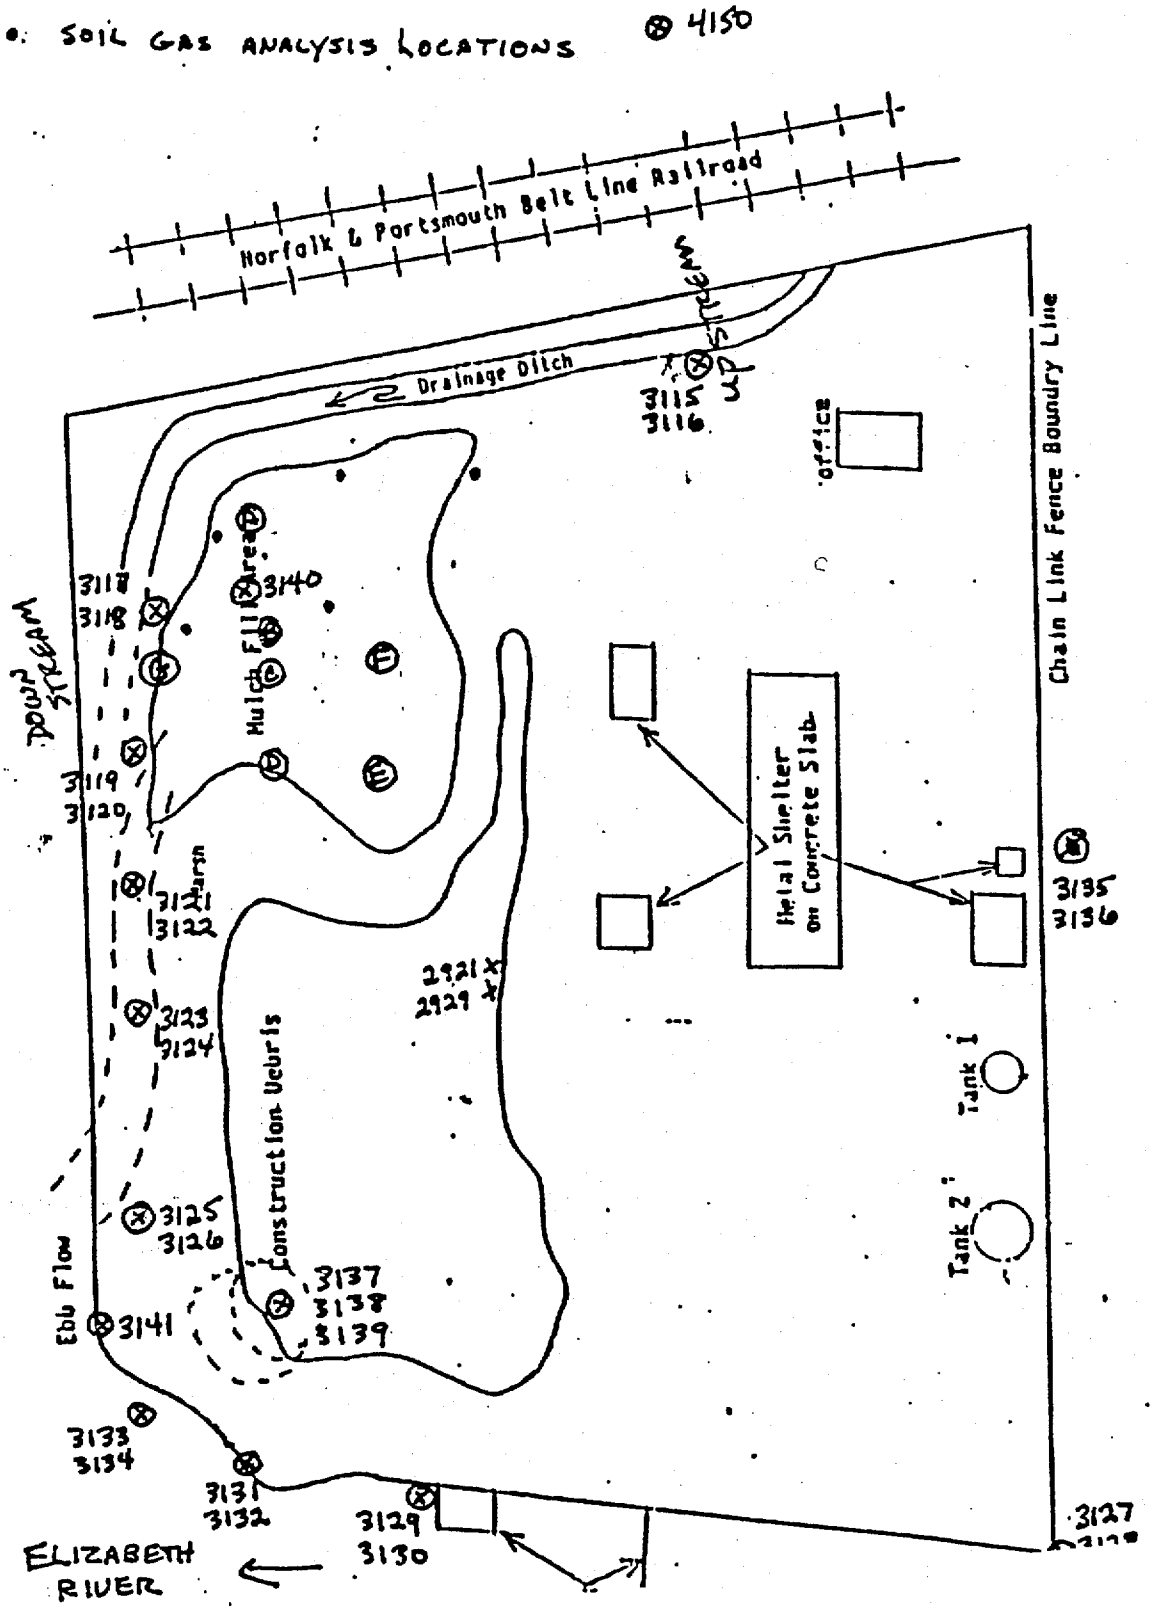
REPUBLIC CREOSOTING (McLEAN CONSTRUCTION) SITE MAP

5. McLean Construction as a source of contamination to the site: During our site visit, we observed that there were numerous empty 55-gallon drums on site, containing what appeared to be asbestos-containing materials and tons of dredged up sediment. We believe that these all need to be evaluated. The question we addressed is whether McLean Construction is adding to the problem? If so, what and how much?

The mulch area is very contaminated with PAH's. At this time, no analytical data collected showed evidence that the PAH contamination has spread from the mulch area or is spreading. The toxicity of PAH's is well documented. The Elizabeth River has several sources of PAH contamination (one
